UNITED STATES
NUCLEAR REGULATORY COMMISSION
WASHINGTON, D. C. 20555

APPLICANT: Consumers Power Company
FACILITY: Midland Plant, Units 1 and 2
SUBJECT: SUMMARY OF FEBRUARY 2-5, 1982 MEETING AND AUDIT ON AUXILIARY
BUILDING UNDERPINNING

Enclosure 1 is a summary of this meeting and audit.

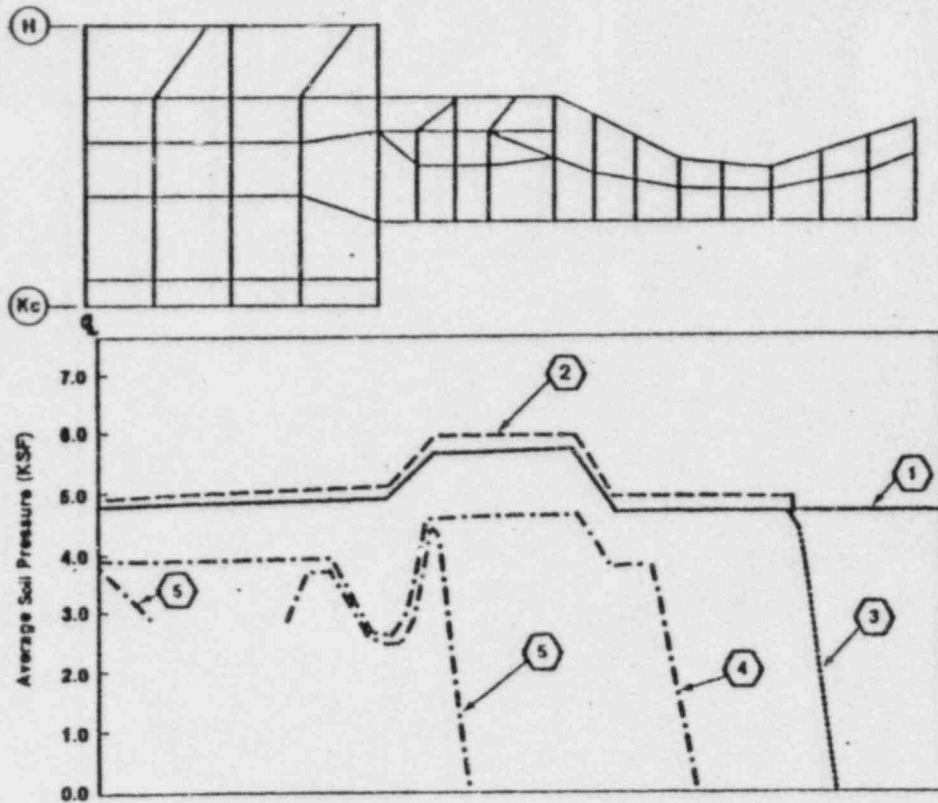
AUXILIARY BUILDING UNDERPINNING CONSTRUCTION CONDITION ANALYSIS SOIL PRESSURES (KSF)

- 1 - EXISTING SOIL PRESSURE
- 2 - STAGE 1 SOIL REMOVAL
- 3 - STAGE 1 WITH JACKING
- 4 - STAGE 2
- 5 - STAGE 3

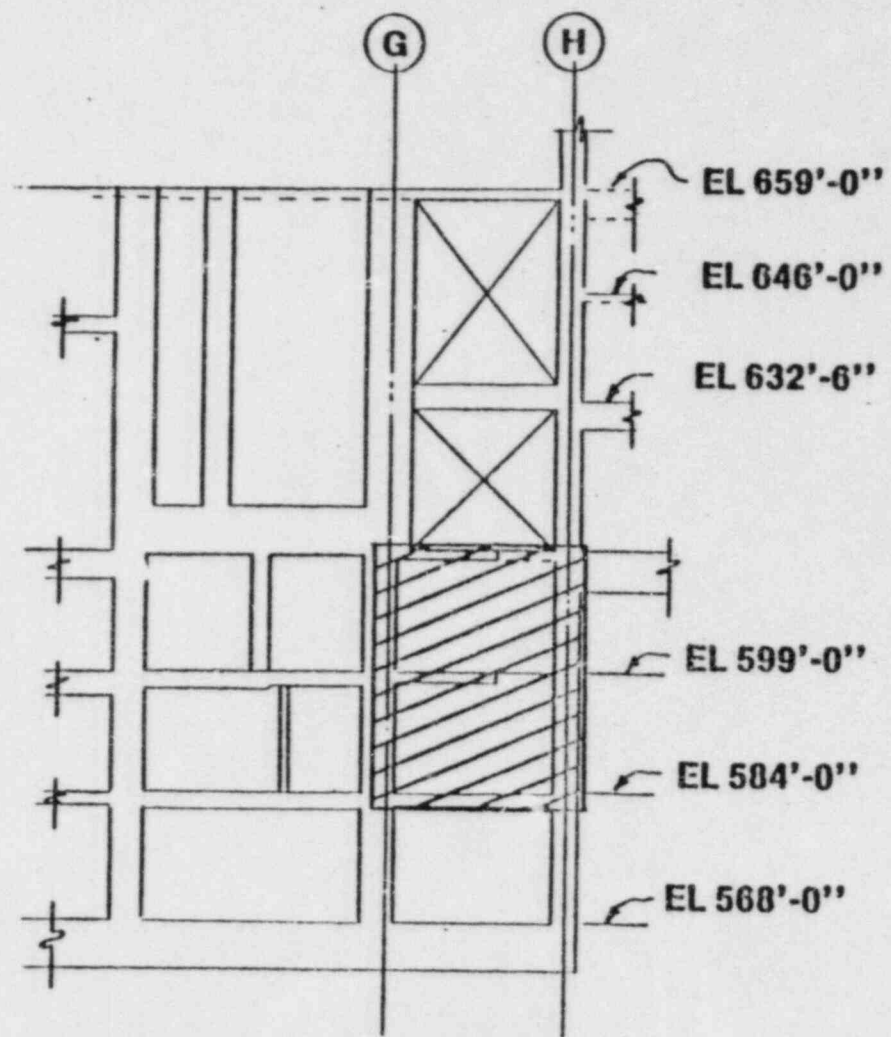
WALL AT COLUMN LINE 7.4 AND 7.8

AUXILIARY BUILDING UNDERPINNING CONSTRUCTION CONDITION ANALYSIS AREAS FOR CRACK MONITORING

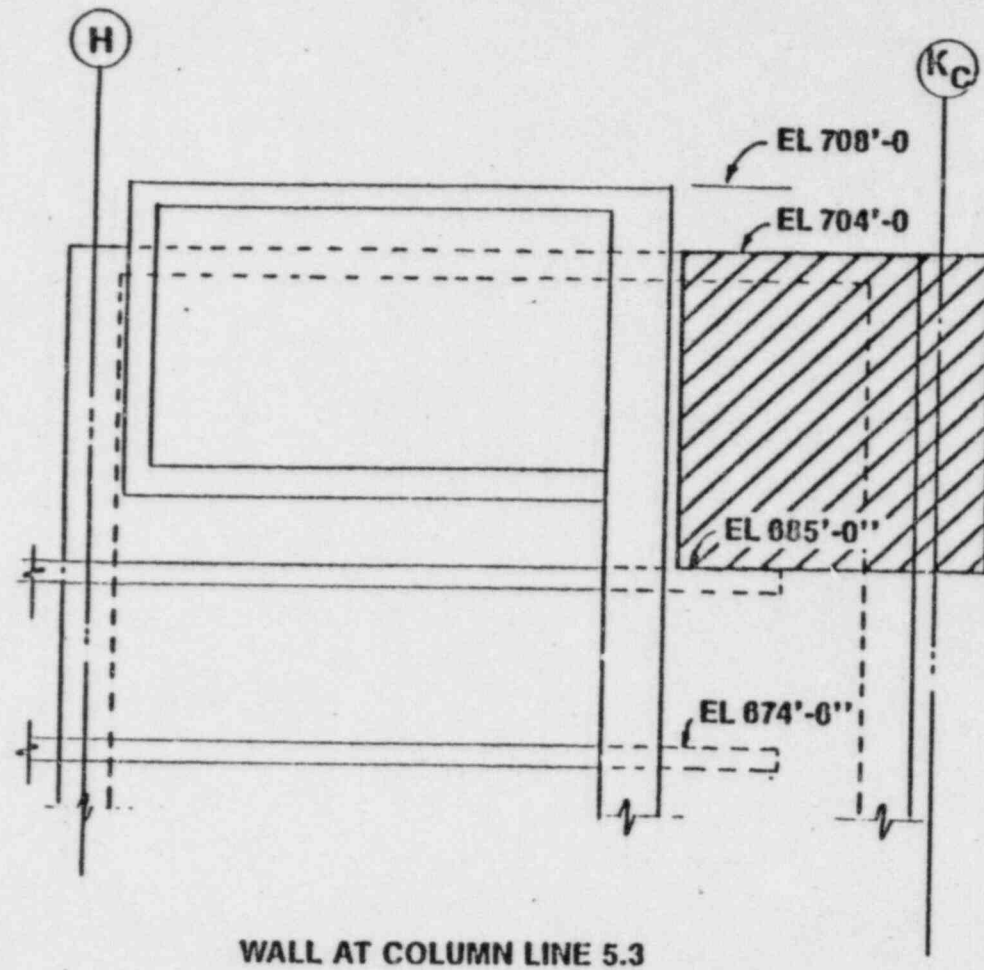
WALL AT COLUMN LINE 5.3

AUXILIARY BUILDING UNDERPINNING CONSTRUCTION CONDITION ANALYSIS AREAS FOR CRACK MONITORING

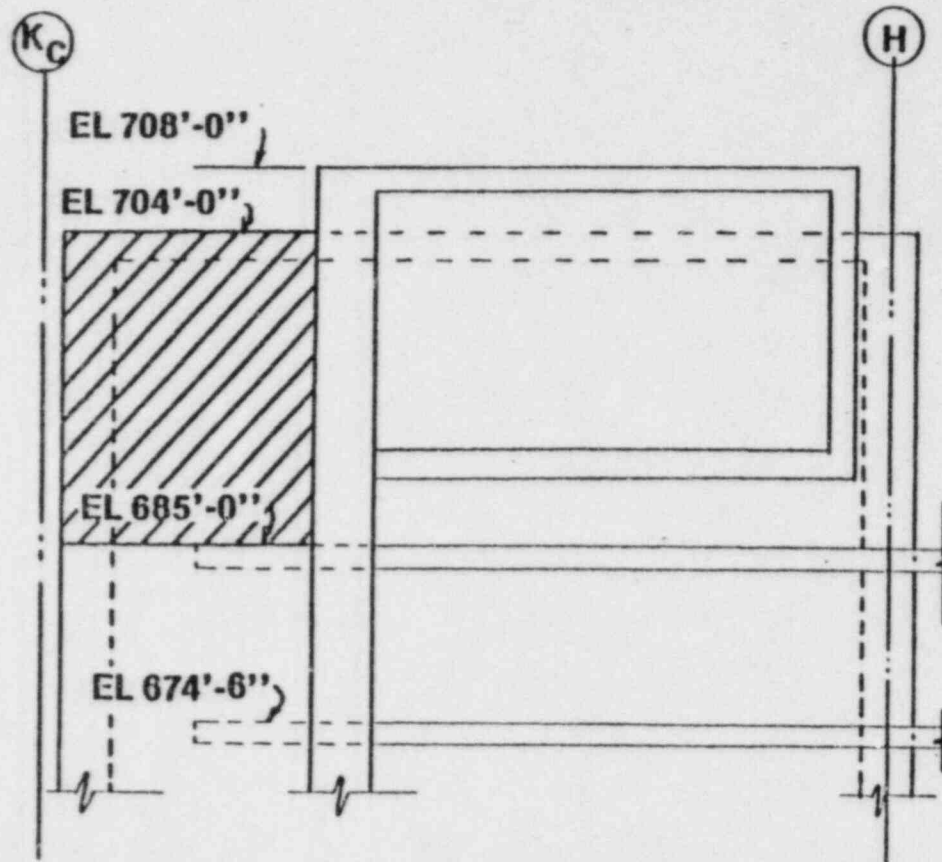
WALL AT COLUMN LINE 7.8

AUXILIARY BUILDING UNDERPINNING CONSTRUCTION CONDITION ANALYSIS AREAS FOR CRACK MONITORING

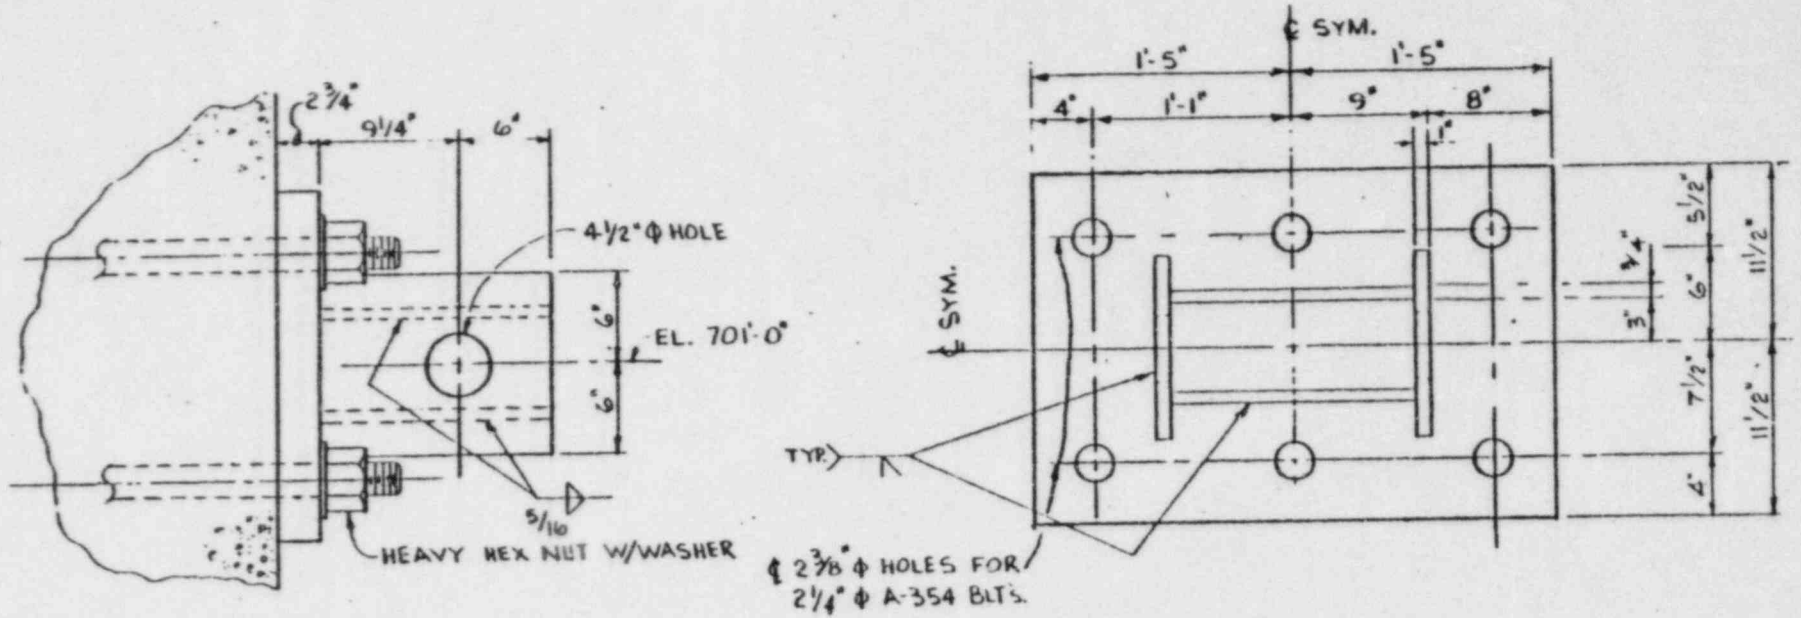
SUPPORT BRACKET DETAIL

- BEARING PLATE UNDER ANCHOR HEAD OMITTED
- NO UNUSUAL DISTORSION OF BRACKET OBSERVED
- CAPACITY OF BRACKET IS 470 Kips BASED ON LIMIT ANALYSIS
- FACTOR OF SAFETY AGAINST BRACKET FAILURE IS 1.5

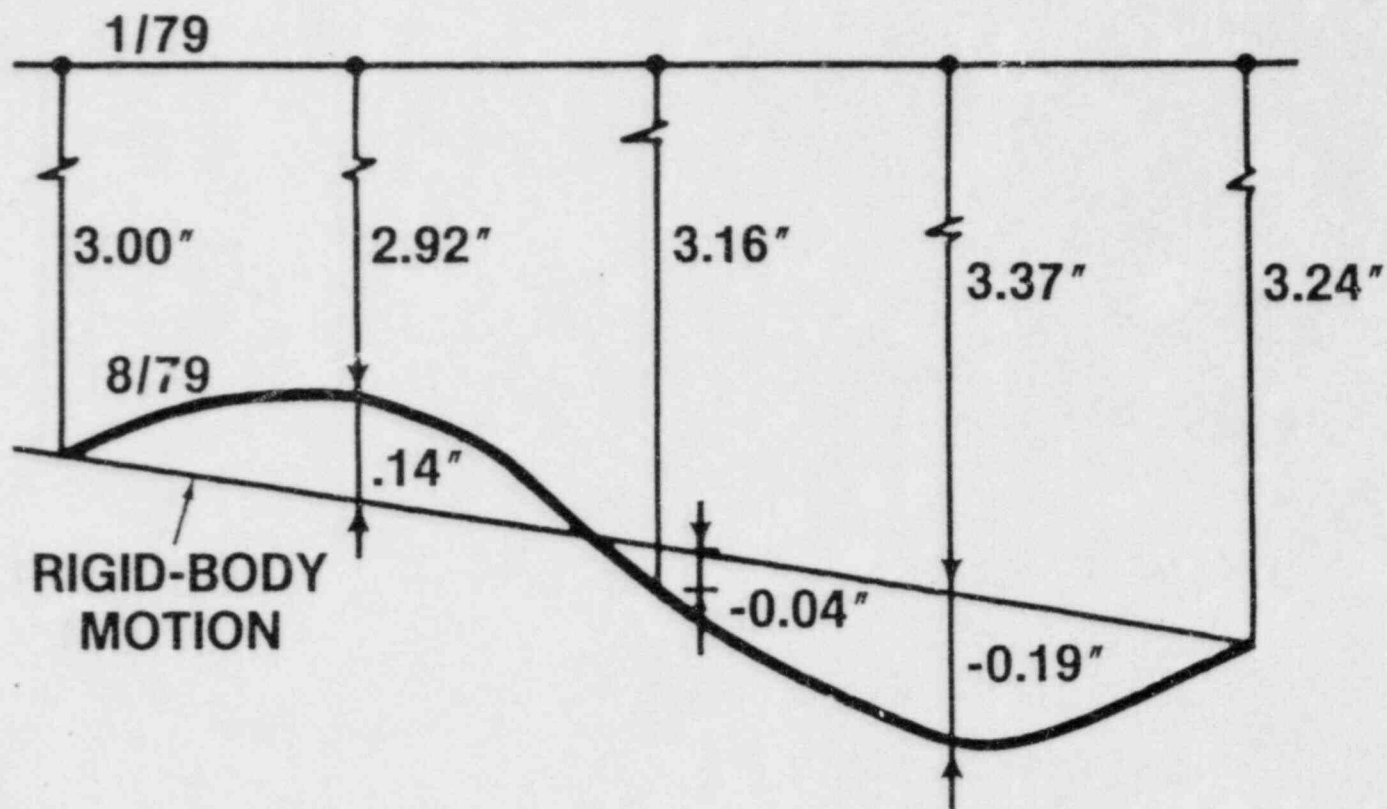
DIESEL GENERATOR BUILDING MEASURED SETTLEMENT ALONG SOUTH WALL

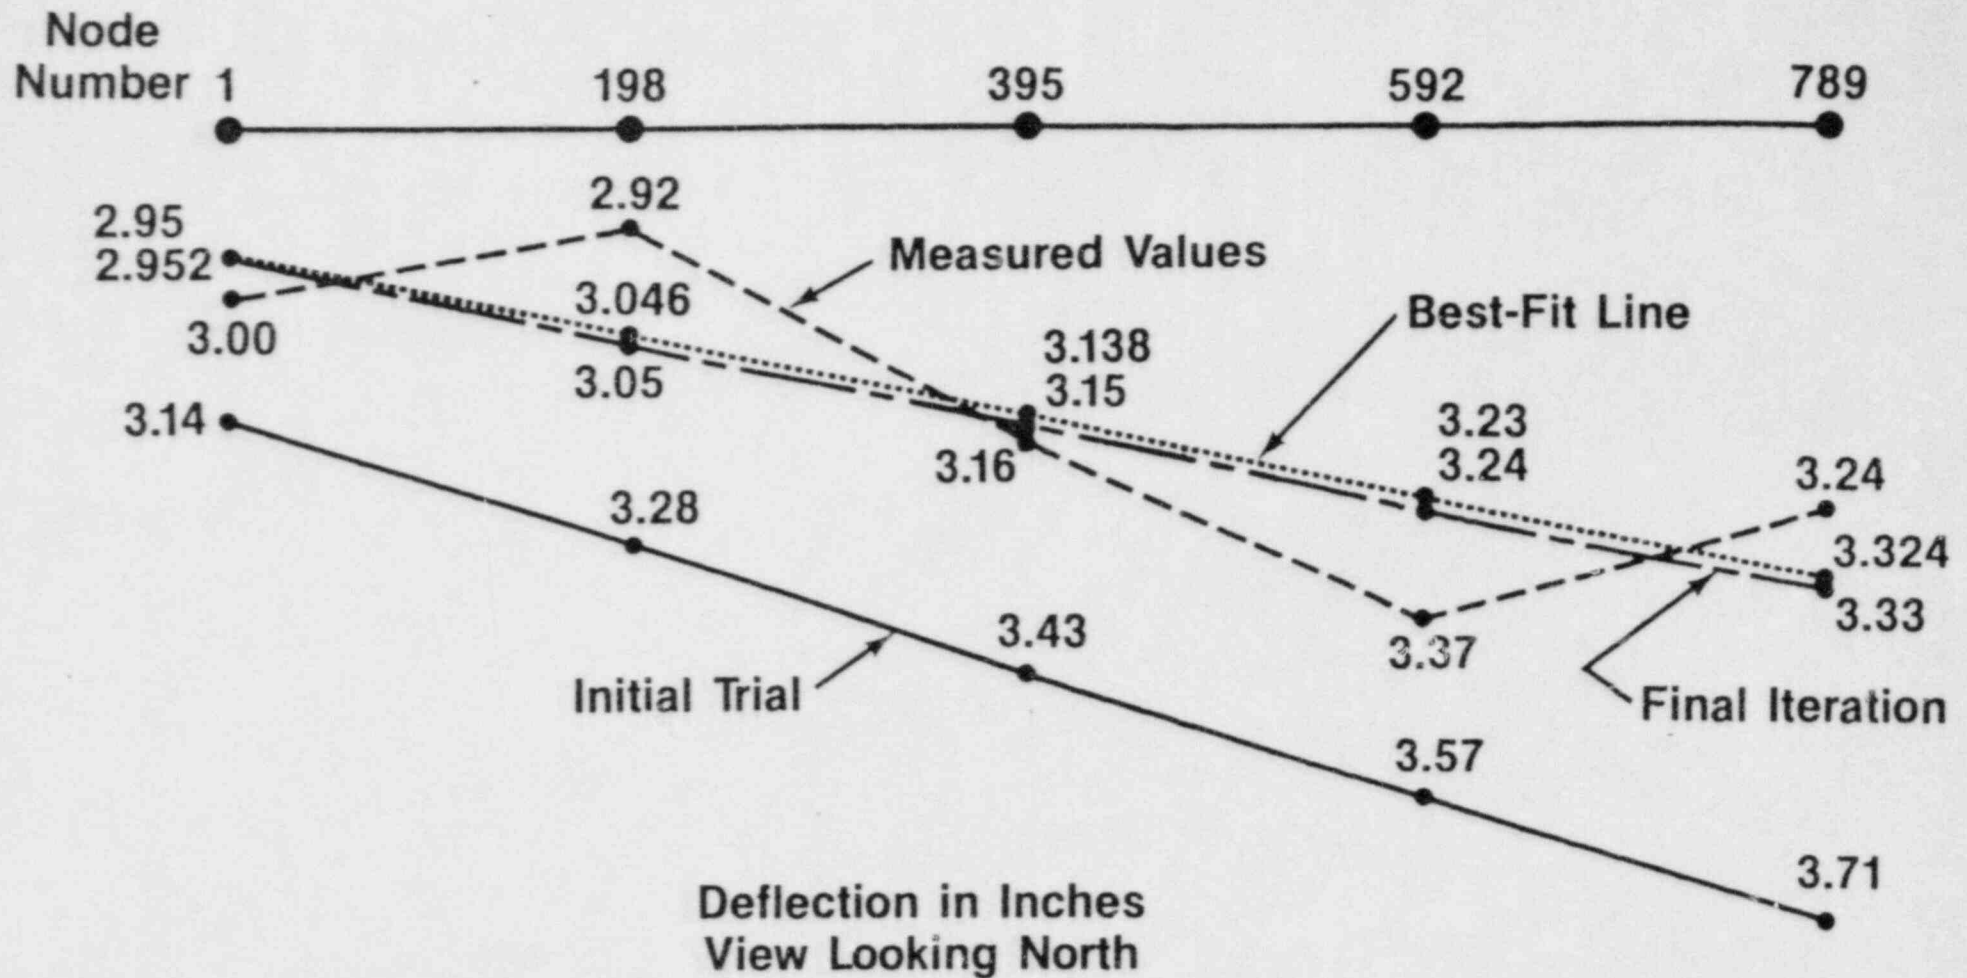
DIESEL GENERATOR BUILDING SOUTH WALL SETTLEMENT — SURCHARGE CONDITION

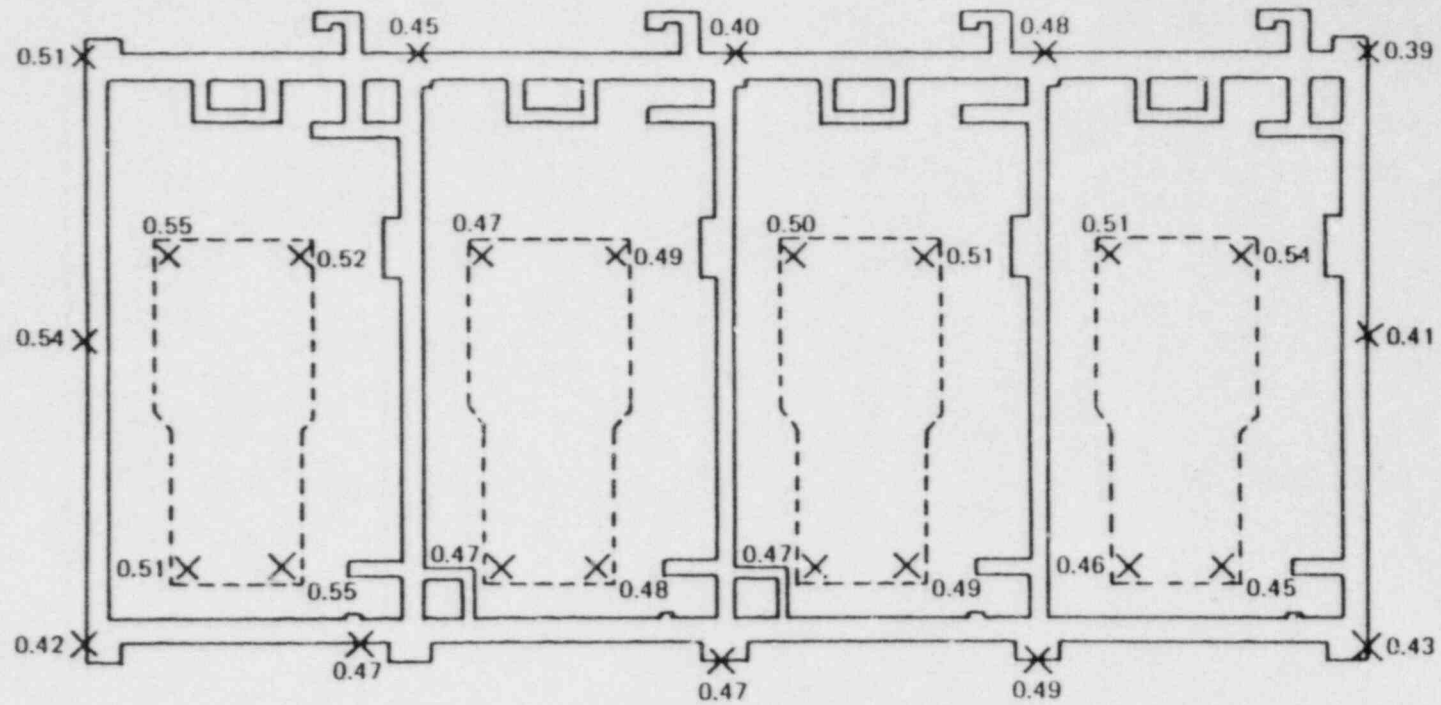
FIGURE ES-8

Following the start of dewatering activities in September 1980 up to December 31, 1981, the building settled 0.4 to 0.5 inch (see Figure ES-8) primarily due to lowering the groundwater table from approximately el 620' to el 595'. Between December 31, 1981, and June 1983, the building settled an additional 0.3 inch primarily due to further lowering of the groundwater table to approximately el 587'. As shown in Figure ES-6, these settlements display relatively steep slopes on the settlement-versus-log-time plot. However, when these data are compared with the observed settlements of the two Borros anchors BA-8 and BA-53 (see Figure ES-9) embedded in the natural soil below the structures, it is seen that most of the observed settlement of the building was due to deep settlement of the underlying natural soil caused by dewatering. When the uniform, deep-seated settlement of the natural soil (below el 603') due to dewatering is subtracted from the total building settlement, the resulting backfill settlement-versus-log-time plot (see Figure ES-10) displays a slope less than the one used for secondary consolidation settlement prediction. Therefore, the predictions of secondary consolidation settlement given in Figure ES-7 are conservative. Furthermore, any future dewatering settlements should be small because future drawdown would exceed the present magnitude by only small amounts.

MEASURED SETTLEMENT FROM
9/14/79 TO 12/31/81

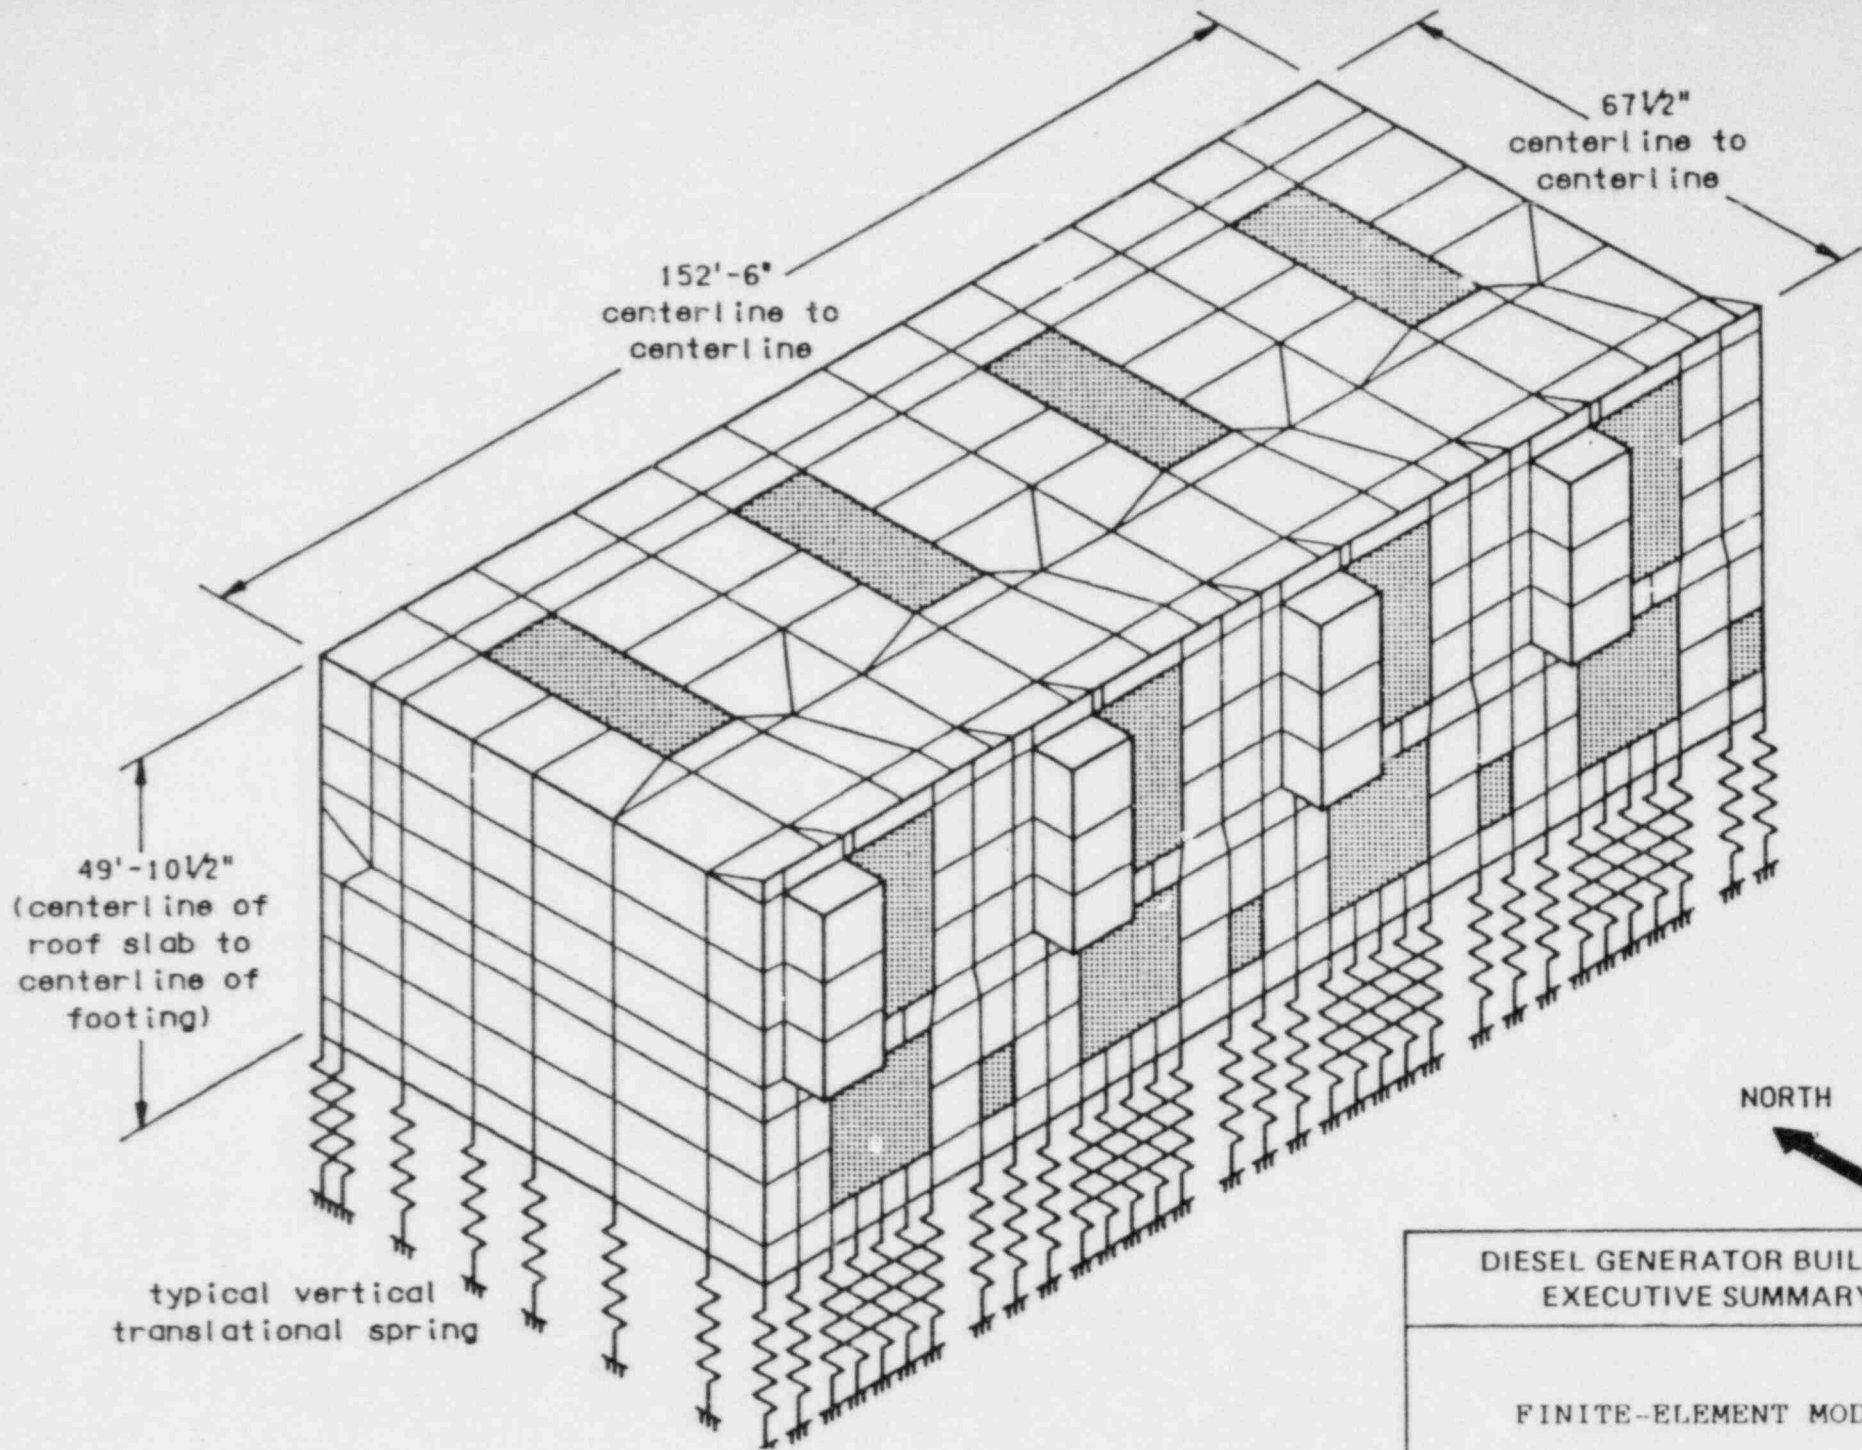
DIESEL GENERATOR BUILDING EXECUTIVE SUMMARY
FINITE-ELEMENT MODEL
FIGURE ES-13

The finite-element model is a mathematical model that reduces the DGB to an interrelated system of finite elements. The building is defined by a set of 853 nodal points and 1,294 elements. Of these elements, 901 are plate elements representing walls and slabs, 141 are beam elements representing the footings, and 252 are boundary elements representing the foundation soil. Horizontal and vertical translational springs are used to simulate

the boundary condition. Figure ES-13 illustrates an isometric view of the finite-element model.

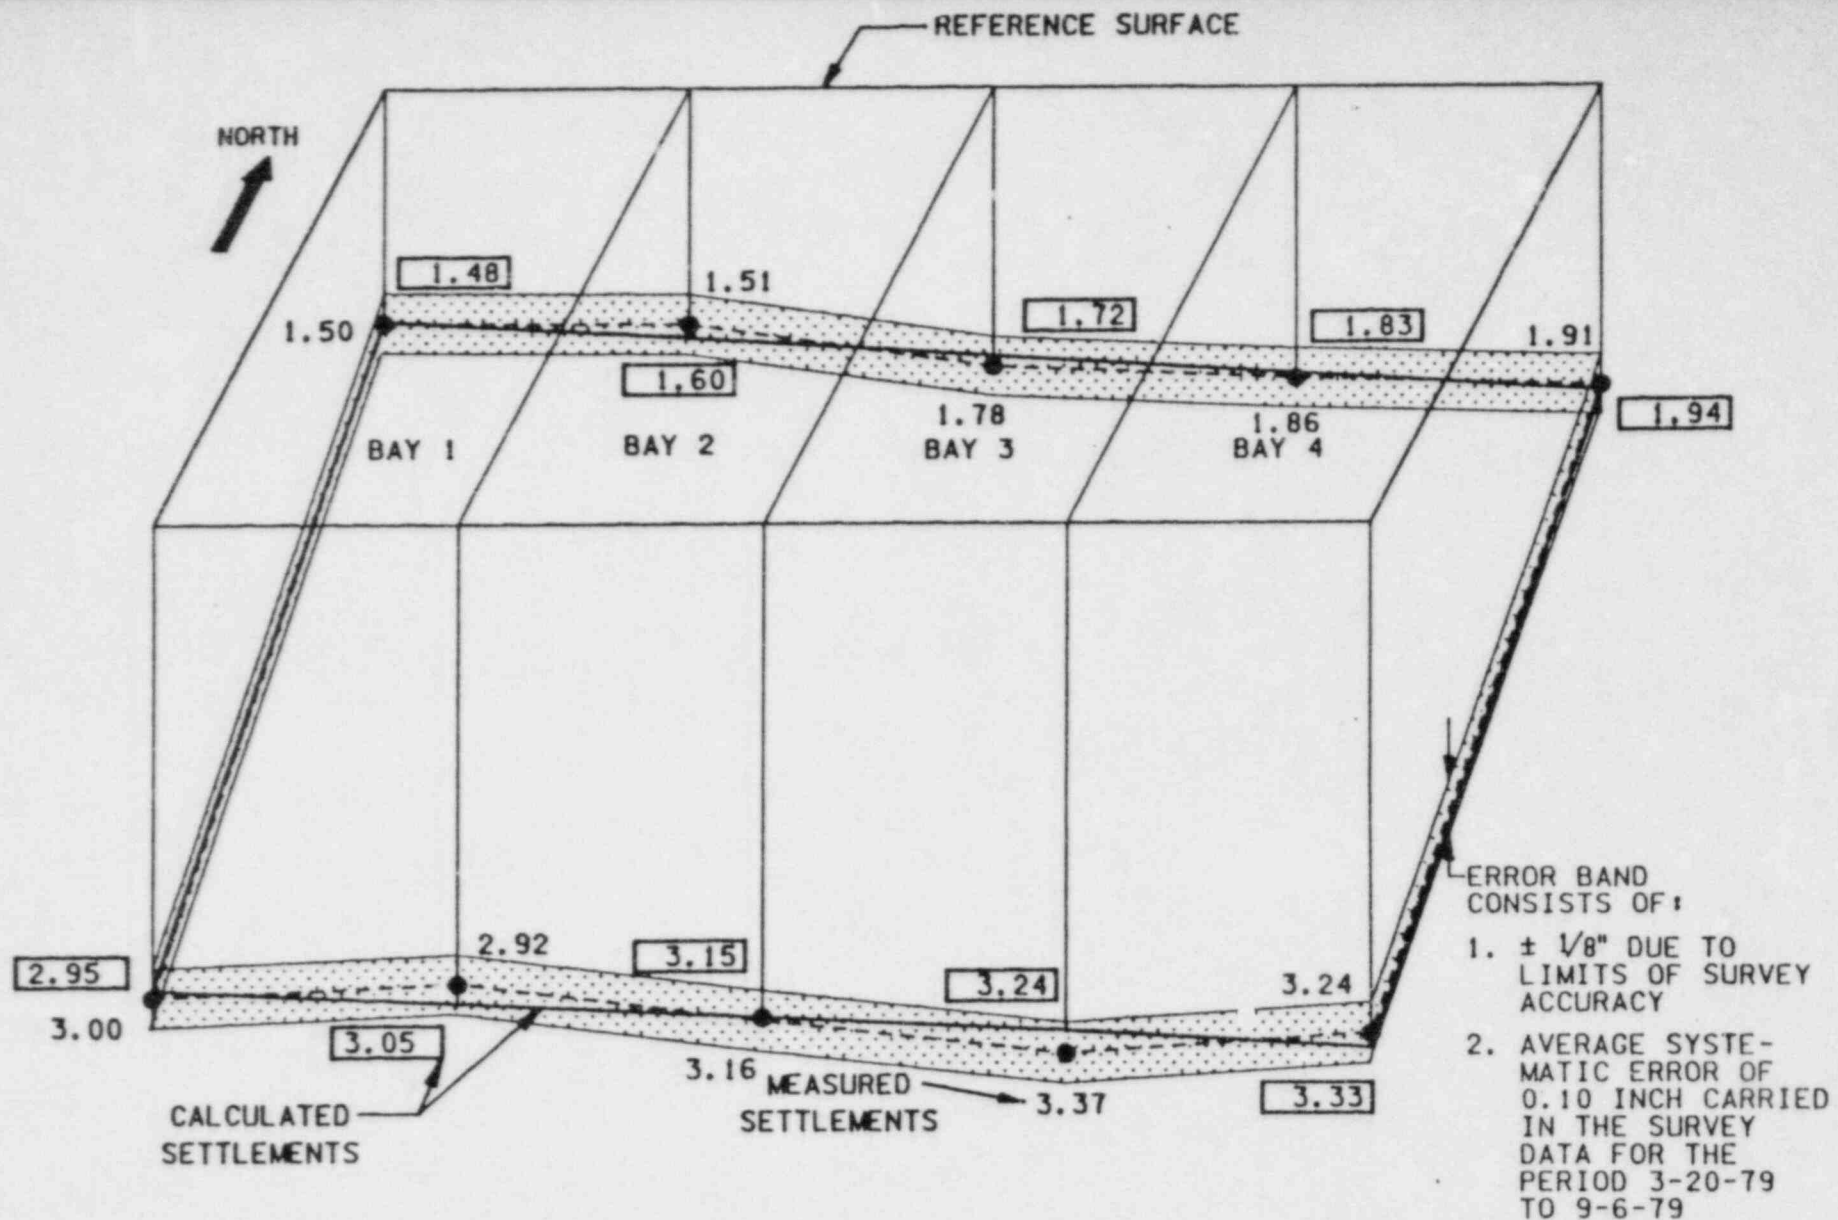
FIGURE 1

COMPARISON OF SETTLEMENT
VALUES
PRE-SURCHARGE PERIOD
AUGUST 1978 - JANUARY 1979

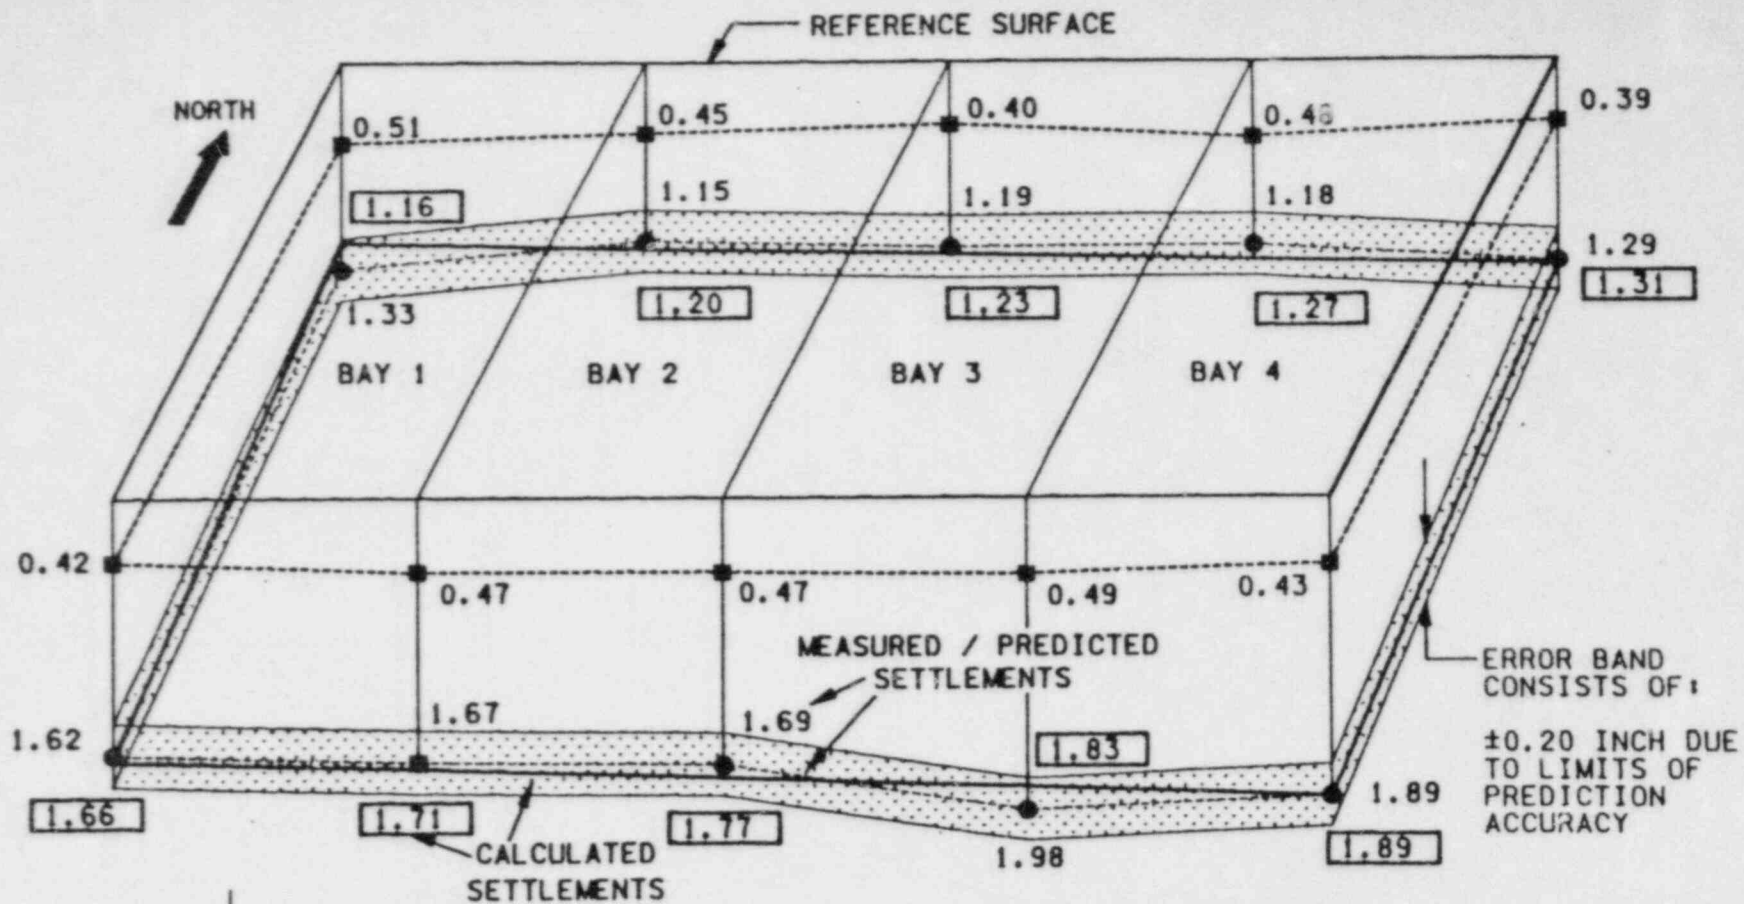
FIGURE ES-16

COMPARISON OF SETTLEMENT
VALUES
SURCHARGE PERIOD
JANUARY 1979 - AUGUST 1979

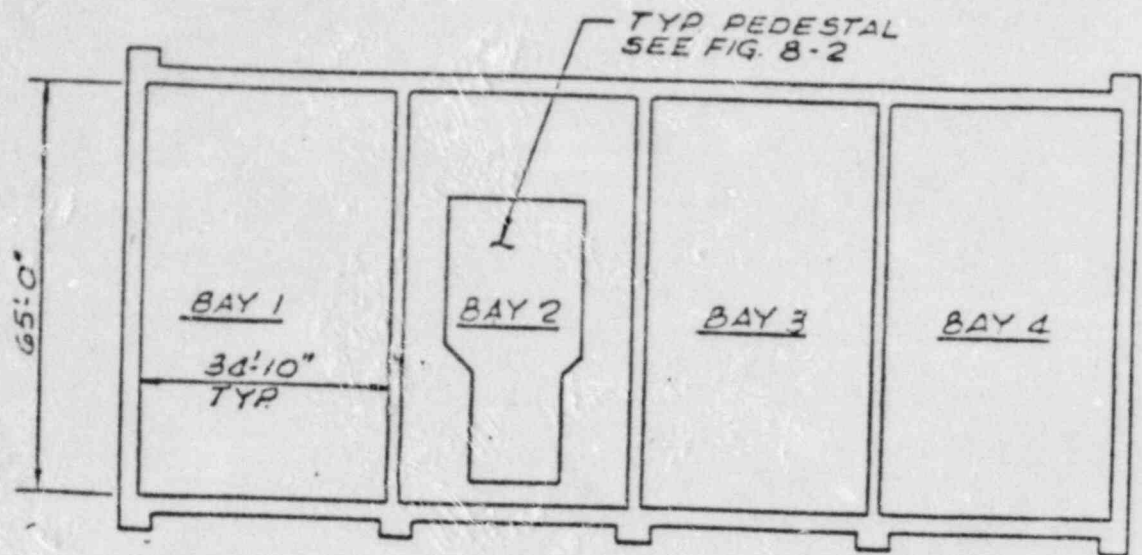
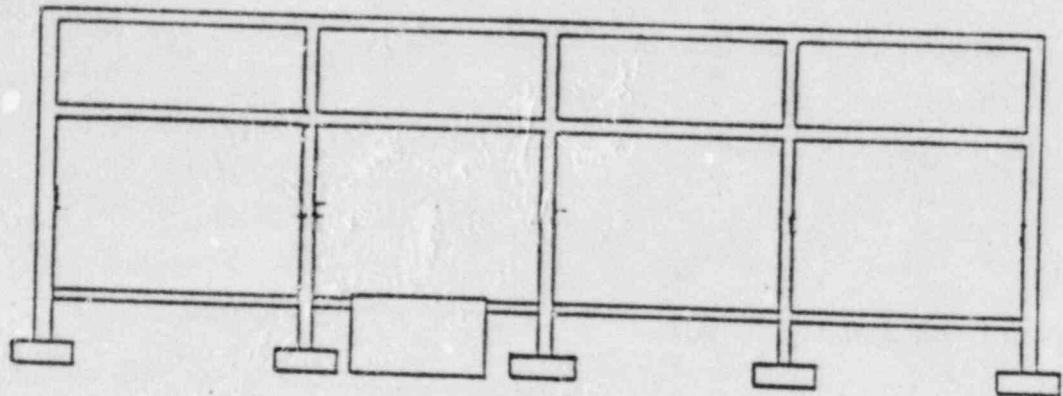
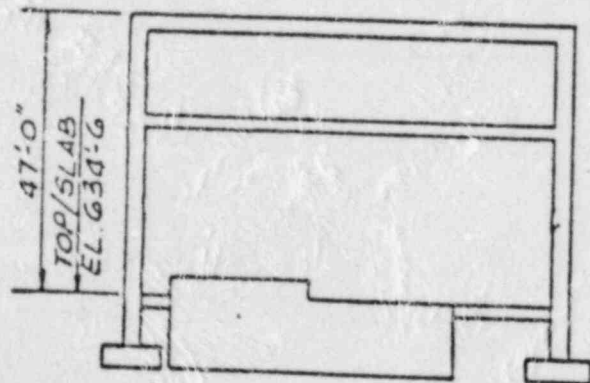
The DGB is a two-story, box-type reinforced-concrete (RC) structure with three cross walls that divide the structure into four cells, each of which contains a diesel generator unit. The building is supported on continuous RC footings 10' - 0" wide and 2' - 6" thick founded at plant elevation 628' and resting on a fill that extends down to approximately elevation 603'. The building has exterior wall thickness of 30", roof slab and interior wall thickness of 18". Plan dimensions of DGB are 155' x 70' with a total internal height of approximately 44'. Each diesel generator rests on a 6'-6" thick, RC pedestal that is not structurally connected to the building foundation. Figure 1 shows the general layout of the DGB.

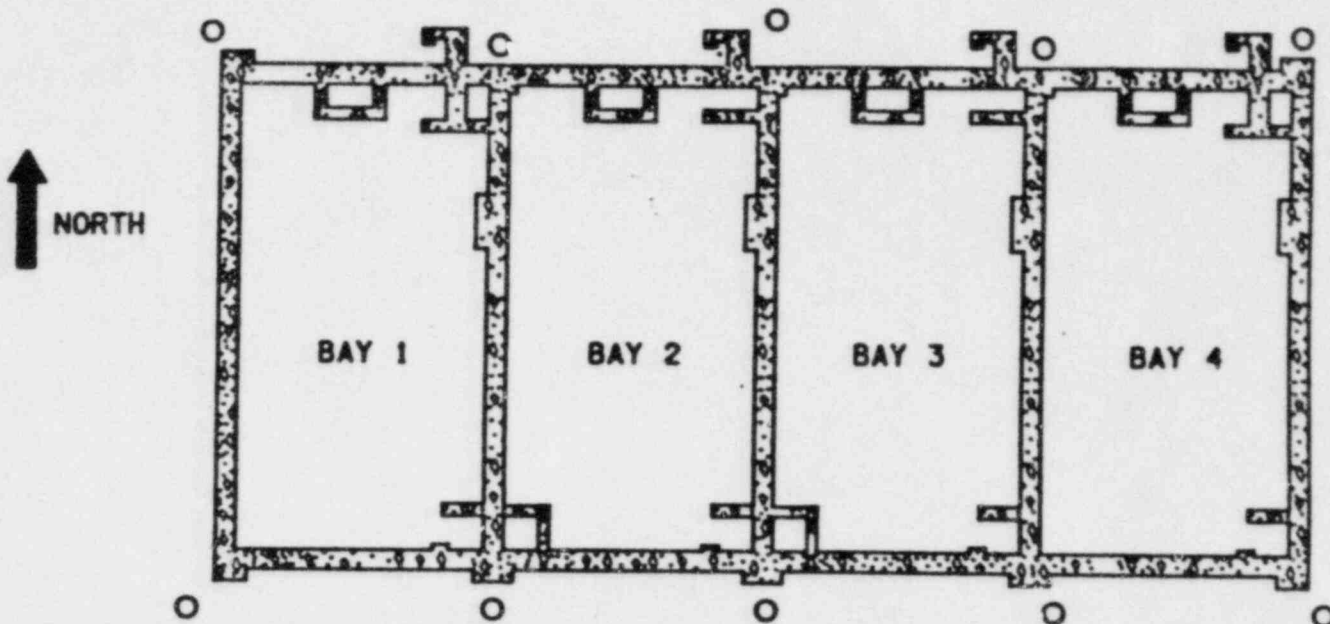
FIGURE 2

3. Para. 92: The settlement of the D.G.B. after the release of the duct banks is not uniform as claimed by the Applicant in the last sentence of this paragraph. As shown in Attachment No.-2 (Fig-2) of the testimony of Mr. H. N. Singh, there has been considerable differential settlement after the release of the duct banks.

The effects of the remedial measures taken can be observed from the amount of settlement which the DGB has gone through as indicated in Figure 2 and also from the crack sizes and crack patterns of the walls as shown in Figure 3. Details of both settlement and cracking issues are discussed in the following sections.
