UNITED STATES
NUCLEAR REGULATORY COMMISSION
WASHINGTON, D. C. 20555

APPLICANT: Consumers Power Company
FACILITY: Midland Plant, Units 1 and 2
SUBJECT: SUMMARY OF FEBRUARY 2-5, 1982 MEETING AND AUDIT ON AUXILIARY
BUILDING UNDERPINNING

Enclosure 1 is a summary of this meeting and audit.

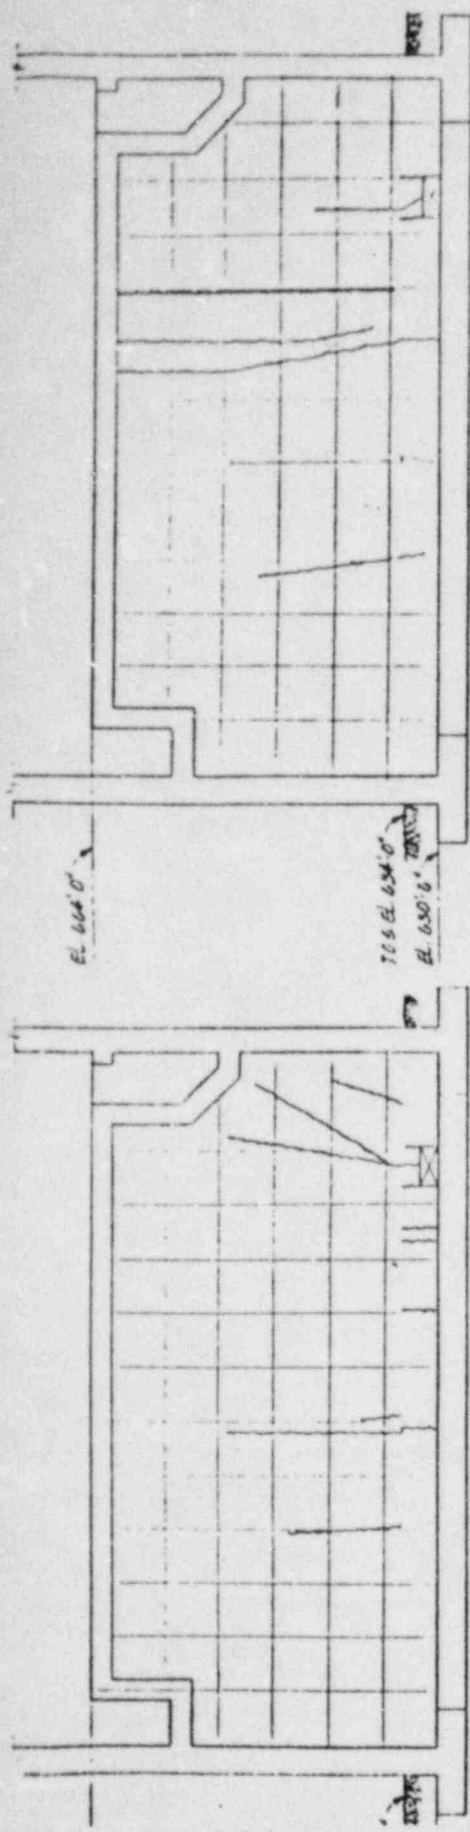
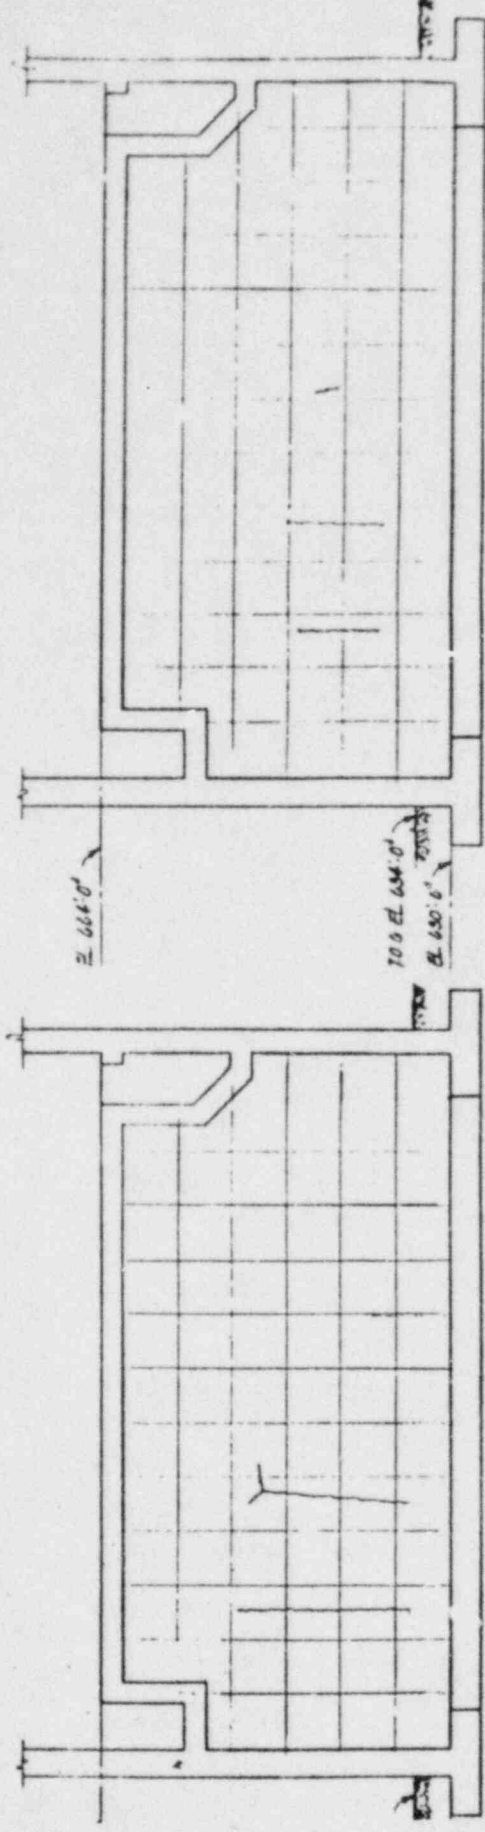
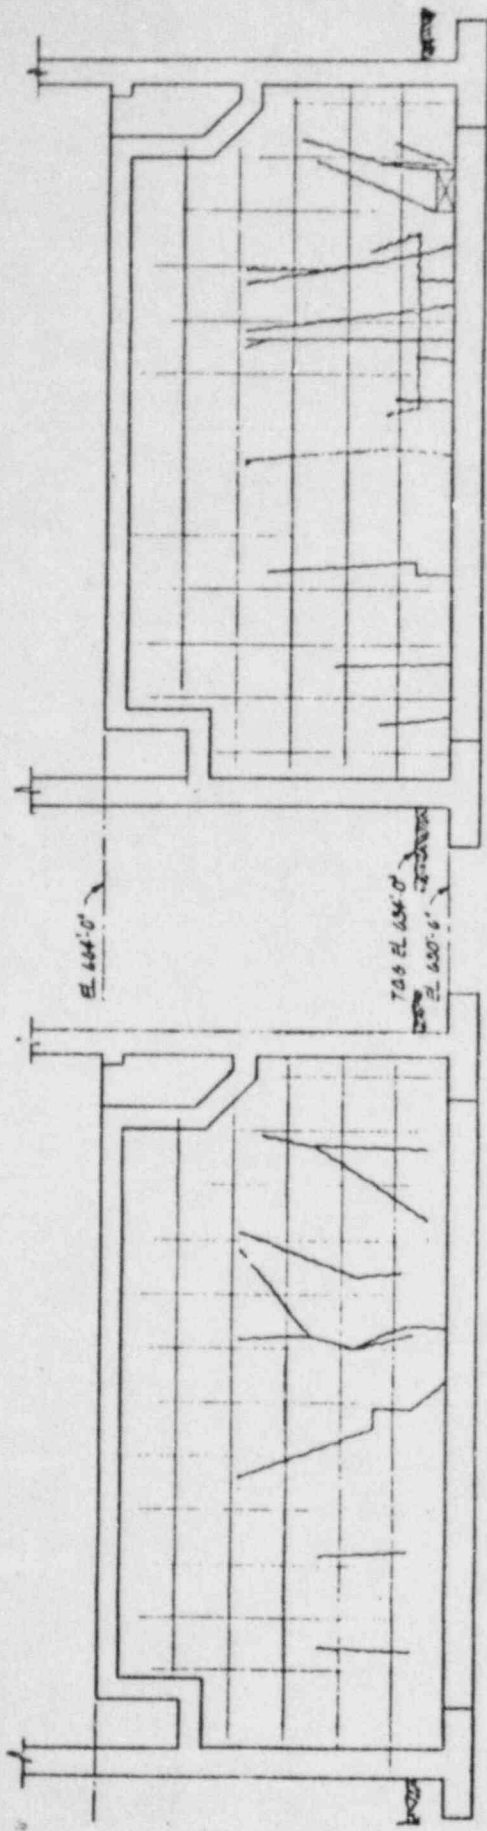
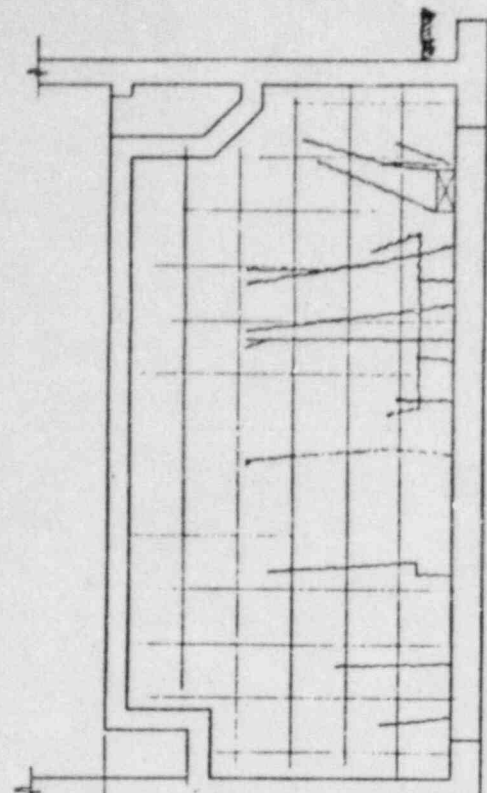
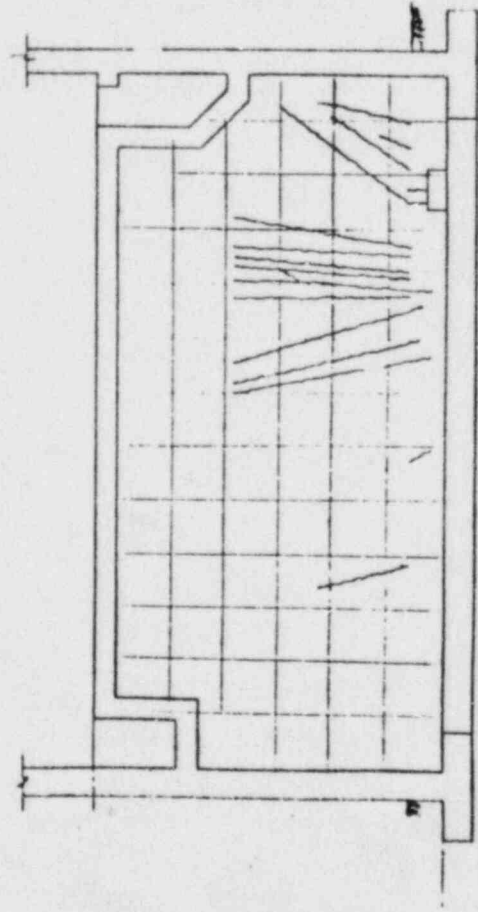
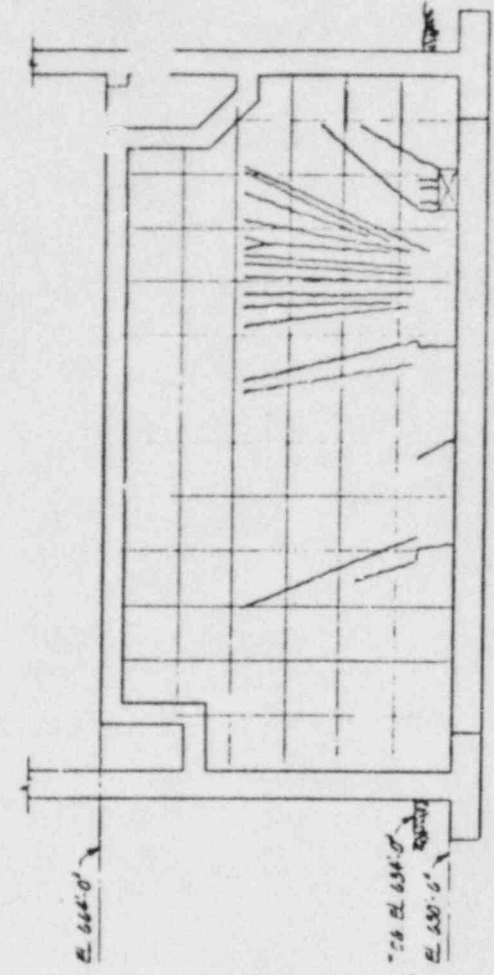
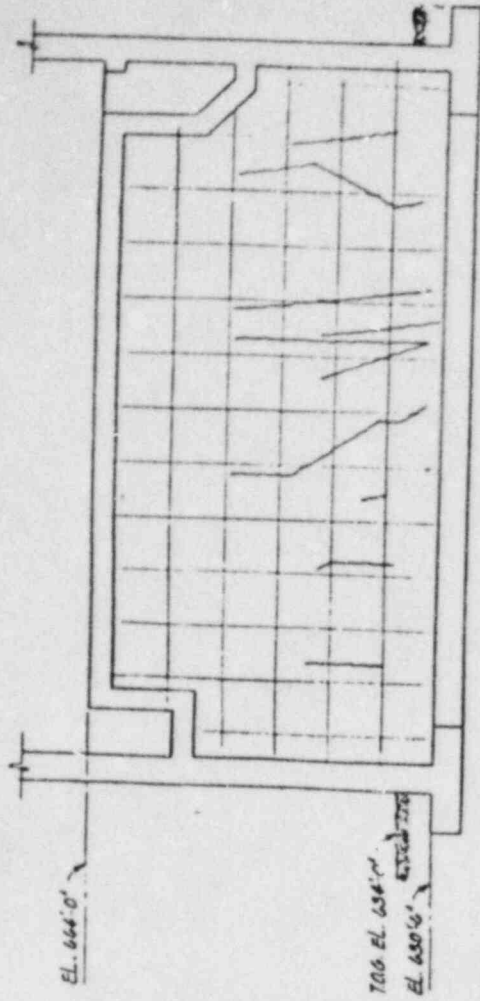
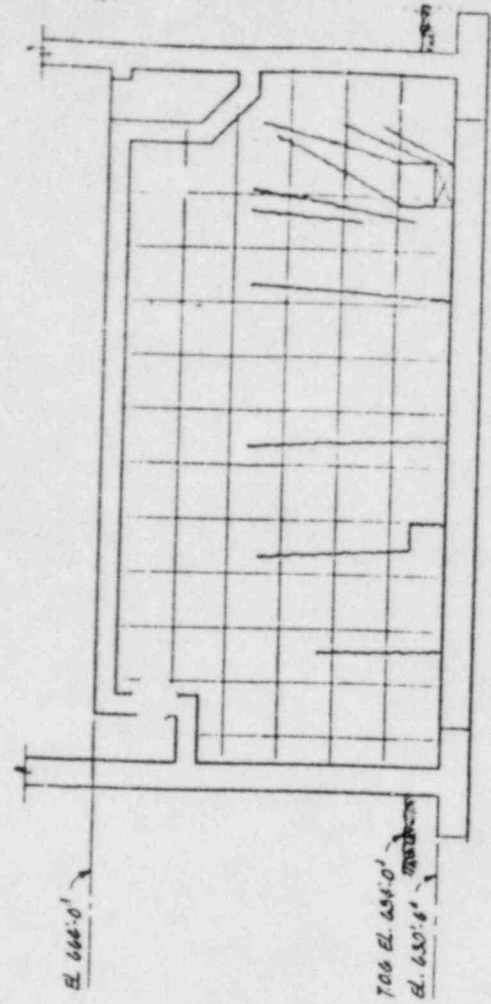
FIGURE 3 A - 3

The effects of the remedial measures taken can be observed from the amount of settlement which the DGB has gone through as indicated in Figure 2 and also from the crack sizes and crack patterns of the walls as shown in Figure 3. Details of both settlement and cracking issues are discussed in the following sections.

1. CRACK SHOWN WERE MAPPED PRIOR TO PLACING THE PRELOAD. (12-15-78 TO 12-18-78).
2. NORTH & SOUTH WERE NOT MAPPED SINCE NO SIGNIFICANT CRACKS WERE OBSERVED.
3. IN GENERAL, ALL CRACKS WERE HAIRLINE WITH SOME CRACKS WITH A THICKNESS OF 28 MILS AS OF 2-2-79.

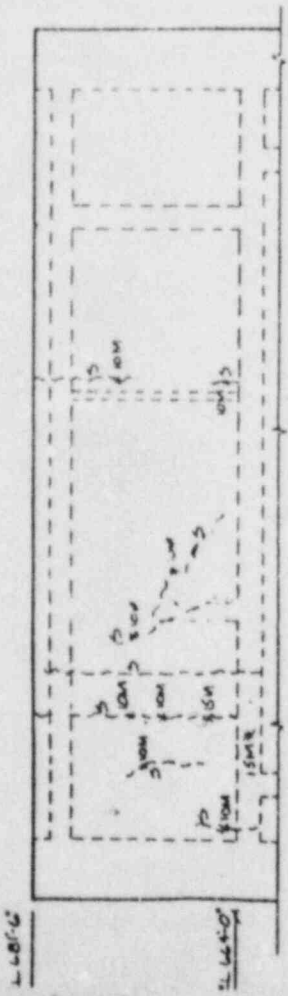
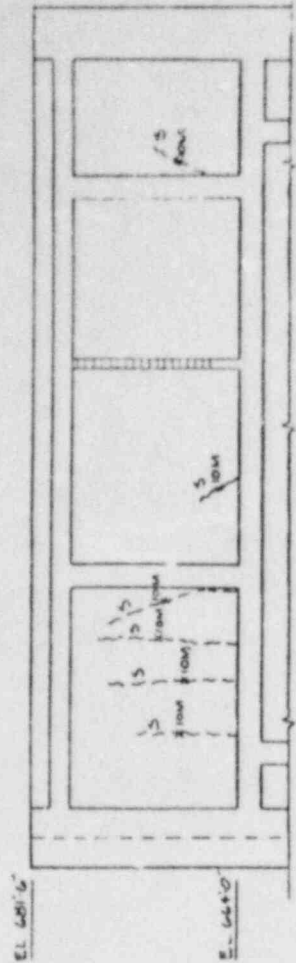
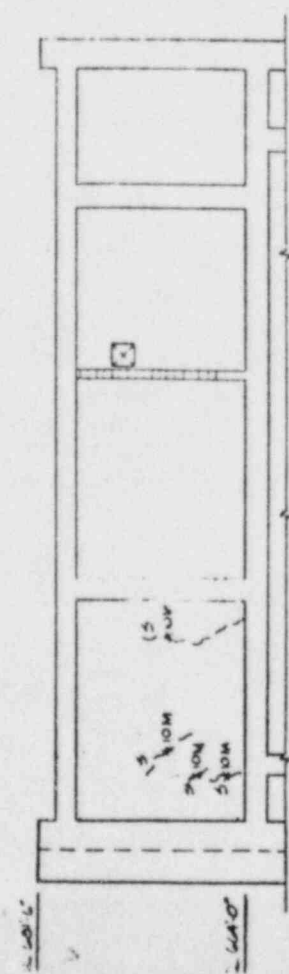
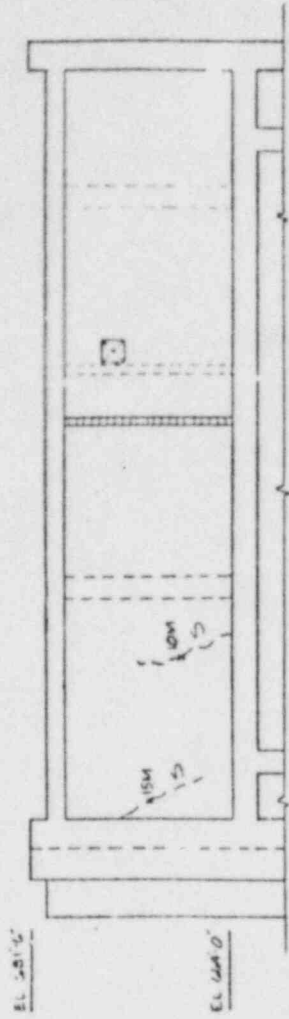
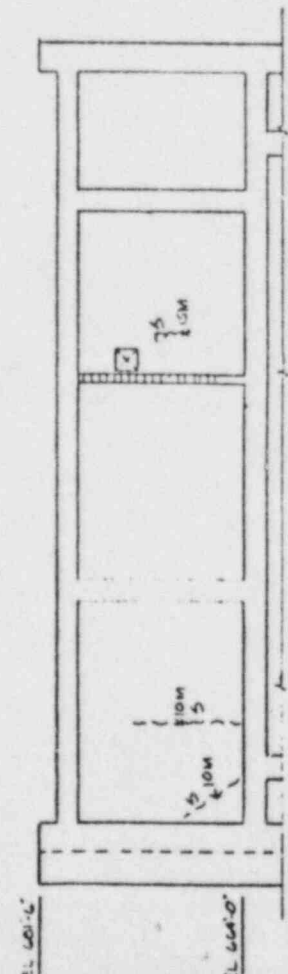
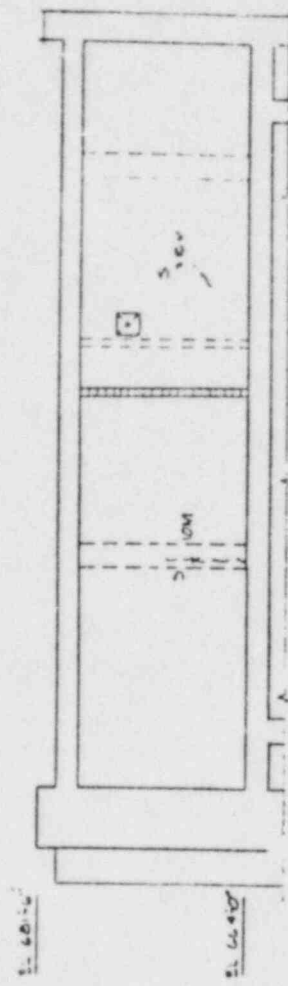
FIGURE 3 B - 2

1. CRACKS SHOWN WERE MAPPED ON JAN 1989.
2. SEE FIG 2B-2 FOR TYPICAL CONSTRUCTION REFERENCE.
3. SEE FIG 2D-2 FOR CRACK MAPPING OF WALLS FROM E.L. 601'-6" TO 664'-0".
4. SEE FIG 2B-2 FOR ADDITIONAL NOTES AND LEGEND.

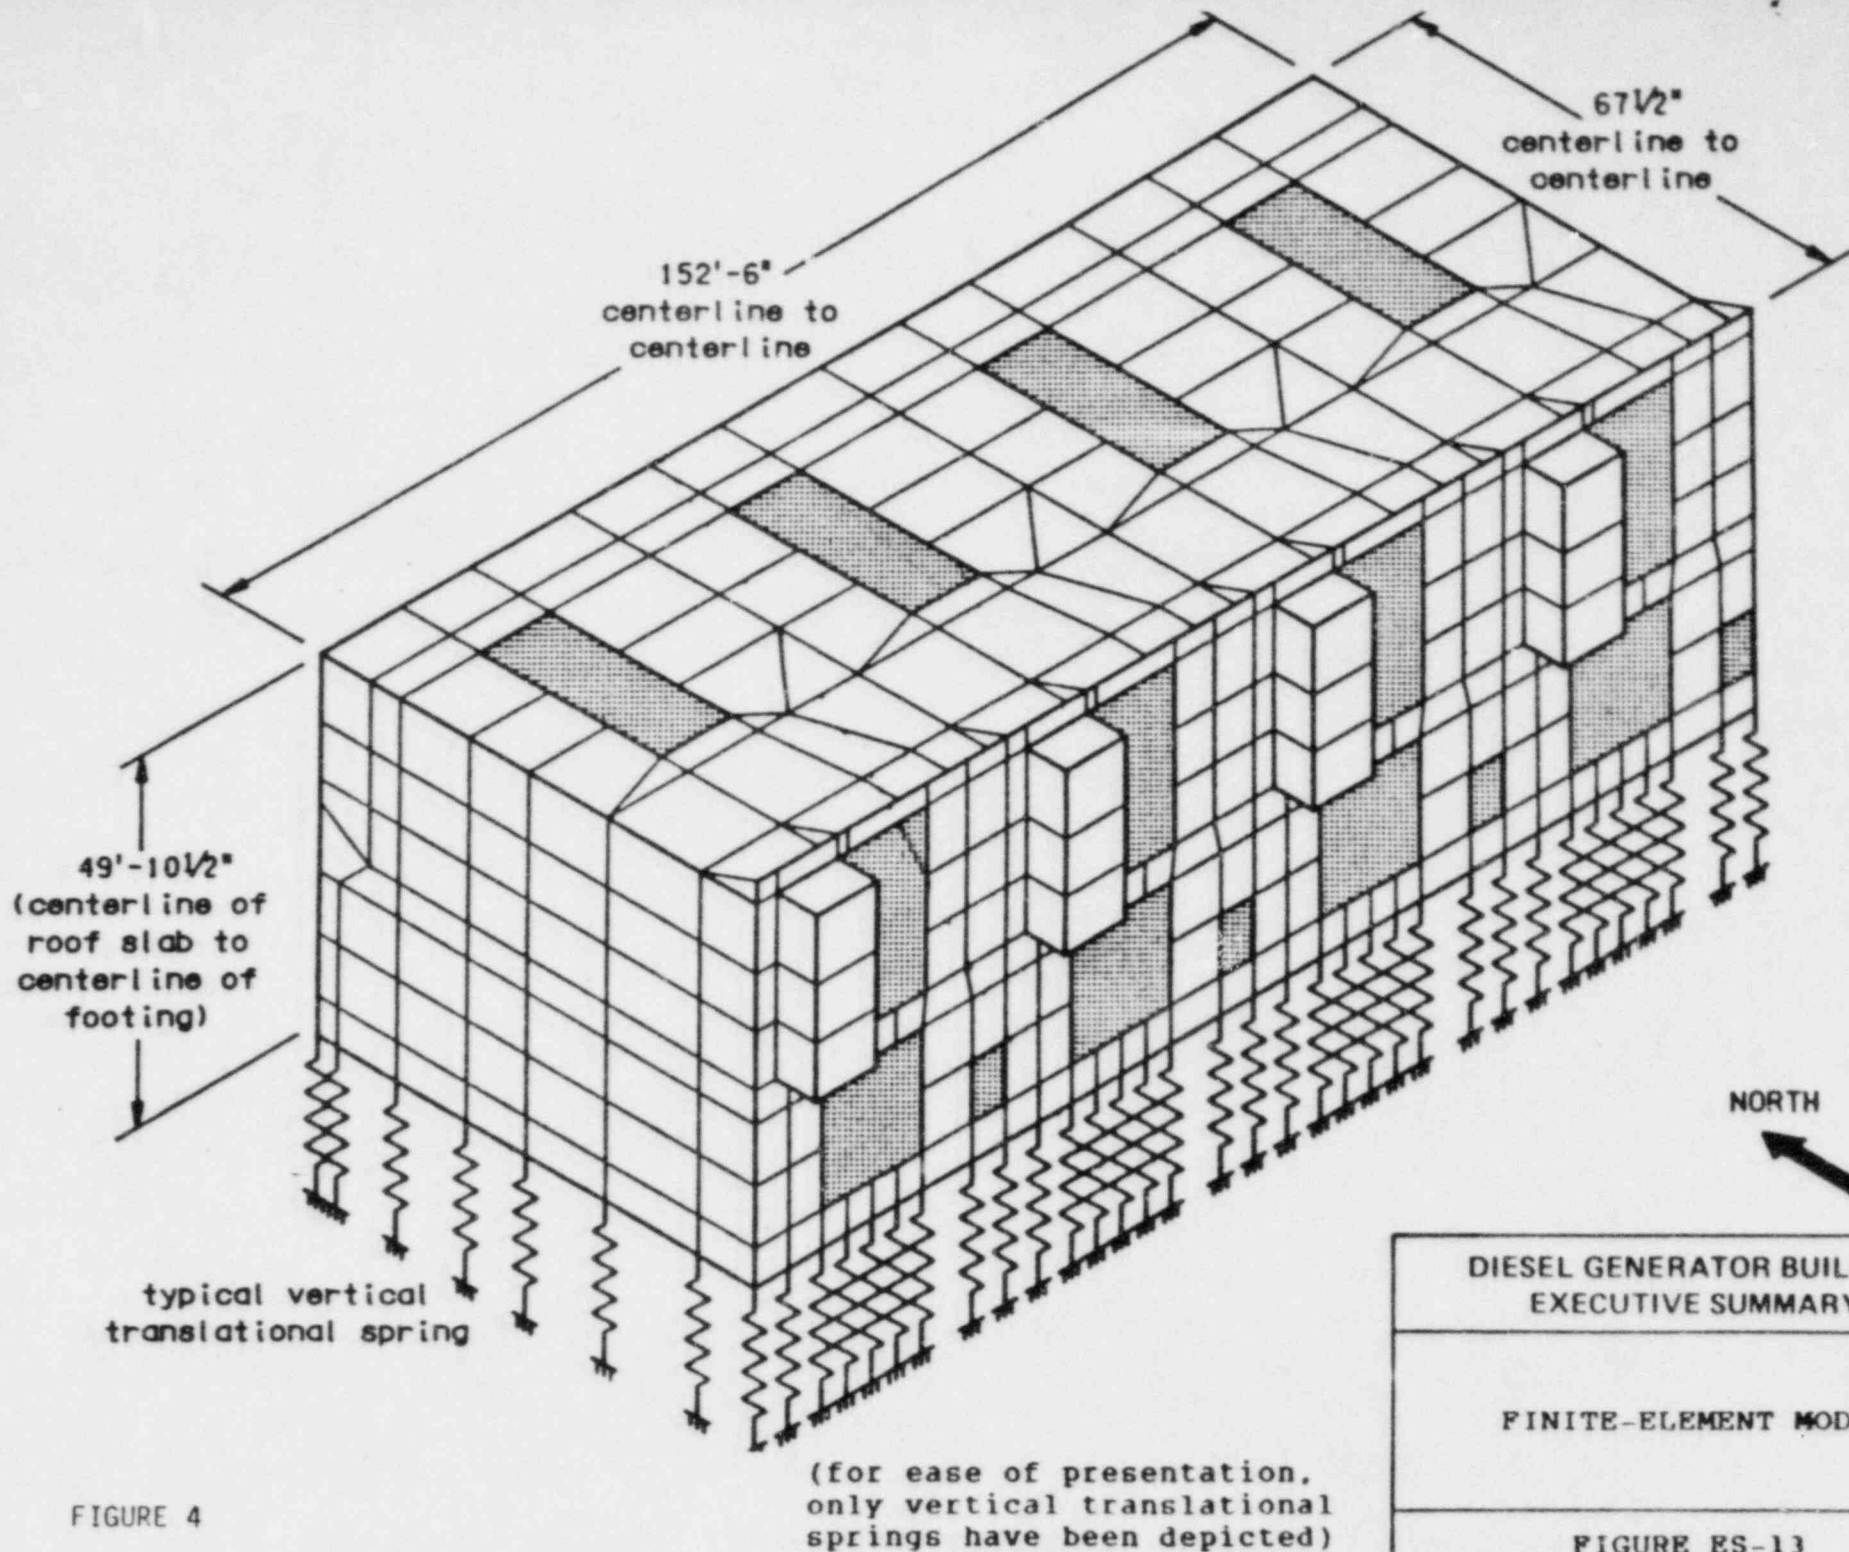
FIGURE 4

shown in Figure 2. With the exception of Case 1A which was analyzed by long hand computation and by idealizing the partially completed DGB as a series of individual beams, the other three cases were analyzed by computer through the discretion of the DGB into a number of finite elements as exemplified in Figure 4. Case 1A was accomplished by passing deflection curve through any three measured neighboring settlement points and selecting the one with the largest curvature for moment computation, and eventually, stress determination. This calculation indicated that the measured displacements would result in a maximum rebar stress of 11 ksi. For the other three settlement cases, individual finite-element models were used. For settlement Case 1B, the finite-element model represents the structure as built to el. 662 f 0 in.

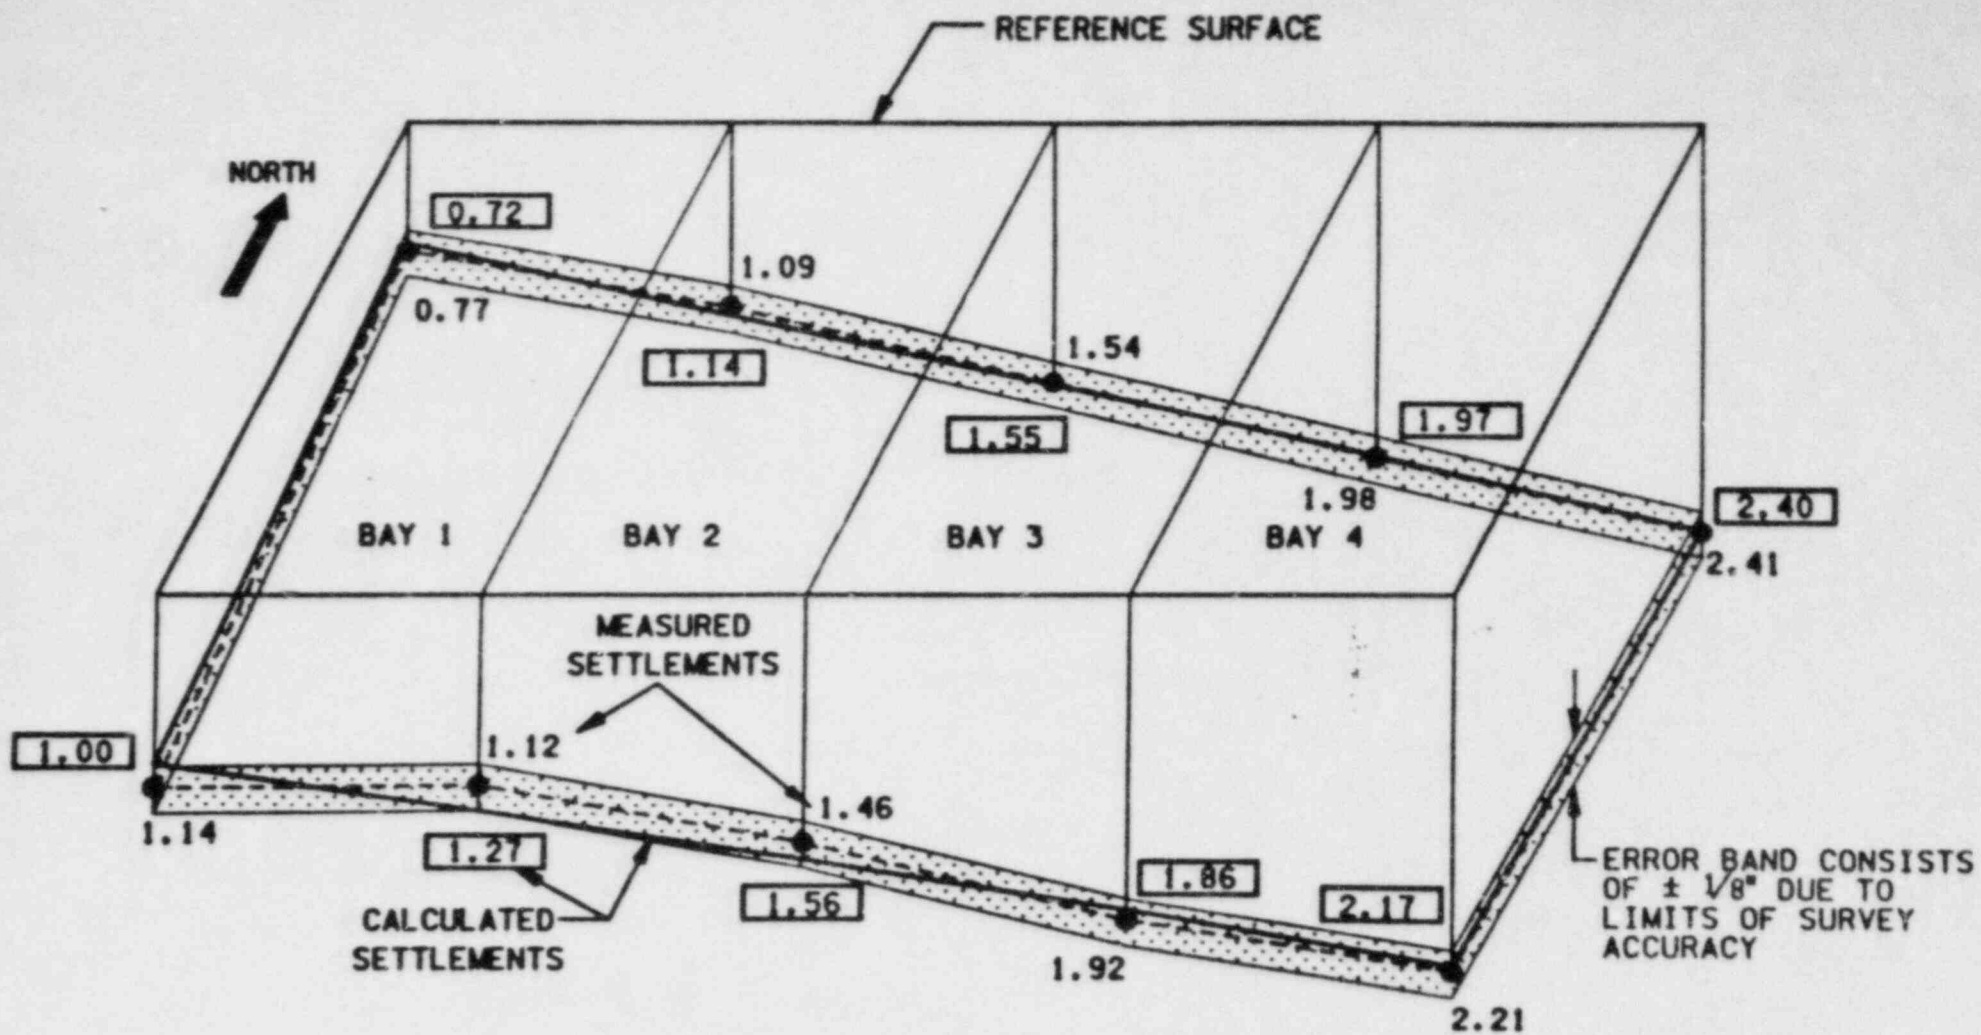
FIGURE 5

DIESEL GENERATOR BUILDING EXECUTIVE SUMMARY
COMPARISON OF SETTLEMENT VALUES PRE-SURCHARGE PERIOD AUGUST 1978 - JANUARY 1979
FIGURE ES-15

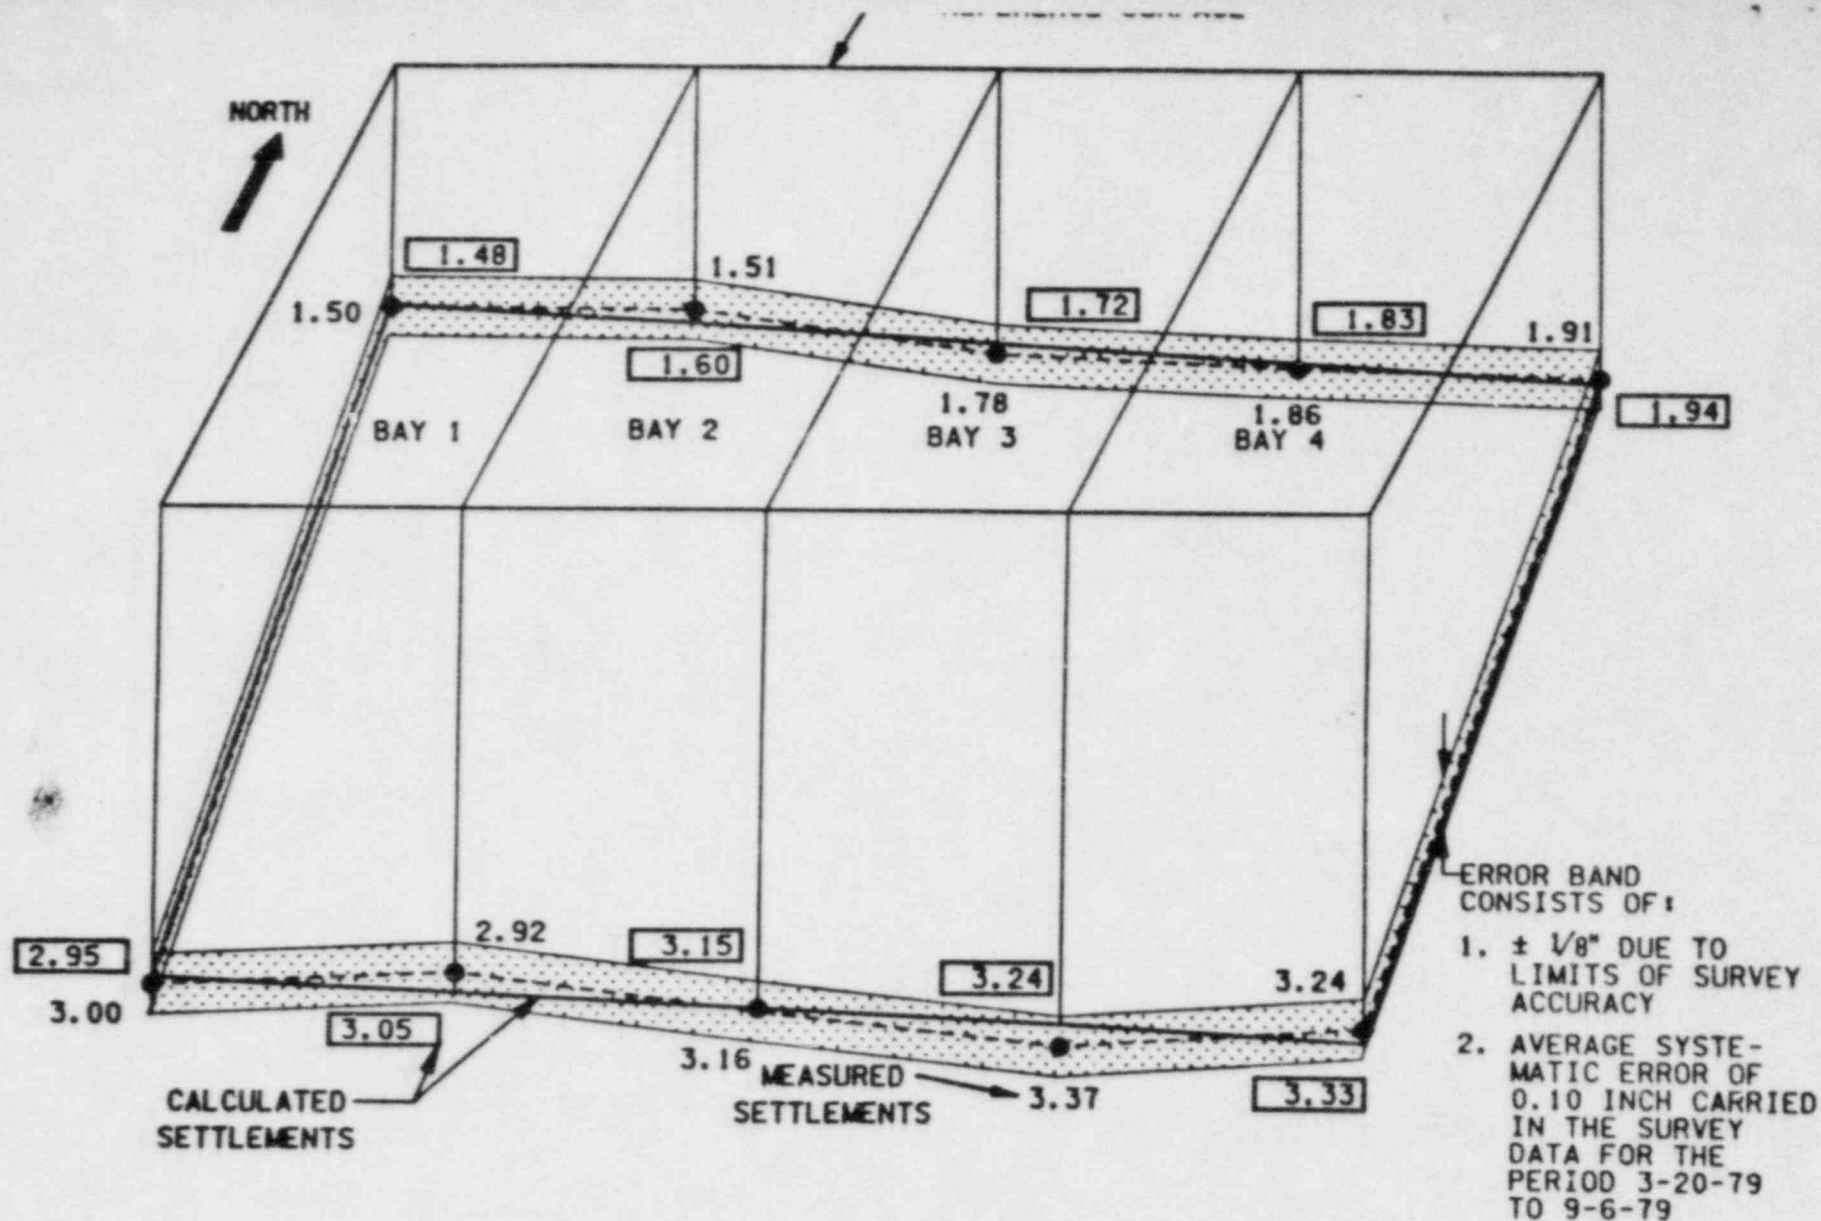
FIGURE 6

**DIESEL GENERATOR BUILDING
EXECUTIVE SUMMARY**
**COMPARISON OF SETTLEMENT
VALUES**
SURCHARGE PERIOD
JANUARY 1979 - AUGUST 1979
FIGURE ES-16

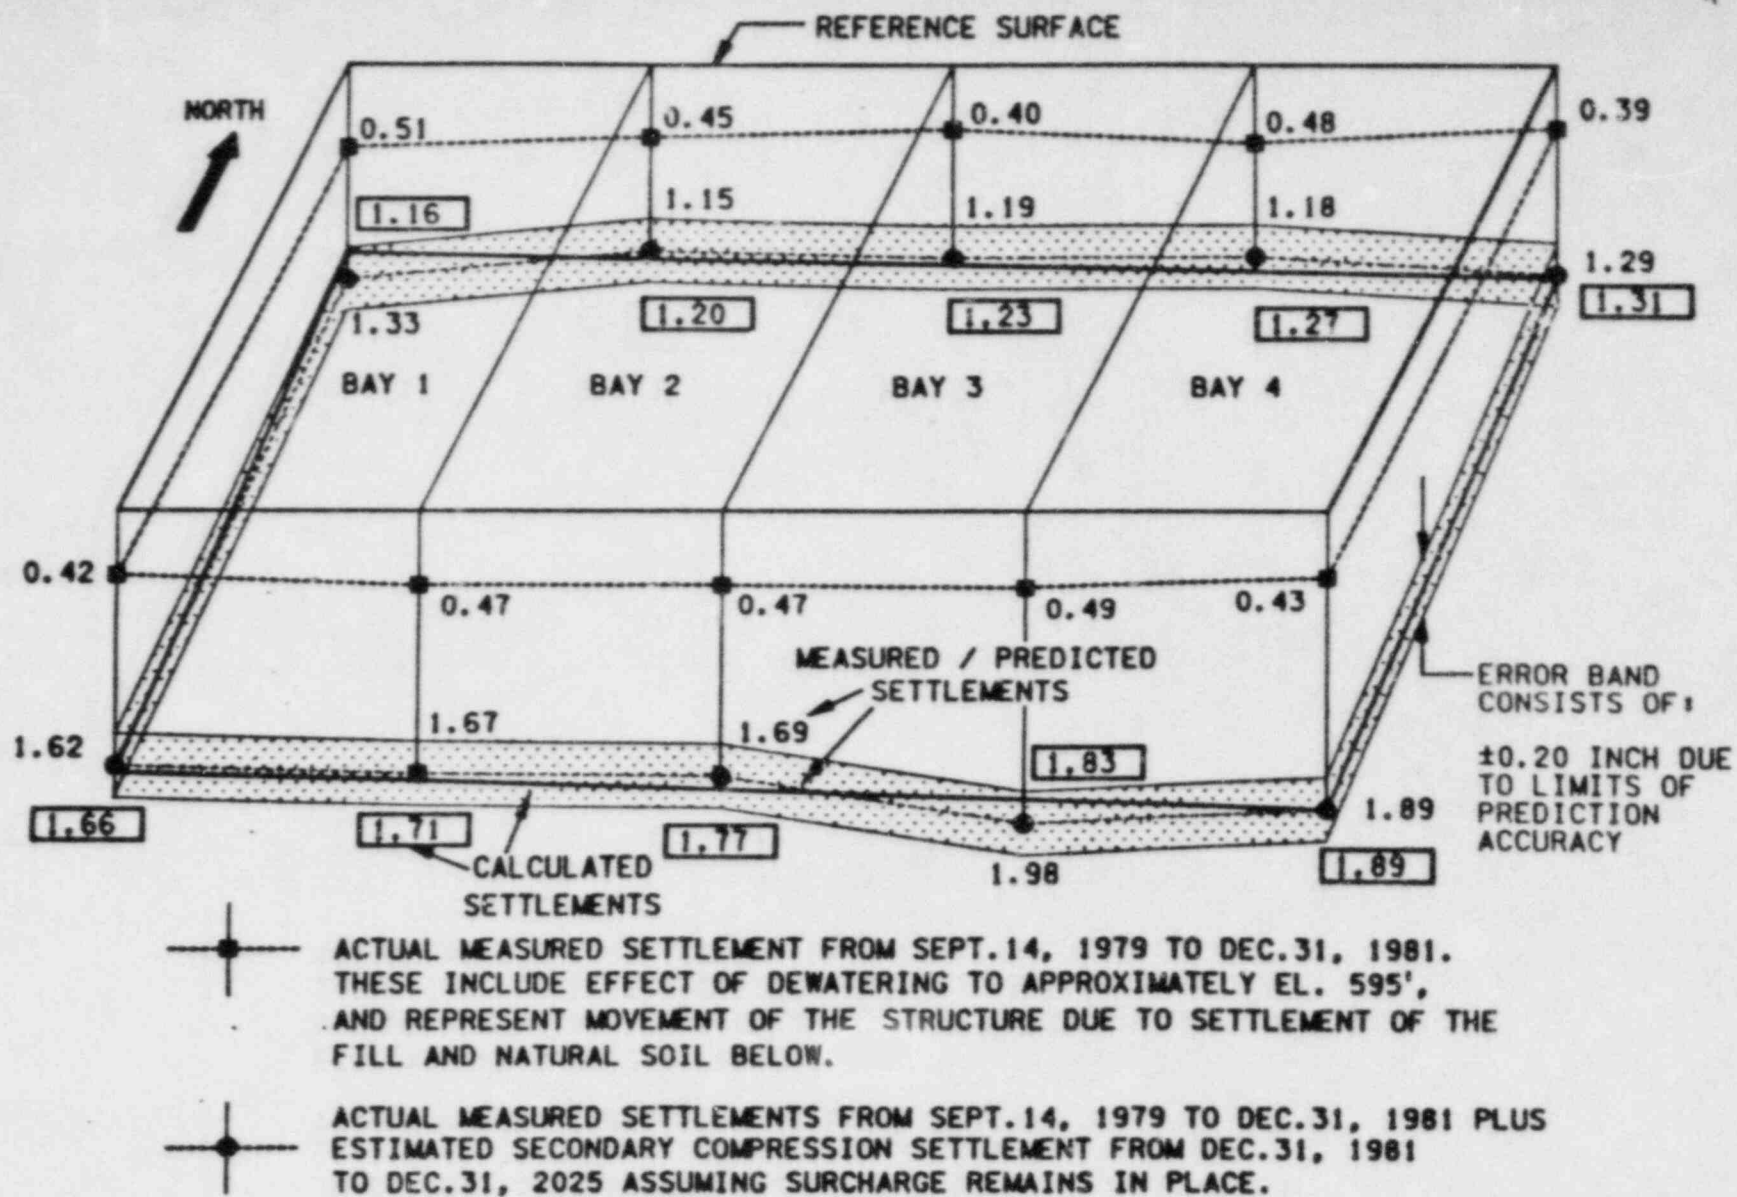
FIGURE 7

DIESEL GENERATOR BUILDING EXECUTIVE SUMMARY
COMPARISON OF SETTLEMENT VALUES POST-SURCHARGE PERIOD SEPTEMBER 1979 - DECEMBER 2025
FIGURE ES-17
