SUBJECT: MEETING SUMMARY - SEQUOYAH ICE CONDENSER AND FEEDWATER  
PIPE CRACKING

**TVA/NRC MANAGEMENT MEETING**

**ICE CONDENSER FLOOR ISSUE**

**CRACKING OF FEEDWATER PIPING**

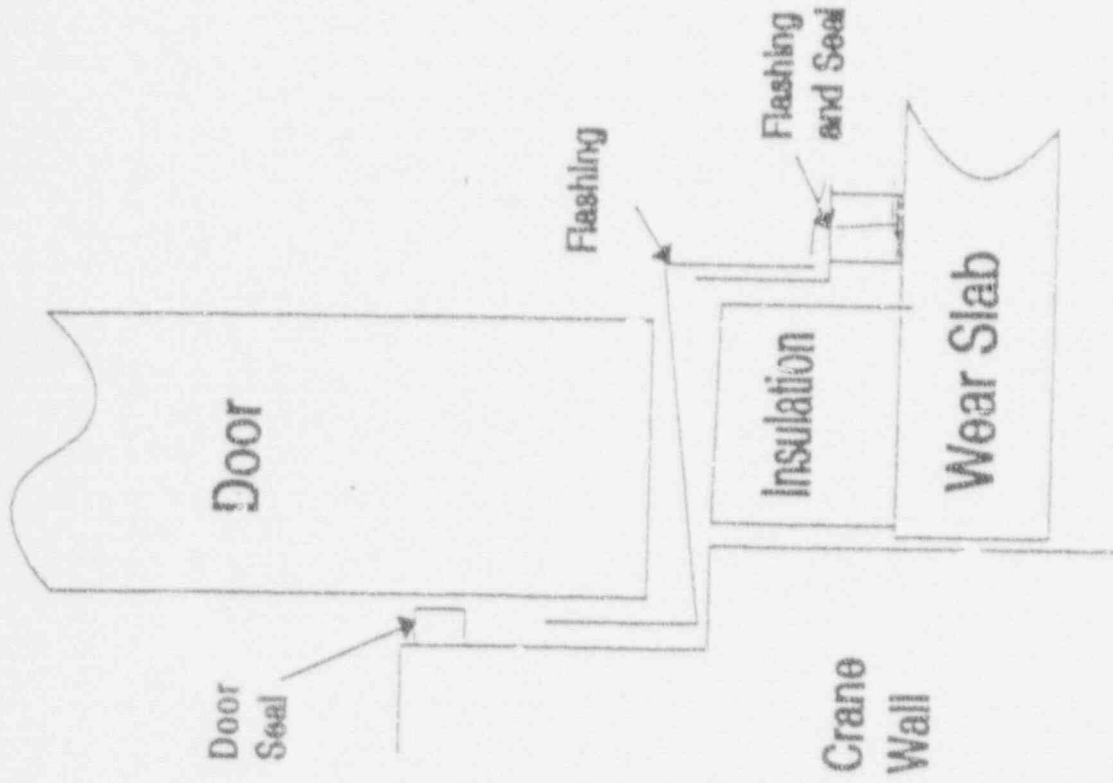
Figure 5

Ice Condenser Lower Inlet Door

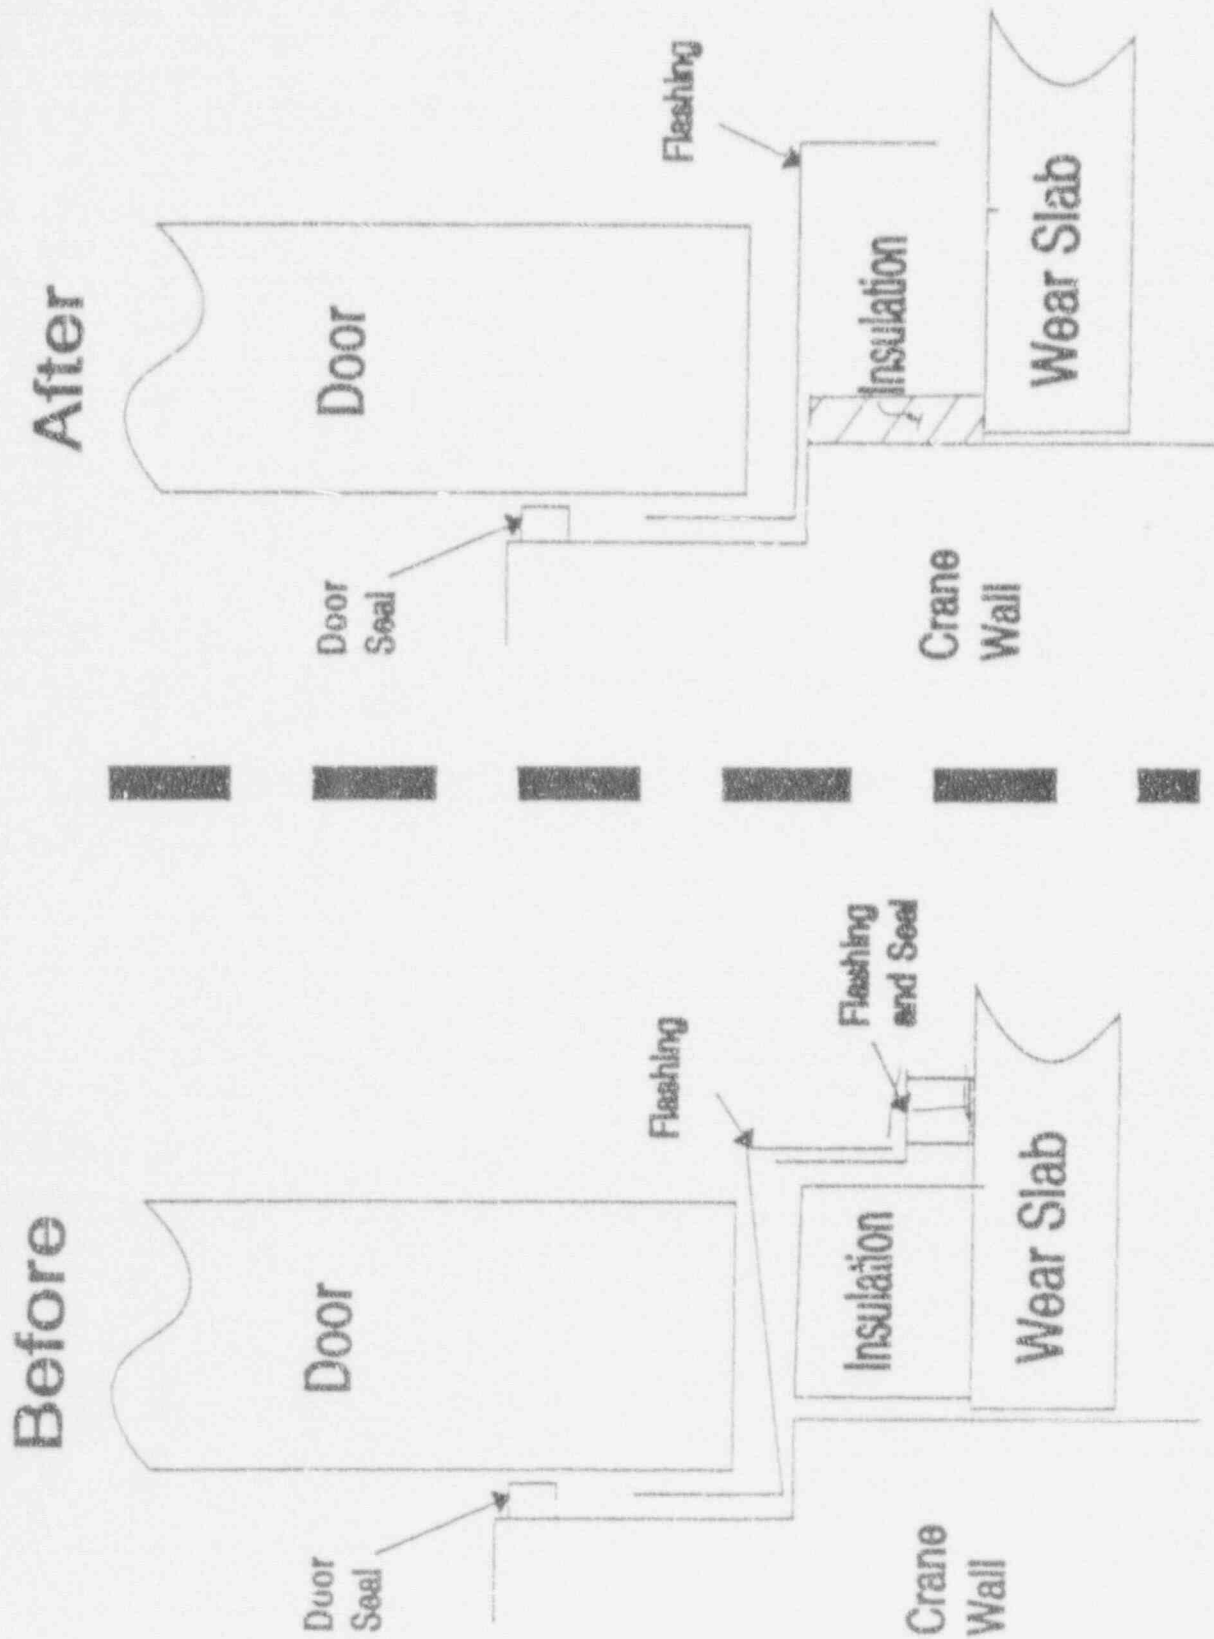
**Ice Condenser Lower Inlet Door**

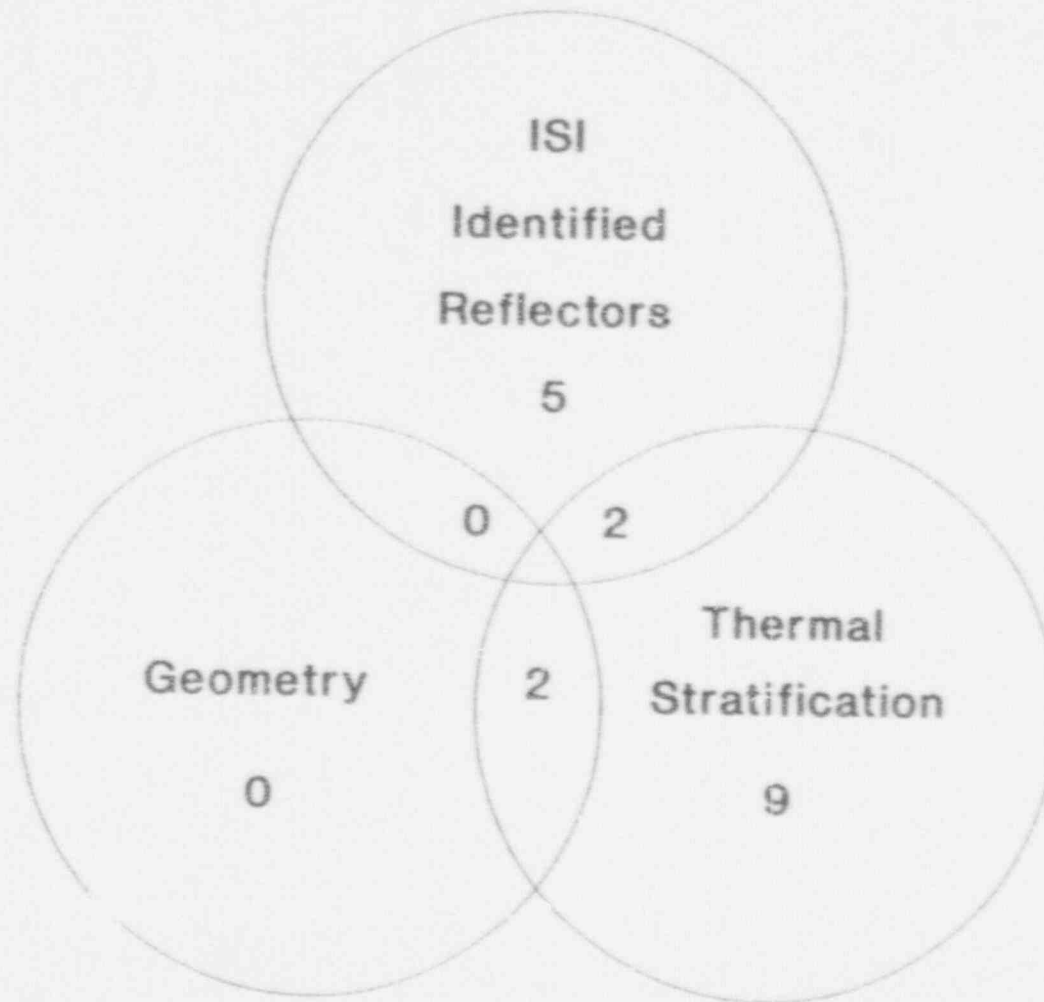
## VII. EVALUATION OF EXTENT OF CONDITION EVALUATION METHOD

- **Failure Mechanism - Thermal Stratification**
- **Inspection Process/ Technique - Geometry**
- **Disposition of Indications - Reflectors**

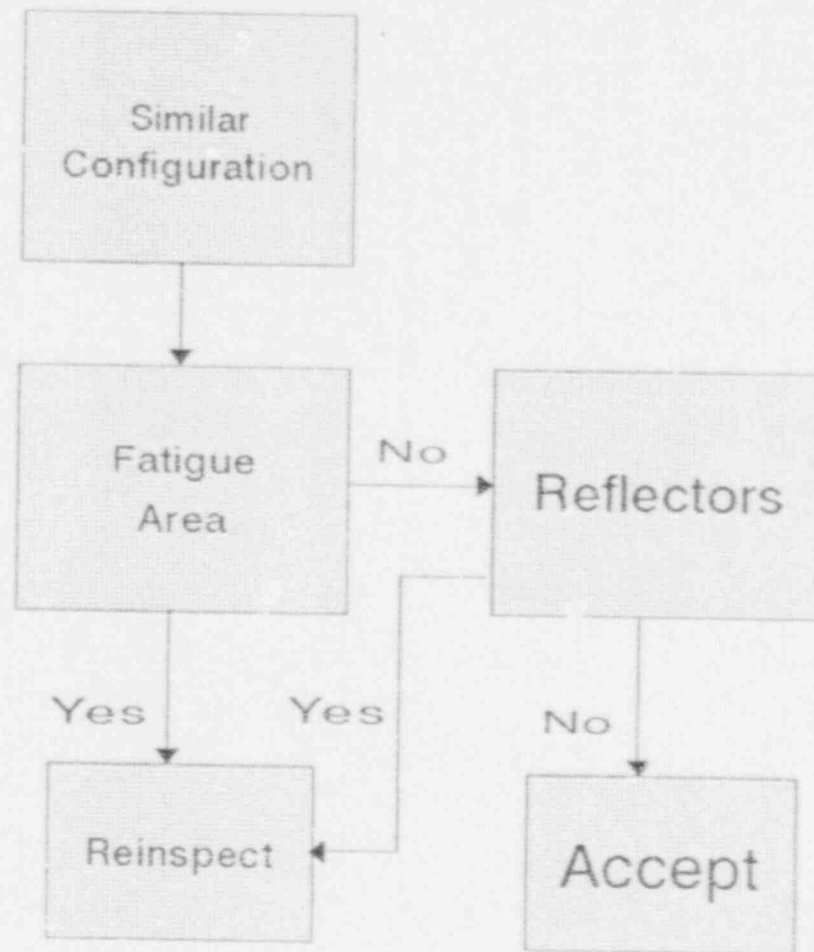
## VII. EVALUATION OF EXTENT OF CONDITION INSPECTION PROCESS/TECHNIQUE

- Construction RT Completed In 1979
- 79-13 RT Performed First RFG In 1982
- Augmented Exams Initiated, UT - 1 Loop/RFO
- Expanded Scope Of Augmented UT Exams In 1988 To Include 4 Loops/RFO
- Indications Recorded At Sites Of Cracks - Misinterpreted As Geometry
