PROJECT: Oyster Creek
Nuclear Generating Station

DOCUMENT TITLE: Isolation Condenser System Piping Cracked Welds - Repair and Failure Analysis

FAILURE ANALYSIS OF OYSTER CREEK ISOLATION CONDENSER PIPING

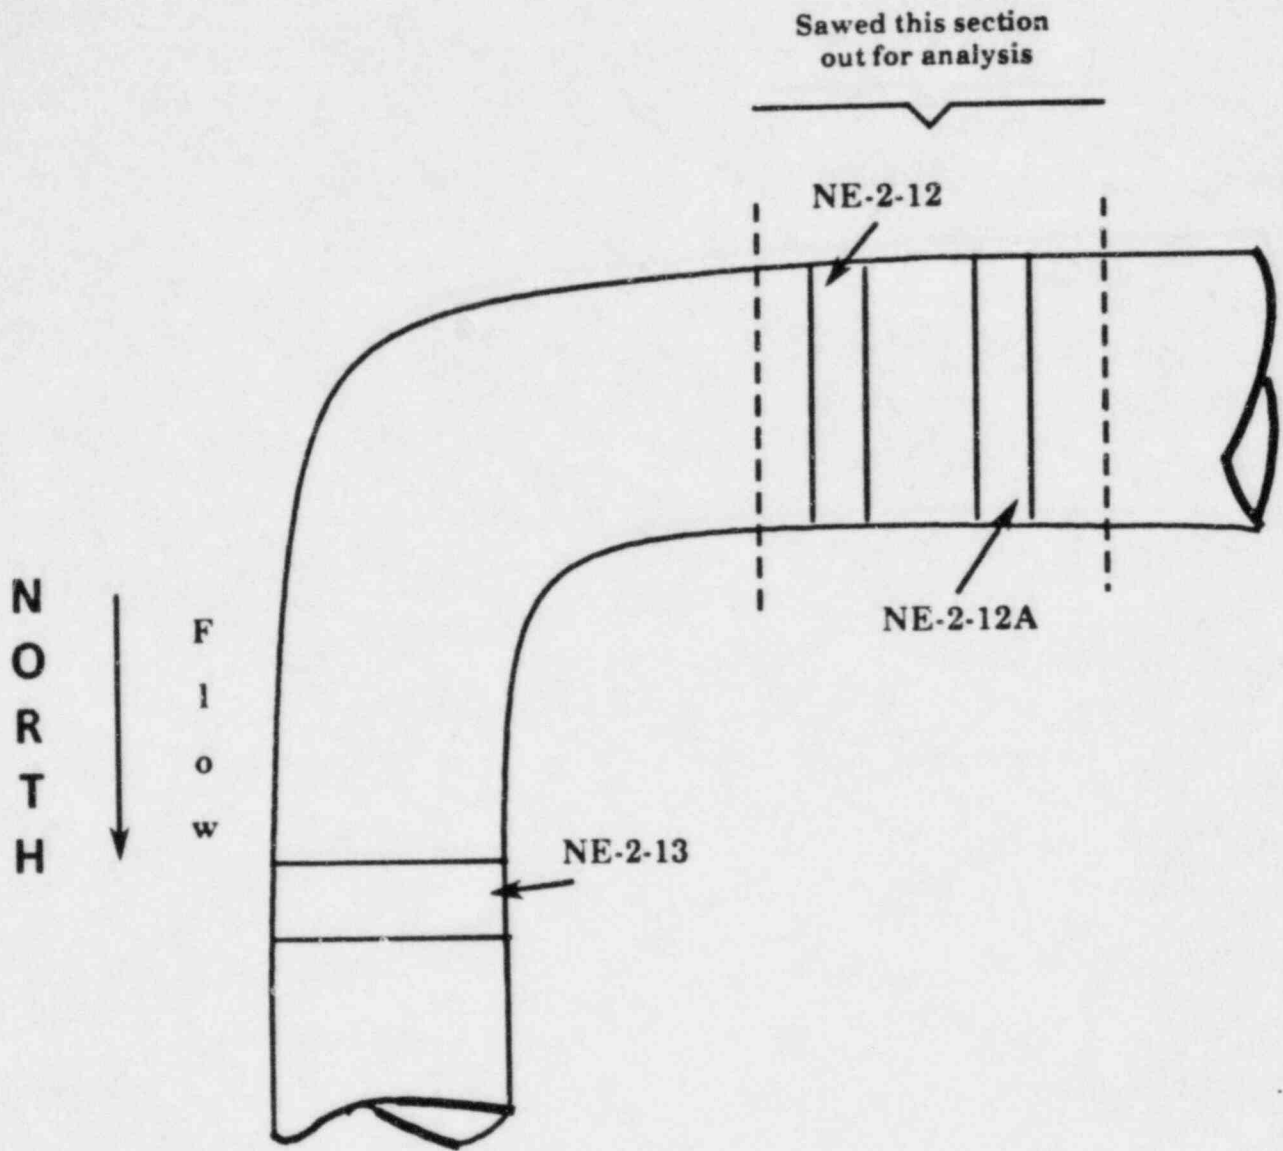
Figure 1: 8" Dia. schedule 80 pipe received from Oyster Creek

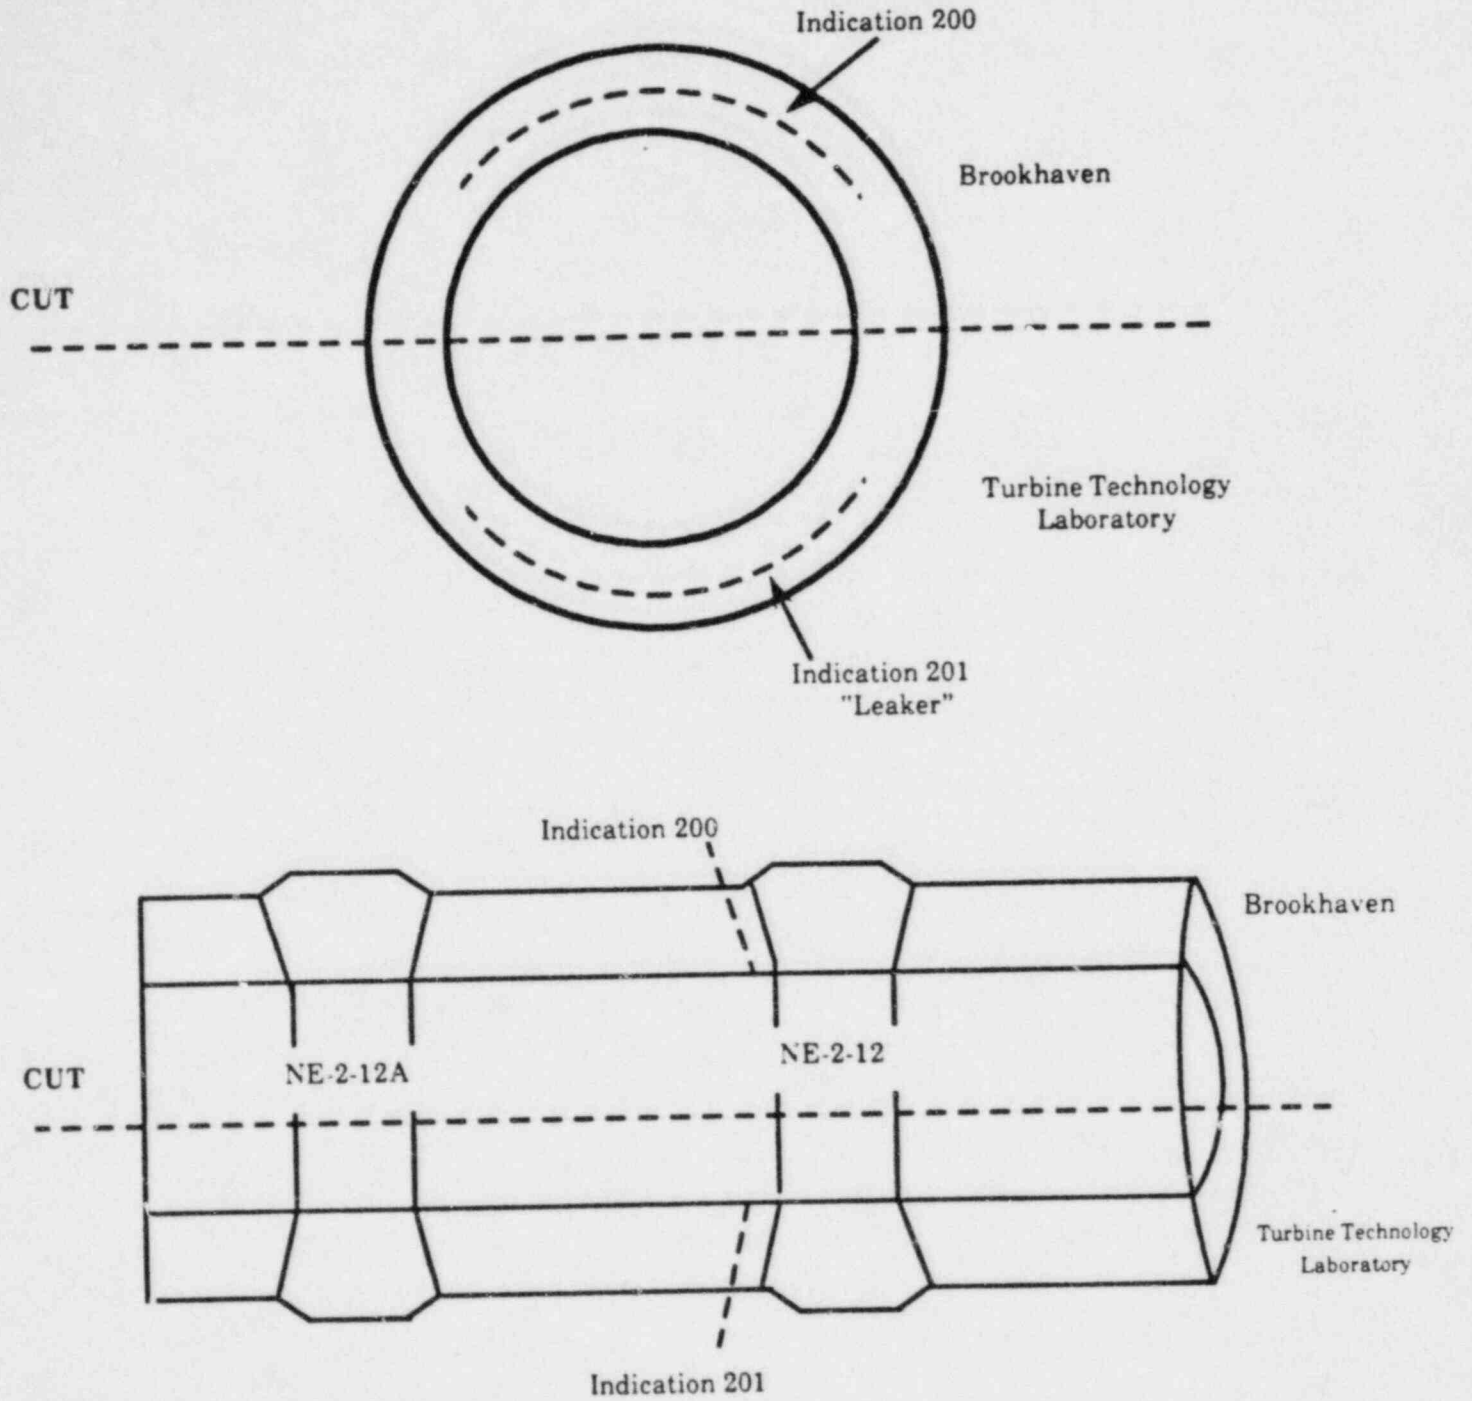
Figure 2: Axial cut to divide NE-2-12 (and NE-2-12A) between Brookhaven National Laboratories and Turbine Technology Laboratory

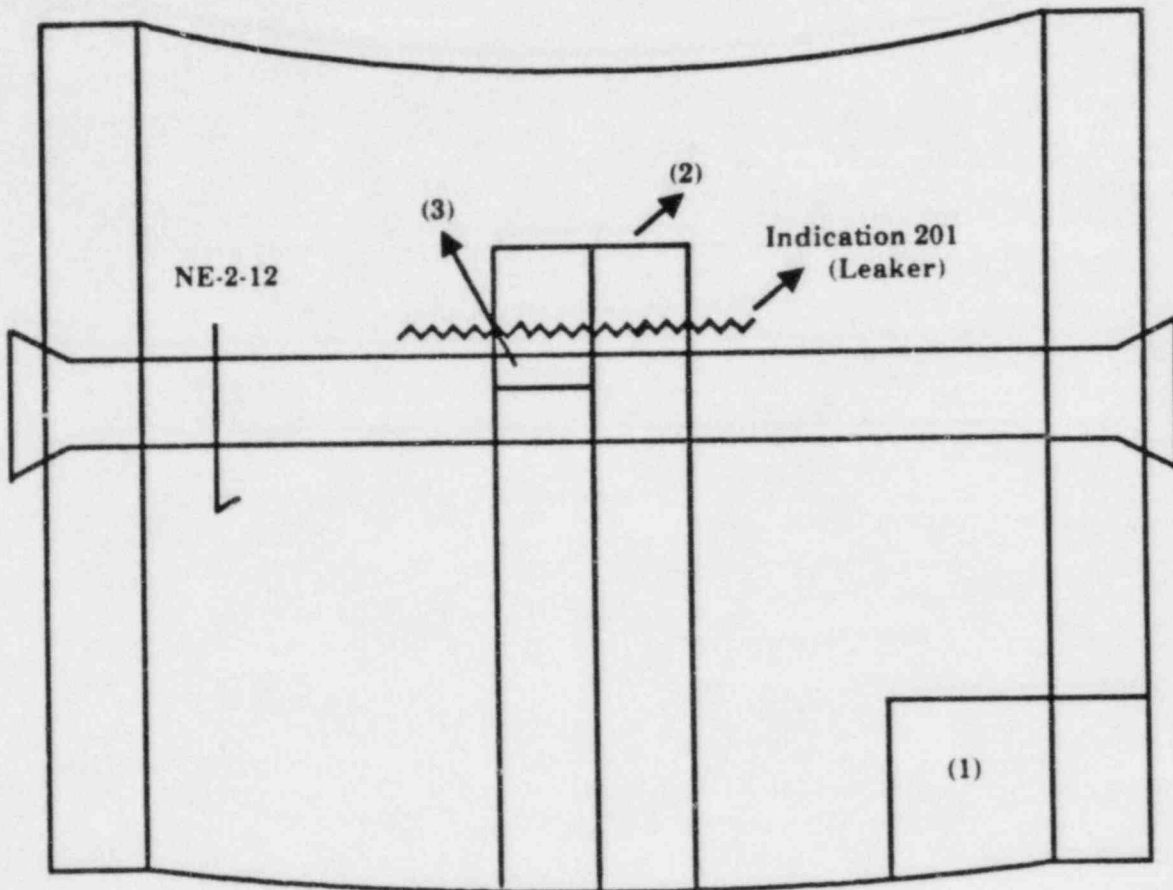
Scanning electron microscopy was performed on the piece marked "2" in Figure 3. The long piece was sawed out and placed in a vise and broken open (by hand) and the fracture surface cleaned by ultrasonic agitation in a detergent water solution.

The results of the chemical analysis done on piece "1" of Figure 3 are shown in Table I.

Metallography carried out on indication 201 "leaker" is shown in Figures 7 through 9. The location of this specimen is shown as "3" in Figure 3.

- (1) Chemical Analysis Sample
- (2) Sem Fractographic Sample
- (3) Metallographic Sample

Figure 3: The half of the pipe kept for analysis at Turbine Technology Laboratory. The other half to Brookhaven National Laboratory.

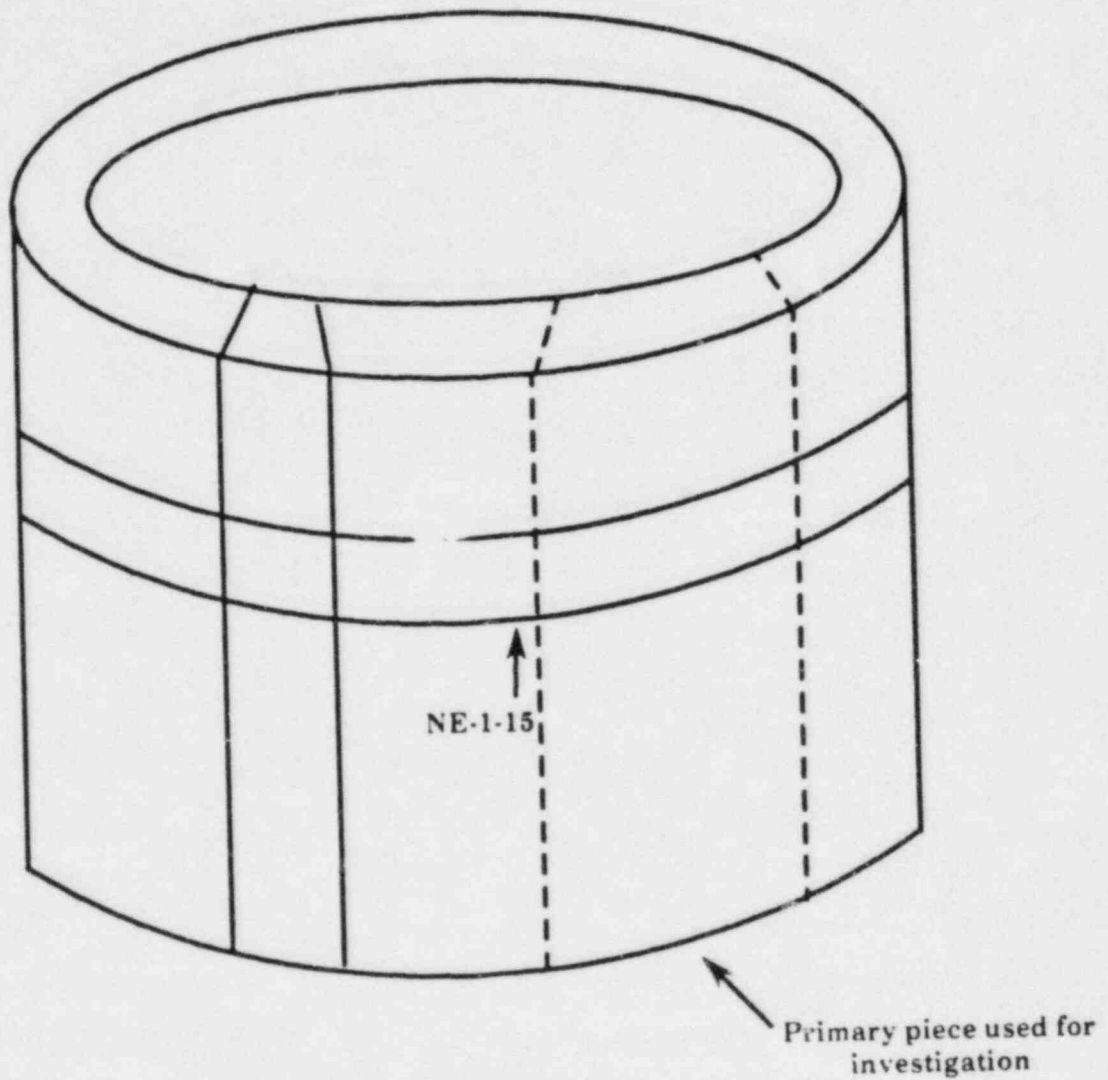
FIGURE 16: Sketch of 12 inch diameter spool piece showing ↑NE-1-15 and axial weld in addition to the piece removed for examination.

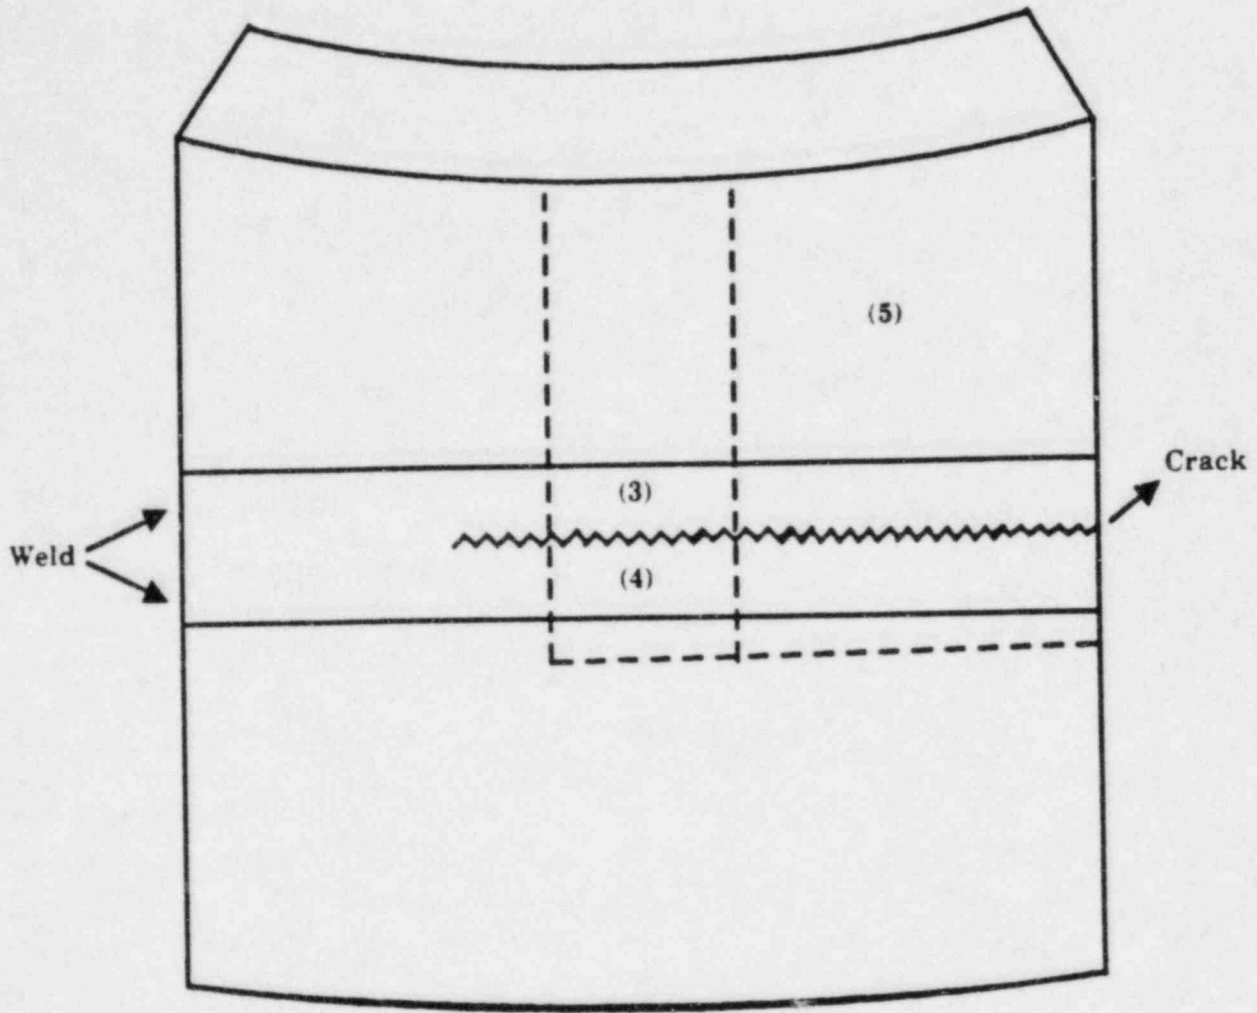
Figure 17 shows the piece removed from the 12" spool piece and the location of the pieces used for each of the subsequent examinations.

Scanning electron microscopy was performed on piece "3" in Figure 17, and in this case, a heavy coating of oxide necessitated the use of ultrasonic agitation for two ten-minute periods in a 5 percent H_2SO_4 solution containing catechol.

The piece marked "5" in Figure 17 was mounted in epoxy resin and ground, polished, and etched with Kalling's etchant prior to being photographed. The weld bead was photographed at 8X while the crack was done at 50X. The location of the 50X pictures is given on the 8X picture.

The results of the chemical analysis by X-ray fluorescence appear in Table II. The location of the chemical analysis specimen is shown in Figure 17 as piece "4".

Figure 17: Piece removed from 12 inch spool piece and the location of fractographic specimen (3); metallographic specimen (5); chemical analysis specimen (4).

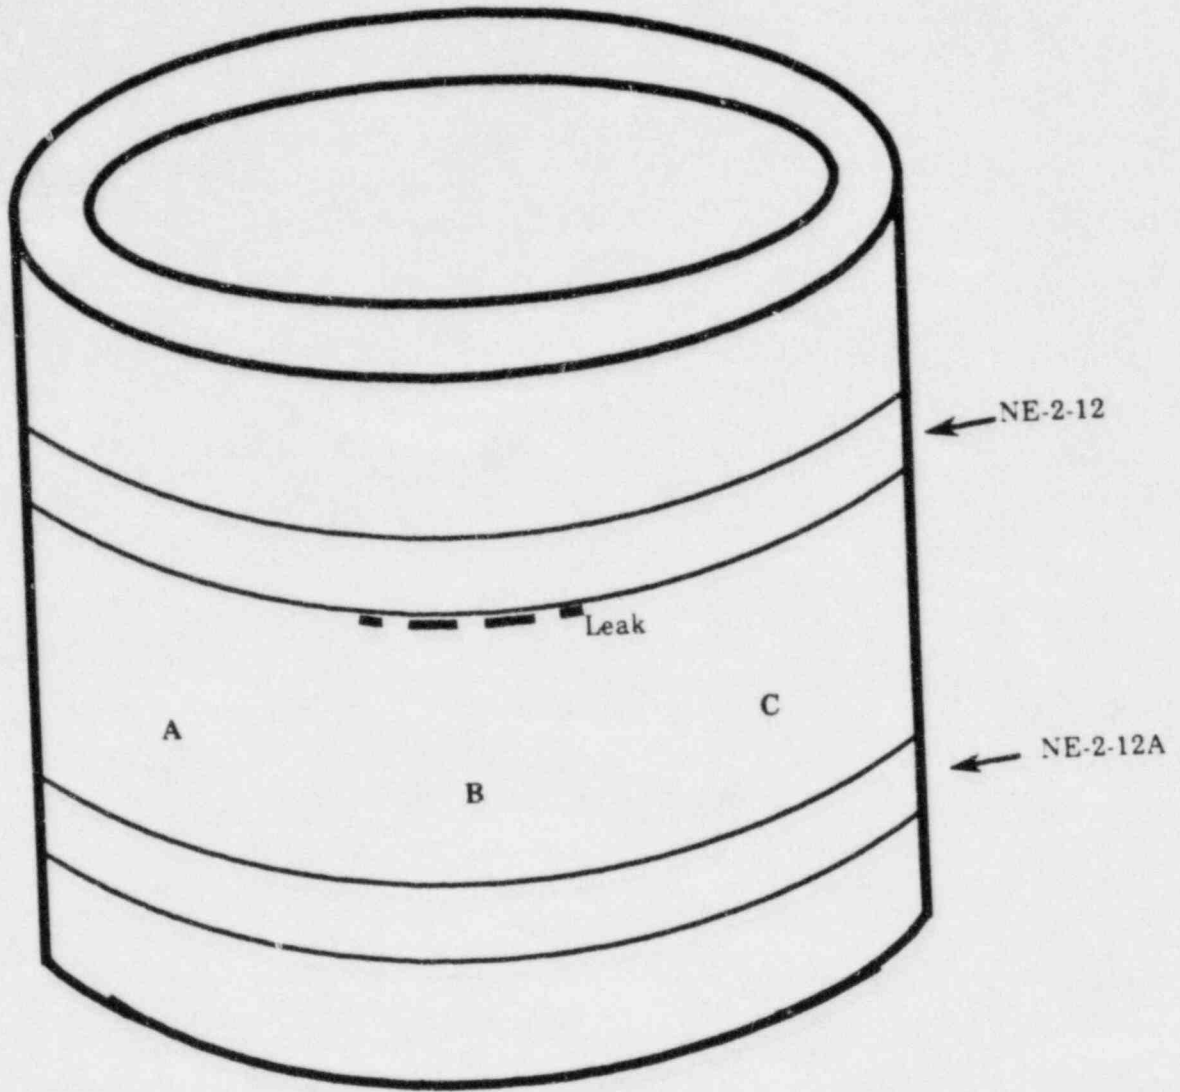
APPENDIX I: Location of the radiographs on NE-2-12 in the 8 inch pipe.

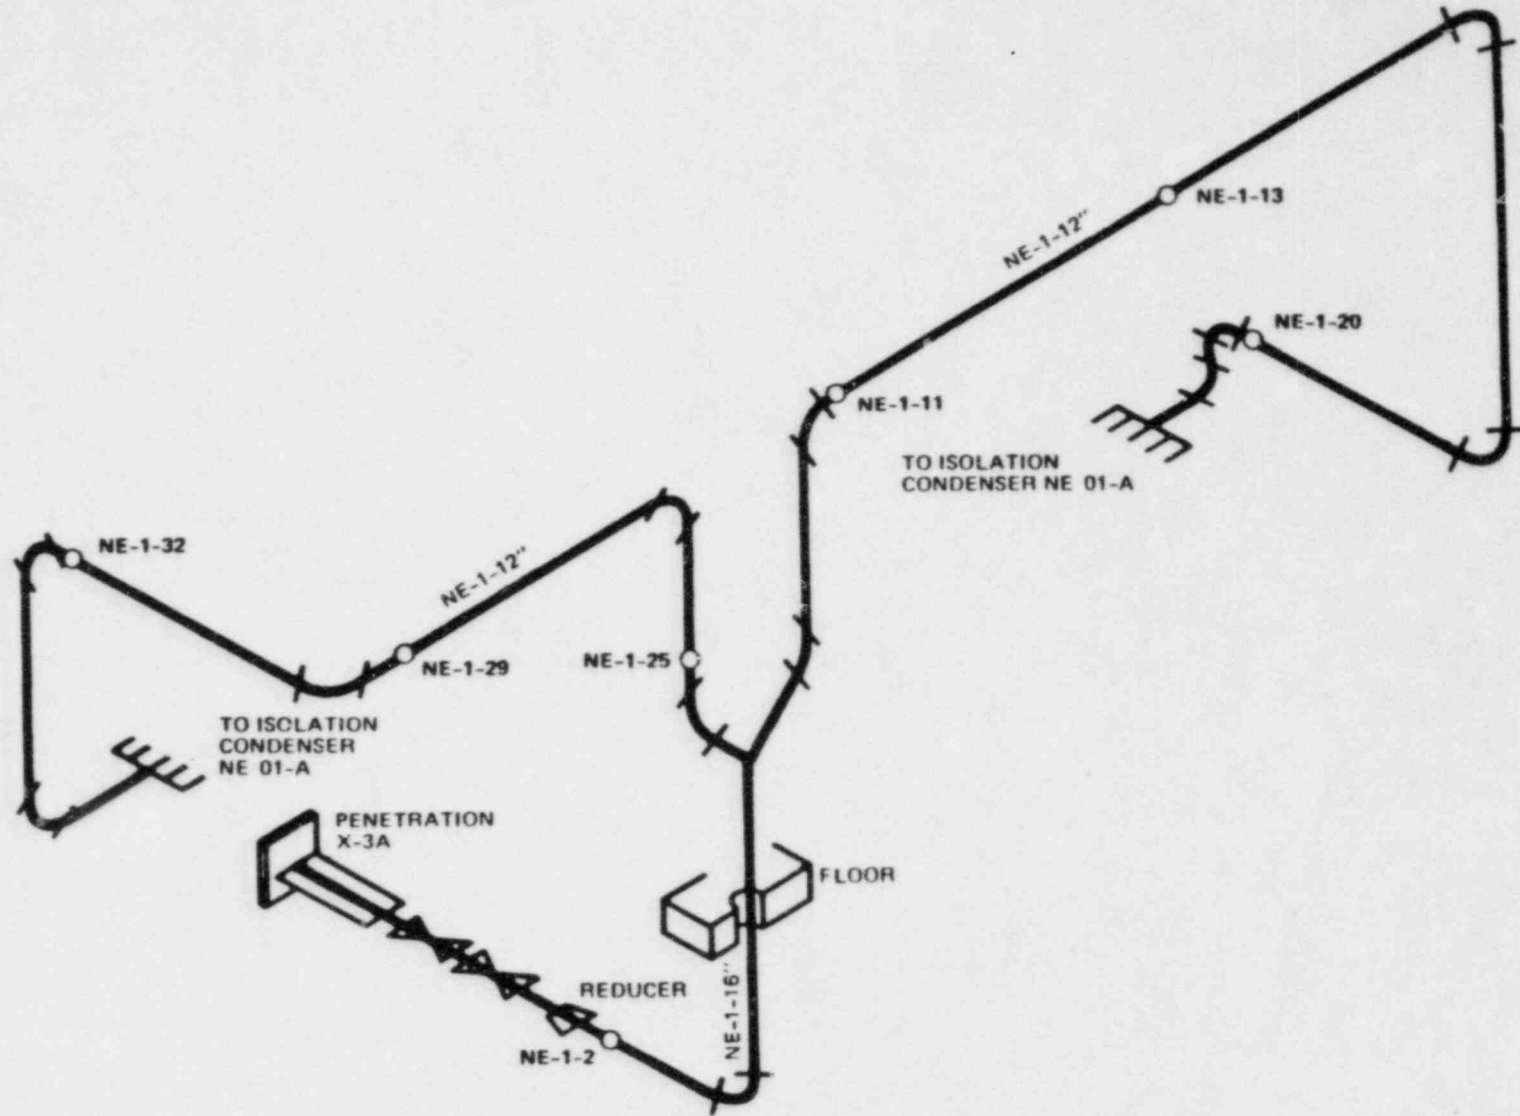
Figure 1

Oyster Creek Isolation Condenser Piping Loop A Supply Line

GPU Nuclear has decided to weld overlay repair eighteen of these welds and replace the remaining nine welds. The four pipe lines and the overlay locations are shown in Figures 1 through 4. Table 1 summarizes all of the welds and the respective pipe lines and pipe diameters. All but two of the indications were found in the 12-inch supply lines and the 8-inch return lines. The other two were at welds in a 10-inch return line and a 16-inch supply line. The overlays are to be designed to assure that the full structural margin intended by IWB-3640, Section XI [1], is maintained. This report provides recommendations for the design of the weld overlays to meet the Code safety margins and specific geometric considerations at each weld. The effects of axial shrinkage of the piping from application of the overlays is also examined in terms of the additional stresses imposed on the piping system.

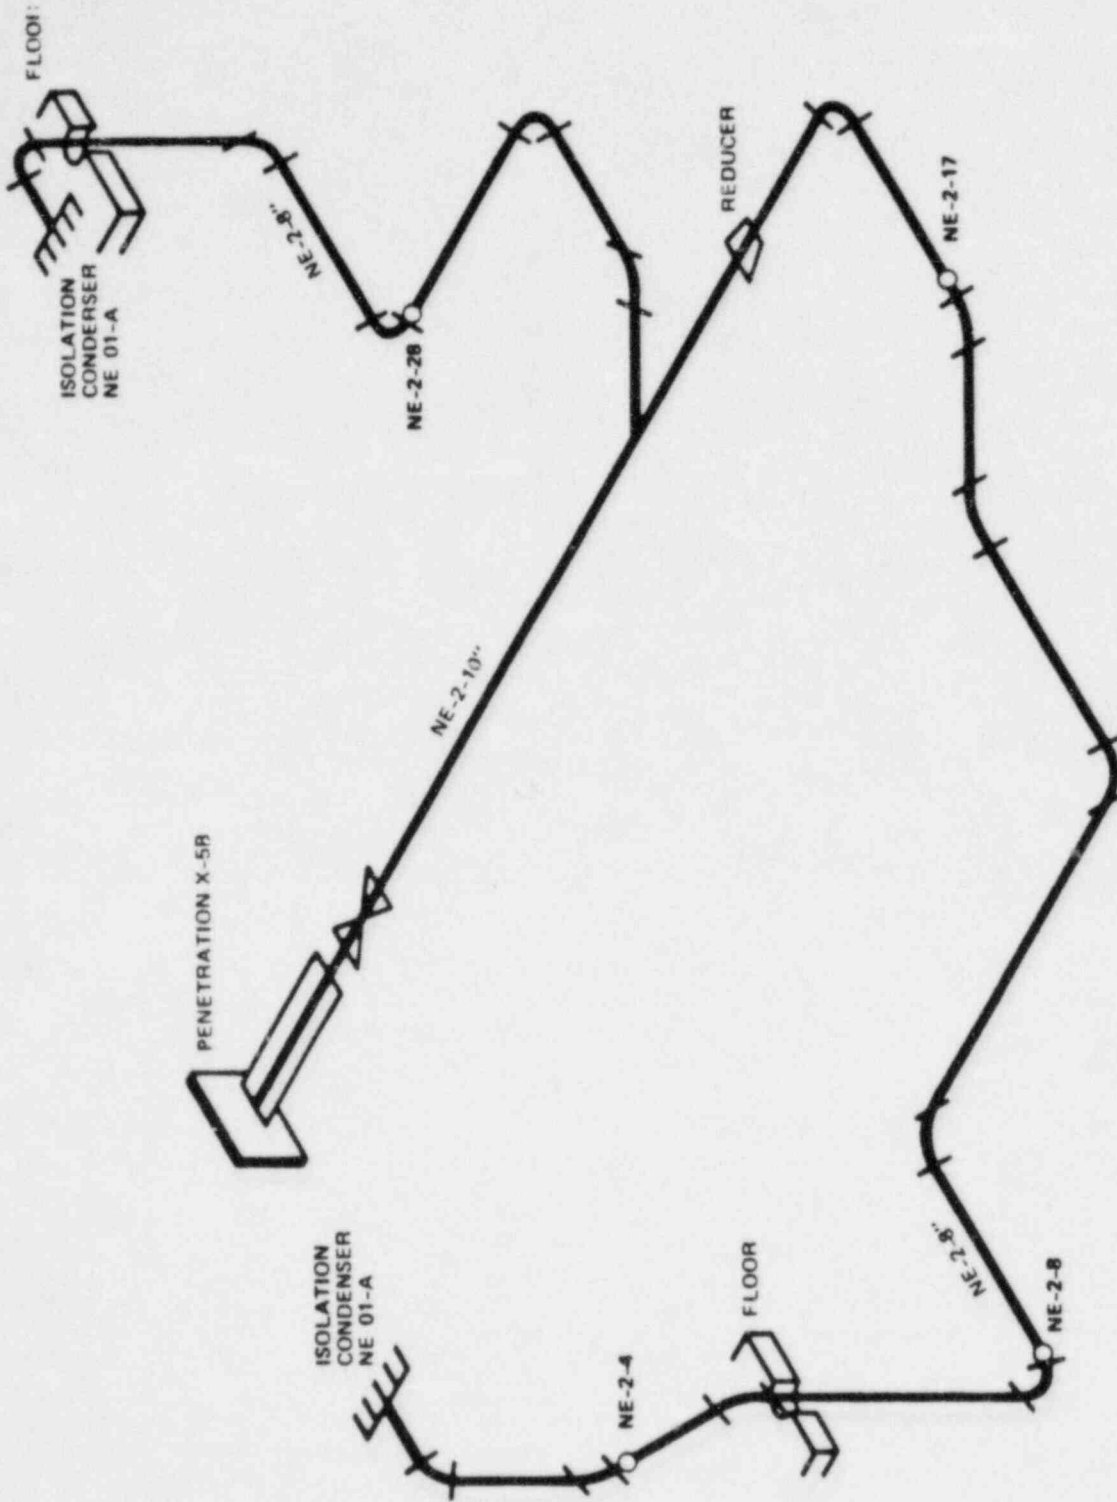
Figure 2

Oyster Creek Isolation Condenser Piping Loop A Return Line

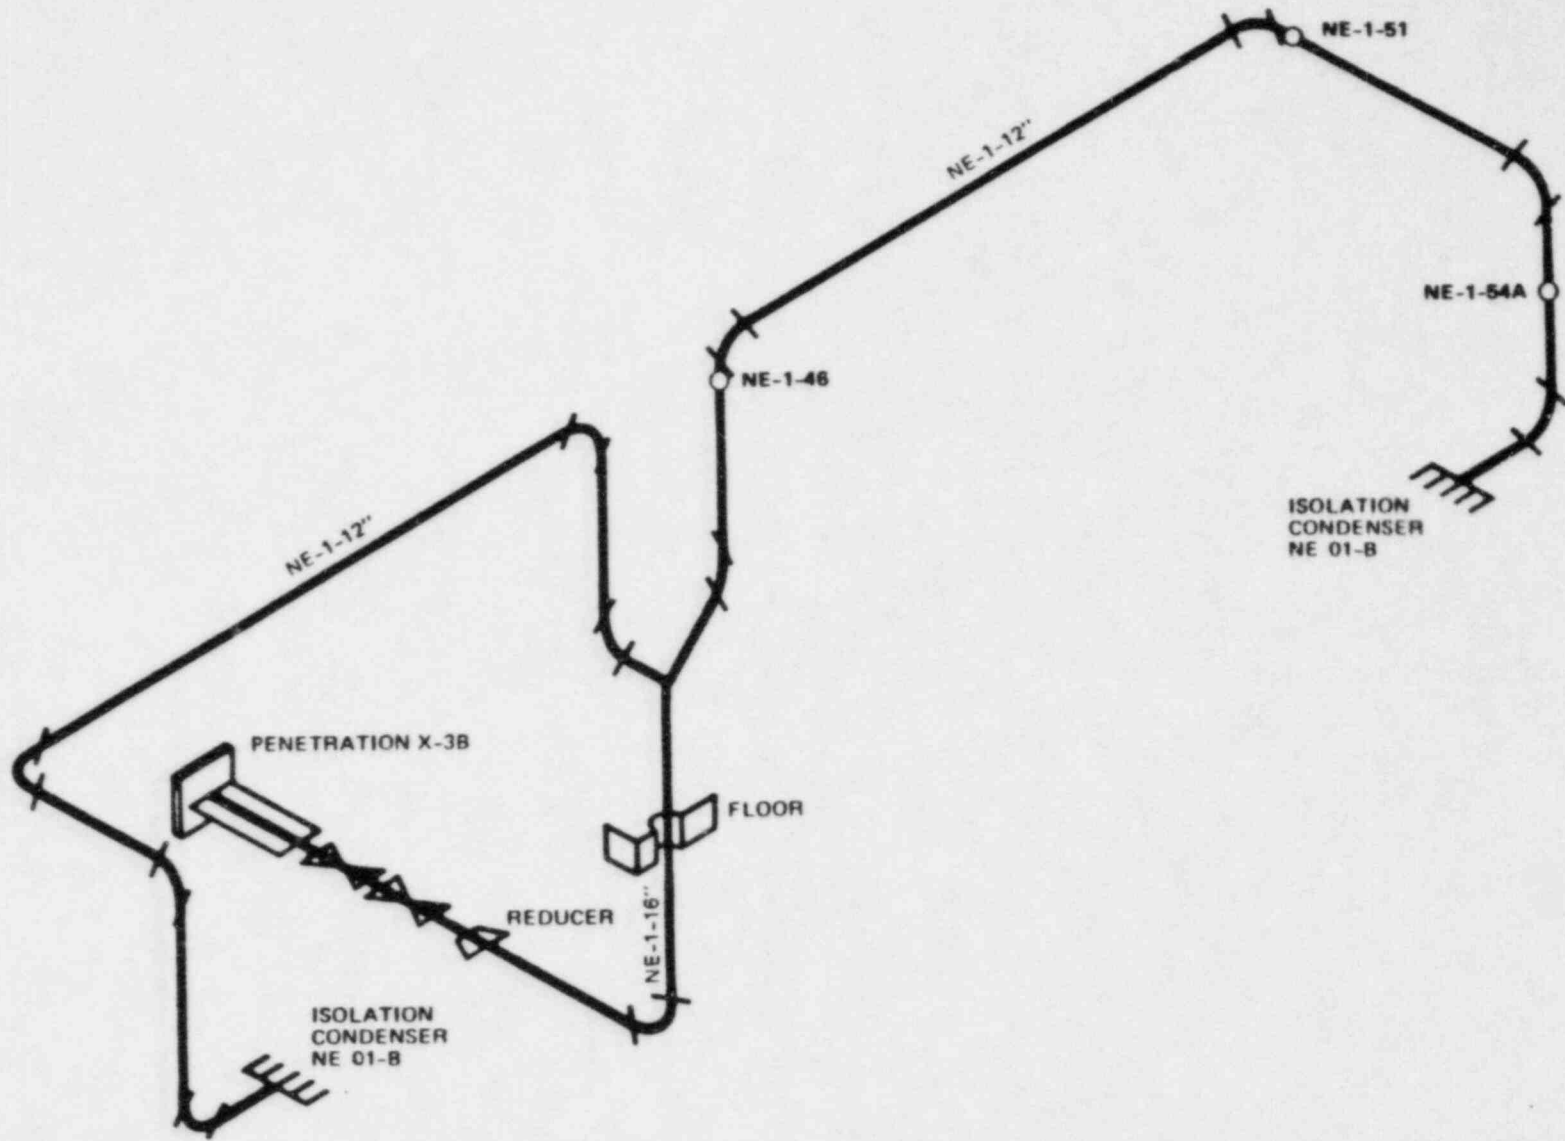
Figure 3

Oyster Creek Isolation Condenser Piping Loop B Supply Line

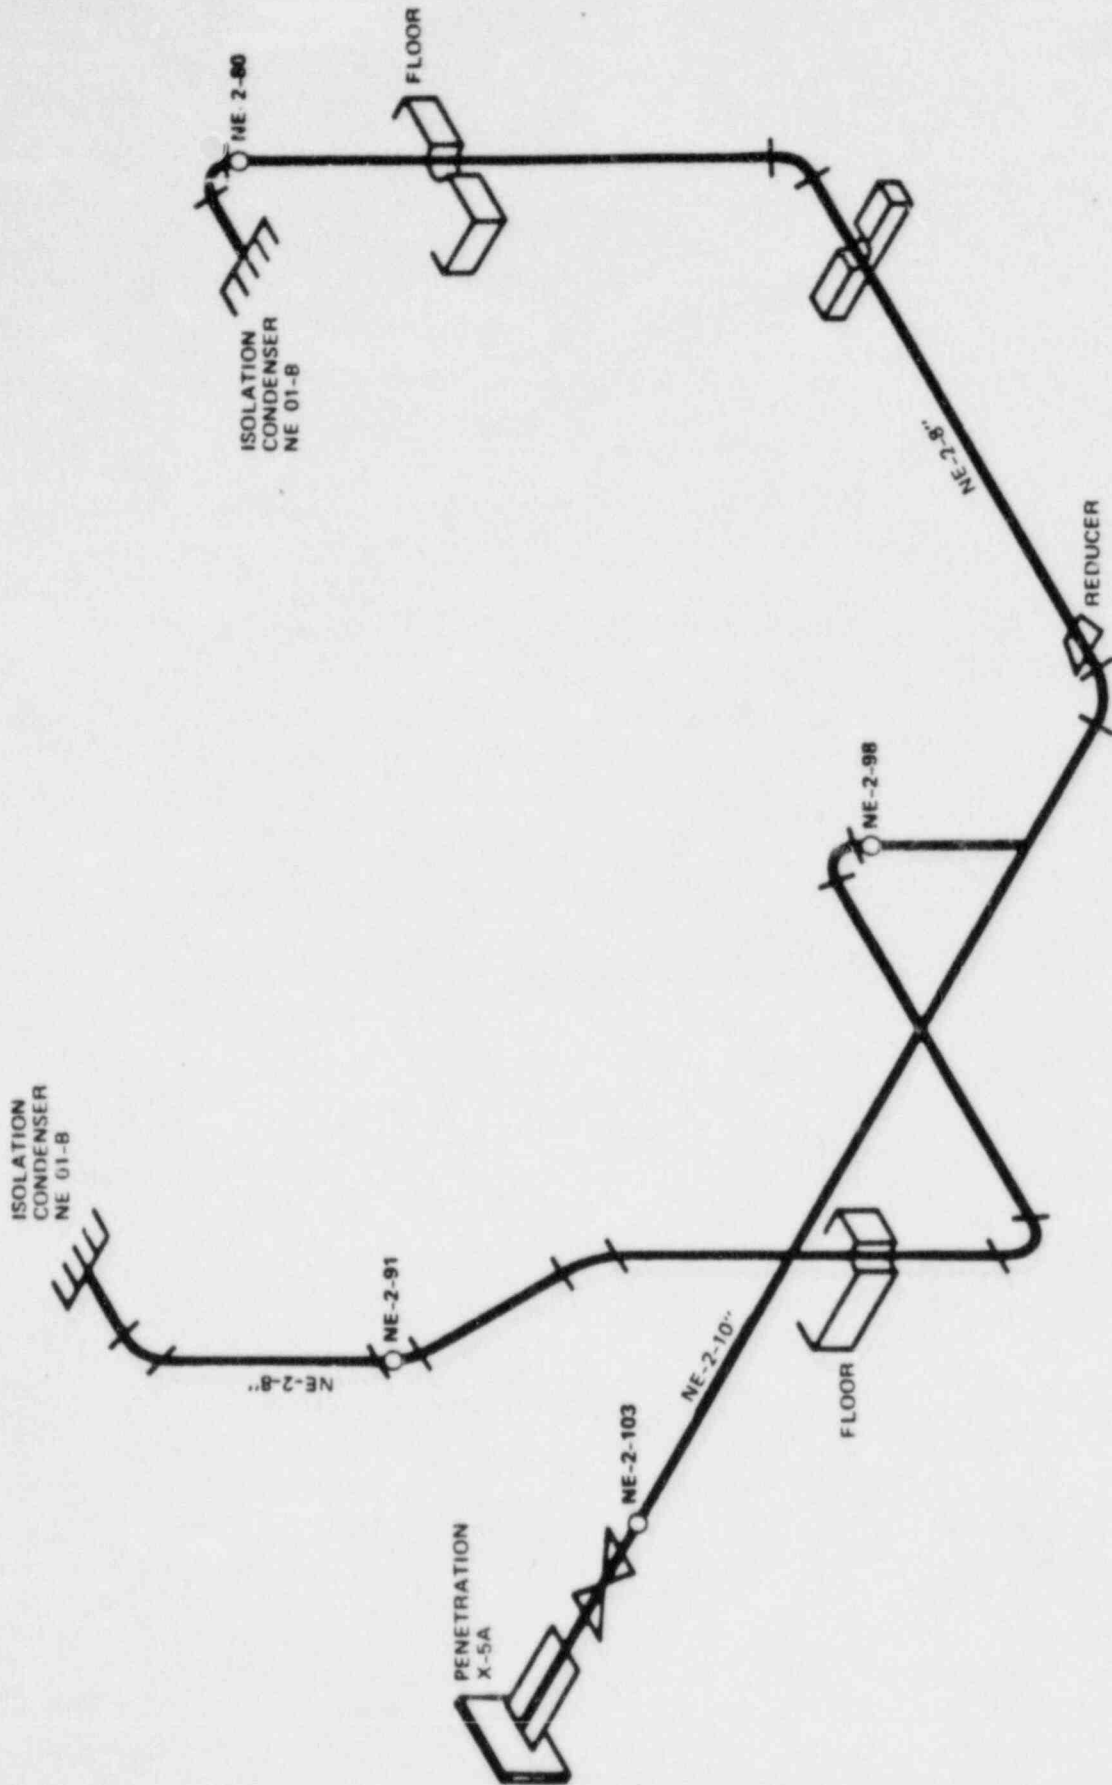
Figure 4

Oyster Creek Isolation Condenser Piping Loop B Return Line

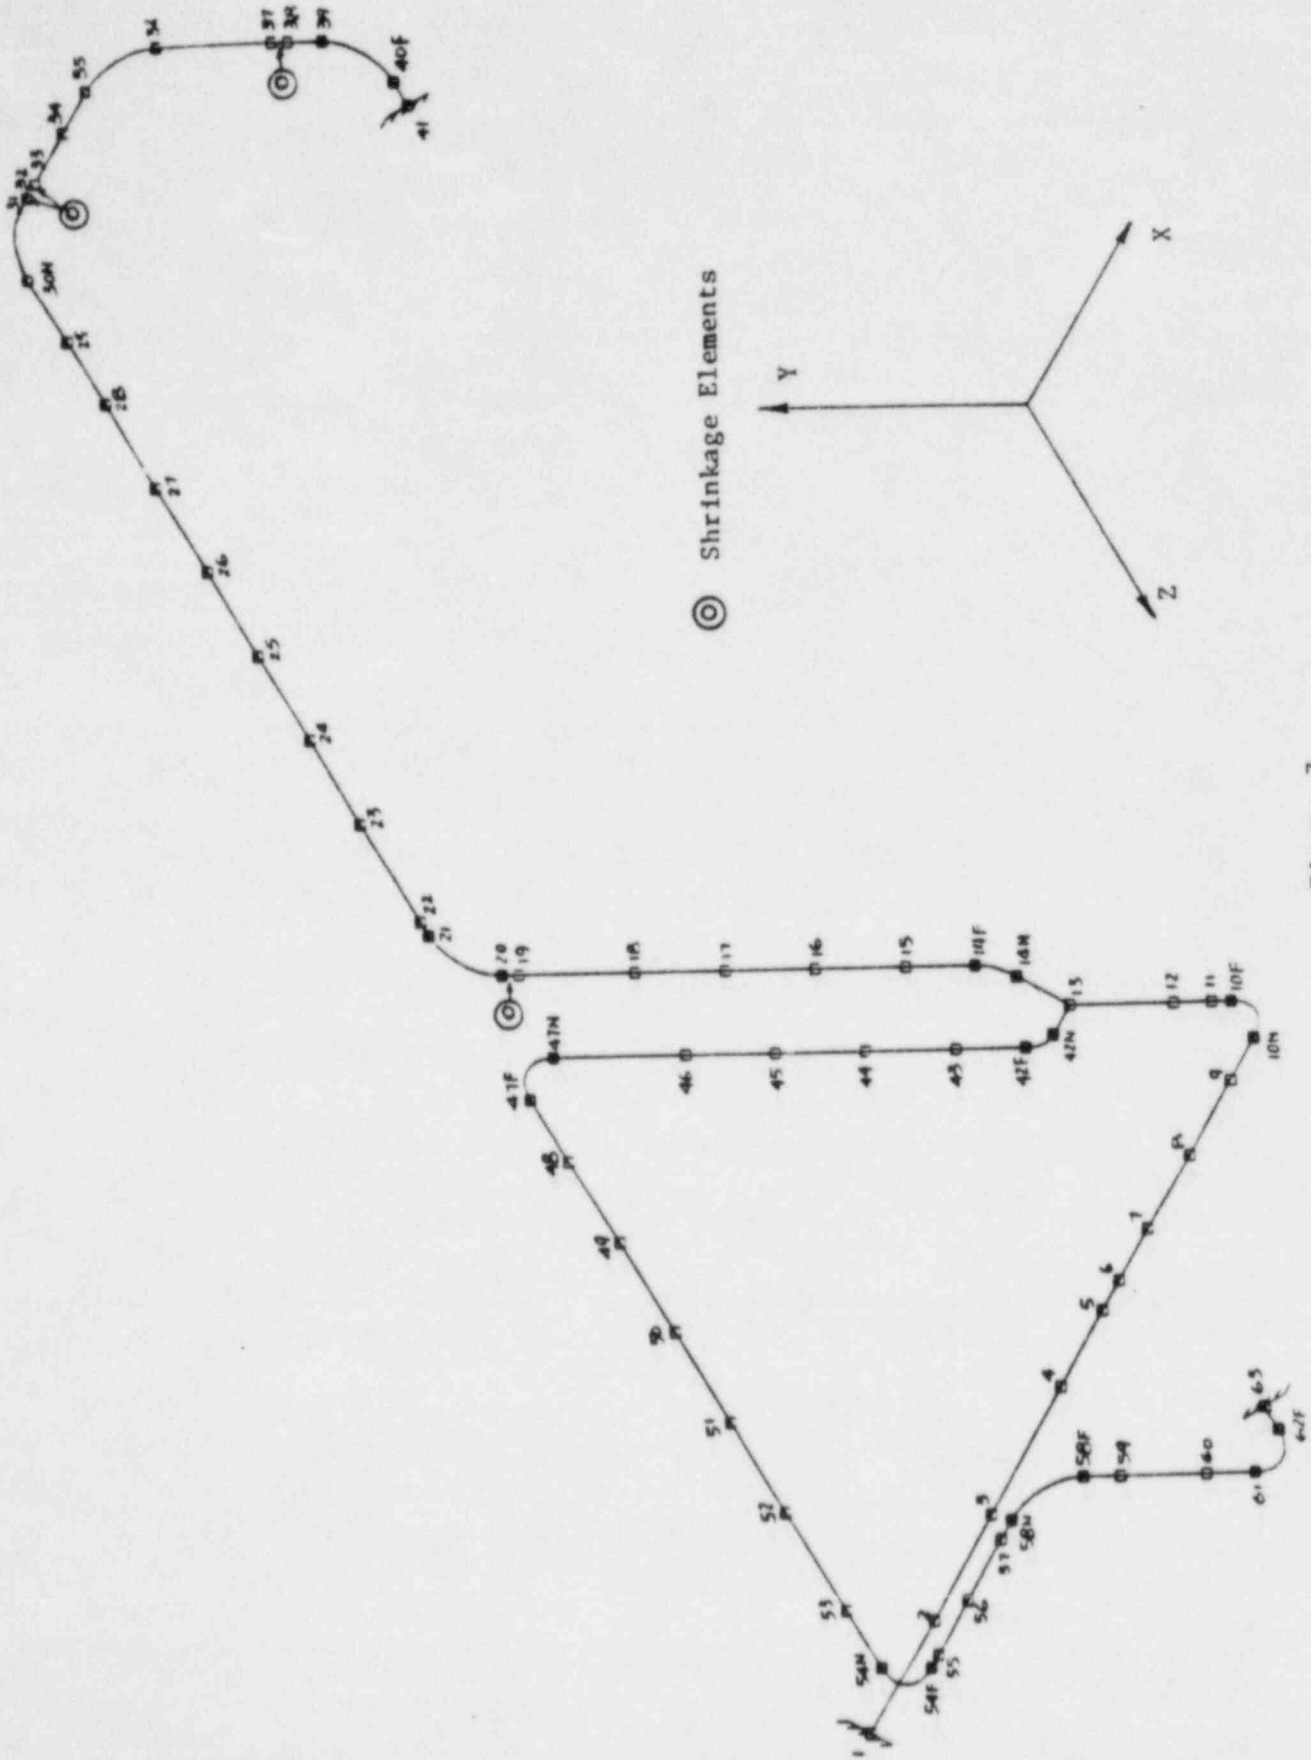
Figure 7

Application of a weld overlay produces an axial contraction of the pipe which is a function of the pipe size and the overlay thickness and width. This shrinkage imposes stresses on the entire piping system. The amount of shrinkage was estimated for the purpose of this analysis based on typical shrinkages observed in similar weld overlay applications. The 8- and 10-inch pipe overlays were assumed to shrink 1/4 inch, and the 12- and 16-inch pipe overlays were assumed to shrink 3/8 inch. A finite element analysis of the Loop B supply and return piping was performed to determine the magnitudes of the stresses due to these assumed shrinkages. This analysis was performed using the PISYS finite element code (Reference 5). The models are provided in Figures 7 and 8. The shrinkage effect was simulated by forcing thermal contractions at the weld overlay locations equivalent to the assumed 1/4- and 3/8-inch overlay shrinkages. A summary of the maximum shrinkage stresses obtained in the Loop B supply and return lines is provided in Table 7.

Isolation Condenser Piping Model for Shrinkage Stress Analysis--
Loop B Supply

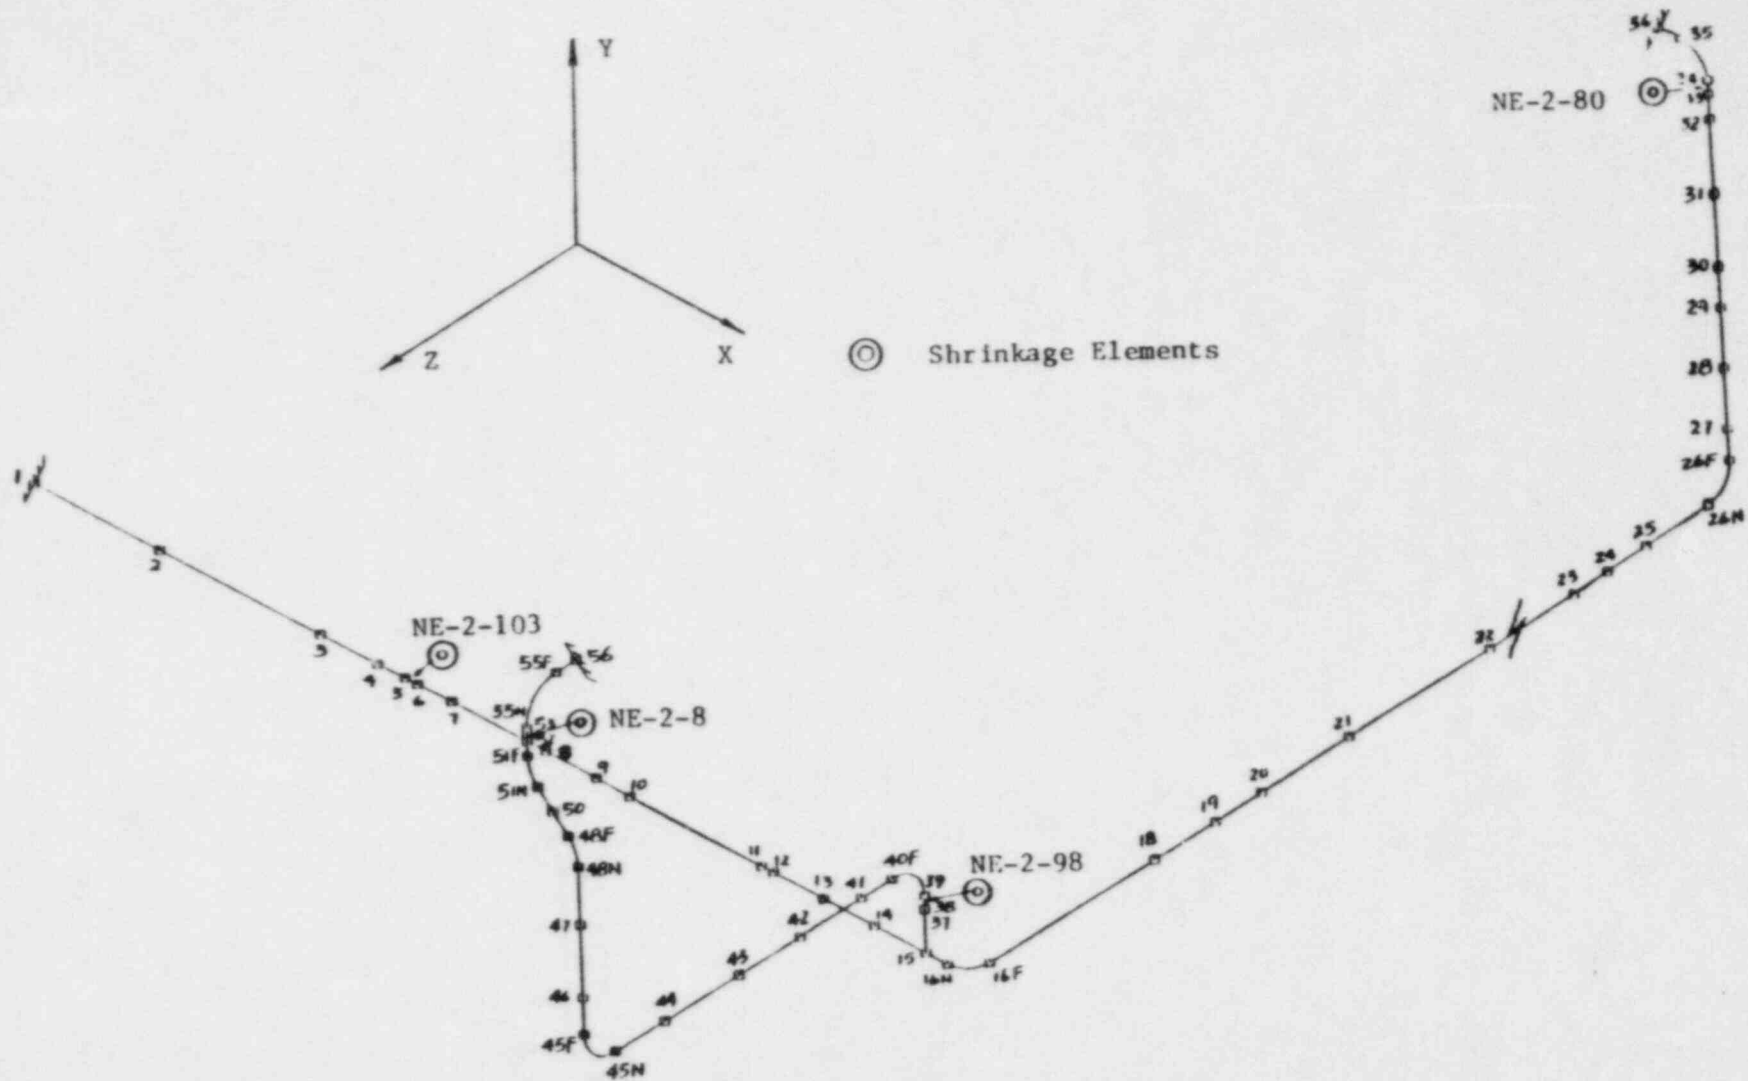
Figure 8

Isolation Condenser Piping Model for Shrinkage Stress Analysis--
Loop B Return
