Iowa Electric Light and Power Company

## April 21, 1992 NG-92-2091

Subject: Duane Arnold Energy Center Docket No: 50-331 Op. License DPR-49 Licensee Event Report #92-004

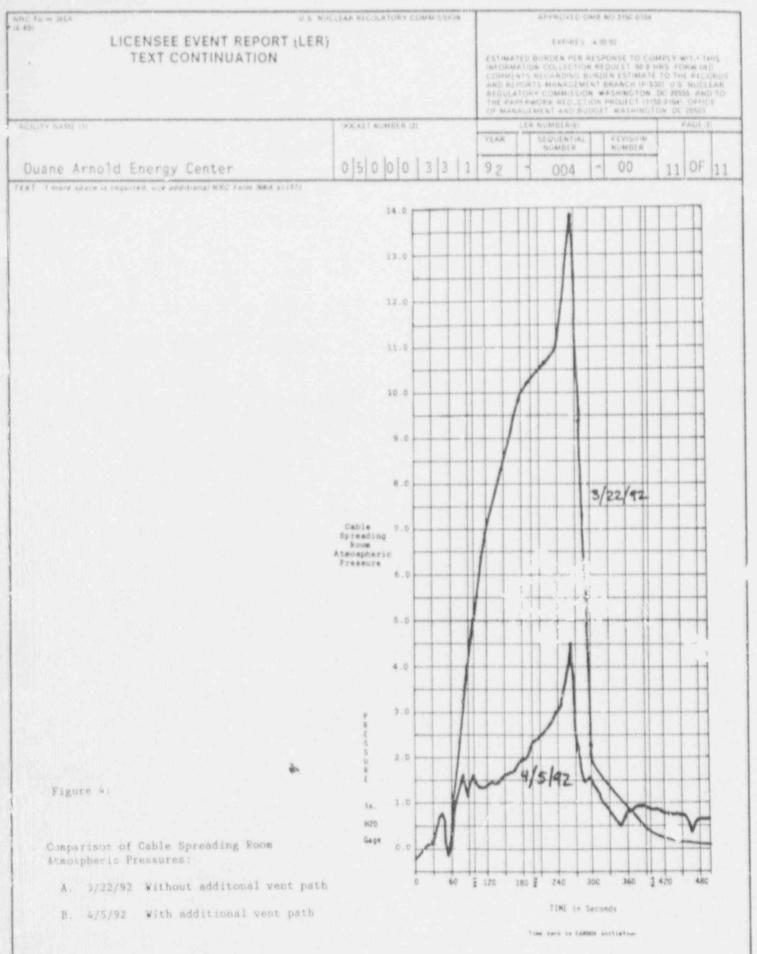
Figure 3: Cable Spreading Room and Control Room Ventilation Interfaces, April 5, 1992

The review of the test data from March 22 indicated that enhancements to reduce pressure further in the CSR during GD2 injection would likely result in significantly less CO2 intrusion into the Control Room while not greatly effecting the fire suppression system. Therefore, an additional, manually-operated temporary vent was added to the Cable Spreading Room (see Figure 3, Damper D), and the automatic damper on the existing vent path (Damper C) was also set to remain open an additional thirty seconds. The test was rerun on April 5, 1992. The reactor vessel was partially fueled, with no fuel movement in progress, nor other work with the potential to drain the vessel. As with the first test on March 22, a number of precautions were taken, including the wearing of SCBAs by Control Room personnel prior to the test commencing. Management personnel were again present.
