**NUREG/CR-3591  
Volume 2  
ORNL/NSIC-217/V2**

**Precursors to Potential Severe  
Core Damage Accidents: 1980-1981**

**A Status Report**

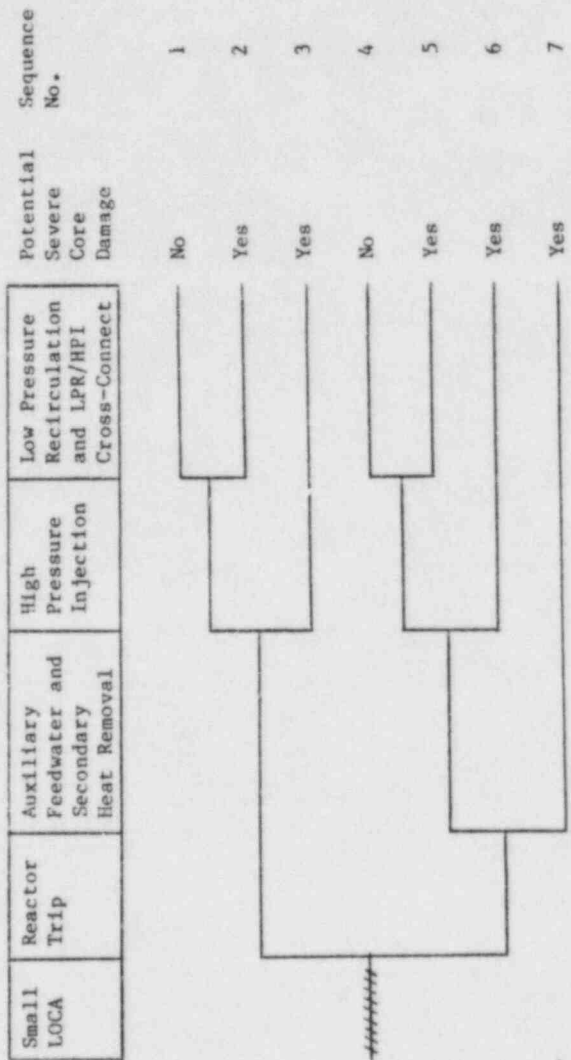
NSIC 154451 - Sequence of Interest for Inadvertent Opening of PORV at Haddam Neck

NSIC ACCESSION NUMBER: 154451  
LER NO.: 80-04/3L  
DATE OF LER: February 12, 1980  
DATE OF EVENT: February 4, 1980  
SYSTEM INVOLVED: Pressurizer relief system  
COMPONENT INVOLVED: PORV and block valve  
CAUSE: Spurious actuation signal  
SEQUENCE OF INTEREST: Small break LOCA  
ACTUAL OCCURRENCE: Inadvertent opening of a PORV and block valve  
REACTOR NAME: Haddam Neck  
DOCKET NUMBER: 50-213  
REACTOR TYPE: PWR  
DESIGN ELECTRICAL RATING: 580 MWe  
REACTOR AGE: 12.5 years  
VENDOR: Westinghouse  
ARCHITECT-ENGINEERS: Stone and Webster  
OPERATORS: Connecticut Yankee Atomic Power Co.  
LOCATION: 13 miles east of Meriden, Connecticut  
DURATION: N/A  
PLANT OPERATING CONDITION: Full power  
TYPE OF FAILURE: Inadequate performance;  
inadvertent operation  
DISCOVERY METHOD: Operational event

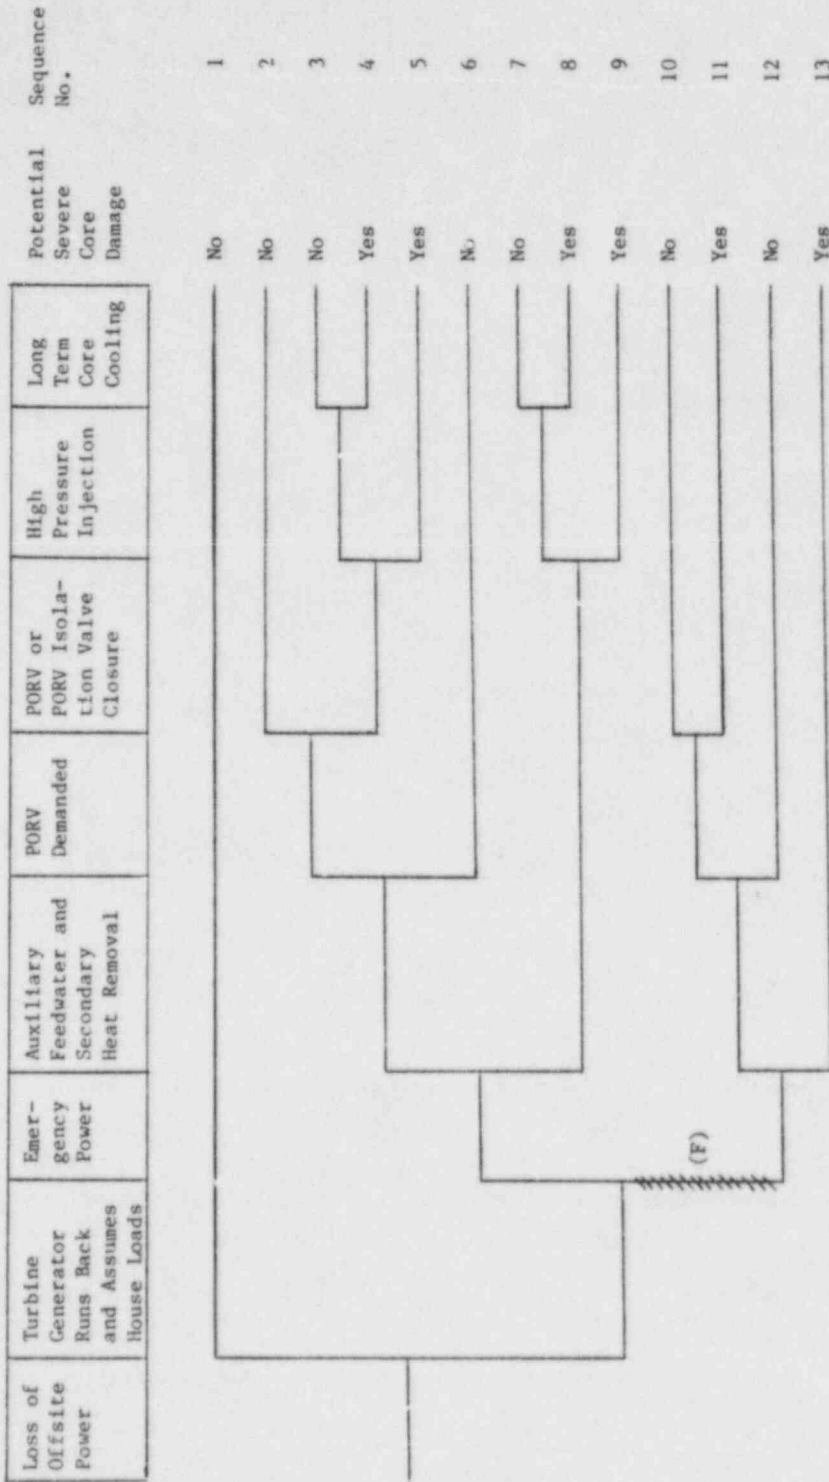
NSIC 154674 - Sequence of Interest for Emergency Power System Unavailability at Calvert Cliffs 2

NSIC ACCESSION NUMBER: 154674  
LER NO.: 80-10/3L  
DATE OF LER: February 8, 1980  
DATE OF EVENT: February 2, 1980  
SYSTEM INVOLVED: Emergency power system  
COMPONENT INVOLVED: Three diesel generators  
CAUSE: SIAS modules improperly reset  
SEQUENCE OF INTEREST: LOOP  
ACTUAL OCCURRENCE: Emergency power system unavailable  
REACTOR NAME: Calvert Cliffs Unit 2  
DOCKET NUMBER: 50-318  
REACTOR TYPE: PWR  
DESIGN ELECTRICAL RATING: 845 MWe  
REACTOR AGE: 3.2 years  
VENDOR: Combustion Engineering  
ARCHITECT-ENGINEERS: Bechtel  
OPERATORS: Baltimore Gas and Electric  
LOCATION: 40 miles south of Annapolis, Maryland  
DURATION: 15 min  
PLANT OPERATING CONDITION: Unit 2 at 100% power  
TYPE OF FAILURE: Made inoperable  
DISCOVERY METHOD: Alarm/annunciator in control room  
COMMENT:

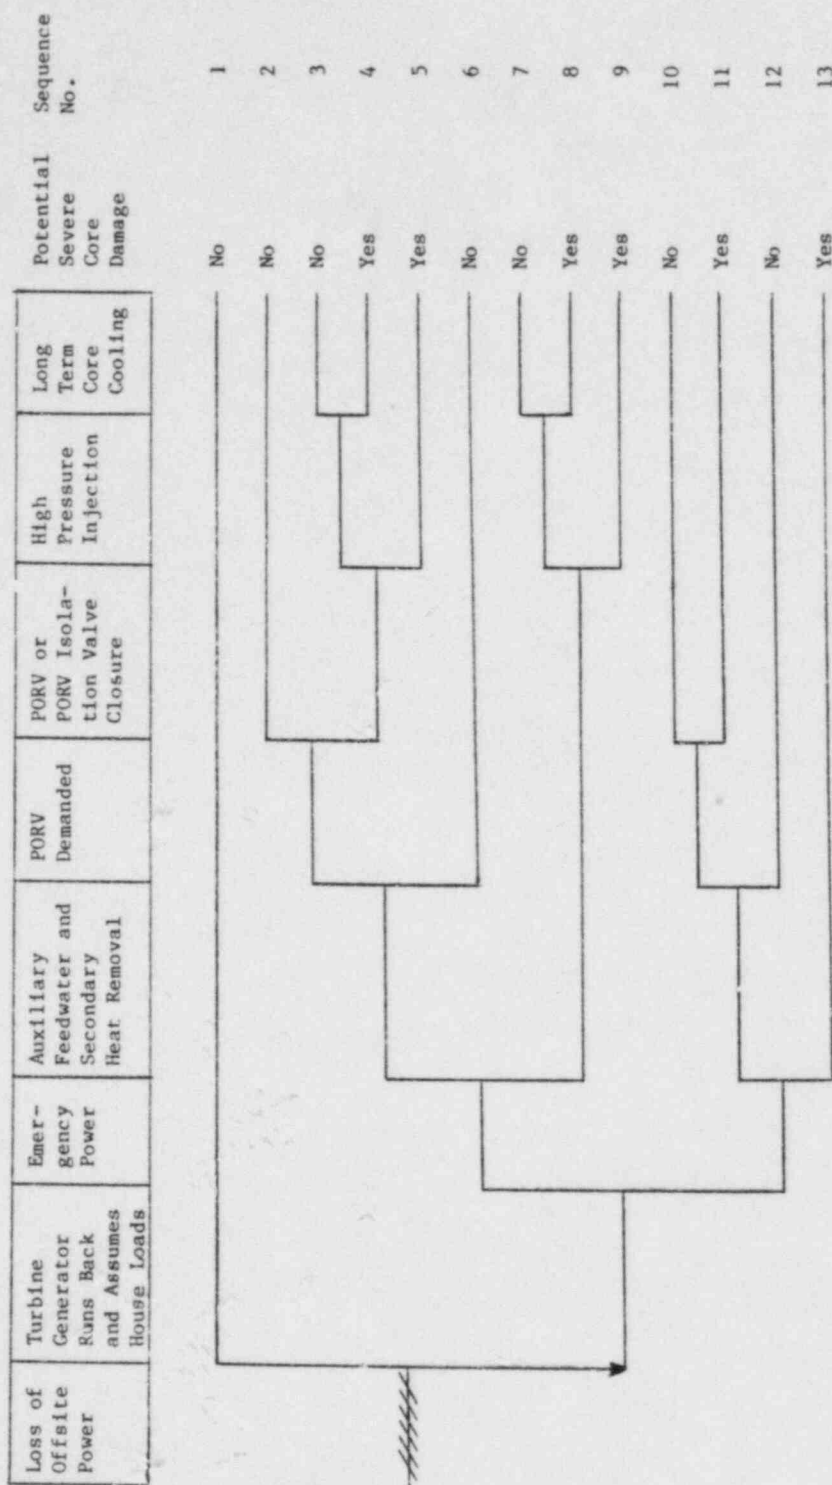
NSIC 158228 - Sequence of Interest for Loss of Offsite Power at Prairie Island 2

1. With Unit 2 at 100% power a severe electrical storm caused operation of several breakers in the substation.
2. The unit generator separated from the grid and the reactor and reactor coolant pumps tripped.
3. About 8 minutes later, the 345/161/13.8 kV No. 10 transformer locked out.
4. The diesel generators started and provided power to safety-related loads.

CAUSE: Electrical storm

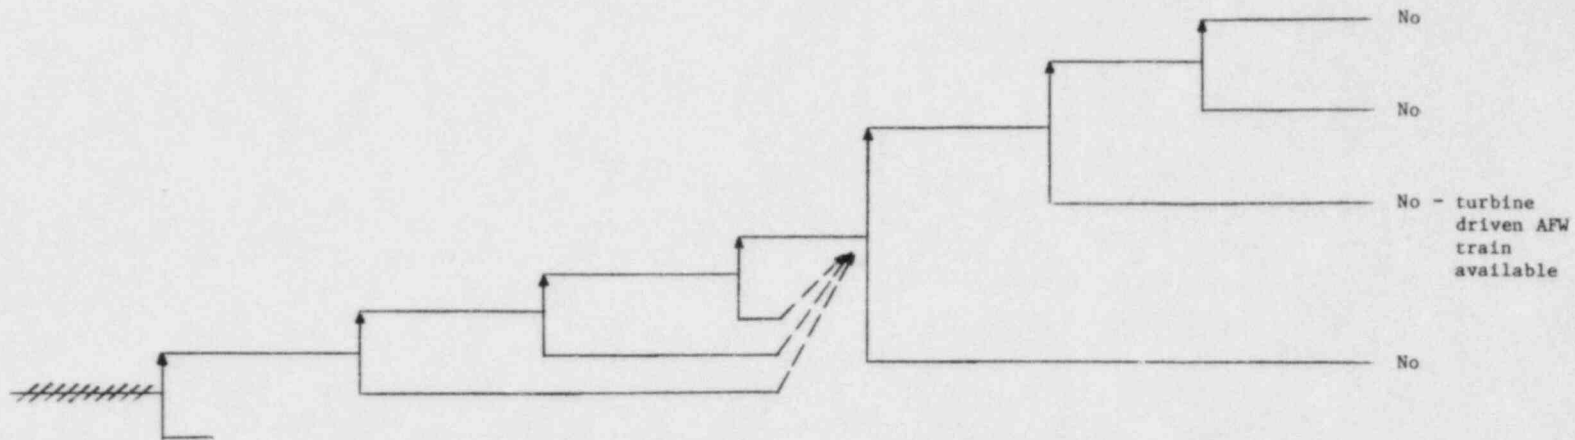
NSIC 158232 - Actual Occurrence for Loss of Offsite Power at Indian Point 2

Reactor at power and lightning strike results in loss of four feeder lines	Two previously started gas turbine generators trip due to loss of 138-kV supply at Buchanan substation	Loss of power to two 6.9-kV and two 480-V buses results in diesel generator start	Loss of the 480-V buses results in 70% turbine run-back and loss of rod position indication	Operator initiates manual turbine trip	Generator trip and subsequent reactor/turbine trip from breaker opening on north ring bus; loss of all 6.9-kV buses	Emergency generators energize safety-related buses	Spurious safety injection due to steam line differential pressure	Potential Severe Core Damage
--	--	---	---	--	---	--	---	------------------------------

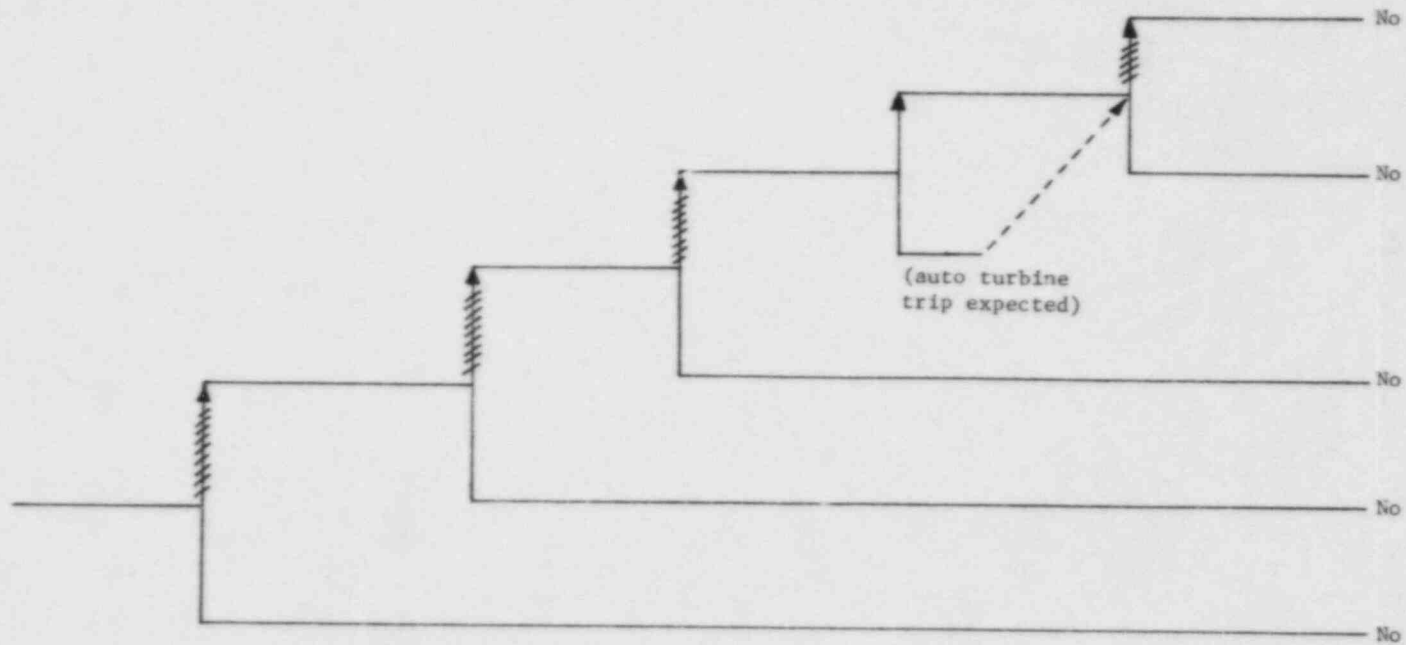
NSIC 158650 - Actual Occurrence for Failure of Service Water System and Subsequent Auxiliary Feedwater Unavailability at Calvert Cliffs 1

Unit at full power and service water heat exchanger maintenance in progress	Air compressor aftercooler air leak results in accumulation of air in isolated heat exchanger	Air bubble travels to both service water subtrains when heat exchanger returned to service	Loss of suction pressure to service water pumps and loss of service water cooling	Manual reactor trip due to high main turbine bearing temperatures. Auxiliary feedwater system provides SG cooling	Condensate storage tank valves incorrectly realigned when AFW flow is terminated and MFW system started for SG cooling	Potential Severe Core Damage
---	---	--	---	---	--	------------------------------

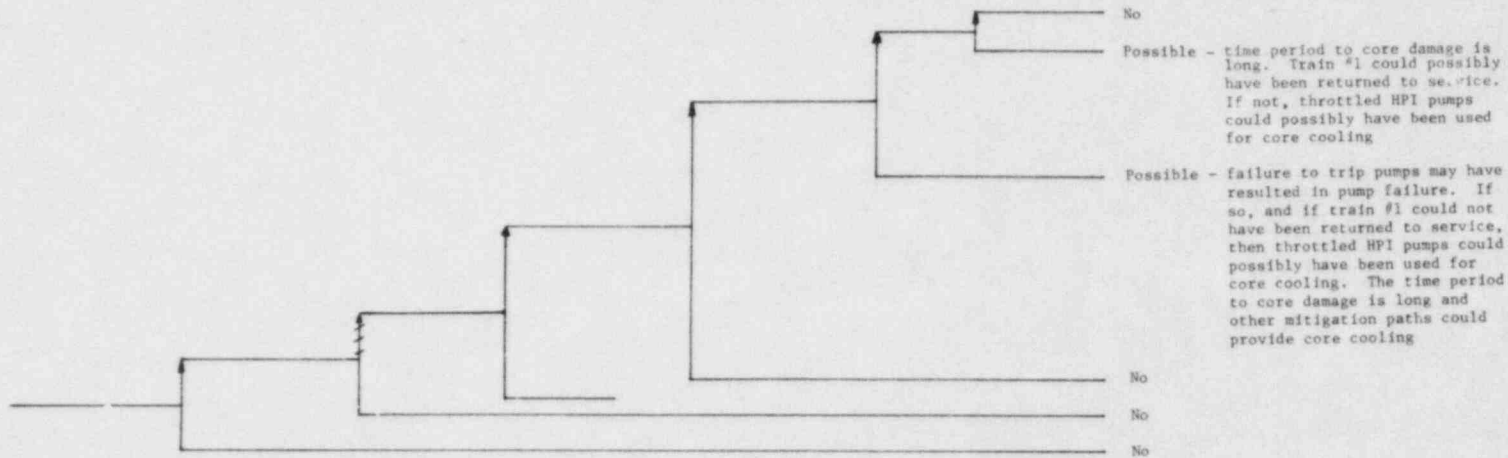
NSIC 158860 - Actual Occurrence for Loss of Two Essential Buses and Loss of Decay Heat Removal Capability at Davis-Besse 1

Unit in Cold Shutdown with Head Detensioned, SG Manways Open, #1 DH Train Drained, Unit Electrical Lineup Revised for Maintenance. Breaker Ground Fault Relay Actuates due to Vibration. Tripping Breaker. Resulting in Level 1-5 SFAS Actuation	DH Drop Line Valves Shut. Stroking Emergency Sump and B&ST Valves Results in Gravity Flow of B&ST Water into Emergency Sump. Open emergency sump Valves and Closed B&ST Valve Result in Air Being Drawn into DH Pump Suction	Operator Trips DH Pump	DH Pump Continues to Operate with Air in Pump Suction	Operator Resets Valve Alignment	DH Loop #2 Refilled and DH Removal Resumed	DH Loop #1 Returned to Service Prior to Core Damage	Other Means of DH Removal Provided (Throttled HPI Pumps, etc.)	Potential Severe Core Damage	Sequence No.
								No	1
								No	2
								No	3
								Yes	4
								No	5
								Yes	6
								No	7
								No	8
								No	9
								Yes	10
								No	11

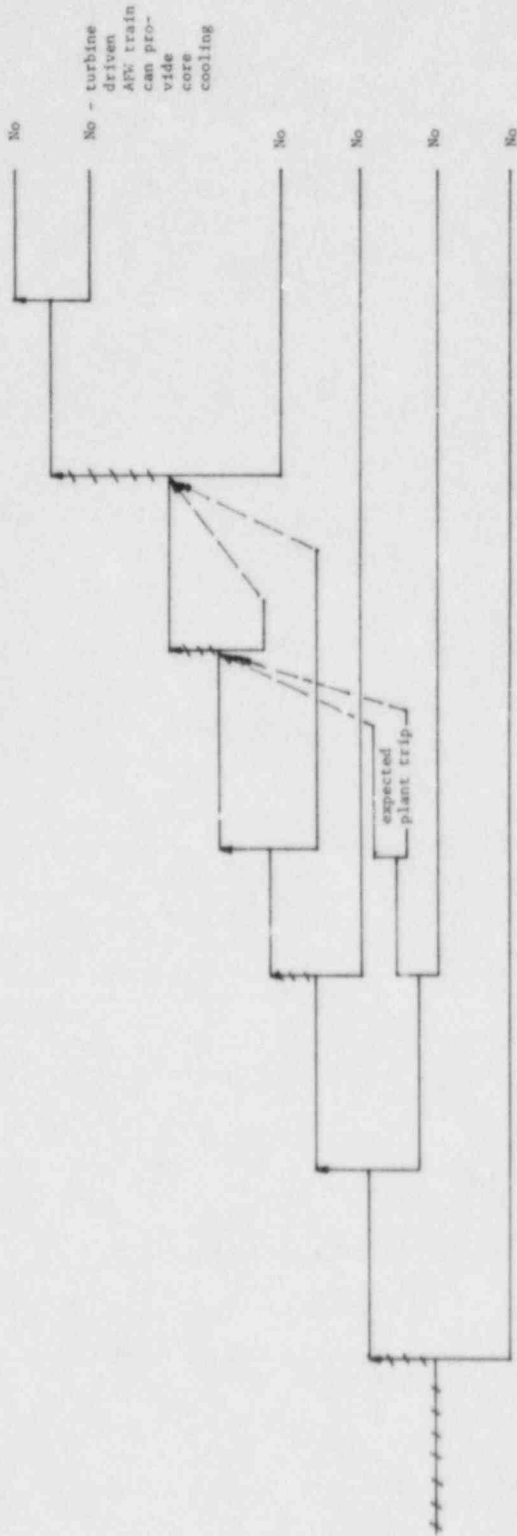
NSIC 159136 - Actual Occurrence for Loss of Offsite Power at Arkansas Nuclear 2

Reactor at 90% power and loss of 500-kV line due to ground fault. (The 500-kV line previously out of service)	Loss of second 500-kV line due to overload	Reactor trip in DNBR due to decreasing RC pump speed because of voltage/frequency problems	Loss of 161-kV line due to overload	Unit auxiliaries transferred to SU transformer #3	Loss of major 6.9-kV loads and 4.16-kV bus loads due to under-voltage	Faulted relay results in SU transformer #3 and Unit 1 SU transformer #1 lockout (loss of voltage in all auxiliary buses)	Diesel Generators start and provide power to safety-related loads	Potential Severe Core Damage
---	--	--	-------------------------------------	---	---	--	---	------------------------------

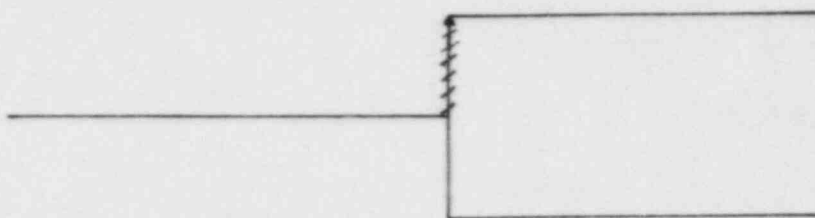
NSIC 159347 - Actual Occurrence for Unavailability of all High Steam Flow Signals at Surry 2

Steam flow transmitters FI-474, 475, 484, 485, 494, 495 found isolated due to operator error following instigated leak rate test

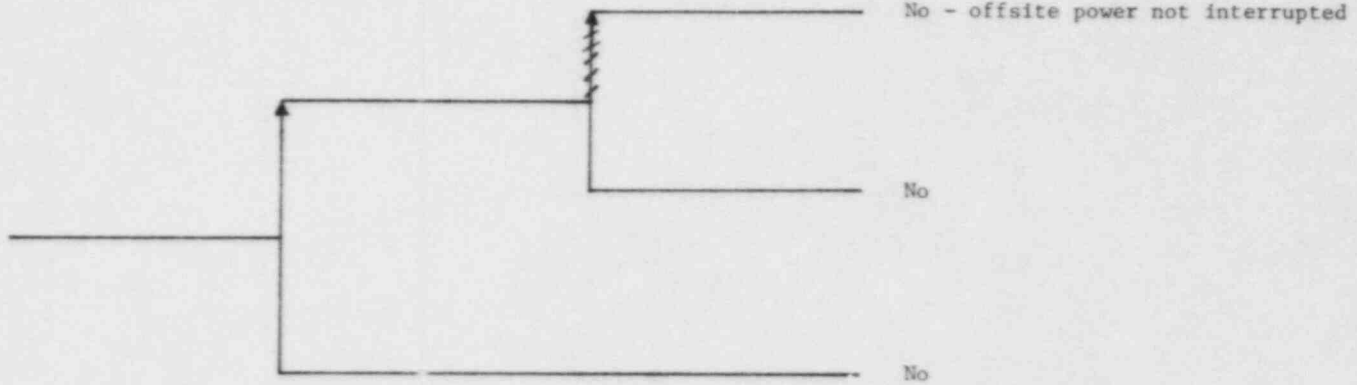
NSIC 160453 - Actual Occurrence for Loss of Emergency Power at Davis-Besse 1

Reactor in cold shutdown	EDG1-2 removed from service for maintenance	EDG1-1 made inoperable due to inadvertent opening of bus breaker control power switch
--------------------------	---	---

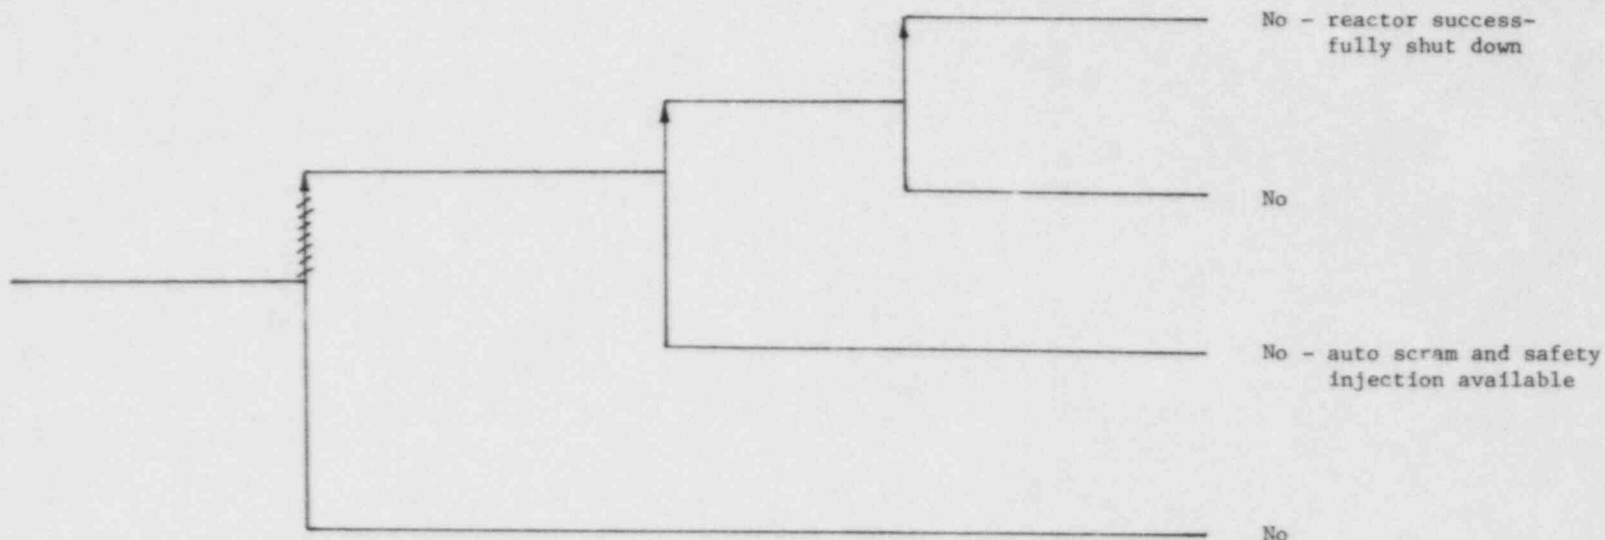
NSIC 160497 - Actual Occurrence for Inadvertent Opening of Safety Relief Valve at Pilgrim 1

Reactor operating at full power	Safety relief valve opens due to N <sub>2</sub> system pressure exceeding design specs for relief valve operators	Reactor is manually tripped	Procedure followed to close the valve results in valve stuck open
---------------------------------	---	-----------------------------	---

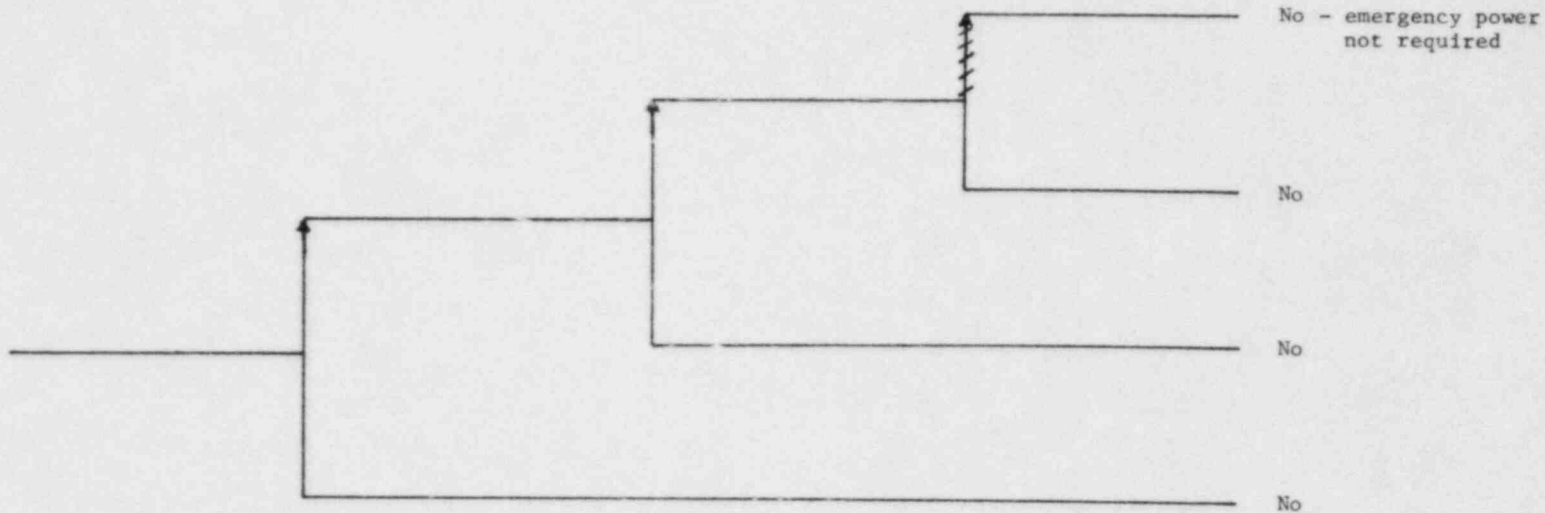
NSIC 161649 - Actual Occurrence for Two Diesel Generators Inoperable at Sequoyah 1

Reactor in mode 4 (0% power)	Diesel generator 1A-A out of service for annual maintenance	Diesel generator 1B-B undergoing testing, running at speed & voltage	Operator replaces indicator bulb, short causes DG 1B-B to trip
---------------------------------	---	---	---

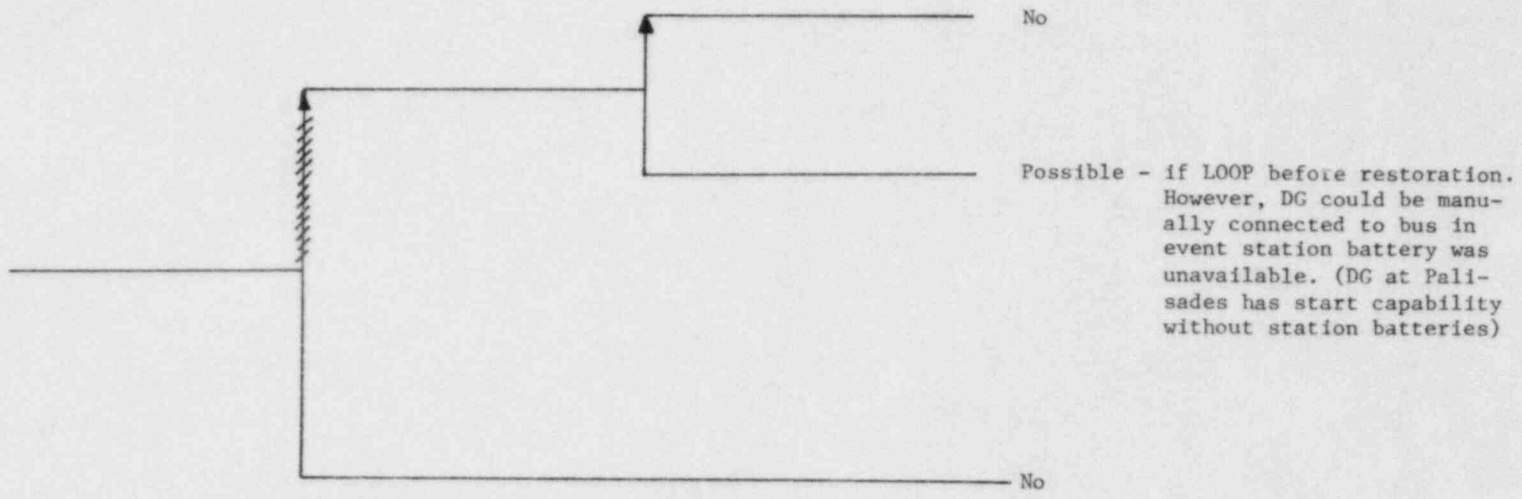
NSIC 163356 - Actual Occurrence for Output Breakers for Both Station Batteries Opened at Palisades

Reactor at full power and battery charge being terminated	Electrician opens station battery breaker in lieu of charger breaker	Supervisor discovers incorrect breaker alignment while troubleshooting inability to adjust bus voltage and restores breaker alignment
---	--	---

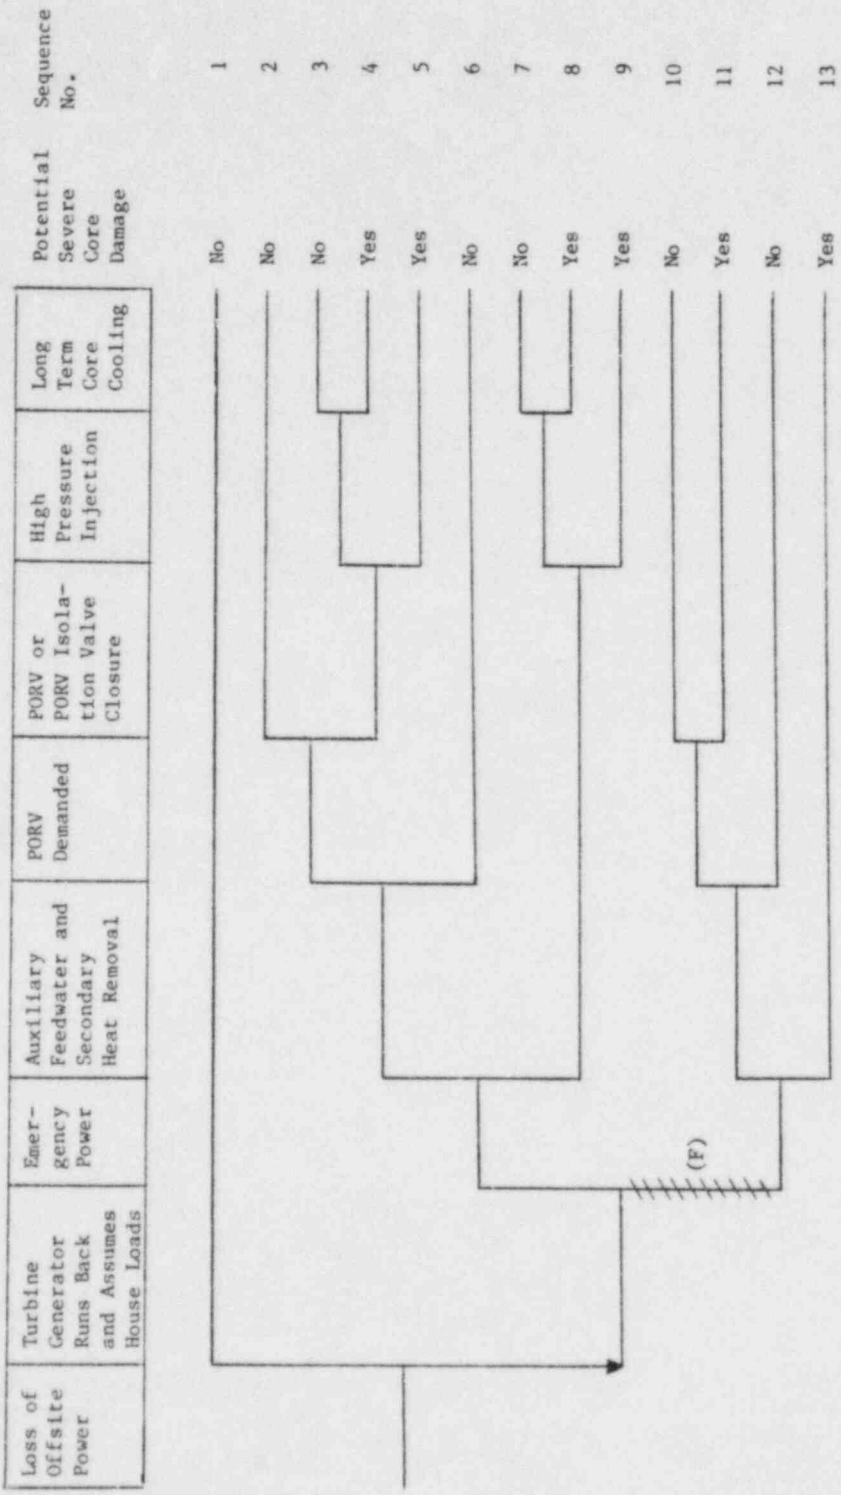
NSIC 163356 - Sequence of Interest for Output Breakers for Both Station Batteries Opened at Palisades

CAUSE: Battery breakers inadvertently opened

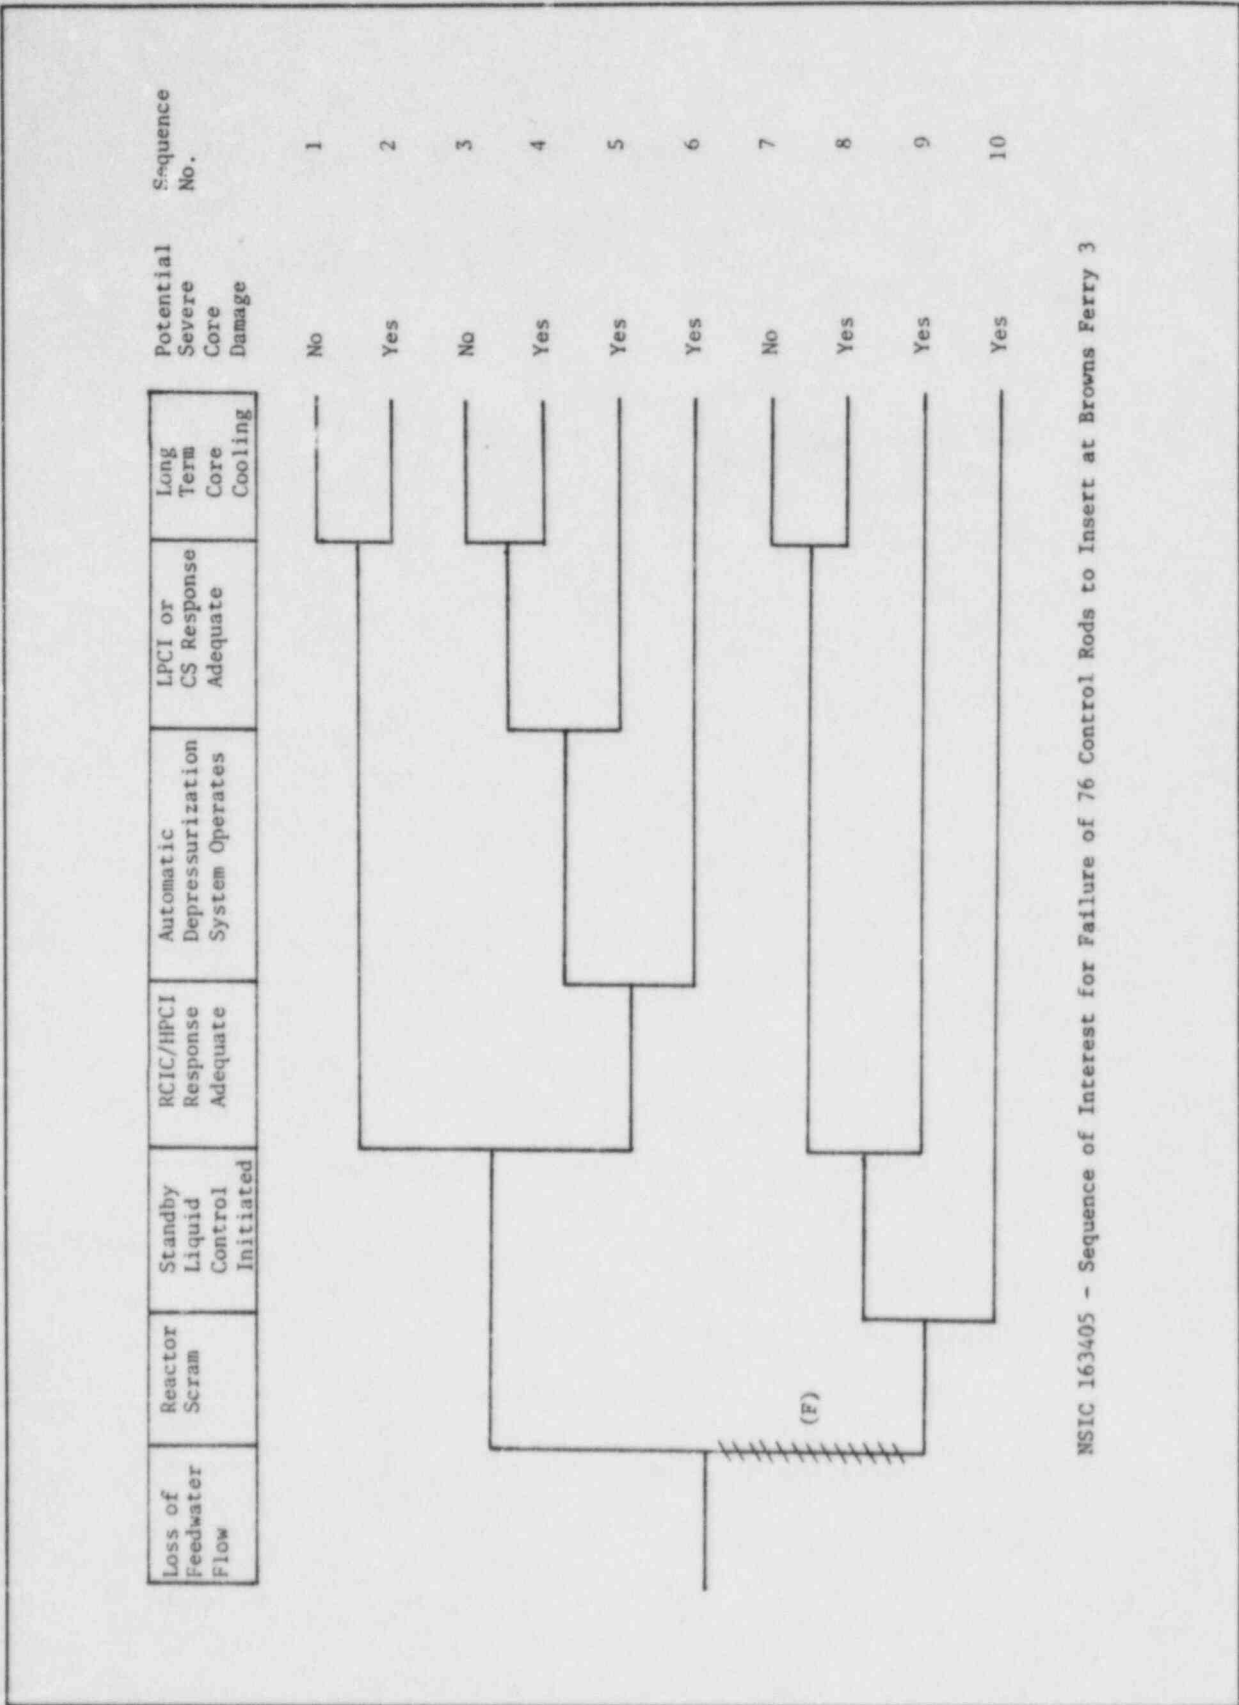
NSIC 163405 - Sequence of Interest for Failure of 76 Control Rods to Insert at Browns Ferry 3

5. However, due to excess water in the east bank scram discharge headers, 75 out of 88 east bank withdrawn rods failed to fully insert, coming to rest at various positions from 46 to 02.

CAUSE: Insufficient drainage from east SDV

COMMENT: The analysis done on the control rod pattern that resulted from the scram showed that if the scram had occurred at 100% power, the maximum power after the scram would have been 345 MW(t) [see Nuclear Safety, 23(5), September-October 1982]. The after-scram power level would likely have been even higher if scram had been demanded at 100% power because some or all of the east side control rods (5) that were manually inserted as part of the power reduction procedure could have also failed to fully insert.

1. The operator manually scrambled all rods. Scram discharge volumes were drained and the bypass was removed from the high-level-drain scram interlock.
2. An investigation was initiated to identify the problem. No problems were identified with the electrical/control system, hydraulic control unit valve lineup, vent and drain piping (i.e., no line blockage found), or seal inleakage to the SDV. The cause for the excess water in the east SDV was not identified.
3. The following measures were to be incorporated promptly to ensure adequate drainage of the scram volume headers:
  - a. Monitor the scram discharge headers daily.
  - b. Increase the test frequency of the scram discharge volume level switches to once per month.
  - c. Develop procedures to verify that the scram discharge volume is free of residual water following each scram and before startup.

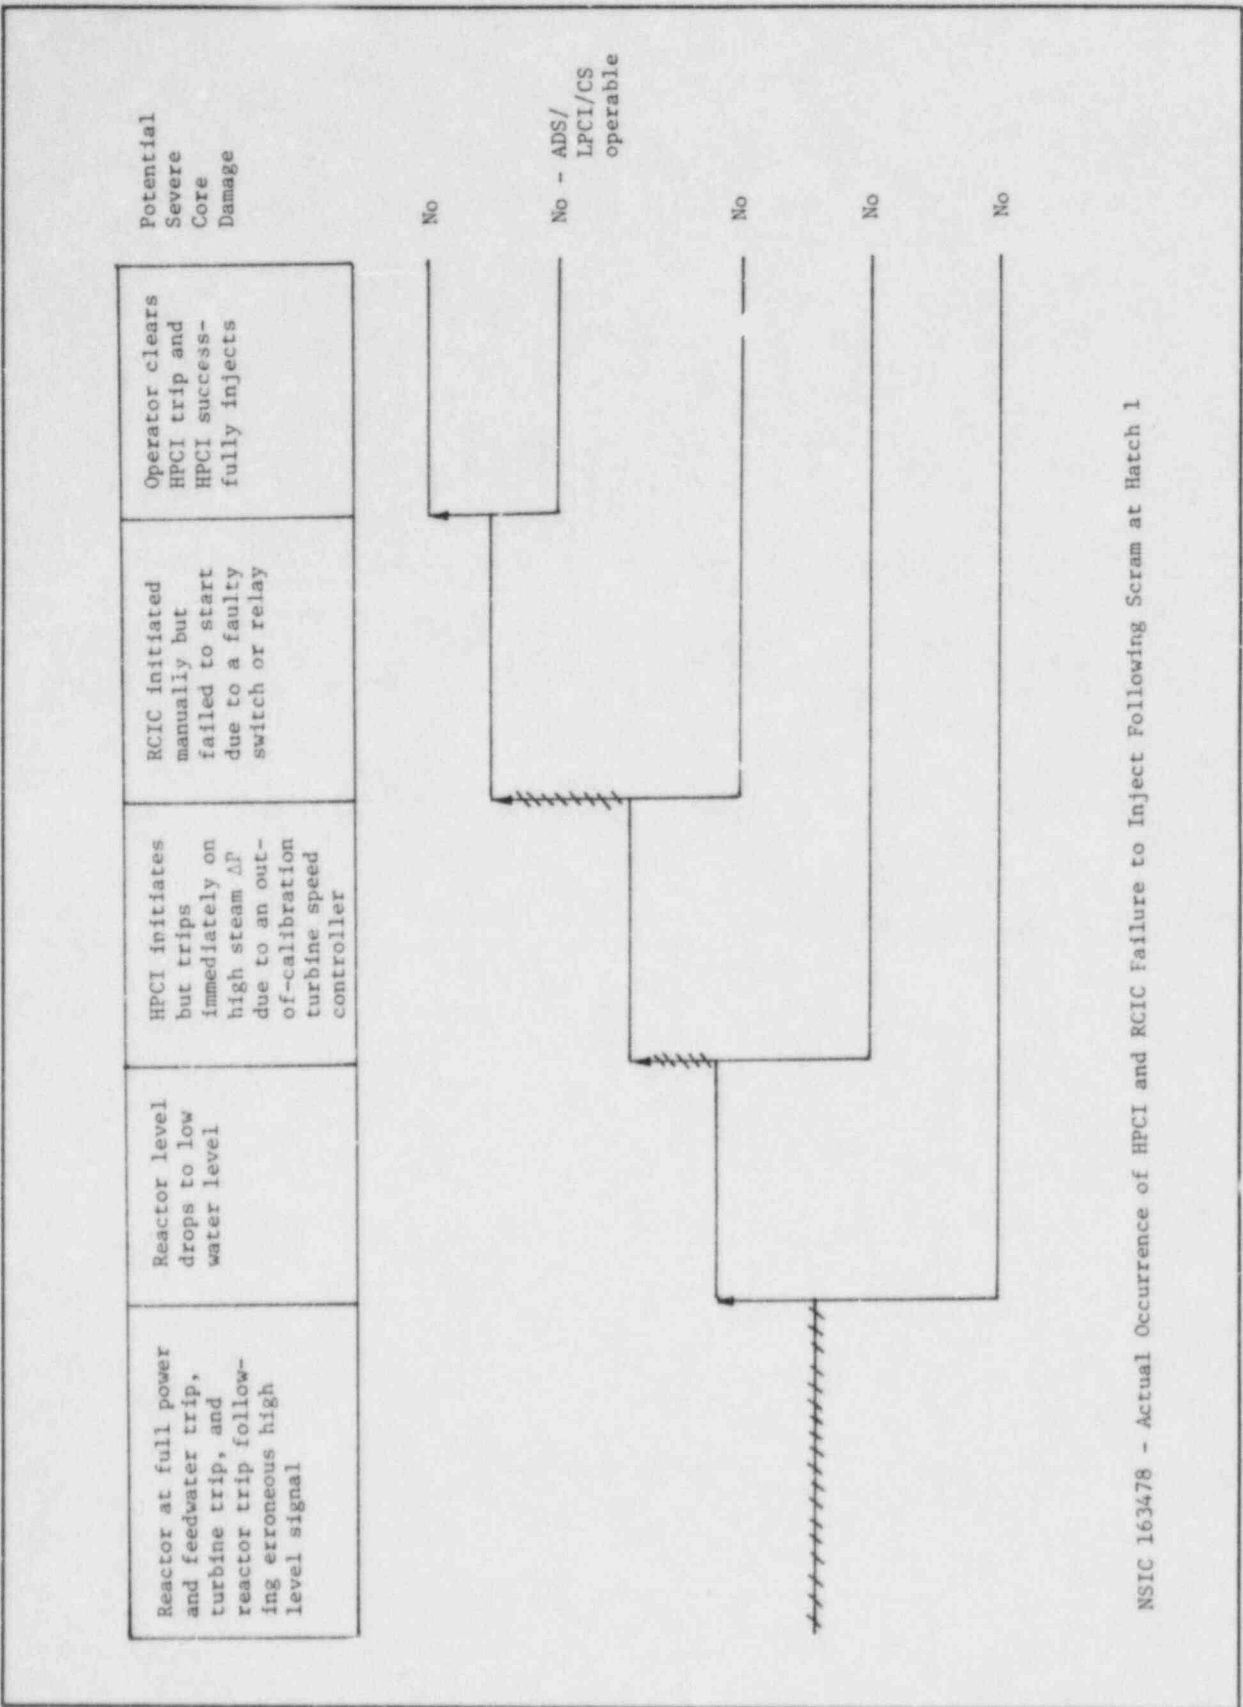
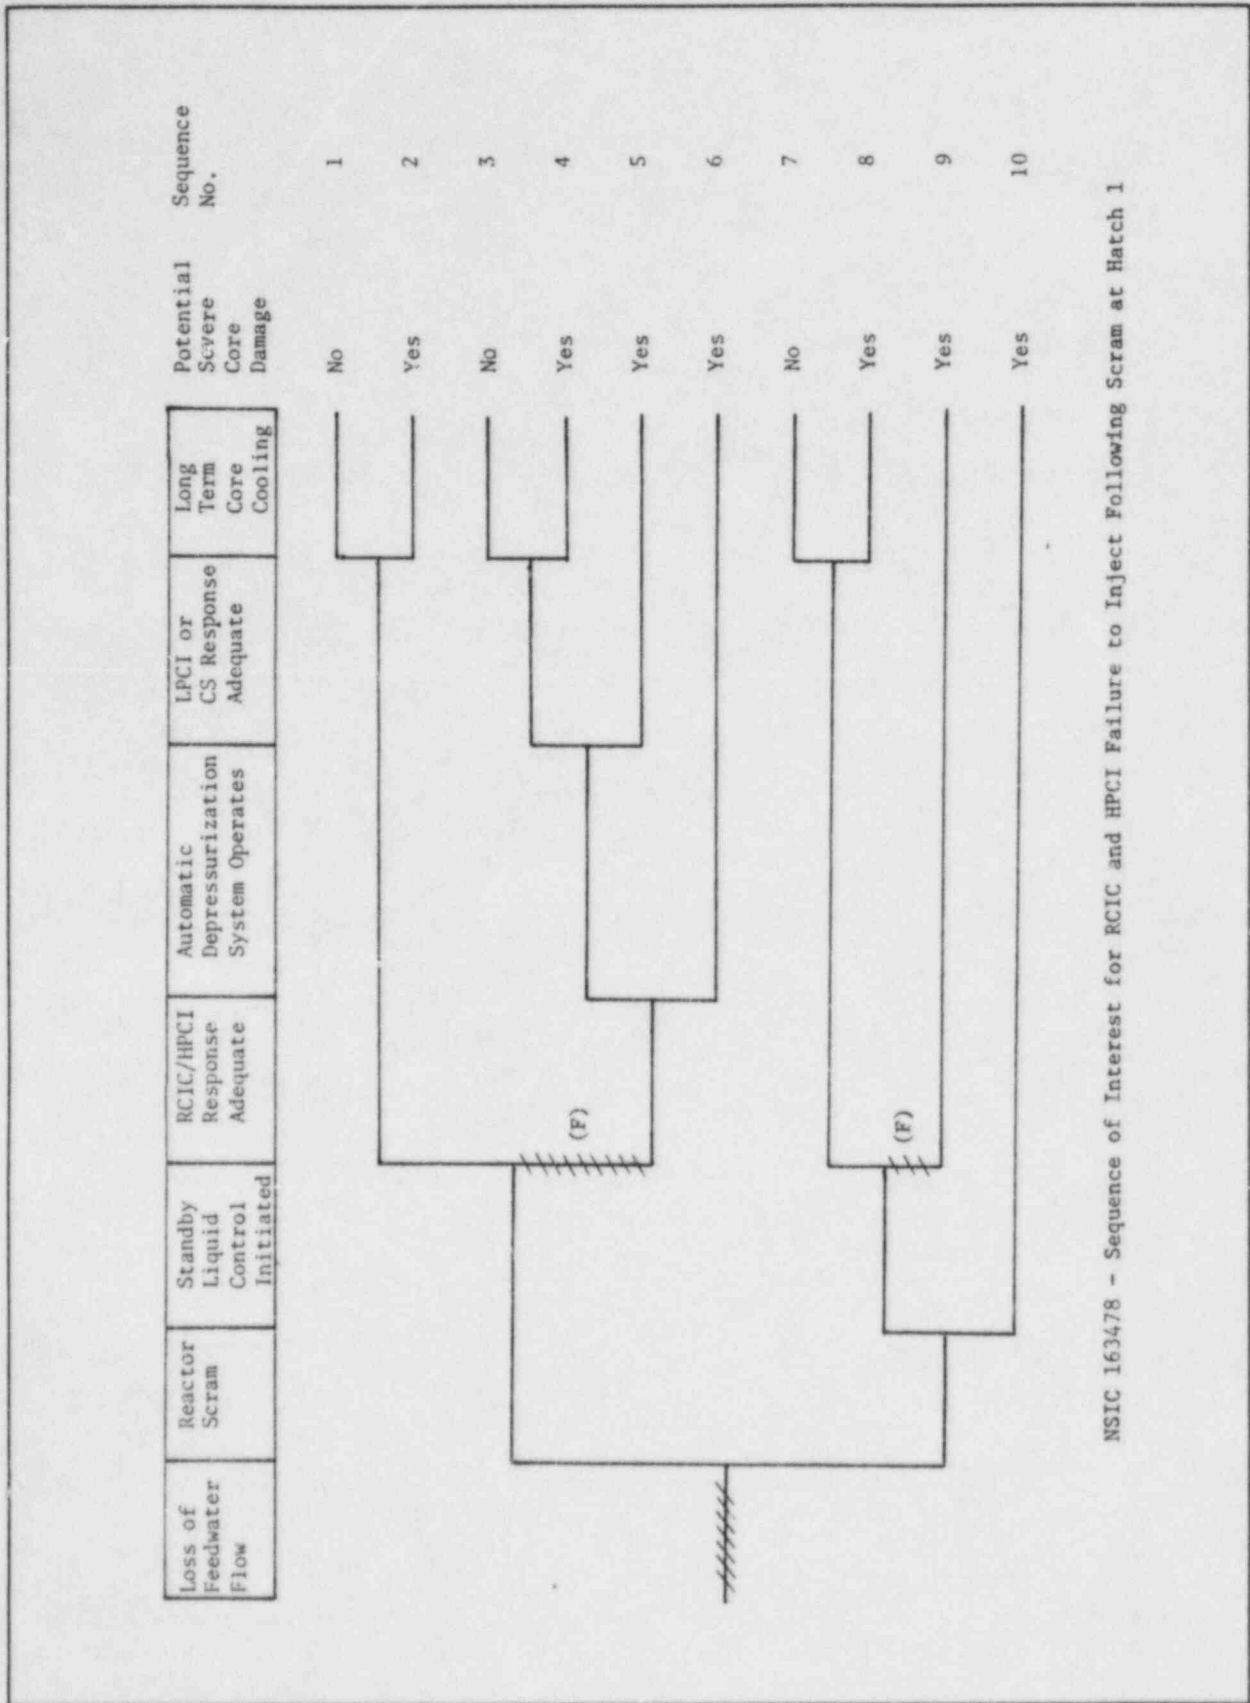
NSIC 163478 - Actual Occurrence of HPCI and RCIC Failure to Inject Following Scram at Hatch 1

1. At 99.4% power, an erroneous reactor high water level signal initiated tripping of the feedwater pumps and the turbine/generator, which subsequently resulted in a reactor scram.
2. The reactor water level dropped to the low-low level set point.
3. The feedwater pump started but tripped since the MSIVs were closed.
4. On low low level the HPCI system received an auto-initiation signal but failed to inject water into the reactor due to automatic isolation of the HPCI turbine caused by the initial high steam pressure to the HPCI turbine.
5. RCIC was manually initiated during the event, but failed to start and remained inoperable throughout the event.
6. About 5 min after the event began, the operators cleared the HPCI steam supply isolation trip and HPCI auto-initiated successfully and injected water into the core.

CAUSE: Failed components, improper calibrating procedures

1. The HPCI isolation, due to steam line high pressure differential, was caused by the turbine speed controller being out of calibration. The system was recalibrated and HPCI tested satisfactorily.
2. The RCIC failure, determined to be due to a faulty limit switch and/or relay, was corrected by replacement of both components. The system was then tested satisfactorily.
3. Calibration surveillance and test procedures were being revised to include cold quickstarts of both HPCI and RCIC.

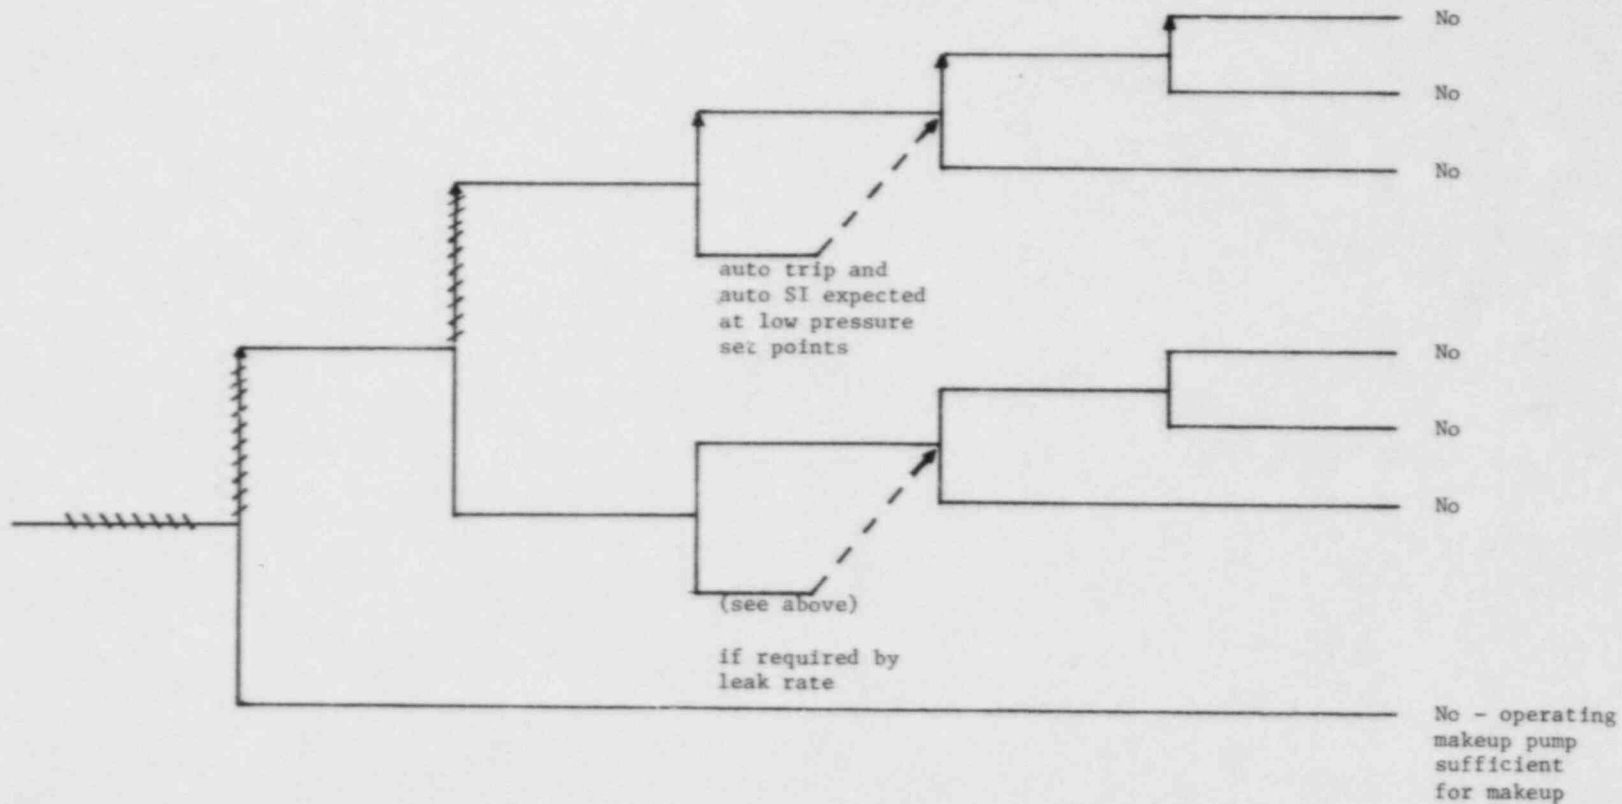
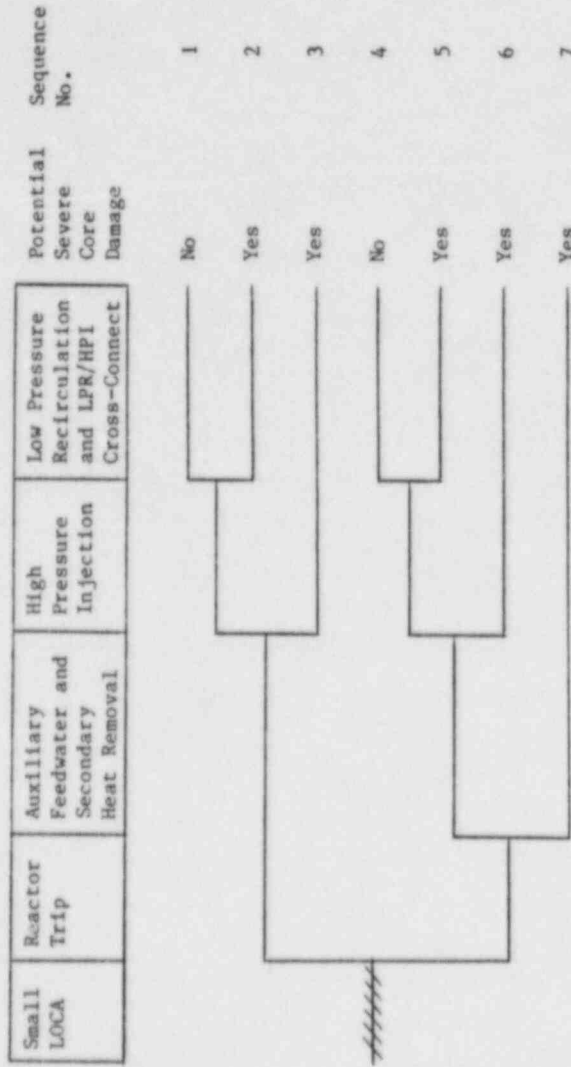
NSIC 163499 - Actual Occurrence for Reactor Coolant Pump Seal Failure at Arkansas Nuclear 1

1. With the reactor at 86% power, reactor coolant pump (RCP) "C" seal failed, resulting in excessive RCS leakage to the containment.
2. A controlled power reduction was begun, and approximately one-half hour later letdown was secured to reduce RCS inventory loss. RCS leak was estimated to be 10-20 gpm.

3. RCS leak rate increased during the power reduction and the plant was subsequently rapidly taken off line. RCP "C" was tripped after the turbine was taken off line but with the reactor critical.

4. RCS leak rate increased substantially when RCP "C" was tripped, and the RCP "C" lift pumps were started and stopped four times in succession in an attempt to reduce the leak rate. On the fourth attempt a reduction in leak rate was noticed. RCS leak rate had increased to a maximum of approximately 350 gpm.

1. The failed seal was examined and extensive damage observed. The cause of the damage could not be identified with certainty.

NSIC ACCESSION NUMBER: 163499  
LER NO.: 80-015 Rev. 1  
DATE OF LER: July 17, 1980  
DATE OF EVENT: May 10, 1980  
SYSTEM INVOLVED: Reactor coolant system  
COMPONENT INVOLVED: Reactor coolant pump seals  
CAUSE: Seal failure  
SEQUENCE OF INTEREST: Small break LOCA  
ACTUAL OCCURRENCE: RCP "C" seal failure  
REACTOR NAME: Arkansas Nuclear 1  
DOCKET NUMBER: 50-313  
REACTOR TYPE: PWR  
DESIGN ELECTRICAL RATING: 850 MWe  
REACTOR AGE: 5.8 years  
VENDOR: Babcock & Wilcox  
ARCHITECT-ENGINEERS: Bechtel  
OPERATORS: Arkansas Power & Light  
LOCATION: 6 miles NW of Russellville, Arkansas  
DURATION: N/A  
PLANT OPERATING CONDITION: 86% power  
TYPE OF FAILURE: Inadequate performance  
DISCOVERY METHOD: Operational event  
COMMENT: See also: NSIC 165417 Arkansas Nuclear 1, 50-313, LER 80-015R,  
April 13, 1981, and Nuclear Safety, Vol. 22, No. 2, March-  
April 1981, pp. 237-238.

2. All remaining RCP seals were inspected and evidence of high temperature operation observed. All seals were replaced.
3. The CFT isolation valve controls were relocated outside containment to facilitate access.
