**NUREG/CR-3591  
Volume 2  
ORNL/NSIC-217/V2**

**Precursors to Potential Severe  
Core Damage Accidents: 1980-1981**

**A Status Report**

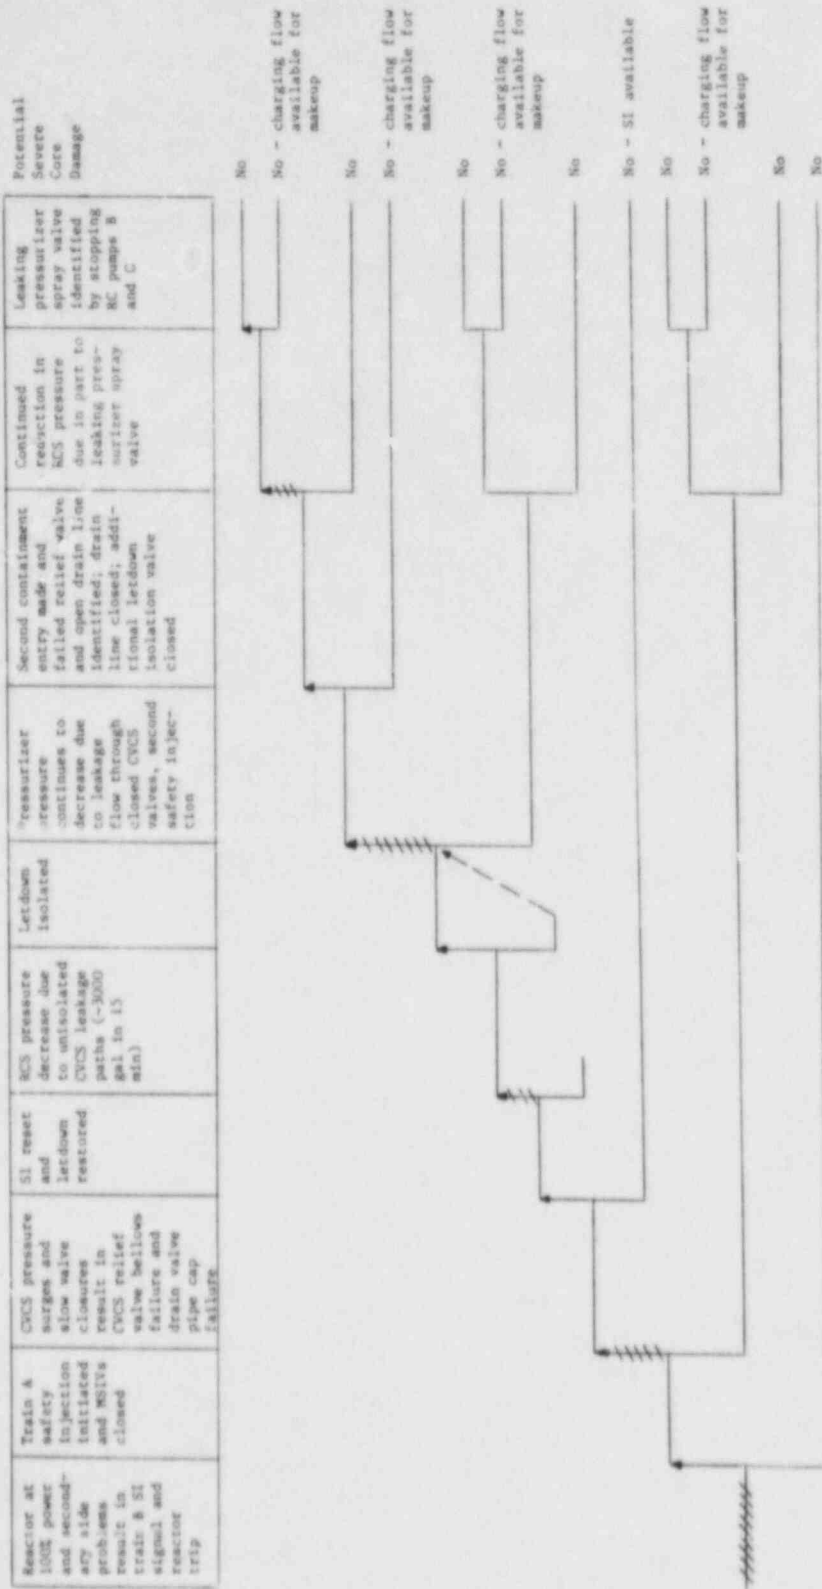
MSIC 144149 - Actual Occurrence for Isolable Small Break LOCA at Robinson 2

4. The "A" SI train was manually actuated and the MSIVs were closed.
5. The "A" containment fire alarm was received shortly after the SI actuation.
6. During the automatic isolation of the letdown line on safety injection, relief valve CVC-RV-203 bellows ruptured, either because of the relatively slower closure of valves upstream of the relief valve compared with those downstream of it, or because of leakage past the upstream valves. In addition, a pressure surge due to the isolation valves closing caused a drain cap on a partially open drain valve to be blown off.

10. Four hours after the first containment entry a second entry was made and the leaking drain line identified. The two upstream level control valves were leaking at approximately 5-7 gpm. The drain valve was closed.

11. After the drain valve was closed RCS pressure still continued to decrease in part as a result of a partially opened pressurizer spray valve. (The pressurizer spray valve position is indicated by demand in lieu of stem position, which delayed identification of the cause of the depressurization.)
12. The leak rate could not be accurately determined but it was estimated to have been approximately 100 gpm while letdown was unisolated. A total of about 4500 to 6000 gallons of water was leaked to the containment sump during the event.

CAUSE: Bellows rupture, drain valve vibrated open, pipe cap blew off,  
leaking spray valve

1. The leaking drain valve was closed and a new pipe cap installed. All other similar valve/pipe cap combinations were verified closed.
2. Corrective action concerning the failed relief valve was not identified.

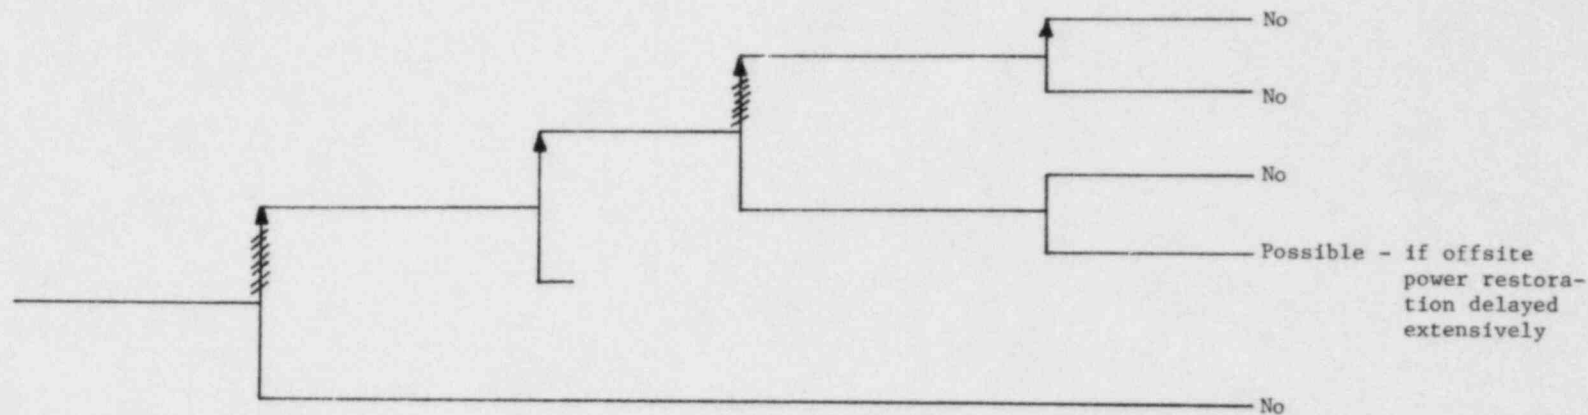
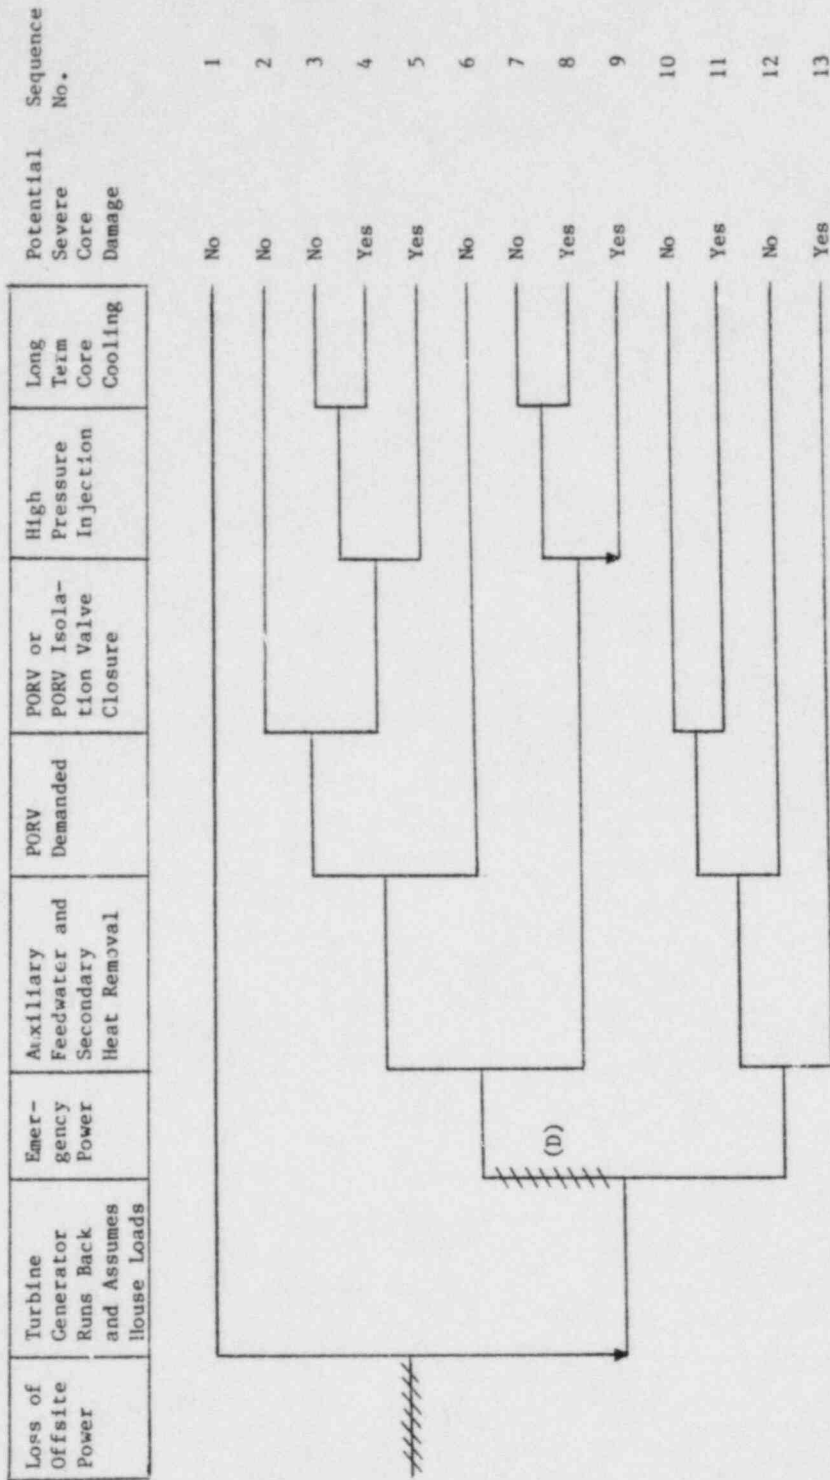
NSIC 164453 - Actual Occurrence for Brief Loss of Offsite and Degraded Load Shed Capability in San Onofre 1

NSIC ACCESSION NUMBER: 164453  
LER NO.: 80-038 Rev. 1  
DATE OF LER: February 2, 1981  
DATE OF EVENT: November 22, 1980  
SYSTEM INVOLVED: Offsite power  
COMPONENT INVOLVED: 4 kV bus circuit breakers  
CAUSE: Operator error  
SEQUENCE OF INTEREST: LOOP  
ACTUAL OCCURRENCE: LOOP and degraded load shed capability  
REACTOR NAME: San Onofre 1  
DOCKET NUMBER: 50-206  
REACTOR TYPE: PWR  
DESIGN ELECTRICAL RATING: 436 MWe  
REACTOR AGE: 13.4 years  
VENDOR: Westinghouse  
ARCHITECT-ENGINEERS: Bechtel  
OPERATORS: Southern California Edison  
LOCATION: 5 miles south of San Clemente, California  
DURATION: N/A  
PLANT OPERATING CONDITION: Cold shutdown  
TYPE OF FAILURE: Failed to start  
DISCOVERY METHOD: Operational event

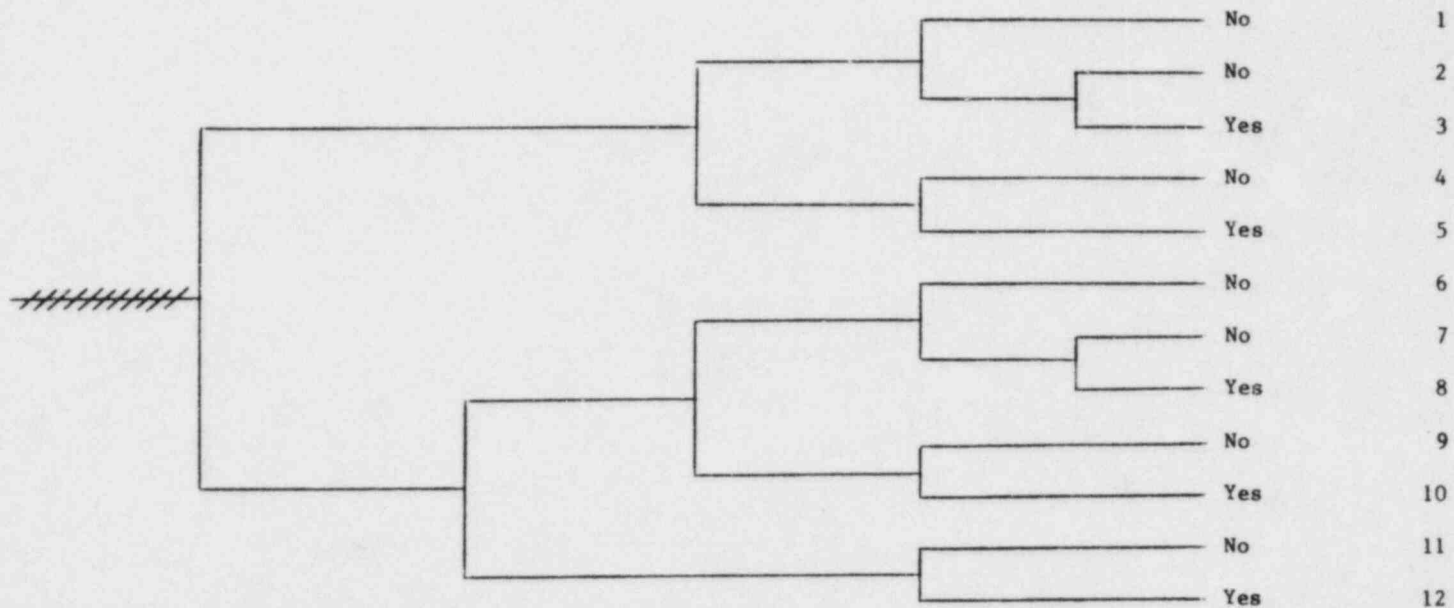
NSIC 164617 - Sequence of Interest for Loss of dc Bus and Diesel Generator Trip at Millstone 2

17. The "B" diesel generator tripped automatically because of a service water flange leak (a result of improper gasket compression during a recent modification) which sprayed the electronic governor and caused the diesel generator to trip. Because of this, the "B" 4.16 kV emergency bus was deenergized.

18. The load shed signal was overridden and the "B" 4.16 kV emergency bus was reenergized from the reserve transformer.
19. Numerous instruments powered from the "B" main were not available as a result of blown fuses caused by increased currents to inductive loads during the diesel trip.

NSIC ACCESSION NUMBER: 164617  
LER NO.: 81-005  
DATE OF LER: January 30, 1981  
DATE OF EVENT: January 2, 1981  
SYSTEM INVOLVED: Offsite power, emergency 4.16 kV and dc power  
COMPONENT INVOLVED: 125 V dc bus, diesel generator  
CAUSE: Inadvertent trip of dc bus and diesel generator trip due to  
leaking service water flange  
SEQUENCE OF INTEREST: Loss of dc bus  
ACTUAL OCCURRENCE: Loss of dc bus and diesel generator trip  
REACTOR NAME: Millstone 2  
DOCKET NUMBER: 50-336  
REACTOR TYPE: PWR  
DESIGN ELECTRICAL RATING: 870 MWe  
REACTOR AGE: 5.2 years  
VENDOR: Combustion Engineering  
ARCHITECT-ENGINEERS: Bechtel  
OPERATORS: Northeast Nuclear Energy Company  
LOCATION: 5 miles SW of New London, Connecticut  
DURATION: N/A  
PLANT OPERATING CONDITION: Full power  
TYPE OF FAILURE: Inadequate performance;  
made inoperable  
DISCOVERY METHOD: Operational event

1. The emergency procedure for loss of a dc bus was revised to reflect information gained during the event.
2. Circuit modifications were made to prevent the shutdown of a running diesel upon reapplication of dc power, following a complete loss of dc to all control circuits, and to the fail-to-start feature, the latter to preclude the possibility of forced shutdown via operation of the shutdown relay in the event a diesel which starts on an autostart signal does not achieve a speed of 250 rpm in 12 seconds.
3. Instrument loops were to be protected with manufacturer-recommended slow-blow fuses instead of the currently installed quick-blow fuses.

4. The utility proposed redundant power supplies for the control room annunciator system.
5. The diesel generator flange gasket was replaced.

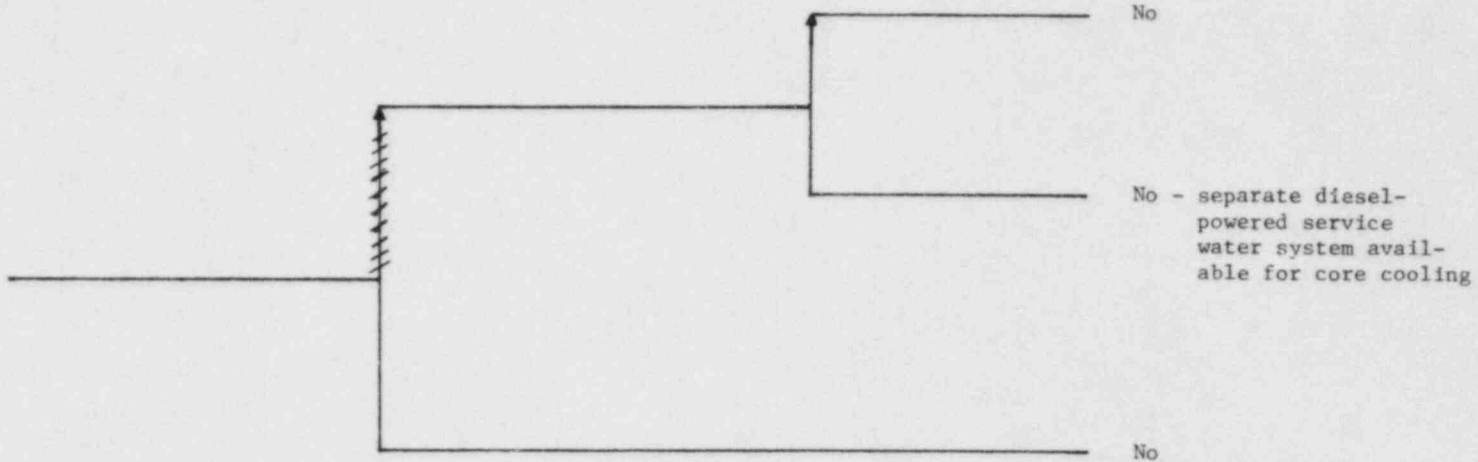
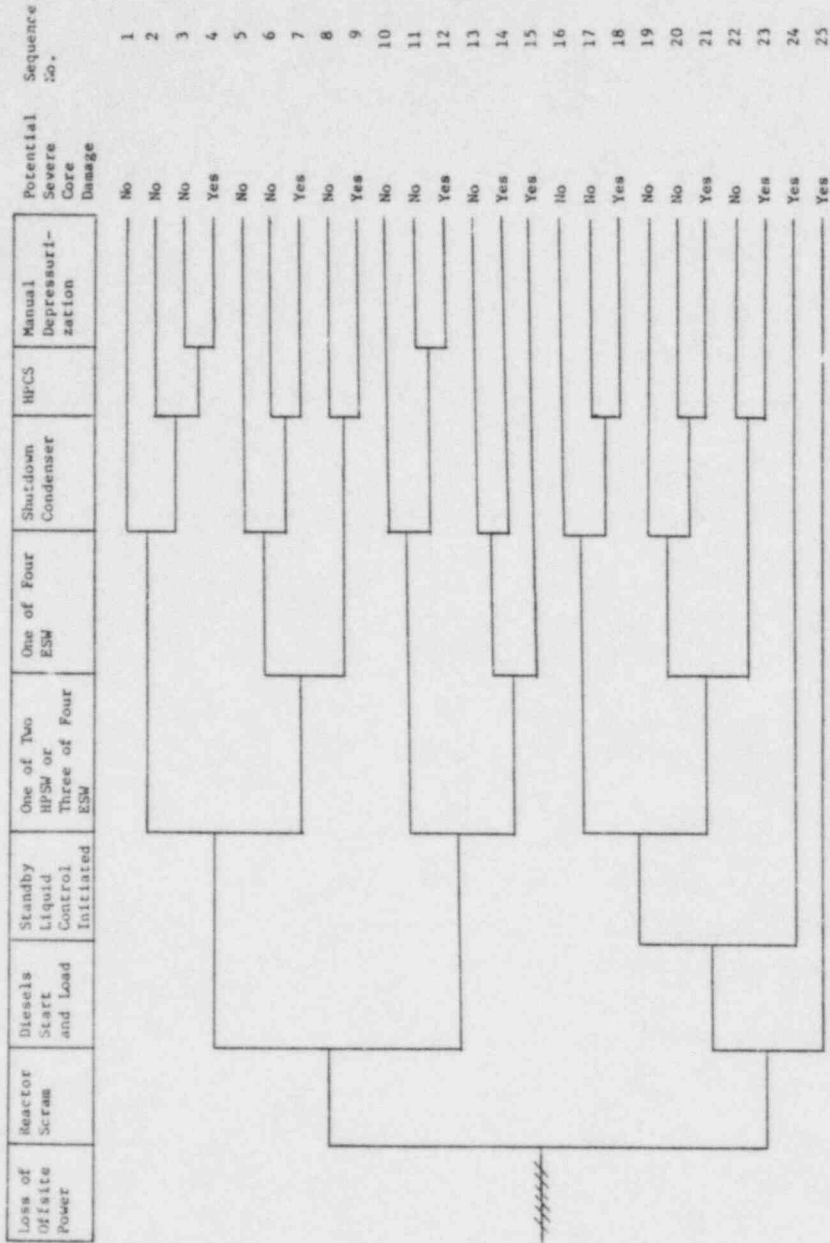
NSIC 164703 - Actual Occurrence for Loop at LaCrosse

CAUSE: Operator error

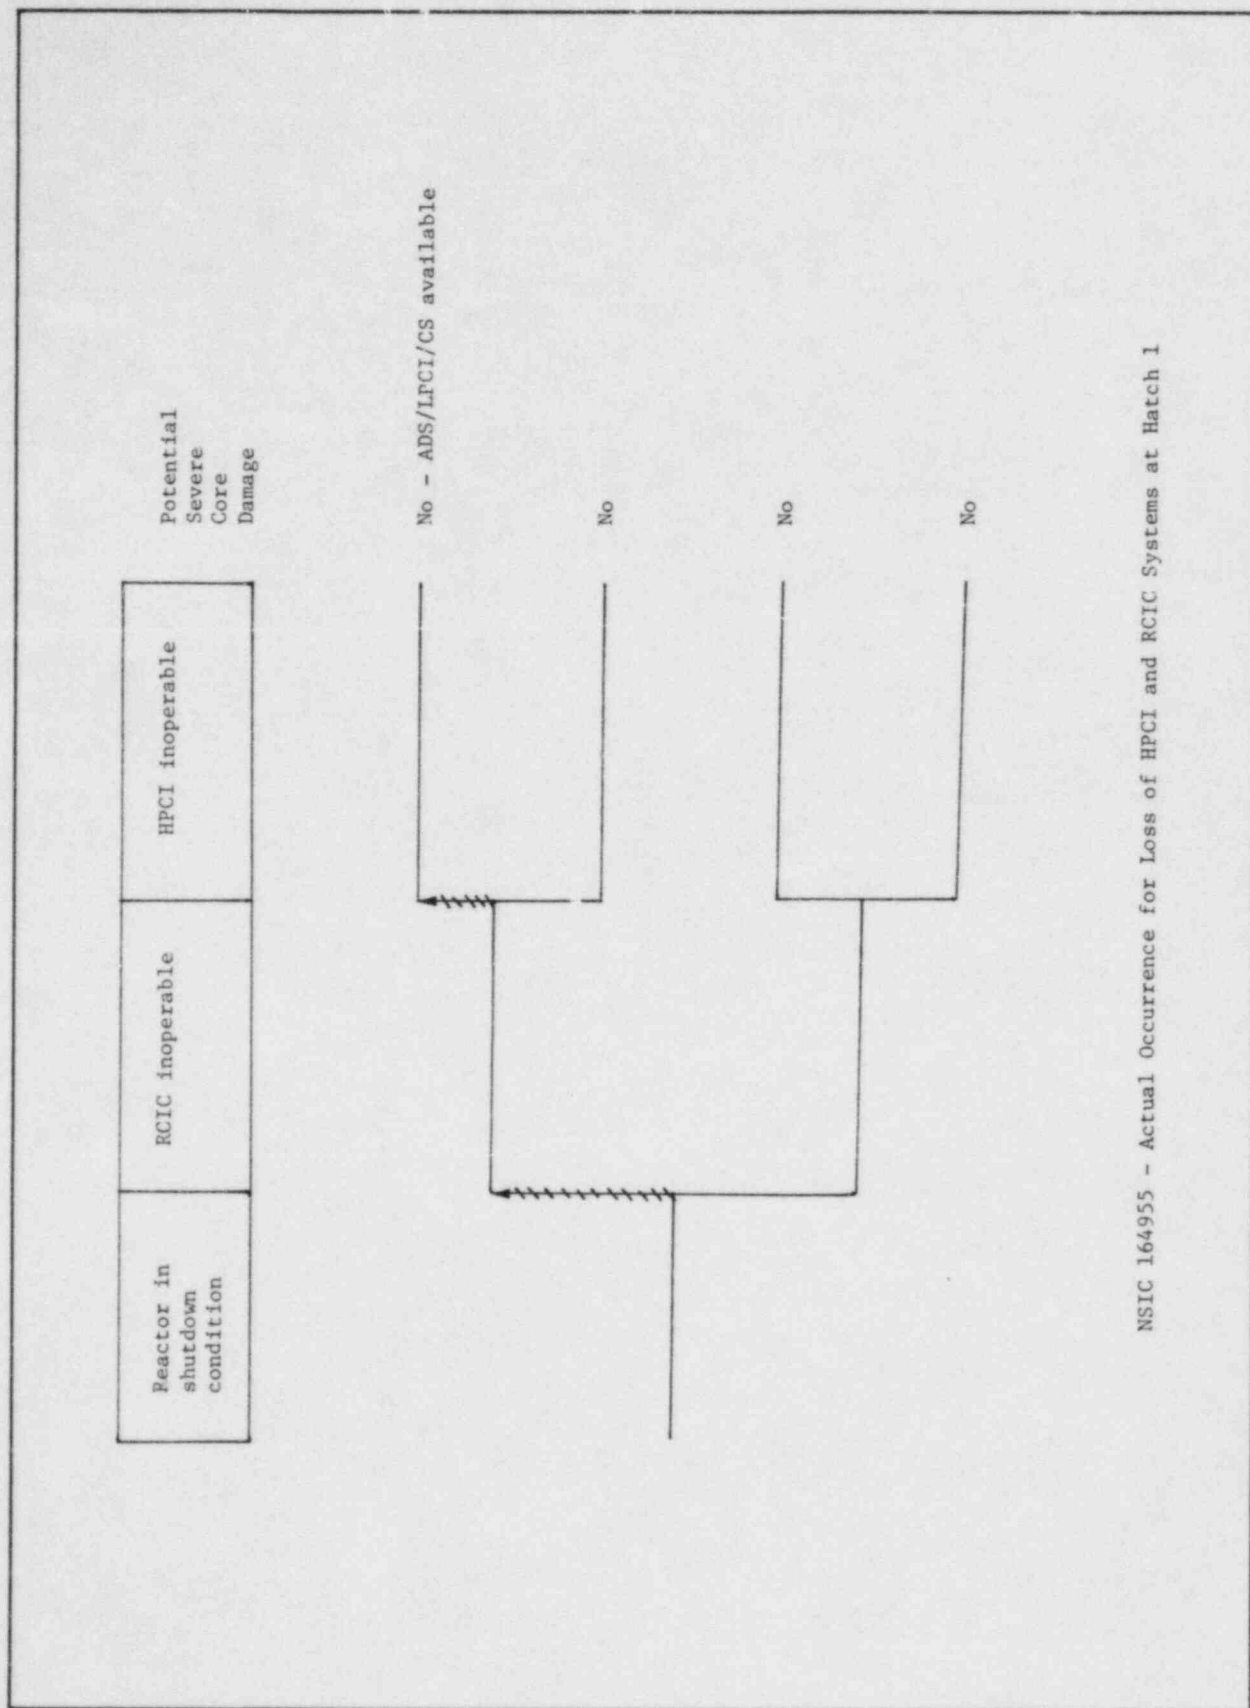
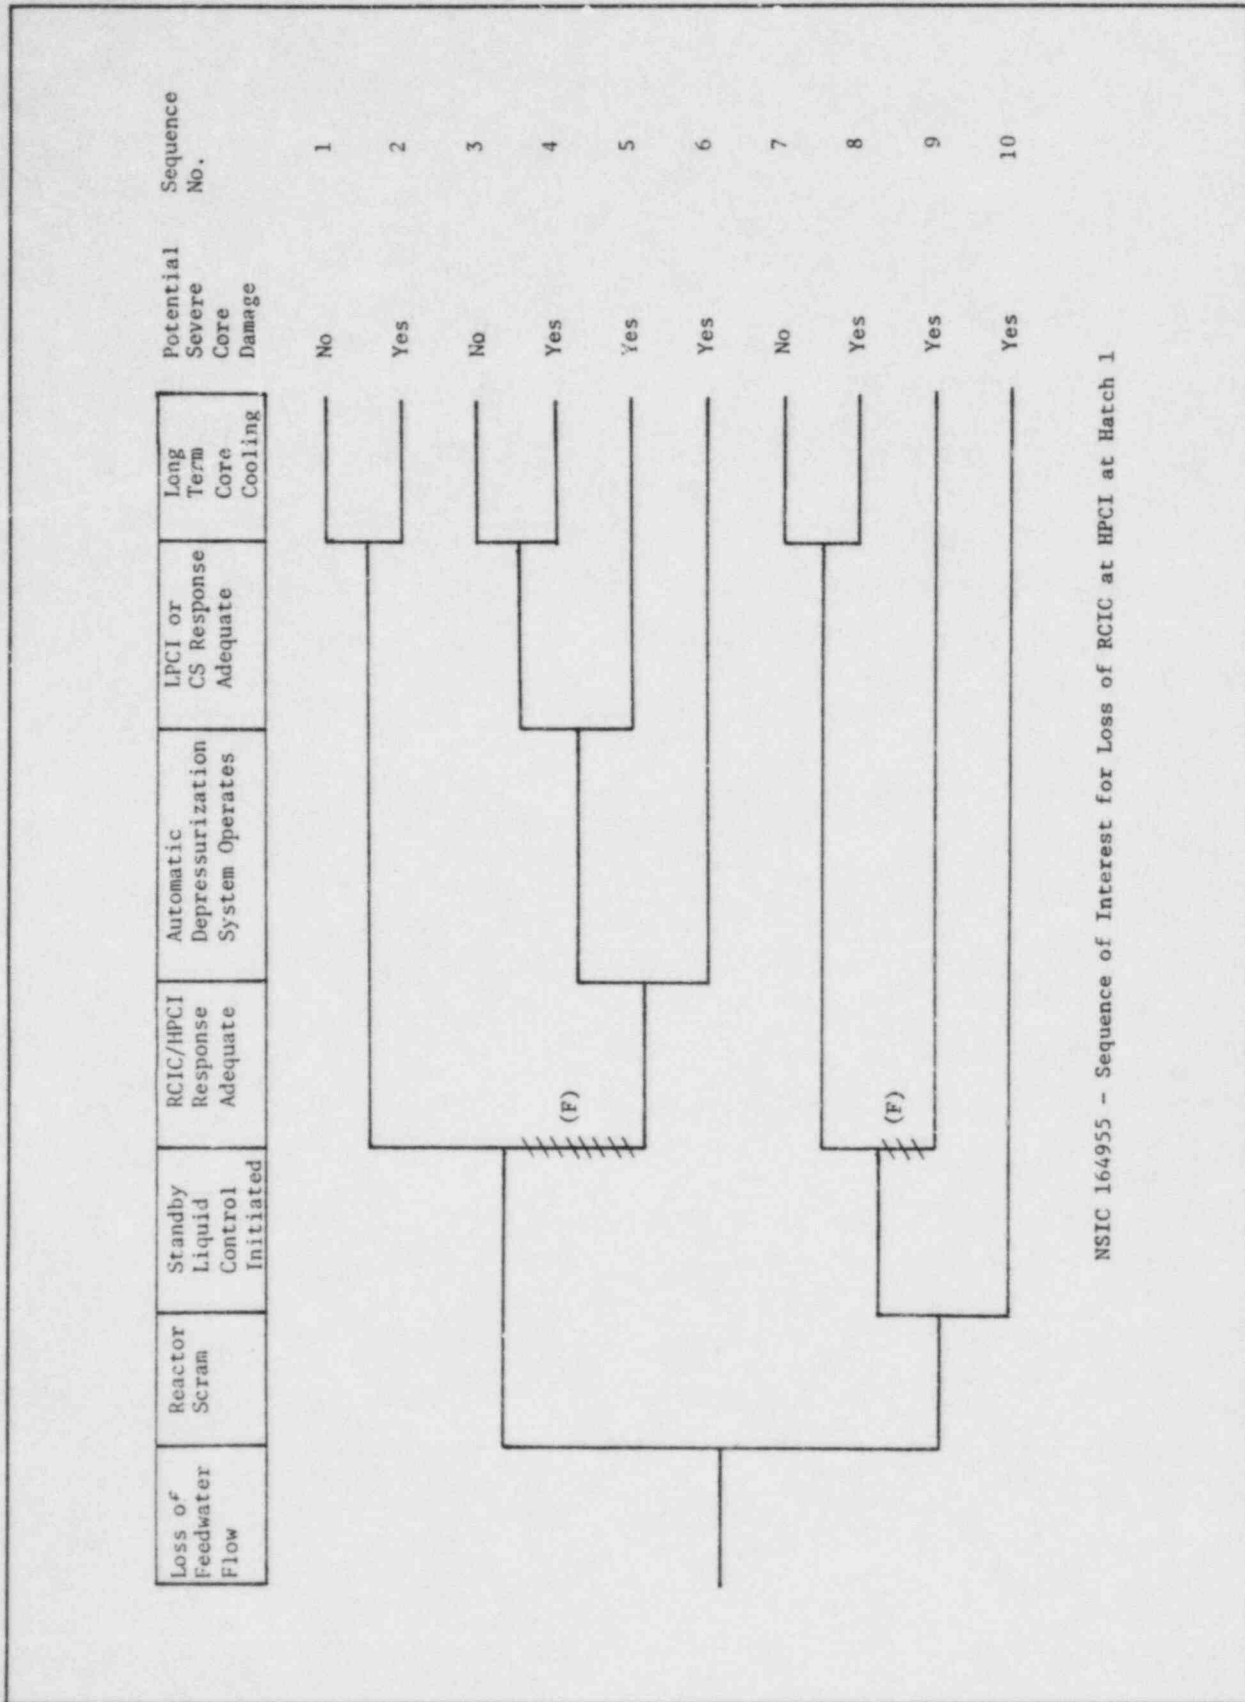
NSIC 164955 - Actual Occurrence for Loss of HPCI and RCIC Systems at Hatch 1

COMPONENT INVOLVED: HPCI (broken oil line); RCIC (unknown)

CAUSE: Personnel error

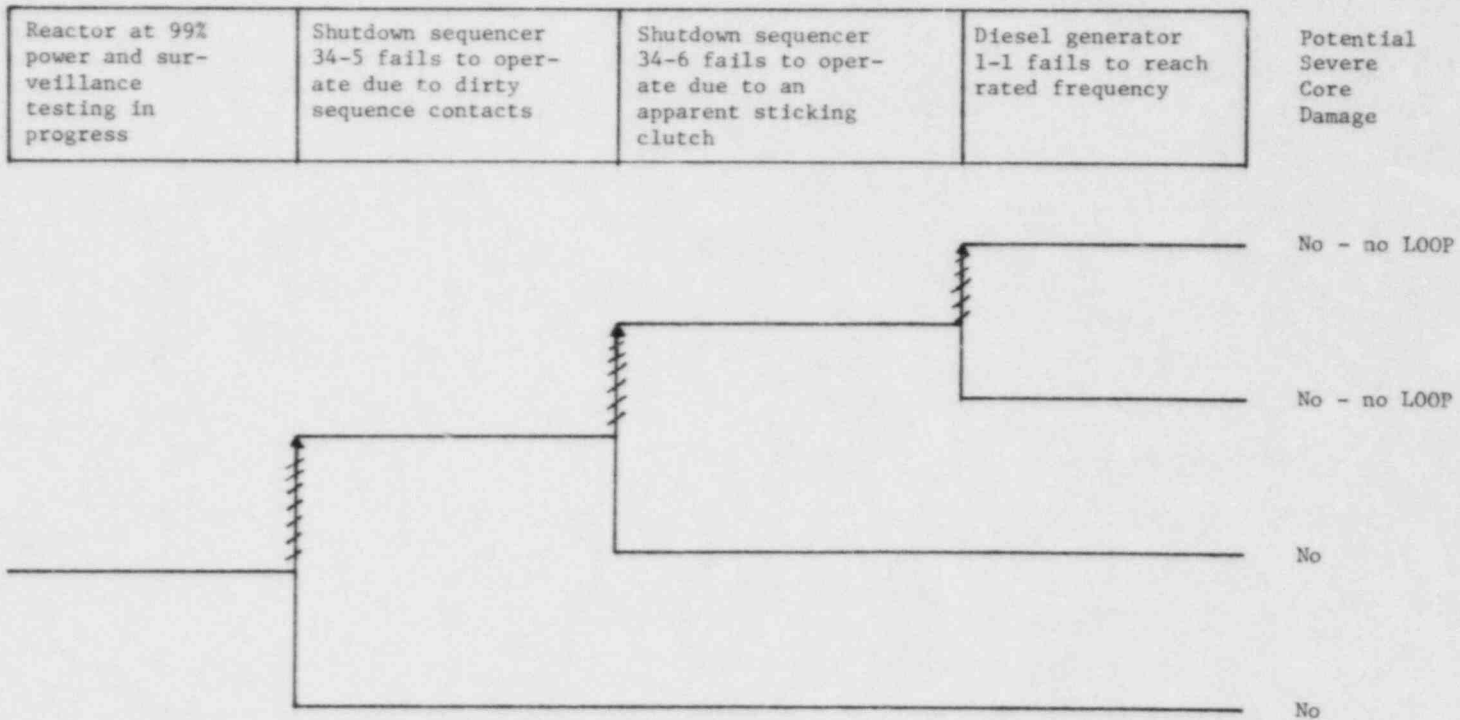
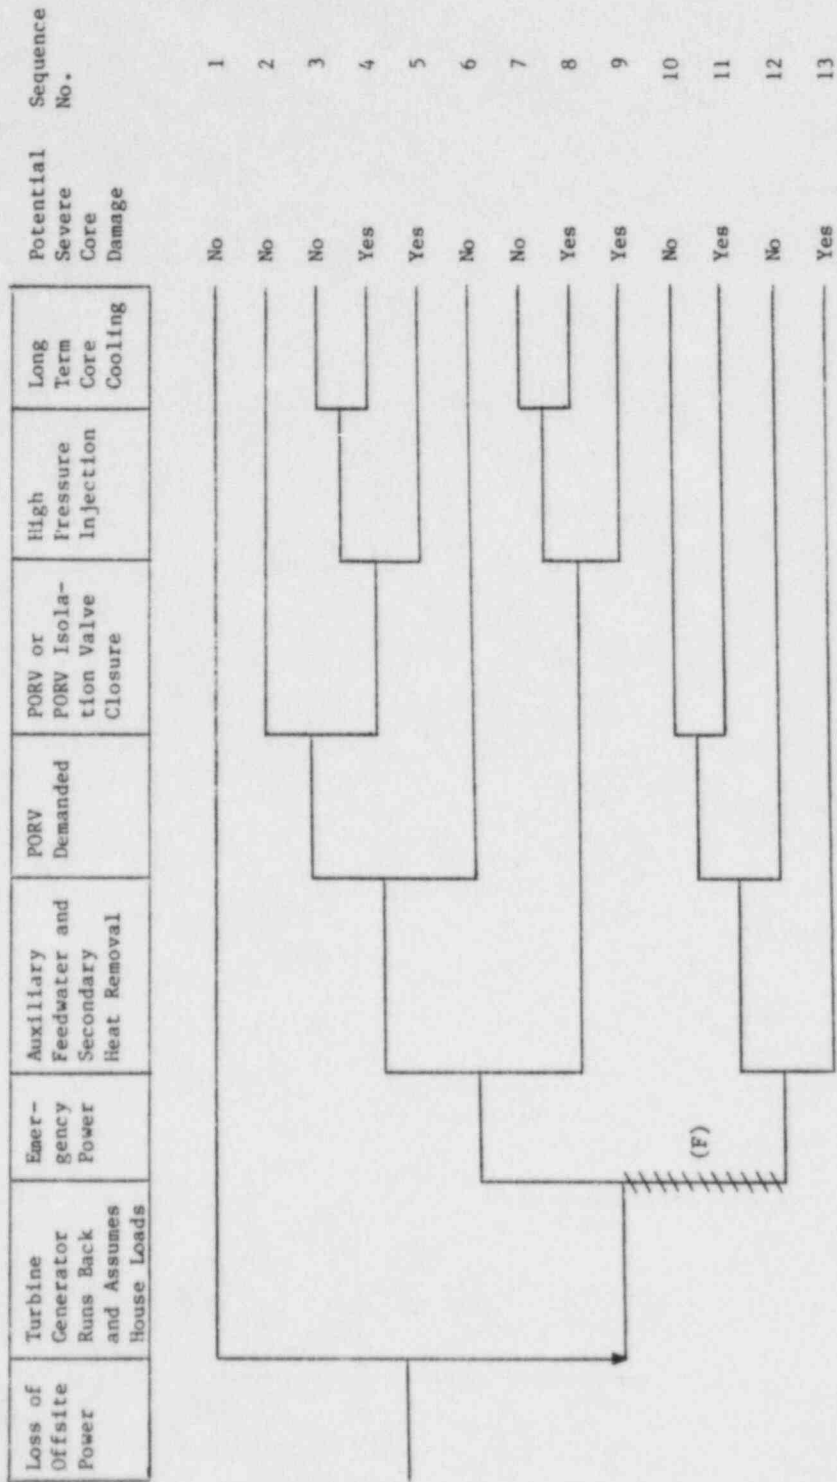
NSIC 166745 - Actual Occurrence for Two Shutdown Sequencers and Diesel Generator Unavailable at Palisades

Sequencer failure would require the loads tabulated above to be manually started following a loss of offsite power event.

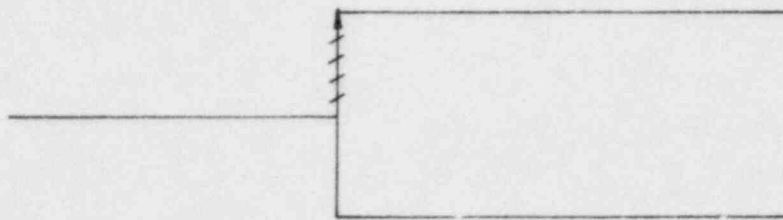
NSIC 169587 - Actual Occurrence for Safety Injection Path to RCS Obstructed at Turkey Point 4

Reactor beginning refueling outage	Safety injection system blocked by boric acid solidification
---------------------------------------	--

NSIC ACCESSION NUMBER: 169587  
LER NO.: 81-011  
DATE OF LER: November 4, 1981  
DATE OF EVENT: October 21, 1981  
SYSTEM INVOLVED: Safety injection  
COMPONENT INVOLVED: 4-in. piping tee  
CAUSE: Boric acid solidification blocked tee  
SEQUENCE OF INTEREST: LOCA  
ACTUAL OCCURRENCE: Unavailability of high head safety injection paths  
REACTOR NAME: Turkey Point 4  
DOCKET NUMBER: 50-251  
REACTOR TYPE: PWR  
DESIGN ELECTRICAL RATING: 693 MWe  
REACTOR AGE: 8.4 years  
VENDOR: Westinghouse  
ARCHITECT-ENGINEERS: Bechtel  
OPERATORS: Florida Power & Light  
LOCATION: 25 miles south of Miami, Florida  
DURATION: 360 h (estimated)  
PLANT OPERATING CONDITION: Entering refueling shutdown  
TYPE OF FAILURE: Made inoperable  
DISCOVERY METHOD: Testing  
COMMENT:

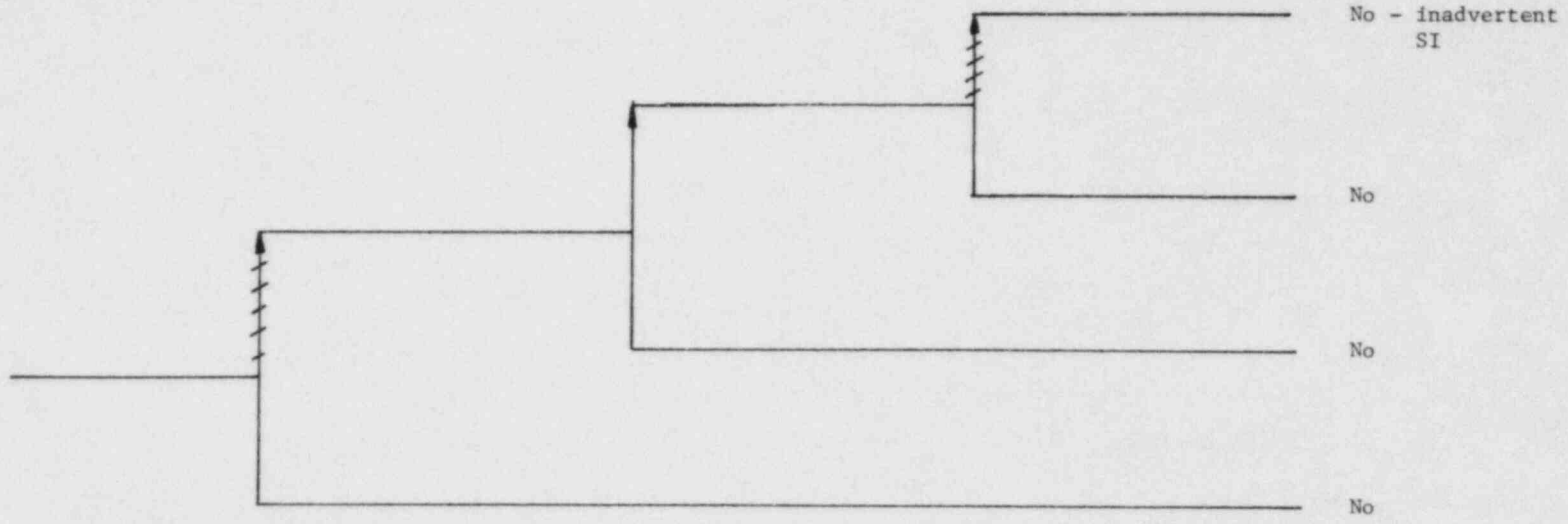
NSIC 170098 - Actual Occurrence for Two Boron Injection Tank Inlet Valves Fail to Open at Salem 1

Reactor in hot shutdown following a reactor trip	During replacement of inverter 1A cabinet fan unit fuses, a voltage transient was induced in the inverter control wiring, resulting in loss of 1A inverter and loss of the 1A vital bus	Safety injection occurs due to high steam flow indication caused by loss of vital bus	Boron injection tank inlet valves 1SJ4 and 1SJ5 fail to open fully due to boron crystal accumulations on the valves
--	---	---	---

CAUSE: Boric acid crystal buildup around valve stems

ACTUAL OCCURRENCE: BIT inlet valves failed to open on demand from inadvertent SI signal

- COMMENT:
1. Valves may have opened sufficiently to permit boron injection for MSLB mitigation. However, the utility reported BIT dilution only after stroking the valves during subsequent maintenance.
  2. Additional information: LERS 81-111/03L, 81-112/03L, 81-110/03L.
  3. During the inadvertent SI, fan coil unit No. 11 failed to start in the slow speed mode due to a failure to close of the automatic trip shutter on the low speed circuit breaker when the breaker was racked in. This resulted in the breaker tripping every time it was reset.

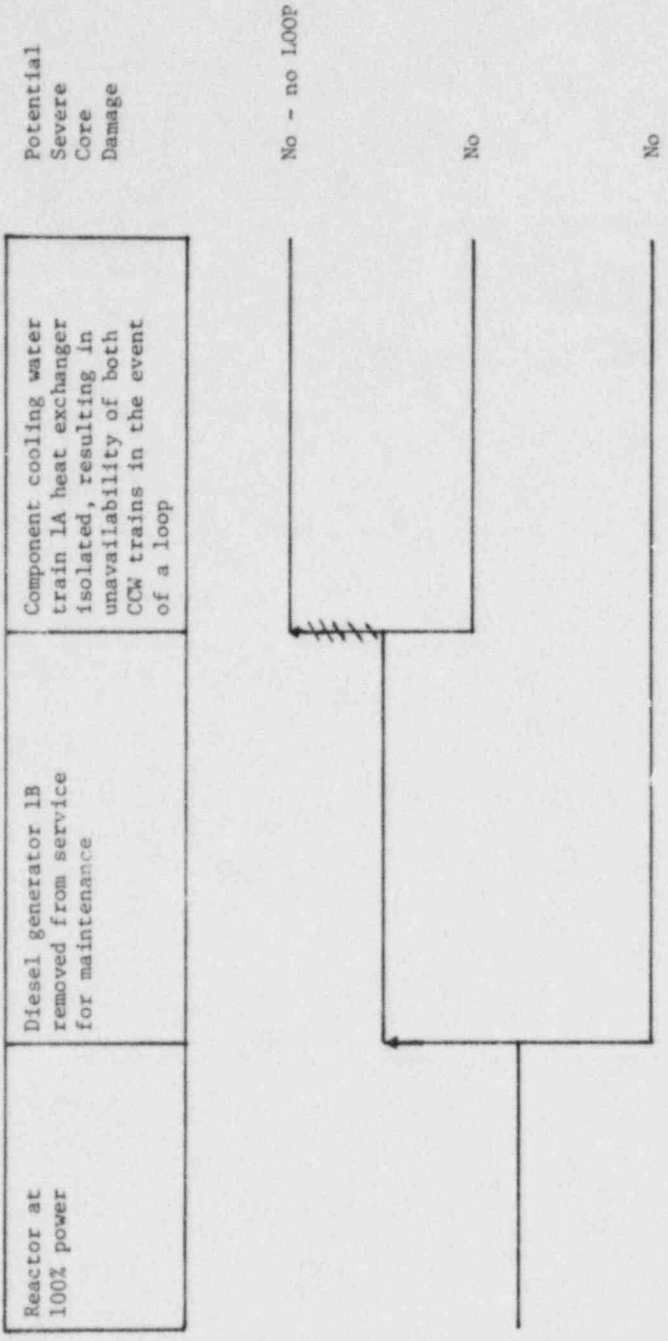
NSIC 170199 - Actual Occurrence for Unavailability of Diesel Generator and CCW Train at Kewaunee

CAUSE: Operator error

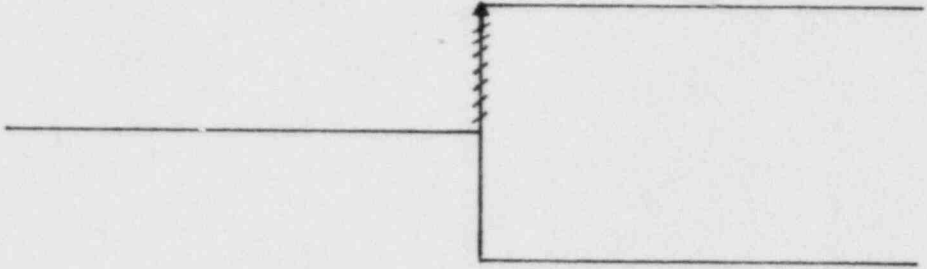
NSIC 171202 - Actual Occurrence for Unavailability of Emergency Power System at Turkey Point 3

1. With Units 3 and 4 in cold shutdown, maintenance was being performed on the "B" emergency diesel generator.
2. Diesel generator "A" was started and subsequently stopped due to the inability of its start motor to disengage (a result of a broken diaphragm in the starting air solenoid).
3. This rendered both diesel generators inoperable for approximately 30 min.

<p>Reactor in cold shutdown and DC "B" out of service for maintenance</p>	<p>DC "A" fails to run due to inability of start motor to disengage, a result of a failed starting air solenoid diaphragm</p>
---	---

CAUSE: Component failure on one diesel while other was out for maintenance

1. The solenoid was replaced and the "A" diesel generator tested and returned to service.

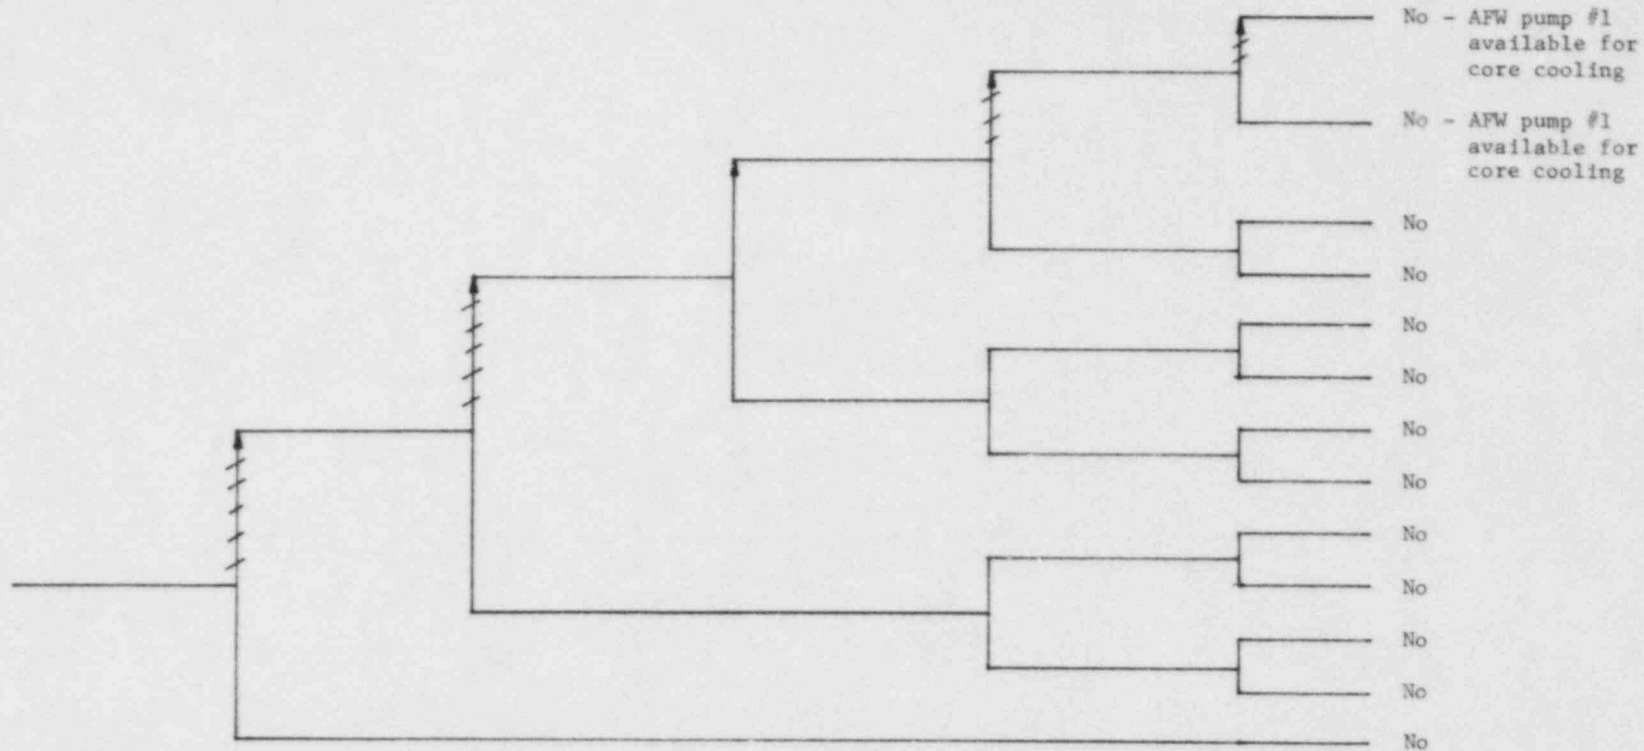
NSIC 171667 - Actual Occurrence for Loss of Two Instrument Buses at Davis-Besse 1

1. With the reactor at 74% power, "A" control rod drive breaker was deenergized as part of a Control Rod Drive Breaker Logic Test.
2. Construction personnel inadvertently caused a mechanical shock to nonessential breaker HAAEZ which caused a ground fault relay to activate and trip the breaker, resulting in loss of bus E2. This caused loss of the control rod drive Inductrol Power Supply which, in conjunction with the "A" CRD breaker being open for testing caused a loss of power to the control rods and a reactor trip.

3. The loss of bus E2 deenergized the power supply (E23) to the regulated instrumentation distribution panel YAR.
4. The inverter supply (YVA) for uninterruptible instrumentation distribution panel YAU had previously transferred to its alternate supply YAR due to a defective static sensing and transfer logic card in the static switch. Because of this, YAU was also deenergized when YAR deenergized. Panel YAU provides power to the following:

6. During recovery, the auxiliary feedwater pumps were manually actuated using the steam and feedwater rupture control system and AFW pump 2 did not respond properly due to a maladjusted governor slip clutch and bent low speed step pin.

7. Main steam safety valve SP17B4 opened and failed to properly reseal and was gagged.
8. Approximately 13 minutes after unit trip, bus E2 was reenergized from its alternate source by manually connecting bus E2 to its alternate feed on the B bus.

Reactor at 74% power and "A" control rod drive breaker deenergized as part of CRD breaker logic test	Breaker HAAEZ inadvertently struck and trips, resulting in loss of bus E2, deenergization of panel YAR and reactor trip	Inverter supply YVA previously transferred to YAR due to defective static sensing and transfer logic cord	Bus YVA deenergized due to deenergization of YAR. Resultant loss of indication on both saturation meters, loss of AFW pump #1 flow indication, and trip of makeup pump 1-1	AFW pump #2 fails to start when manually actuated due to misadjusted governor slip clutch and bent low speed stop pin	Main steam relief valve SP17B4 fails to fully reset
--	---	---	--	---	---

CAUSE: Mechanical shock to breaker, faulted static sensing and  
transfer logic card

1. All type ITH relays at the unit were adjusted to as wide a gap as possible consistent with proper relay operation.
2. The defective static sensing and transfer logic ca.d in inverter YVA was replaced and YAU was returned to its normal power supply.
3. The 2 AFW pump turbine governor slip clutch was adjusted and the low speed stop pin straightened. The governor was subsequently replaced with a space.
4. Saturation margin meter wiring was modified to power the meters from one power supply each.

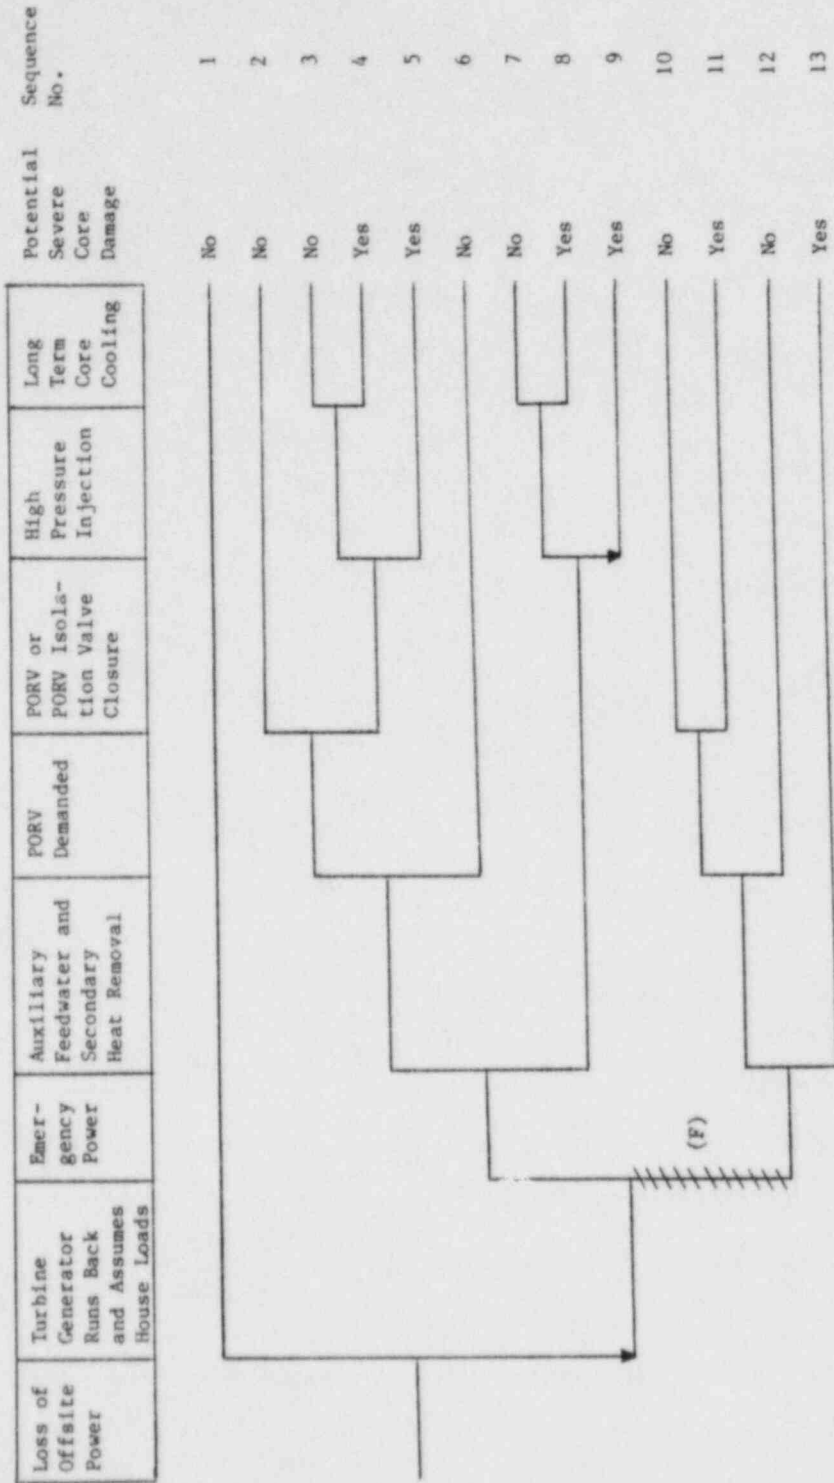
NSIC 171700 - Sequence of Interest for Unavailability of Emergency Power System at San Onofre 1

Reactor at 87% power and diesel generator #2 secured for preventive maintenance	Diesel generator #1 trips due to low governor oil level	Potential Severe Core Damage
---	---	------------------------------

NSIC ACCESSION NUMBER: 171700  
LER NO.: 81-029  
DATE OF LER: December 17, 1981  
DATE OF EVENT: November 19, 1981  
SYSTEM INVOLVED: Emergency power system  
COMPONENT INVOLVED: Both diesel generators  
CAUSE: Trip of one diesel while other was secured for maintenance  
SEQUENCE OF INTEREST: LOOP  
ACTUAL OCCURRENCE: Unavailability of two diesel generators  
REACTOR NAME: San Onofre Unit 1  
DOCKET NUMBER: 50-206  
REACTOR TYPE: PWR  
DESIGN ELECTRICAL RATING: 436 MWe  
REACTOR AGE: 14.4 years  
VENDOR: Westinghouse  
ARCHITECT-ENGINEERS: Bechtel  
OPERATORS: Southern California Edison  
LOCATION: 5 miles south of San Clemente, California  
DURATION: 2 h (estimated)  
PLANT OPERATING CONDITION: 87% power  
TYPE OF FAILURE: Failed to start;  
made inoperable  
DISCOVERY METHOD: During testing  
COMMENT:

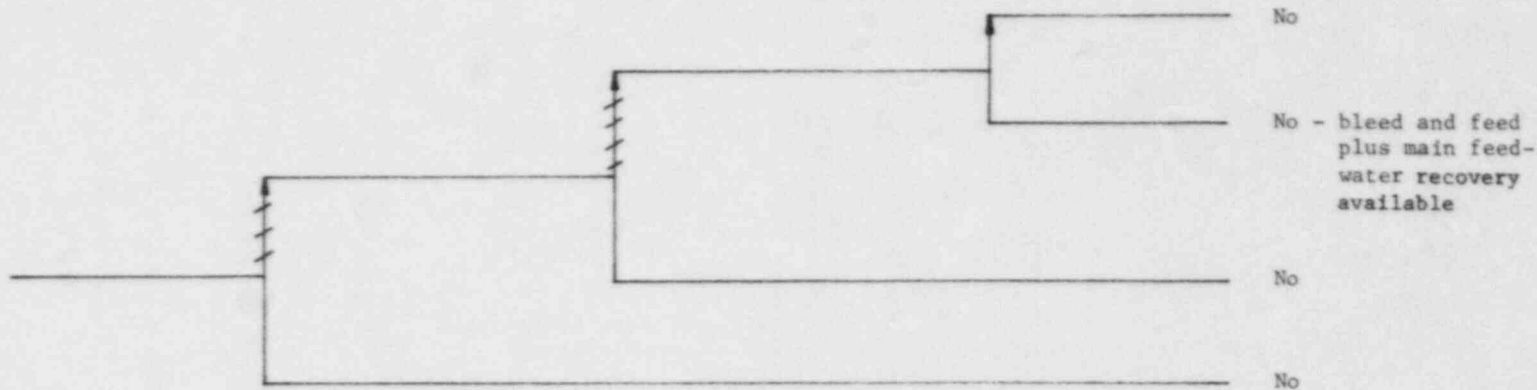
NSIC 171733 - Actual Occurrence for Unavailability of Three Auxiliary Feedwater Pumps at Zion 2

1. With the reactor at 90% power and 2A turbine-driven AFW pump out of service for maintenance, water leaks from two hydrogen coolers in the unit generator resulted in a generator trip and subsequent reactor trip.
2. Motor-driven auxiliary feedwater pumps 2B and 2C failed to start and run on steam generator low-low level due to improperly sensed pump suction pressure. (It was determined that, immediately after start, reverse flow existed in the pressure switch sensing line, resulting in a momentary low suction pressure indication when adequate pressure actually existed.)
3. Both pumps were manually started.

Reactor at 90% power and 2A turbine-driven AFW pump out of service for maintenance	Water leaks from two hydrogen coolers in the unit generator result in generator trip and subsequent reactor trip	Motor-driven AFW pumps fail to auto-start and run on low-low steam generator level due to low suction pressure trip caused by improperly sensed suction pressure	Motor-driven AFW pumps manually started
--	--	--	---

CAUSE: One pump was unavailable due to maintenance and the other two pumps tripped due to incorrectly sensed low suction pressure on starting

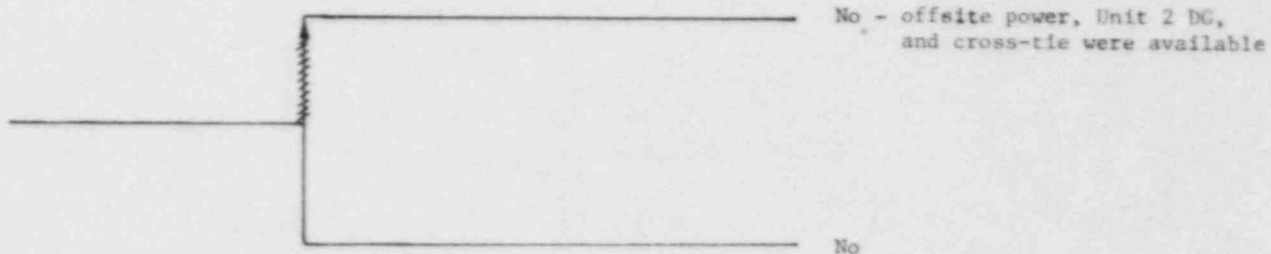
NSIC 171842 - Actual Occurrence for Failure of Emergency Diesel Generators at Dresden 3

1. On October 23, 1981, with the plant at 66% power, DG 2/3 tripped due to high cooling water temperature during surveillance. Unit 3 DG was manually tripped due to high cooling water temperature indication during subsequent testing. In both cases the DG cooling water pumps had tripped prior to the DG trips. Both cooling water pumps were restarted and the diesels subsequently declared operable. The cause of the pump trips was not determined at the time.
2. On November 19, 1981, the unit 3 DG was again shut down during testing because of high coolant temperatures.
3. Subsequent testing revealed that both the Unit 2/3 and Unit 3 cooling water pump discharge check valve disks had separated from the valve operating arms and restricted cooling water flow.
4. During the event, DG U2, DG 2/3, 4-kV cross-tie, and offsite power were still available.

Reactor at power	Both diesel generators for Unit 3 declared inoperable during test due to insufficient cooling caused by defective diesel cooling water pump discharge check valves
------------------	--

1. The defective valves were replaced, the systems were satisfactorily tested and placed back in service.
2. A procedure revision was to be initiated to inspect these valves annually.

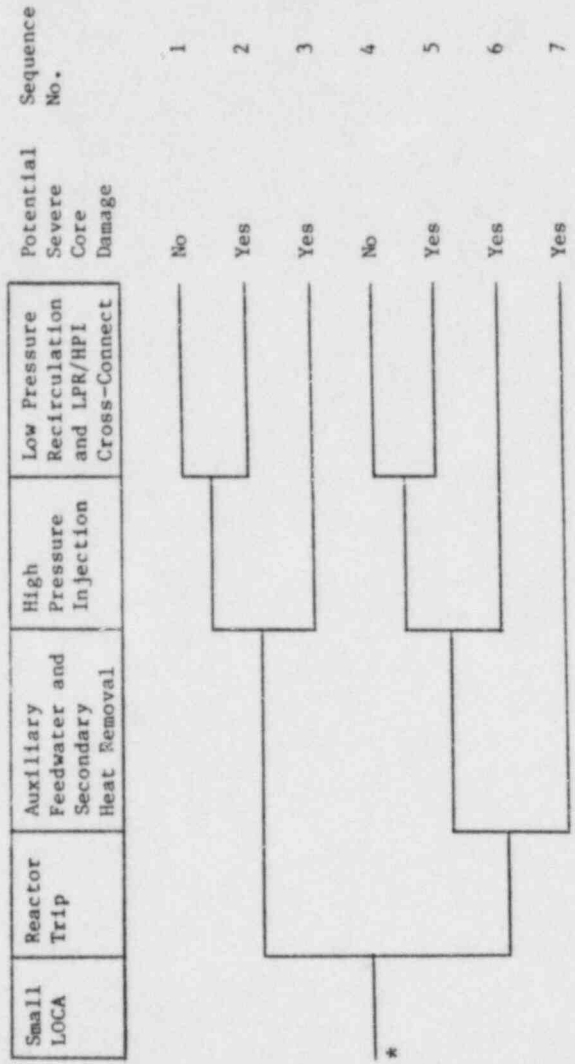
NSIC 172198 - Sequence of Interest for Inadvertent Pressurizer Code Safety Valve Opening at St. Lucie 1

\*reseating of safety valve V1200 would provide mitigation
