2.790 MATERIAL
Withhold From Public Disclosure
METALLURGICAL ANALYSIS
of
FERMI 2 LP3 EIGHTH STAGE
TURBINE BLADING

Report No. 94V70 - 13
June 20, 1994

Subject: **Metallurgical Examination of Fermi-2 Low Pressure
Seventh Stage Turbine Blading**
Technical & Engineering Services Report 94V70-22

Subject: Metallurgical Analysis of Fermi-2 Low Pressure
Seventh and Eighth Stage Turbine Blading
Technical & Engineering Services Report 94V70-30

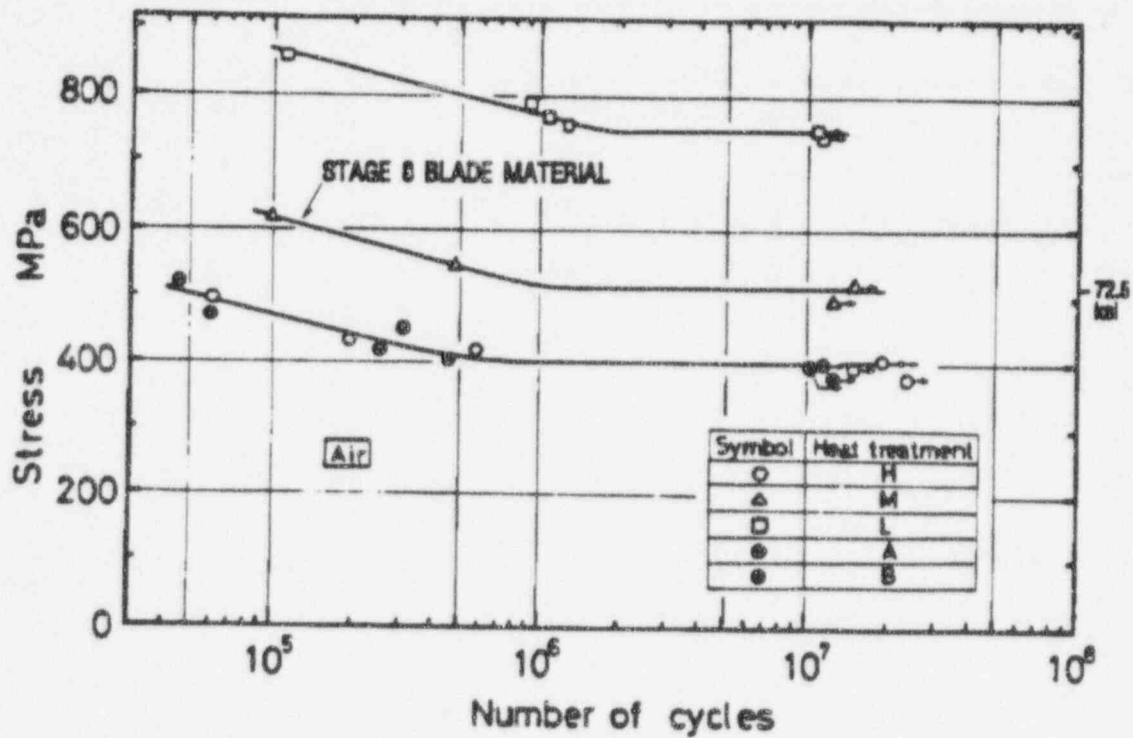
Figure 11 - Fatigue Plot for Type 403 Stainless Steel Blade Material. Plot for Heat Treatment Equivalent to Stage 8 Blades is Indicated.

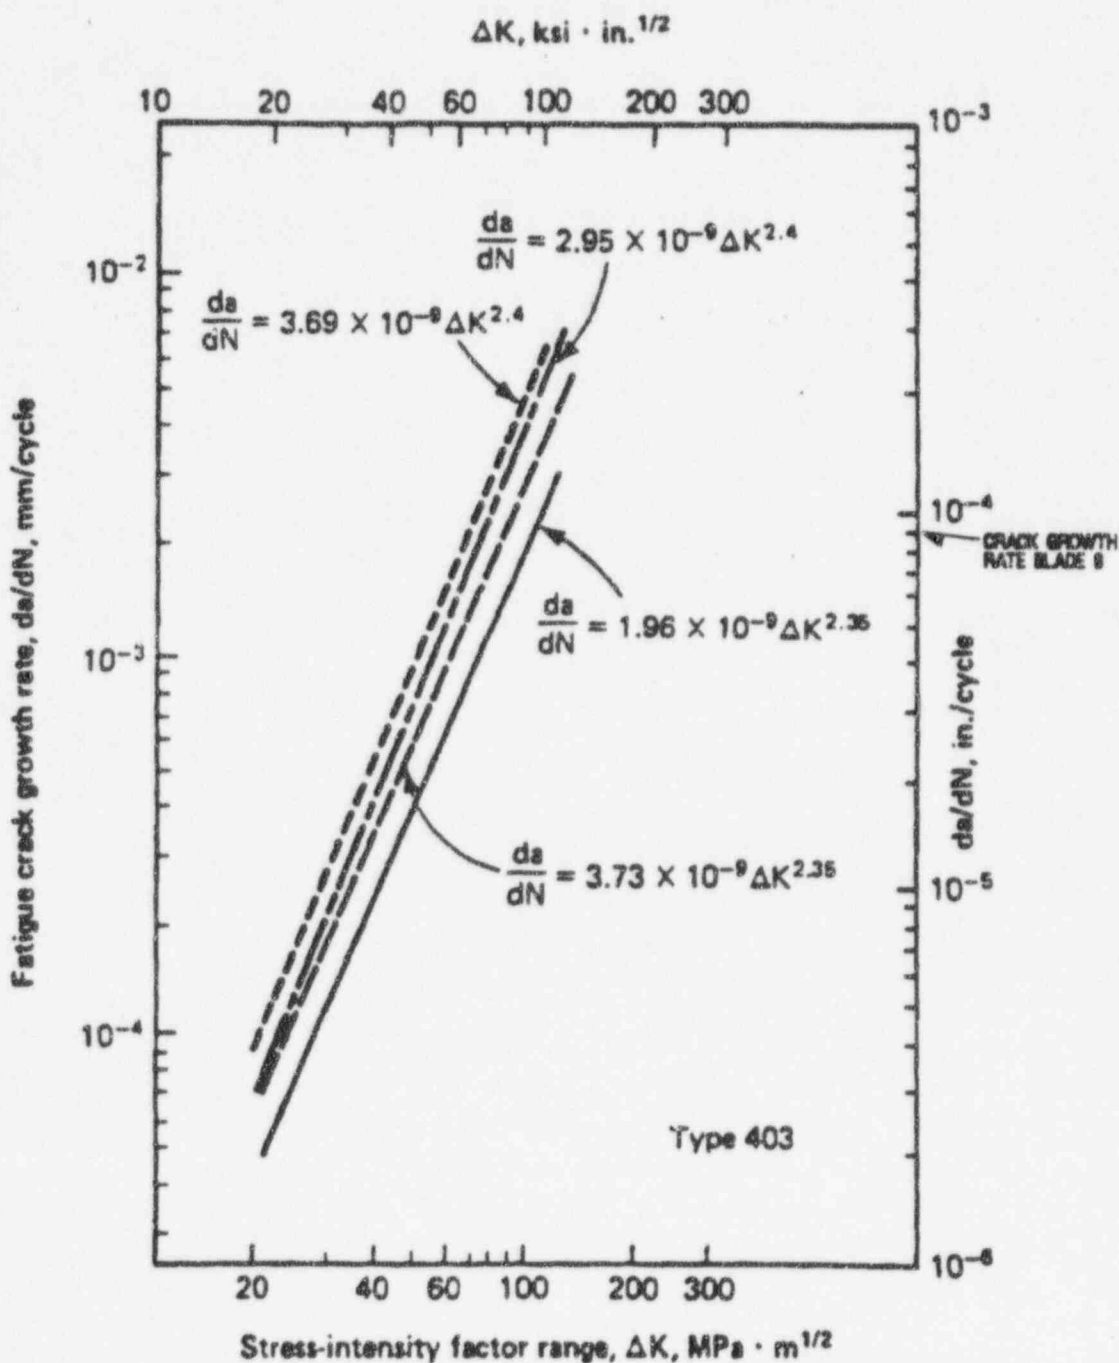
Figure 12 - Crack Growth Data for Type 403 Stainless Steel.
