# **1995 Annual Inspection of the Burrell, Pennsylvania, UMTRA Project Vicinity Property Disposal Site**

**December 1995**

**U.S. Department of Energy  
Grand Junction Projects Office  
Grand Junction, Colorado**

**Prepared by  
Rust Geotech  
Under DOE Contract No. DE-AC04-86ID12584  
U.S. Department of Energy  
Grand Junction Projects Office  
Grand Junction, Colorado**

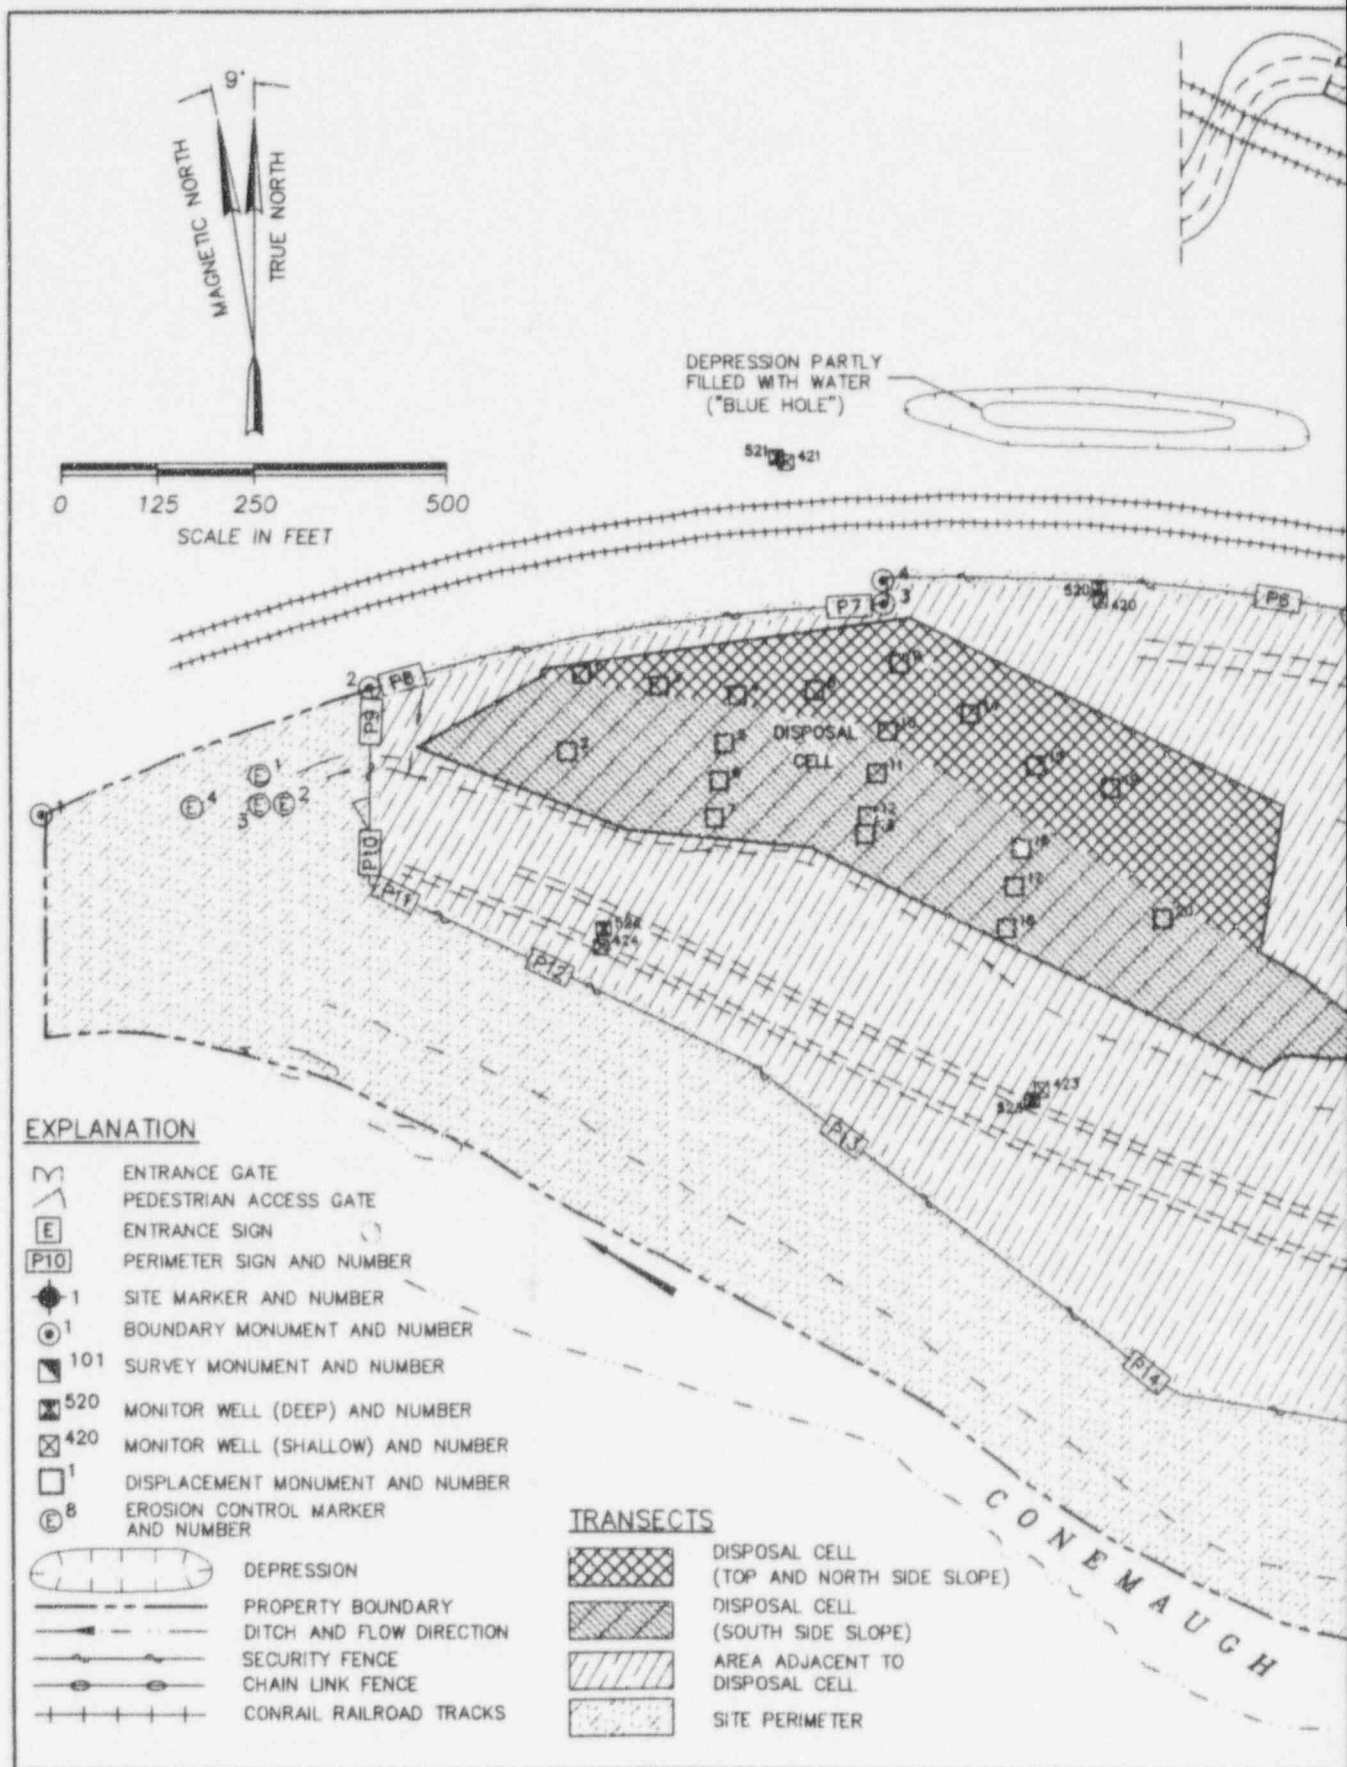
Figure 2. Map of Inspection Transects

Inspection transects are listed in Table 1 and are shown, except for the "outlying areas" transect, in Figure 2.
