U.S. NUCLEAR REGULATORY COMMISSION  
REGION IV

NRC Inspection Report No. 50-482/92-06

Facility Name: Wolf Creek Generating Station (WCGS)

Areas Inspected: Nonroutine, announced special inspection of the circumstances and activities associated with the noise event that occurred at the WCGS on February 28, 1992.

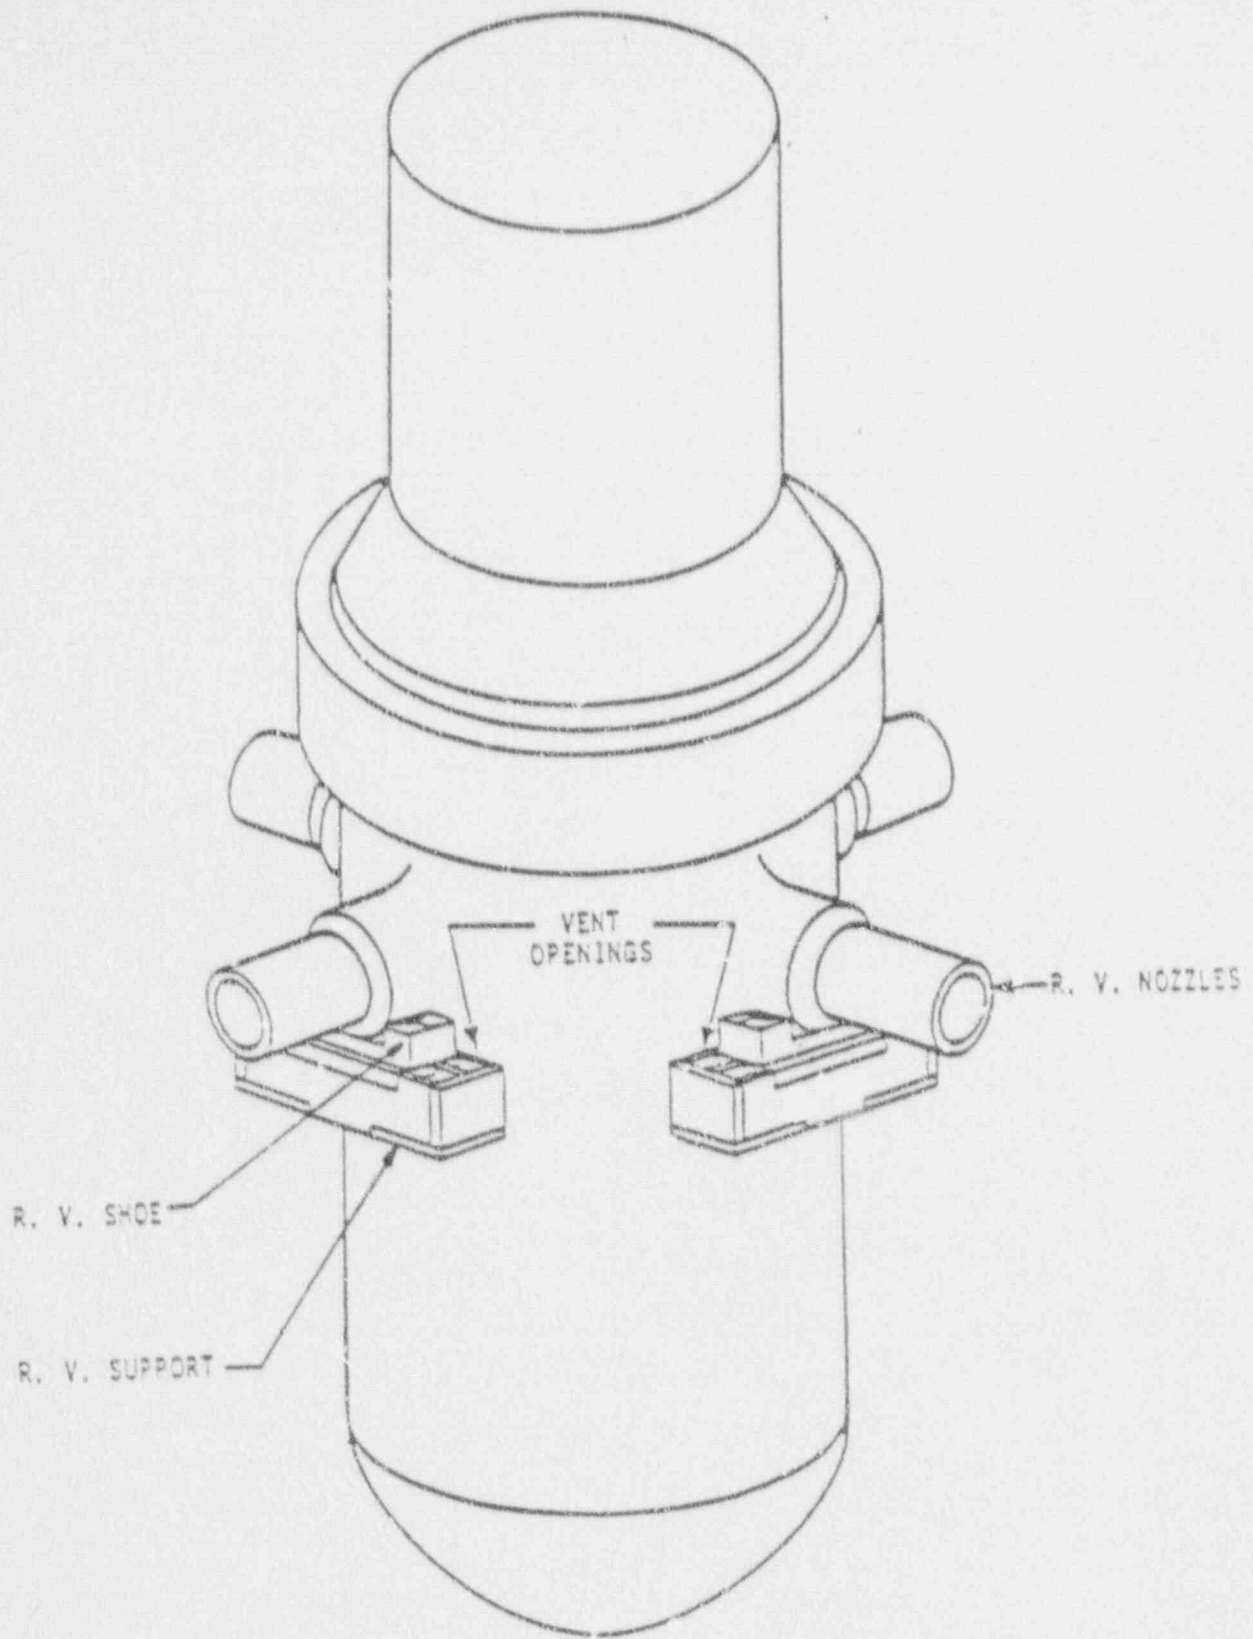
REACTOR VESSEL SUPPORT SYSTEM

## CONCLUSIONS

- o LOADS PRIMARILY TRANSMITTED TO THE SHIELD WALL
- o INITIAL MOVEMENT TOWARD WEST-SOUTHWEST
- o NO STRUCTURAL DISTRESS IS INDICATED

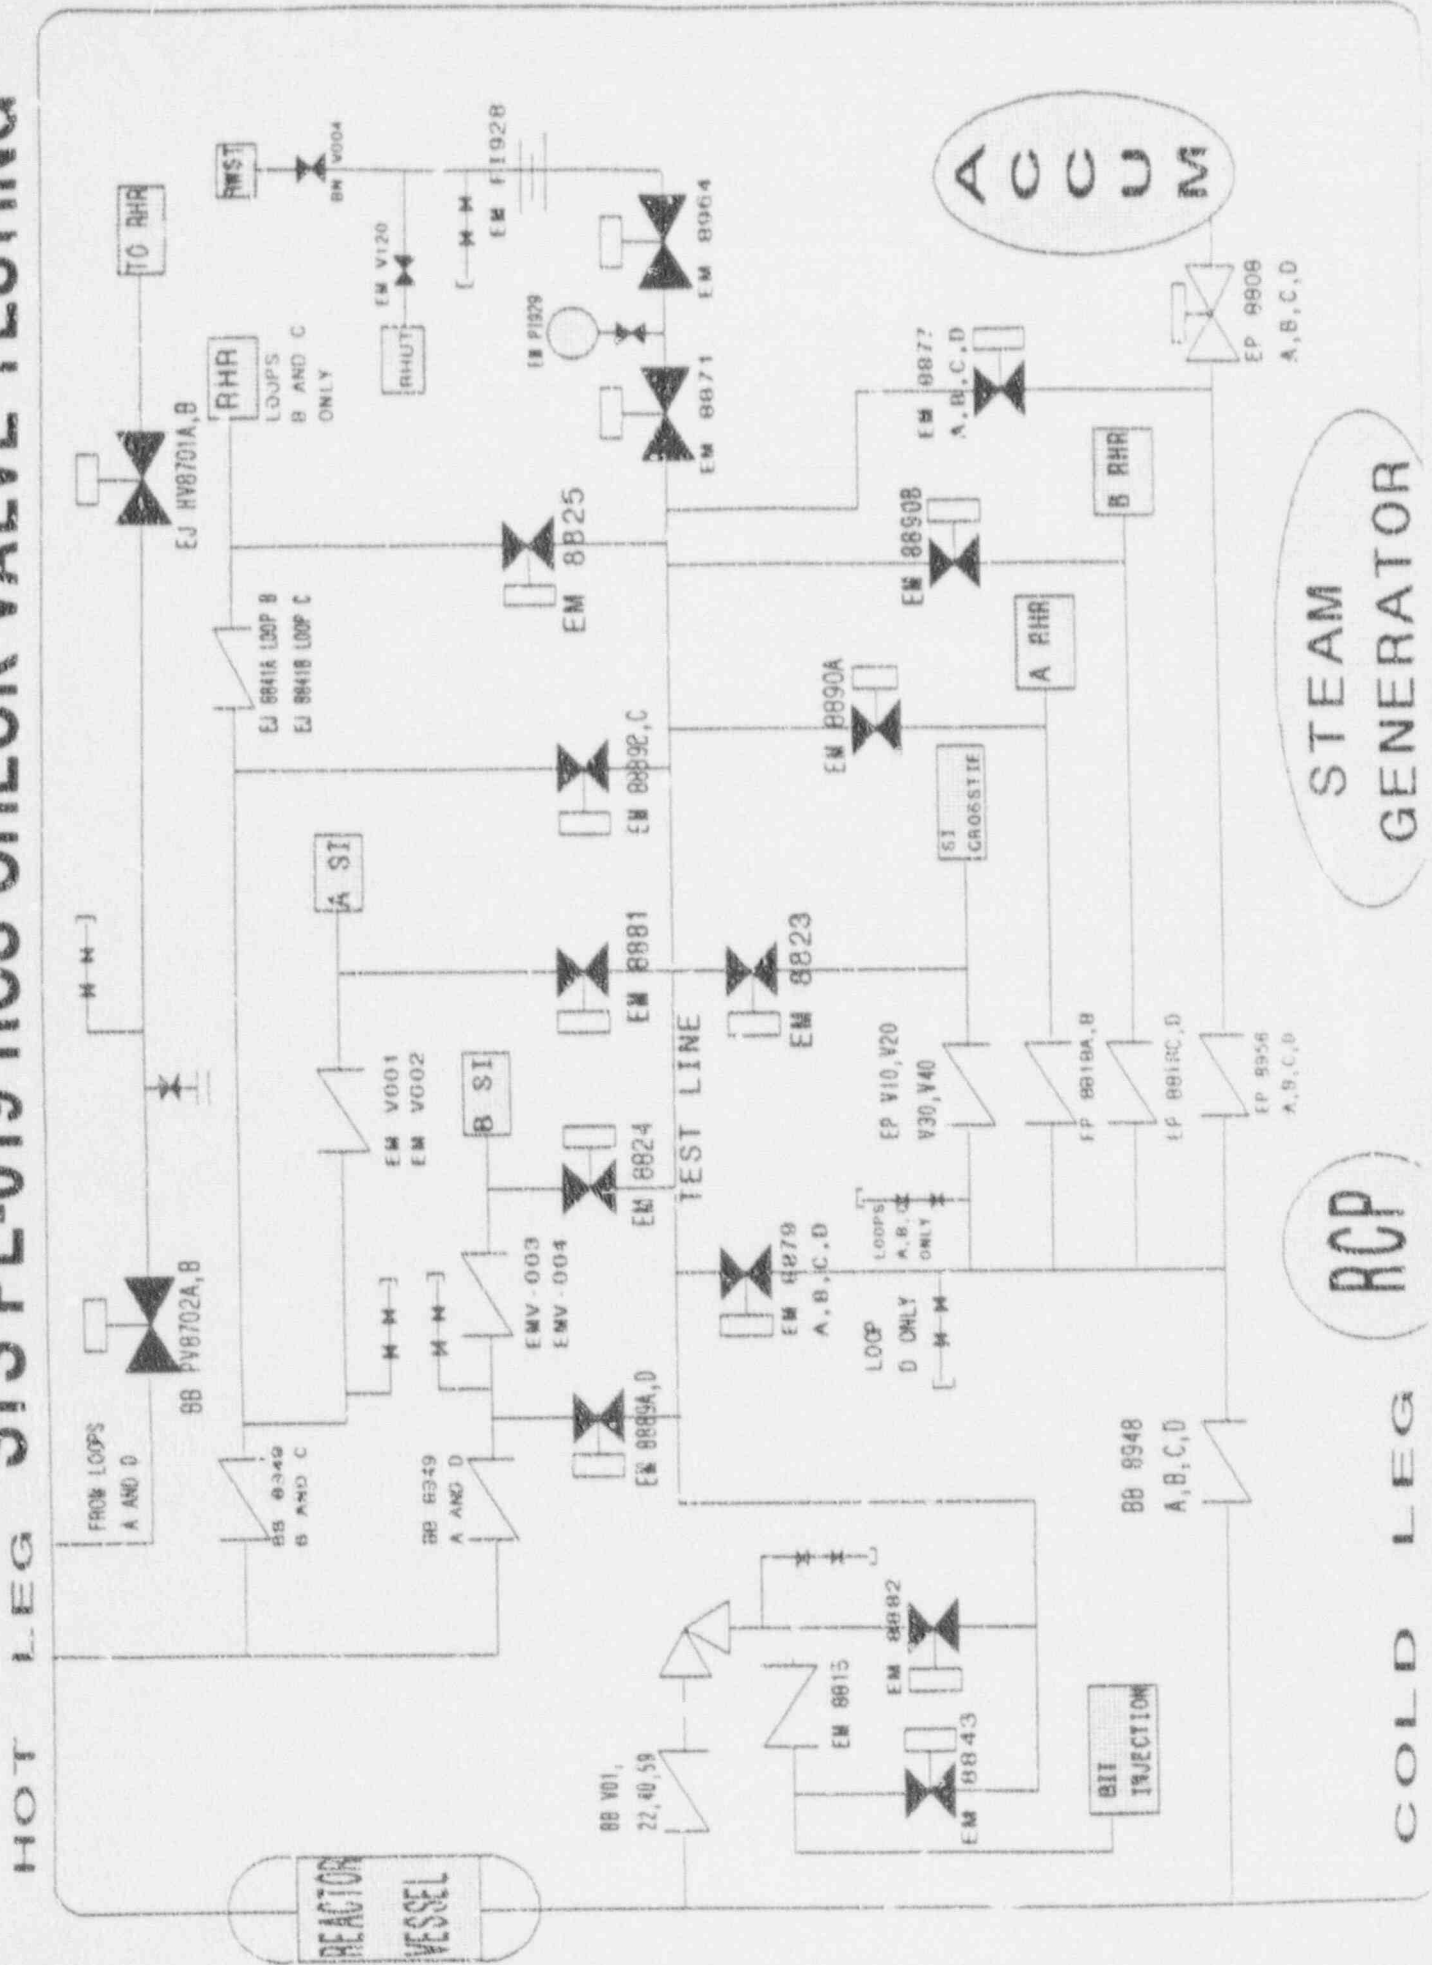
# STS PE-019 RCS CHECK VALVE TESTING

Based on the data provided from the above, concluded that this was not the mechanism that caused the noise.

Changed check valve test program to lessen the possibility of a thermal hydraulic event when restoring the accumulators to service. The March heatup confirmed the effectiveness of these measures.

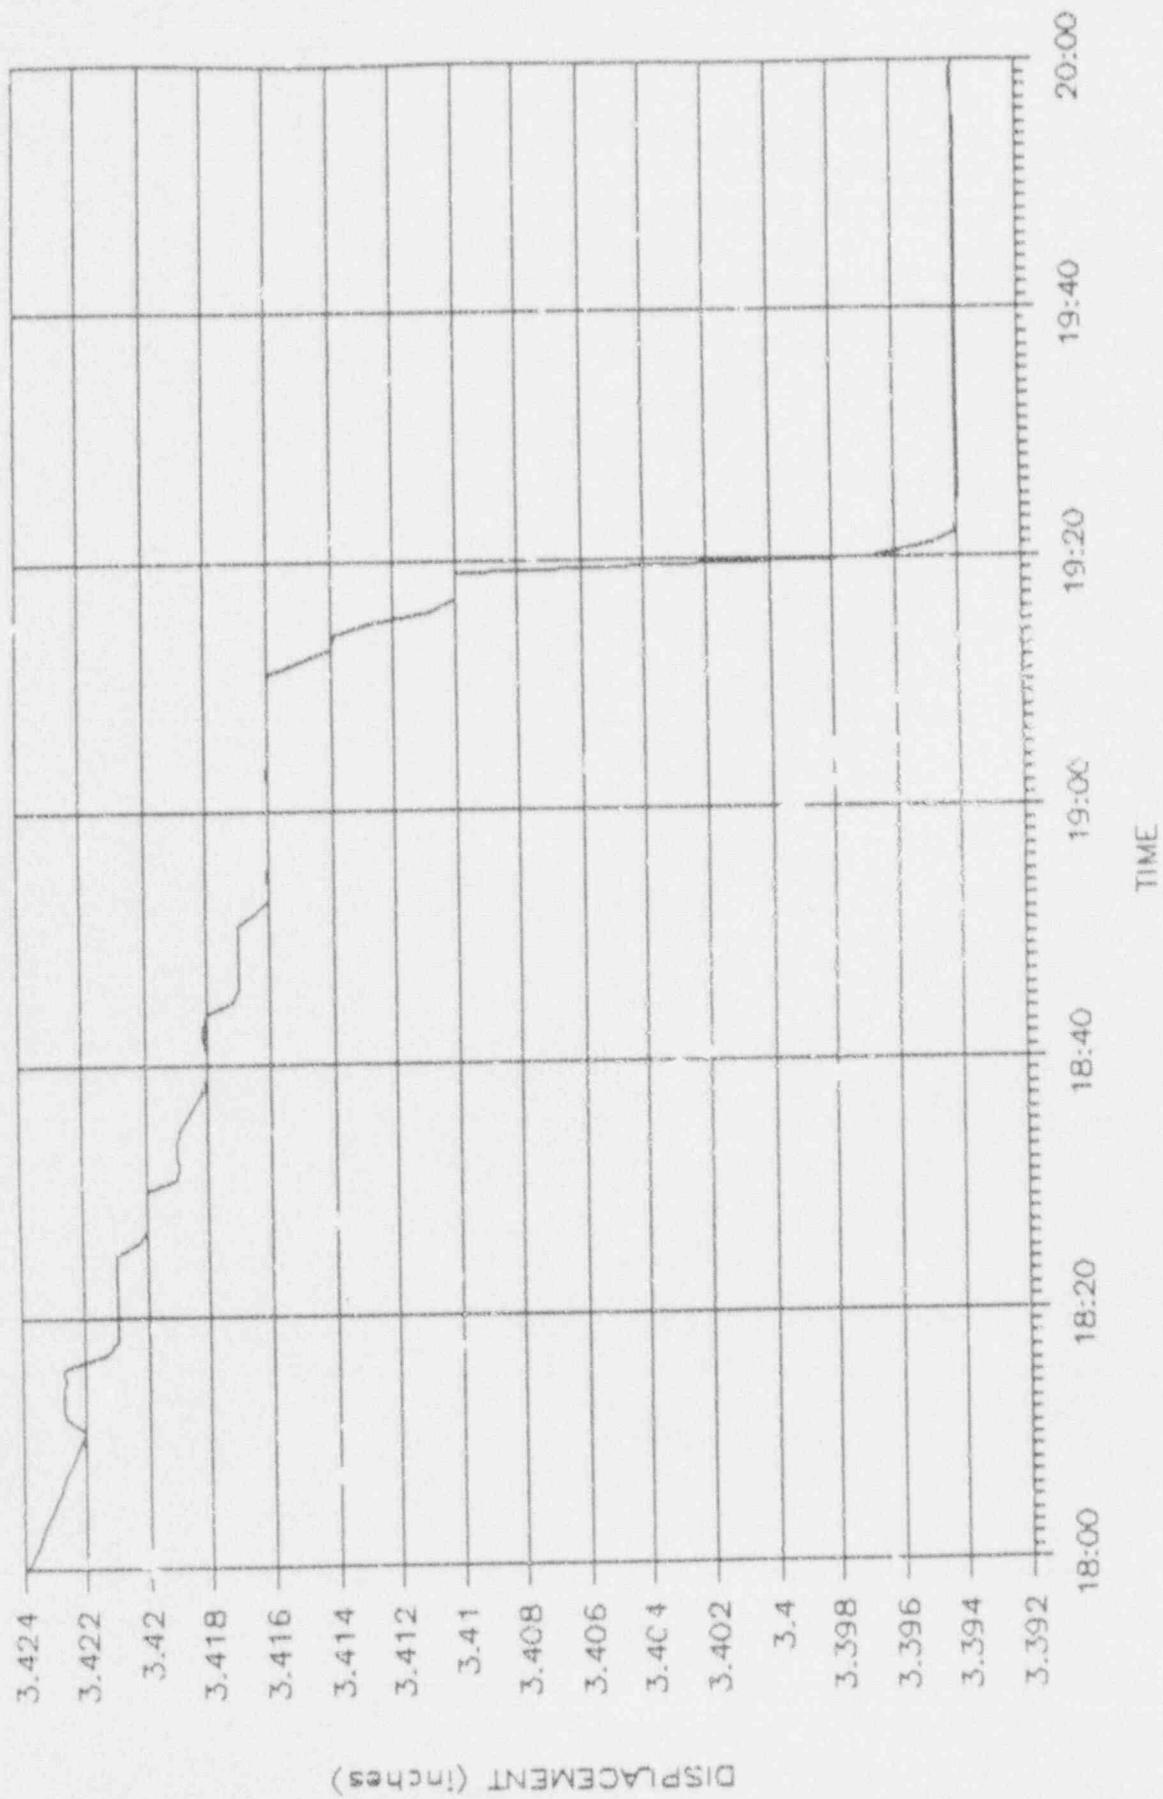
# LOOP 4

LANYARD DATA

**An inspection of the shims in the crossover leg pipe whip restraint revealed evidence of hard contact.**

**To eliminate this as a cause, the shims were removed and milled to restore the desired clearance.**
