BRUNSWICK STEAM ELECTRIC PLANT, UNIT 2
NRC DOCKET NO. 50-324
OPERATING LICENSE NO. DPR-62
NUREG-0619 FEEDWATER NOZZLE AND SPARGER EXAMINATION RESULTS

FEEDWATER SPARGER
CIRCUMFERENTIAL CRACKING EVALUATION
FOR BRUNSWICK UNITS 1 AND 2
General Electric Report GE-NE-523-112-1191
November 1974

FEEDWATER SPARGER
CIRCUMFERENTIAL CRACKING
EVALUATION FOR
BRUNSWICK UNITS 1 AND 2

BRUNSWICK STEAM ELECTRIC PLANT UNIT 2
NINETH REFUELING OUTAGE - OCTOBER, 1991
INVESSEL VISUAL INSPECTION (IVVI)
INSPECTION REPORT AND VIDEO REVIEW

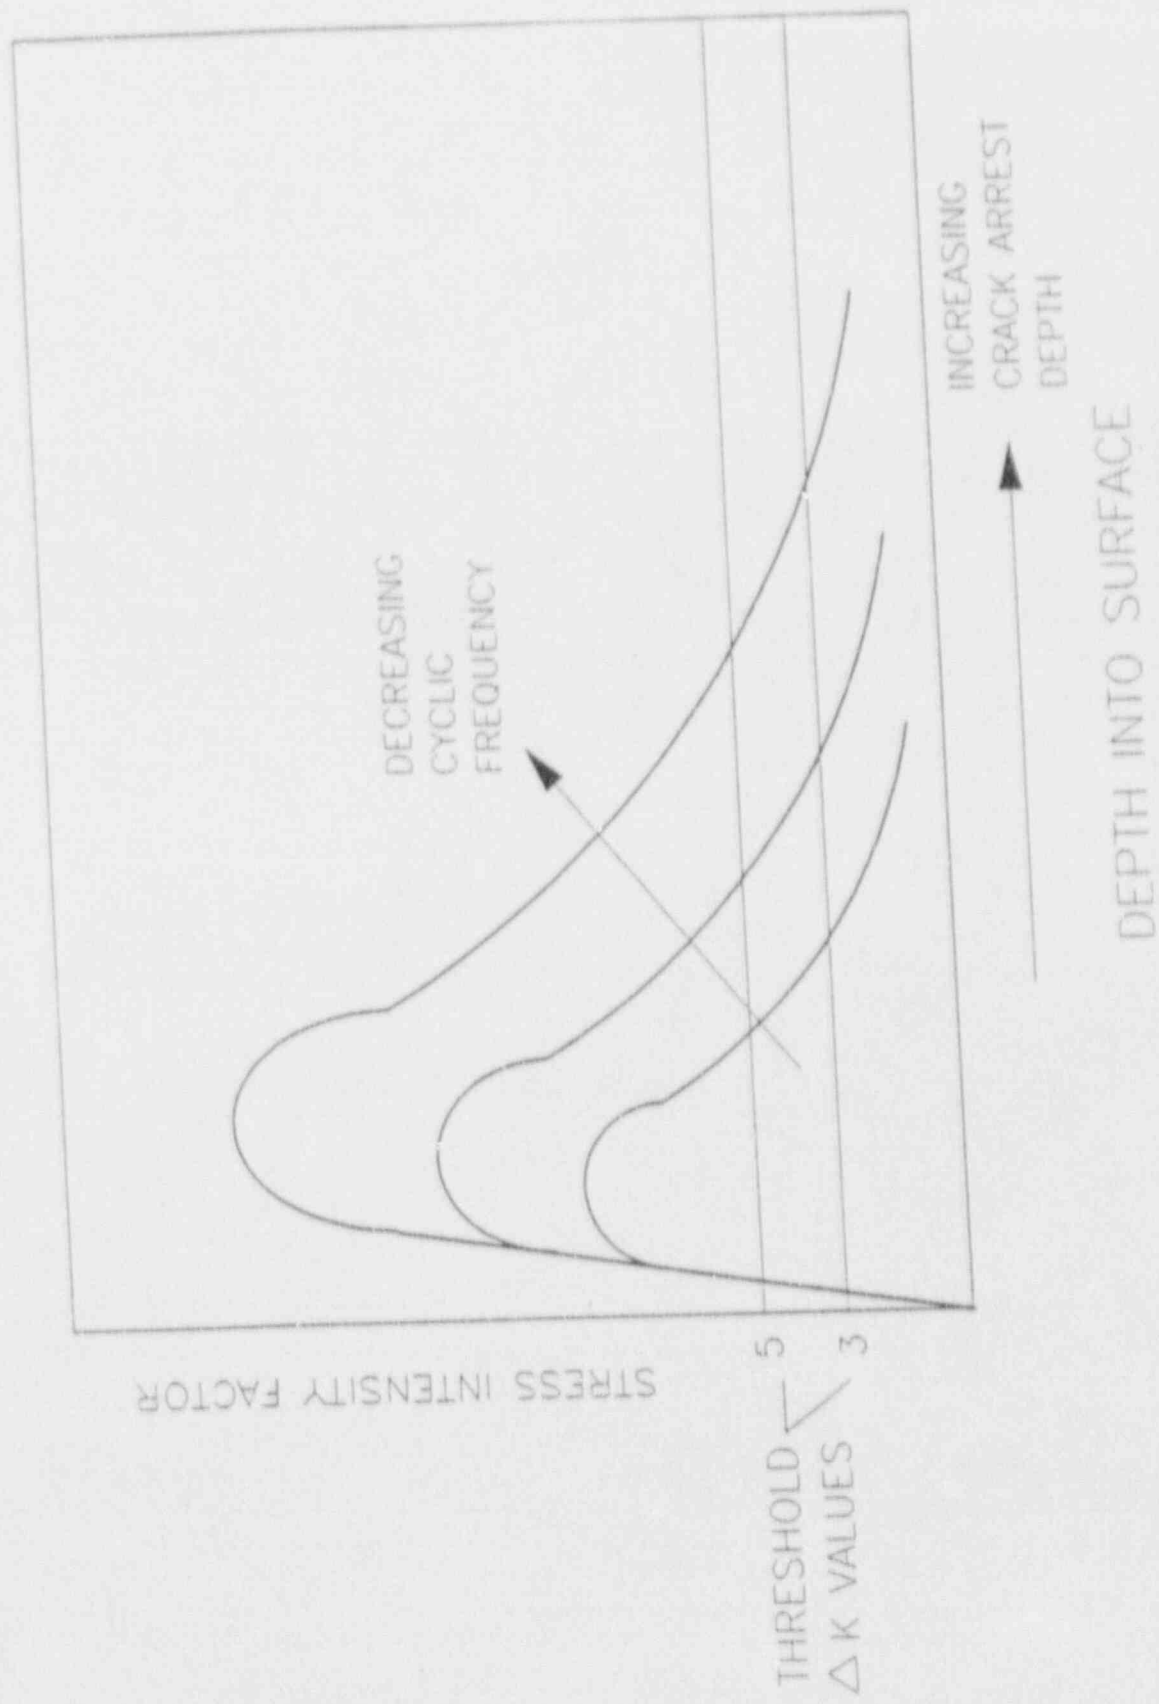
Figure 4-1. Schematic of Frequency Dependency on Crack Arrest Depth

Extensive testing and analysis of the thermal sleeve leakage rapid cycling was conducted in the process of designing the triple thermal sleeve. Among the analyses done was an evaluation of the expected crack growth in the blend radius due to rapid cycling [4]. The results showed that ΔK values associated with the rapid thermal cycling drop as a crack proceeds into the nozzle until the crack arrest ΔK threshold of 3 ksi- $\sqrt{\text{in}}$ (for high R-ratios) is reached. The depth of the arrested crack is a function of the frequency of the cycling, as shown in Figure 4-1.

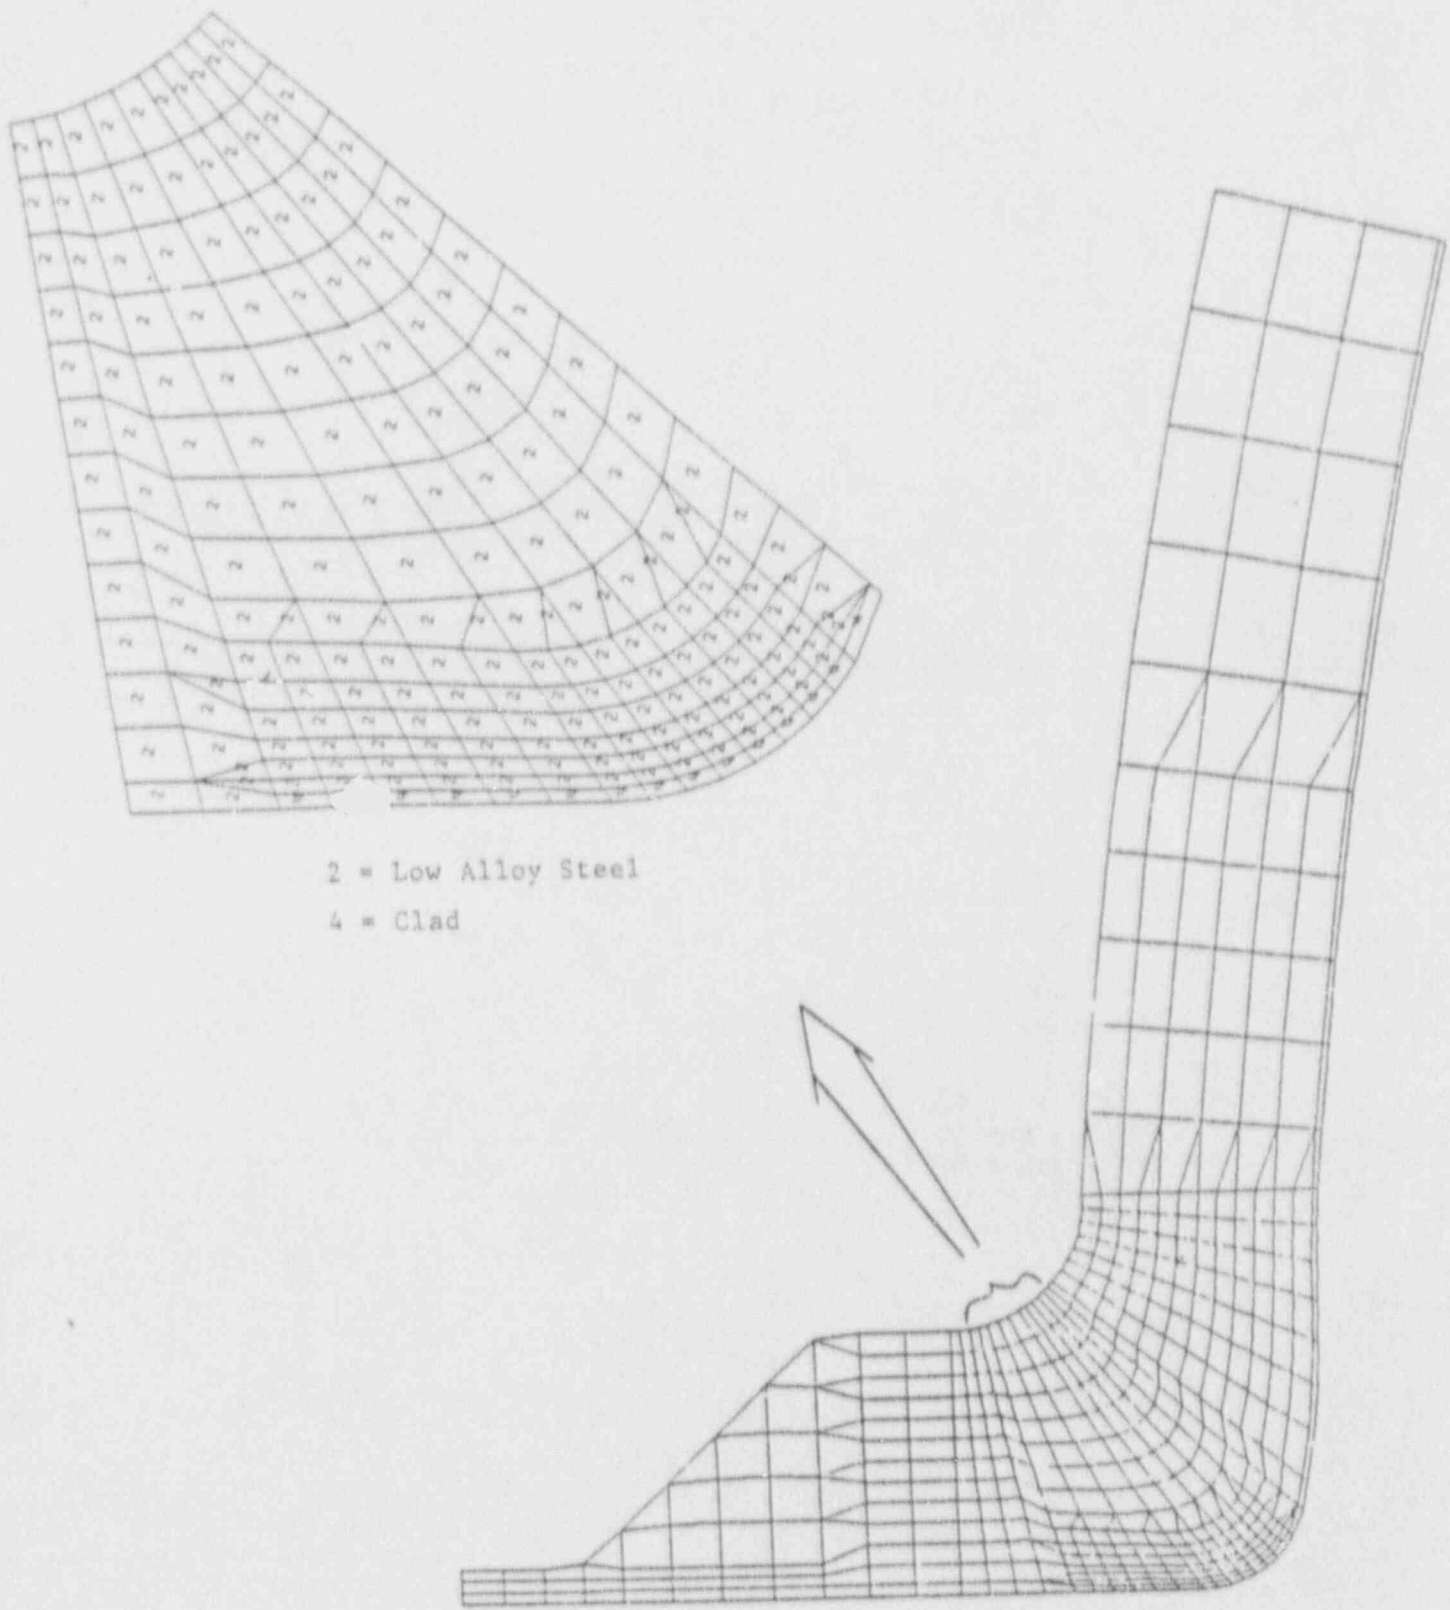
Figure 4-2. ANSYS Model of Feedwater Nozzle Blend Radius

The feedwater nozzle blend radius was modeled, as shown in Figure 4-2, for finite element analysis by ANSYS. The model was subjected to cycles of 130°F step changes between 550°F and 420°F at varying frequencies, and thermal and stress computations were performed. The ANSYS results were used with the ΔK relationship from [4]:

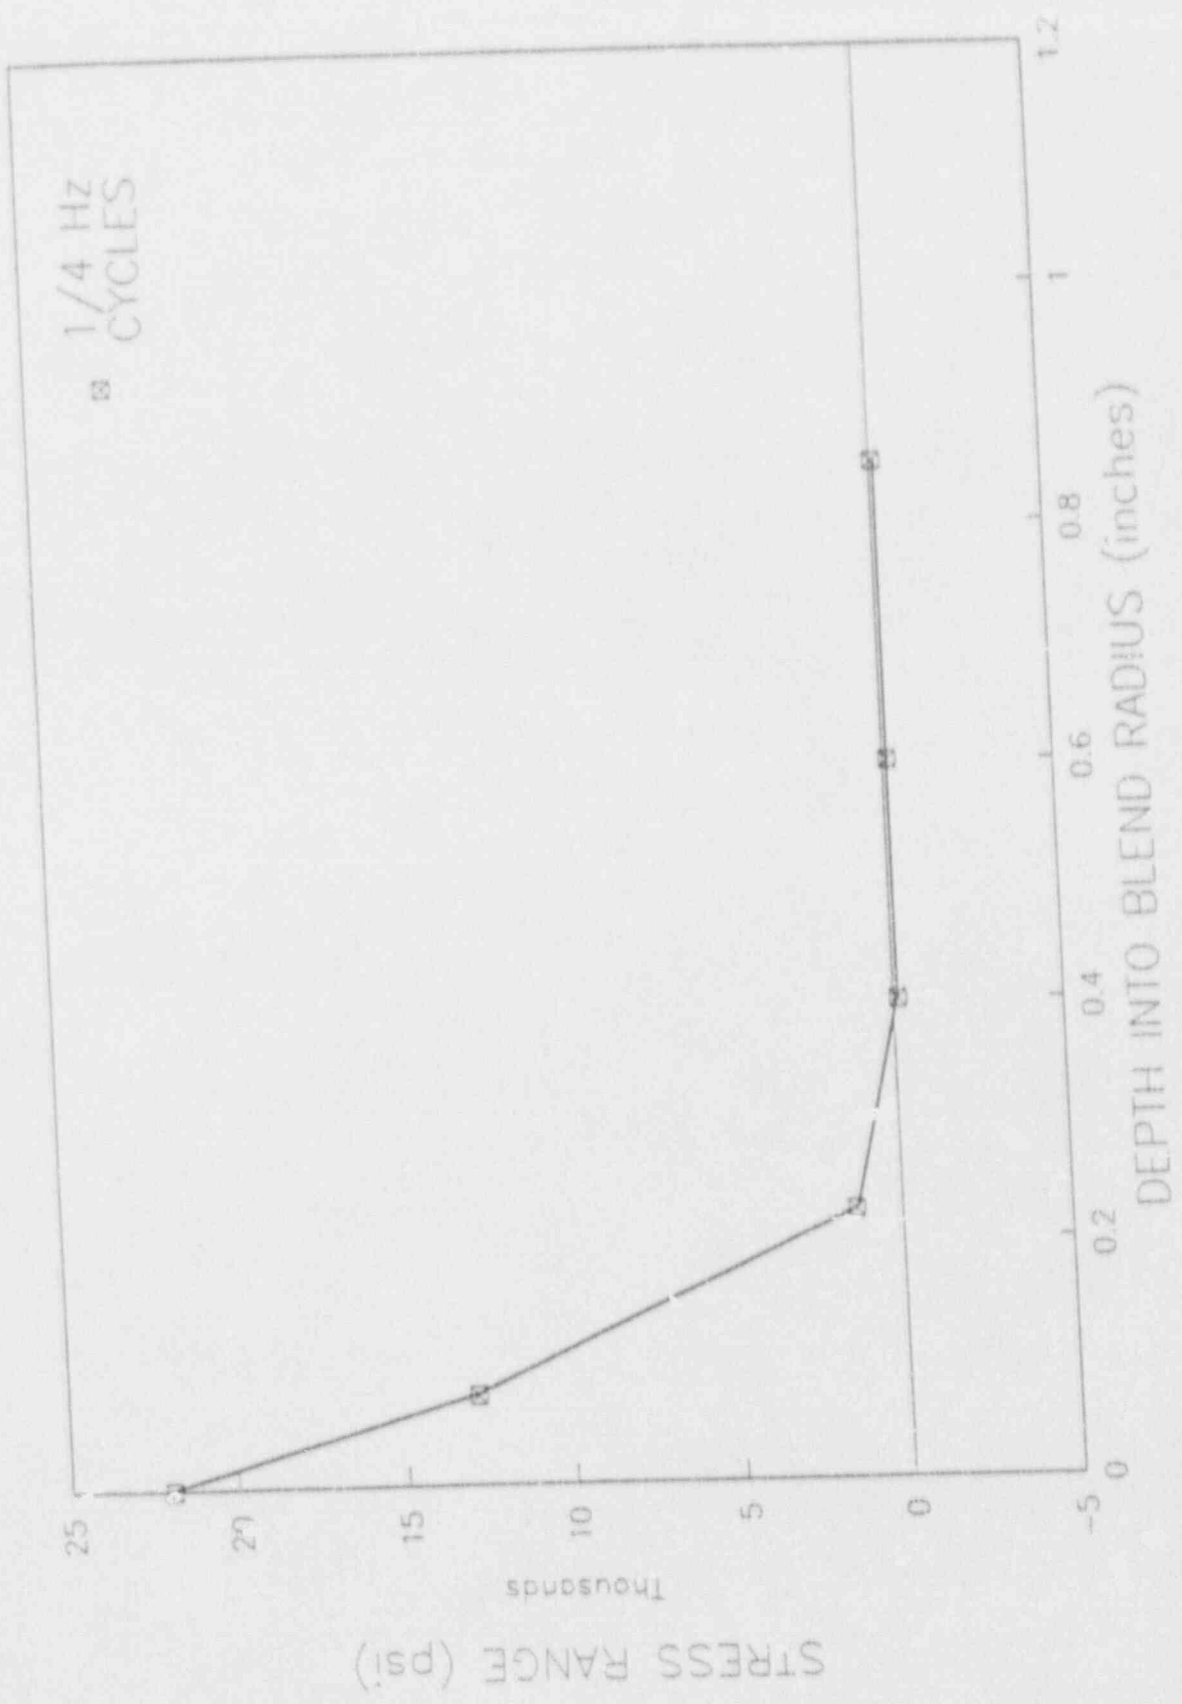
Figure 4-3. Stress Range Profile for Cyclic Leakage on Nozzle

Stress range and ΔK profiles were developed for frequencies of 1/8, 1/4 and 1/3 Hz. The 1/4 Hz case was found to come closest to meeting the benchmark condition of 5 ksi- $\sqrt{\text{in}}$ at 0.5 inches. The stress range profile is shown in Figure 4-3. The stress range profile was fit with a cubic polynomial, and then the coefficients were adjusted slightly until the benchmark conditions were met. The resulting ΔK vs. depth plot is shown in Figure 4-4. The curve extends to the high mean stress threshold of 3 ksi- $\sqrt{\text{in}}$ at a depth of 0.85 inches. Therefore, rapid cycling behavior which causes a crack of 0.5 inches at the flow holes is predicted to cause a crack of 0.85 inches in the blend radius.
