U. S. NUCLEAR REGULATORY COMMISSION
REGION 1

Report Nos. 92-13
92-12

Facility: Beaver Valley Power Station, Units 1 and 2

Inspection Period: April 19 - May 25, 1992

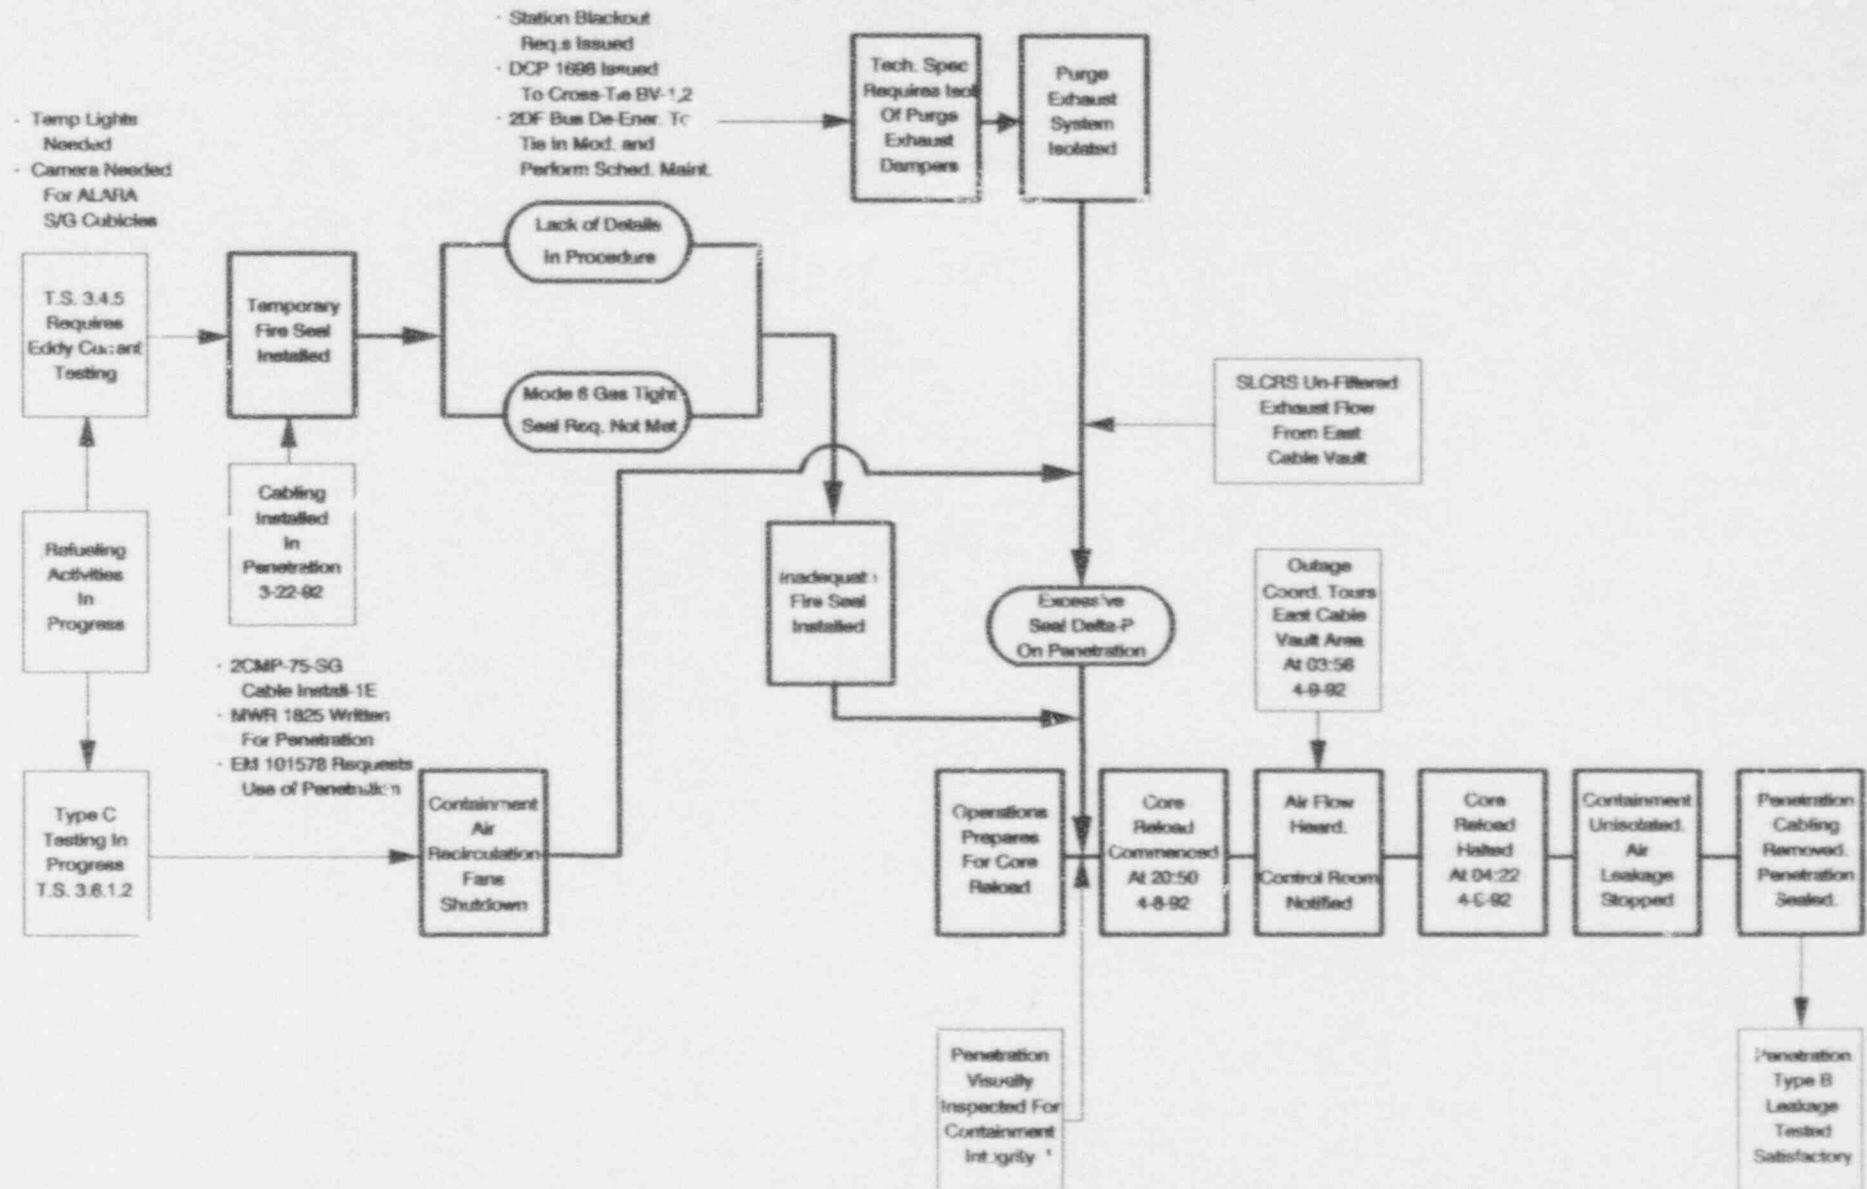
IMPROPERLY SEALED CONTAINMENT PENETRATION (LER 92-005-00)

One of the Unit 2 containment building penetrations did not conform to the technical specification 3.9.4 configuration requirements. Technical specification 3.9.4 requires that each penetration providing direct access from the containment atmosphere to the outside atmosphere shall be closed by an isolation valve, blind flange, or manual valve, or exhausting at less than or equal to 7500 cfm through operable containment purge and exhaust isolation valves. Contrary to the above, spare electrical penetration 2RCP-11E was discovered to be leaking and therefore not meeting the requirements of technical specification 3.9.4.

The condition, when electrical penetration 2RCP-11E did not conform to the requirements of technical specification 3.9.4 existed for 7.5 hours (best estimate) and less than 72 hours (worst case). The violation was not easily discovered due to the following factors:
