Sequoyah Nuclear Plant

Unit 1 Cycle 7 Refueling Outage

RESULTS OF STEAM GENERATOR TUBE INSERVICE INSPECTION
(AS REQUIRED BY TECHNICAL SPECIFICATION SECTION 4.4.5.5.b)

RESULTS OF C-3 STEAM GENERATOR TUBE INSPECTIONS AND
RESULTS OF INVESTIGATIONS CONDUCTED TO DETERMINE
CAUSE OF TUBE DEGRADATION AND CORRECTIVE MEASURES
(AS REQUIRED BY TECHNICAL SPECIFICATION SECTION 4.4.5.5.c)

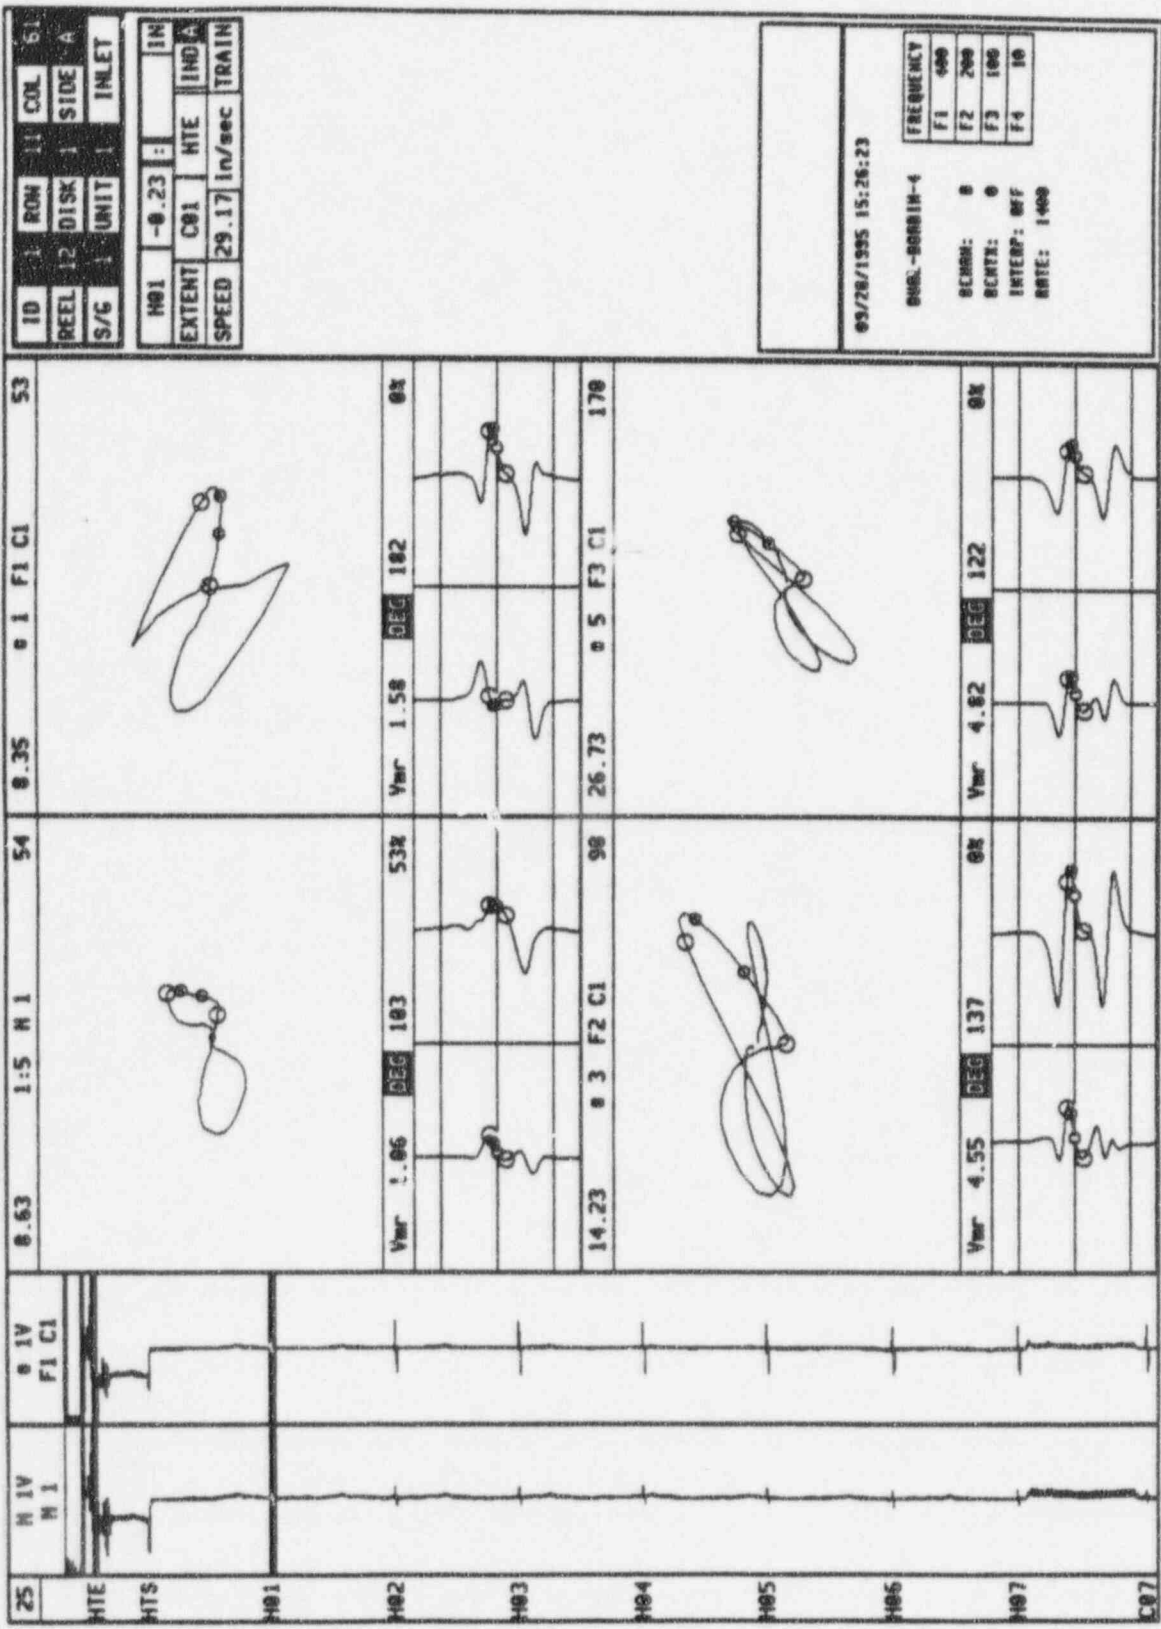
Figure 3-10 R11C61-TSP1: Laboratory Reanalysis of Bobbin Field Data.

The indication at R11C61, TSP 1 requires further evaluation as this indication was called a 76° circumferential indication by +Point inspection, was bobbin NDD in the field call and has a 0.96 volt bobbin indication by laboratory reanalysis of the field data. The bobbin analysis for this indication is shown in Figure 3-10. Figures 3-11 to 3-13 show the RPC flaw shapes from the +Point, 80 mil pancake and 115 mil pancake coils respectively. The +Point response is typical of a circumferential indication while the 80 and 115 mil pancake coils show significant

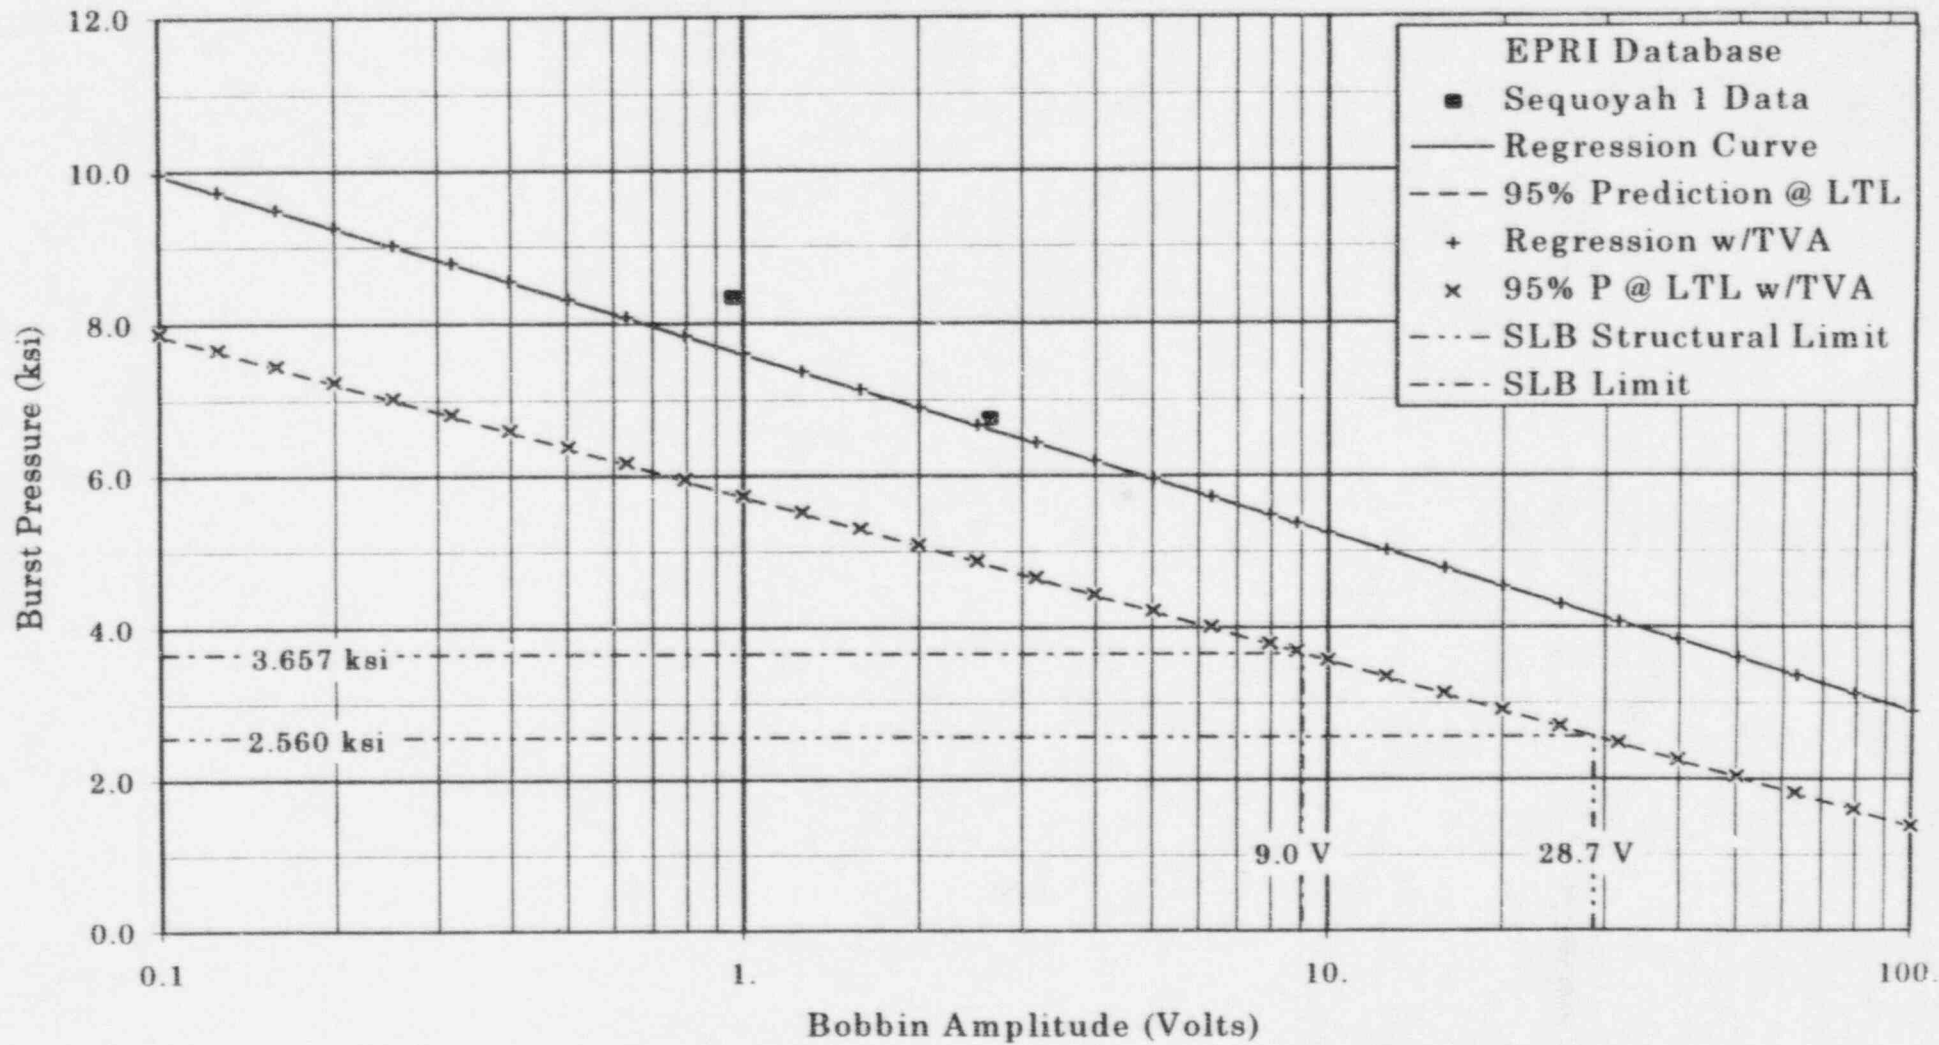
Results from two (2) burst tests, performed on tube specimens which exhibited non-zero bobbin amplitudes at TSP elevation locations, were considered for evaluation. A plot of the burst pressures of the Sequoyah 1 specimens is depicted on Figure 3-14 relative to the burst pressure correlation developed using the reference database.²

1. A visual examination of the data relative to the EPRI database indicated that the burst pressures measured fall within the scatter band of the reference data. This is also apparent from the nearness of the data points to the reference regression line illustrated on Figure 3-14.
2. Both data points fall within a 90% non-simultaneous two-sided prediction band about the regression line (the one-sided 95% prediction curve depicted

Since the Sequoyah-1 burst pressure data were not indicated to be from a separate population from the reference data, the regression analysis of the burst pressure on the common logarithm of the bobbin amplitude was repeated with the additional data included. A comparison of the regression results obtained by including these data in the regression analysis is provided in Table 3-7. Regression predictions obtained by including these data in the regression analysis are also shown on Figure 3-14. A summary of the changes is as follows:

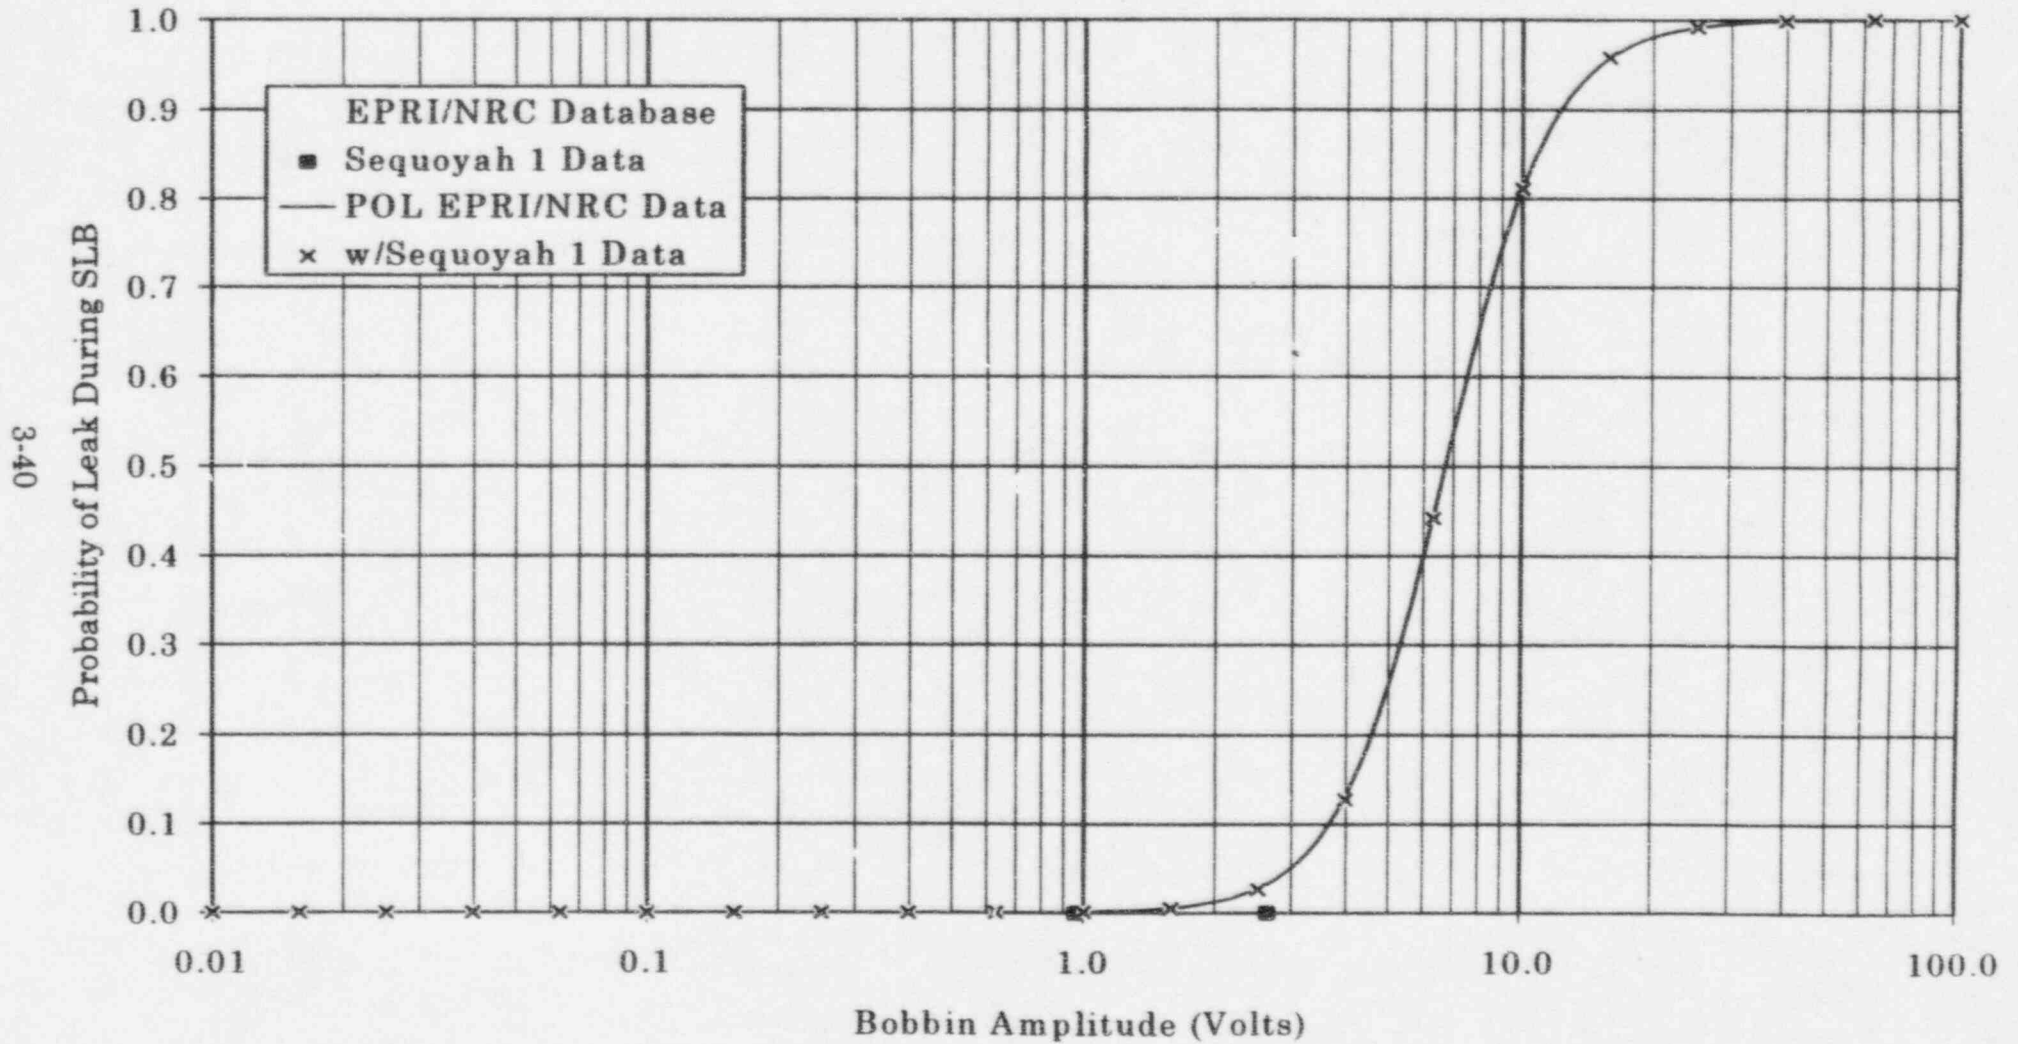
The data of Table 3-6 were examined relative to the reference correlation for the PoL as a function of the common logarithm of the bobbin amplitude. Figure 3-15 illustrates the Sequoyah 1 data relative to the reference correlation. All of the specimens exhibited PoL behavior commensurate with expectations indicated by

In order to assess whether or not these changes are significant, the reference correlation and the new correlation were also plotted on Figure 3-15. An examination of Figure 3-15 reveals essentially no change, in an absolute sense, in the correlation over the entire range of the data. It is noted that when the total leak rate is determined using the leak rate to bobbin volts correlation, the resulting value can be quite insensitive to the form of the PoL function. Hence, the effect of the changes in the parameter values and variances is judged to be insignificant relative to the calculation of the expected total leak rate.

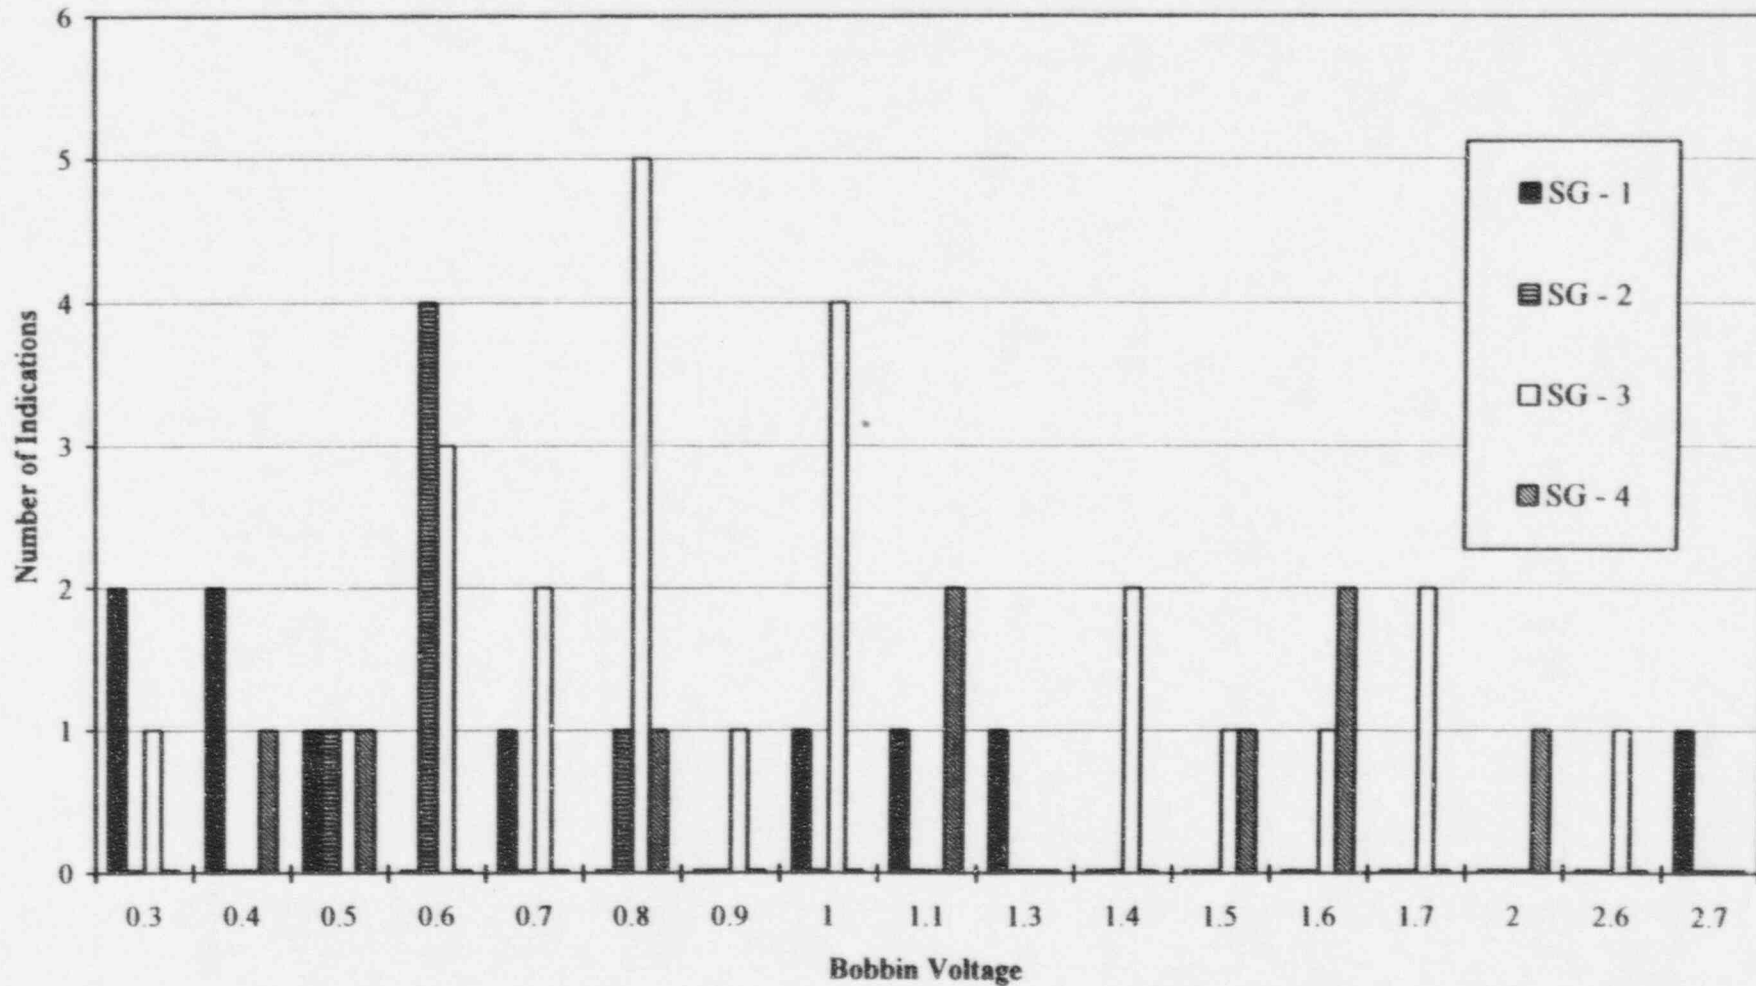
Figure 4 - 1
Sequoyah Unit -1 October 1995
Distributions of Actual Bobbin Voltage
(Six Indications at Dented Intersections Detected by +Point Probe are Included)

Only 49 axial TSP ODSCC indications (including the six indications at dented intersections detected with +Point probe) were found in all four steam generators combined in the EOC-7 inspection. Of these, only two indications have a voltage above 2 volts. These two indications plus five other bobbin indications below 2 volts were RPC inspected and confirmed as flaws.

A summary of EC indication statistics for all four SGs is shown on Table 4-1. The table shows the number of field bobbin indications detected during the current (EOC-7) inspection, the number of these field bobbin indications that were RPC inspected, the number of RPC confirmed indications, the number of repaired indications, and the total number of indications in tubes returned to service for Cycle 8 operation. Bobbin voltage distribution for all indications detected during the current inspection is also shown in graphical form in Figure 4-1.
