Precursors to Potential Severe Core Damage Accidents: 1994 A Status Report

Appendix I

Oak Ridge National Laboratory

**Prepared for
U.S. Nuclear Regulatory Commission**

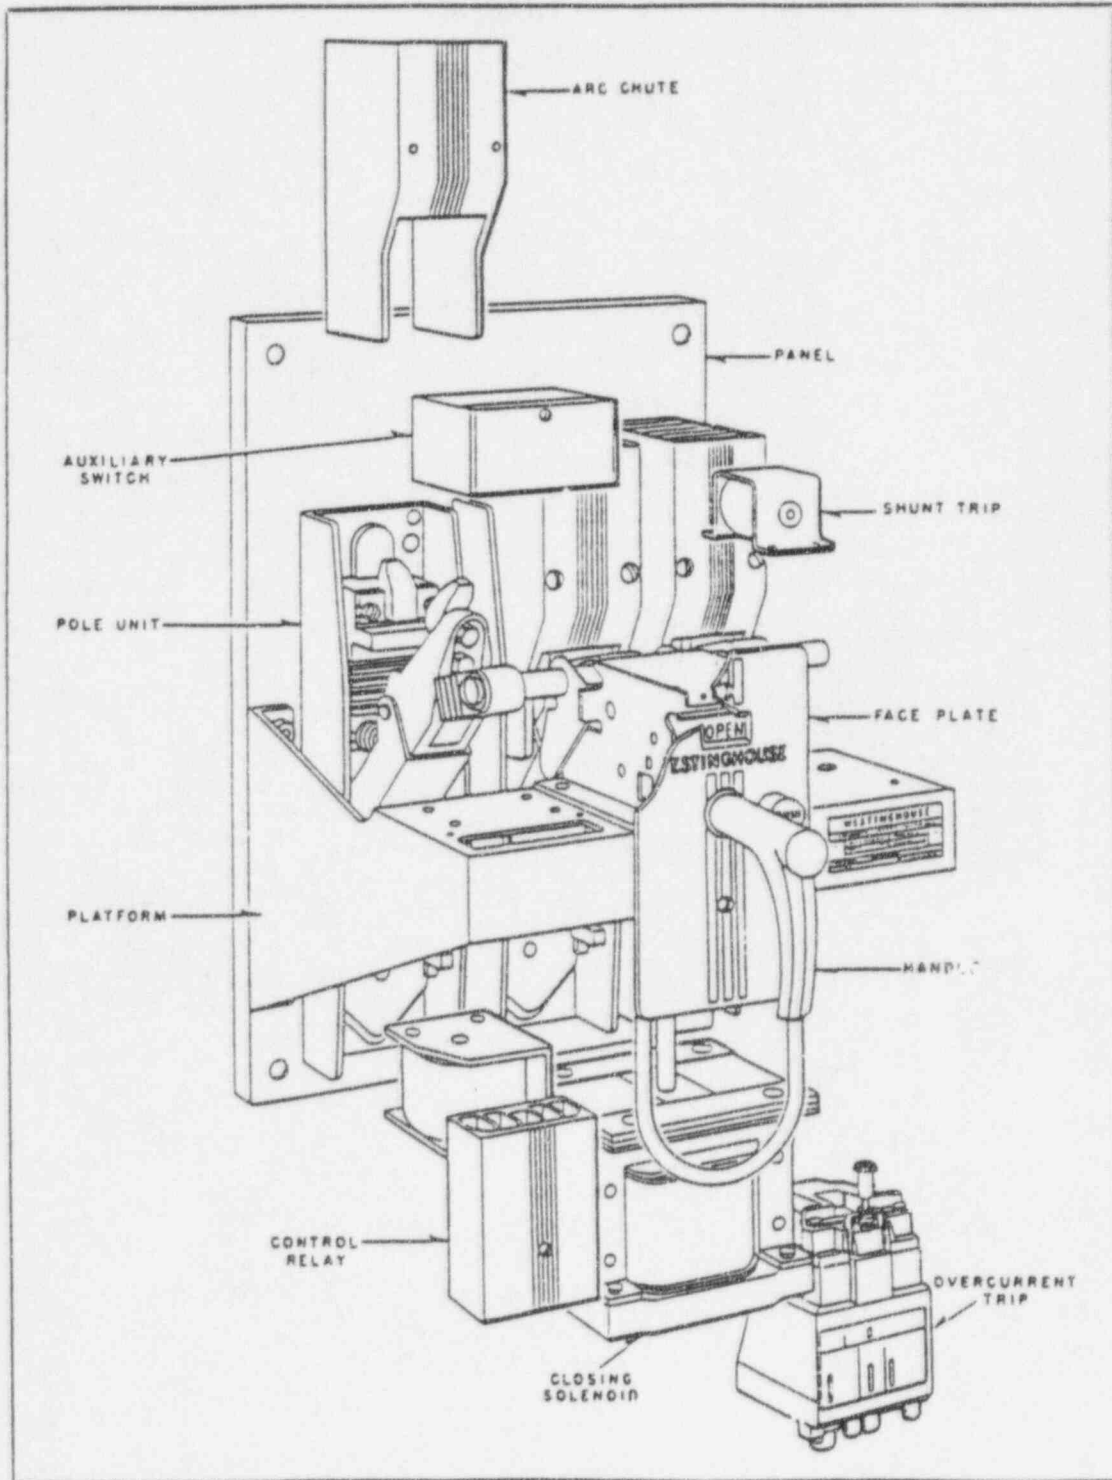
FIGURE 3
VIEW OF DB-25 BREAKER

Breakers 9C and 11C are Westinghouse Model DB-25 air circuit breakers. Figures 3 through 5 show the relevant features of the DB-25 design details. The licensee conducted visual inspections of the breaker 11C components on February 19. Covers to the auxiliary switches were removed and the auxiliary switch wiring and contacts were visually inspected. No abnormalities were identified during the visual examination of the auxiliary switches. The amptector (overcurrent device) and the cover to the closing/trip linkage was removed. During a visual inspection of the linkage, the licensee identified that the snap ring on the manual closing linkage was not properly located in the snap ring slot (see Figure 5). The snap ring was back away from the slot, toward the manual closing handle, approximately 1 to 1 1/2 inches. This allowed the manual breaker closing linkage to protrude into the closing/trip linkage.

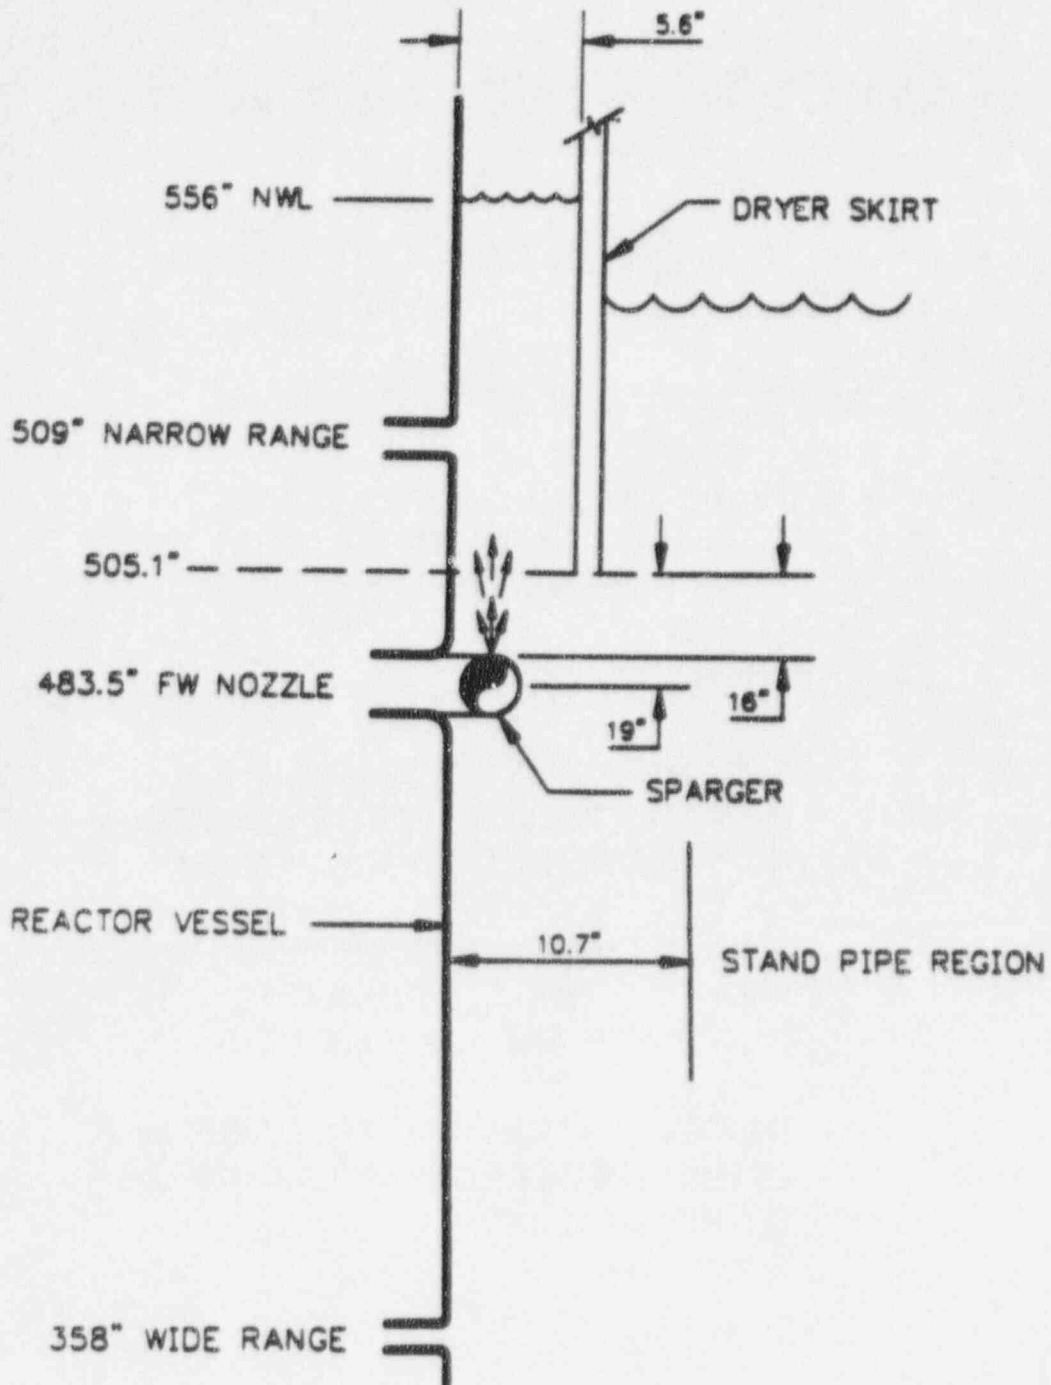
LEVEL SWELL SCENARIO

- **HYDRAULIC DISTURBANCE: INTERNAL TO VESSEL**
