UNITED STATES
NUCLEAR REGULATORY COMMISSION
WASHINGTON, D.C. 20555-0001

LICENSEE: Houston Lighting and Power Company (HL&P), et al.
FACILITY: South Texas Project, Units 1 and 2 (STP)
SUBJECT: SUMMARY OF JANUARY 18, 1996, MEETING ON THE UNIT 1 CONTROL ROD
INSERTION ANOMALY AND THE RESULTING ACTION PLANS

MEETING BETWEEN HL&P AND NRC ON CONTROL ROD ACTION PLANS

UNIT 1 CONTROL ROD INSERTION ANOMALY
TO
NRC

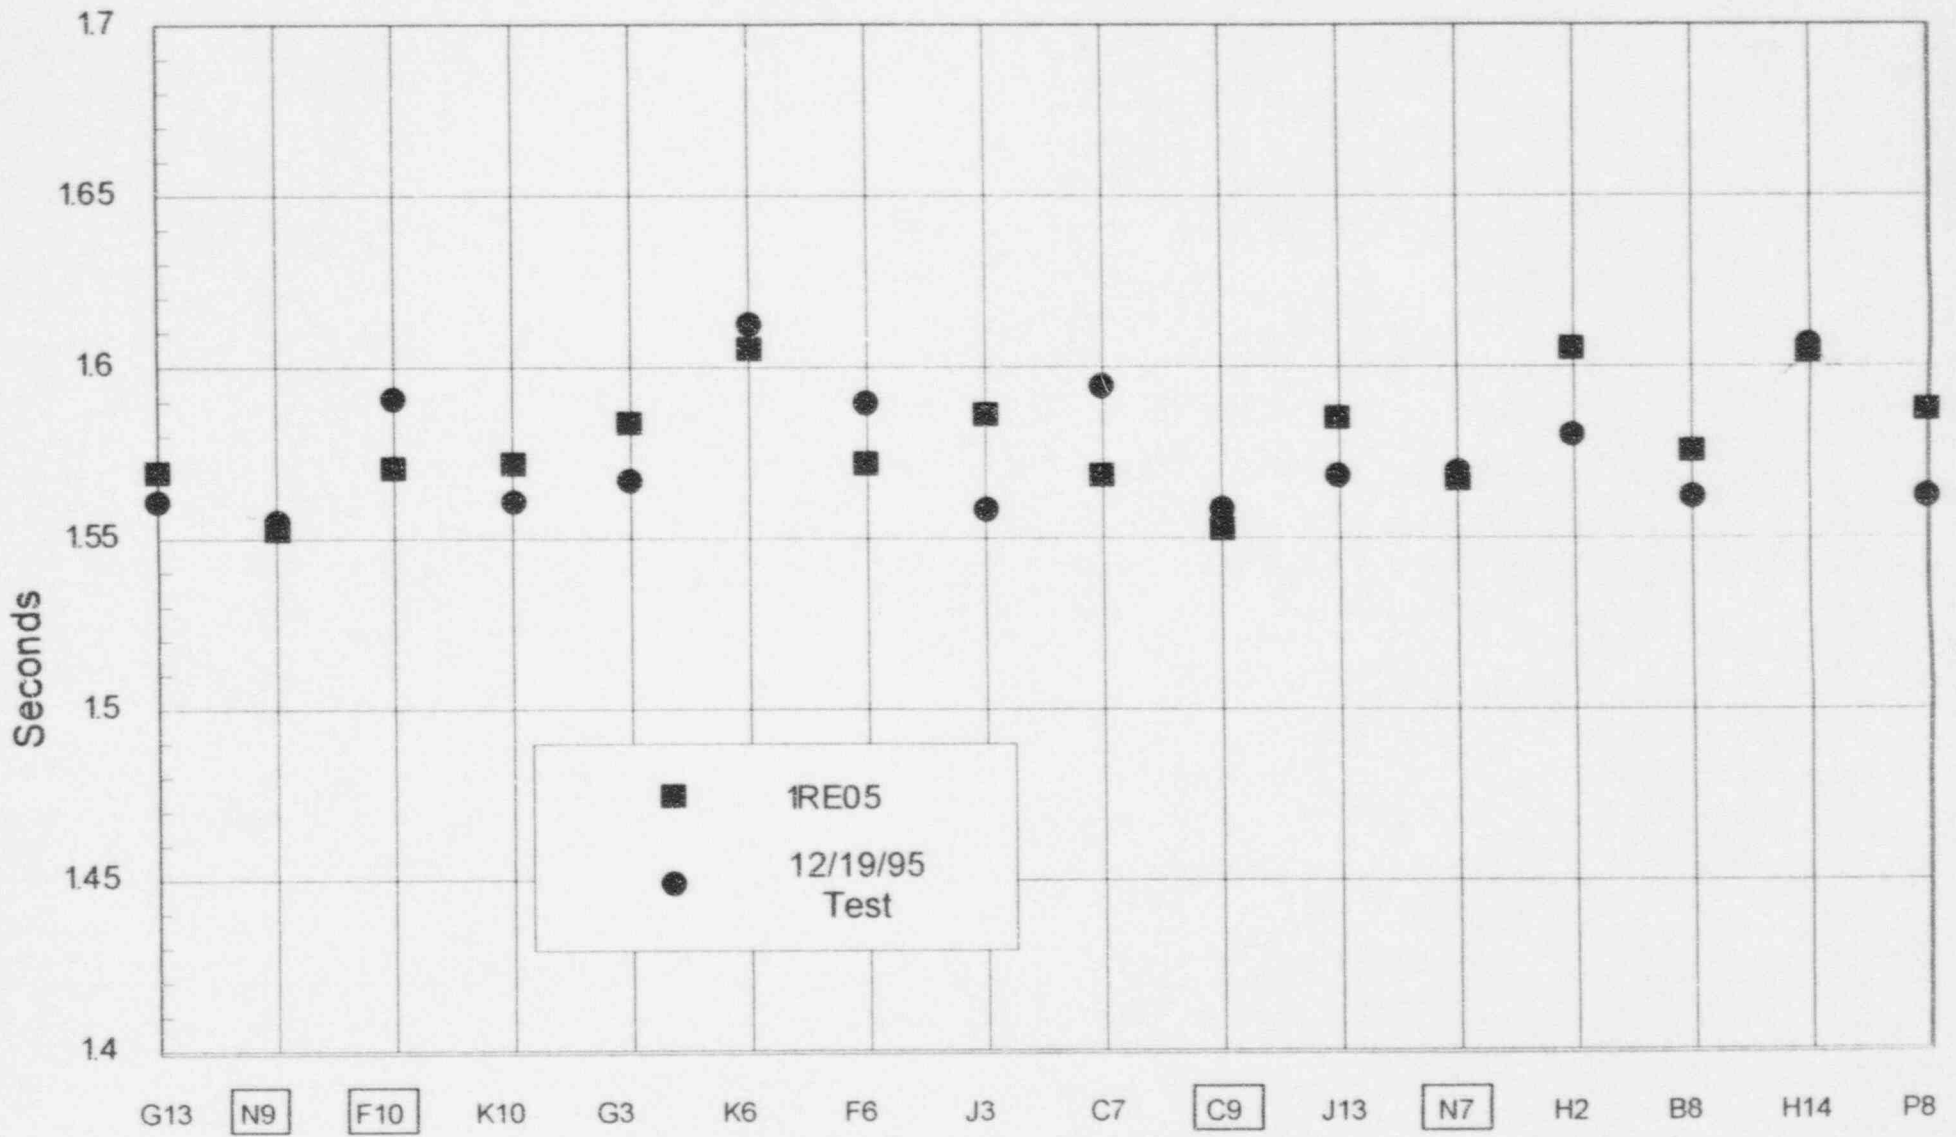
COMPARISON OF DASHPOT ENTRY TIMES TESTED RODS

- Unit 1 Cycle 6 reactor trip on 12/18/95
- 3 of 57 control rods not at rod bottom - DRPI indicated 6 steps from rod bottom
- Core locations F-10, C-9, and N-7
- N-7 DRPI indication changed to rod bottom within about 1 hour
- No indications from Loose Parts Monitoring System
- DRPI indication was correct
