GENE-523-A092-0995  
DRF 137-0010-8

## Evaluation of the Peach Bottom Unit 3 Core Spray Line

September 1995

GE Nuclear Energy  
175 Curtner Ave  
San Jose, CA 95125

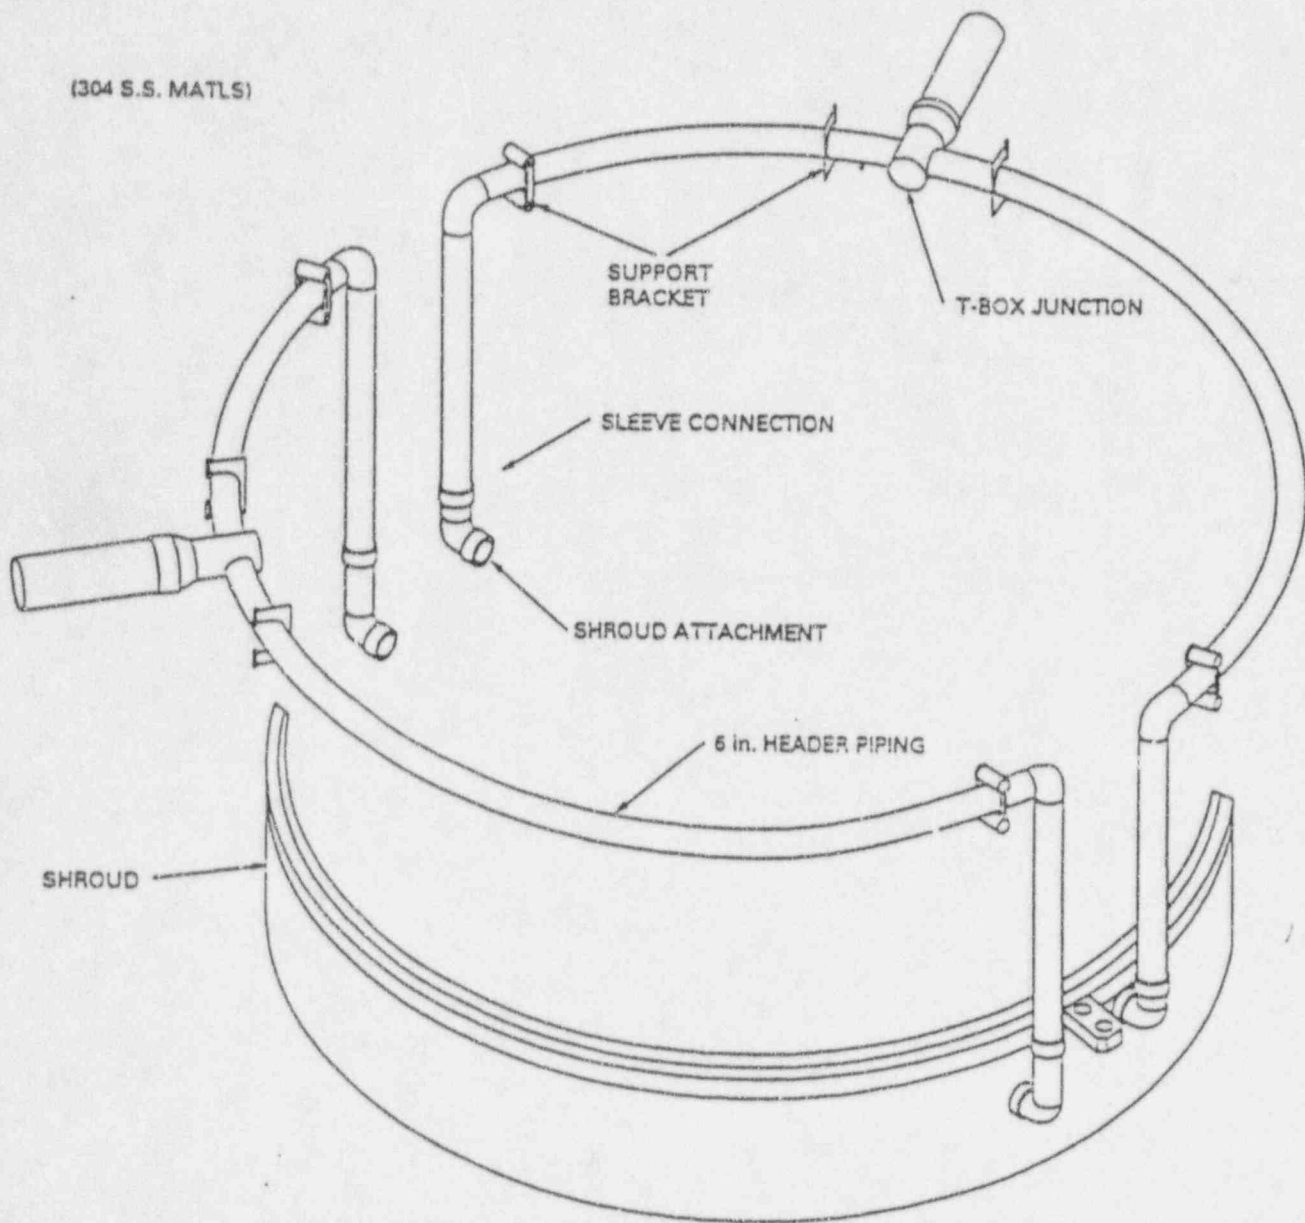
In-vessel visual inspection (IVVI) of the Peach Bottom Unit-3 core spray piping revealed an indication on a sleeve in one of the four downcomers. After passing through the nozzle, each core spray pipe passes through a tee-box and then splits in horizontal directions. Each of these horizontal pipes turns downward into a vertical section (downcomers) and eventually penetrate the core shroud above the top guide (See Figure 1-1).

Figure 1-1 - Schematic of Core Spray Piping
