ENGINE REBUILD REPORT

Motor Vessel Columbia

State of Alaska  
Division of Marine Transportation  
Department of Public Works

March 31, 1981

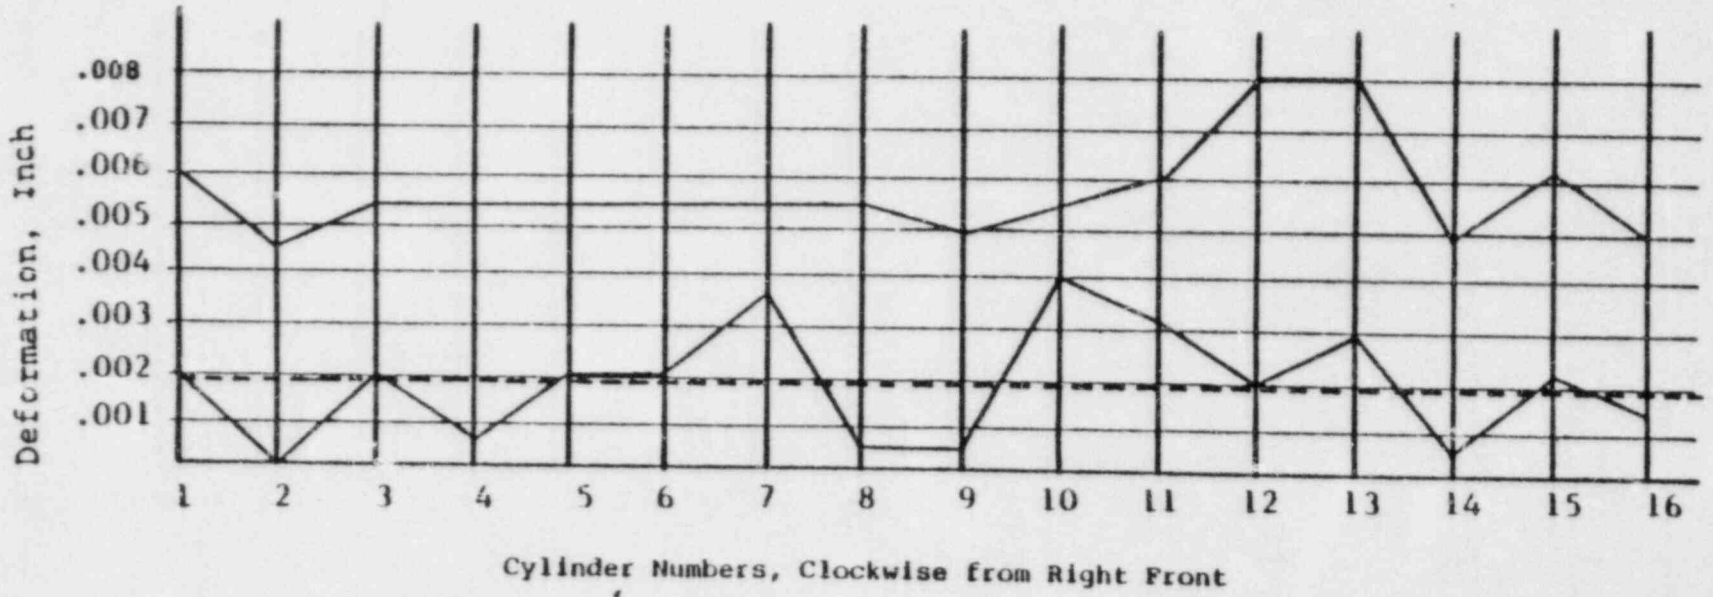
Figure 9. Permanent Deformation of the Cylinder Bore and the Liner Bore, Starboard Main Engine

A comparison of the difference in deformation of the blocks and that of the cylinder liners is shown for the starboard engine in Figures 9 and 10 (pp. II-3 and II-4). Figure 9 shows the average deformation of the block and the liners for each cylinder. Figure 10 shows that the design clearance of .005 inch had increased to a clearance of .009 inch. This difference explains why the liners were easier to remove than when they were new.

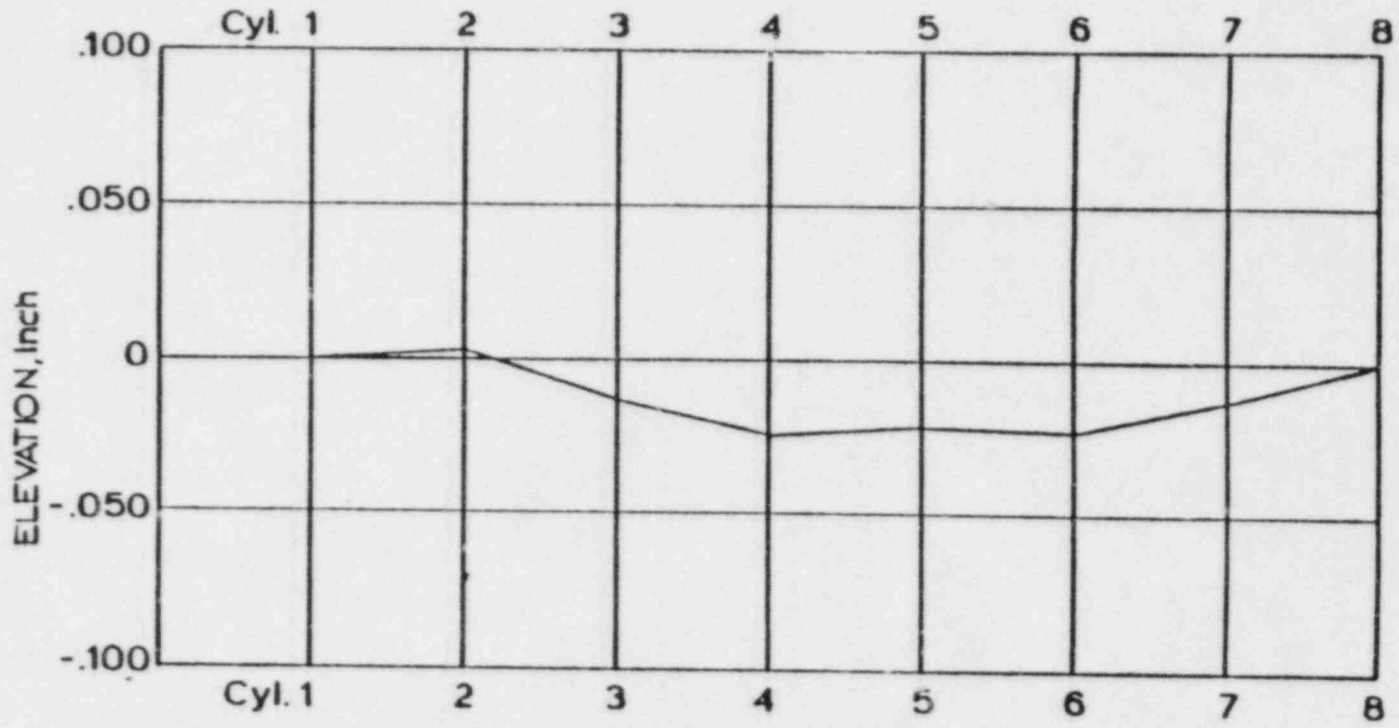
Figure 16. Elevation of the Air Side of the Cylinder Block for the Right Bank, Port Main Engine

Figures 16 and 17 (pp. V-2 and V-3) show a sag in the middle of the engine from front to rear of .030 inch. Cylinder 4 shows a slight warping where the exhaust or top of the block is .020 inch below the bottom side. All other cylinders follow a uniform trend. Warping was a concern in setting up equipment to refinish the bore and counterbore surfaces.

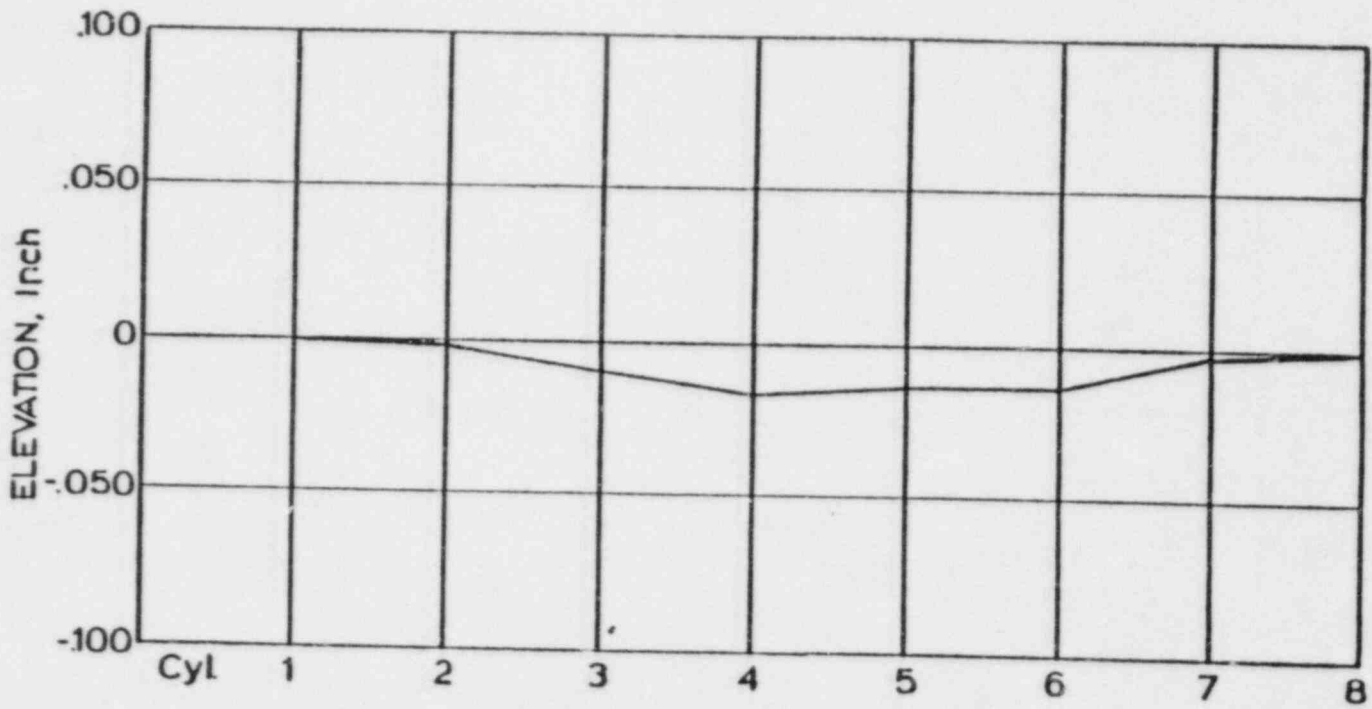
Figure 20. Elevation of the Air Side of the Cylinder Block for the Right Bank, Starboard Main Engine

Figures 20 and 21 (pp. V-6 and V-7) show a sag in the center of the engine and a slight twist with the block dropping on the exhaust side.

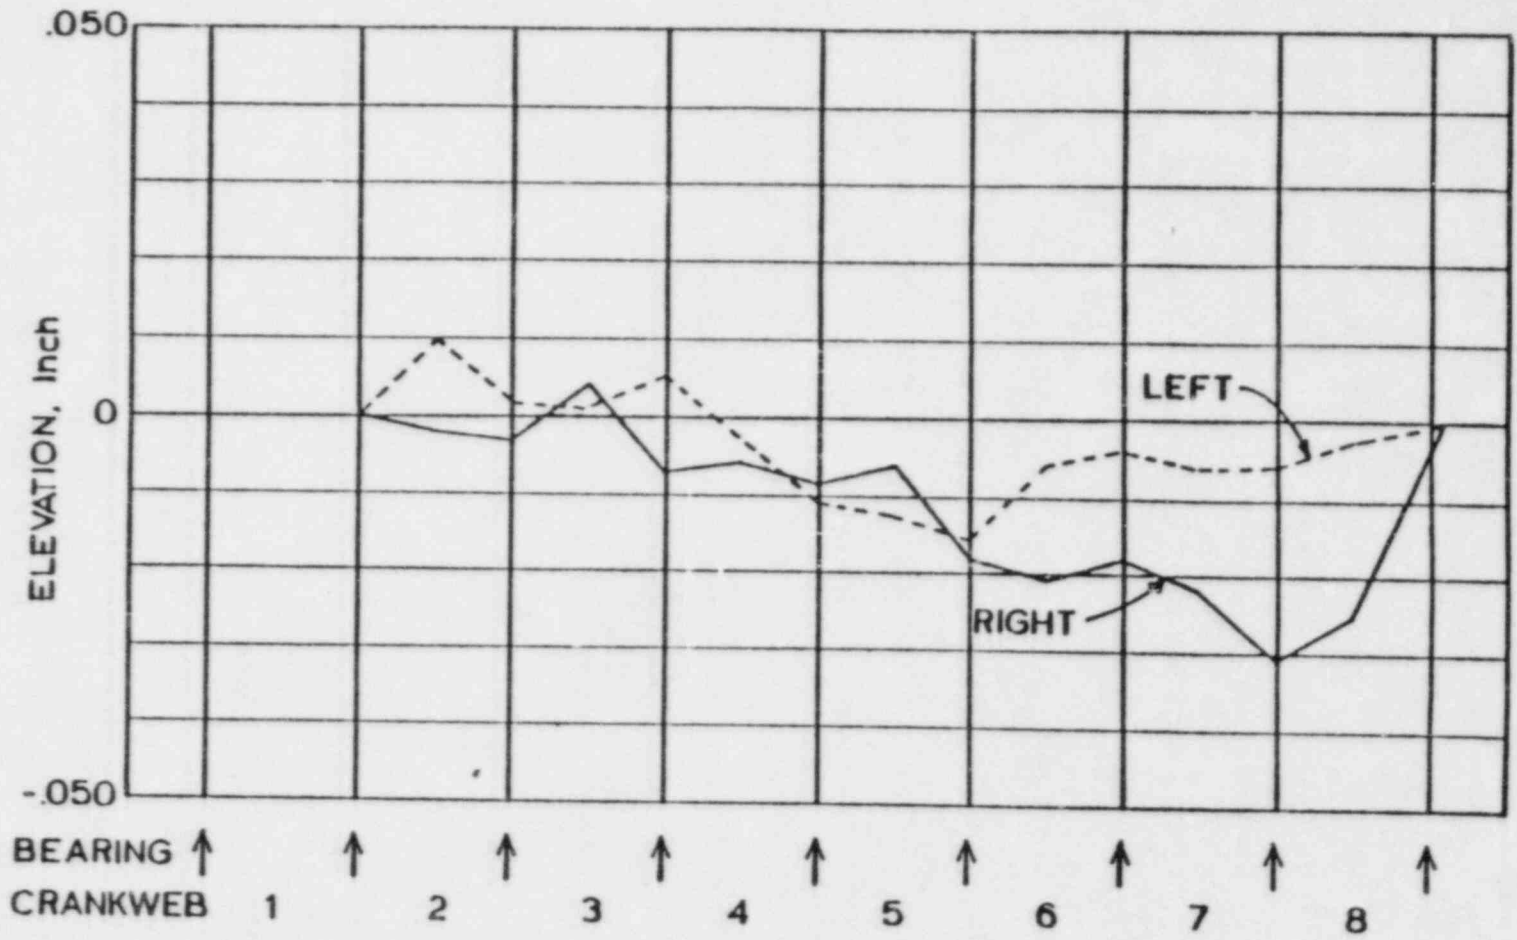
Figure 24. Elevation of the Subbase of the Port Main Engine

Optical sighting of the base of the port engine produced the data in Figure 24 (p. V-11). It shows the elevation of the engine from front to rear for the right and left sides of the engine. The front half of the engine was flat with some variation, but nothing over .010 inch. The rear of the engine showed a dramatic difference between the right and left sides. The left side returns to its zero point in a gradual fashion while the right side continues to drop to nearly .030 inch between cylinders 7 and 8. The dropping of the base explains variations in crankshaft deflection data.

Comparison between crankshaft deflection data (Figures 25, 26 and 27) and subbase elevation data (Figure 24) indicates the rear of the engine is out of alignment. The engines should be aligned before putting them back in service.

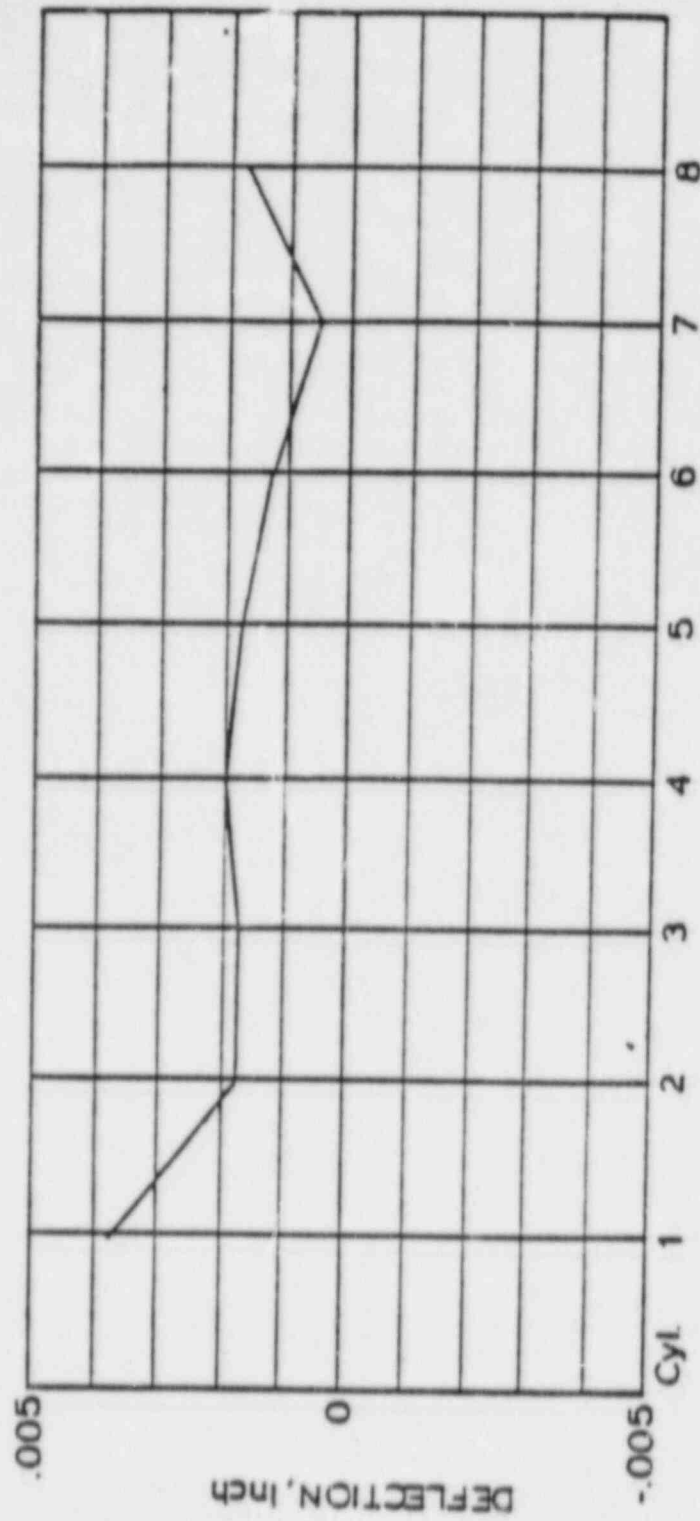
Figure 27. Change in Crank Deflection for the Port Main Engine, Hot vs Cold

Figure 25 shows historical data when the engine was hot and Figure 26 during rebuilding when the engine was cold. Deflection tolerance of .003 inch is allowed. The forward end of the engine, although changing sign (+ or -), is within acceptable limits. The aft end of the engine, however, is outside acceptable limits in both hot and cold conditions. Figure 27 shows the comparison between hot and cold. The front end of the engine is within acceptable limits. At the rear, both readings are similar and thermal changes do not alter the out-of-tolerance readings. Cold readings at the rear of the engine accurately represent hot reading for operating conditions.
