**TESTING OF NUCLEAR GRADE LUBRICANTS AND  
THEIR EFFECT ON A540 B24 AND A193 B7  
BOLTING MATERIALS**

Carl J. Czajkowski

March 1984

**MATERIALS TECHNOLOGY DIVISION  
DEPARTMENT OF NUCLEAR ENERGY, BROOKHAVEN NATIONAL LABORATORY  
UPTON, LONG ISLAND, NEW YORK 11973**

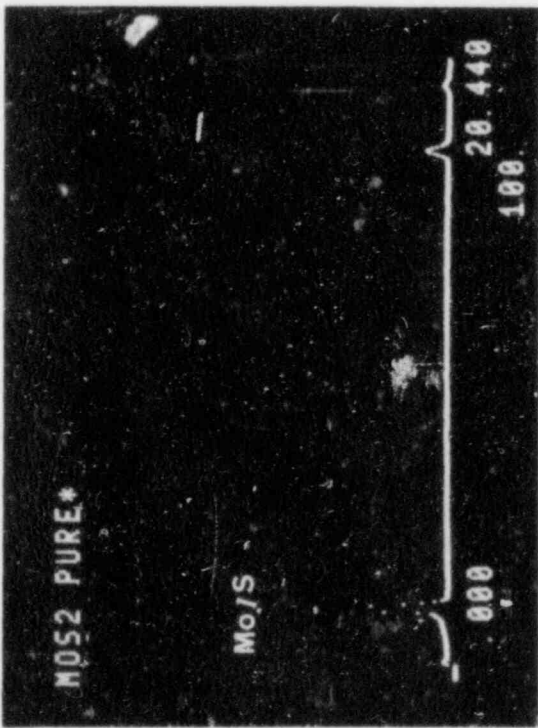
Figure 1 EDS Scan of Lubricant #1

Figure 1 is the EDS scan of lubricant #1. It is clearly seen that only molybdenum and sulfur ( $\text{MoS}_2$ ) are present in the scan.

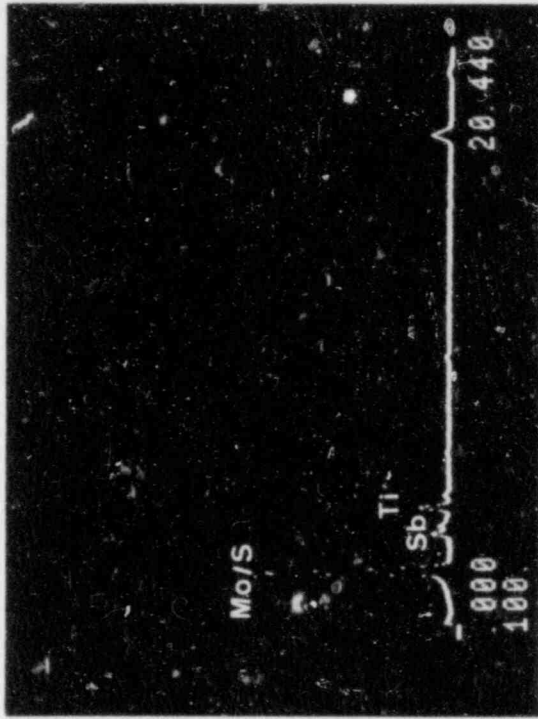
Figure 2 EDS Scan of Lubricant #2

Figure 2 is an EDS scan of a commercially available  $\text{MoS}_2$  (lubricant #2) spray. The scan detected both antimony and titanium in addition to the molybdenum and sulfur. The titanium is possibly used for coloring. The significance of the antimony addition is unknown.

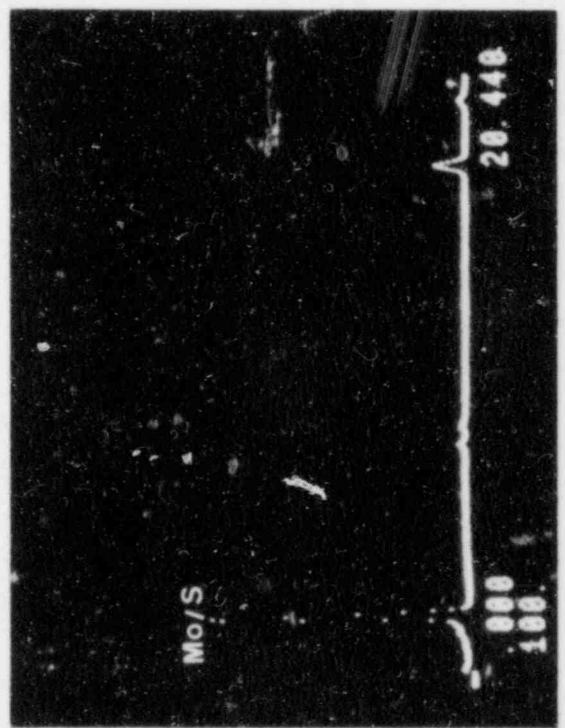
Figure 3 EDS Scan of Lubricant #3

Figure 3 is a scan of lubricant #3 which is a second manufacturer's molybde type spray and shows only molybdenum and sulfur present in the spray. This would be the expected scan of a molybdenum disulfide lubricant.

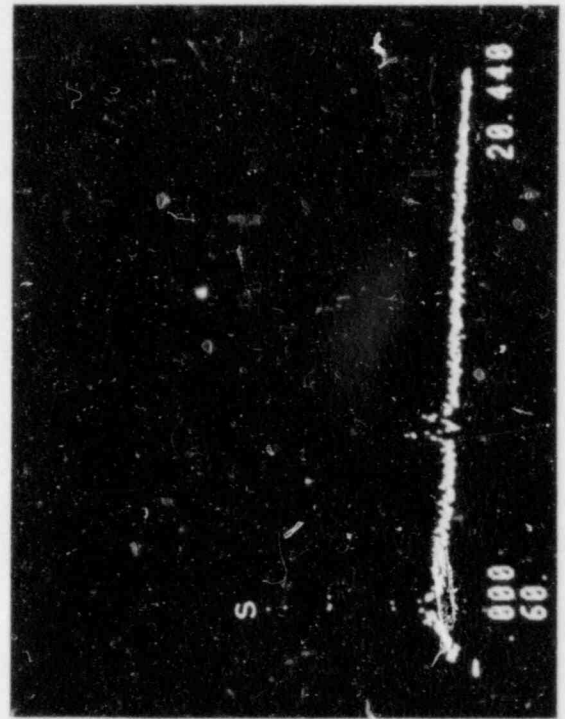
Figure 4 EDS Scan of Lubricant #4

The EDS scan of lubricant #4 which is another moly-lube spray is shown in Figure 4. This scan showed only a sulfur peak with no molybdenum present at all.

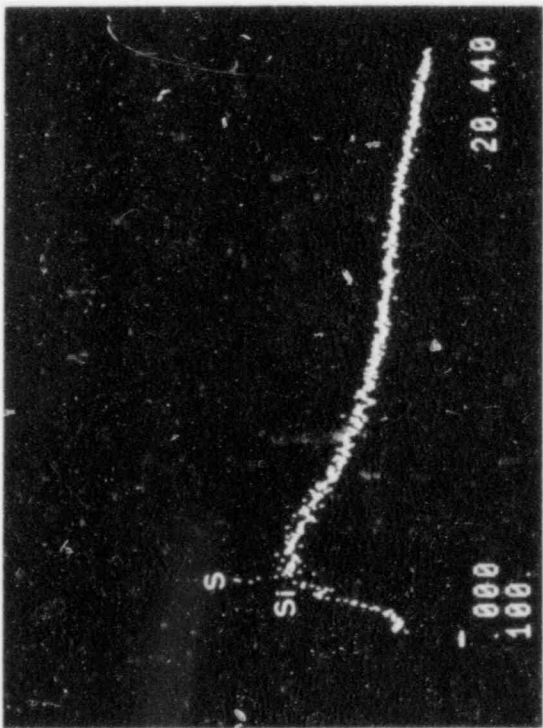
Figure 5 EDS Scan of Lubricant #5

Lubricant #5, which is a graphite and isopropanol lubricant, was subjected to EDS and the resultant scan is shown in Figure 5. This lubricant showed a high sulfur peak with a trace of silicon also present. The presence of sulfur would not be normally anticipated in a graphite + alcohol lubricant and might be detrimental to highly alloyed steels under the proper conditions.

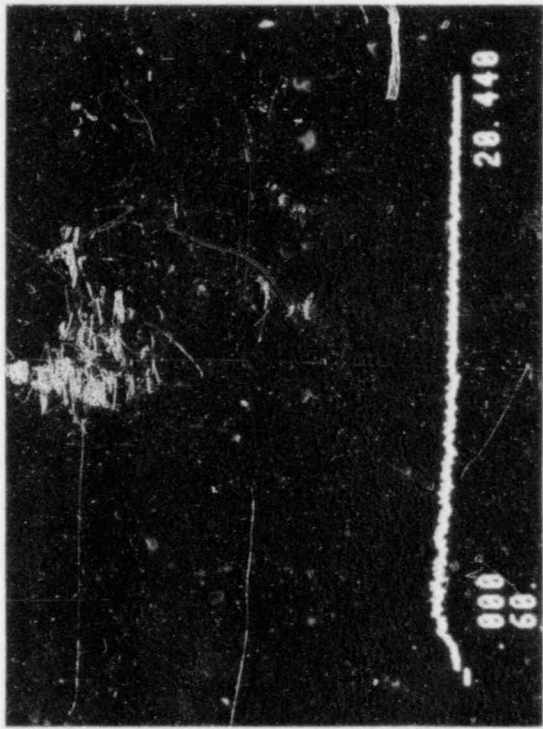
Figure 6 EDS Scan of Lubricant #6

Figure 6 is a scan of lubricant #6 which is graphite + ammonia. The absence of any peaks would be expected and was the final result. (C, N, H all have atomic numbers lower than sodium.)

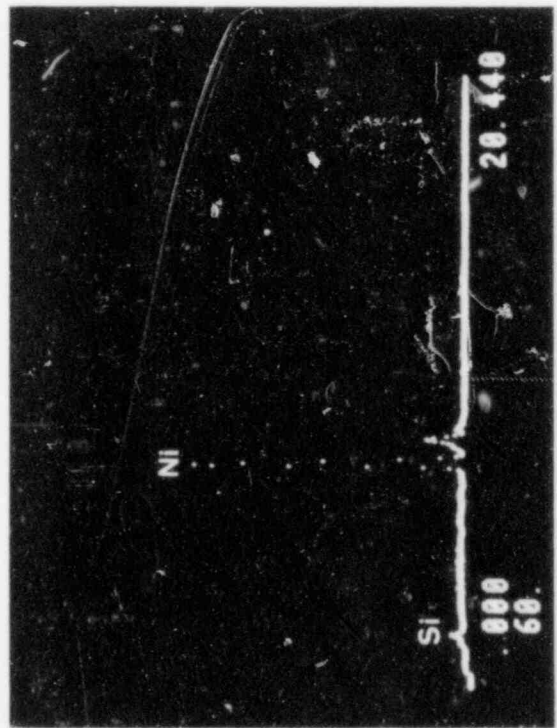
Figure 7 EDS Scan of Lubricant #7

Figure 7 is an EDS scan of the nickel + graphite lubricant #7. The scan shows only a trace of silicon with nickel present. Graphite (carbon) would not show on the scan. This scan is the expected result for this lubricant.

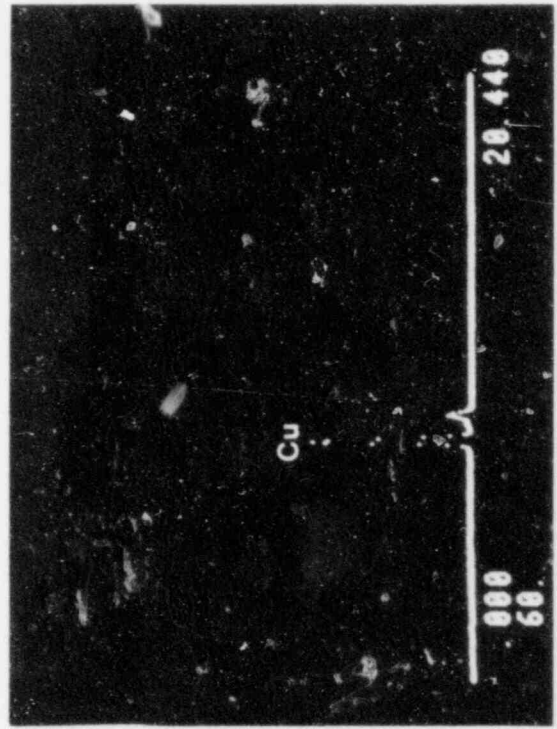
Figure 8 EDS Scan of Lubricant #8

Lubricant #8 is a copper + graphite lubricant and Figure 8 shows a scan of only copper which would be expected for this lubricant.

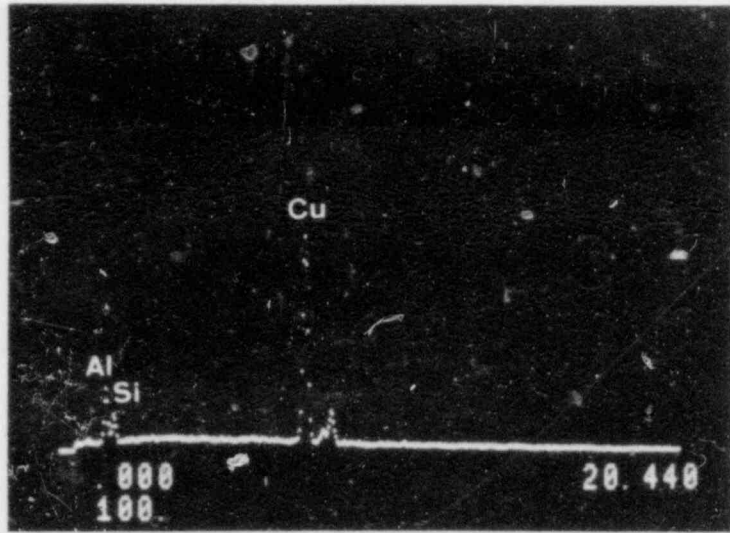
Figure 9 EDS Scan of Lubricant #9

Figure 9 is a photograph of the EDS scan of the anti-seize type lubricant #9. The scan showed an aluminum peak (possibly for coloration) and a silicon peak with the major constituent being copper.

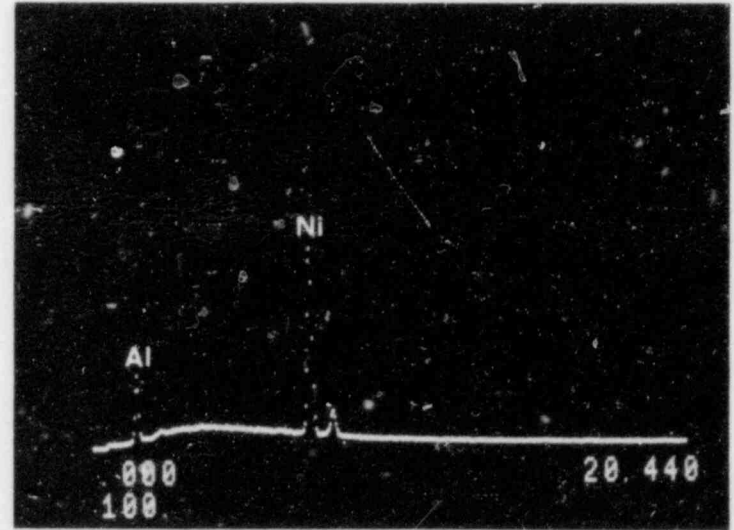
Figure 10 EDS Scan of Lubricant #10

The nickel based never seize type lubricant (lubricant #10) is shown in the EDS scan (Figure 10) with a predominant nickel peak and a secondary peak of aluminum.

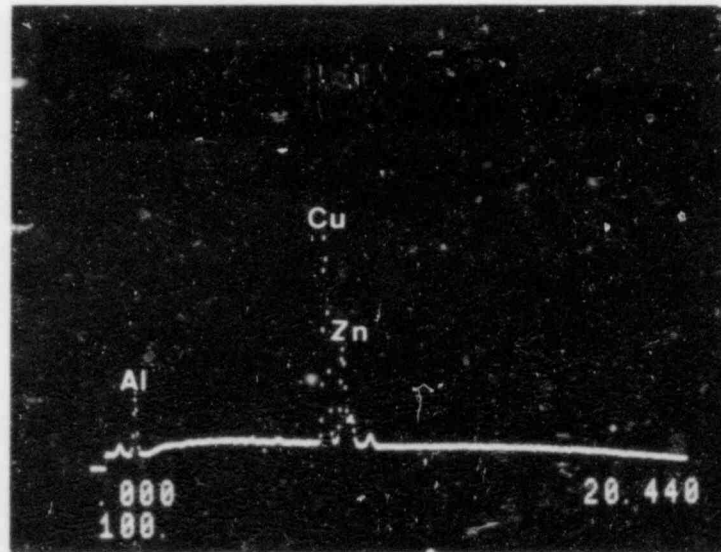
Figure 11 EDS Scan of Lubricant #11

Figure 11 is a representative EDS scan of the never seize type lubricant #11. It is clearly seen that copper is the primary constituent of the lubricant with a significant amount of both zinc and aluminum also present.

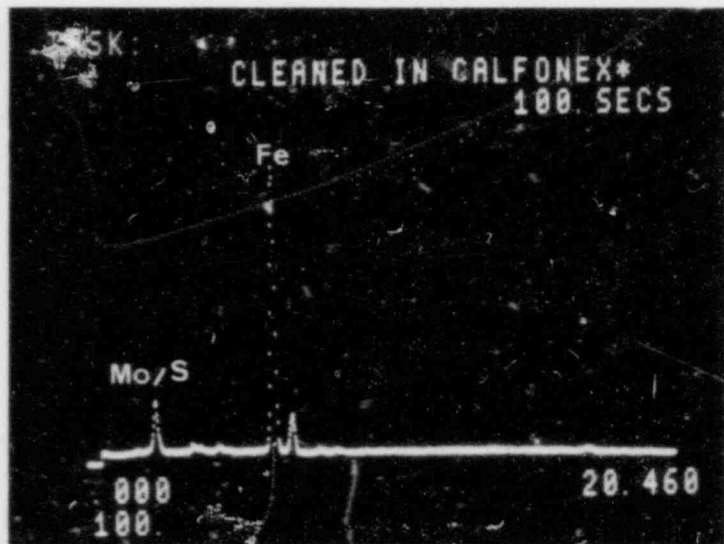
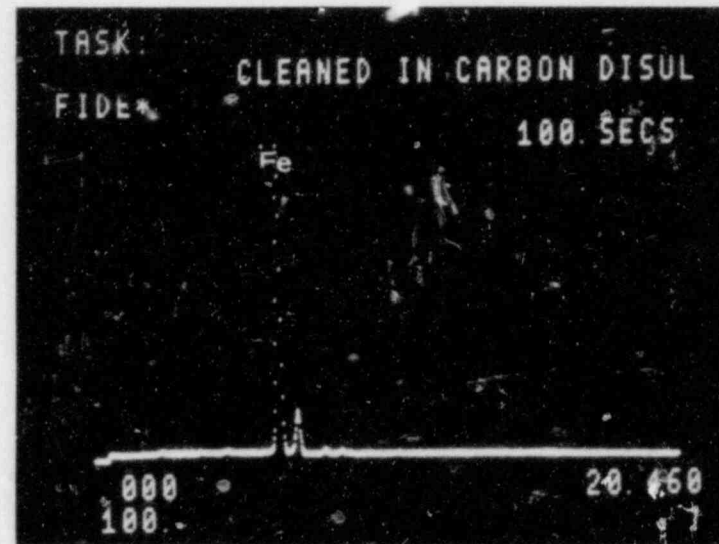
To this end two bolts were sprayed with lubricant #2 and allowed to dry. The bolts were then ultrasonically cleaned, one bolt in a bath of carbon disulfide (CS<sub>2</sub>) and the other in a bath of Calfonex 78-A. The Calfonex had been previously shown [7] to remove sprayed on MoS<sub>2</sub> and the carbon disulfide was used as a result of discussions between the U.S. NRC-MTEB and BNL [8]. After ultrasonic cleaning for 15 minutes, the two bolts were rinsed in distilled water, and then again ultrasonically cleaned in methanol for an additional 15 minutes. The bolts were again rinsed in distilled water, hot air dried and then subjected to EDS in the SEM to determine the extent of MoS<sub>2</sub> removal. The results of this cleaning procedure are shown in Figures 12 and 13.

Figure 12 EDS Scan of MoS<sub>2</sub> Sprayed Bolt  
(Cleaned with Calfonex)

Figure 13 EDS Scan of MoS<sub>2</sub> Sprayed Bolt  
(Cleaned with Carbon Disulfide)

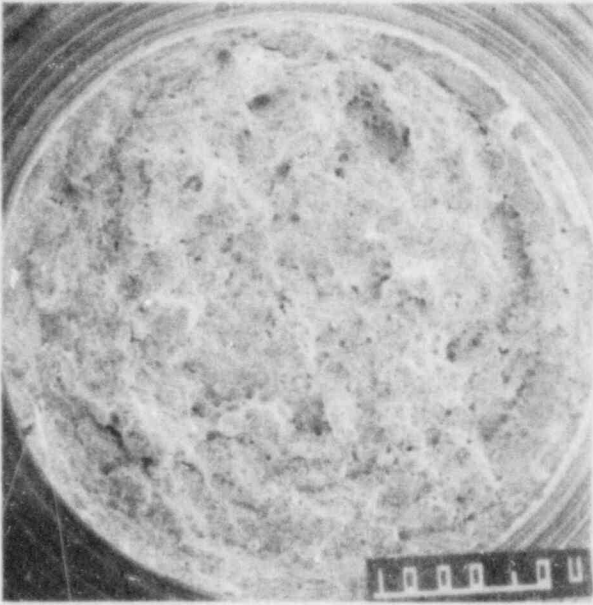
Figure 27. 27X  
SEM Photo of Fracture Face for  
Specimen #7.

Specimen #7 was tested at 280°C in demineralized water and displayed a tensile value of approximately 210 Ksi. The fracture face (Figures 27 and 28) exhibited a typical overload failure.

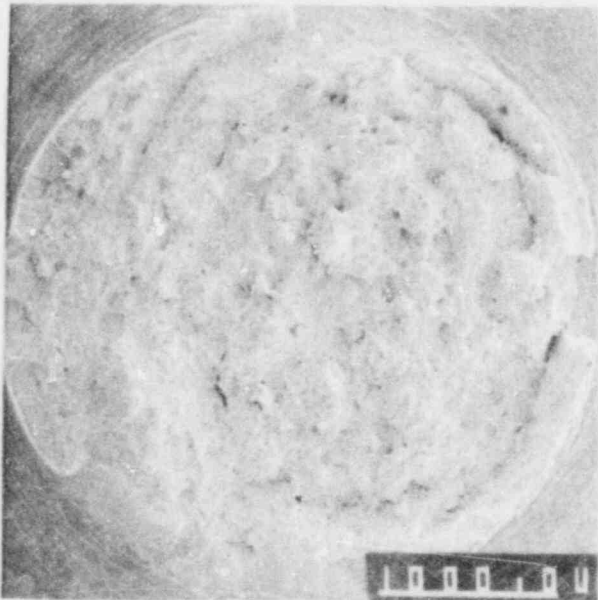
Figure 101. 27X  
SEM Photo of Fracture Face for  
Specimen #44.

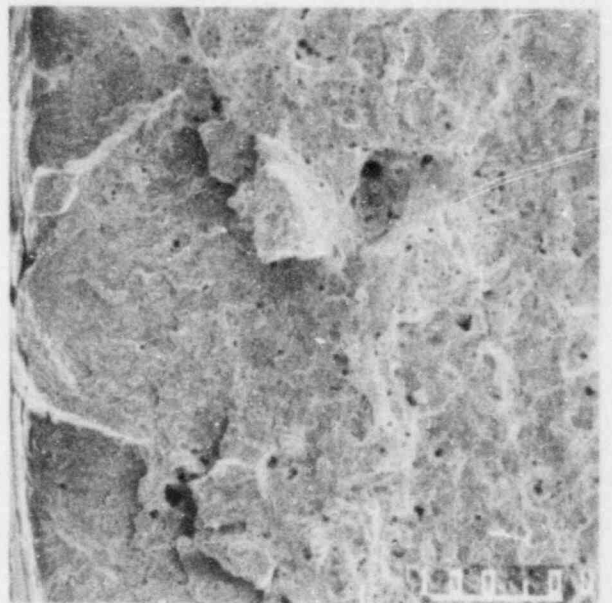
Figure 102. 200X  
Higher Magnification Photo of  
Transgranular Area.

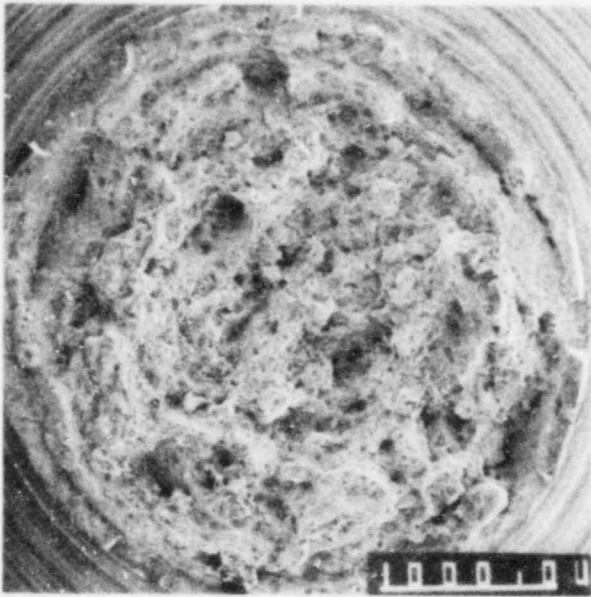
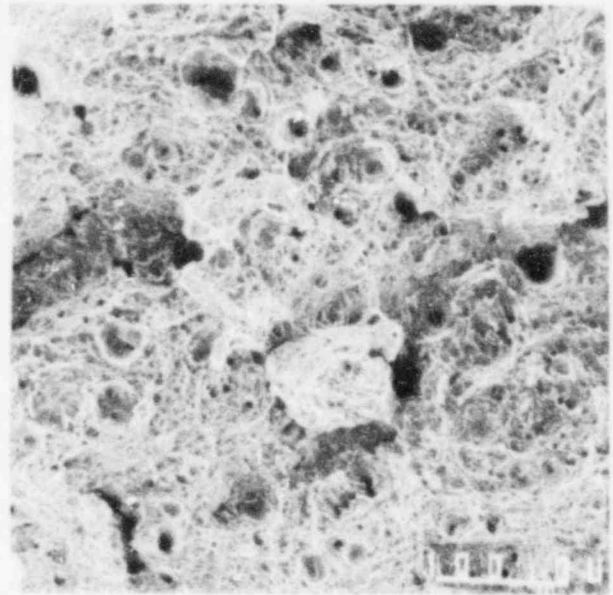
Specimens #45-49 were all tested at 280°C in demineralized water. The fracture faces of specimens #45, 47, 48, and 49 (Figures 103, 104 and 107-112) all showed ductile overload. The notch tensile strengths of these specimens ranged between 224 Ksi and 261 Ksi. Specimen #46 attained a notched tensile strength of only 171.2 Ksi and exhibited transgranular areas on the fracture face (Figures 105, 106) defining a SCC susceptibility under these conditions.

Figure 103. 27X  
SEM Photo of Fracture Face for  
Specimen #45.

Figure 104. 200X  
Higher Magnification Fractograph  
Showing Typical Ductile Fracture.

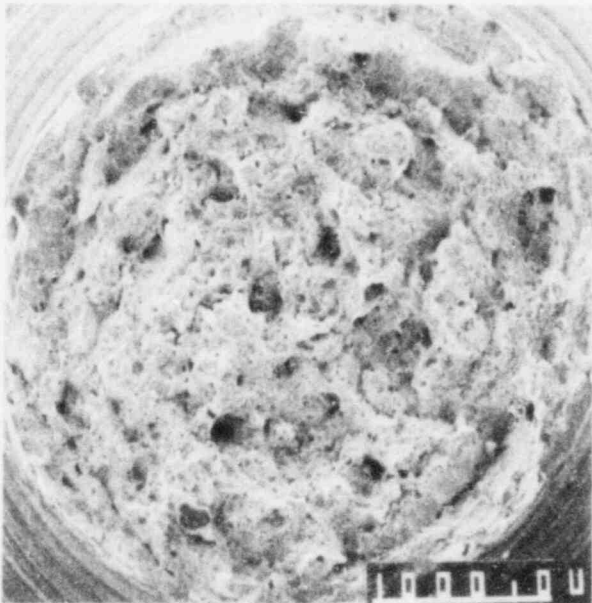
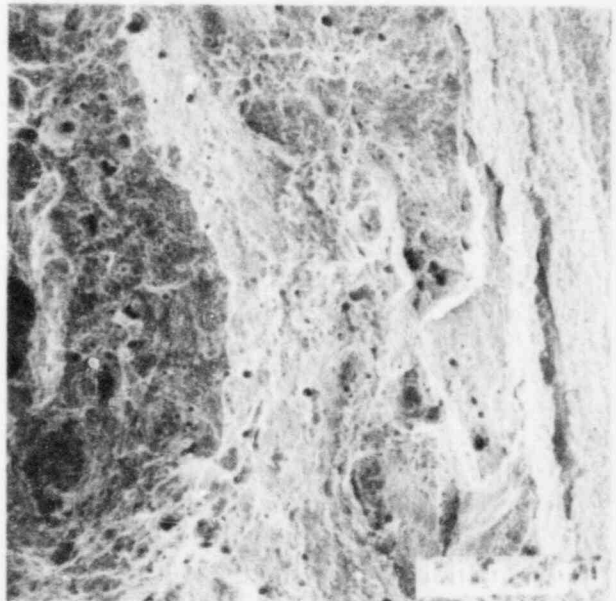
Figure 105. 27X  
SEM Photo of Fracture Face for  
Specimen #46.

Figure 106. 200X  
Higher Magnification Photo of  
Transgranular Area.

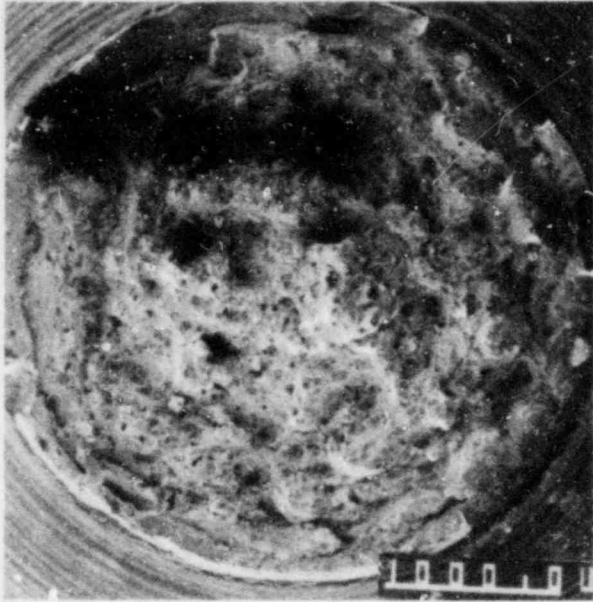
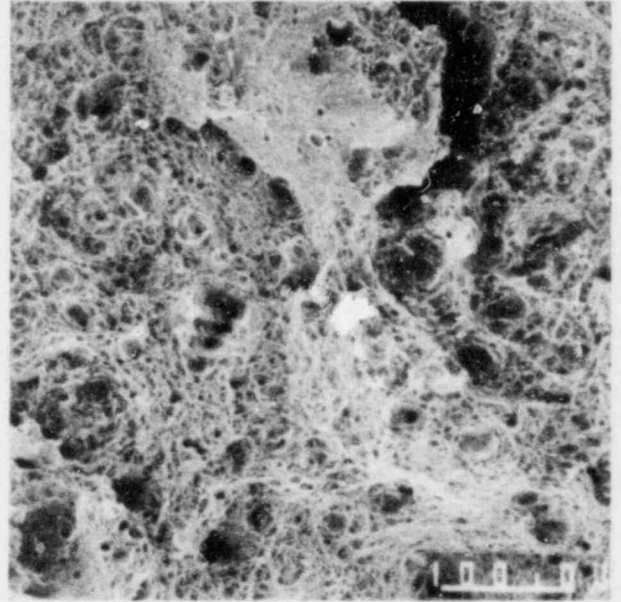
Figure 107. 27X  
SEM Photo of Fracture Face for  
Specimen #47.

Figure 108. 200X  
Higher Magnification Fractograph  
Showing Typical Ductile Fracture.

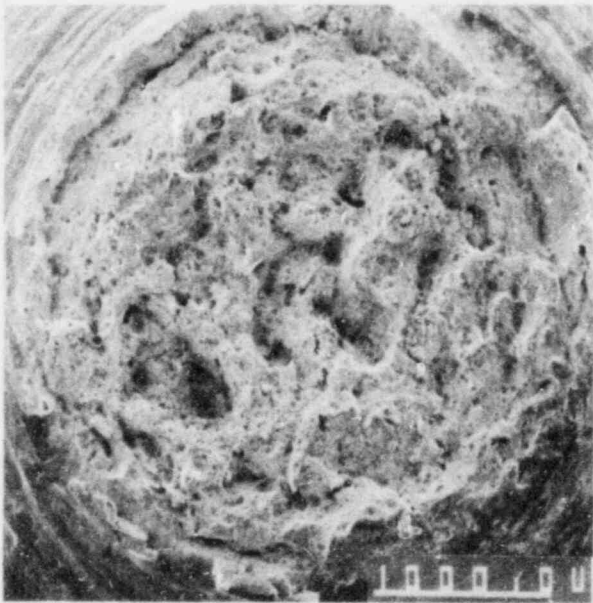
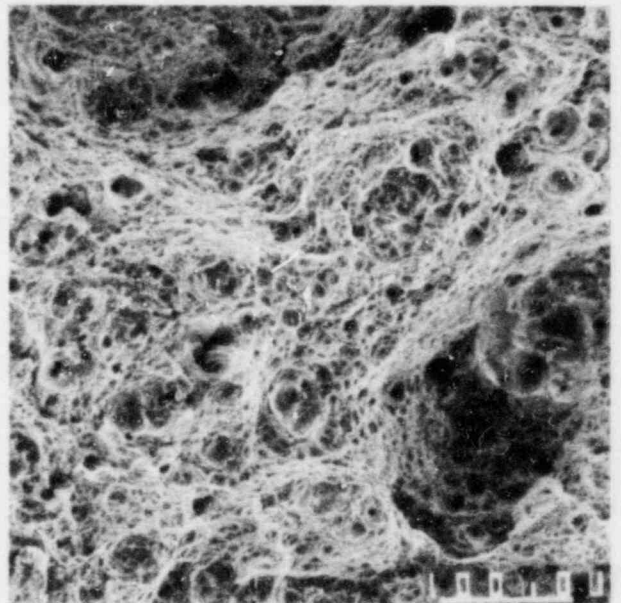
Figure 109. 27X  
SEM Photo of Fracture Face for  
Specimen #48.

Figure 110. 200X  
Higher Magnification Fractograph  
Showing Typical Ductile Fracture.

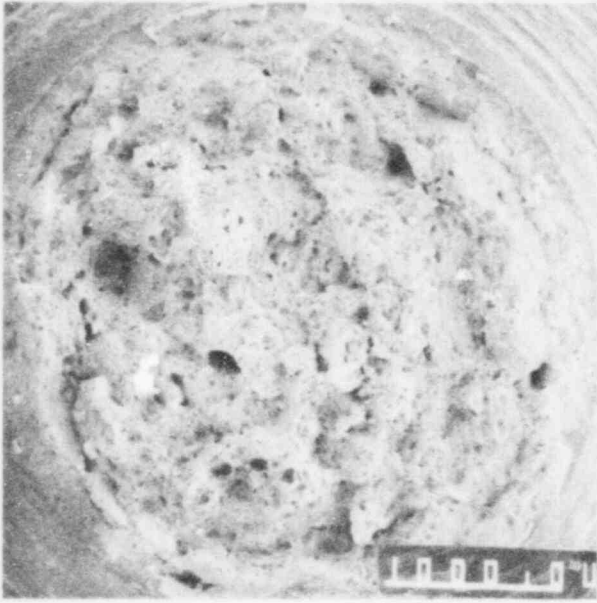
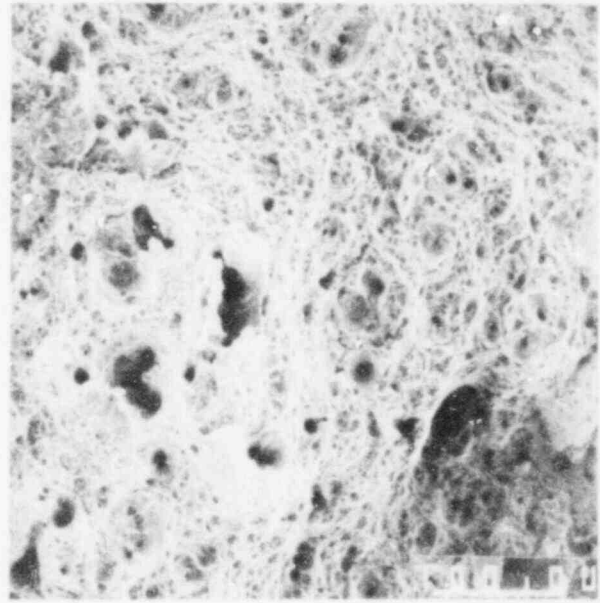
Figure 111. 27X  
SEM Photo of Fracture Face for  
Specimen #49.

Figure 112. 200X  
Higher Magnification Fractograph  
Showing Typical Ductile Fracture.

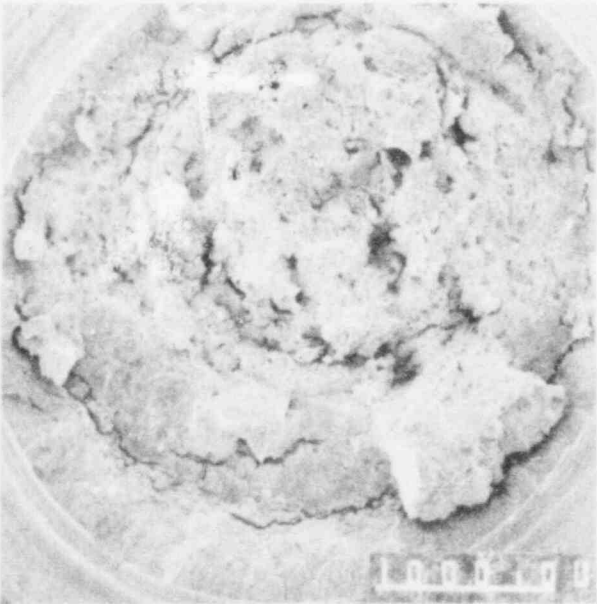
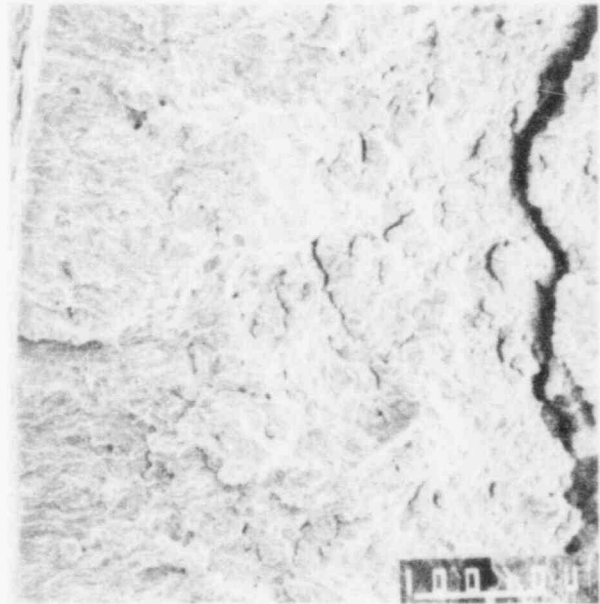
Tests were performed at 280°C with chemically pure MoS<sub>2</sub> on half of the notch on specimens #50-53. Specimen #50 attained a notched tensile strength of 203.8 Ksi and had transgranular areas in evidence on the fracture face (Figures 113, 114). Specimen #51 showed an entirely ductile fracture (Figures 115-116) and had a notched tensile strength of 293.5 Ksi. Specimen #52 had large areas of transgranular fracture (Figures 117-118) and only had a measured notched tensile strength of 171 Ksi. The final MoS<sub>2</sub> test (Specimen #53) was basically ductile in appearance (Figures 119, 120) and attained a notched tensile strength of 228.9 Ksi.

Figure 113. 27X  
SEM Photo of Fracture Face for  
Specimen #50.

Figure 114. 200X  
Higher Magnification Photo of  
Transgranular Area.

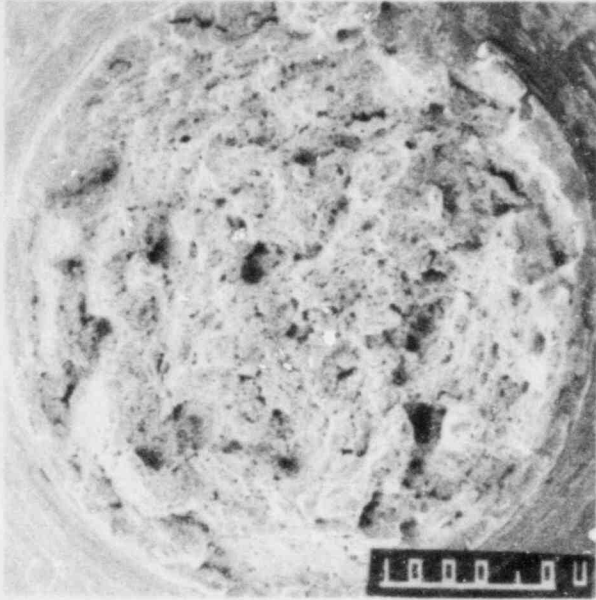
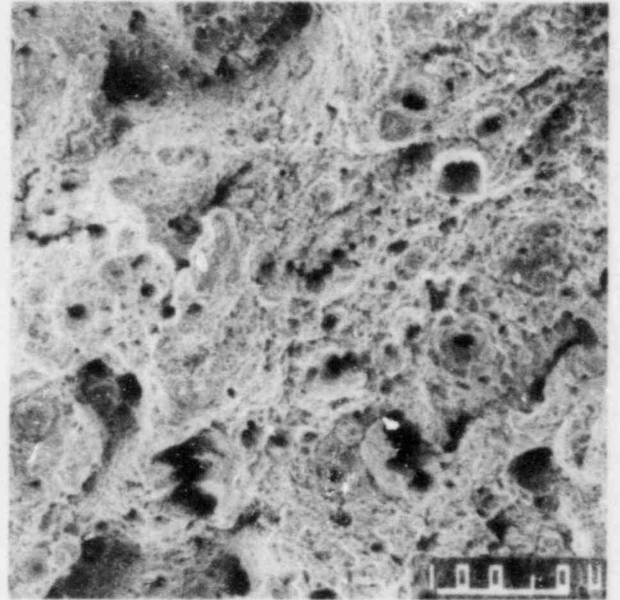
Figure 115. 27X  
SEM Photo of Fracture Face for  
Specimen #51.

Figure 116. 200X  
Higher Magnification Fractograph  
Showing Typical Ductile Fracture.

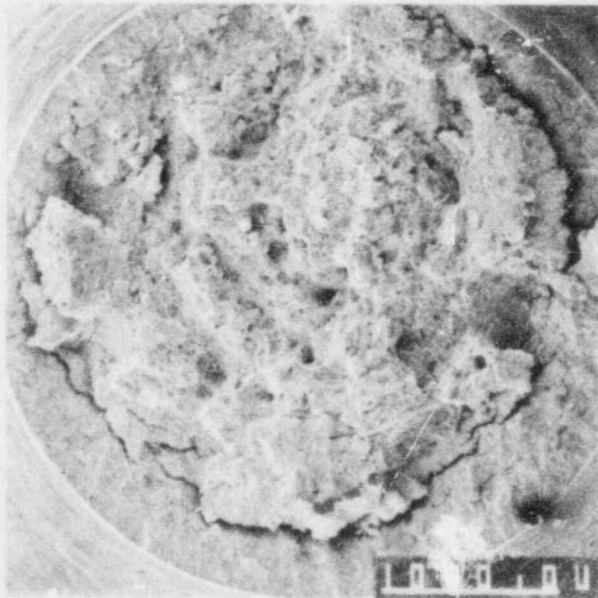
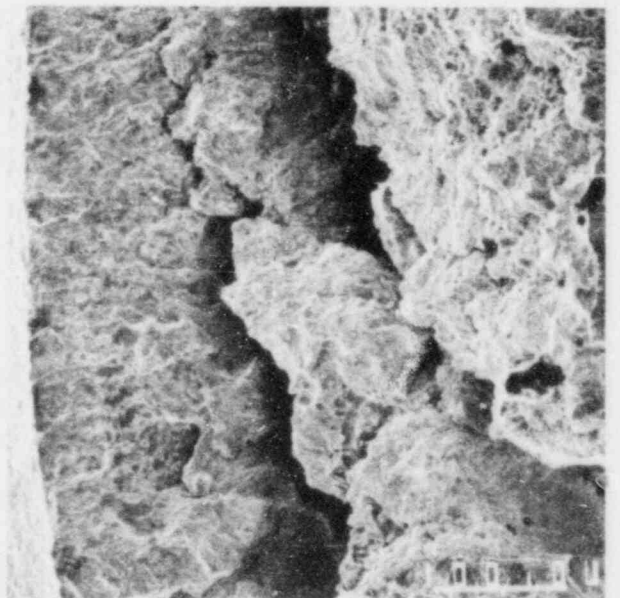
Figure 117. 27X  
SEM Photo of Fracture Face for  
Specimen #52.

Figure 118. 200X  
Higher Magnification Photo of  
Transgranular Area.

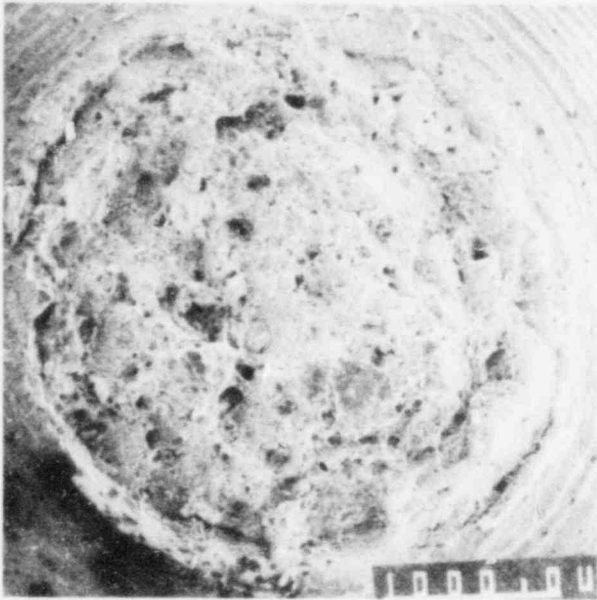
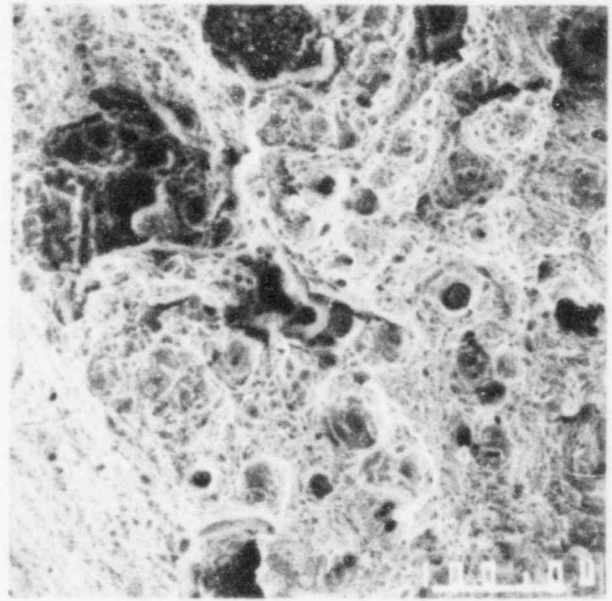
Figure 119. 27X  
SEM Photo of Fracture Face for  
Specimen #53.

Figure 120. 200X  
Higher Magnification Fractograph  
Showing Typical Ductile Fracture.

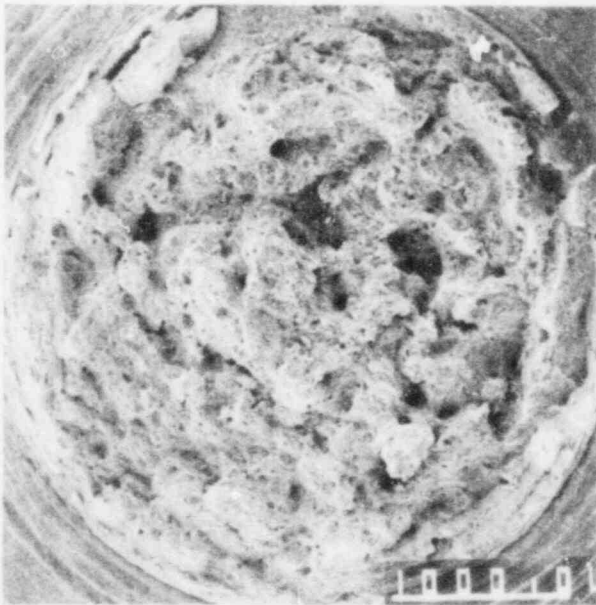
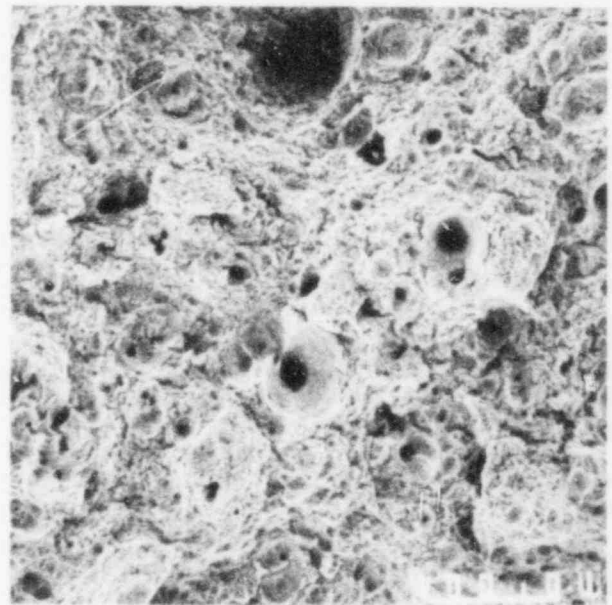
Specimen #54 tested at 280°C with lubricant #8 showed no environmental effect (Figures 121, 122) with a ductile fracture evident and a notched tensile value of 256.8 Ksi.

Figure 121. 27X  
SEM Photo of Fracture Face for  
Specimen #54.

Figure 122. 200X  
Higher Magnification Fractograph  
Showing Typical Ductile Fracture.

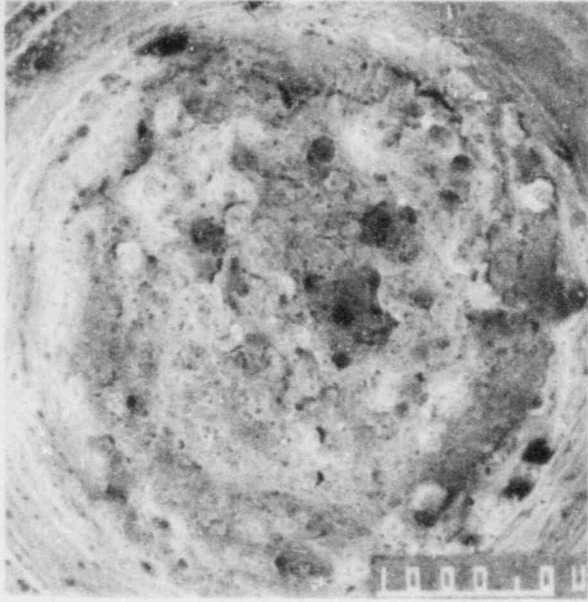
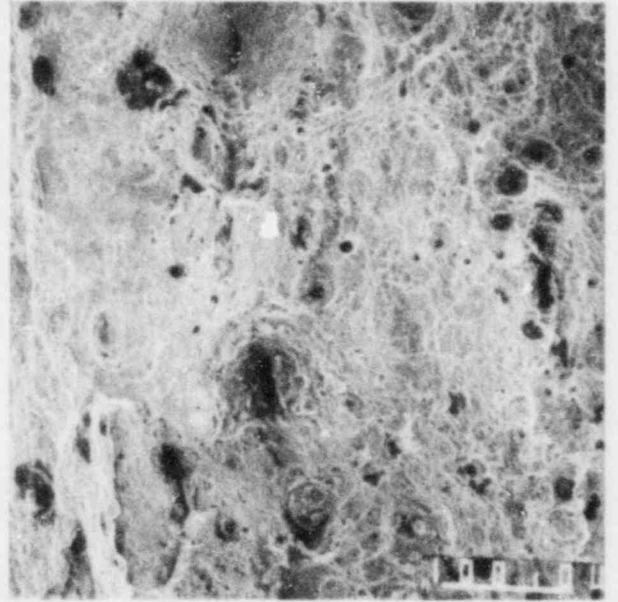
Figure 123. 27X  
SEM Photo of Fracture Face for  
Specimen #55.

Figure 124. 200X  
Higher Magnification Fractograph  
Showing Typical Ductile Fracture.

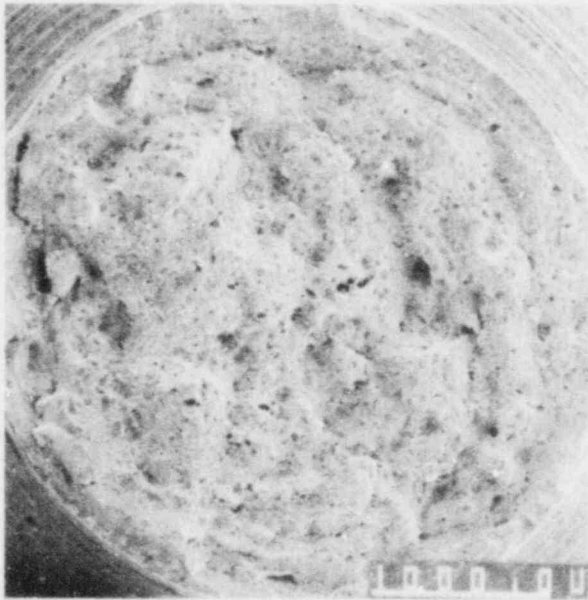
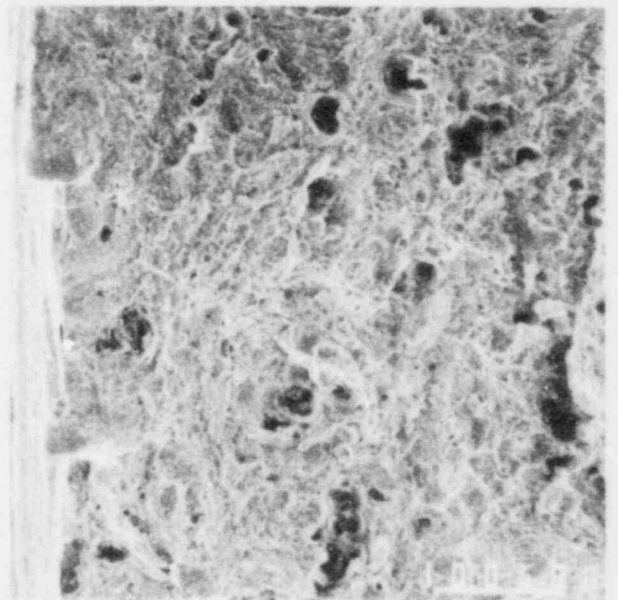
Figure 125. 27X  
SEM Photo of Fracture Face for  
Specimen #56.

Figure 126. 200X  
Higher Magnification Photo of  
Transgranular Area.

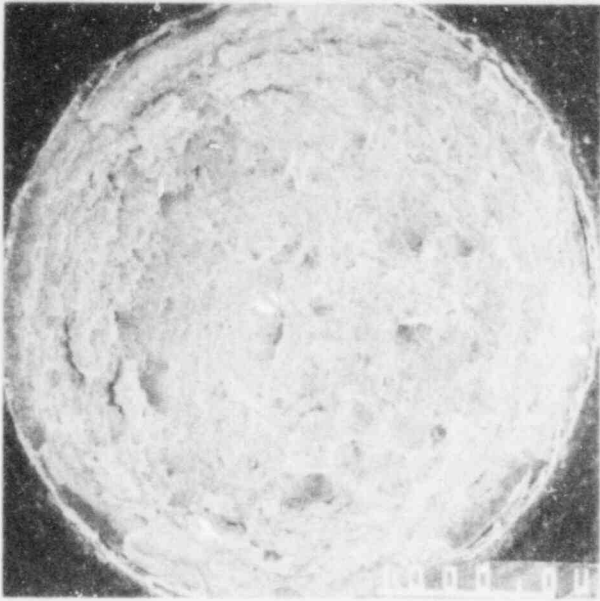
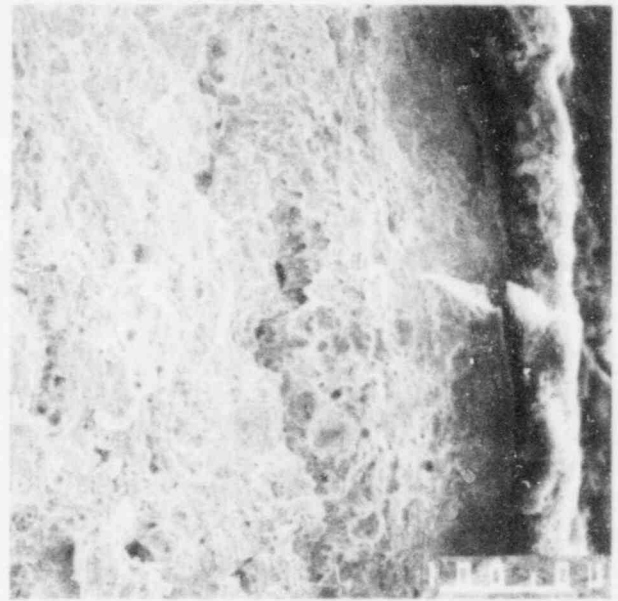
The last six notched tensile tests were performed on A193 B7 material. Specimens #57-58 were tested at 100°C in demineralized water. Specimen #57 had areas of transgranular fracture evident on the fracture face (Figures 127, 128) and had a notched tensile strength of 216 Ksi. Specimen #58 achieved a tensile value of 232 Ksi and had a ductile fracture in evidence (Figures 129, 130).

Figure 127. 27X  
SEM Photo of Fracture Face for  
Specimen #57.

Figure 128. 200X  
Higher Magnification Photo of  
Transgranular Area.

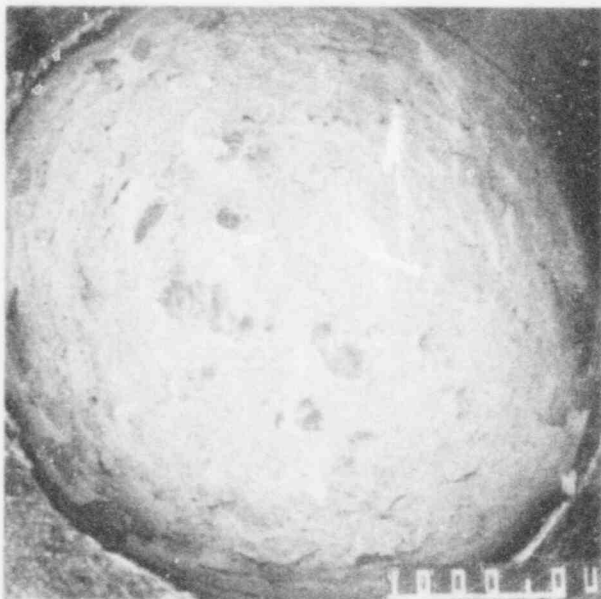
Figure 129. 27X  
SEM Photo of Fracture Face for  
Specimen #58.

Figure 130. 200X  
Higher Magnification Fractograph  
Showing Typical Ductile Fracture.

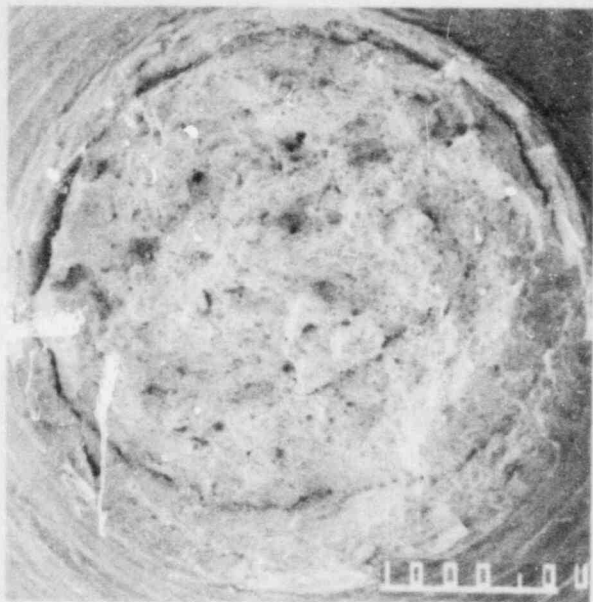
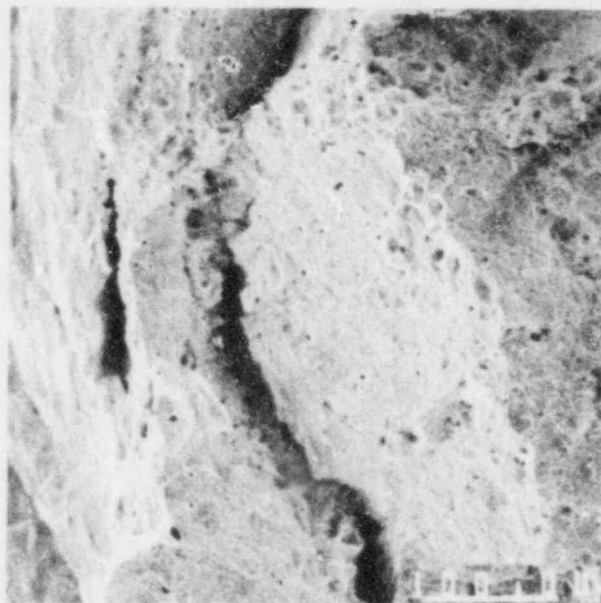
Specimen #59 was tested in demineralized water at 280°C. It had an area of transgranularity on the fracture face (Figures 131, 132) and had a notched tensile strength of 216 Ksi.

Figure 131. 27X  
SEM Photo of Fracture Face for  
Specimen #59.

Figure 132. 200X  
Higher Magnification Photo of  
Transgranular Area.

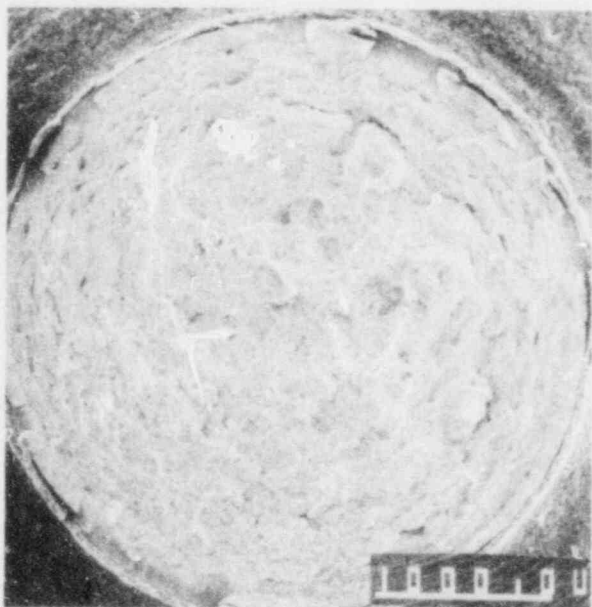
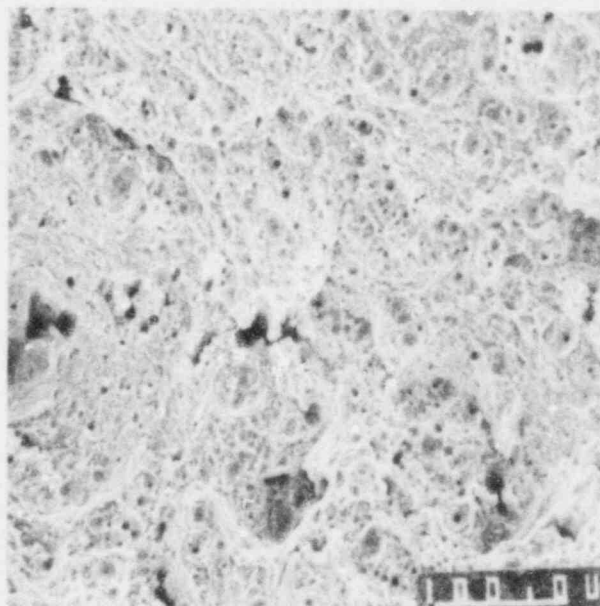
Figure 133. 27X  
SEM Photo of Fracture Face for  
Specimen #60.

Figure 134. 200X  
Higher Magnification Fractograph  
Showing Typical Ductile Fracture.

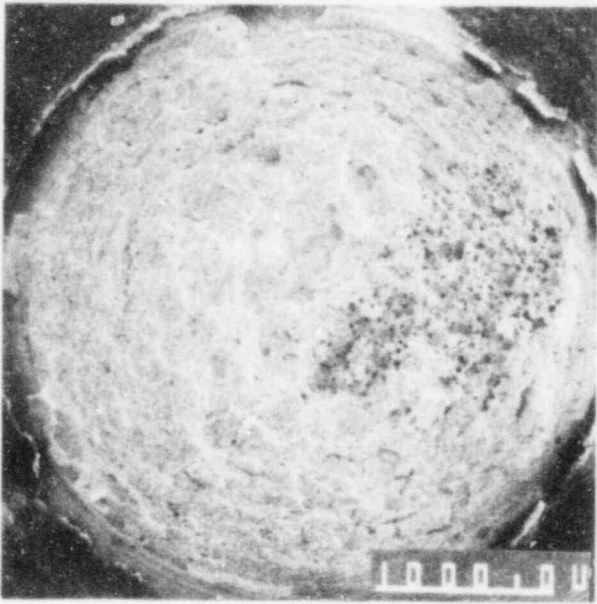
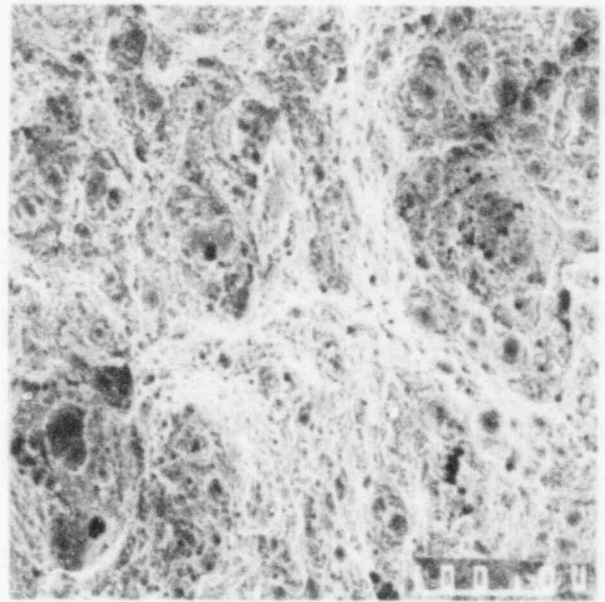
Figure 135. 27X  
SEM Photo of Fracture Face for  
Specimen #61.

Figure 136. 200X  
Higher Magnification Fractograph  
Showing Typical Ductile Fracture.

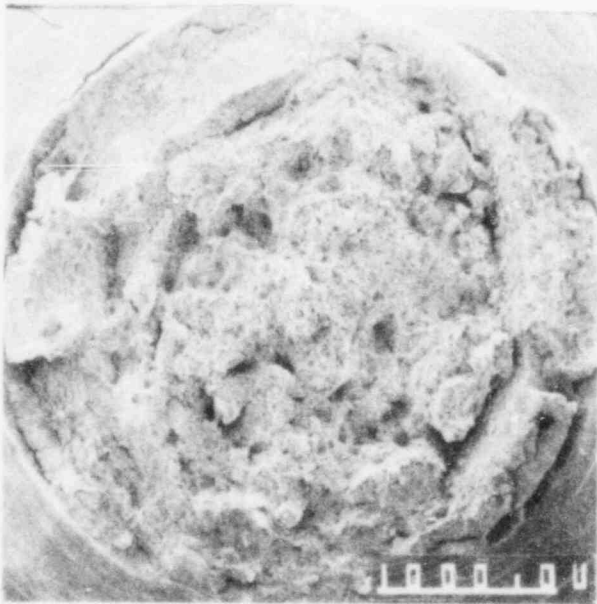
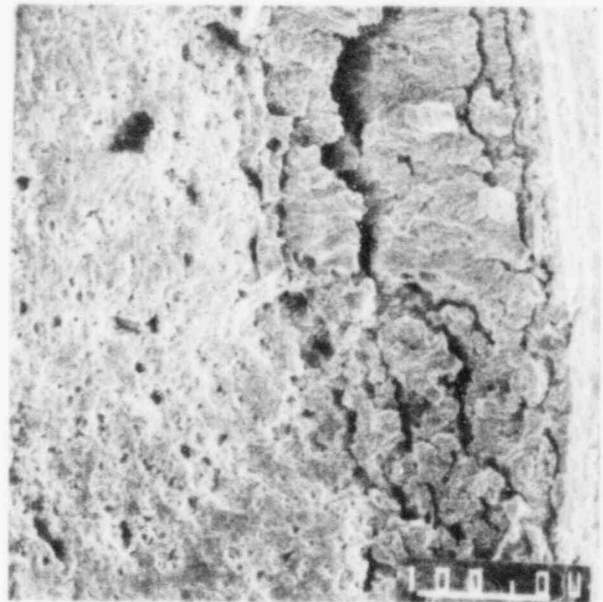
Figure 137. 27X  
SEM Photo of Fracture Face for  
Specimen #62.

Figure 138. 200X  
Higher Magnification Photo of  
Transgranular Area.
