**TESTING OF NUCLEAR GRADE LUBRICANTS AND  
THEIR EFFECT ON A540 B24 AND A193 B7  
BOLTING MATERIALS**

Carl J. Czajkowski

March 1984

**MATERIALS TECHNOLOGY DIVISION  
DEPARTMENT OF NUCLEAR ENERGY, BROOKHAVEN NATIONAL LABORATORY  
UPTON, LONG ISLAND, NEW YORK 11973**

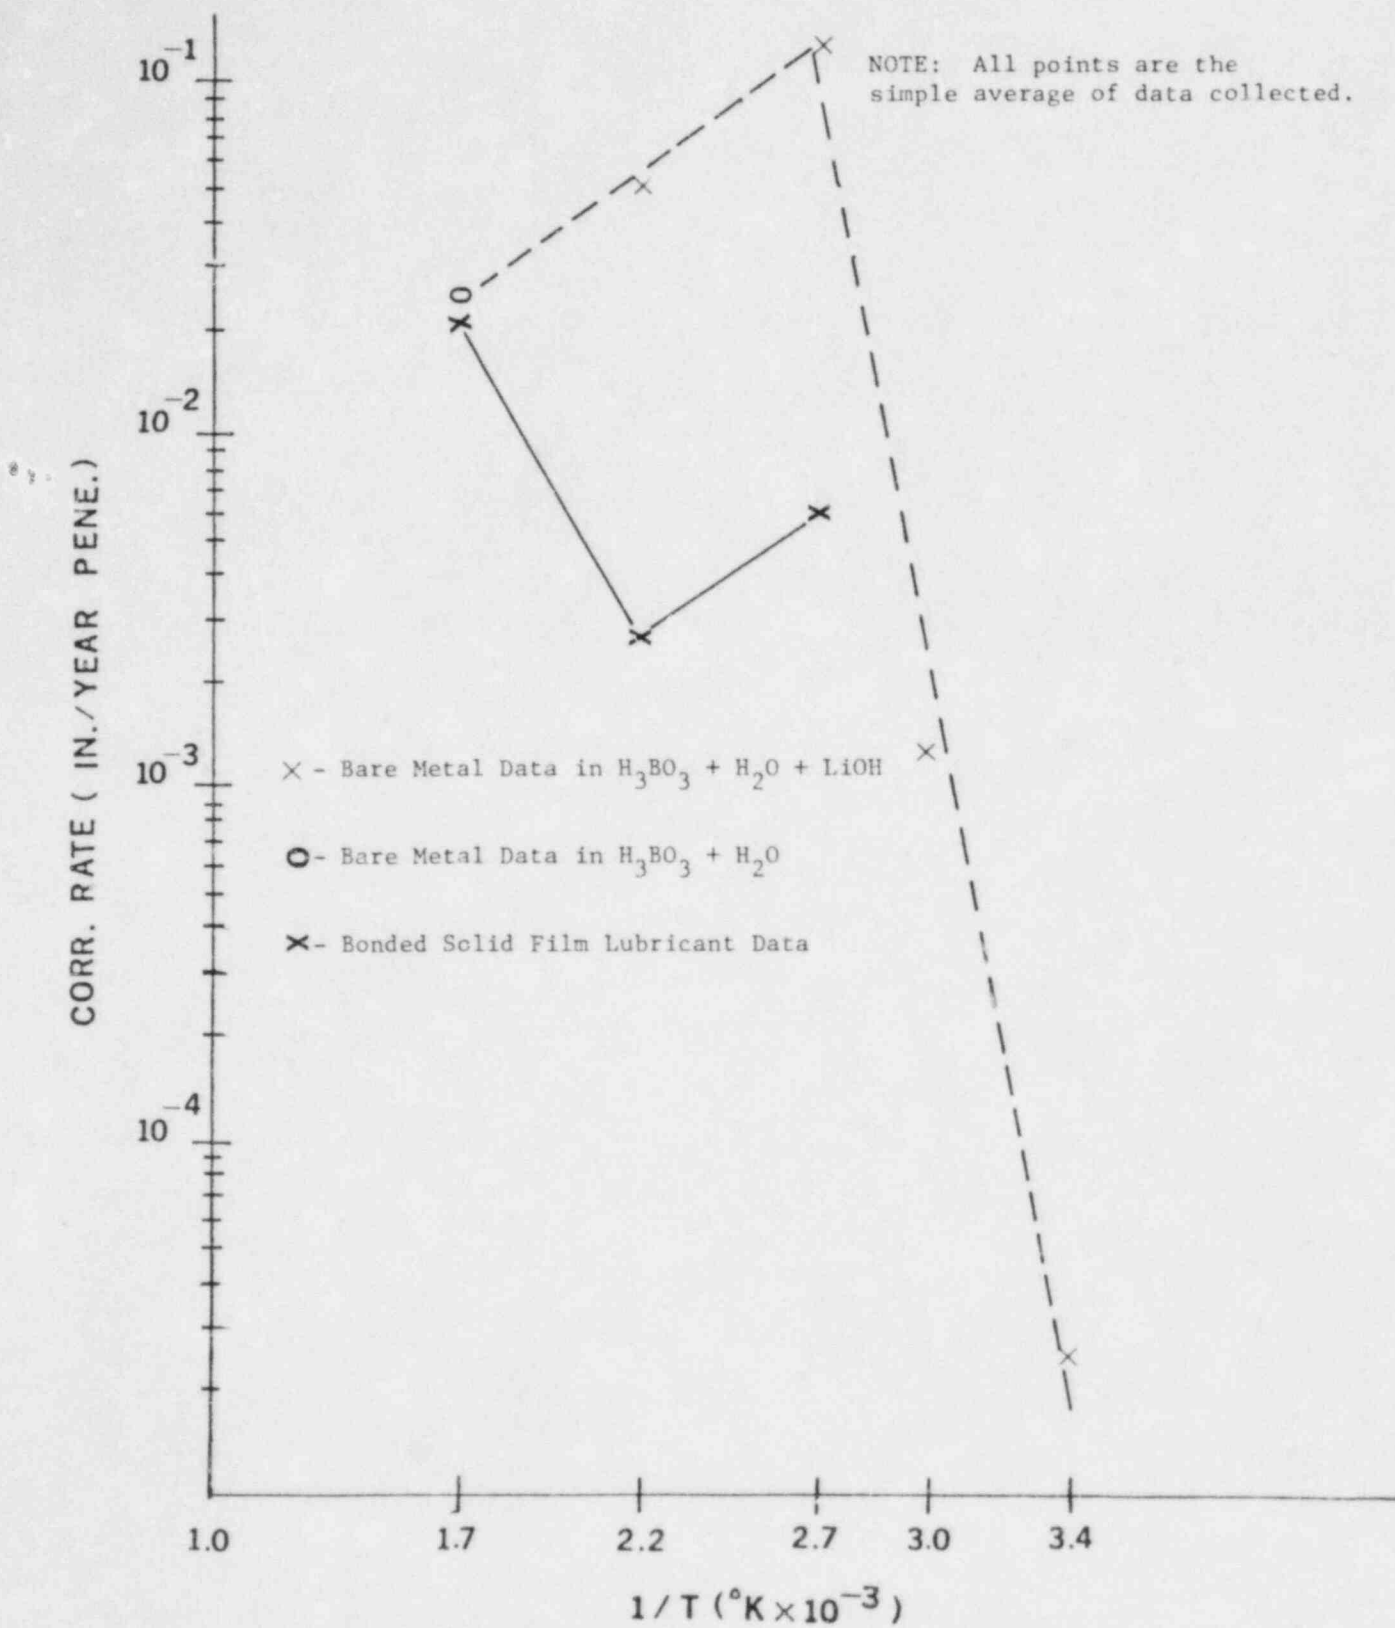
Figure 139 Graphical Representation of Weight Loss Experiments

Previously published data [11] were accumulated by BNL on an AISI 4135 steel in  $H_3BO_3$  and  $H_3BO_3 - KOH$  solutions at  $70^\circ F$  and  $140^\circ F$ . In addition, BNL work on A193-B7 and AISI 4130 material at higher temperatures was plotted to determine if extrapolations were valid. The temperature dependence of the graph (Figure 139) is evident. As temperature increases to the boiling point of water, the corrosion rate increases at much faster rates. This increase continues until the boiling point is reached and then starts to diminish, probably due to the loss of water in solution. The decrease in corrosion rate continues through at least a temperature of  $352^\circ F$  in  $H_3BO_3 + LiOH$ . As the higher temperatures are attained, water of hydration would also start to evaporate, which would probably deposit a lithium salt of meta-boric acid  $LiBO_2$  ( $LiBO_2$  has a melting point as high as  $845^\circ C$  in non-hydrated form). Other corrosion products may have a similar stifling effect in the case of  $H_3BO_3$  by itself, accounting for the drop in rate after  $H_2O$  is lost, although they have not been examined in any detail.

The data generated from these tests are plotted on the graph of the original test data in Figure 139.
