<b>Nuclear</b> <b>TECHNICAL DATA REPORT</b>	TDR NO. <u>580</u>	REVISION NO. <u>1</u>
	BUDGET ACTIVITY NO. <u>323357</u>	PAGE <u>1</u> OF <u>110</u>
PROJECT: <u>Oyster Creek Nuclear Generating Station</u>	DEPARTMENT/SECTION <u>E&amp;D</u>	
RELEASE DATE <u>9-17-84</u> REVISION DATE <u>9-11-84</u>

DOCUMENT TITLE: Isolation Condenser System Piping Cracked Welds - Repair and Failure Analysis

**TITLE** Isolation condenser system cracked welds-repair and failure analysis

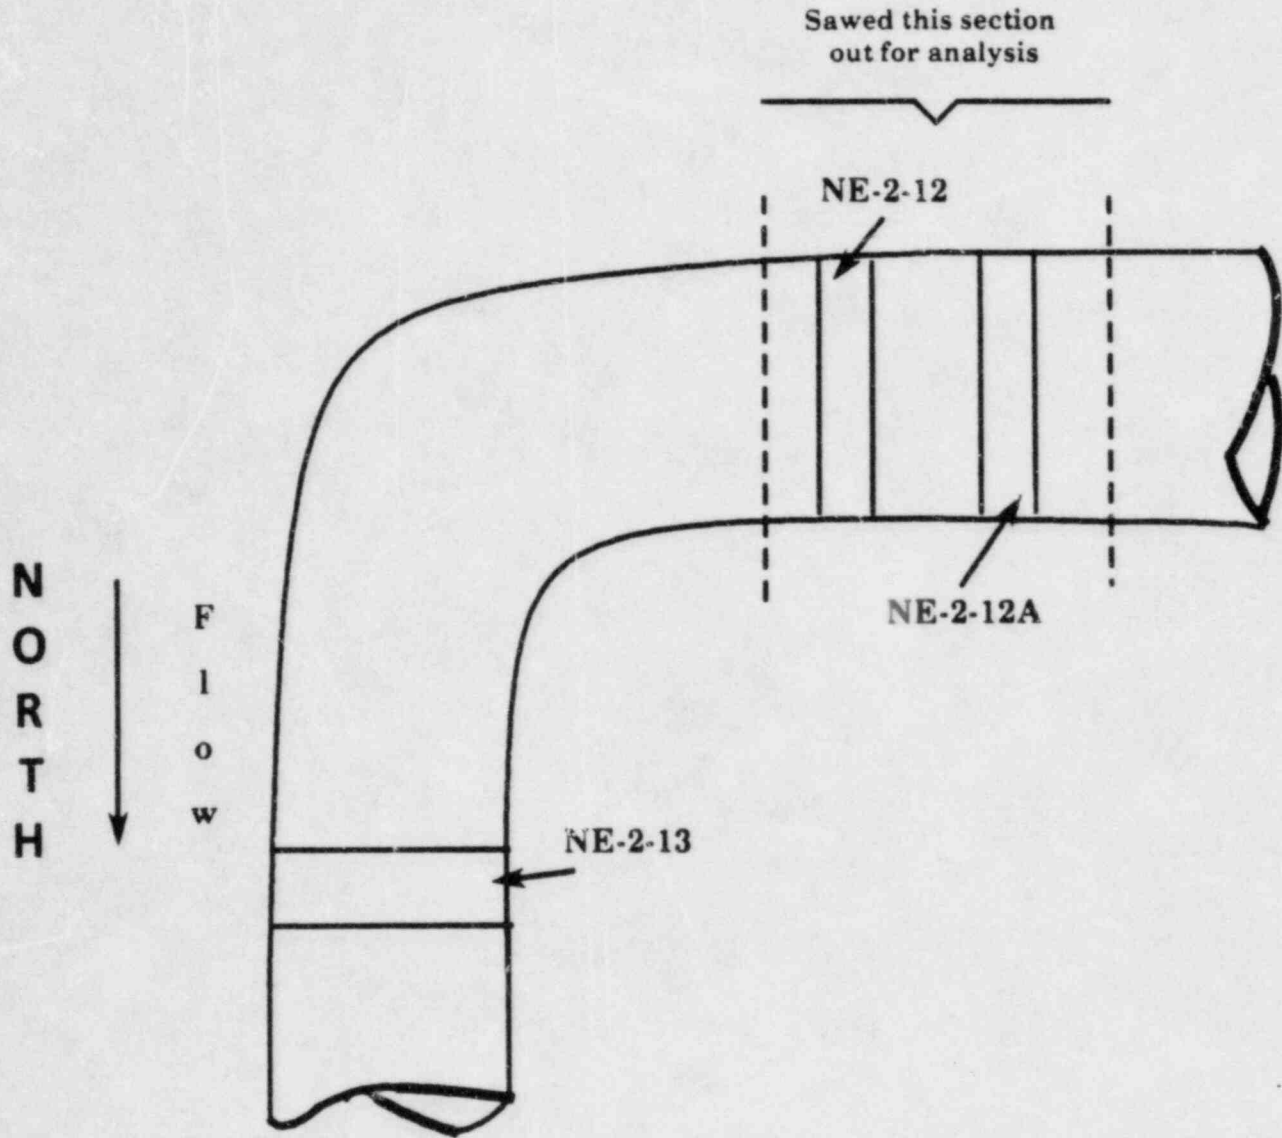
Figure 1: 8" Dia. schedule 80 pipe received from Oyster Creek

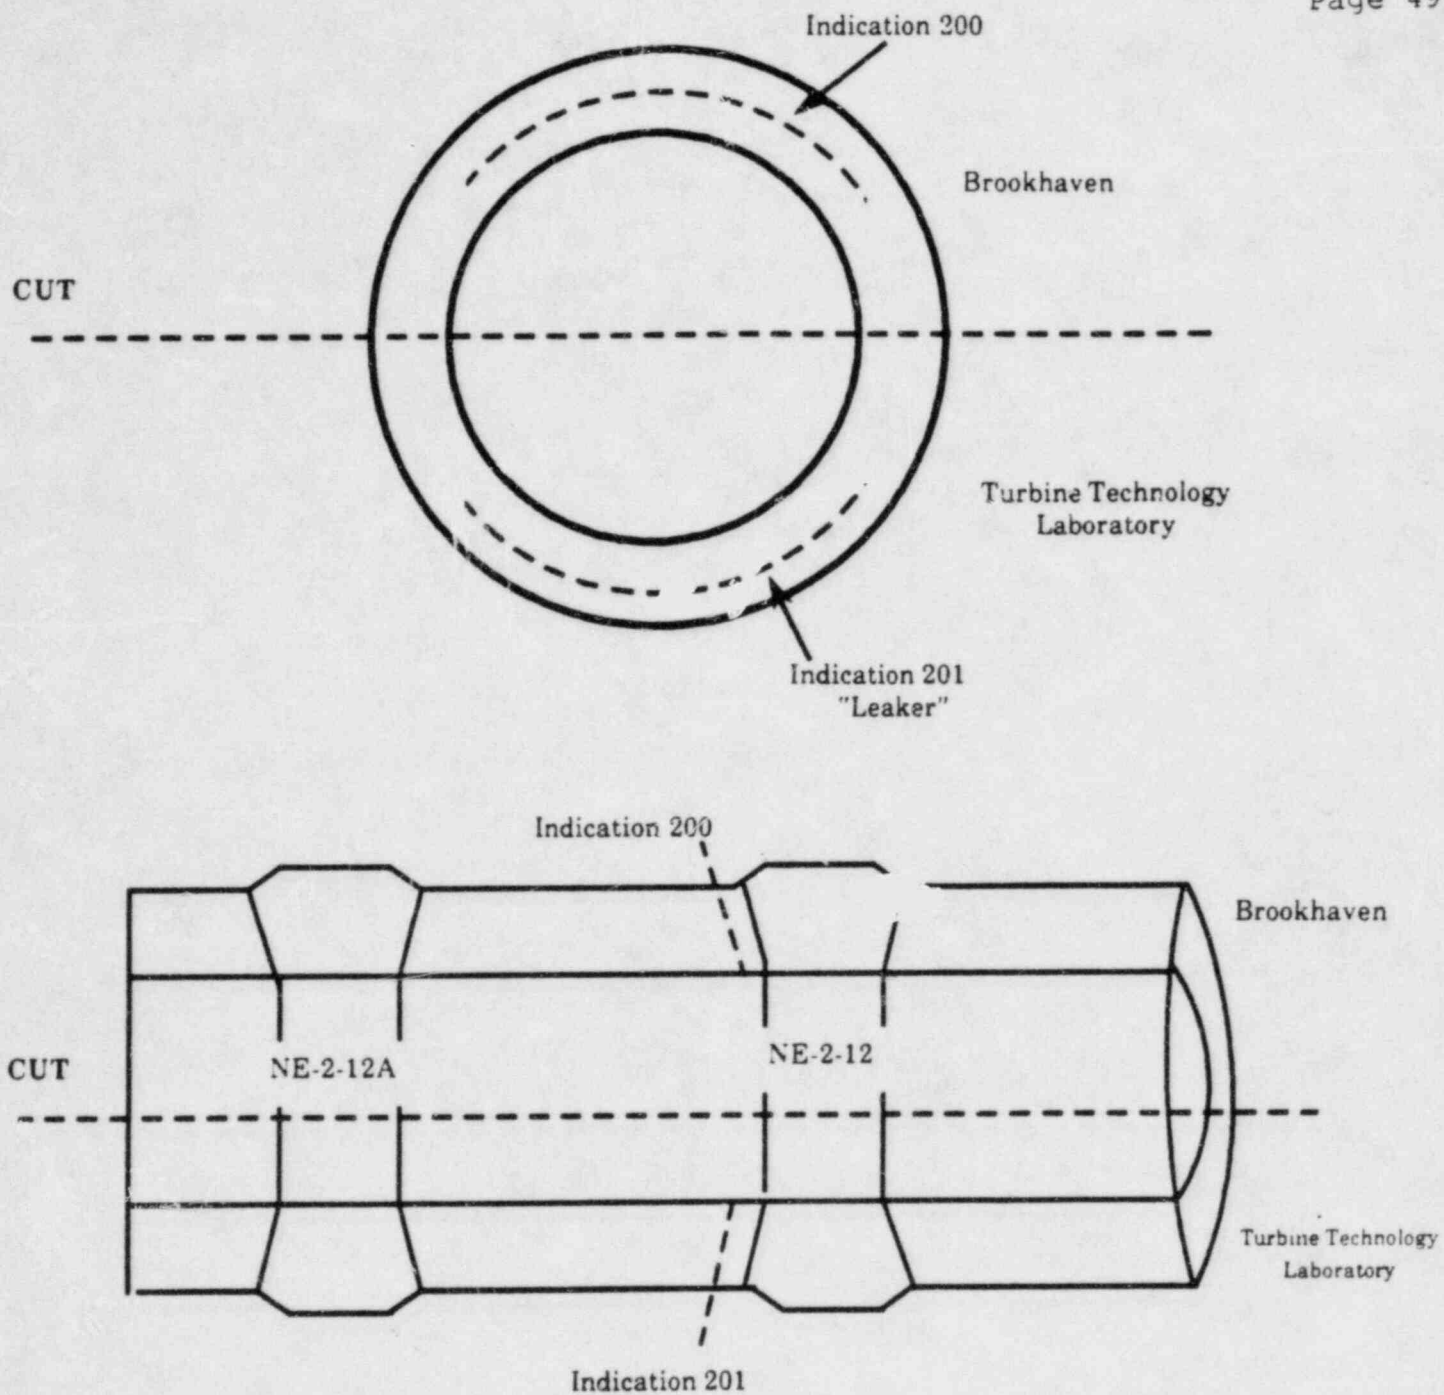
**Figure 2: Axial cut to divide NE-2-12 (and NE-2-12A) between Brookhaven National Laboratories and Turbine Technology Laboratory**

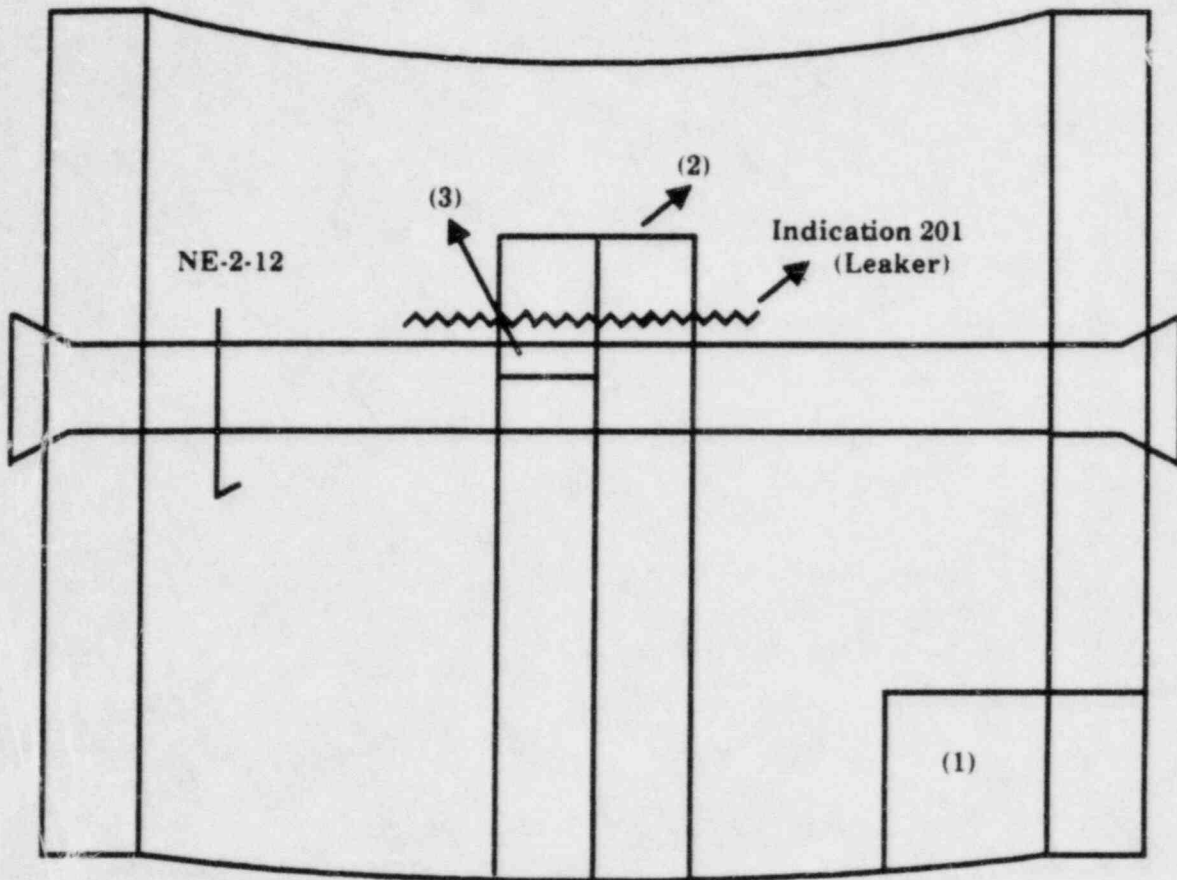
Scanning electron microscopy was performed on the piece marked "2" in Figure 3. The long piece was sawed out and placed in a vise and broken open (by hand) and the fracture surface cleaned by ultrasonic agitation in a detergent water solution.

The results of the chemical analysis done on piece "1" of Figure 3 are shown in Table I.

Metallography carried out on indication 201 "leaker" is shown in Figures 7 through 9. The location of this specimen is shown as "3" in Figure 3.

- (1) Chemical Analysis Sample
- (2) Sem Fractographic Sample
- (3) Metallographic Sample

**Figure 3:** The half of the pipe kept for analysis at Turbine Technology Laboratory. The other half to Brookhaven National Laboratory.

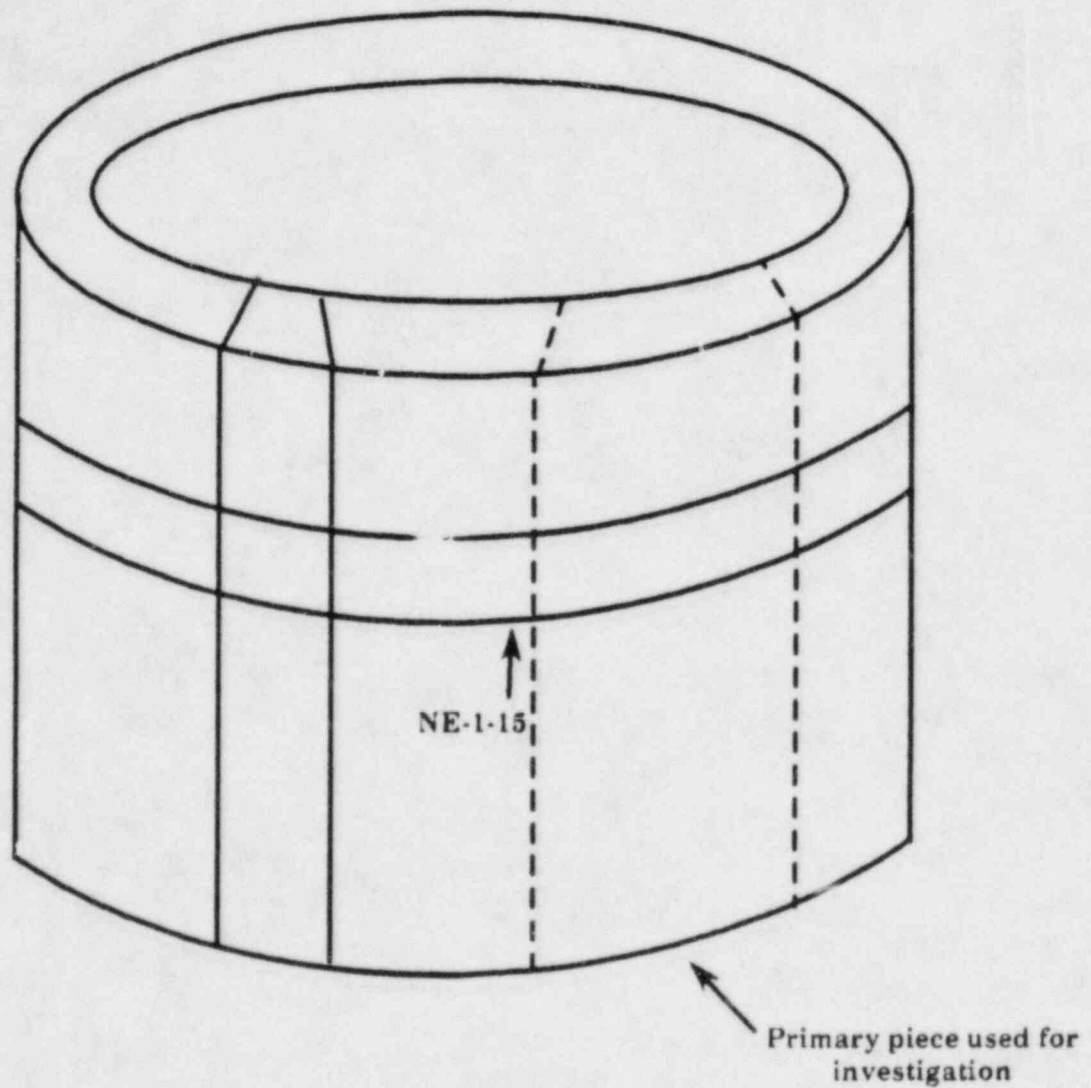
The 8" long section of 12" diameter pipe was received May 20, 1984, at approximately 9:00 p.m. The level of radiation measured was about 110 mR/hour at contact on the inside surface and 6 mR/hour at three feet. The sample as-received is shown in Figure 15. A slice of the 12" pipe wall was cut from the spool piece as shown in the sketch in Figure 16.

**FIGURE 16:** Sketch of 12 inch diameter spool piece showing ↑ NE-1-15 and axial weld in addition to the piece removed for examination.

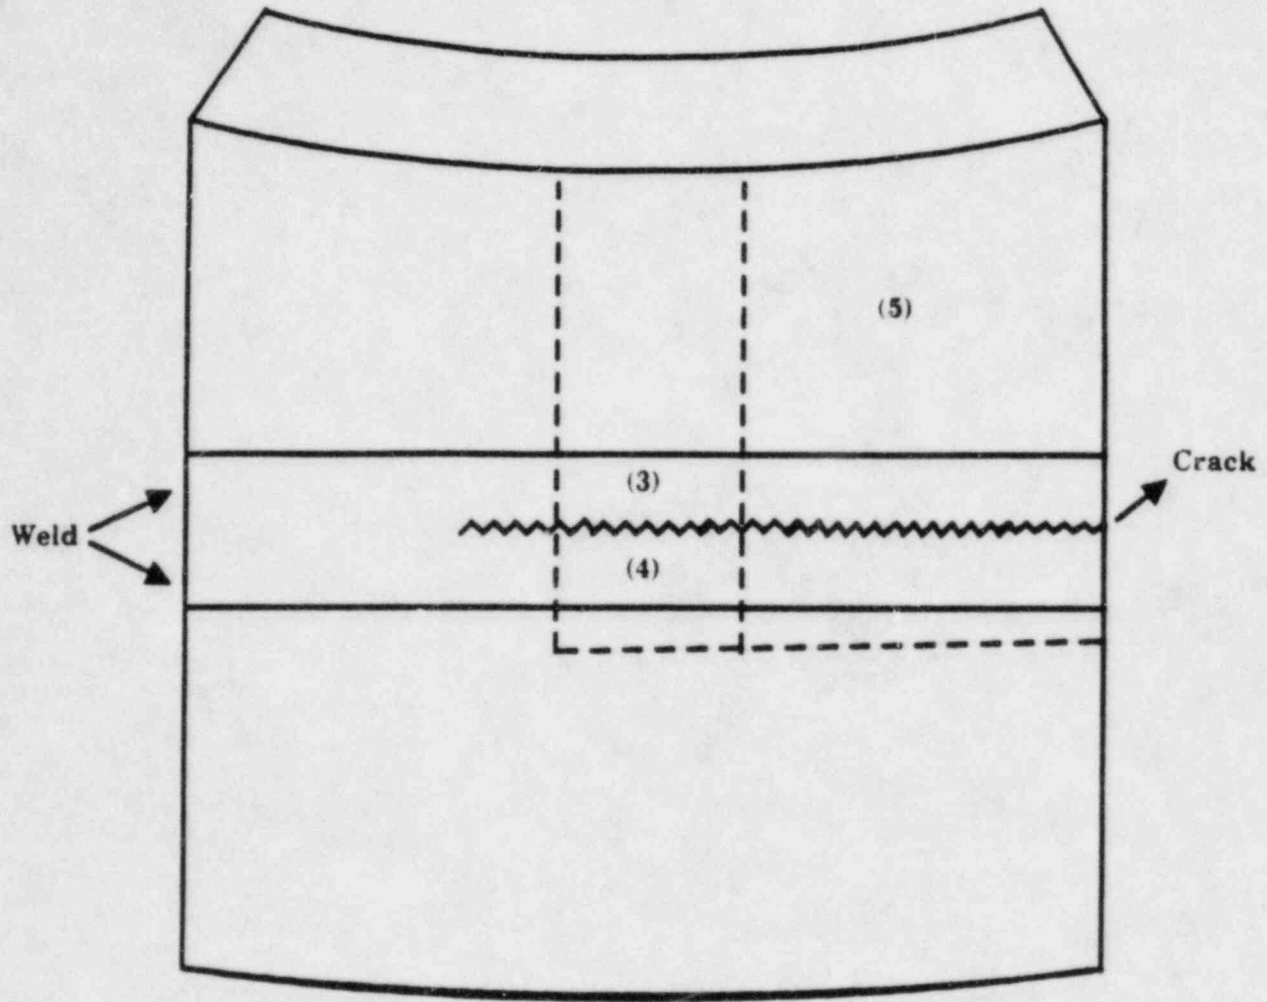
Figure 17 shows the piece removed from the 12" spool piece and the location of the pieces used for each of the subsequent examinations.

Scanning electron microscopy was performed on piece "3" in Figure 17, and in this case, a heavy coating of oxide necessitated the use of ultrasonic agitation for two ten-minute periods in a 5 percent  $H_2SO_4$  solution containing catechol.

The piece marked "5" in Figure 17 was mounted in epoxy resin and ground, polished, and etched with Kalling's etchant prior to being photographed. The weld bead was photographed at 8X while the crack was done at 50X. The location of the 50X pictures is given on the 8X picture.

The results of the chemical analysis by X-ray fluorescence appear in Table II. The location of the chemical analysis specimen is shown in Figure 17 as piece "4".

**Figure 17: Piece removed from 12 inch spool piece and the location of fractographic specimen (3); metallographic specimen (5); chemical analysis specimen (4).**

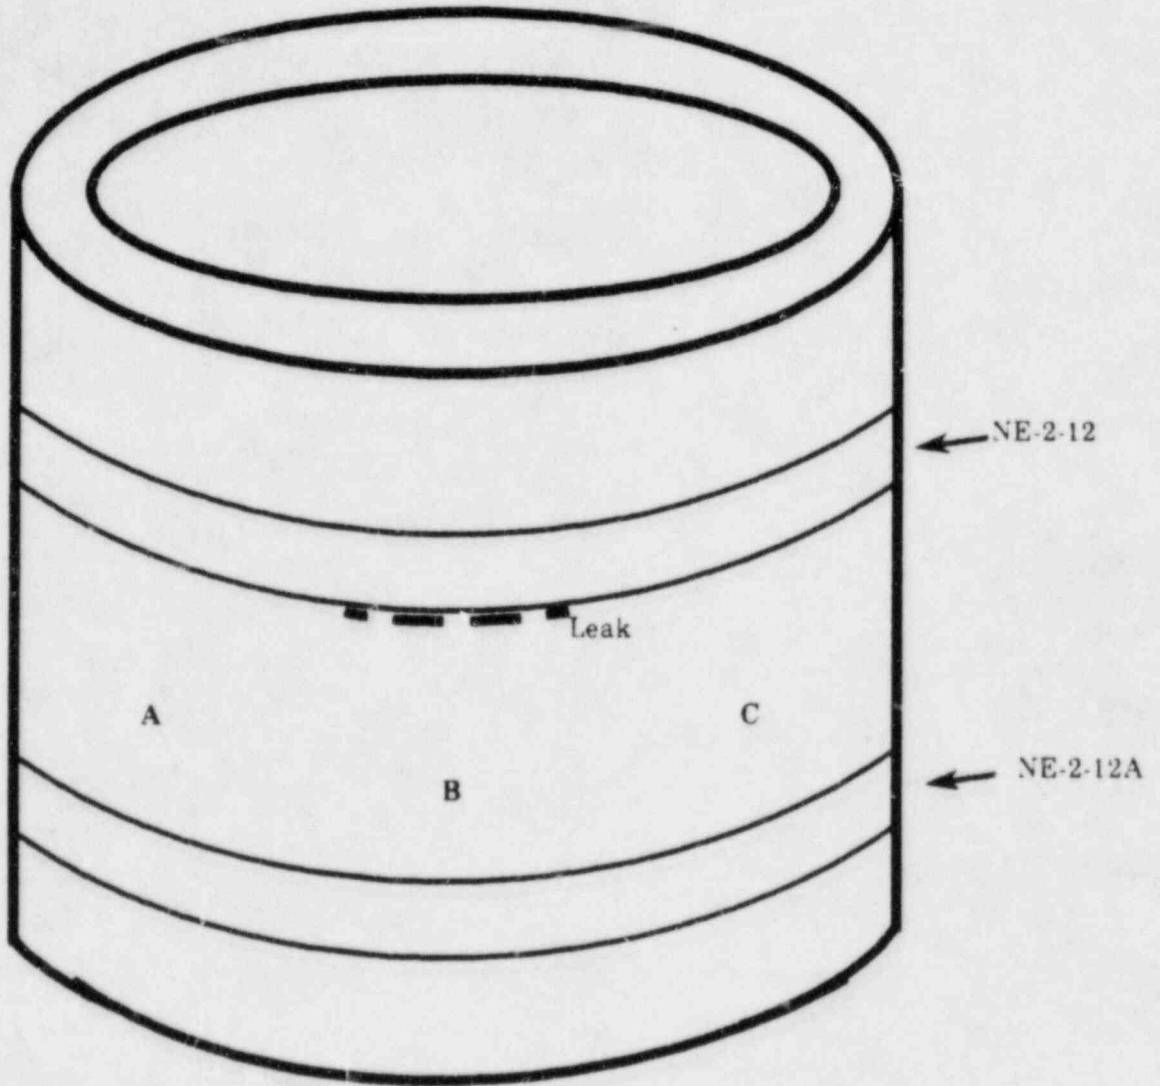
APPENDIX I: Location of the radiographs on NE-2-12 in the 8 inch pipe.

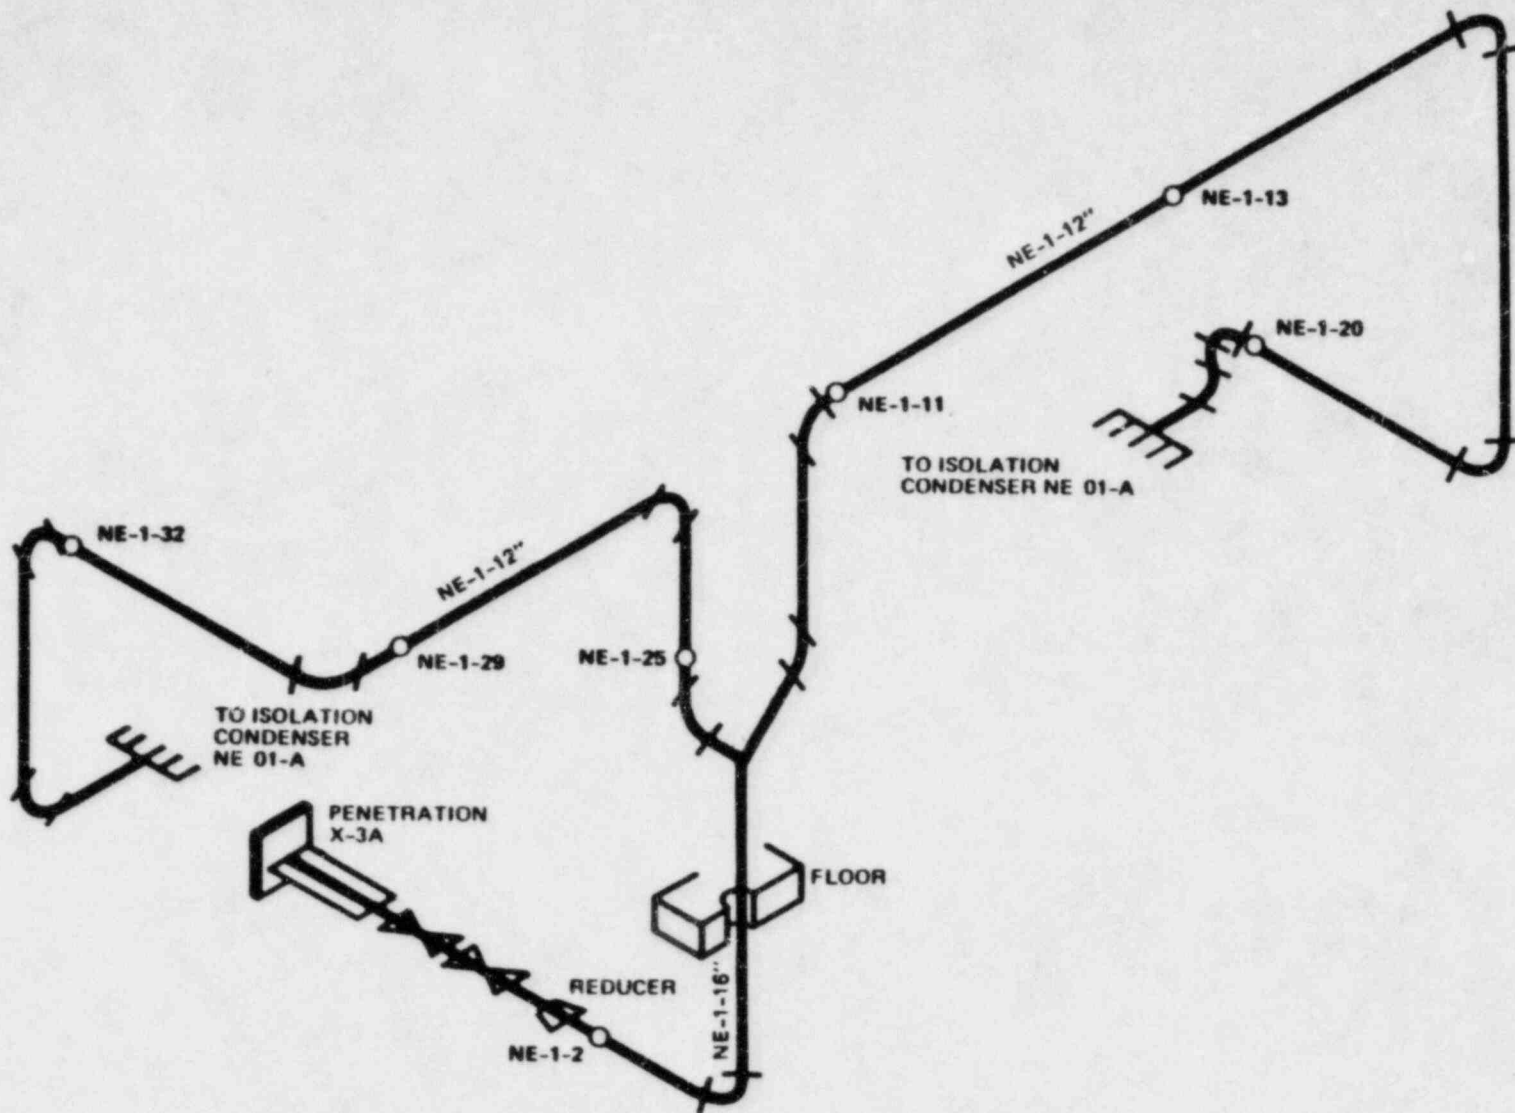
Figure 1

Oyster Creek Isolation Condenser Piping Loop A Supply Line

GPU Nuclear has decided to weld overlay repair eighteen of these welds and replace the remaining nine welds. The four pipe lines and the overlay locations are shown in Figures 1 through 4. Table 1 summarizes all of the welds and the respective pipe lines and pipe diameters. All but two of the indications were found in the 12-inch supply lines and the 8-inch return lines. The other two were at welds in a 10-inch return line and a 16-inch supply line. The overlays are to be designed to assure that the full structural margin intended by IWB-3640, Section XI [1], is maintained. This report provides recommendations for the design of the weld overlays to meet the Code safety margins and specific geometric considerations at each weld. The effects of axial shrinkage of the piping from application of the overlays is also examined in terms of the additional stresses imposed on the piping system.

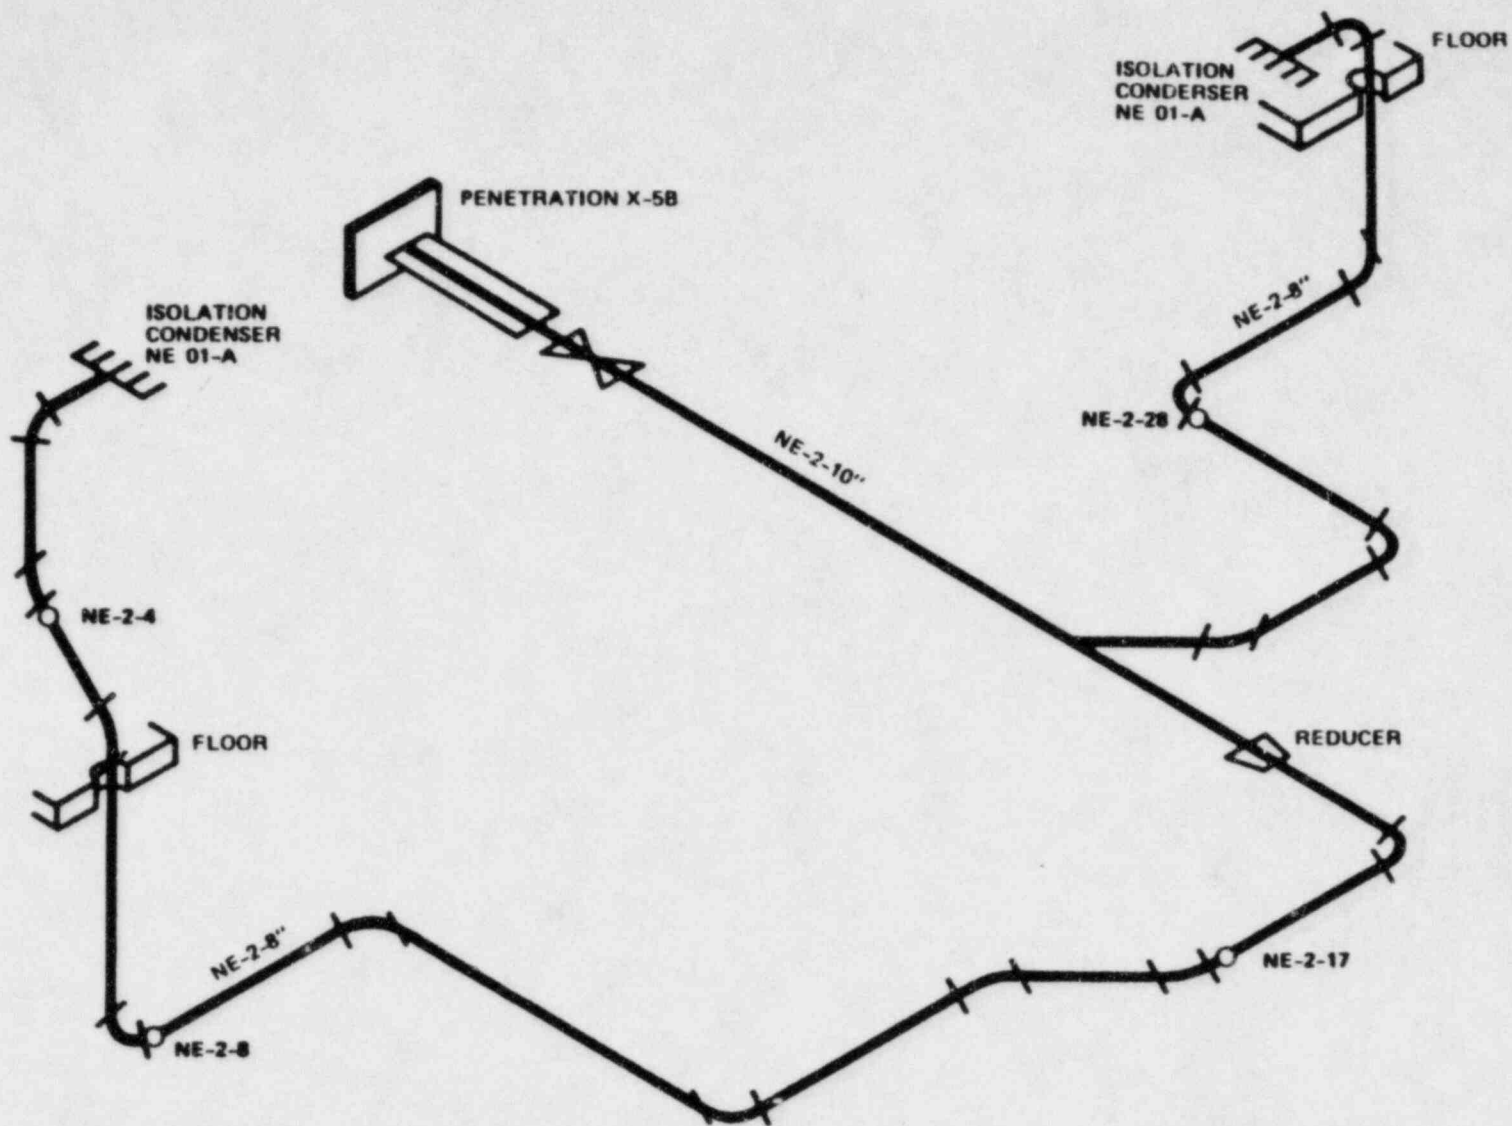
Figure 2

Oyster Creek Isolation Condenser Piping Loop A Return Line

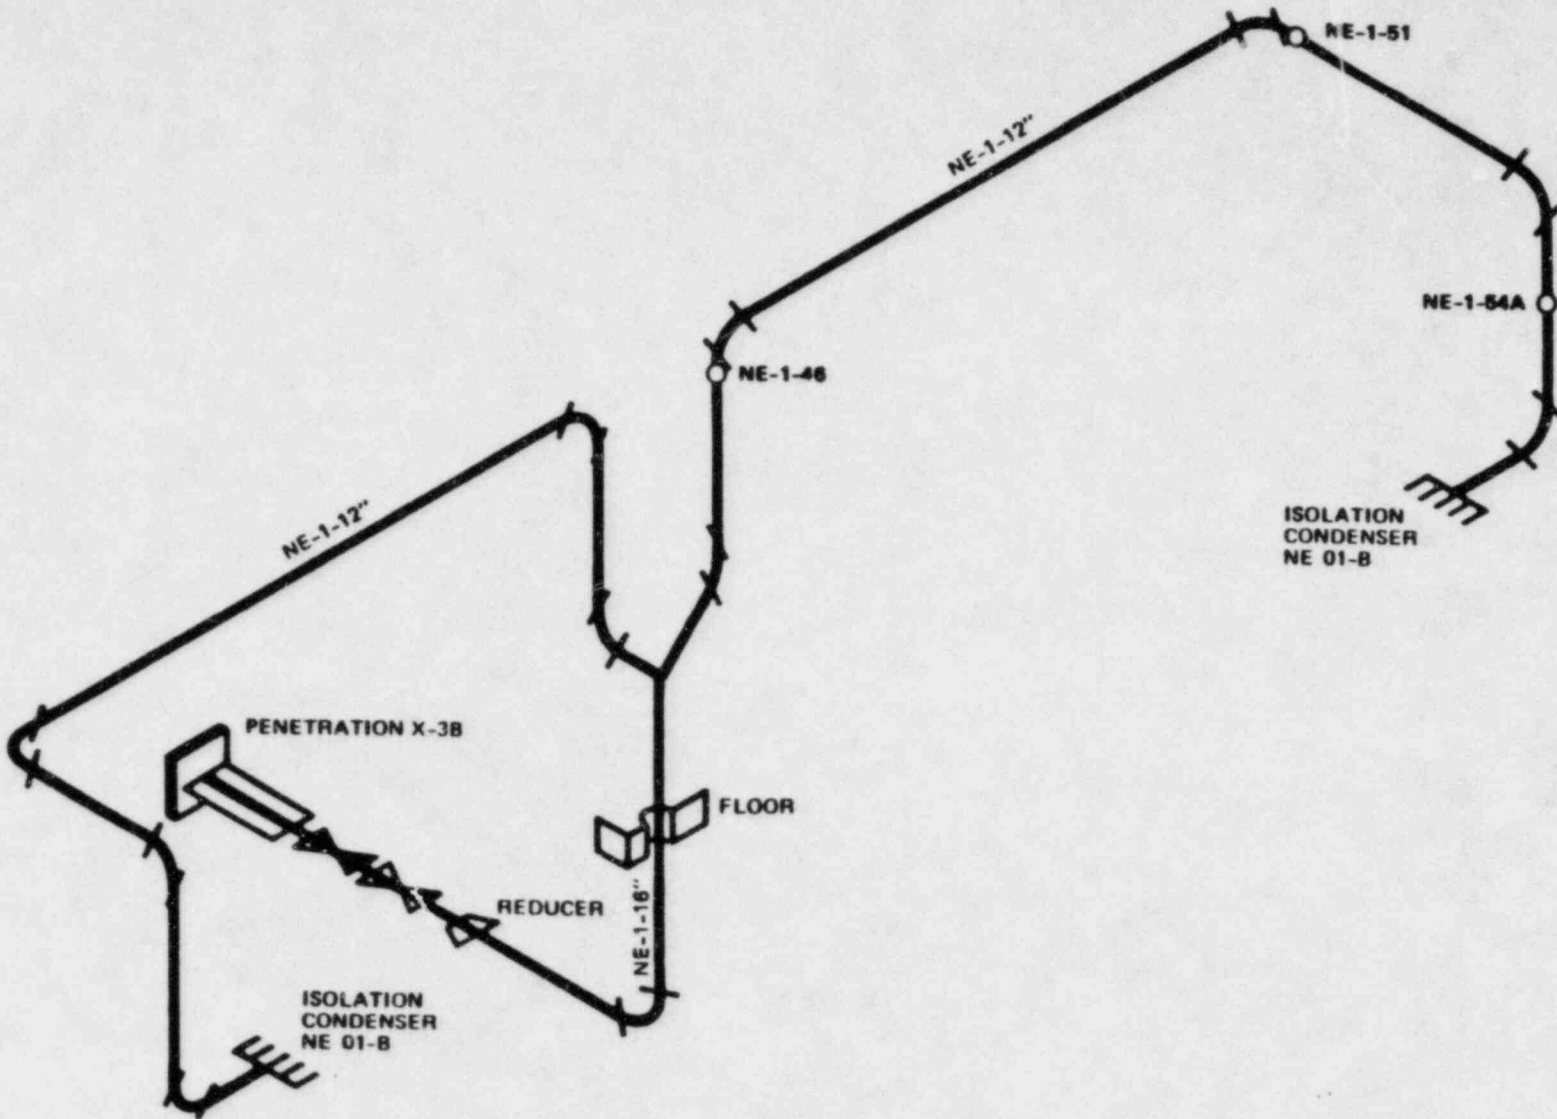
Figure 3

Oyster Creek Isolation Condenser Piping Loop B Supply Line

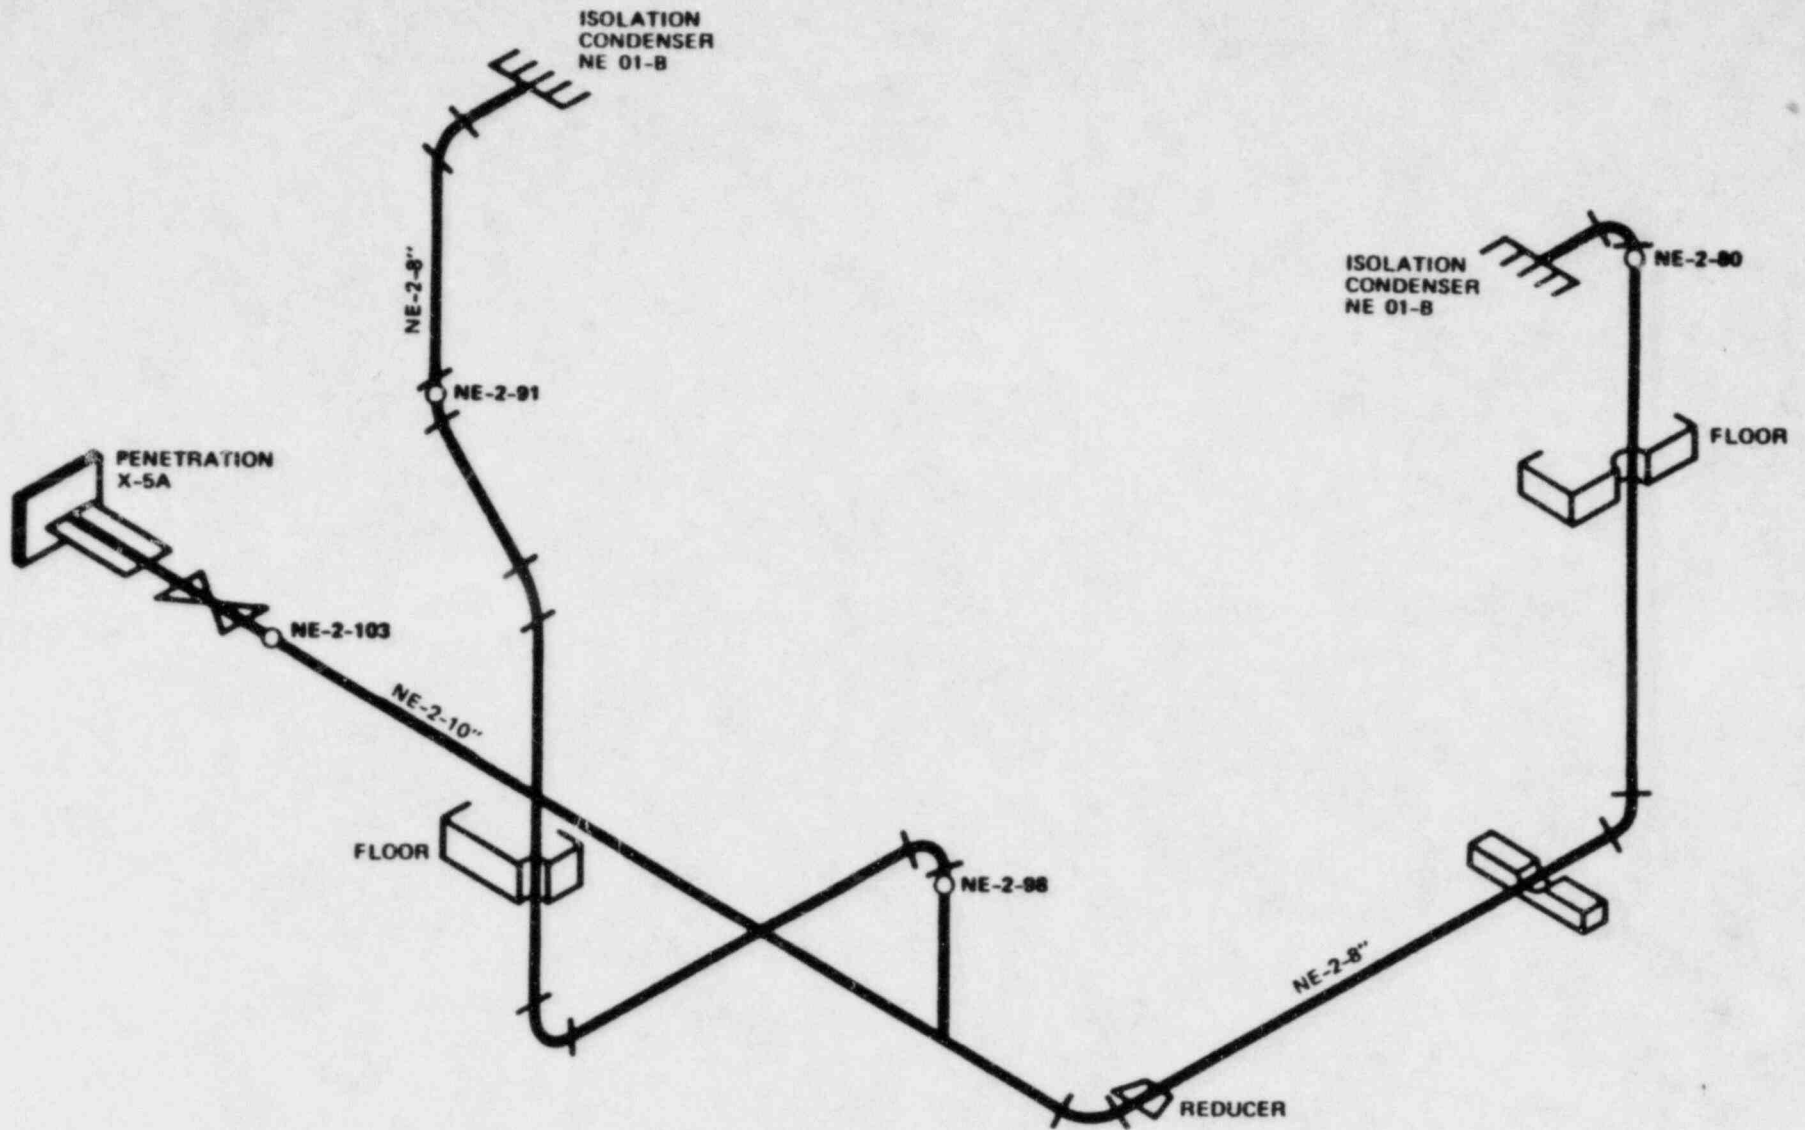
Figure 4

Oyster Creek Isolation Condenser Piping Loop B Return Line

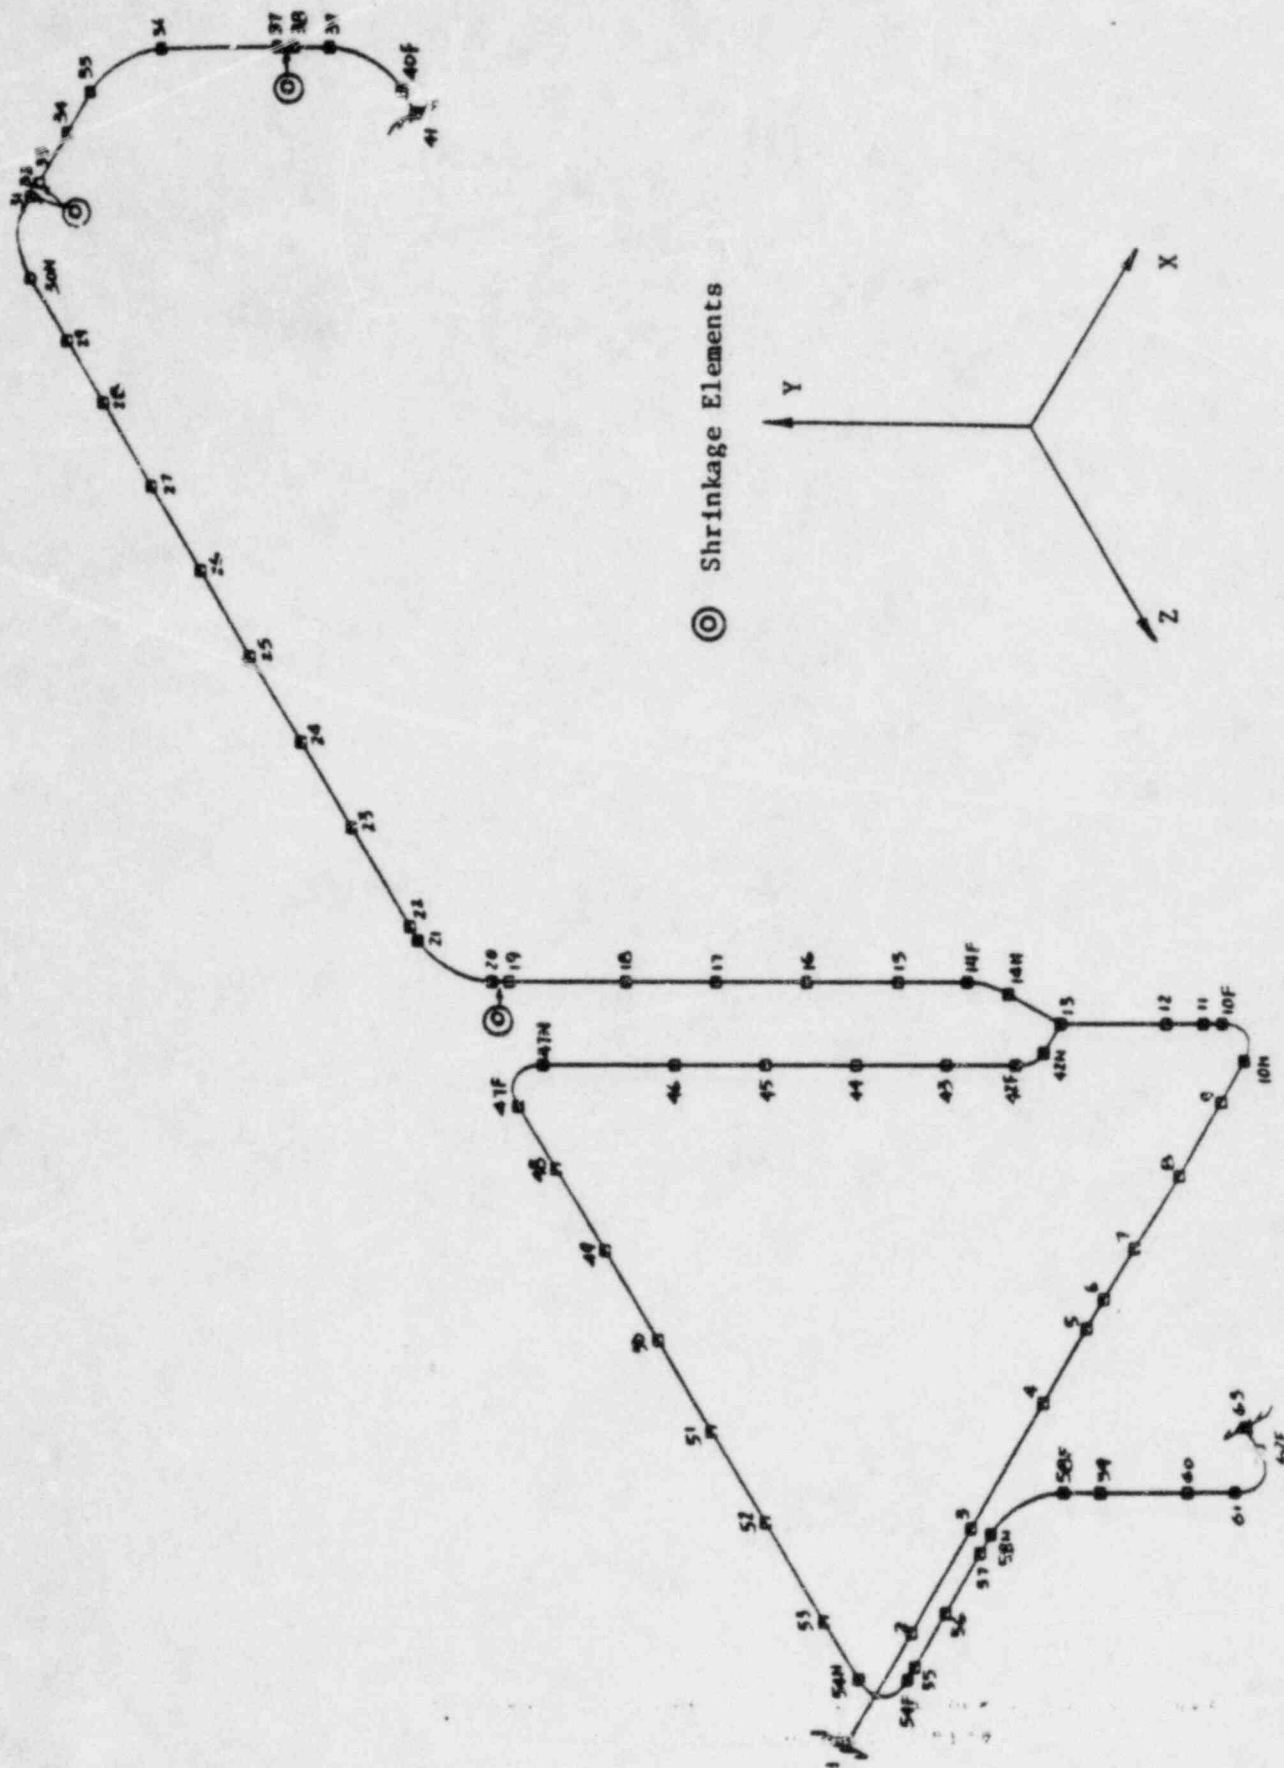
Application of a weld overlay produces an axial contraction of the pipe which is a function of the pipe size and the overlay thickness and width. This shrinkage imposes stresses on the entire piping system. The amount of shrinkage was estimated for the purpose of this analysis based on typical shrinkages observed in similar weld overlay applications. The 8- and 10-inch pipe overlays were assumed to shrink 1/4 inch, and the 12- and 16-inch pipe overlays were assumed to shrink 3/8 inch. A finite element analysis of the Loop B supply and return piping was performed to determine the magnitudes of the stresses due to these assumed shrinkages. This analysis was performed using the PISYS finite element code (Reference 5). The models are provided in Figures 7 and 8. The shrinkage effect was simulated by forcing thermal contractions at the weld overlay locations equivalent to the assumed 1/4- and 3/8-inch overlay shrinkages. A summary of the maximum shrinkage stresses obtained in the Loop B supply and return lines is provided in Table 8.

Figure 7  
Isolation Condenser Piping Model for Shrinkage Stress Analysis--  
Loop B Supply

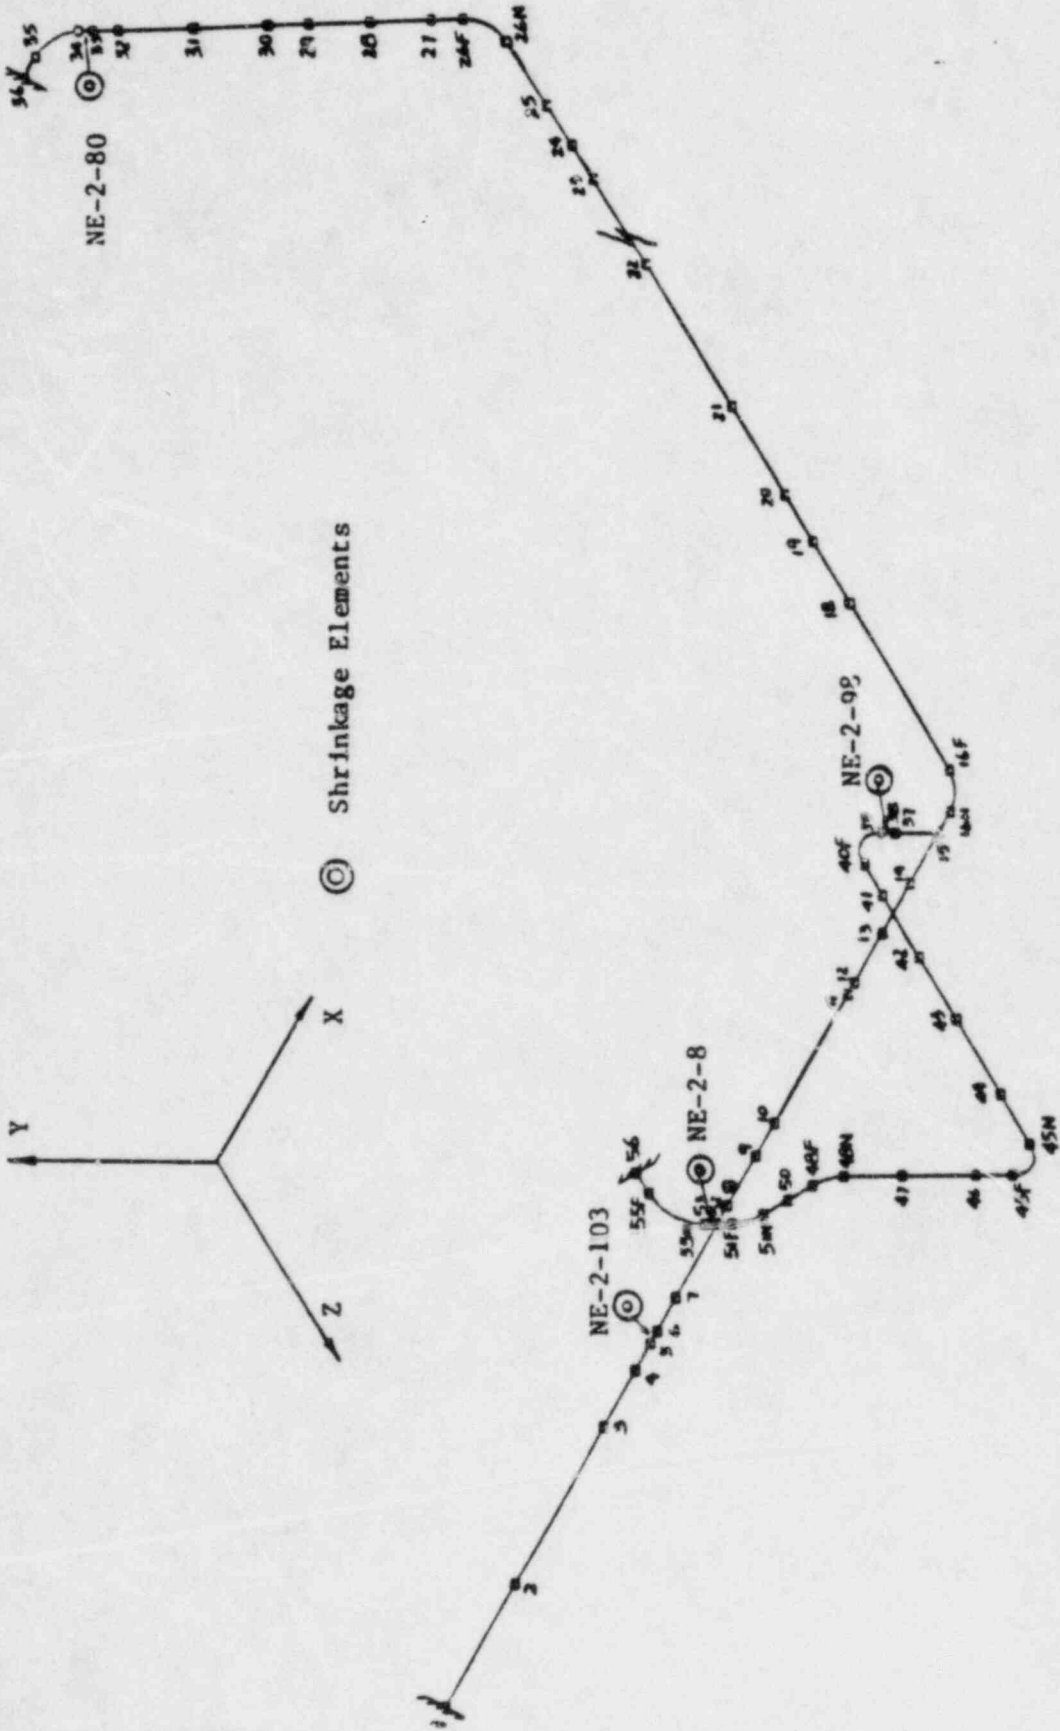
Figure 8  
Isolation Condenser Piping Model for Shrinkage Stress Analysis--  
Loop B Return
