Doc. No. BECO/ESR-1
SEPTEMBER 1984
REV. 1

Detailed Control Room Design Review

Executive Summary Report

Pilgrim Station

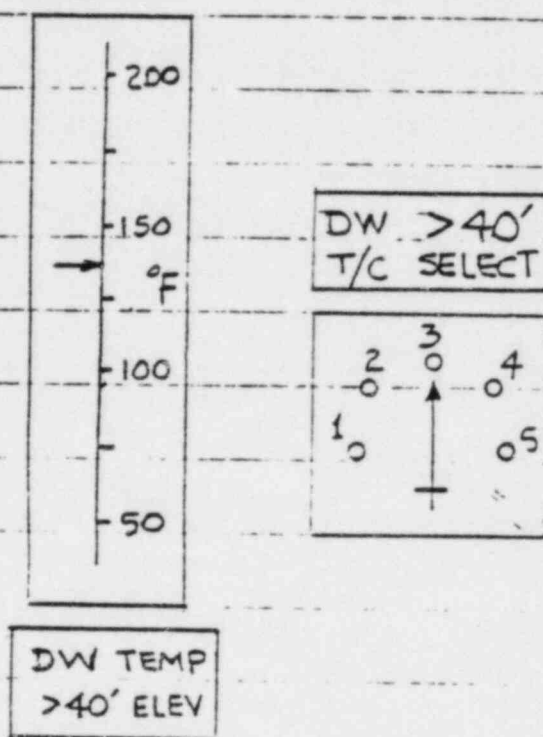
Sketch for HED # SA010
HEO # 6.5.044

Typical DW Temperature indicator with multiple inputs

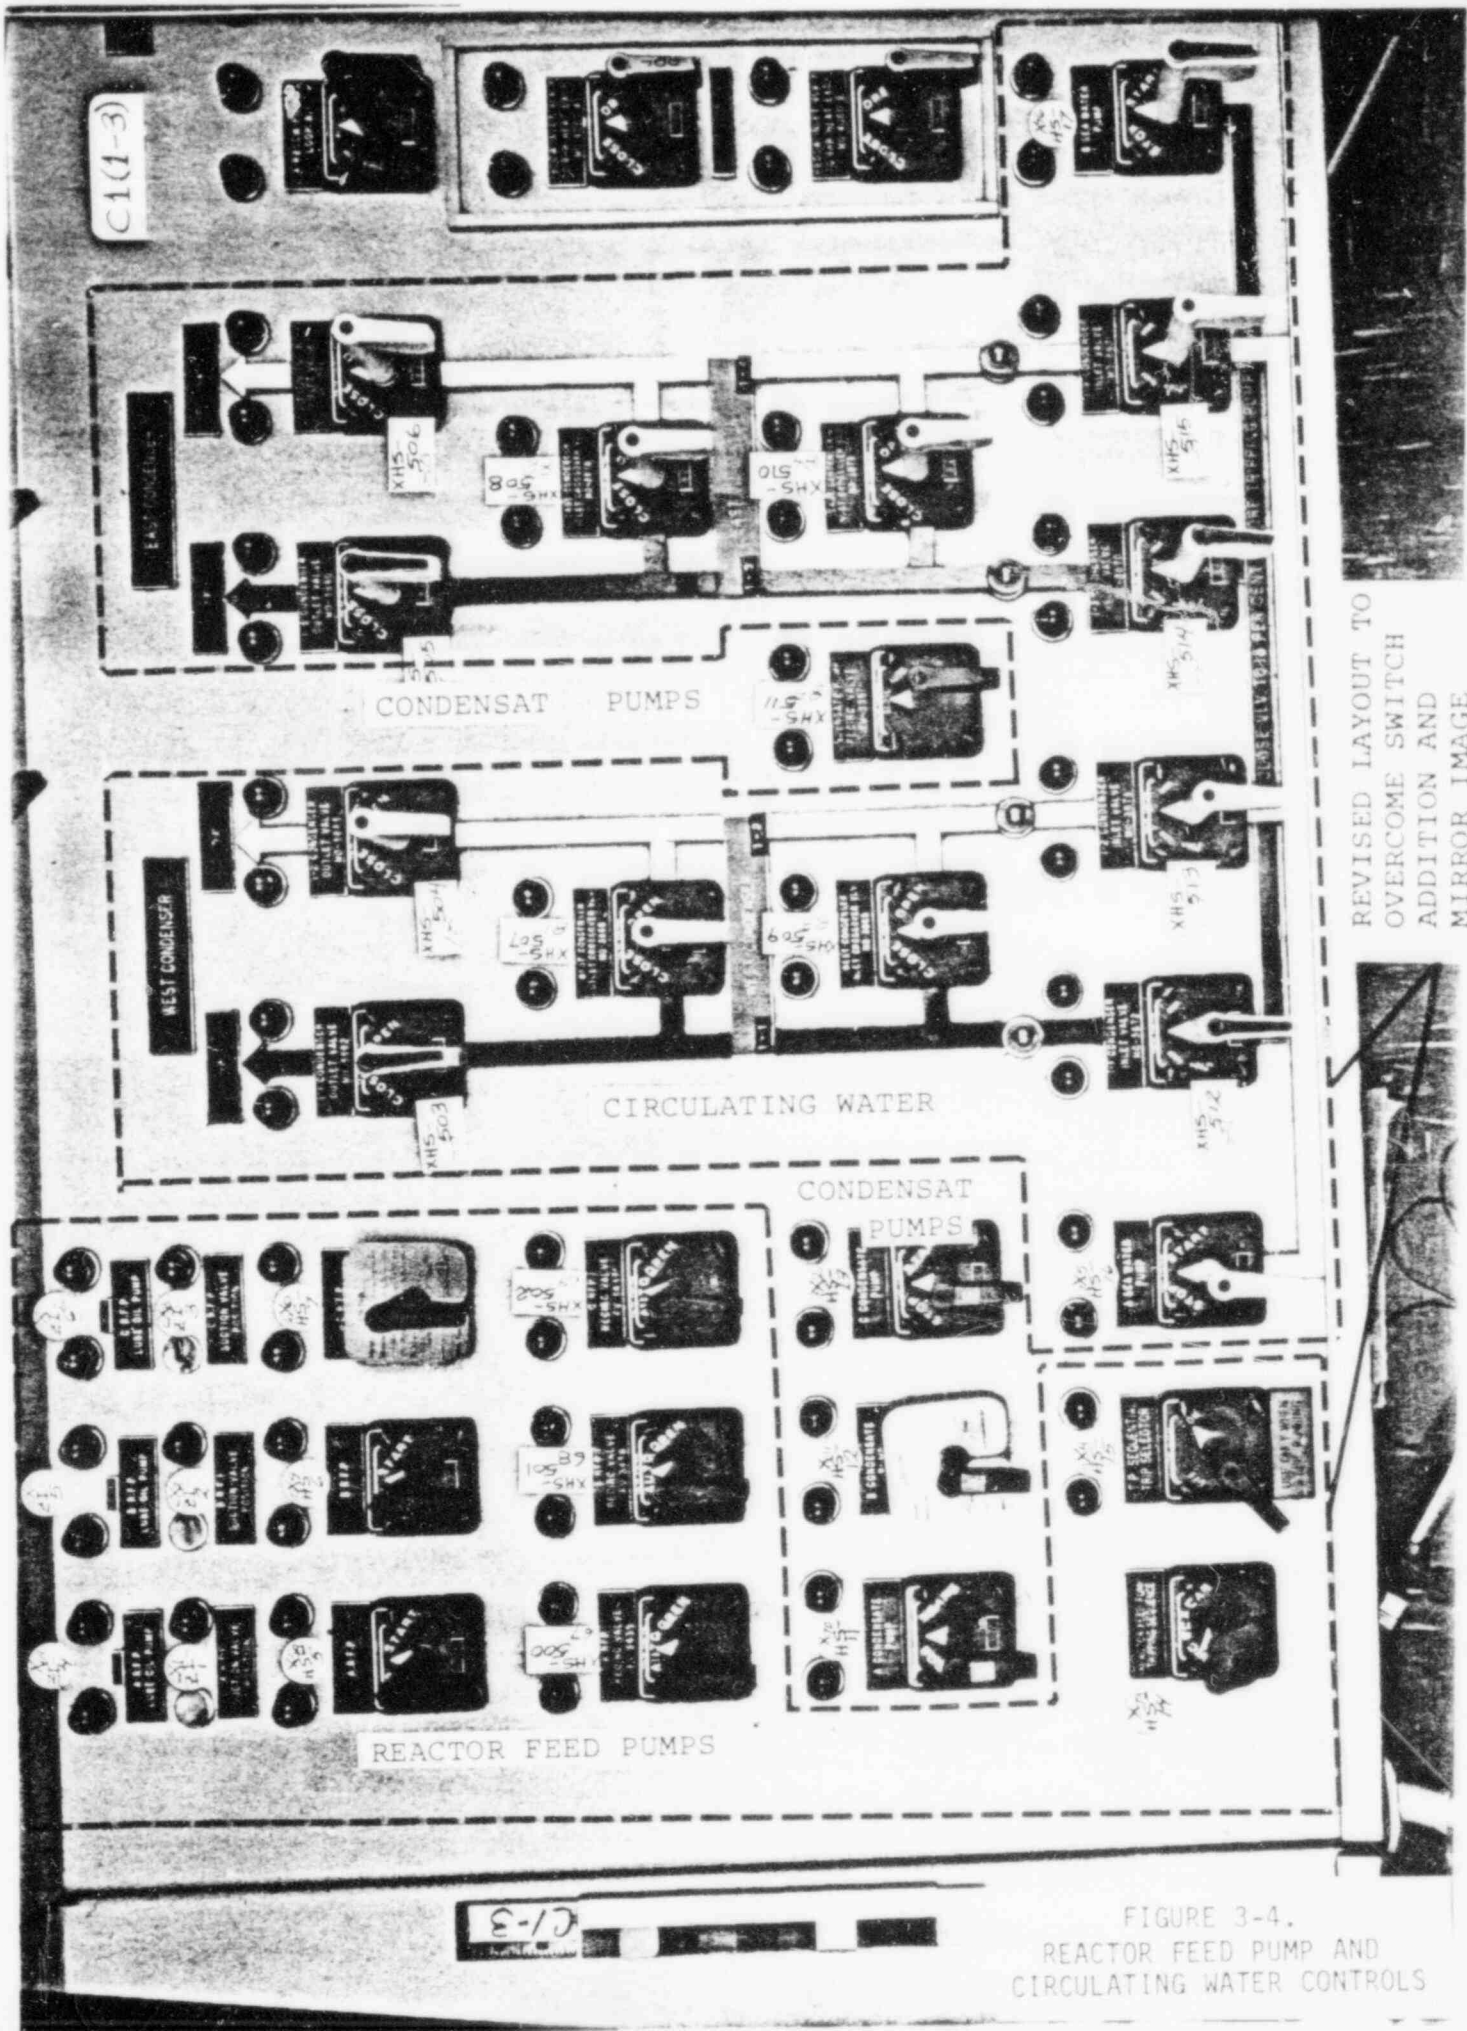
FIGURE 3-4.
 REACTOR FEED PUMP AND
 CIRCULATING WATER CONTROLS

Figure 3-4 shows the control equipment for the reactor feed pumps as it presently is. Included is a brief description of the change brought on by the addition of the Auto Trip (43/TCOS) switch relocated to this area by HED 4B126.5. The switch cannot be added to the panel without moving something else because there is no room to put it near the RFP controls. To put it anywhere else would not resolve the reported discrepancy. The layout of the RFP controls will need to be revised in order to fit the switch in. Figure 3-5 is the proposed Reactor Feed Pump (RFP) arrangement. The valve controls have been changed to a smaller switch so that the arrangement will meet minimum switch separation requirements. Smaller RFP ammeters have been incorporated into the layout. This will increase operator comprehension and make the total required panel area about the same.

The revised reactor feed pump arrangement creates a domino effect on the arrangements for the condensate pumps which in turn affects the arrangement for the circulating water system. Figure 3-4 shows the condensate pumps and circulating water system controls as they presently are. It also has a brief description of the change required.

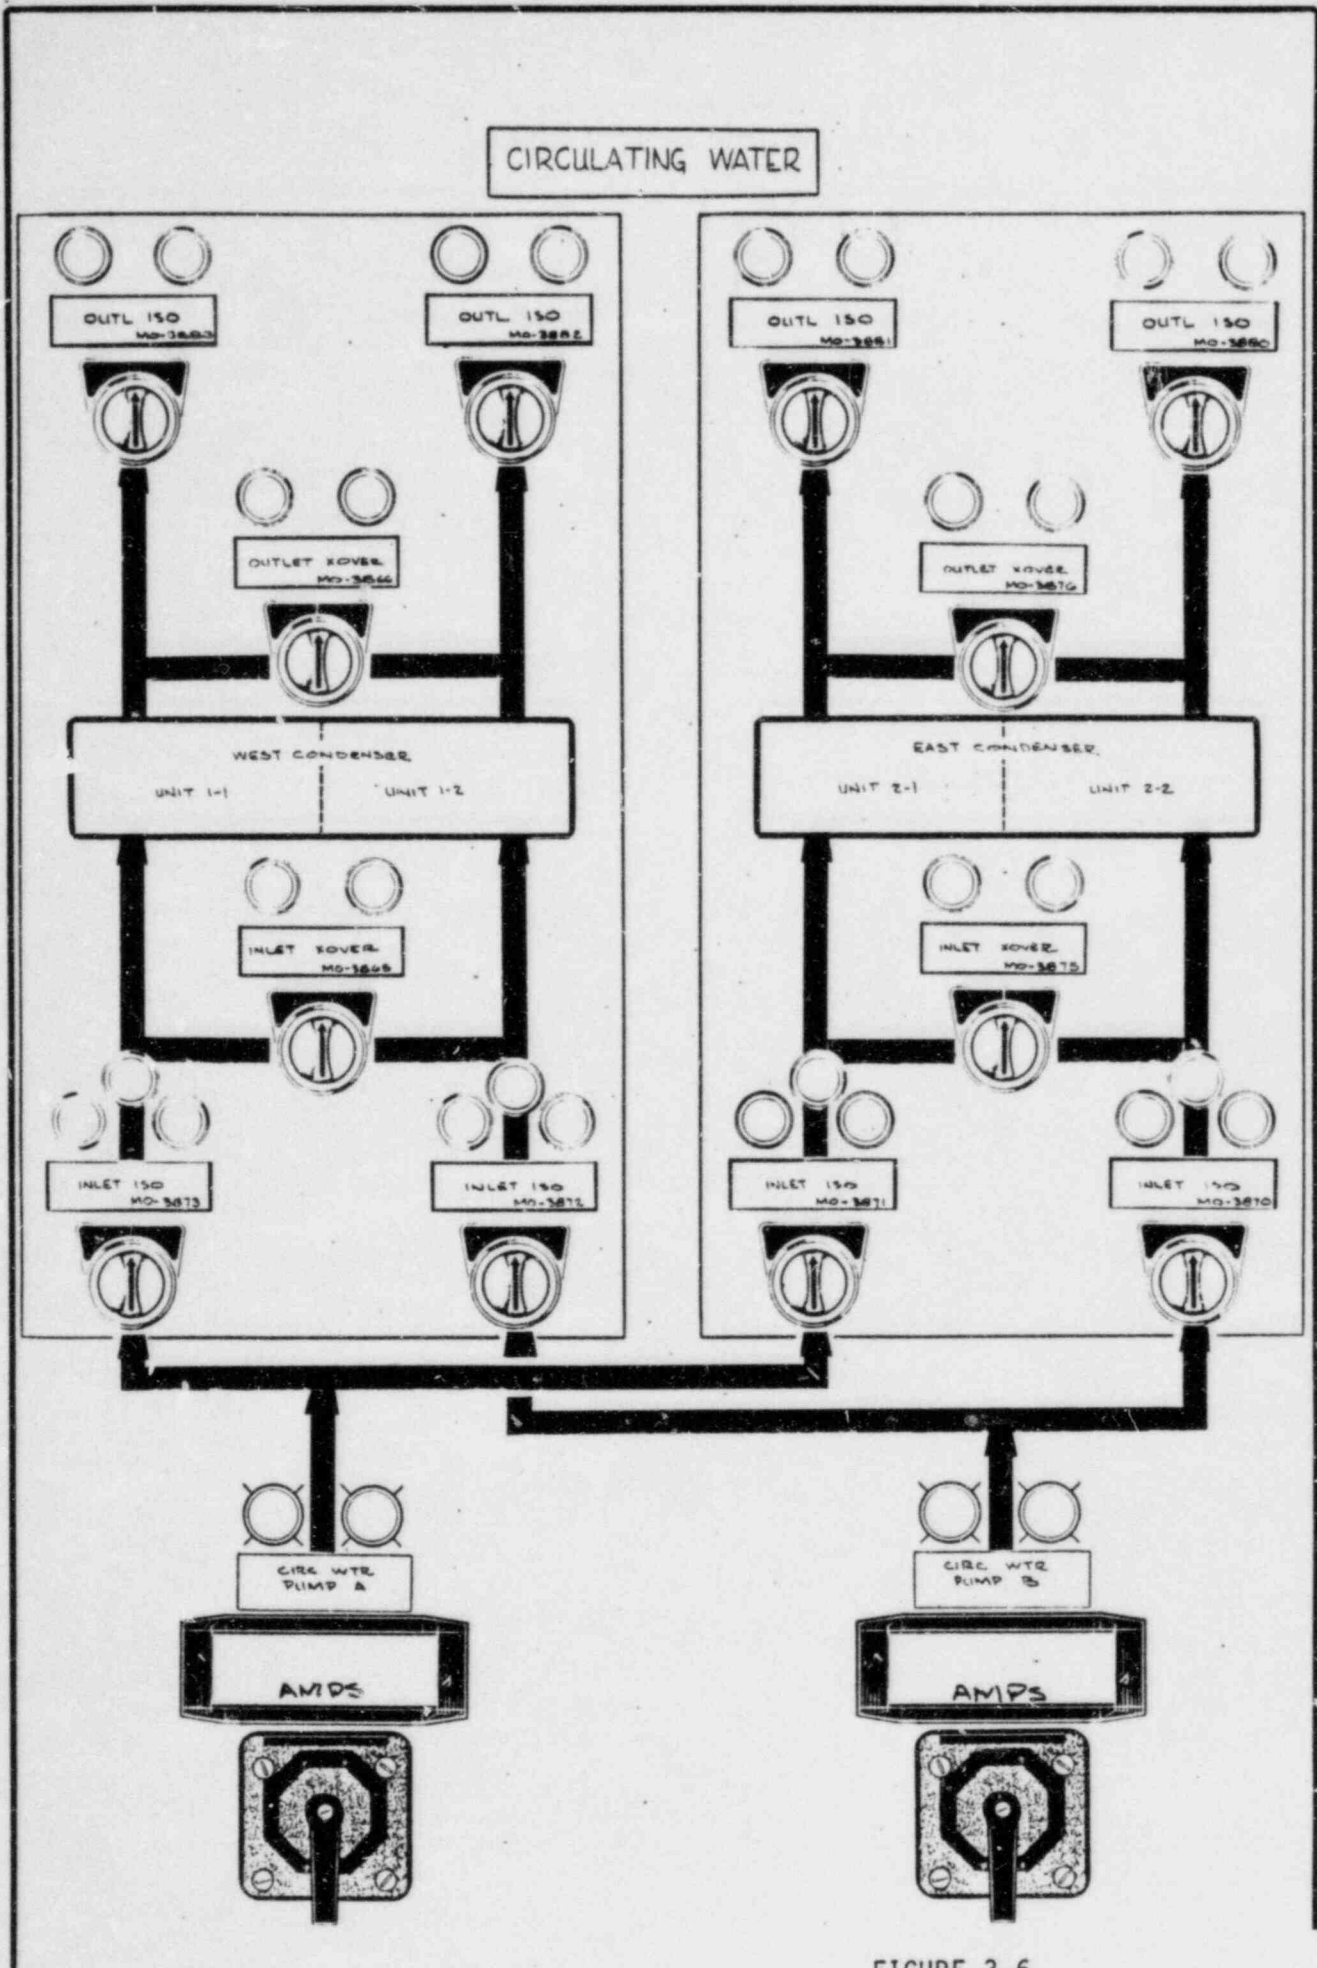
FIGURE 3-6.
PROPOSED CIRCULATING WATER SYSTEM ARRANGEMENT

Figure 3-6 is the proposed circulating water system arrangement. The value controls have been changed to a smaller switch so that the arrangement will meet minimum switch separation requirements and still occupy about the same area.

HED 4B126.5 requires that the reactor feed pump auto trip switch be relocated to the Feedwater and Condensate panel C1 in the close proximity to the reactor feed pump controls. See Figure 3-6 for the new proposed layout.

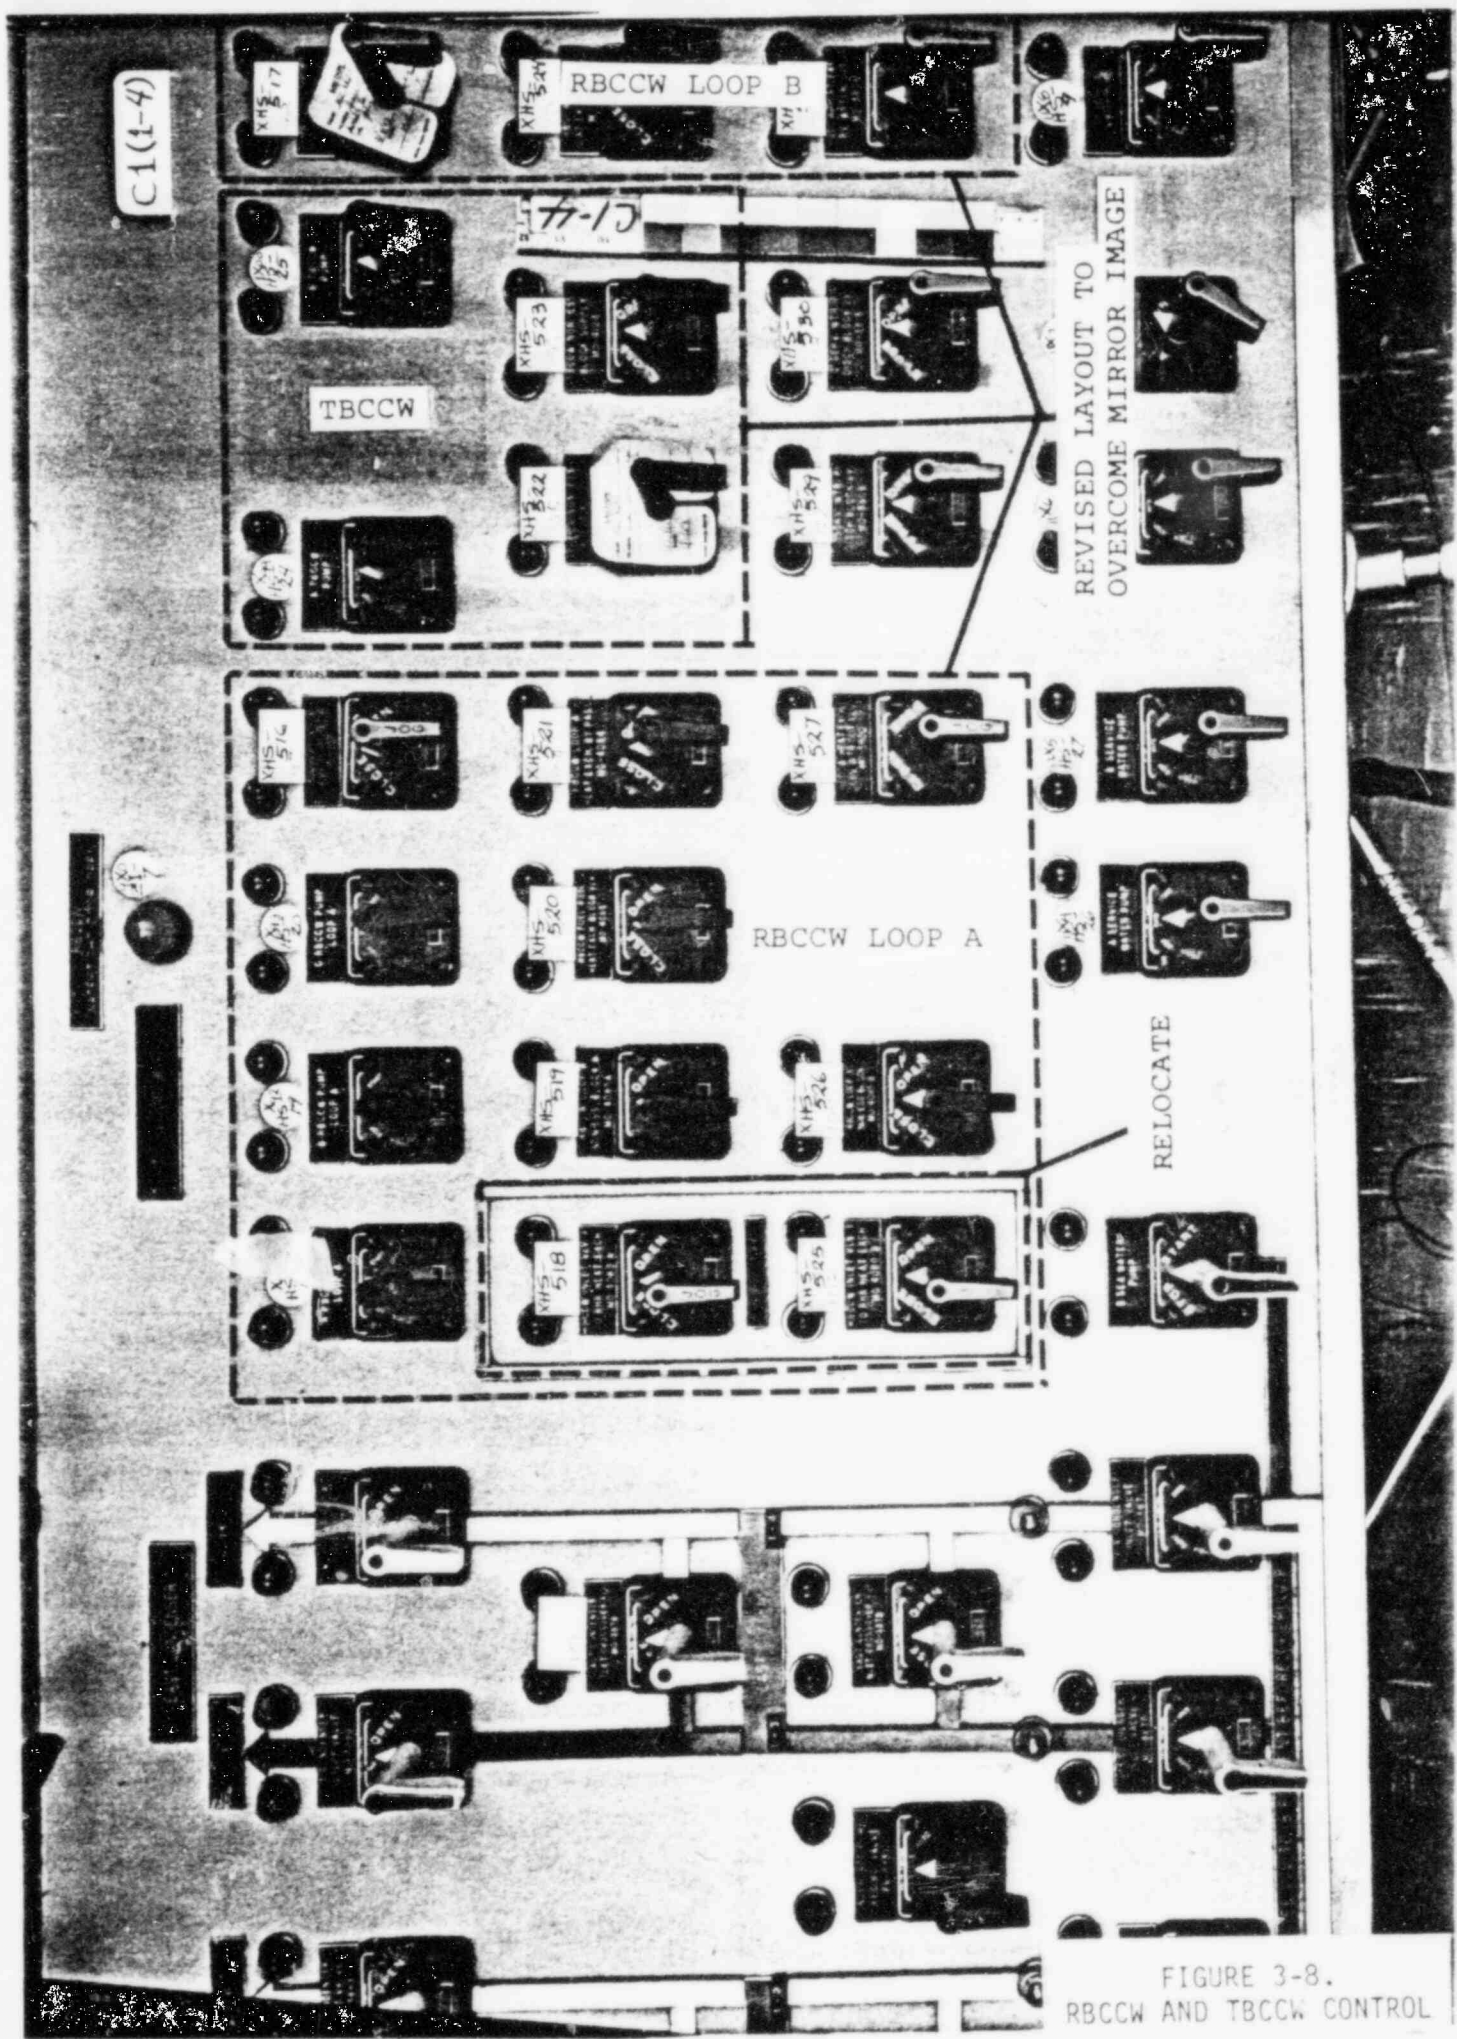
FIGURE 3-8.
RBCCW AND TBCCW CONTROL

The Reactor Building Cooling Water (RBCCW), Turbine Building Cooling Water (TBCCW), and Service Water (SW) systems are interrelated. Figures 3-8 and 3-9 show the present systems arrangement and give a brief description to the proposed solution to the mirror image problem described in HEDs 4B053.5 and 8B097.5.

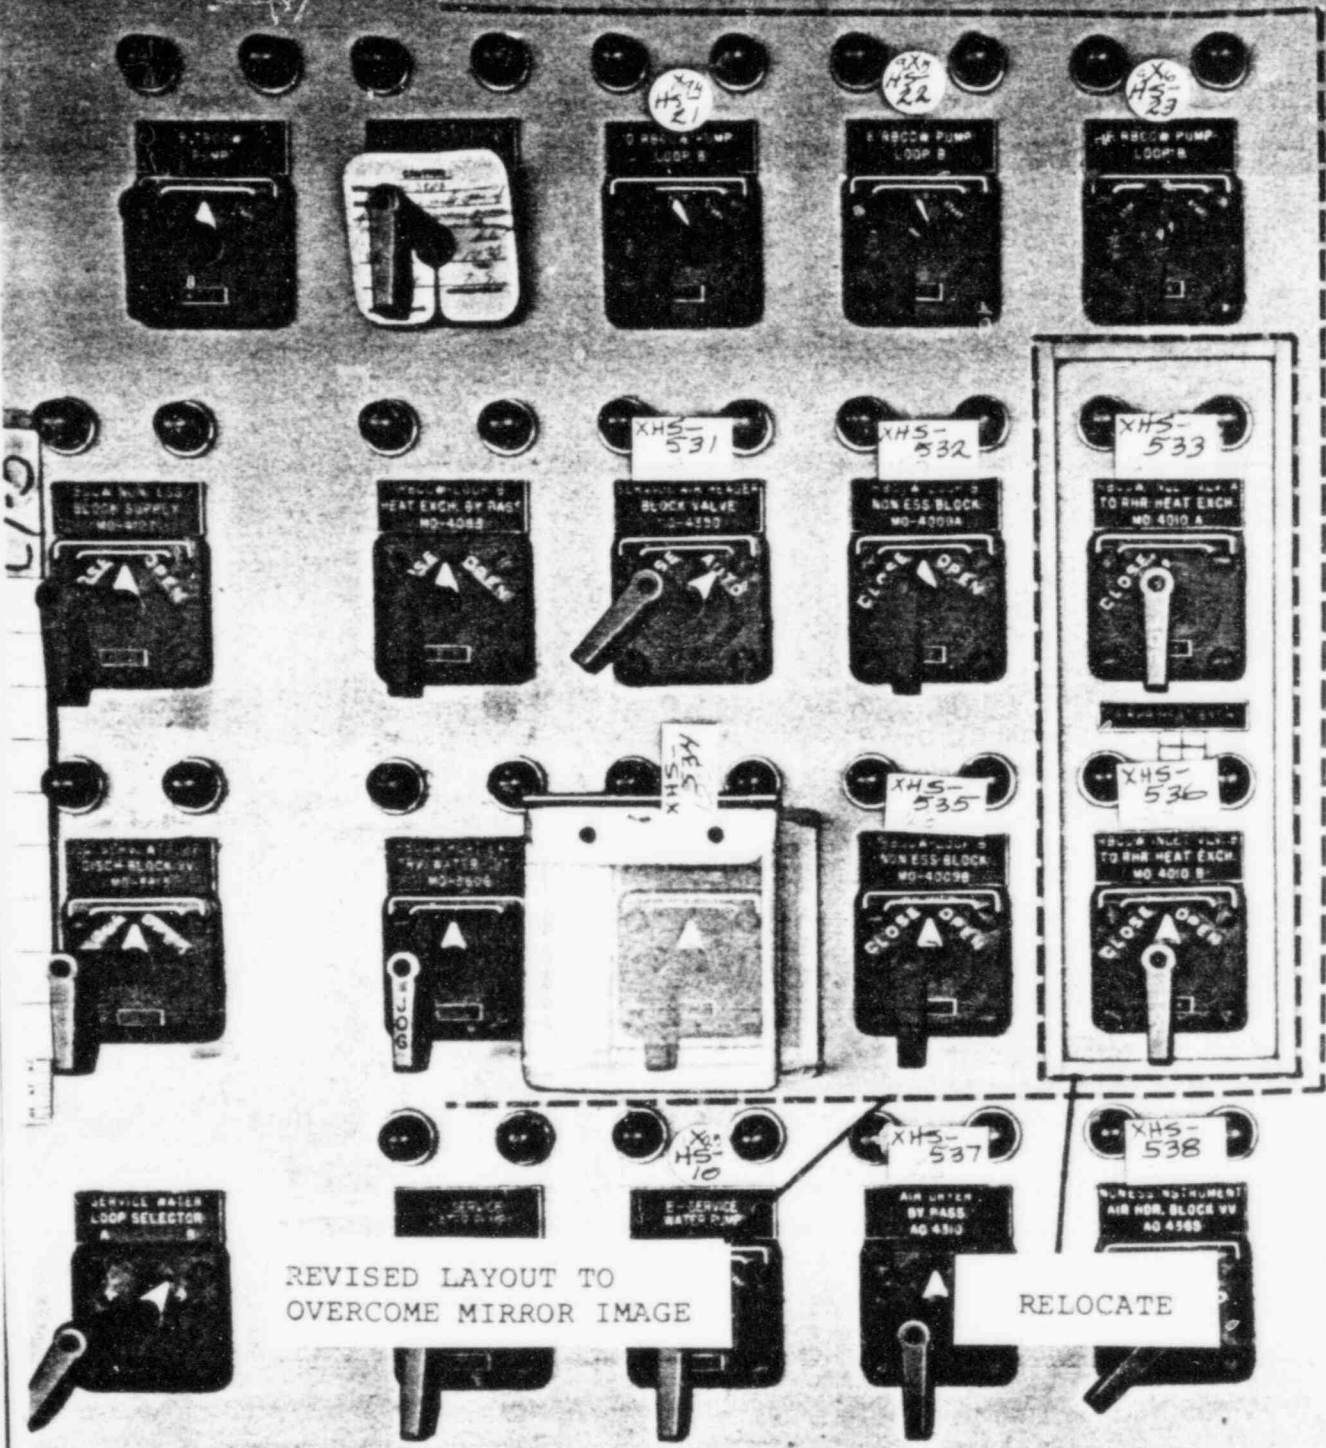
FIGURE 3-9.
RBCCW LOOP B CONTROL

REVISED LAYOUT TO
OVERCOME MIRROR IMAGE

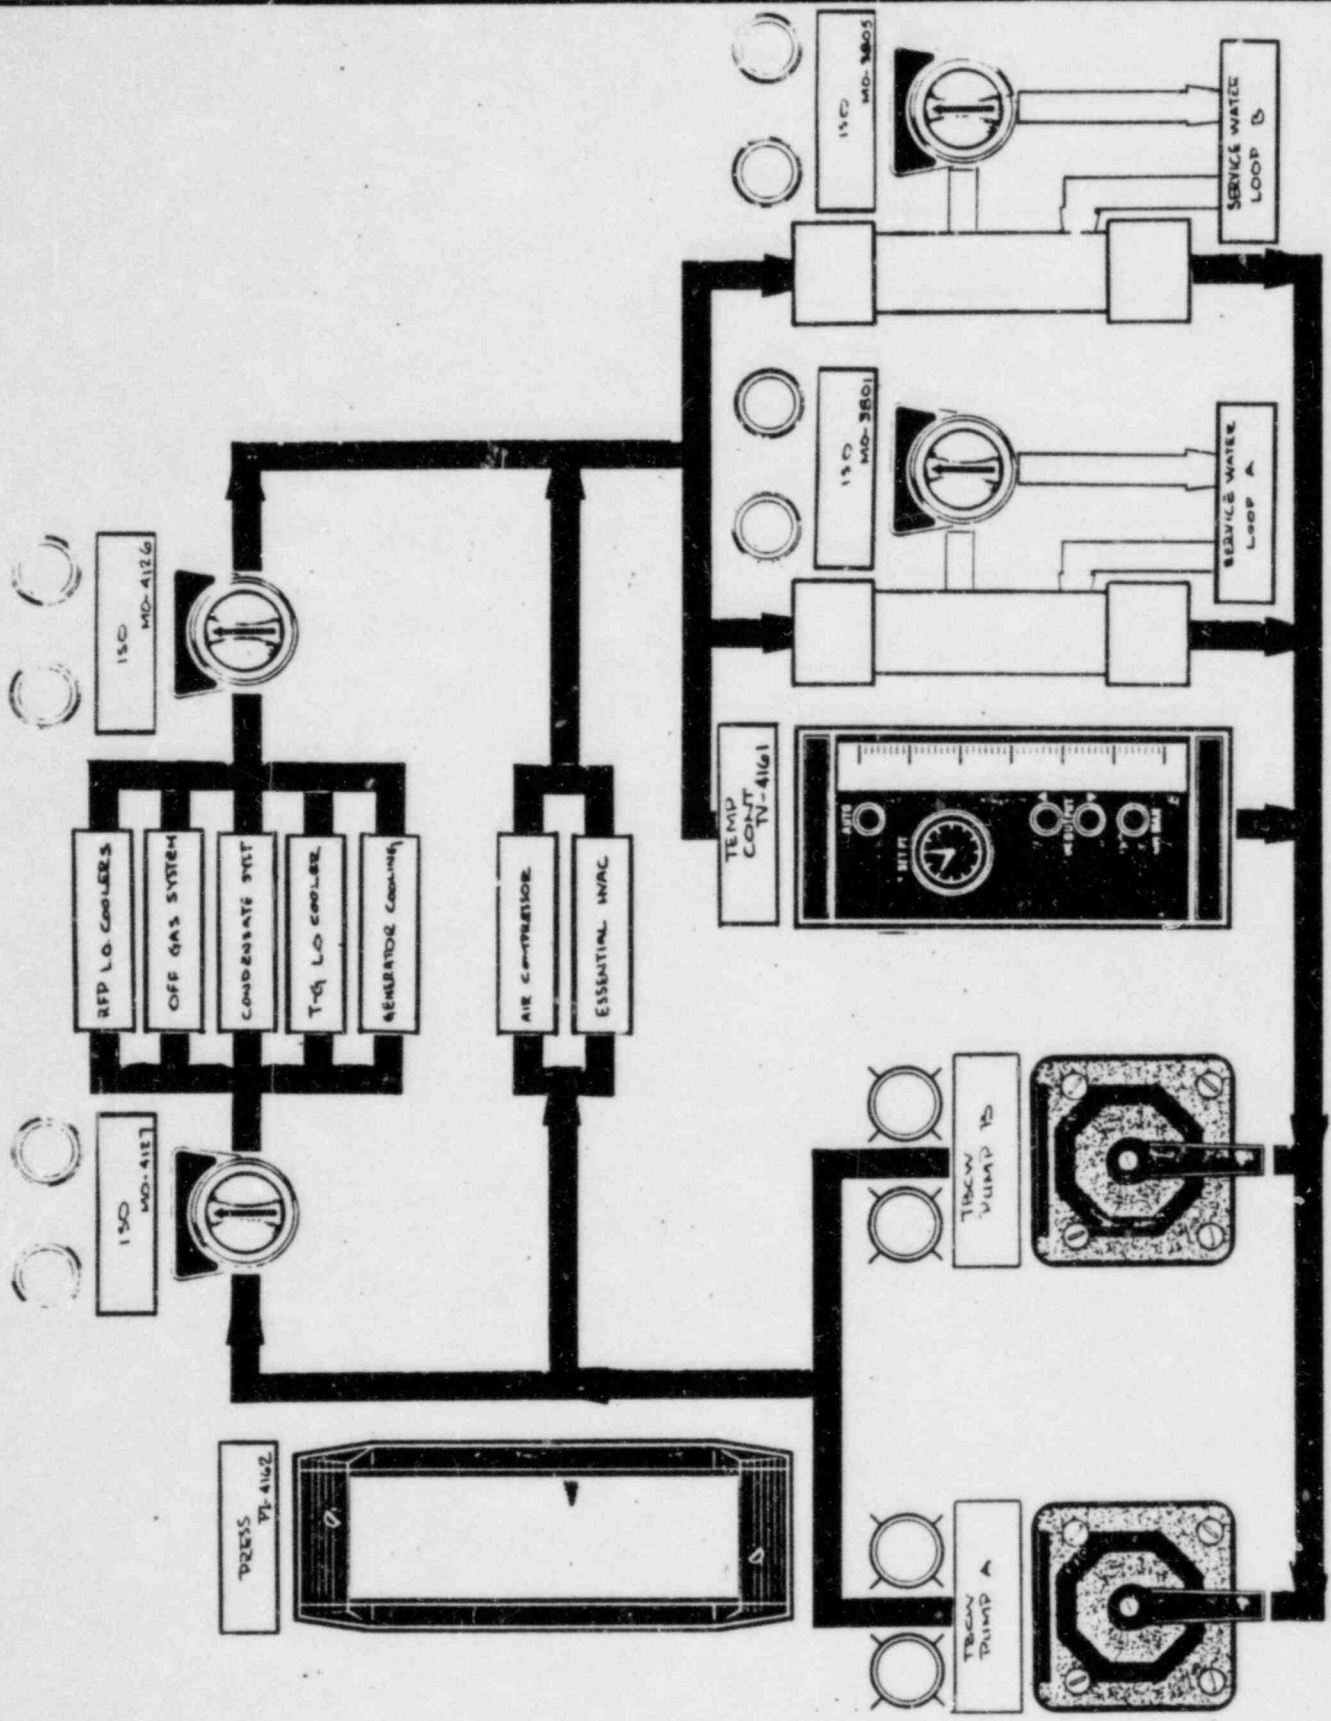
FIGURE 3-10.
PROPOSED TBCCW ARRANGEMENT

Figure 3-10 is the proposed TBCCW arrangement. It features a graphic presentation to show the interrelationship with the service water system and the

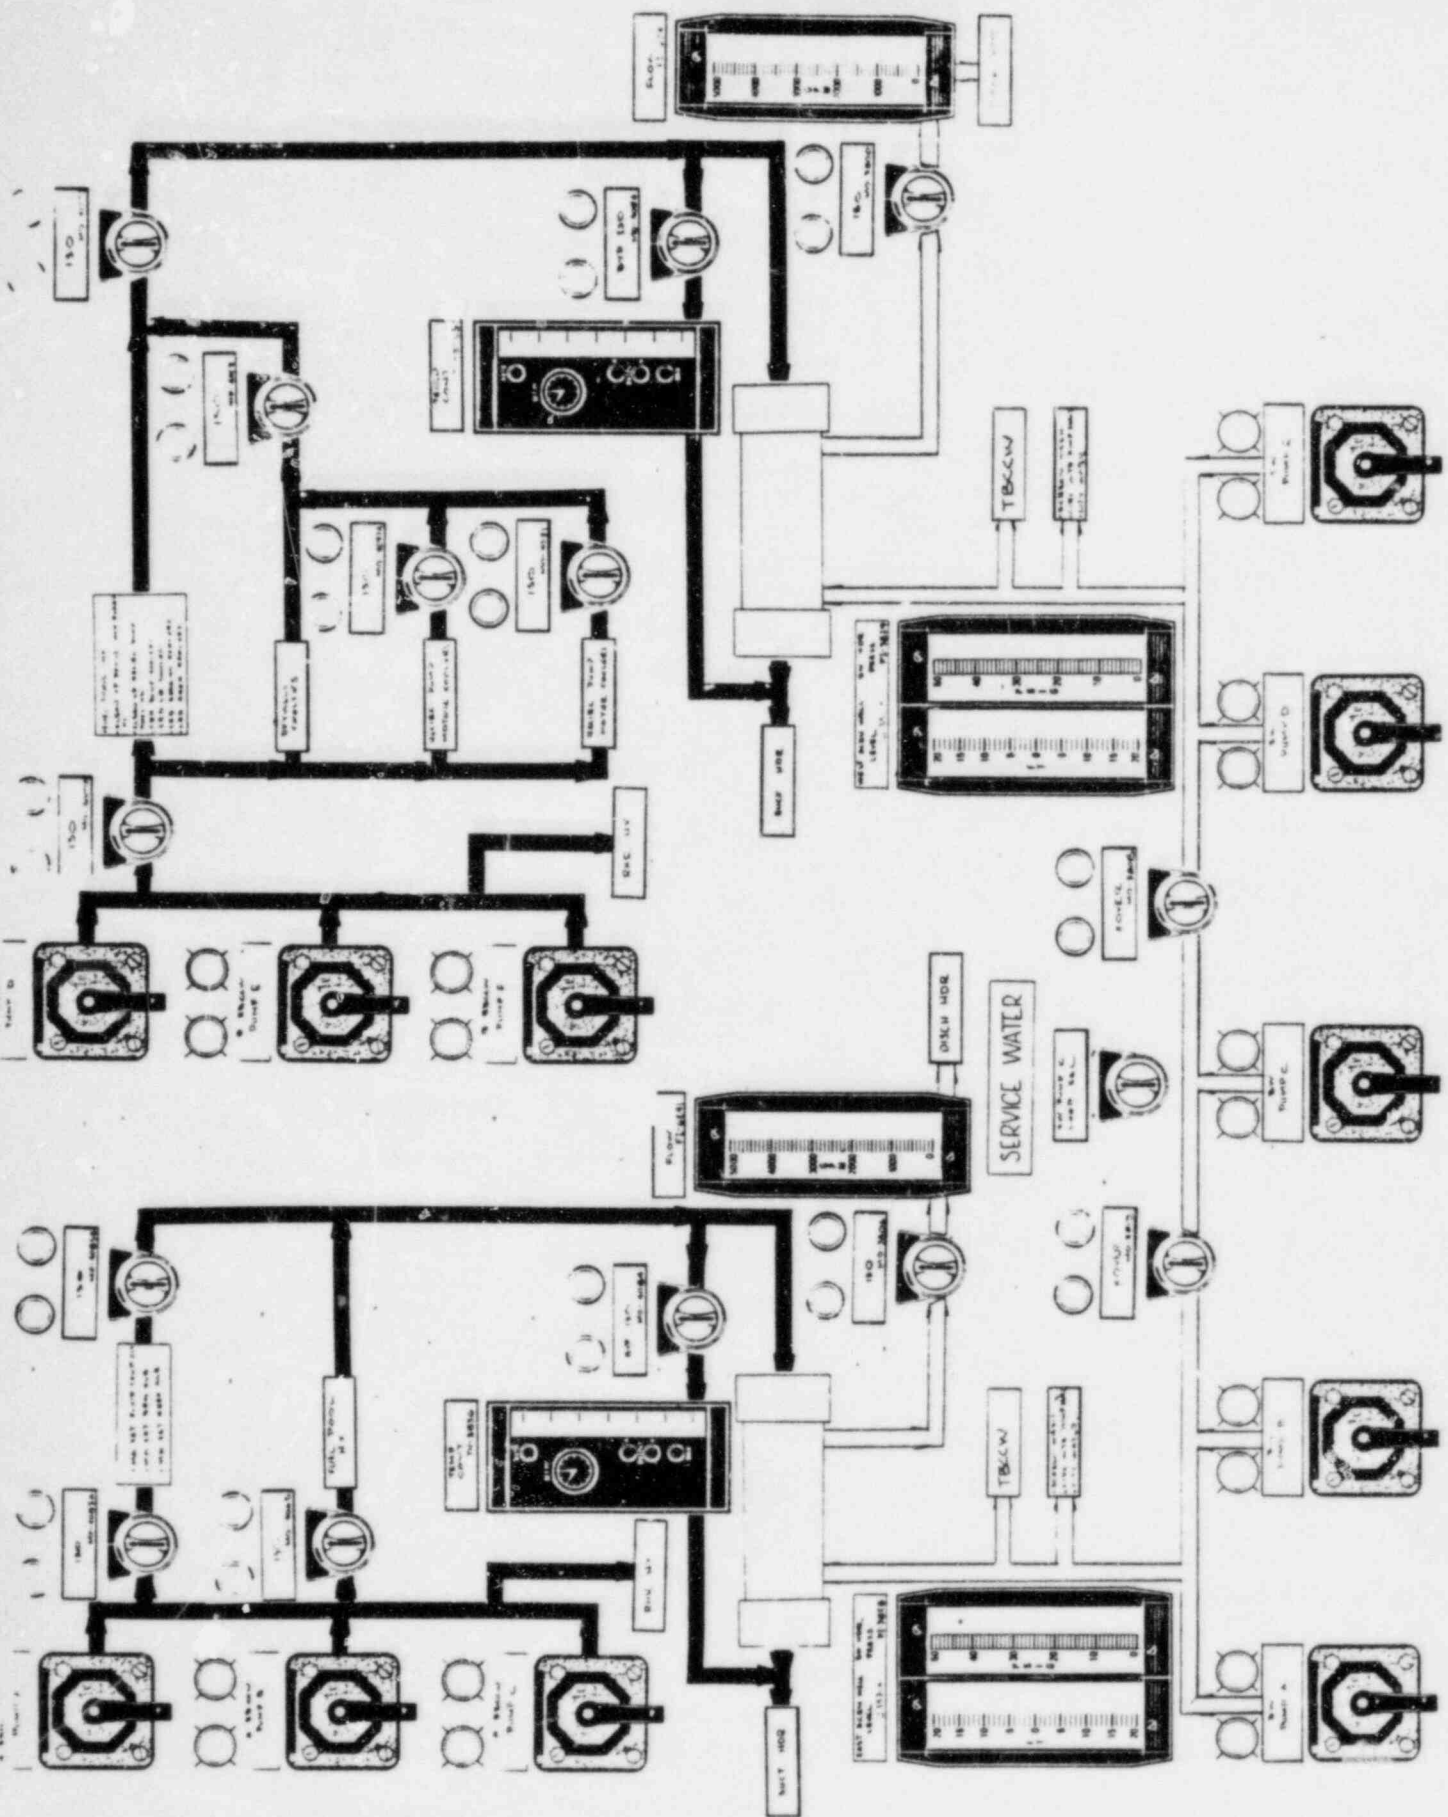
FIGURE 3-11.
PROPOSED RBCCW AND SERVICE
WATER ARRANGEMENT

Figure 3-11 is the proposed arrangement for the RBCCW and Service Water Systems. It features a graphic representation to show the interrelationships that the service water system has with RBCCW Loops A and Loop B. It also shows the tie-in with the TBCCW, Screen Wash System, Circulating Water Pumps, and city water. It is intuitive from the arrangement that alternate lineups can be made and what they are.

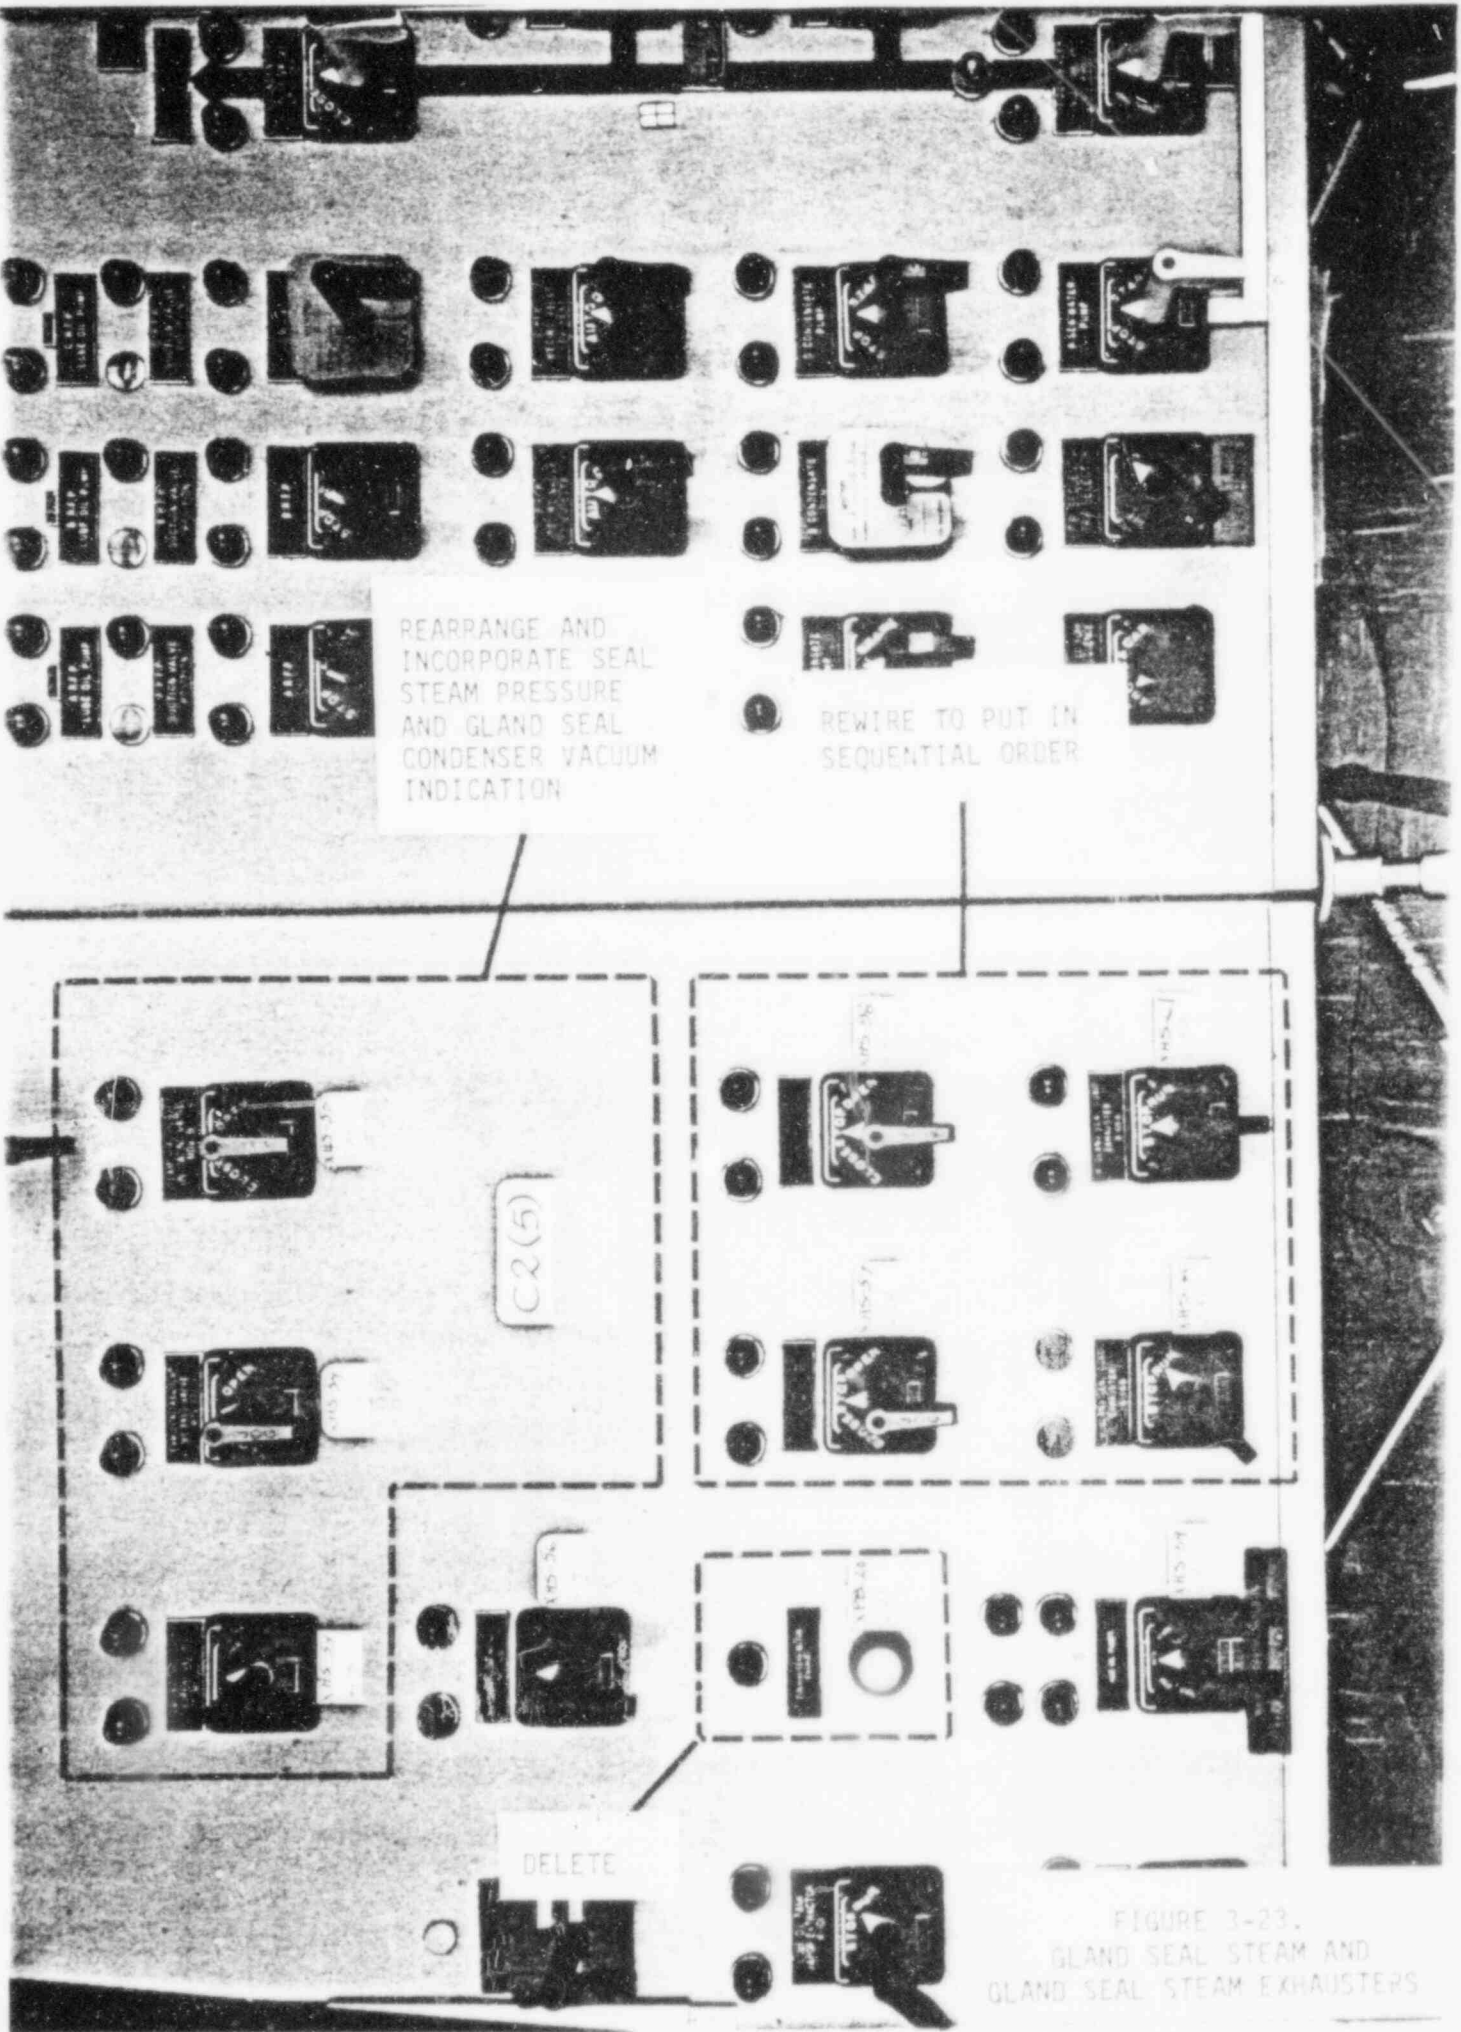
FIGURE 3-23.
GLAND SEAL STEAM AND
GLAND SEAL STEAM EXHAUSTERS

Figure 3-23 shows the gland seal condenser exhausters associated with HED 8B103.5 as they are presently arranged. HED 8B103.5 requires that they be rearranged to be pumps A and B on top, and pumps C and D on the bottom.

Figure 3-23 shows the gland seal system components as they are at present. HED 9B109.5 requires that the gland steam seal header pressure meter and gland seal condenser pressure, from Figure 3-17, be integrated with the gland seal system components shown in Figure 3-23 causing a system rearrangement.

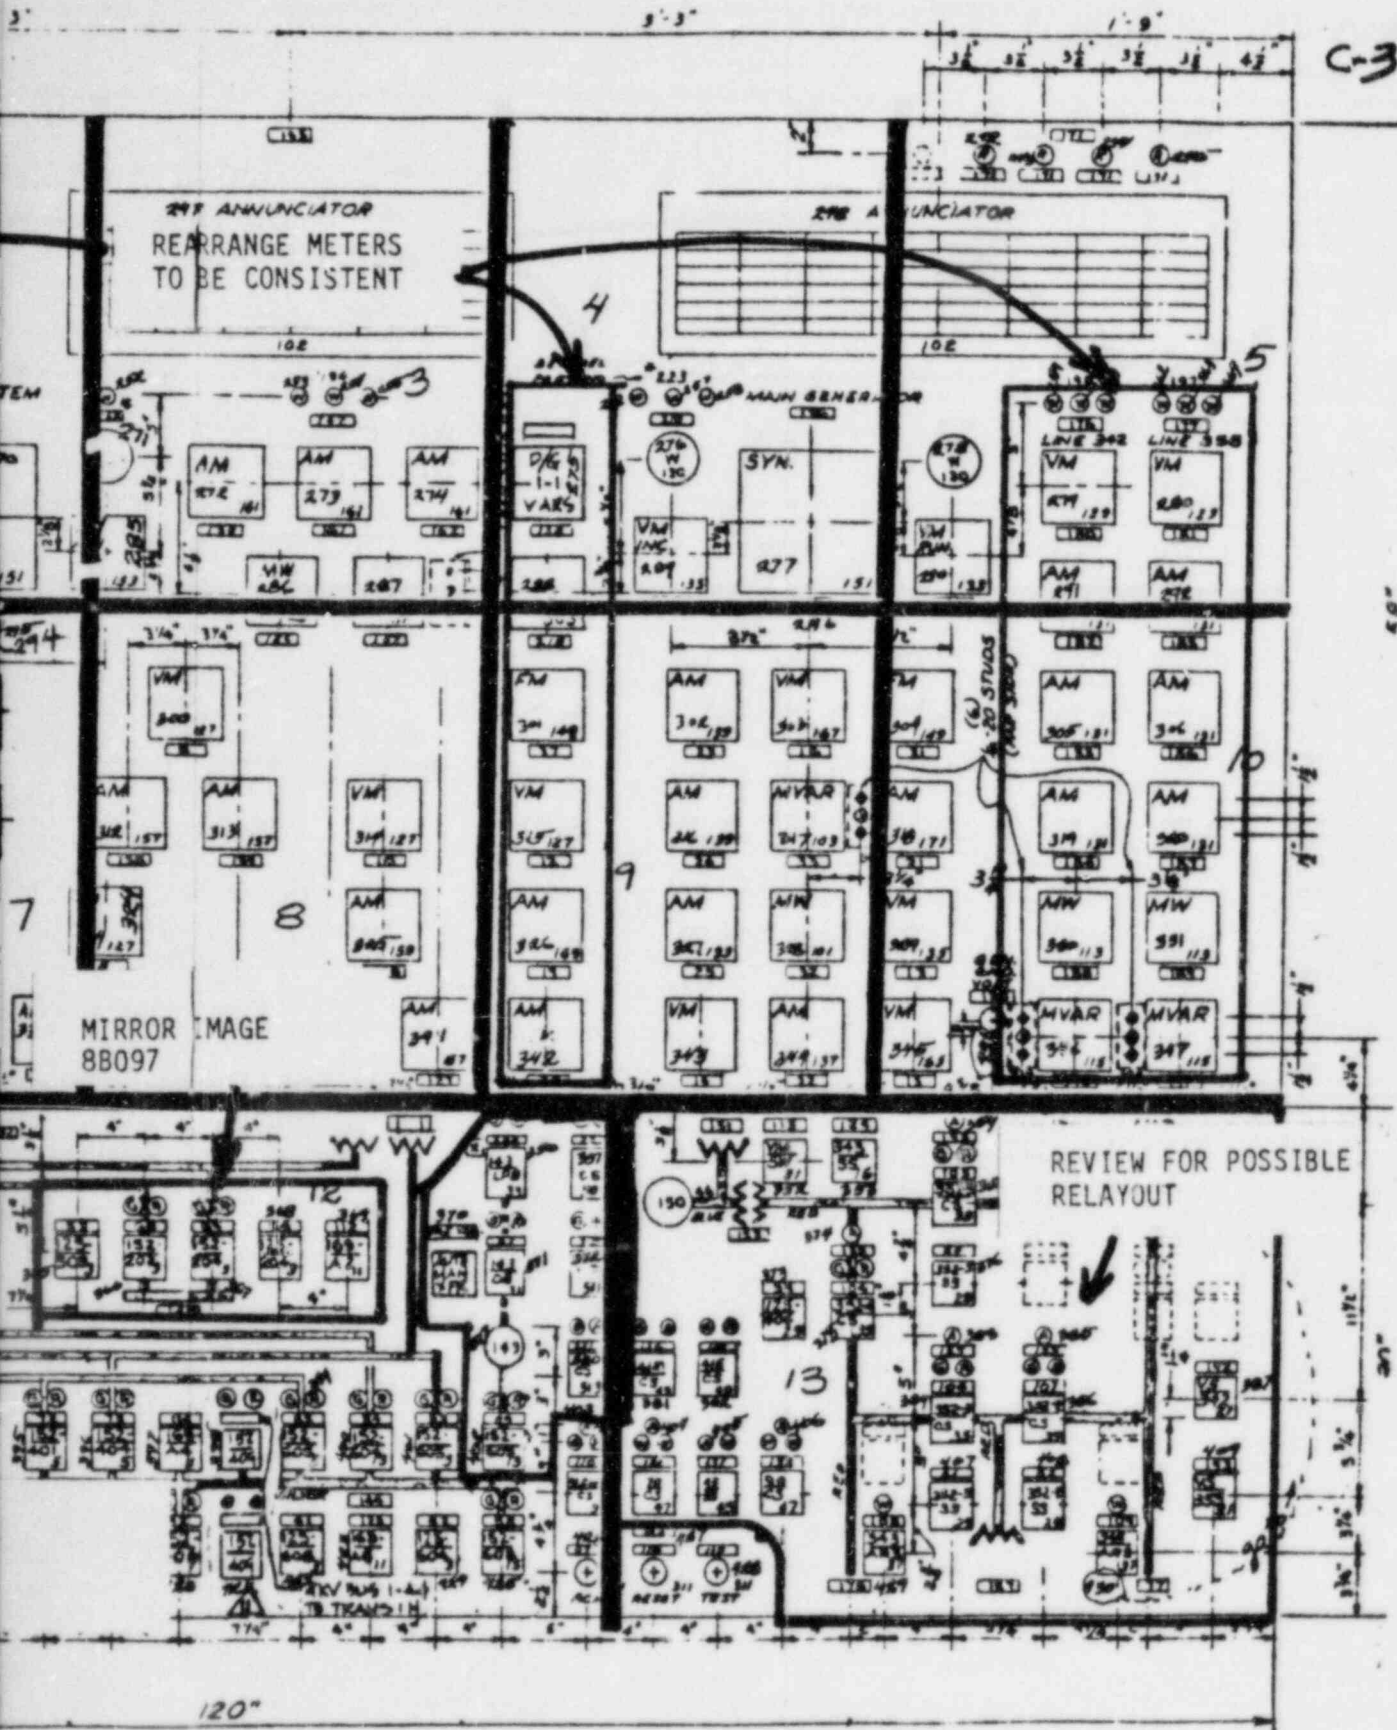
FIGURE 3-24.
ELECTRICAL DISTRIBUTION
FRONT PANEL LAYOUT

The HEDs listed above have been outlined and briefly described on the Front Panel Layout, Figure 3-24.

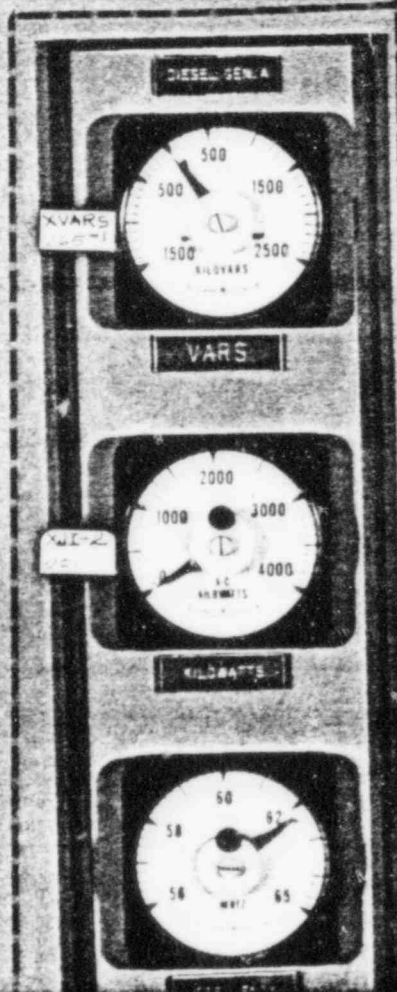
FIGURE 3-25. DIESEL GENERATOR "A" METERING

REARRANGE TO PUT METERS IN ORDER BY IMPORTANCE AND CONSISTENT WITH THE OTHER DIESEL GENERATOR AND INCOMING LINE METERING

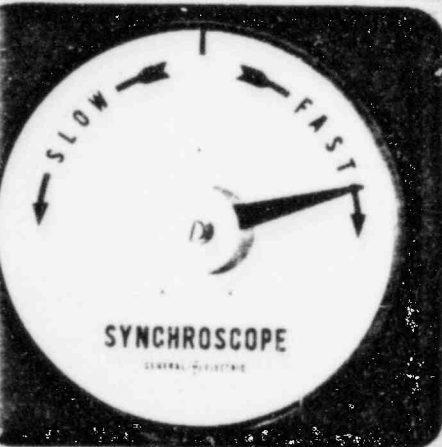
FIGURE 3-27. INCOMING LINE METERING

REARRANGE TO PUT METERS IN ORDER BY IMPORTANCE AND CONSISTENT WITH THE DIESEL GENERATOR METERING
