Doc. No. BECO/ESR-1
SEPTEMBER 1984
REV. 1

Detailed Control Room Design Review

Executive Summary Report

Pilgrim Station

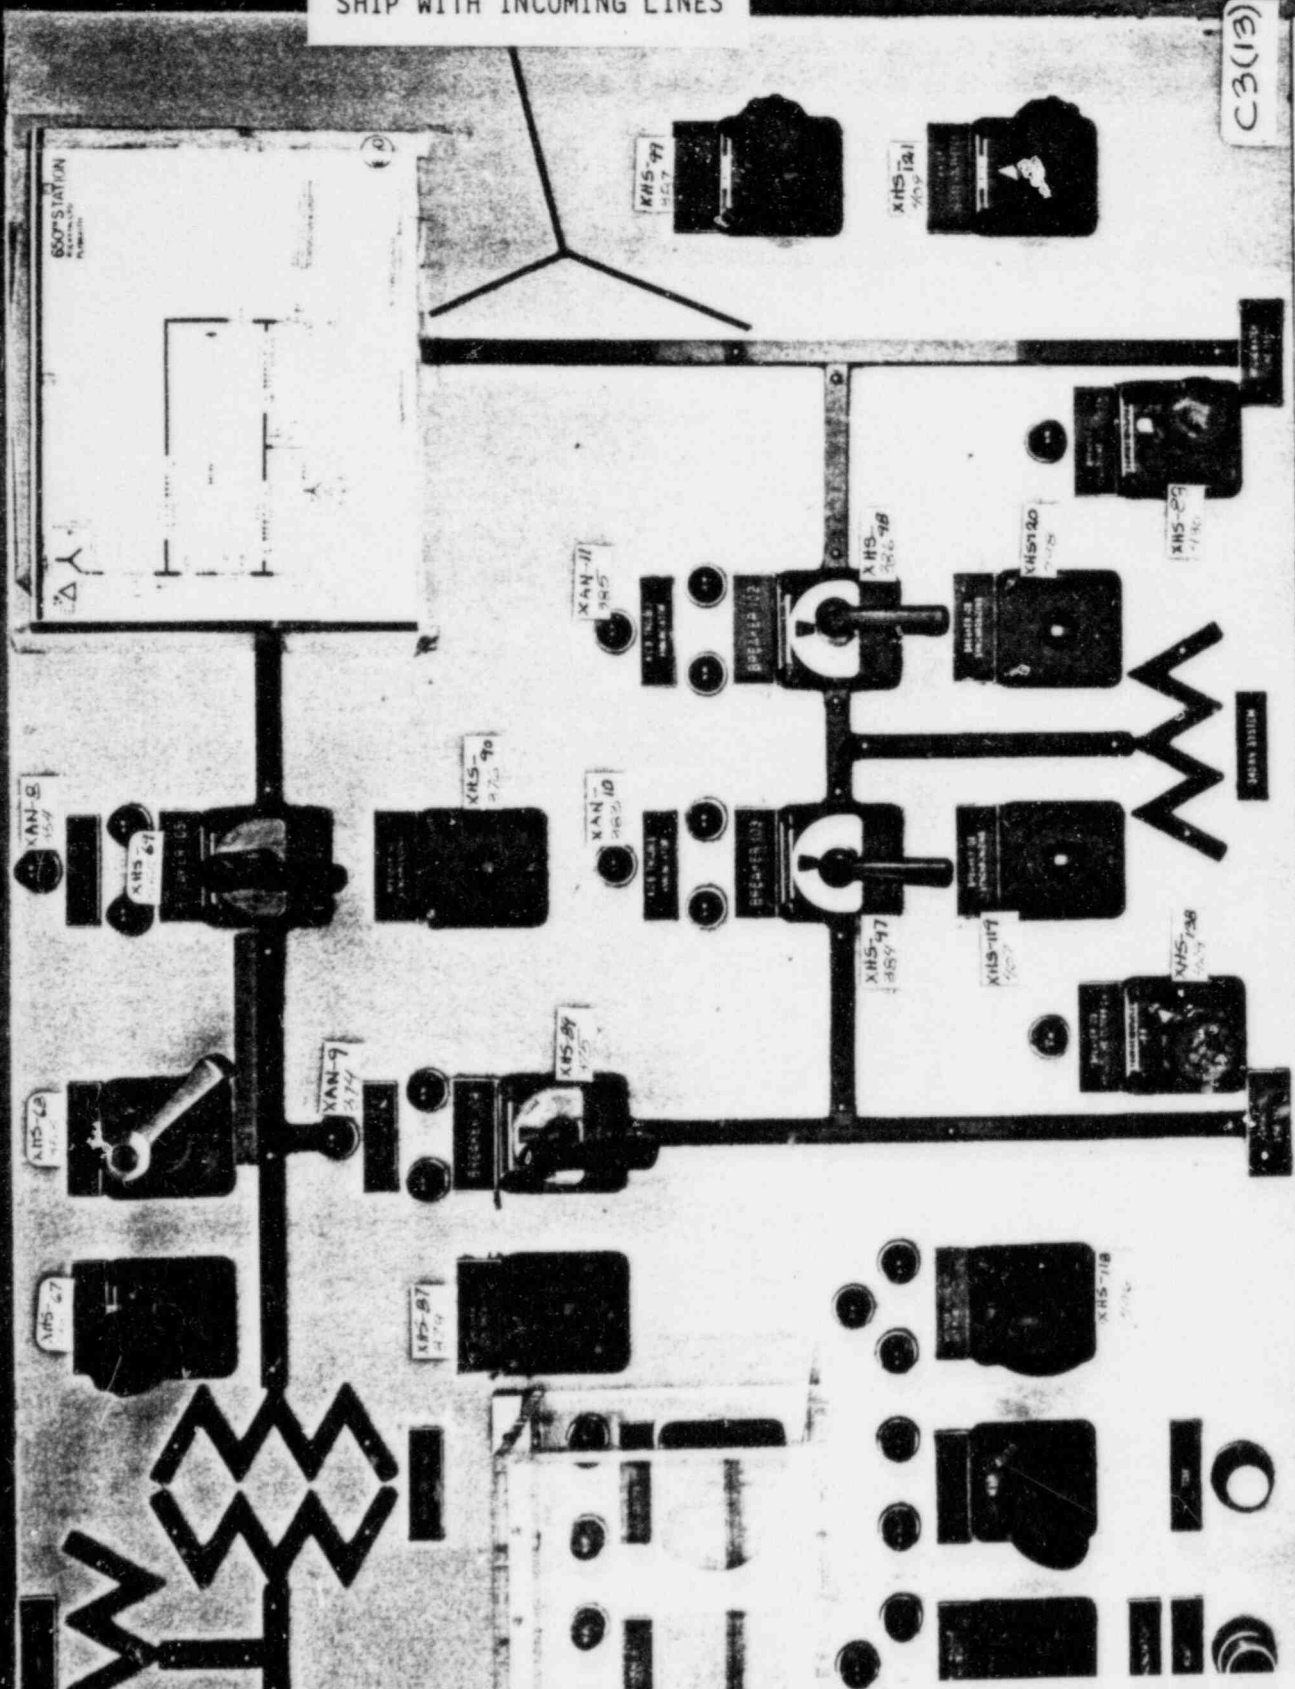
FIGURE 3-33.
GENERATOR OUTPUT BREAKERS

Figure 3-33 shows the generator output breakers and generator controls. These are being considered for rearrangement to clarify the interrelationship between the generator controls and incoming lines.

REVIEW FOR POSSIBLE
REARRANGEMENTS TO
CLARIFY INTERRELATION-
SHIP WITH INCOMING LINES

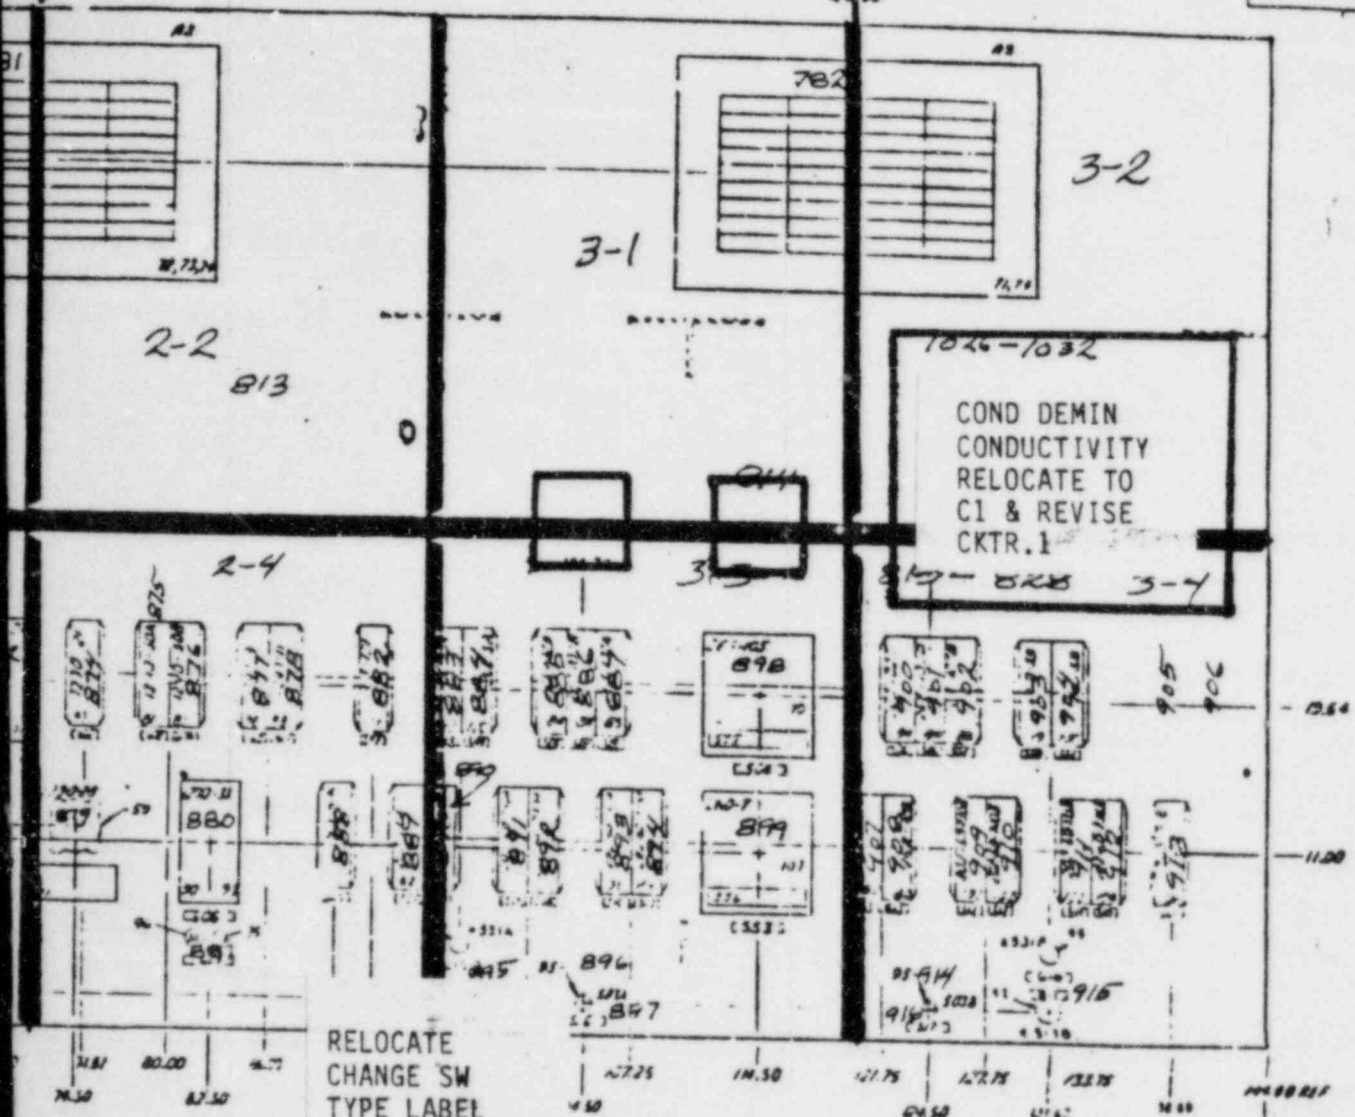
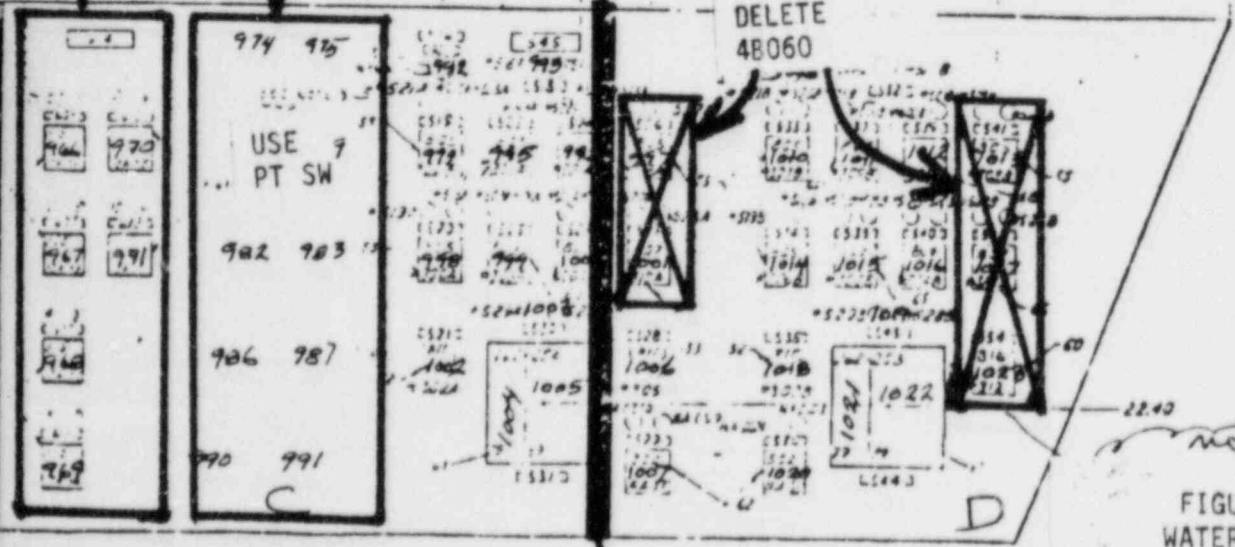
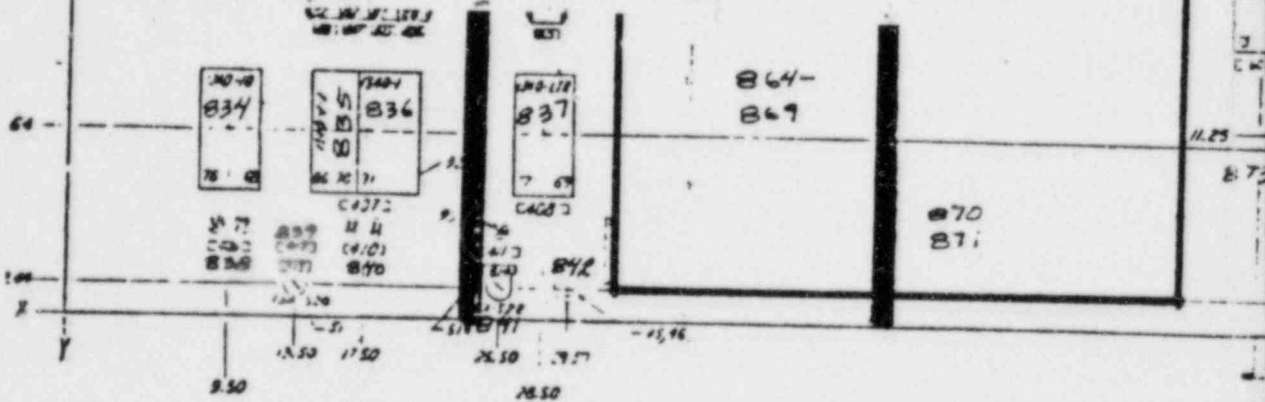
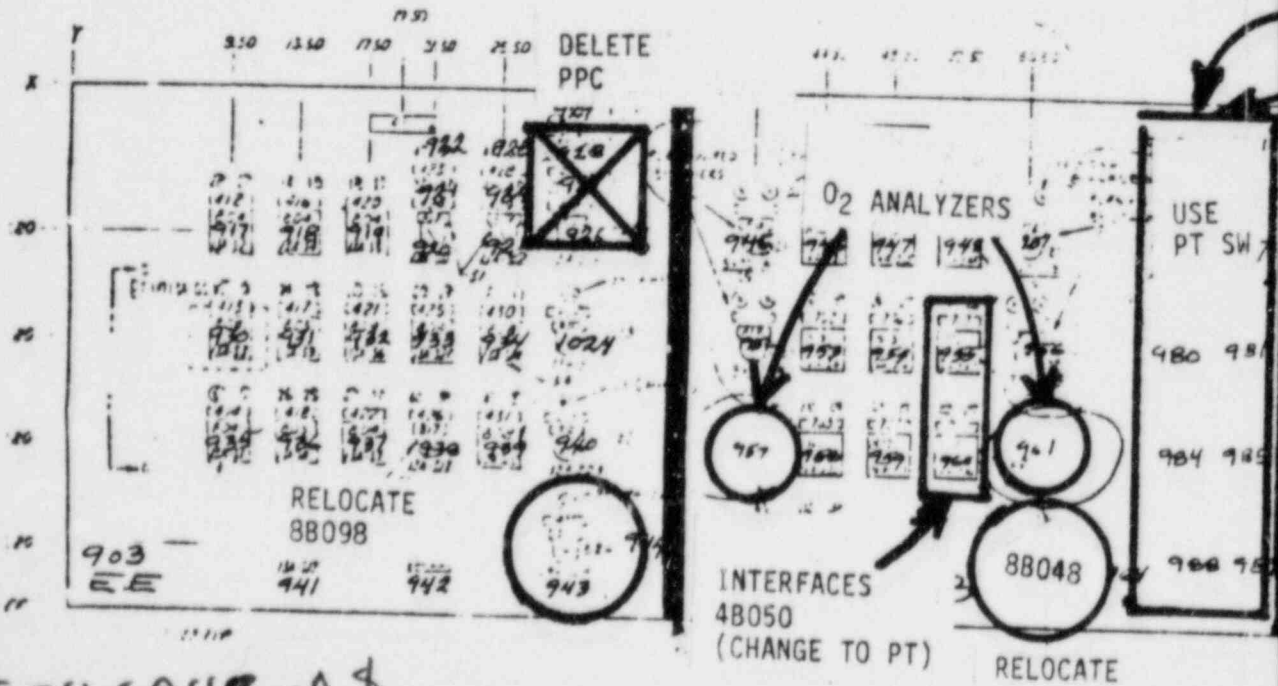
FIGURE 3-46.
 WATER CLEANUP
 FRONT PANEL LAYOUT

The equipment associated with the HEDs has been highlighted and briefly described in Figure 3-46.

RELOCATE
 CHANGE SW
 TYPE LABEL
 UNKNOWN
 8B098

PROPOSE DRAWING ALL OF THIS, REARRANGE LIGHTS SPACE & DEMARCATION 2-3

REARRANGE LIGHTS

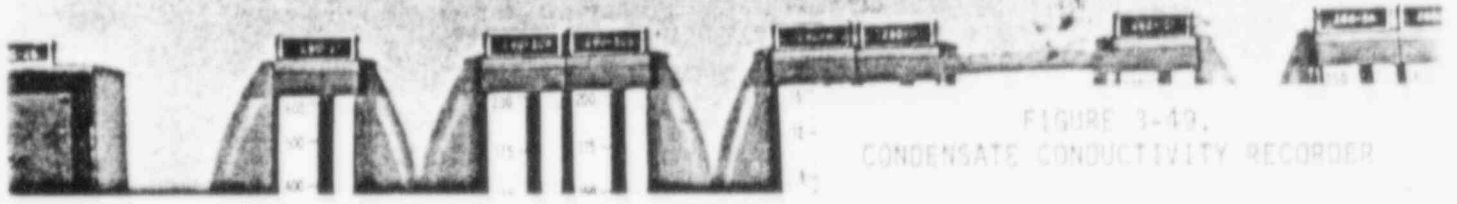
FIGURE 3-49.
CONDENSATE CONDUCTIVITY RECORDER

Figures 3-49, 50, 51, and 55 show the recorders associated with HEDs 5A004.5 and 5C019.5 as they are at present. Included in the figures is a brief description of the proposed solutions.

REPLACE RECORDER
AND RELOCATE TO
PANEL C-1, FEEDWATER
AND CONDENSATE

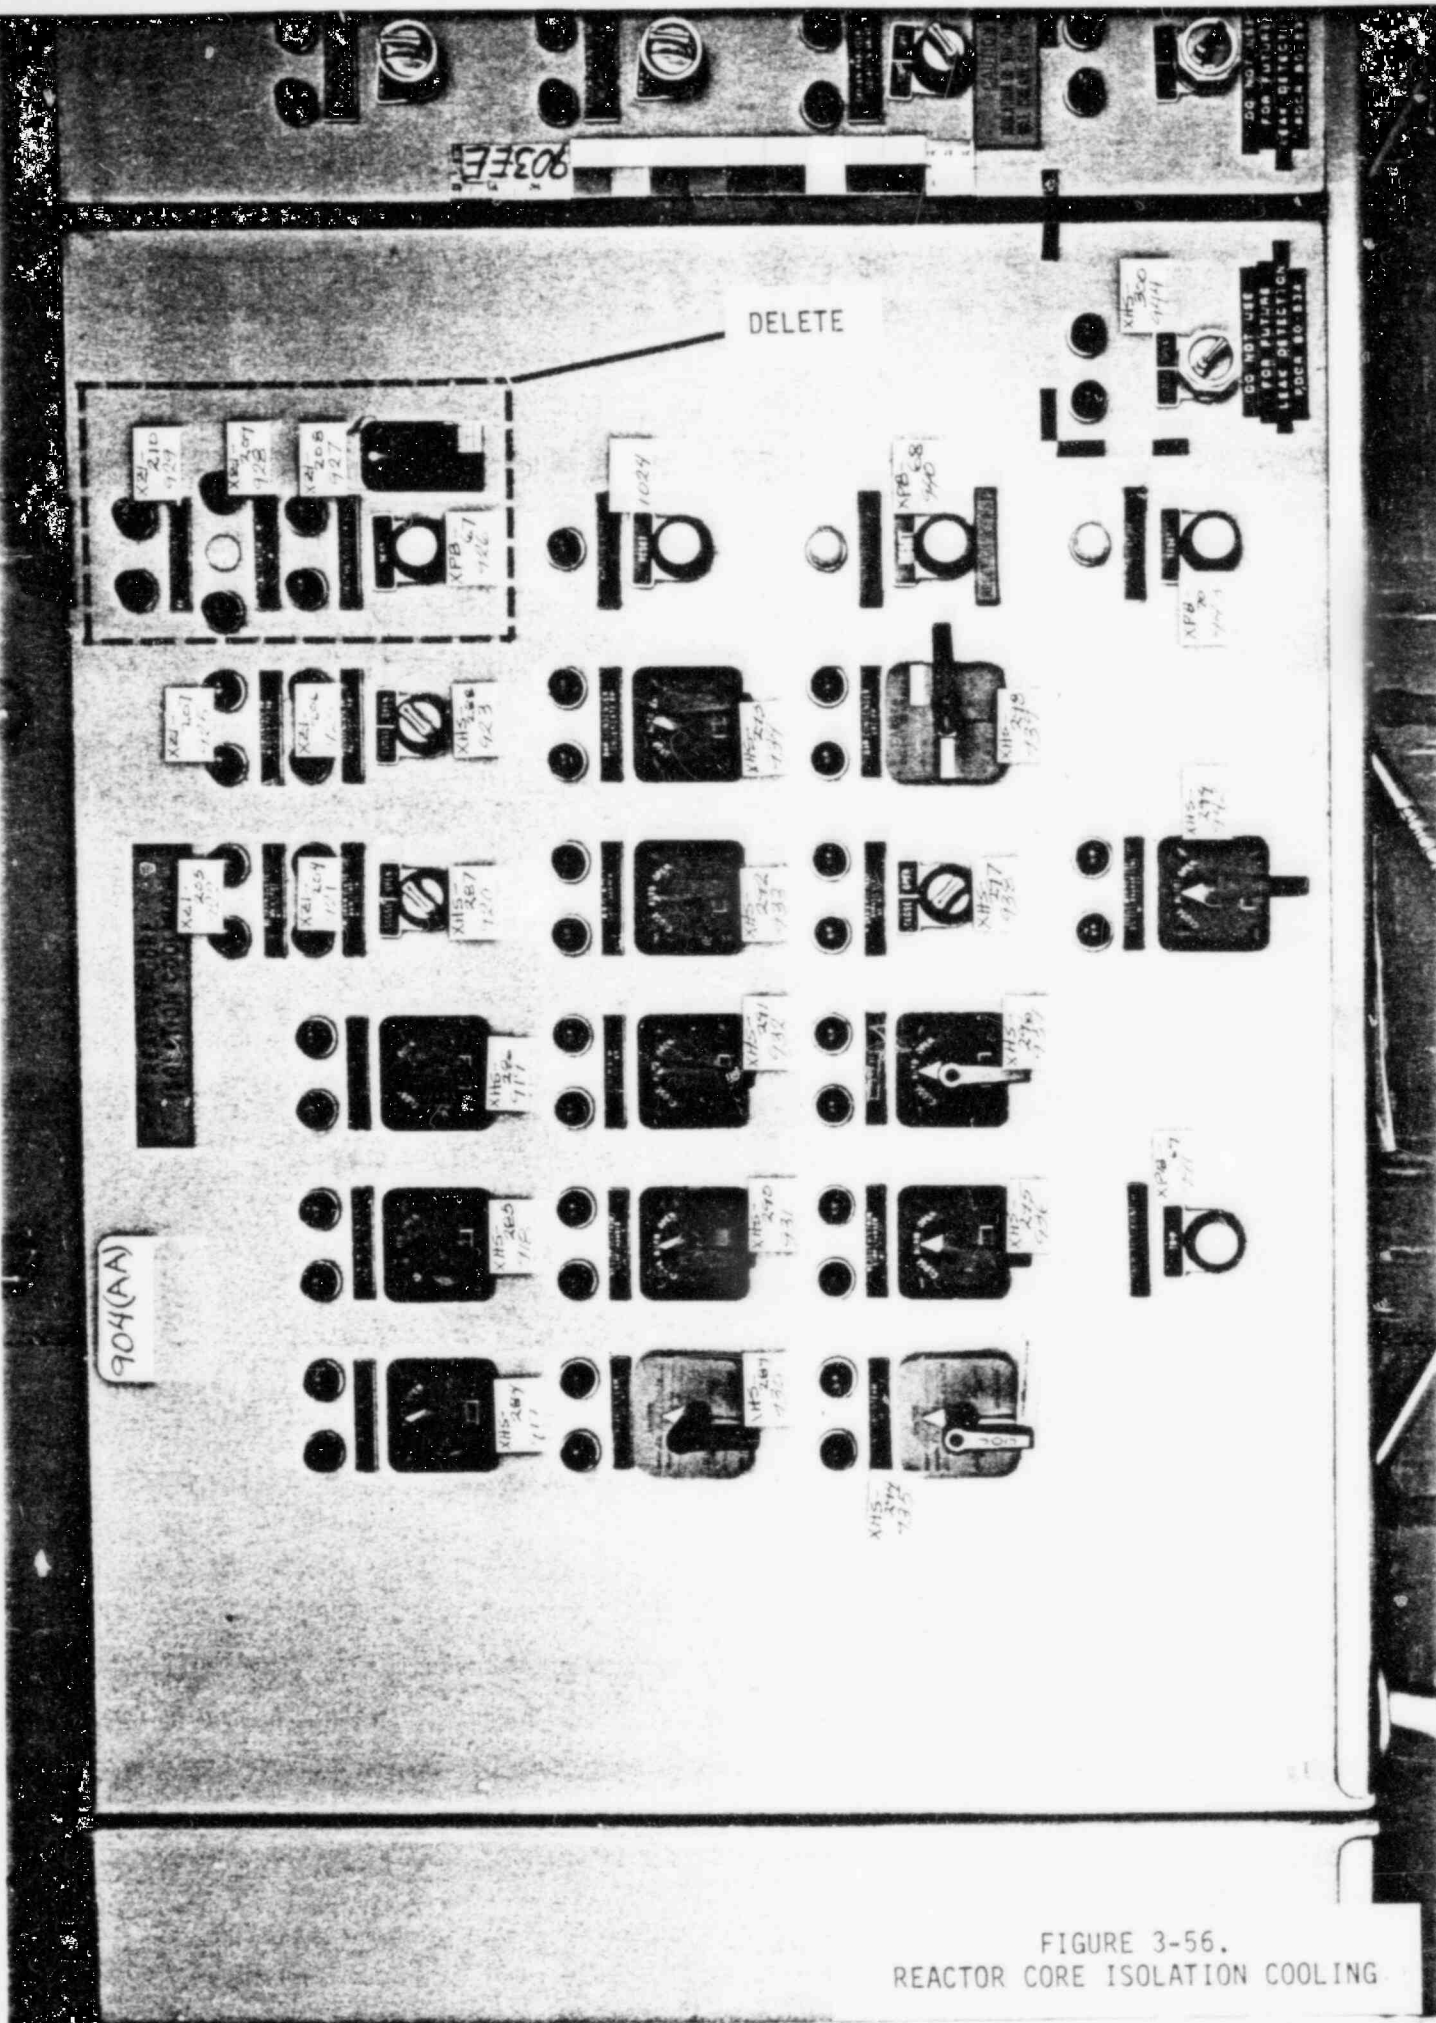
FIGURE 3-56.
REACTOR CORE ISOLATION COOLING.

Figure 3-56 shows the RCIC system arrangement. The testable check valve controls have been deleted by HED 4B060.5.

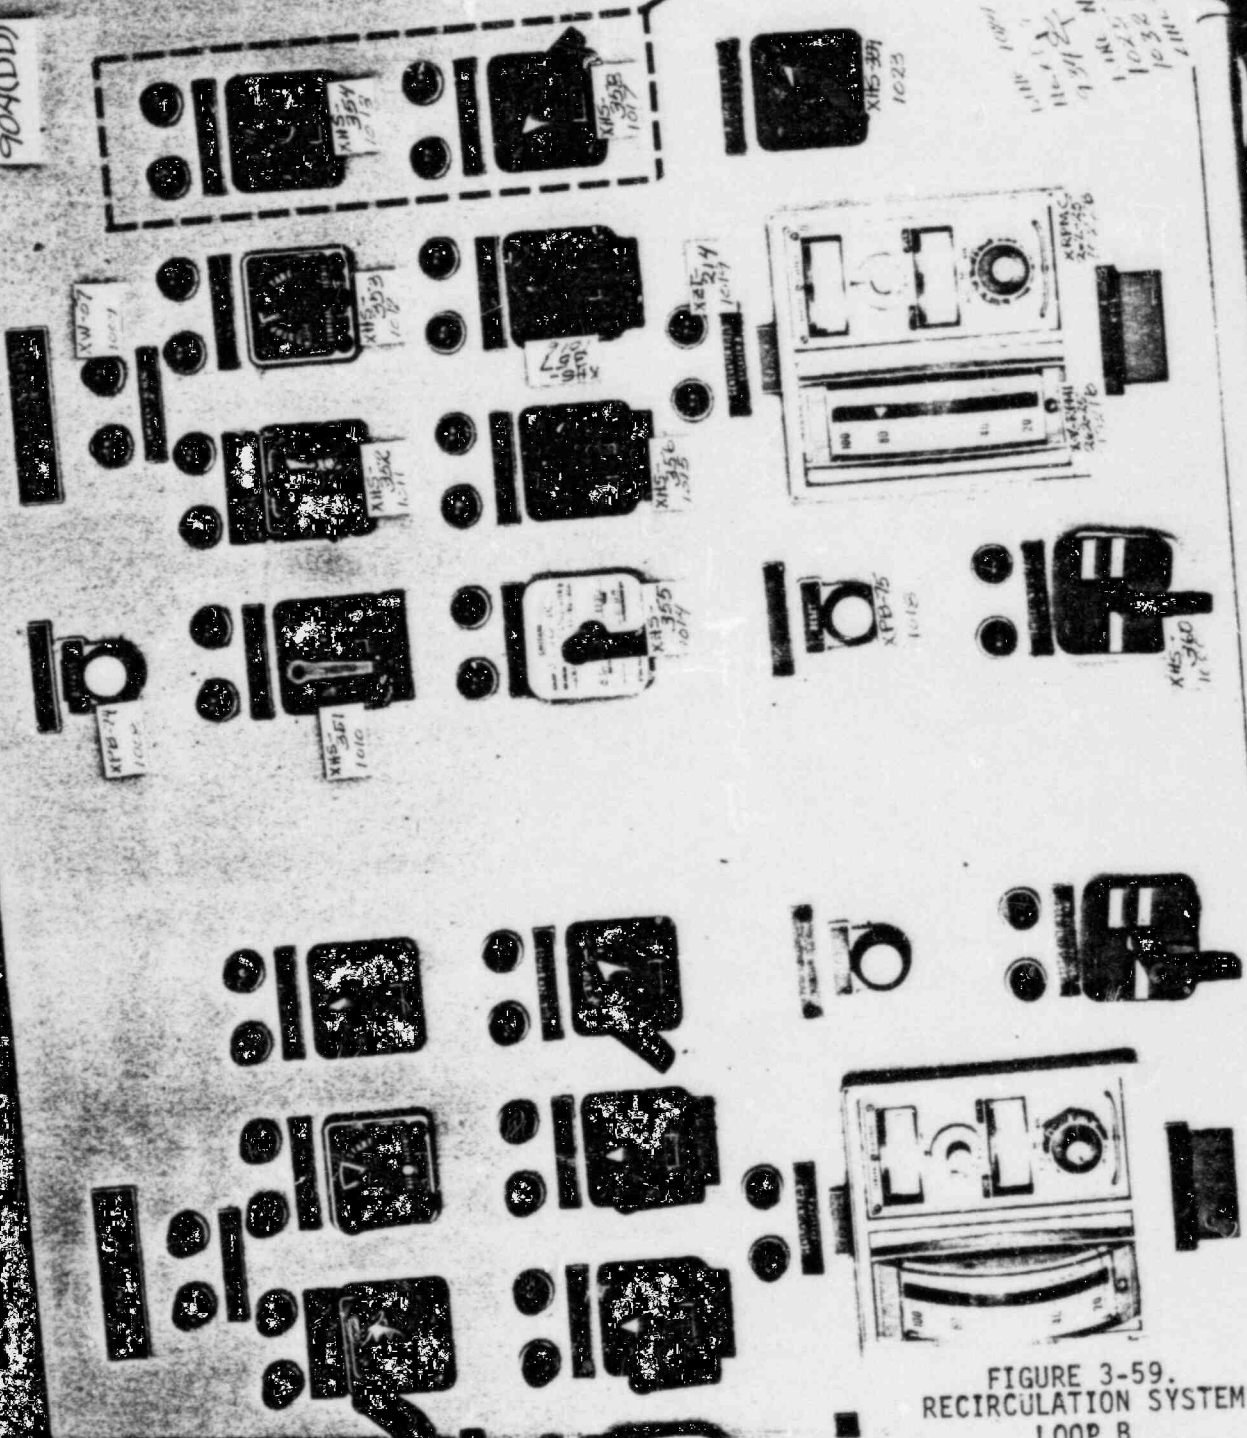
FIGURE 3-59.
RECIRCULATION SYSTEM
LOOP B

Figure 3-59 shows the recirculation system arrangement associated with HED 4B060.5. The loops A and B bypass valves control switches have been abandoned.

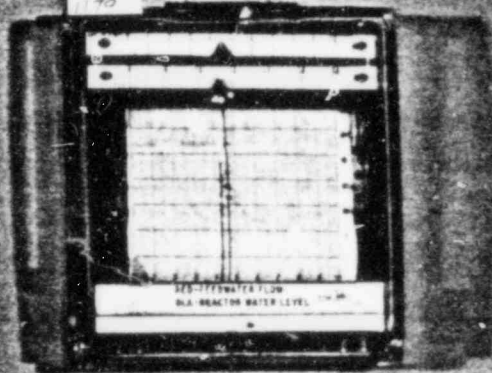
FIGURE 3-69. NUCLEAR INSTRUMENTS AND REACTOR VESSEL LEVEL

Figure 3-69 shows the present location of the steam flow/reactor level recorder selector switch. HED 9B107.5 requires that it be relocated in close proximity to the recorders shown on Figure 3-70. This requirement is part of the final layout.

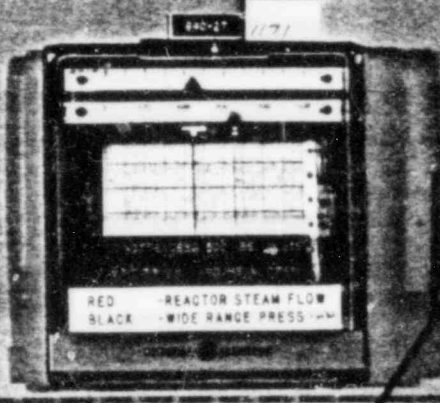
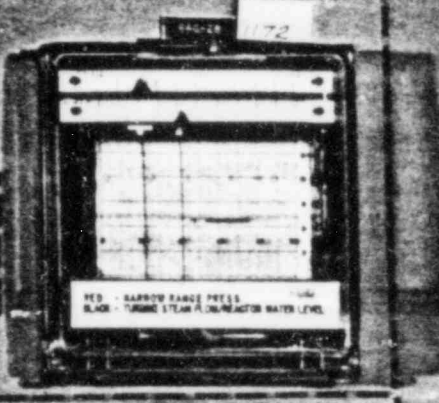
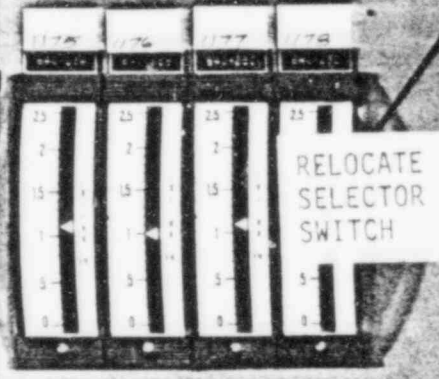
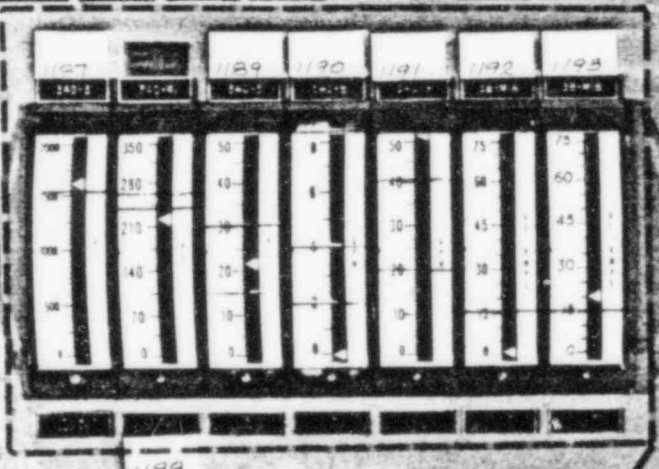
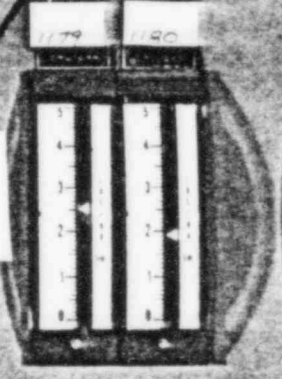
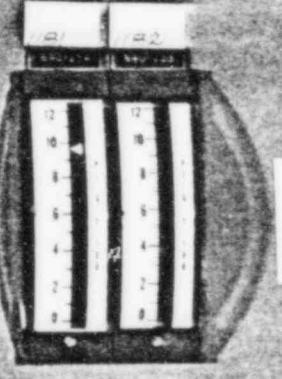
FIGURE 3-70. RECORDERS AND CONTROL ROD DRIVE INDICATORS

Figure 3-70 shows the control rod drive indicators. HED 8B095.5 requires these to be rearranged to break the meter string to less than 5 meters. This requirement is part of the final panel layout.

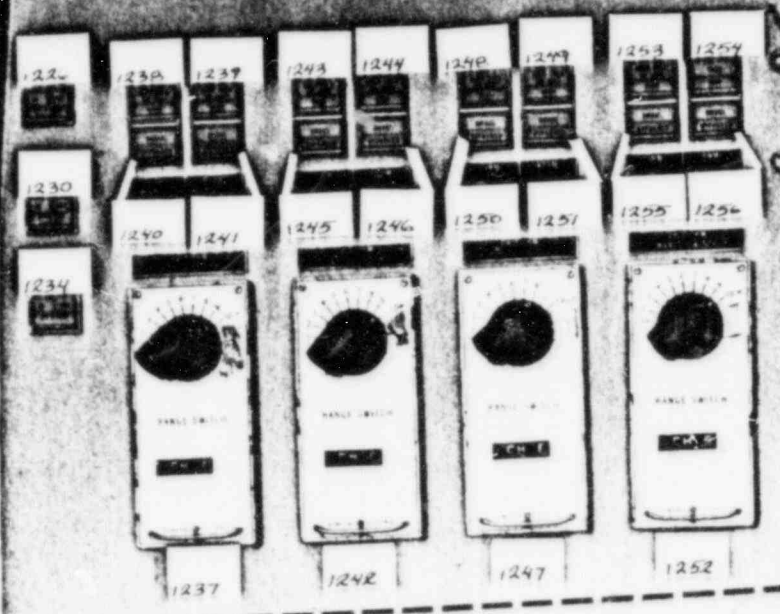
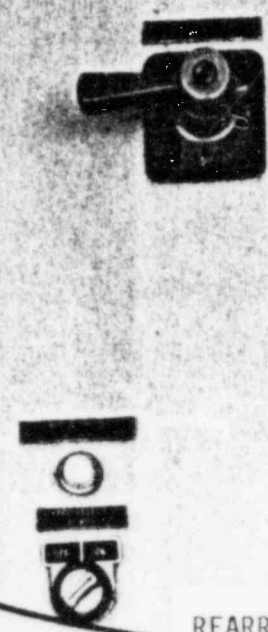
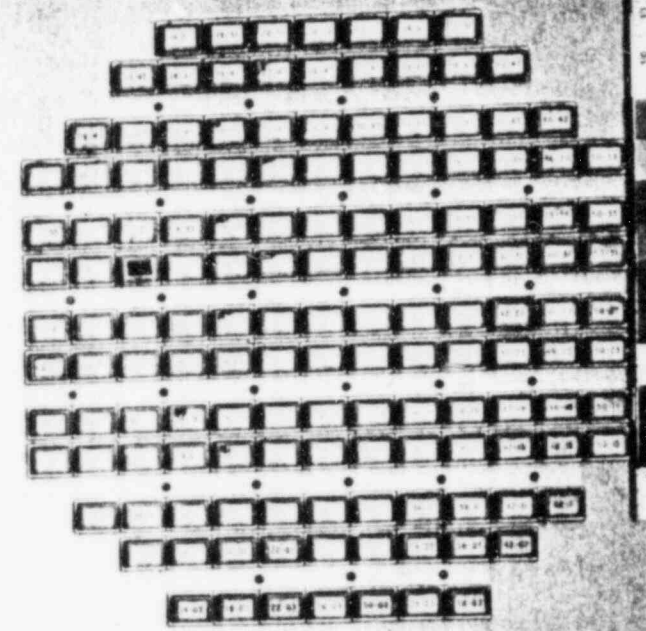
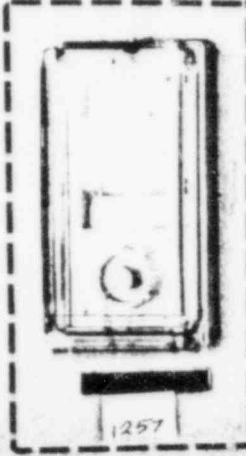
FIGURE 3-72.
NUCLEAR INSTRUMENTS

Figure 3-72 shows the master recirculation flow control switch that is deleted by HED 4B060.5.

REARRANGE TO
RESOLVE MIRROR
IMAGE

DELETE
