FERMI 2  
RESPONSE TO RECOMMENDATIONS  
FROM THE DUKE POWER COMPANY  
FINAL ASSESSMENT OF CONSTRUCTION

DETROIT EDISON  
SEPTEMBER 1984

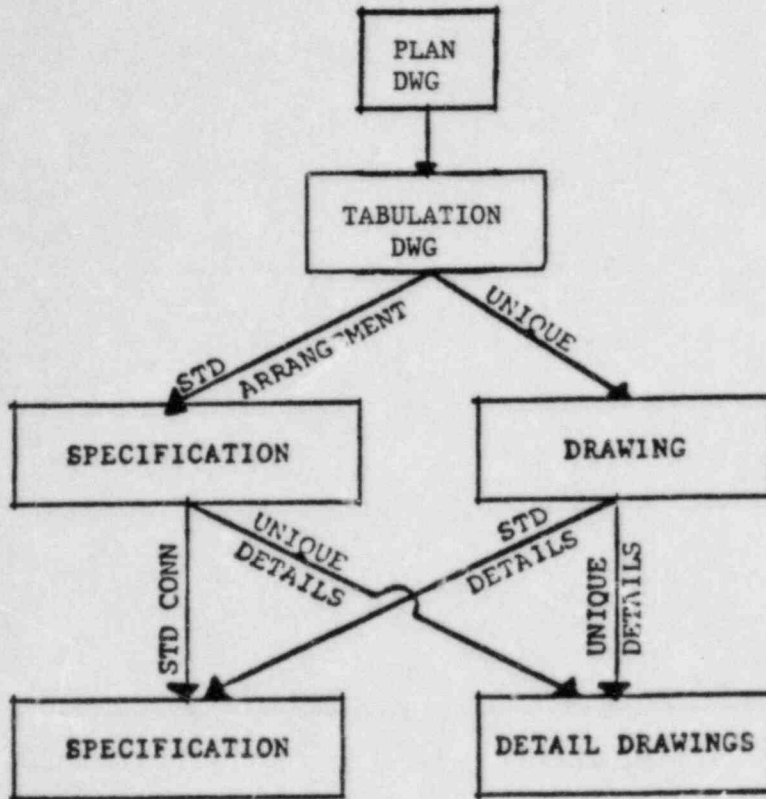
FIGURE 1-1

is to be found. For standard hangers, this is in the electrical specification; for unique hangers, the reference is to a drawing. Both of these documents, in turn, refer to the location of details and connections. If standard connections are utilized, they are as shown in the specification; if the connections are unique, they are shown in the hanger drawing. (This drawing process is illustrated in Figure 1-1.)

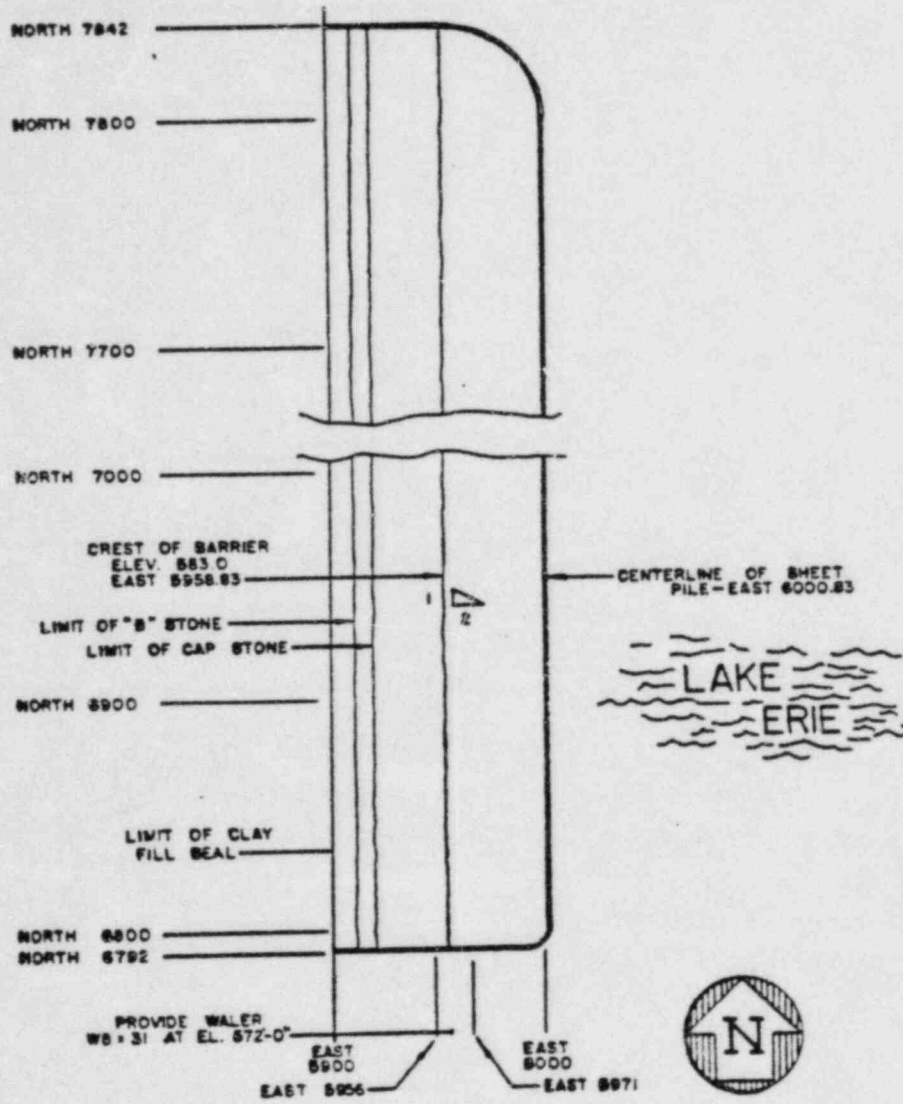
FIGURE 6-1

the barrier was designed to be at grade level (El 593') and the toe at approximately the lake level (El 572'). (See Figures 6-1 and 6-2.) The top surface of the barrier is a layer of 3 to 5 ton cap stones.

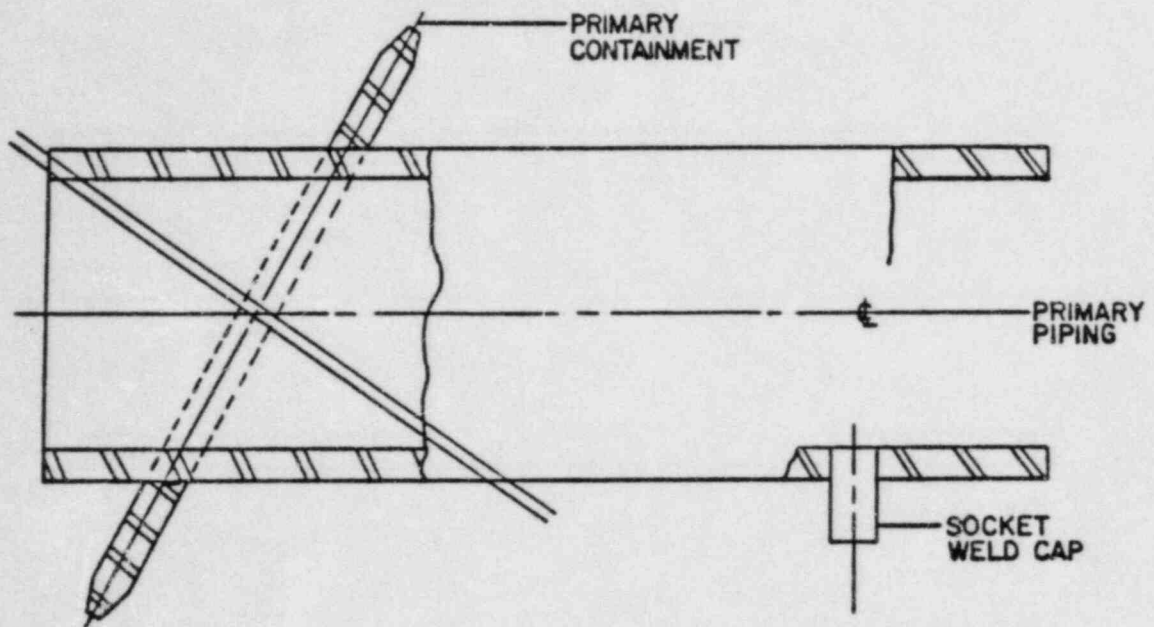
FIGURE 11-1  
DRYWELL PENETRATION

Mechanical penetrations were supplied and installed in the drywell with small diameter connections for draining and blowing out the larger penetration piping. Figure 11-1 illustrates the drywell penetrations. The small diameter connections to the penetration must be plugged before the integrated leak rate test is performed; otherwise, primary containment will not hold pressure as is required by the test.

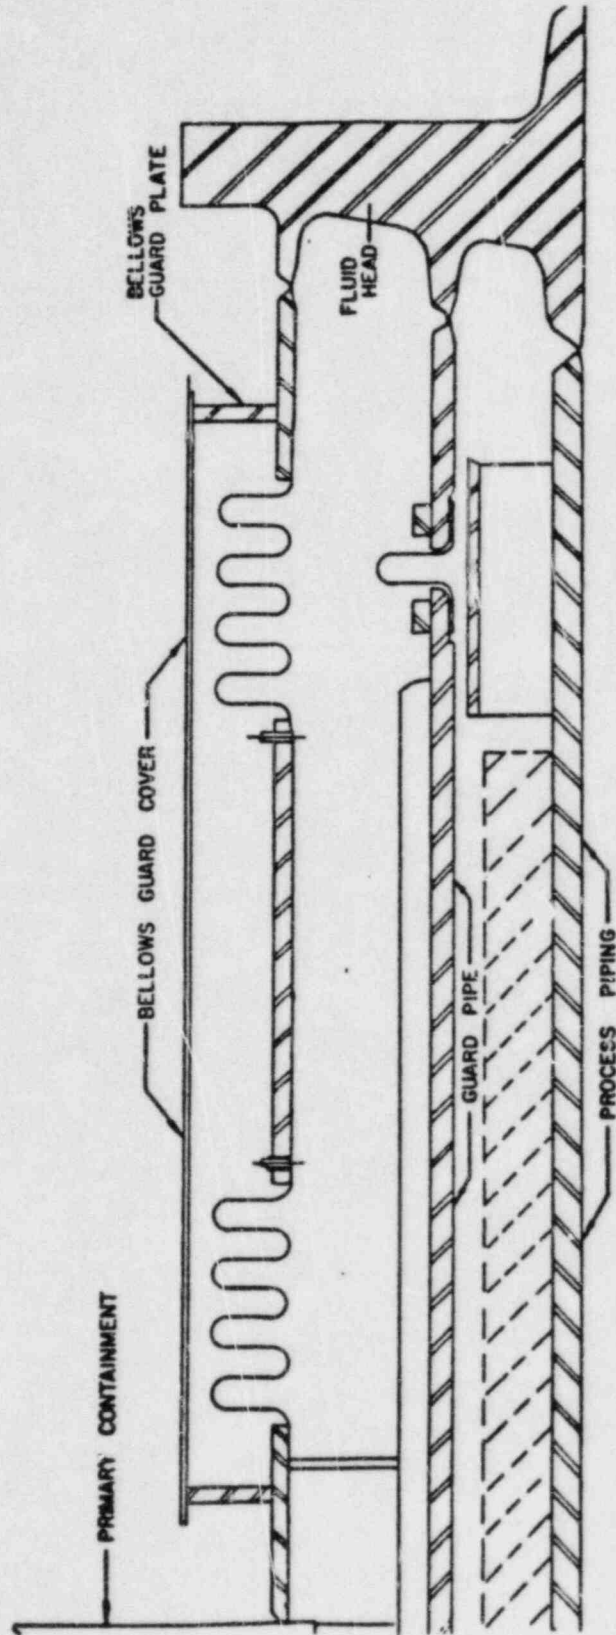
FIGURE 11-2

Also, some of the mechanical penetrations of the drywell have expansion bellows to allow for movement of attached piping relative to the connected primary containment shell. Expansion bellows type containment penetration is shown in Figure 11-2. Figure 11-2 shows a protective covering over the bellows section of the penetration assembly. Because local leak rate testing is presently being done to prepare
