BRUNSWICK STEAM ELECTRIC PLANT, UNIT 2  
NRC DOCKET NO. 50-324  
OPERATING LICENSE NO. DPR-62  
NUREG-0619 FEEDWATER NOZZLE AND SPARGER EXAMINATION RESULTS

GE-NE-523-112-1191

FEEDWATER SPARGER  
CIRCUMFERENTIAL CRACKING  
EVALUATION FOR  
BRUNSWICK UNITS 1 AND 2

BRUNSWICK STEAM ELECTRIC PLANT UNIT 2  
NINETH REFUELING OUTAGE - OCTOBER, 1991  
INVESSEL VISUAL INSPECTION (IVVI)  
INSPECTION REPORT AND VIDEO REVIEW

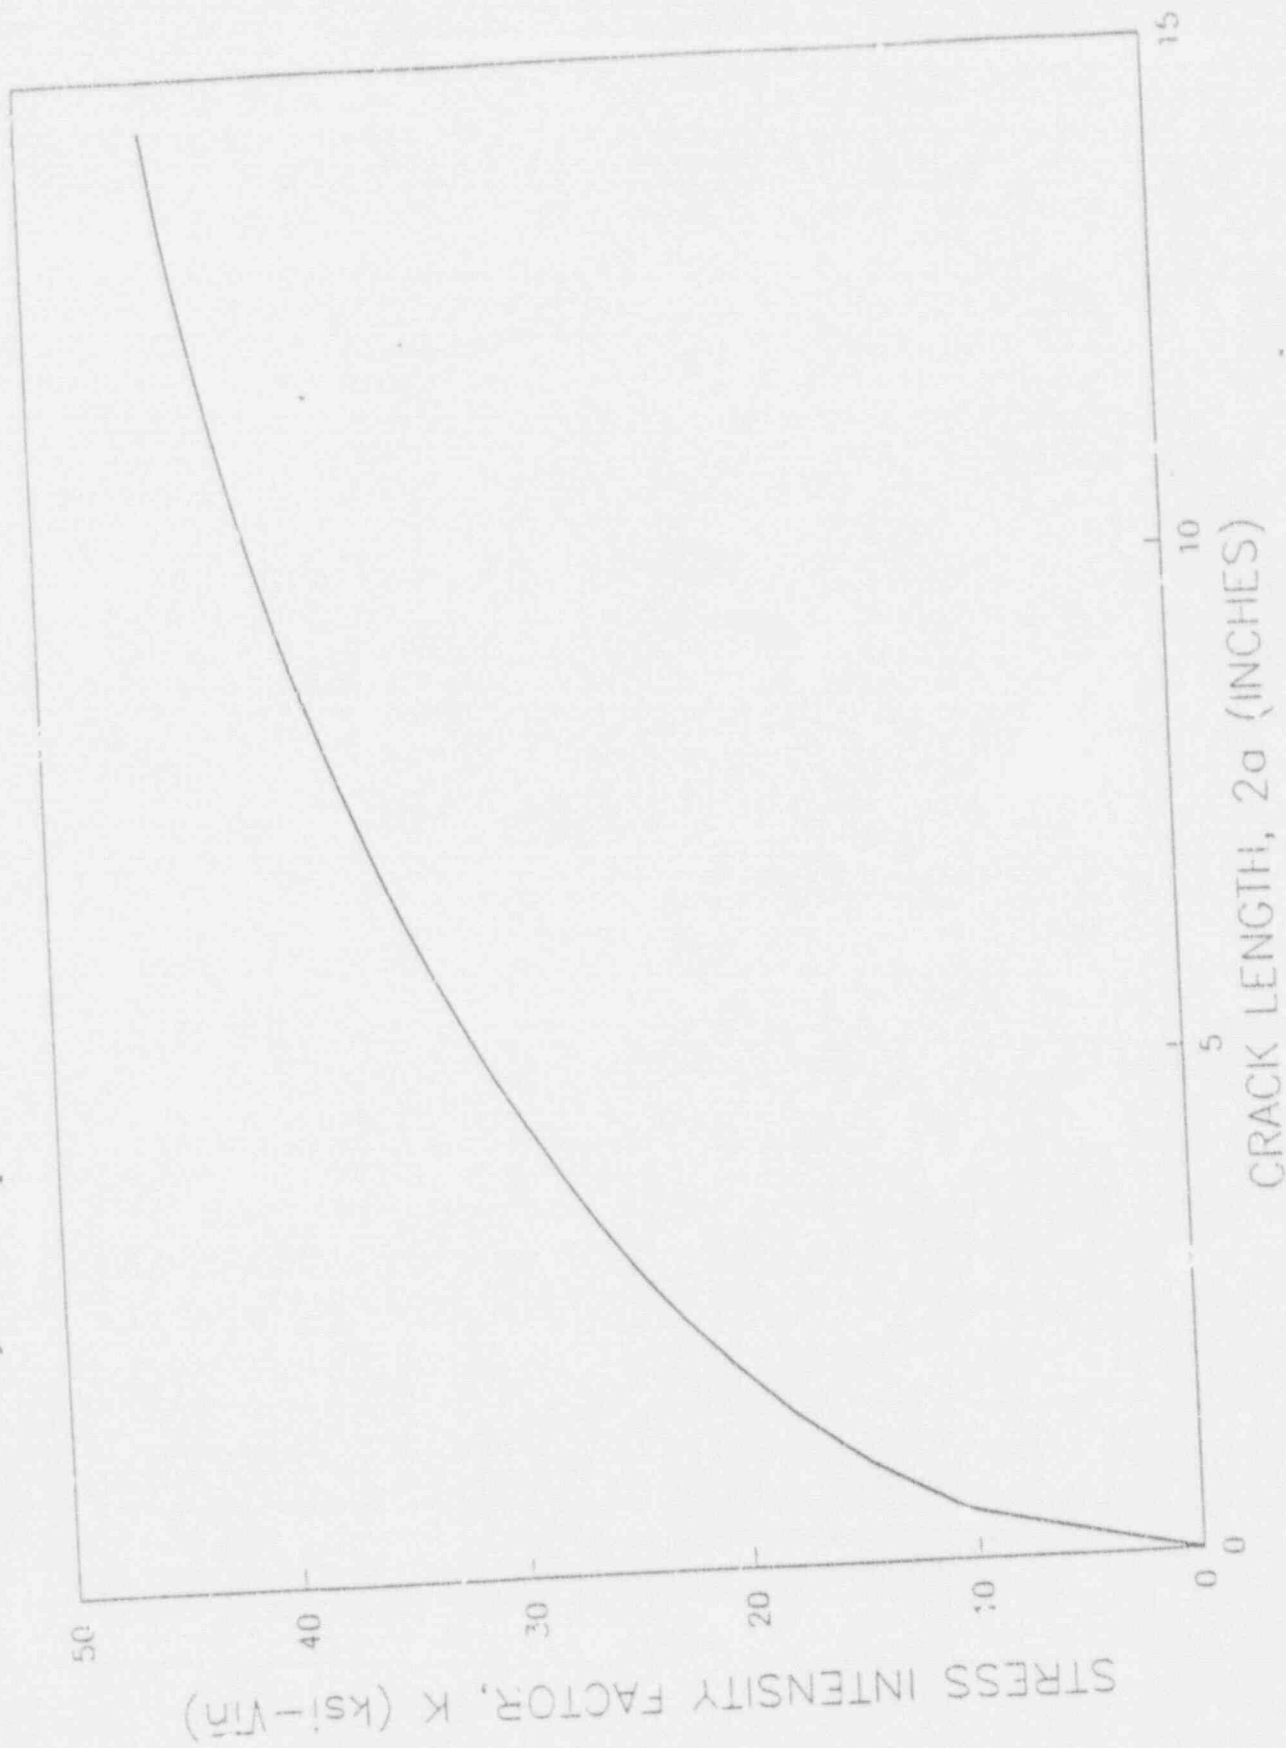
Figure 3-3. K vs. 2a for Cracks in Circumferential Sparger Weld

where  $C_m$  and  $C_b$  are membrane and bending factors, between 0 and 1, from [3]. Use of this expression is expected to be conservative for this application, based on comparison of flat plate and cylindrical shell models used to evaluate circumferential vessel flaws. The resulting relationship of  $K$  versus crack length  $2a$  is shown in Figure 3-3.

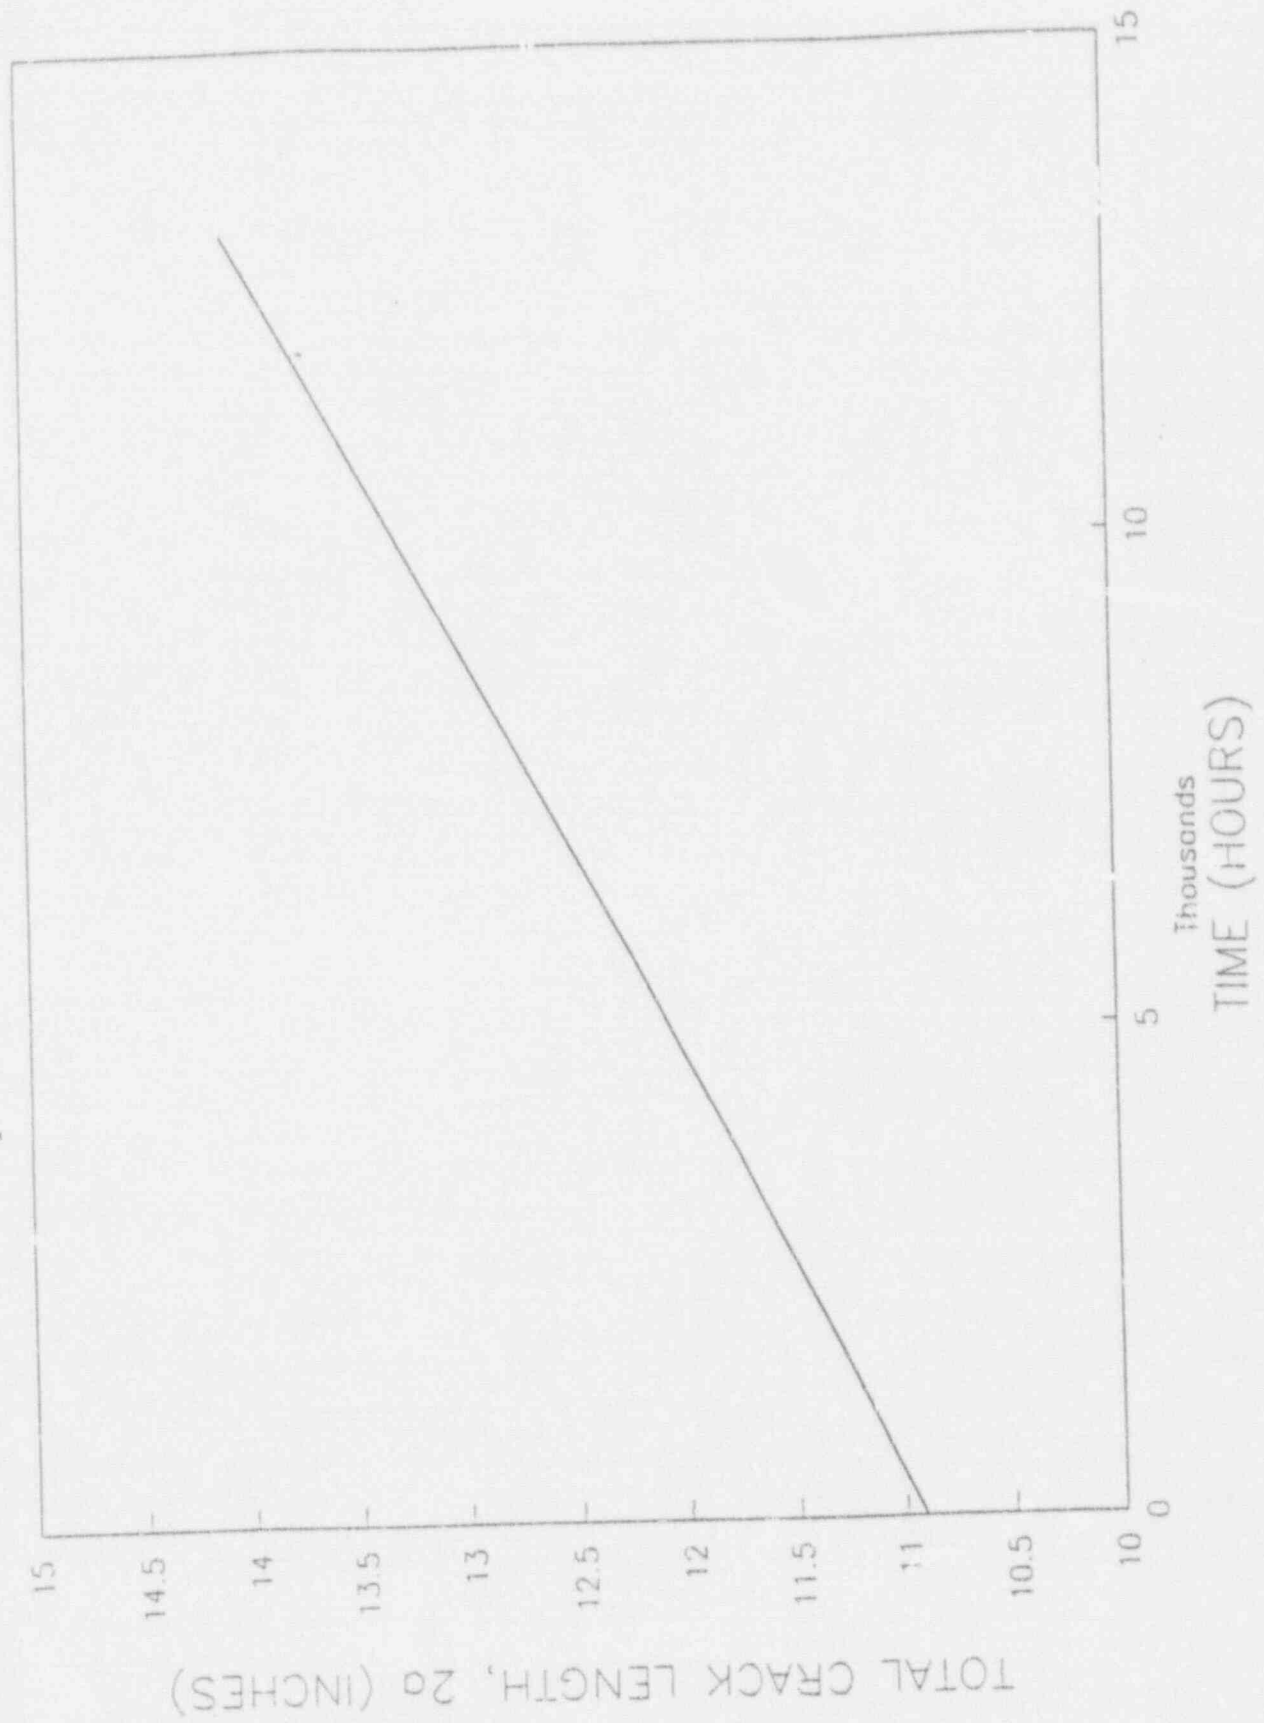
Figure 3-4. IGSCC Growth Predicted for 18 Month Cycle

The results of the IGSCC growth analysis are shown in Figure 3-4. The largest allowable crack which would reach the critical flaw size in one cycle is 10.9 inches. This initial flaw size experiences 3.16 inches of IGSCC, using the methods above. The calculated crack growth rate is a maximum of  $1.3 \times 10^{-4}$  inches/hour. However, this rate is a function of crack length.

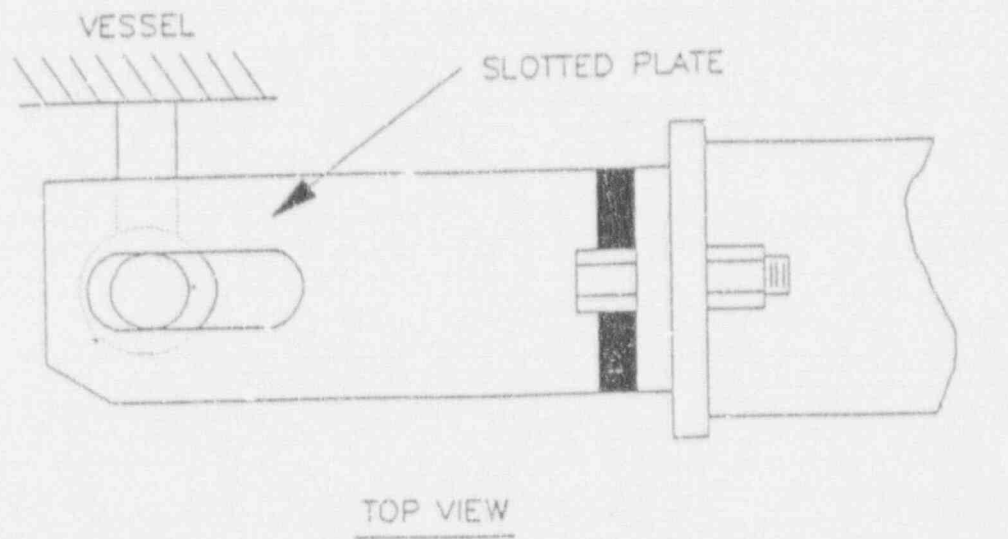
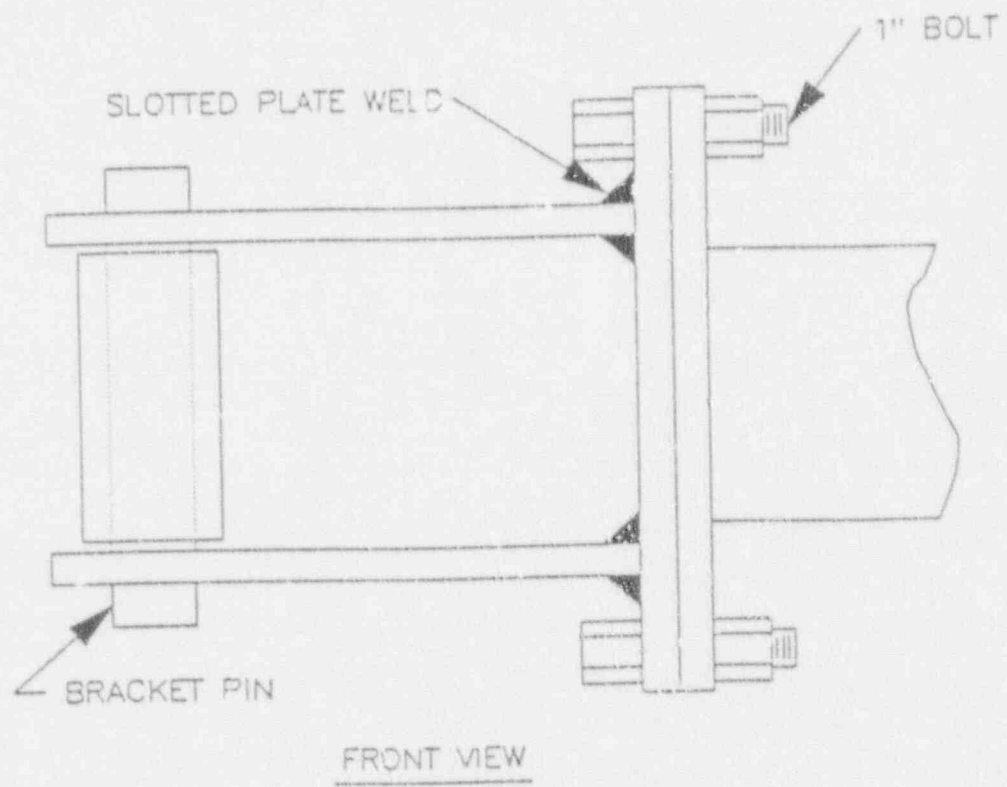
Figure 3-5. Schematic of Sparger Arm Bracket Connection

The sparger connection bracket is shown schematically in Figure 3-5. Four locations were evaluated: The one inch bolts connecting the bracket to the sparger, the slotted bracket plates, the welds connecting the slotted bracket plates to the bolted plates, and the bracket pins. Only vertical loads were considered, based on the restraint conditions for the pin and bracket for the assumed condition of the sparger arm being severed from the tee.

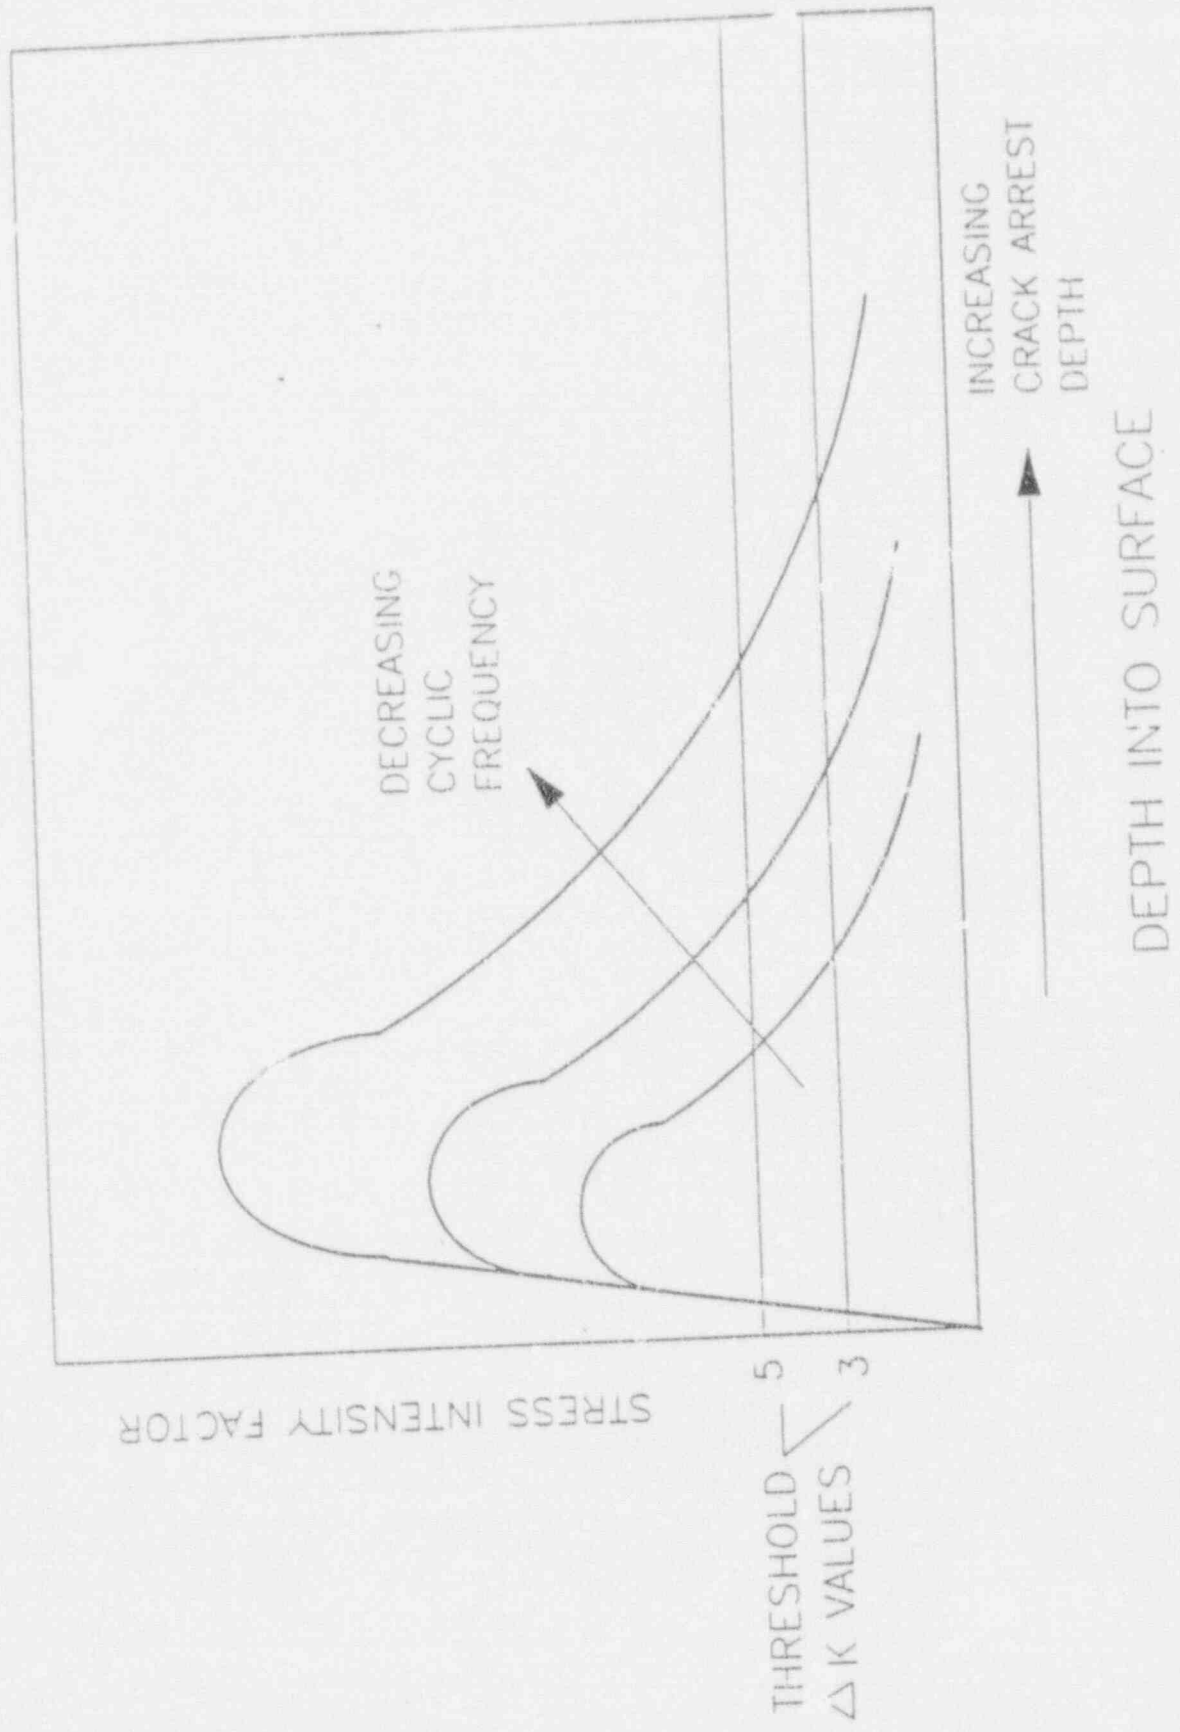
Figure 4-1. Schematic of Frequency Dependency on Crack Arrest Length

Extensive testing and analysis of the thermal sleeve leakage rapid cycling was conducted in the process of designing the triple thermal sleeve. Among the analyses done was an evaluation of the expected crack growth in the blend radius due to rapid cycling [4]. The results showed that  $\Delta K$  values associated with the rapid thermal cycling drop as a crack proceeds into the nozzle until the crack arrest  $\Delta K$  threshold of 3 ksi- $\sqrt{\text{in}}$  (for high R-ratios) is reached. The depth of the arrested crack is a function of the frequency of the cycling, as shown in Figure 4-1.

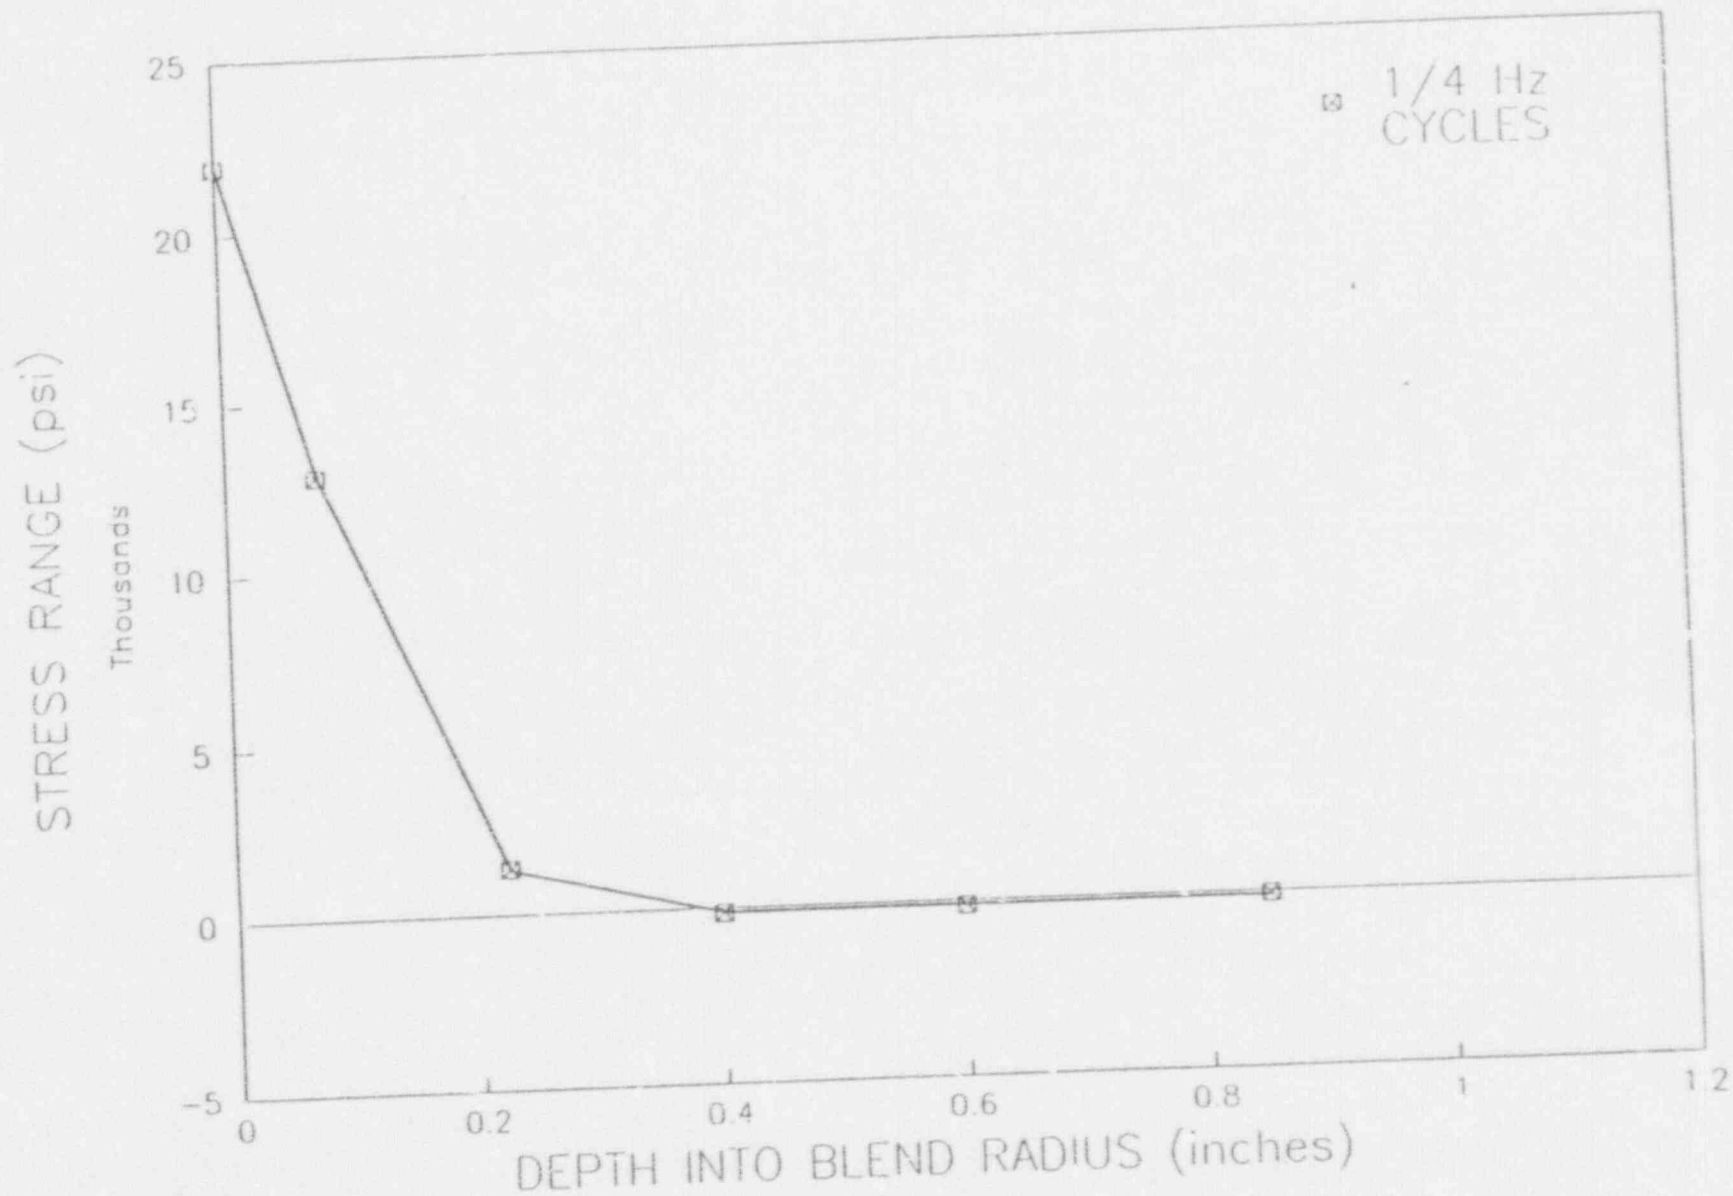
Figure 4-3. Stress Range Profile for Cyclic Leakage on Nozzle

Stress range and  $\Delta K$  profiles were developed for frequencies of 1/8, 1/4 and 1/3 Hz. The 1/4 Hz case was found to come closest to meeting the benchmark condition of 5 ksi- $\sqrt{\text{in}}$  at 0.5 inches. The stress range profile is shown in Figure 4-3. The stress range profile was fit with a cubic polynomial, and then the coefficients were adjusted slightly until the benchmark conditions were met. The resulting  $\Delta K$  vs. depth plot is shown in Figure 4-4. The curve extends to the high mean stress threshold of 3 ksi- $\sqrt{\text{in}}$  at a depth of 0.85 inches. Therefore, rapid cycling behavior which causes a crack of 0.5 inches at the flow holes is predicted to cause a crack of 0.85 inches in the blend radius.

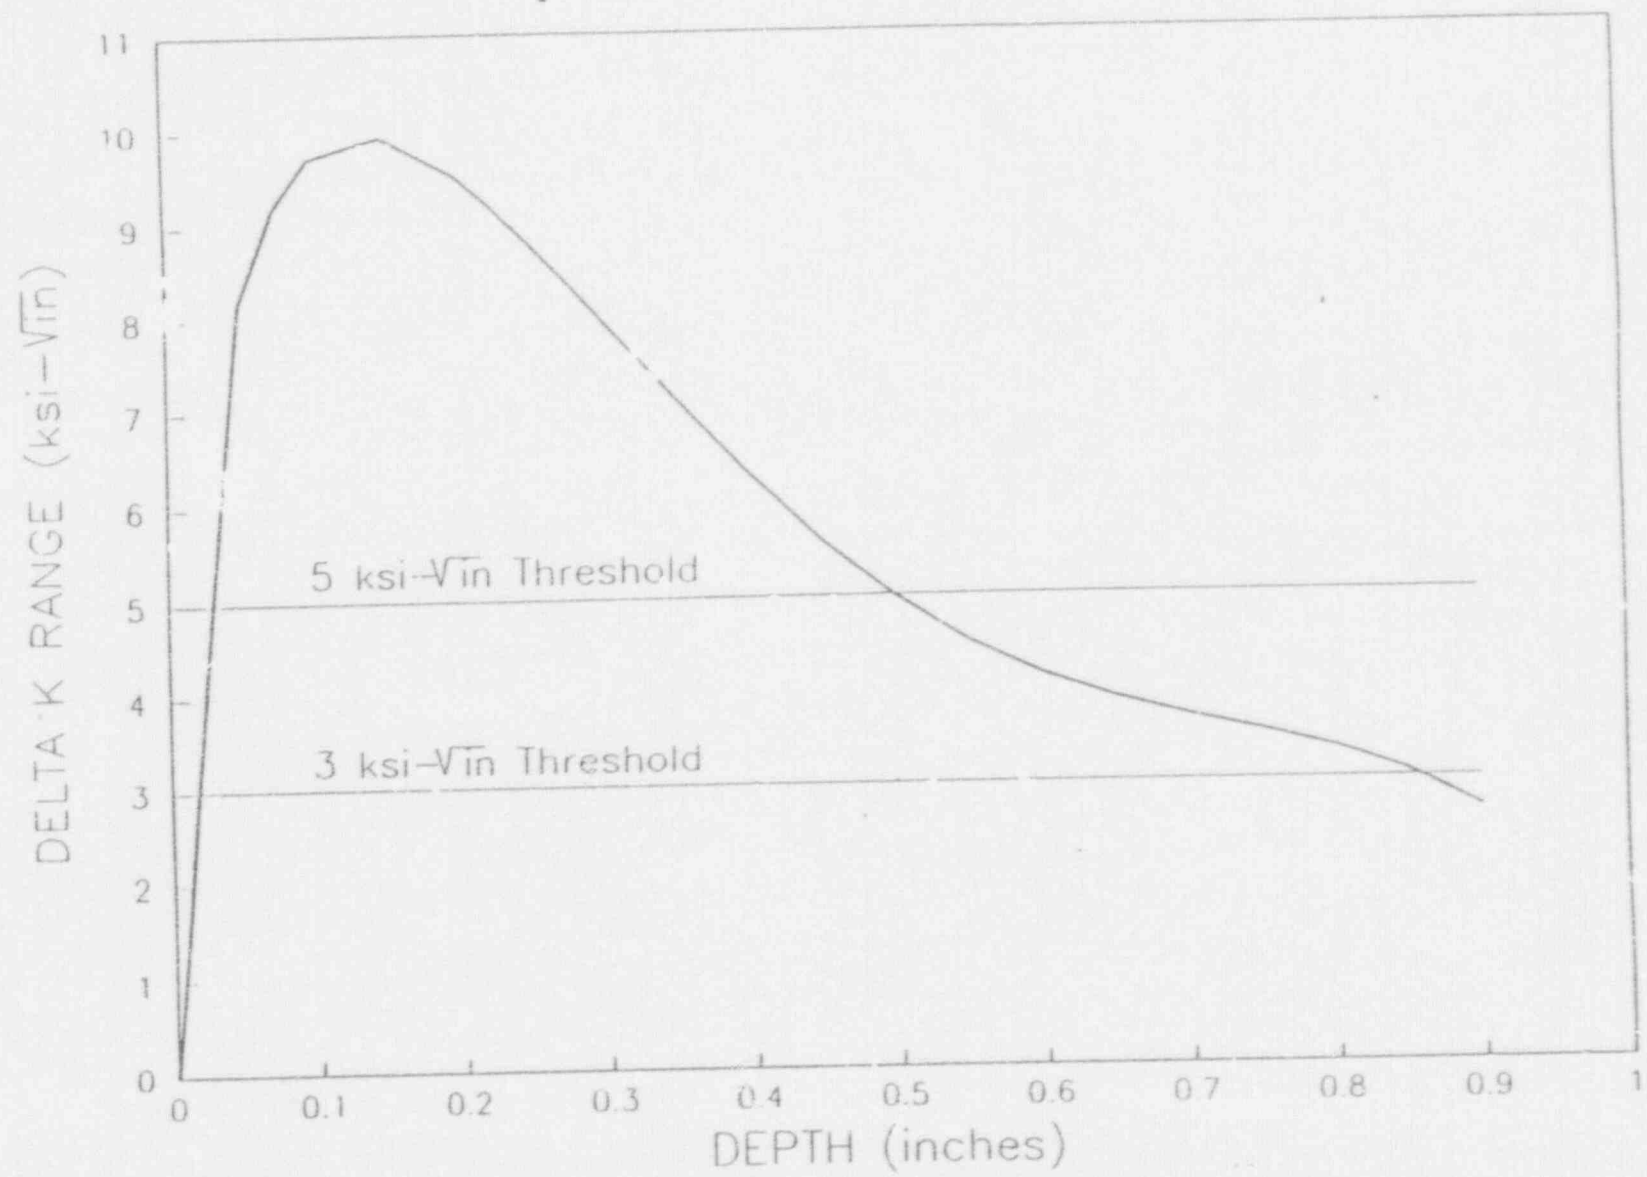
Figure 4-4. Attenuation of  $\Delta K$  with Depth into Nozzle

In addition to the possible crack growth due to rapid cycling, system cycling crack growth could occur. In the most recent NUREG-0619 analysis for Unit 2 [6], which has the greater crack growth rate, the system cycling crack growth for 18 months of operation with a crack 0.85 inches deep is 0.05 inches. Therefore, the maximum expected crack depth for sparger leakage into the nozzle is 0.9 inches. While this is significant, it is less than the flaw depth allowed in NUREG-0619 of 1.0 inch.
