**Plant Vogtle**

**Diesel Generators  
Airstart Cap Evaluation**

**Log No. 95-MT-039**

**Southern Company Services  
Stress and Metallurgy**

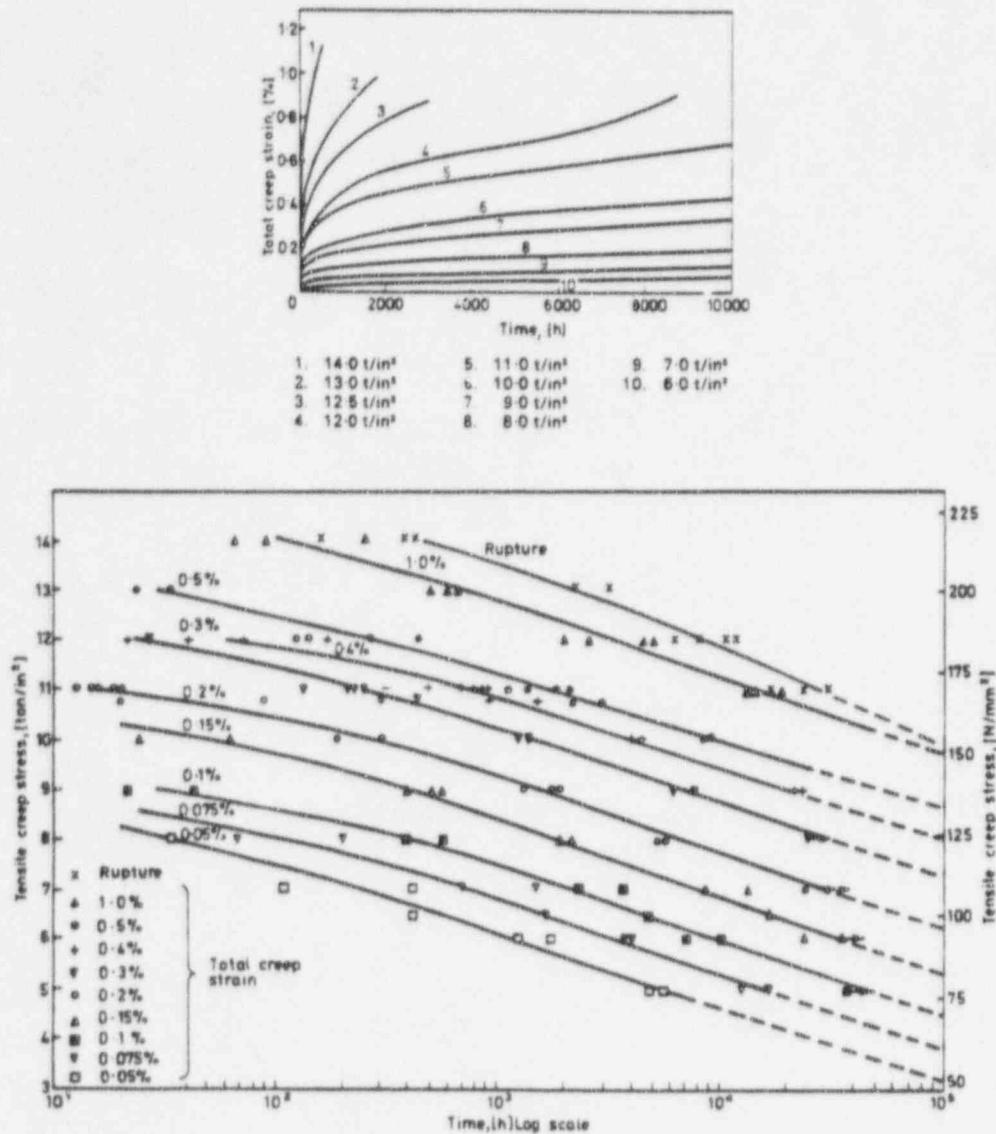
**APPENDIX B**

Creep curves of strain against time at 350 °C for 1.2-in. cast section size (top) and stress/log time curves for given strains and rupture of 3-in. cast section size at 350 °C.

Typical total creep strain curves for tests at stresses ranging from 6 tons/in.<sup>2</sup> (90 N/mm<sup>2</sup>) to 14 tons/in.<sup>2</sup> (215 N/mm<sup>2</sup>) for times up to 10,000 h are shown for a 1.2-in. (30-mm) section size in the top figure. A similar family of curves was obtained on a 3-in. (76-mm) section size, and from these curves, the stresses to produce various creep strains and rupture are shown plotted against the logarithm of time in the bottom figure. For a grade 17 gray iron, variations in cast section size from 1.2-in. (30-mm) to 3-in. (76-mm) diameter have little effect on stress-rupture properties at 350 °C. The rupture specimens had elongations after failure of 1.2-2.3%.
