NED-84-605

December 10, 1984

NRC DOCKET 50-321
OPERATING LICENSE DPR-57
EDWIN I. HATCH NUCLEAR PLANT UNIT 1
INSERVICE INSPECTION OF STAINLESS STEEL PIPING -
1984 REFUELING OUTAGE

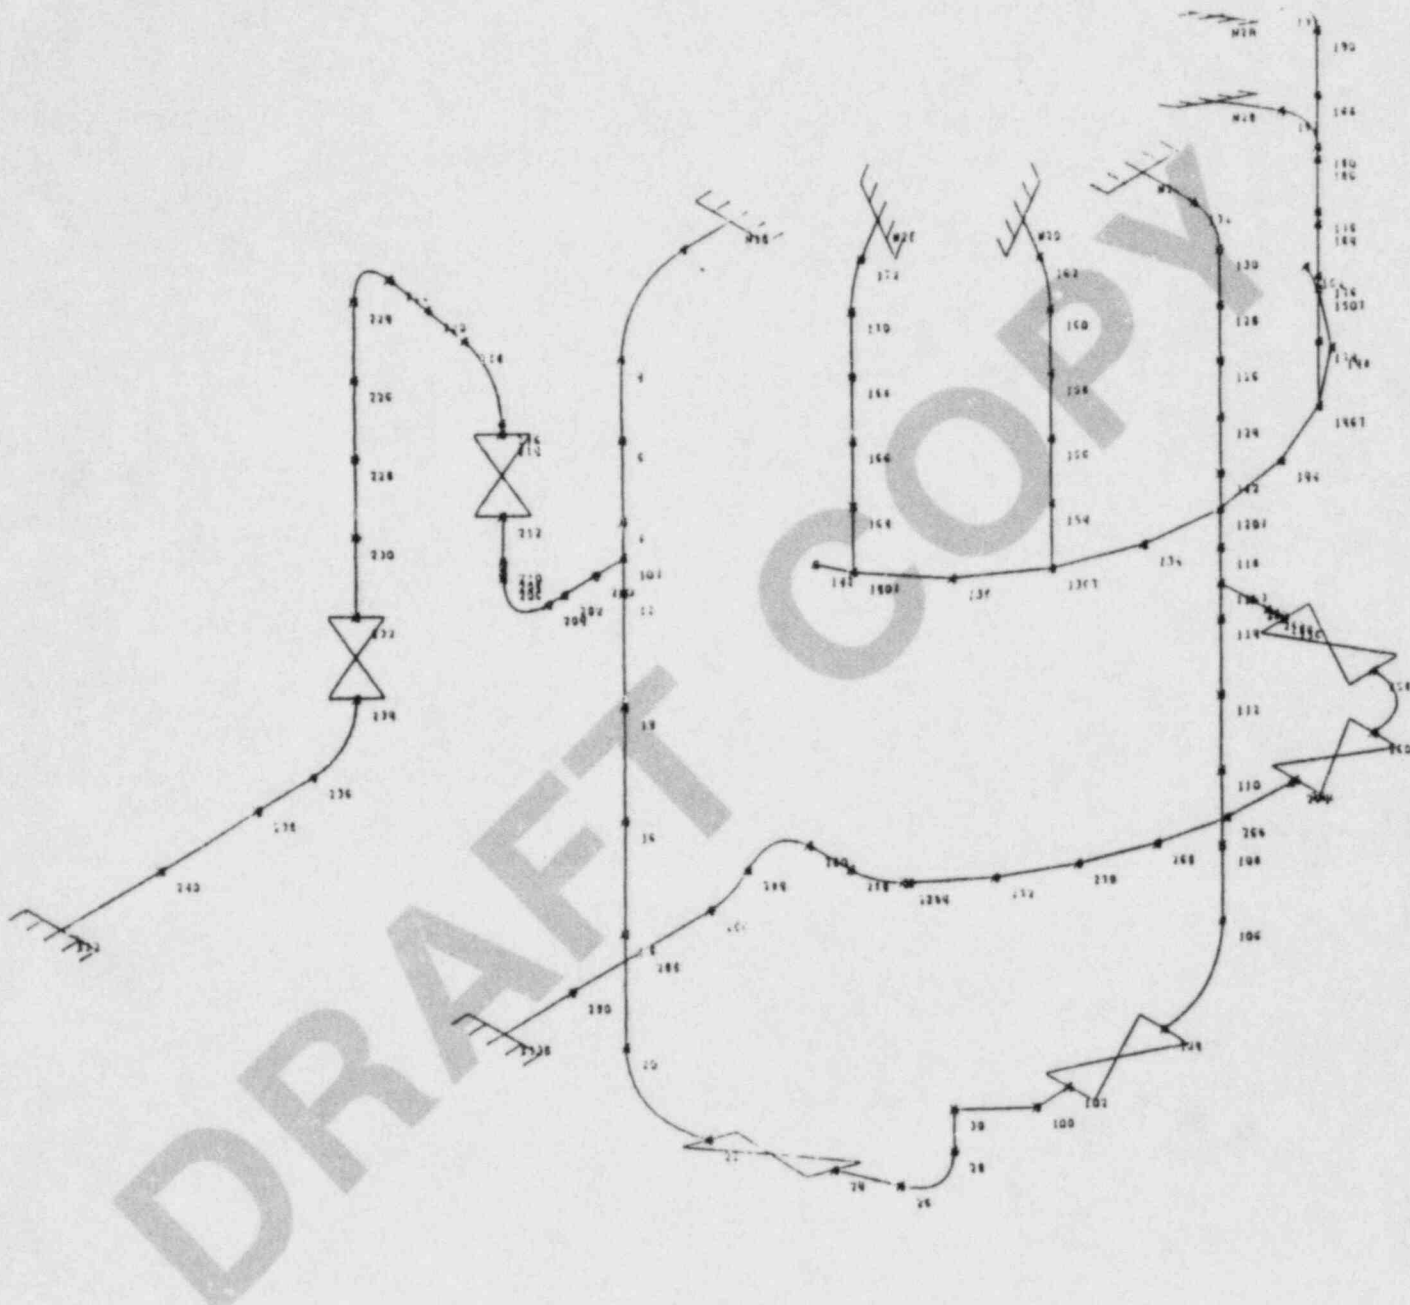
Figure 5.5
E. I. Hatch Unit 1 Recirculation
System Piping Model

Figure 5.5. The measured shrinkages of all weld overlay repairs were imposed as boundary conditions on this model. Since the ASME Code does not limit weld residual stress, all stress indices were set equal to 1.0.

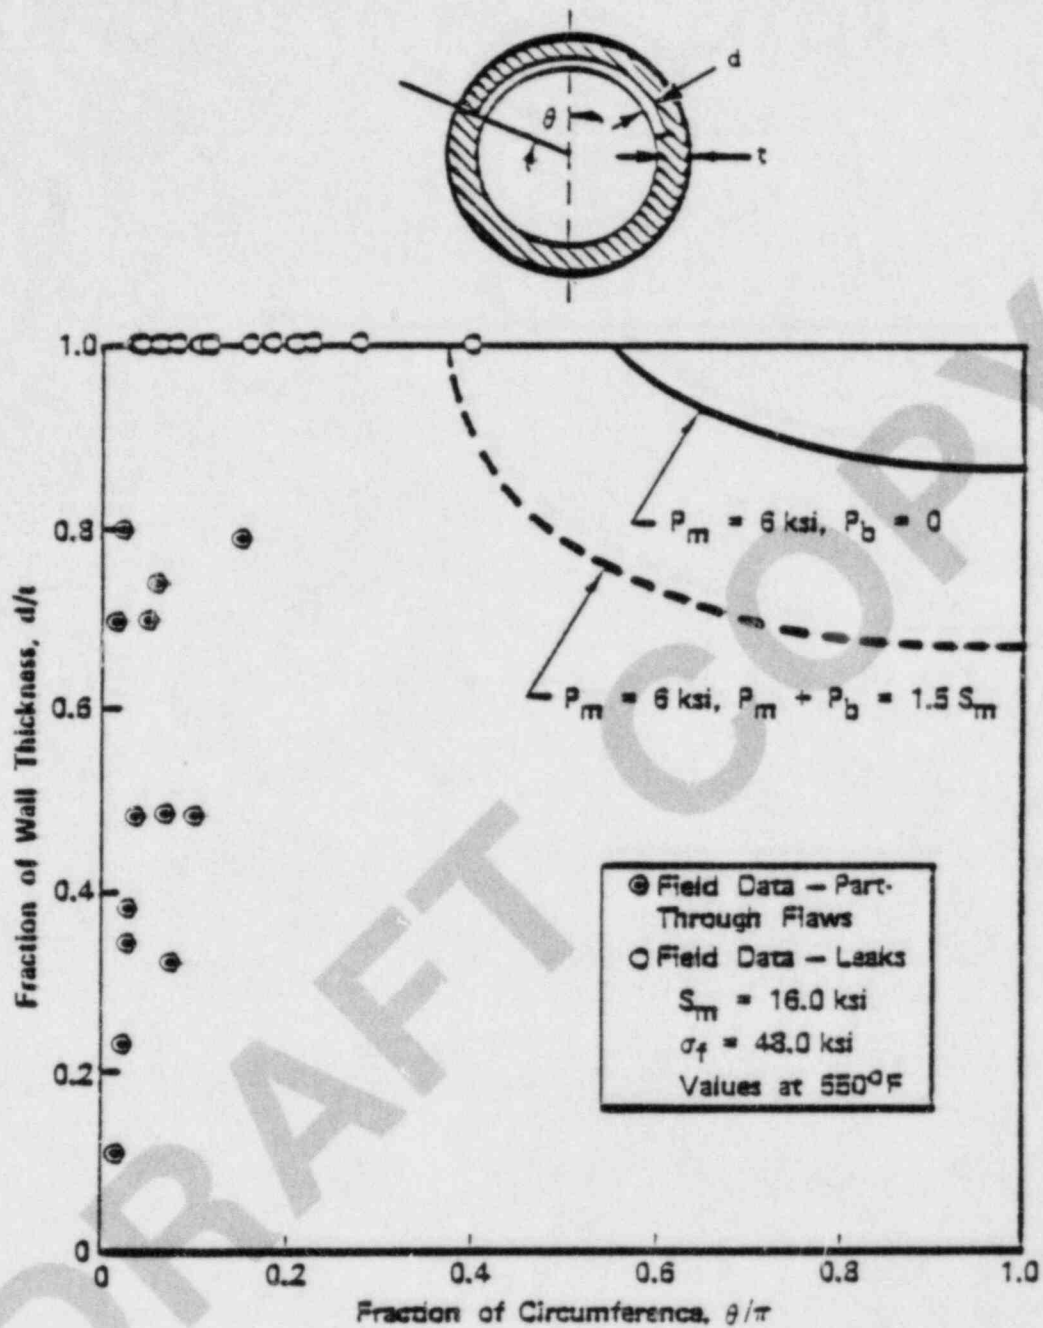
Also shown in Figure 6.1 is a sampling of cracks which have been detected in service, either through UT examination or leakage. In each case there has been a significant margin between the size of crack observed and that predicted to cause failure under service loading conditions. Also, as discussed below, there is still considerable margin between these net section collapse limits and the actual cracks which would cause instability.

Typical Result of Net Section Collapse Analysis of
Cracked Stainless Steel Pipe

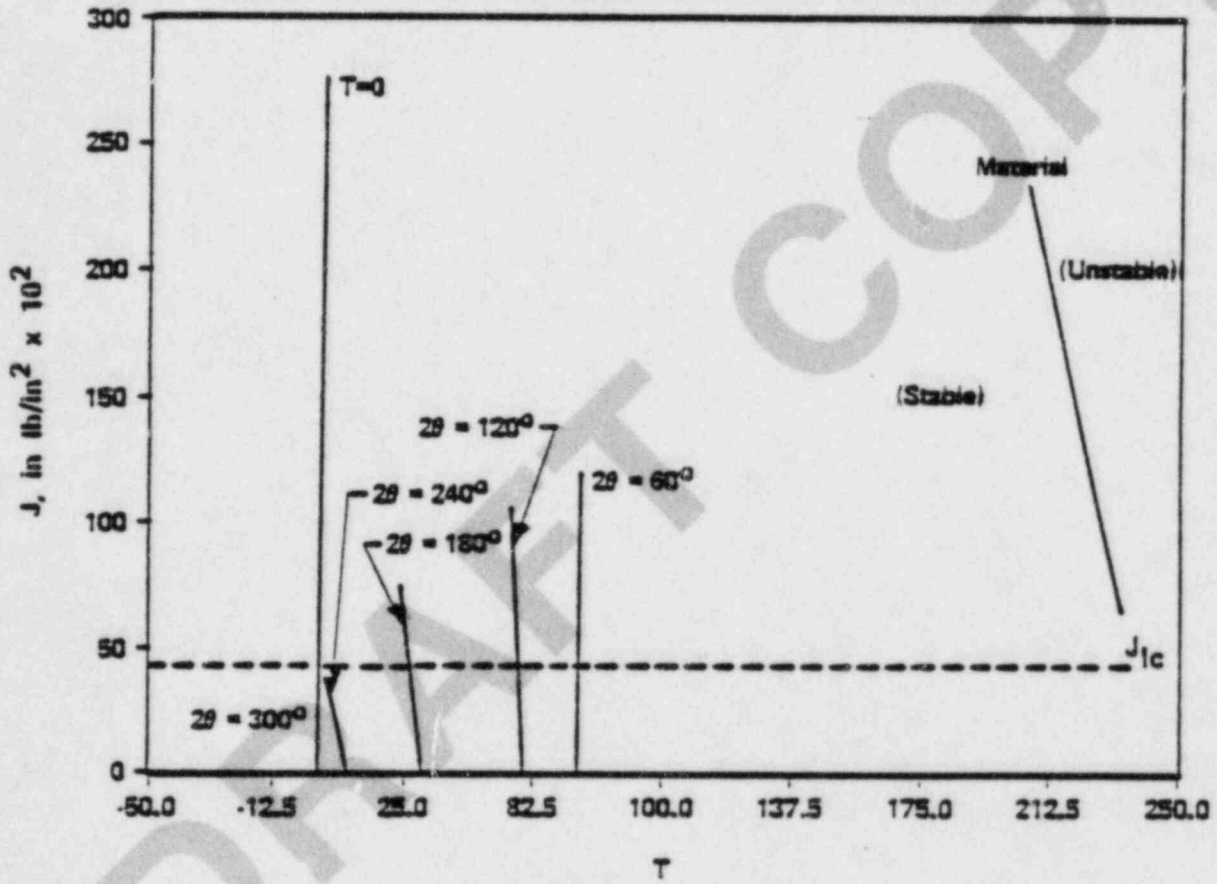
Figure 6.2

Recirculation System. Loads were applied to these sections of sufficient magnitude to produce net section limit load, and the resulting values of tearing modulus were compared to that required to cause unstable fracture (Figure 6.2). Note that in all cases there is substantial margin, indicating that the net section collapse limits of the previous section are not really failure limits. Figure 6.3 summarizes the results of all such analyses performed for 60° through-wall cracks in terms of margin on tearing modulus for stability. The margin in all cases is substantial.

Stability Analysis for BWR Recirculation System
(Stainless Steel)

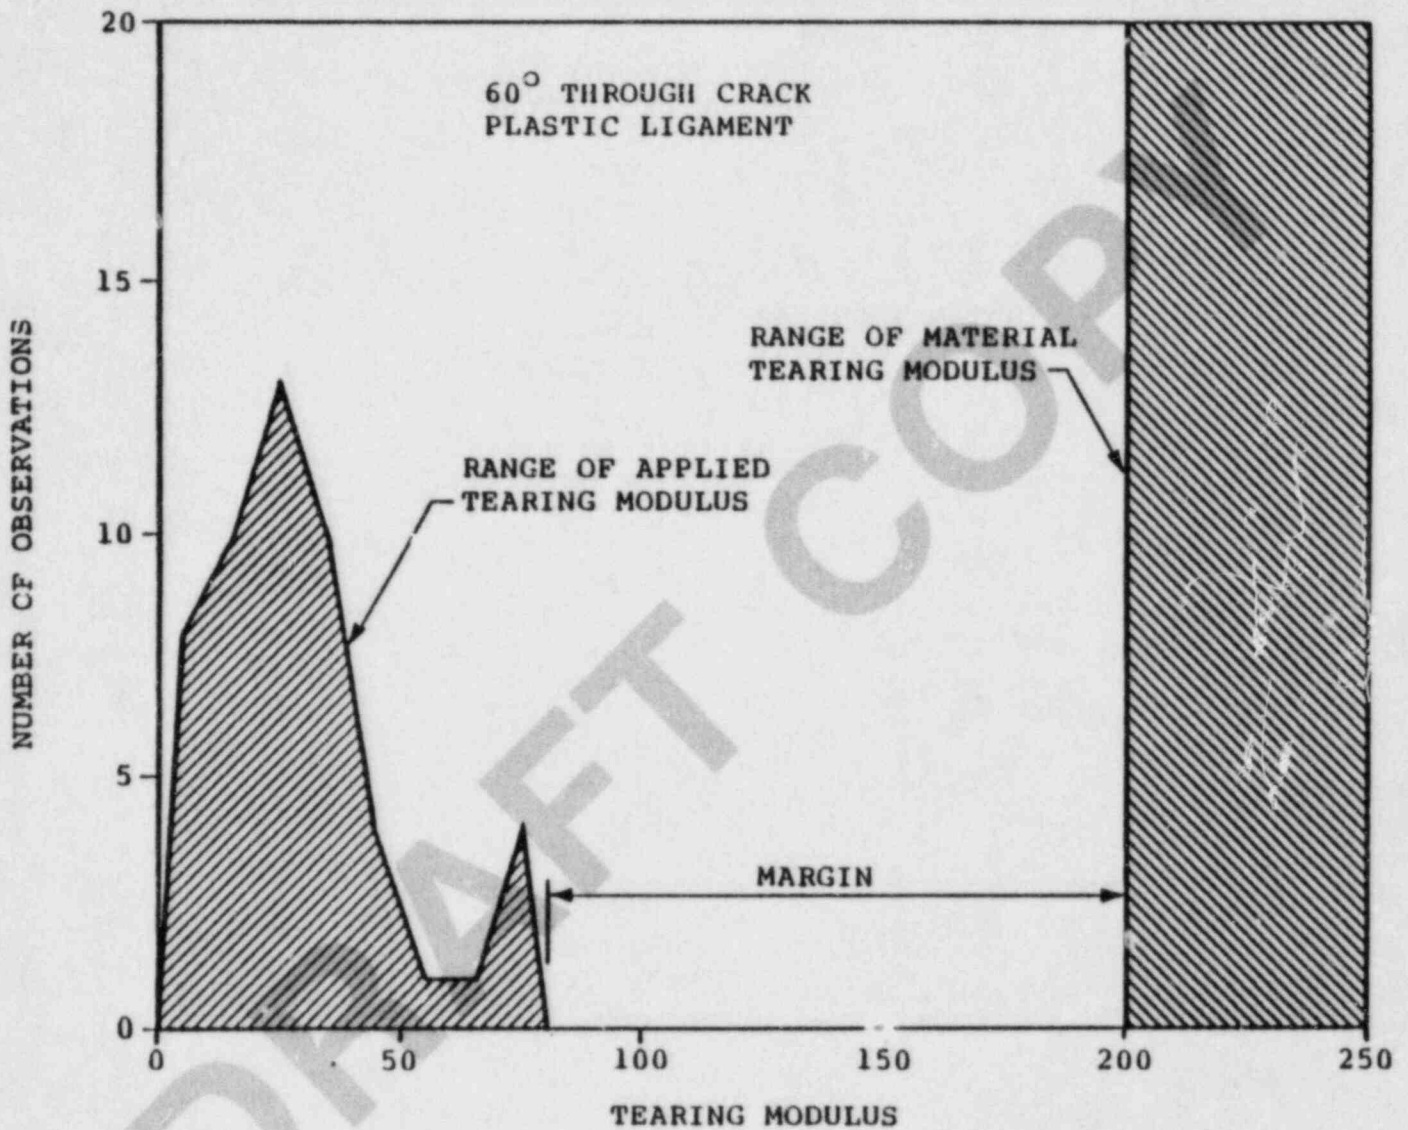
Figure 6.3

Elastic-plastic fracture mechanics analyses are presented in Reference 14 which give a more accurate representation of the crack tolerance capacity of stainless steel piping than the net section collapse approach described above. Figures 6.2 and 6.3 graphically depict the results of such an analysis (Reference 14). Through-wall circumferential defects of arc length equal to 60° through 300° were assumed at various cross sections of a typical BWR

Summary of Leak-Before-Break Assessment
of BWR Recirculation System

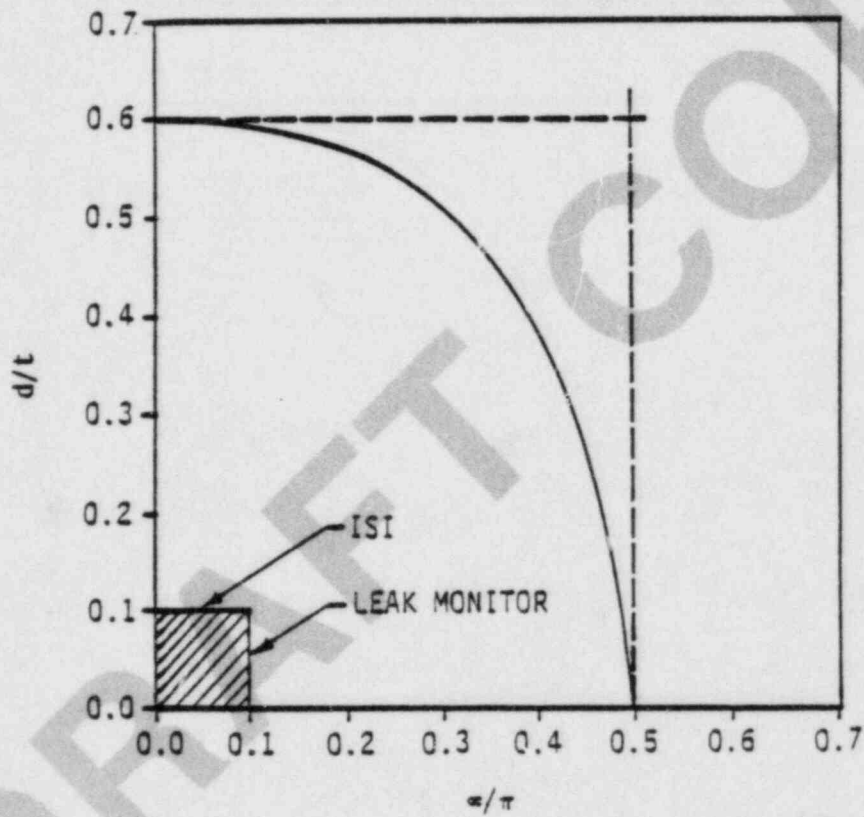
Of perhaps more significance to the leak-before-break argument is the flaw configuration depicted in Figure 6.4. This configuration addresses the concerns raised by the occurrence of part-through flaws growing circumferentially before breaking through the outside surface to cause leakage. Figure 6.4 presents typical size limitations on such flaws based on the conservative net section collapse method of Section 6.1. Note that very large crack sizes are predicted. Also shown on this figure are typical detectability limits for short through-wall flaws

(which are amenable to leak detection) and long part-through flaws (which are amenable to detection by UT). The margins between the detectability limits, and the conservative, net section collapse failure limits are substantial. It is noteworthy that the likelihood of flaws developing which are characterized by the vertical axis shown in Figure 6.4 (constant depth 360° circumferential cracks) is so remote as to be considered impossible. Material and stress asymmetries always tend to propagate one portion of the crack faster than the bulk of the crack front, which will eventually result in "leak-before-break." This observation is borne out by extensive field experience with BWR IGSCC.
