## DESIGN REVIEW OF TDI R-4 AND RV-4 SERIES EMERGENCY DIESEL GENERATOR CYL. DER BLOCKS AND LINERS

Prepared by Failure Analysis Associates Palo Alto, California

TDI Diesel Generator Owners Group

June 1984

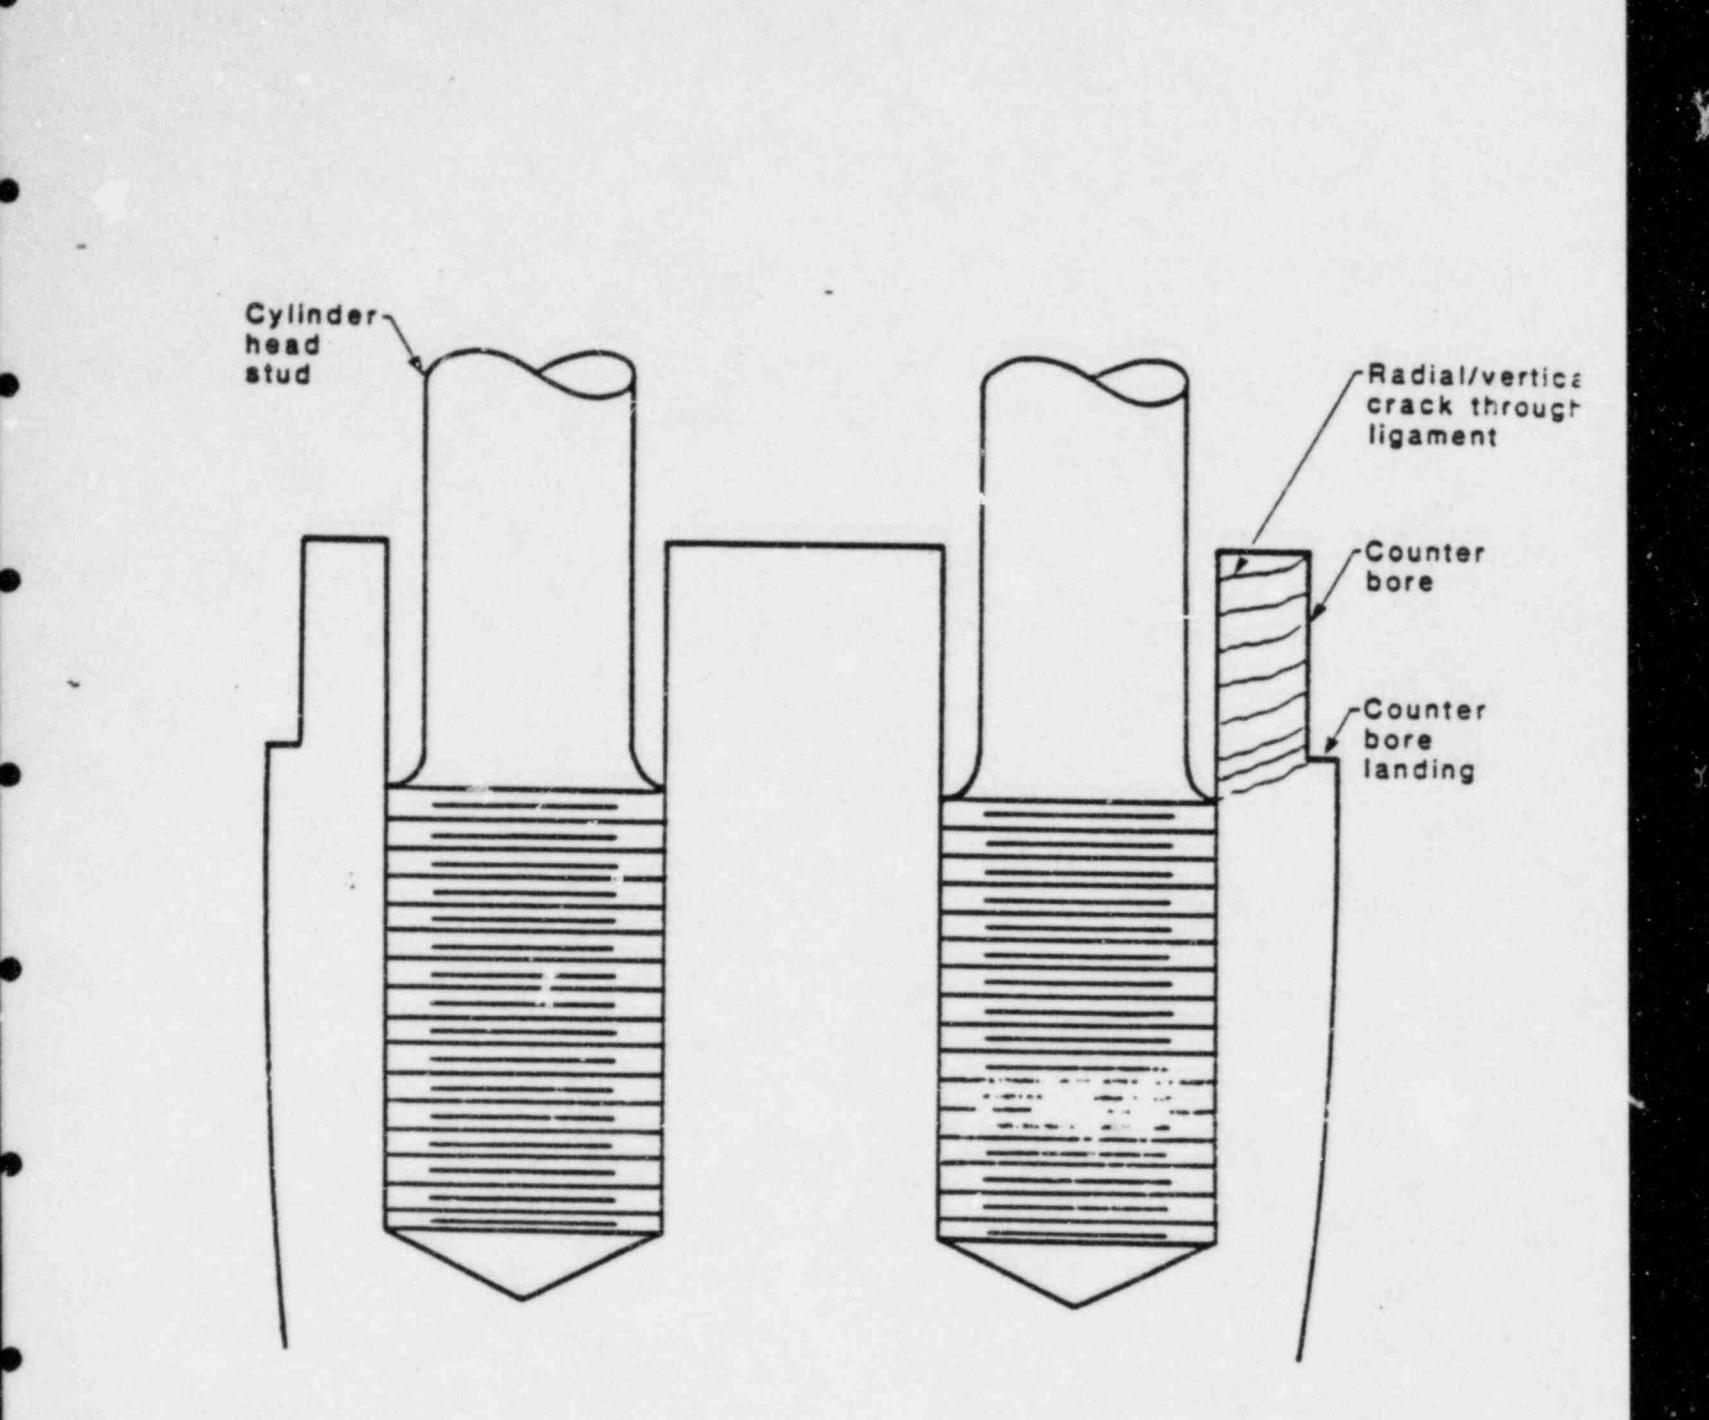
Figure 1-4. SNPS DG103 crack map as of 3/11/84.

Dimensions indicate crack depth

\*Top surface indication. No depth to crack measurable down stud hole
