LICENSEE EVENT REPORT (LER)

FACILITY NAME (1) Fort St. Vrain, Unit No. 1	DOCKET NUMBER (2) 0 5 0 0 0 2 1 6 7	PAGE (3) 1 OF 017
---	--	----------------------

TITLE (4)
During SR 5.1.2c-X, Only 1/2 Of Total RSD Material Was Discharged From CRD#21

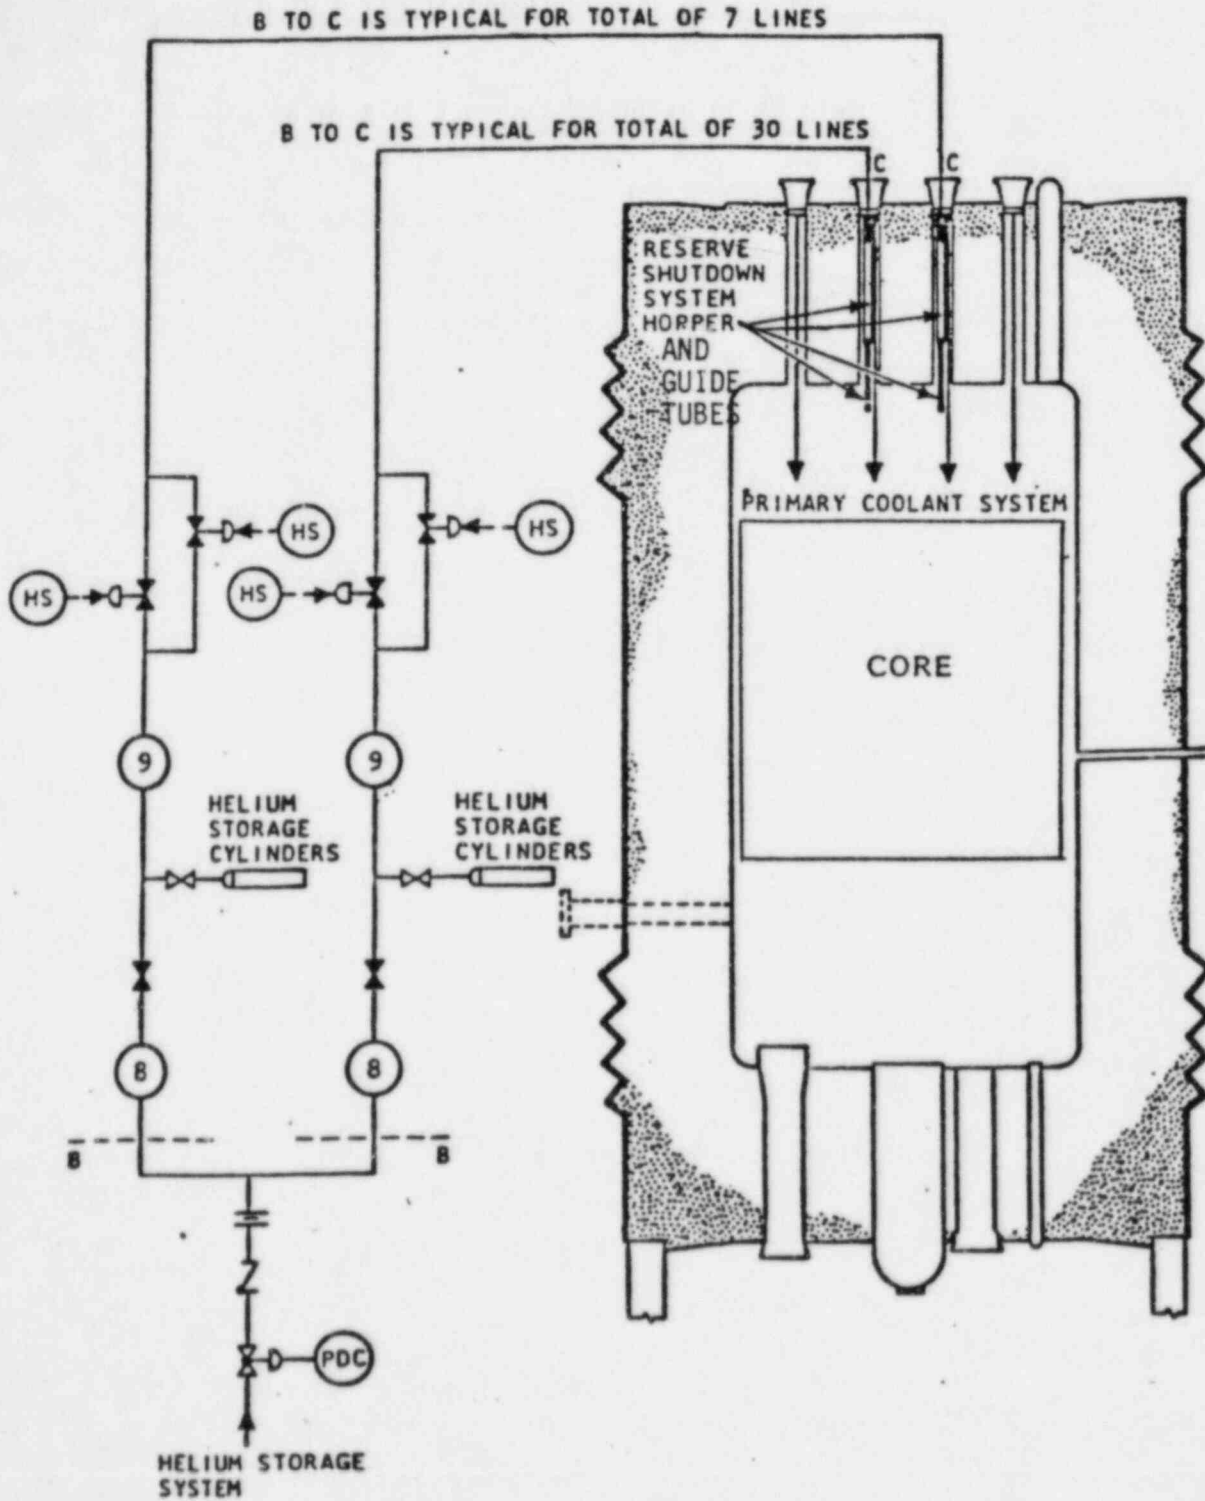
Upon discovering that only forty pounds of reserve shutdown material had been released during the test, maintenance personnel performed a visual inspection of the hopper internals using a borescope. The material that failed to discharge from the hopper was removed, and samples were collected for internal analysis. Samples were also sent to Los Alamos National Laboratories for Nuclear Regulatory Commission independent analysis.

Fig. 3. Reserve shutdown system flow diagram.

As mentioned previously, the cause and extent of this anomaly are presently under investigation, along with the development of an appropriate plan for corrective action prior to returning the plant to operation.
