SONGS 2 EMERGENCY DIESEL GENERATOR 2G003  
CAMSHAFT ASSEMBLY FAILURE  
RCE 91-022

## EXECUTIVE SUMMARY

### DESCRIPTION OF 2G003 FAILURE

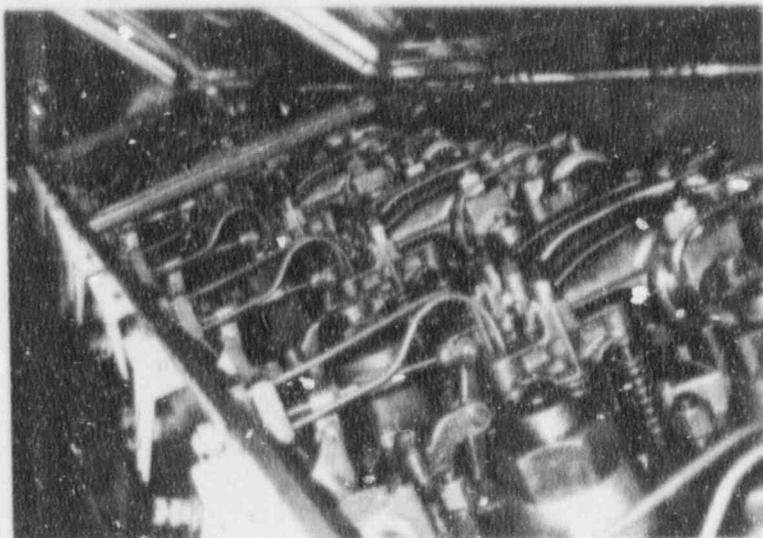
Figure B.2: Overall view of the left top deck area of the engine.

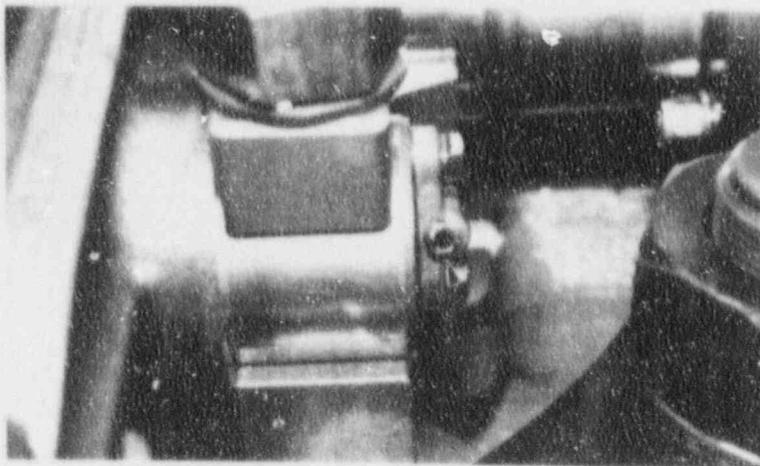
Figure B.6: View of the rocker arm end of the broken oil line that provided oil from bearing cap number 1 to the rocker arm assembly of cylinder number 20. The arrow points to the fracture surface. The oil line failure was considered a secondary event, as a result of the bearing cap coming loose.

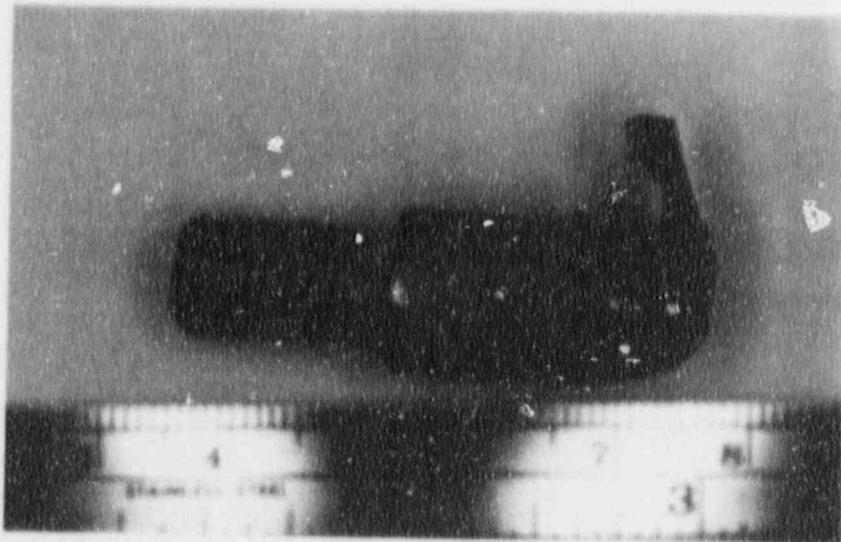
Figure E.2: View of dowel bolt number 1.

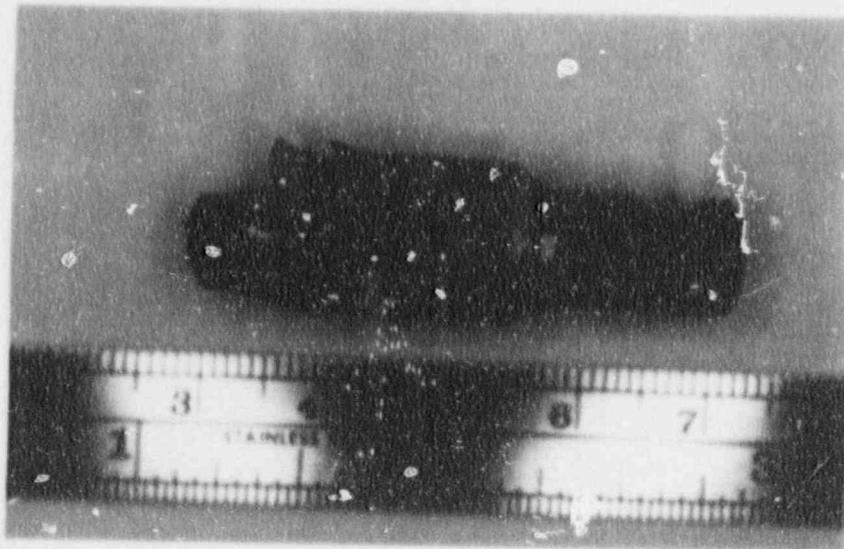
Figure E.3: View of dowel bolt number 2.

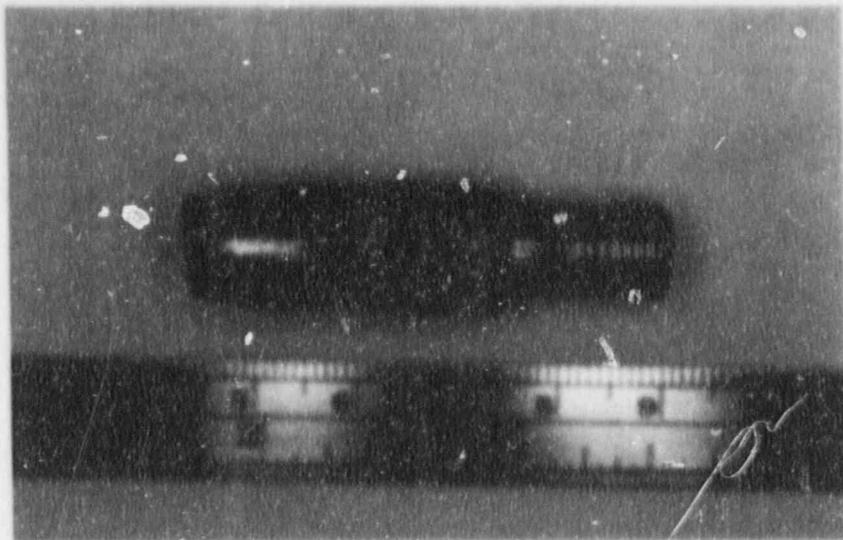
Figure E.4: View of dowel bolt number 3.

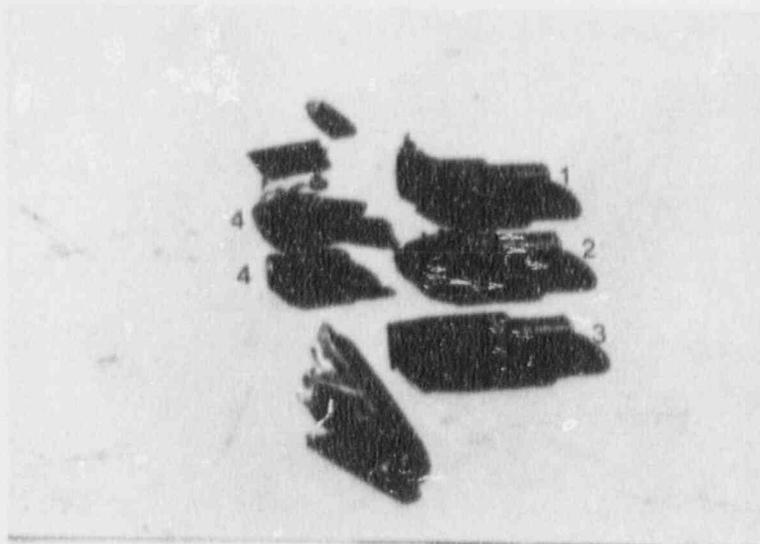
Figure E.5: View of fragments of the dowel bolts.

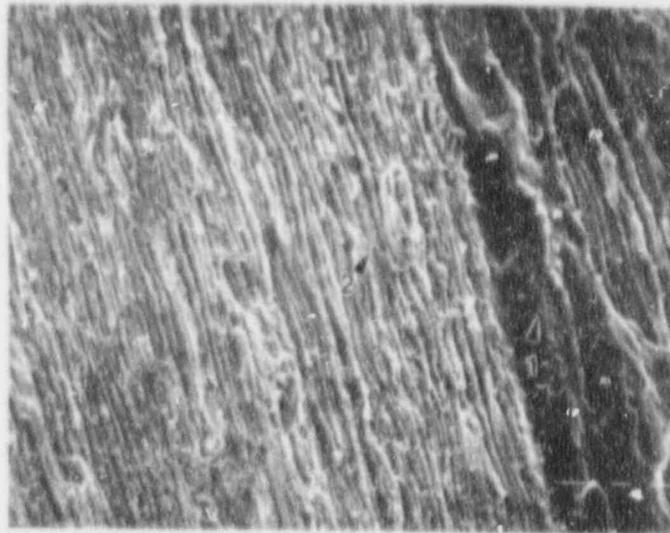
Figure E.7: SEM fractograph of fractured dowel bolt number 4, at 500 X magnification. Arrow 1 points to the location of a large sulfide stringer, and arrow 2 points to a sulfide inclusion.

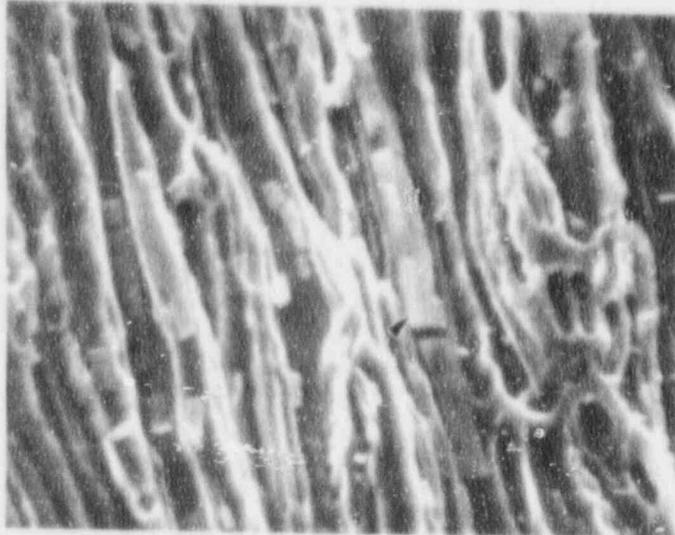
Figure E.8: SEM fractograph of fractured dowel bolt number 4, at 2000 X magnification. The arrow points to a sulfide inclusion.

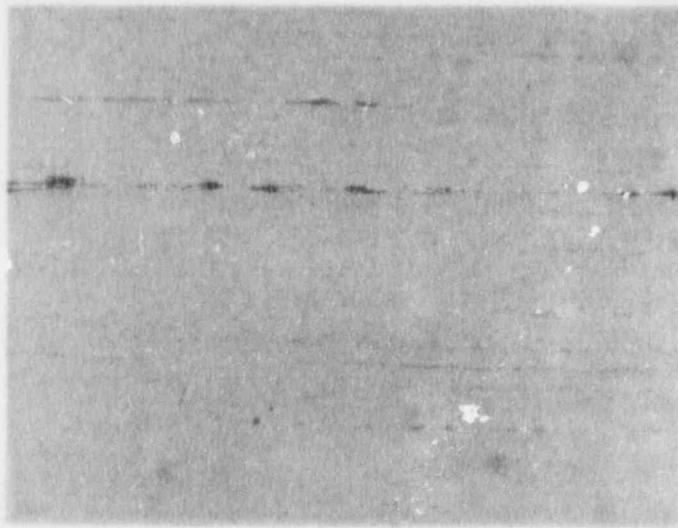
Figure E.10: Optical micrograph of dowel bolt number 3, with an as-polished surface, showing a sulfide stringer, at 100 X magnification.

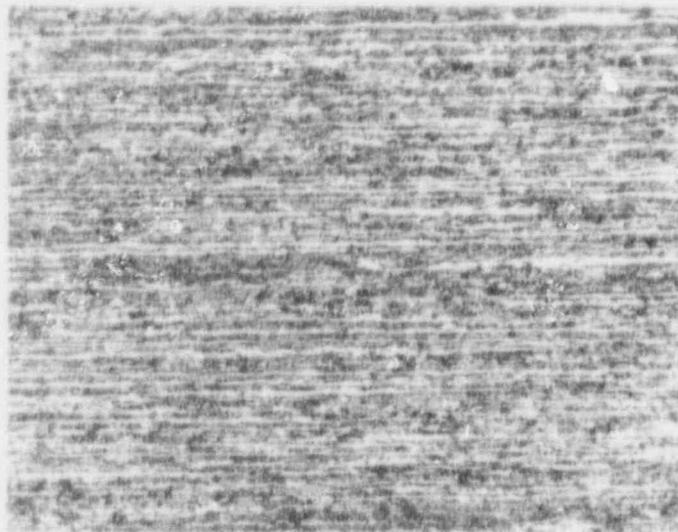
Figure E.11: Optical micrograph of dowel bolt number 3, showing banded microstructure (etched: vital), at 100 X magnification. The microstructure shows bands of ferrite (white paste) and pearlite (dark paste).

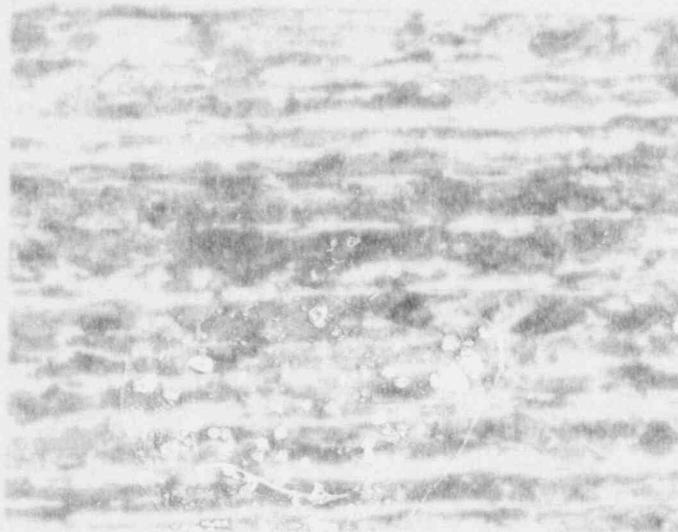
Figure E.12: Optical micrograph of dowel bolt number 3, showing the typical structure (etched: vital), at 400 X magnification. The microstructure shows bands of ferrite (white paste) and pearlite (dark paste).

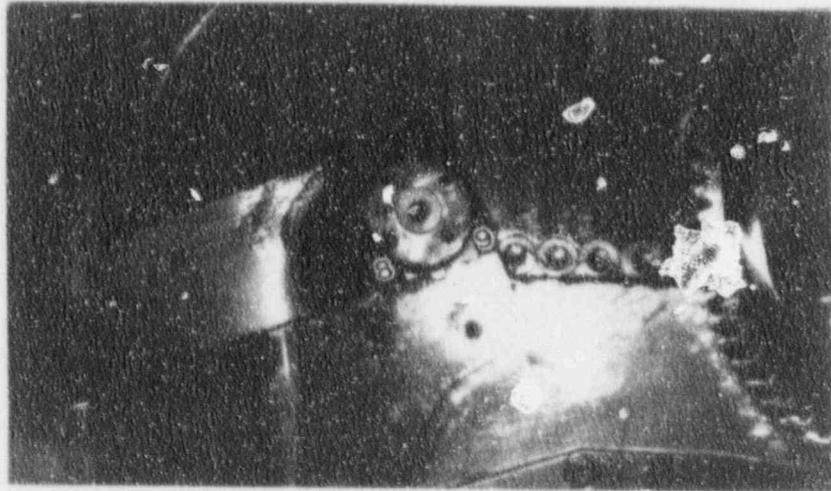
Figure F.2: View of the left rear end sheet of the 20 cylinder engine of 2G003, showing the location of the bolt holes for the 2 vertical bolts that attach the bracket to the engine end sheet.

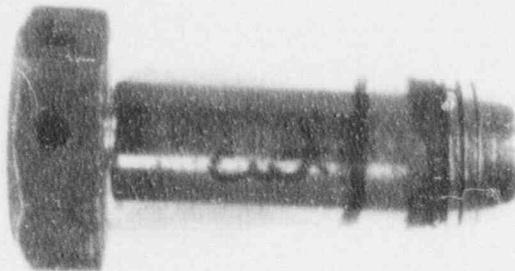
Figure F.3: View of the overall appearance of bolt number 3, illustrating the rubbing and polishing of remaining bolt threads.

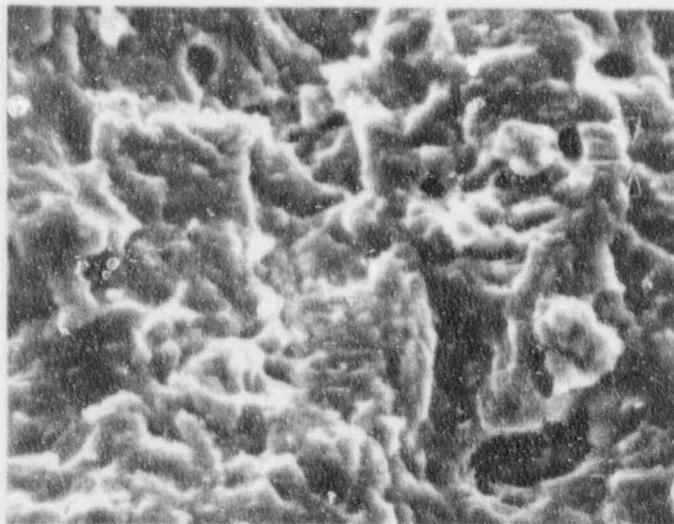
The 6 horizontal and 2 vertical bolts which hold the camshaft bracket to the end sheet failed by reverse bending fatigue followed by overload. Laboratory analysis determined that the bolts failed by overload after approximately 41,000 fatigue cycles. Since the EDG rotates at 900 rpm and is subject to 5th torsional resonance, 41,000 cycles equates to approximately 9 minutes of operation. Appendix F discusses in detail the failure analysis of the stubshaft bracket failure.

Figure F.5: SEM fractograph of bolt number 3, illustrating the fatigue zone. The arrows contain fatigue striations, and a rough estimate of the coarse fatigue striation was  $3.7 \times 10^4$  cycles. Taking into consideration the finer striations near the origin area, the total number of cycles would become  $4.1 \times 10^4$ .

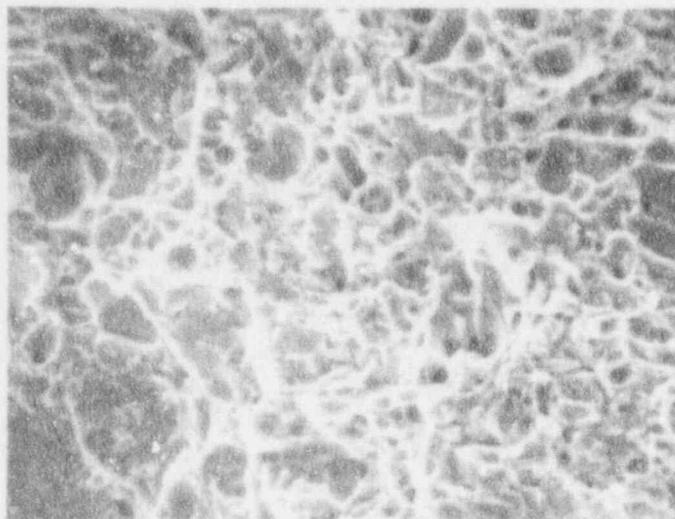
Figure F.6: SEM fractograph of bolt number 3, illustrating the overload zone as a dimple rupture which is indicative of the ductile behavior of the bolt, at 1000 X magnification.

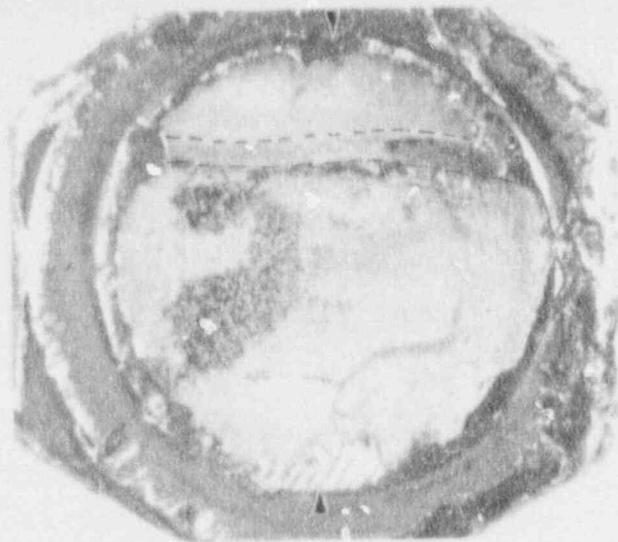
View of a macrofractograph of bolt number 1, illustrating reverse bending fatigue fracture. The overload zone is off center, indicating that the applied bending stresses were not equal in opposite loading directions. The arrows point to the fatigue initiation sites.

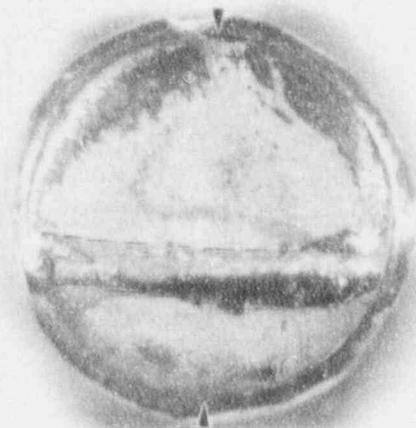
View of a fractograph of bolt number 5, illustrating reverse bending fatigue. The overload zone is bounded by the dotted lines and is only slightly off center, which is indicative of the reverse loading approaching uniaxial conditions.

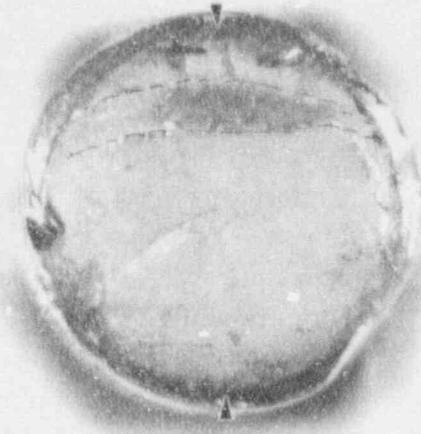
Figure F.10: View of a fractograph of bolt number 4, illustrating reverse bending fatigue. The overload zone is bounded by the dotted lines. The arrows in the figure point to fracture origins. The overload zone is off center which is indicative of unequal bending stresses.

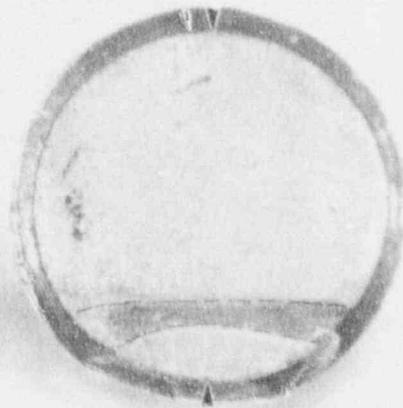
Figure F.11: View of a fractograph of bolt number 7, illustrating reverse bending fatigue. The overload zone is bounded by the dotted lines and the overload zone is off center which is indicative of unequal reverse bending loading.

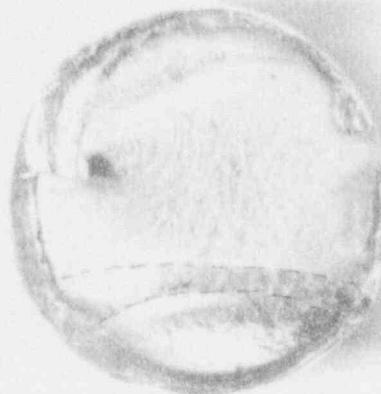
Figure F.12: View of a fractograph of bolt number 6, illustrating reverse bending fatigue. The overload zone is off center which is indicative of unequal bending stresses on both sides of the bolt.

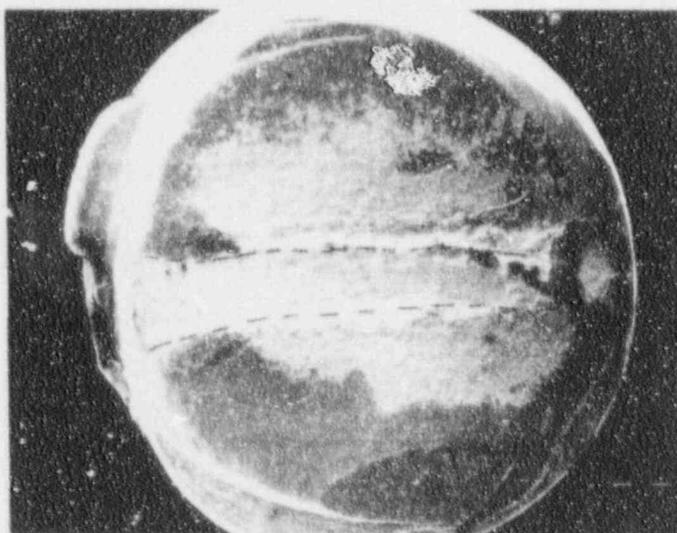
Figure F.14: View of the fracture surface of vertical bolt number 8, illustrating rubbing damage and reverse bending fatigue conditions. The location of the overload zone is in the center of the fracture face which is indicative of even reverse loading of bolt.

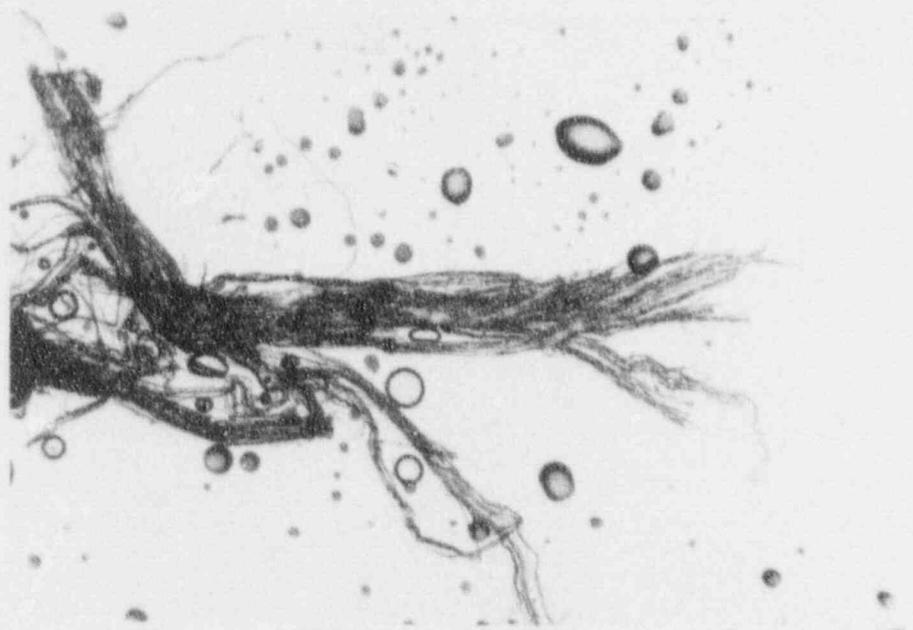
Figure H.2: View of found fragment fibers at 58 X magnification.

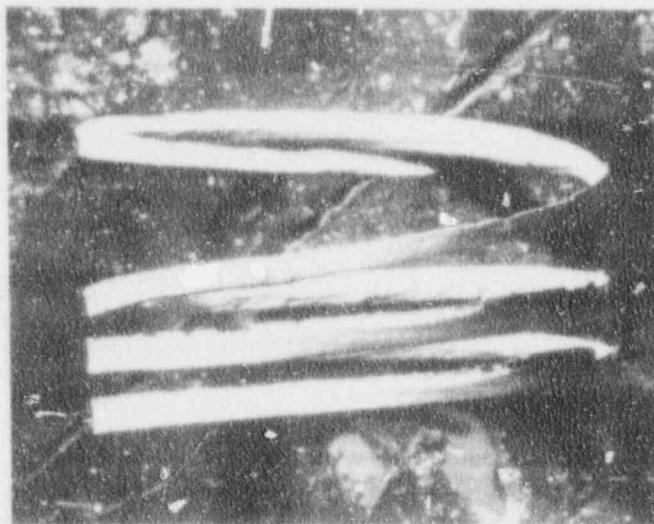
Figure G.2: SEM fractograph of stripped threads found entrapped on the threads of the outboard bolt of bearing block number 3, at 6 X magnification.

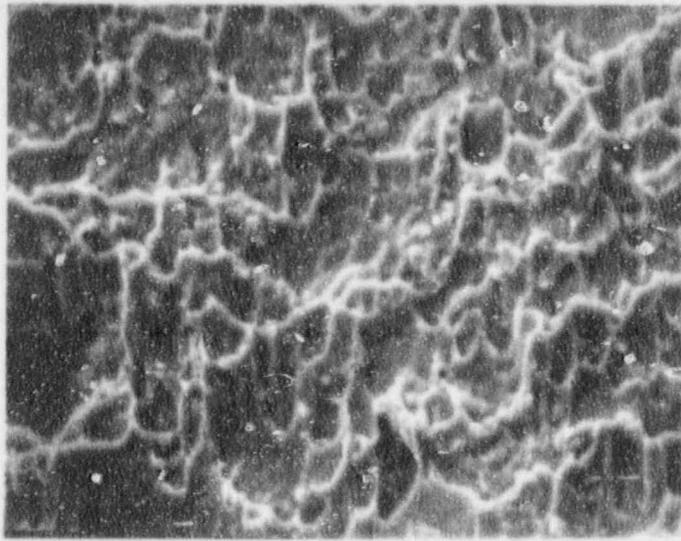
Figure G.4: Detail of sheared zone (B), as shown in Figure N.3, which illustrates elongated dimples typical of either a shear or tear fracture, at 1000 X magnification.

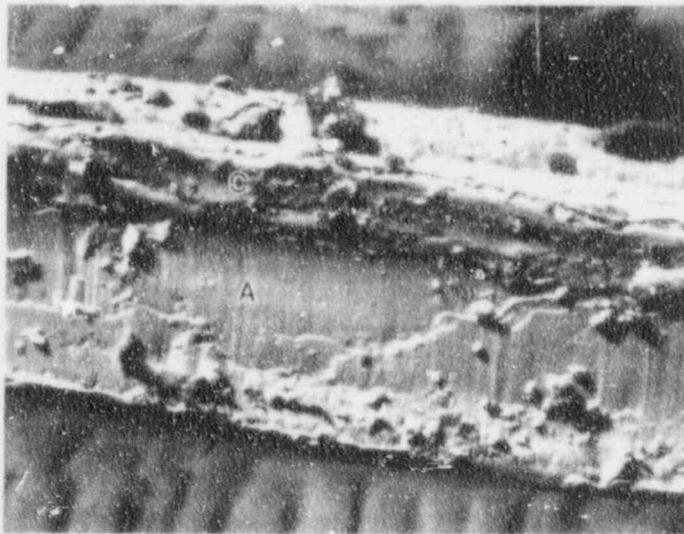
Figure G.5: SEM fractograph of the stripped threads obtained in the lab by cross-threading, illustrating the presence of a rubbed zone (A) in the direction shown, followed by a zone of cracking, tearing, and fragmentation (C), at 250 X magnification.

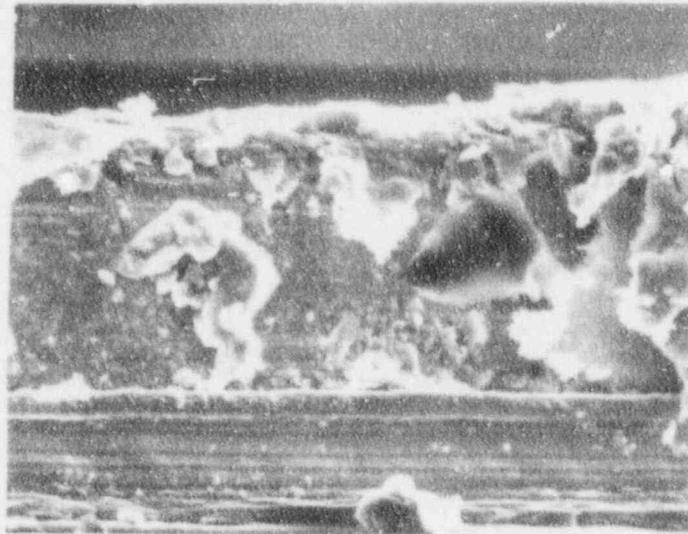
Figure G.6: SEM fractograph of the stripped threads obtained in the lab by cross-threading, at 500 X magnification.

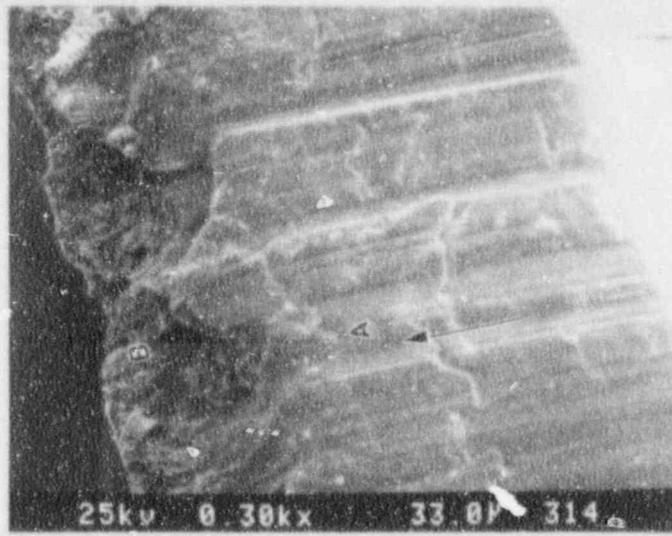
Figure G.7: SEM fractograph of the stripped threads obtained by tensile pull, at 300 X magnification. The photos are oriented 90° away from that of Figure G.3. The fracture surface shows two distinct zones, a rubbed zone (A) and a shear zone (B).

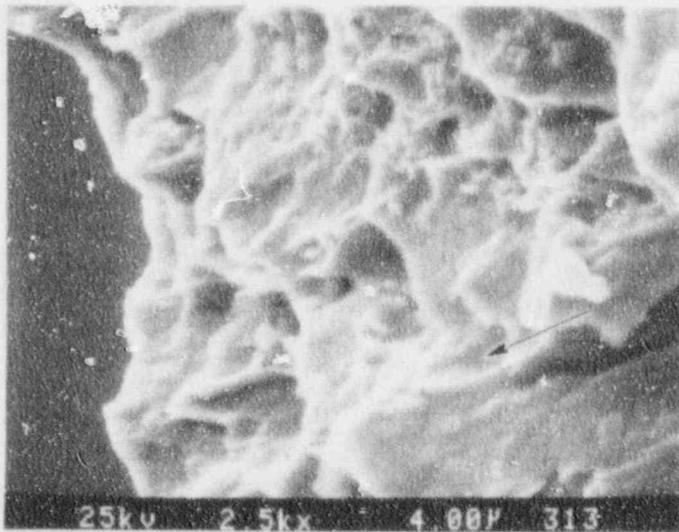
Figure G.8: SEM fractograph of the stripped threads obtained by tensile pull, at 2500 X magnification, illustrates shear elongated dimples in the shear zone.

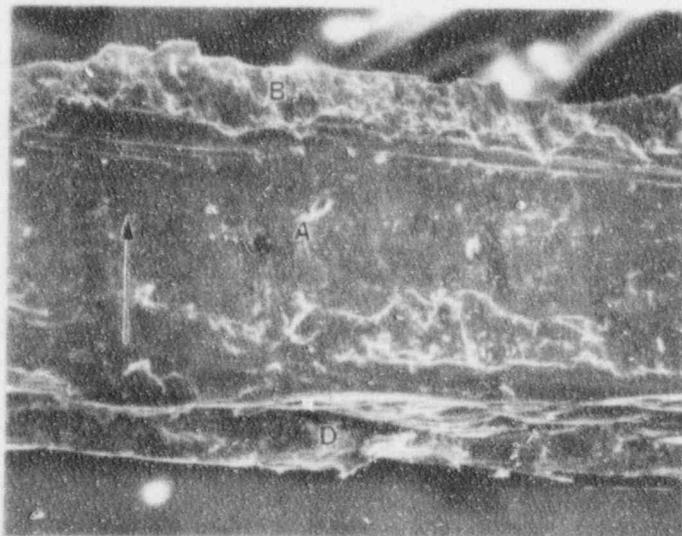
Figure G.9: SEM fractograph of the stripped threads obtained by overtorquing, illustrating the presence of three distinct zones, a tearing zone (D), a rubbed zone (A), and a shearing zone (B), at 150 X magnification.

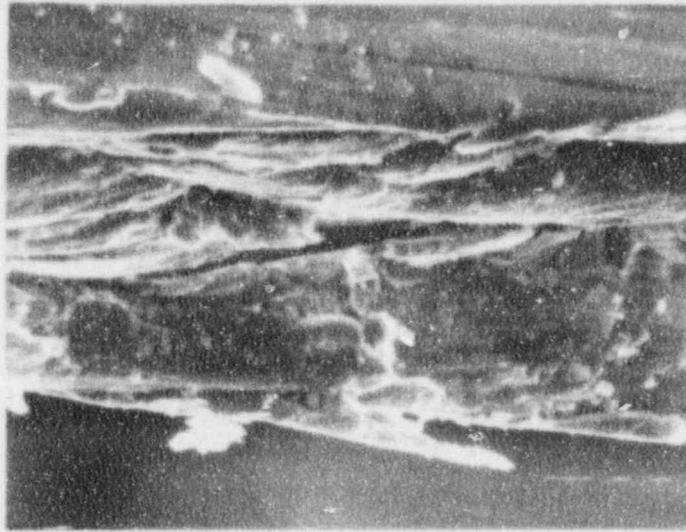
Figure G.10: SEM fractograph of the stripped threads obtained by overtorquing, illustrating the tearing zone, at 750 X magnification.

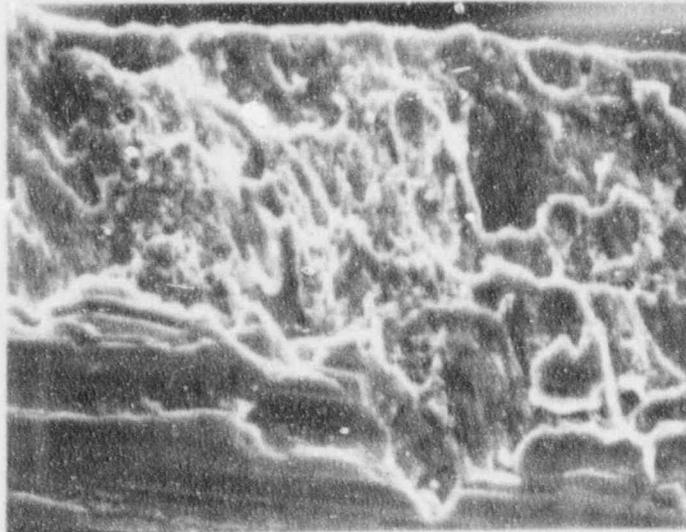
Figure G.11: SEM fractograph of the stripped threads obtained by overtorquing, illustrating the shearing zone, at 1000 X magnification.

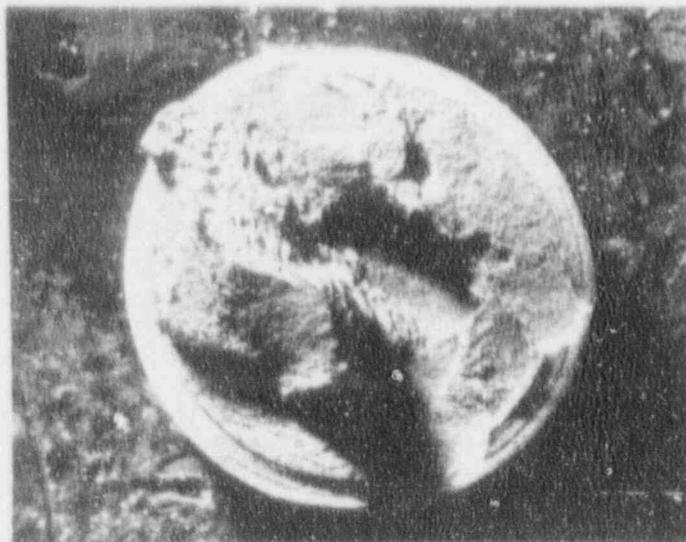
Figures K.3 to K.5, show the broken dowel bolt which has been identified as bolt number 1. The crack initiated in the root of the first thread, propagated in the transverse direction, and then propagated in the longitudinal direction. The change in direction has been attributed to the presence of longitudinal sulfide inclusions which were the path of least resistance for crack propagation. The fracture surface was fibrous in nature.

Figure K.3 is a macrophotograph of the fracture surface of the broken bolt. Figure K.4 is an optical photograph of a longitudinal microsection, in the as-polished condition, illustrating the presence of large sulfide stringers and fine sulfide inclusions. The sulfide stringers were quite large, and larger than the largest sulfide inclusion size identified by ASTM Standard E-45. Figure K.5 shows the longitudinal microstructure, in the as-etched condition, illustrating platelets of ferrite and pearlite.

Figure K.3: A macrophotograph of the fracture surface of broken bolt 1, at 7 X magnification.

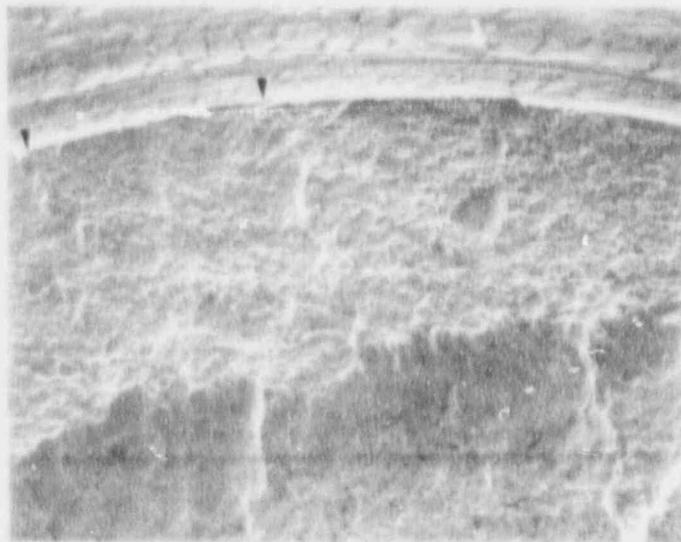
Figures K.6 through K.10, show the cracked dowel bolt which has been identified as bolt number 2. The crack initiated at the root of the first thread, propagated in the transverse direction, and then propagated in the longitudinal direction. The change in direction has been attributed to the presence of longitudinal sulfide inclusions which were the path of least resistance for the crack propagation.

Figure K.8: A SEM fractograph of cracked bolt number 2, illustrating details of the fracture surface of the crack, with the arrows illustrating hackle marks, at 60 X magnification.

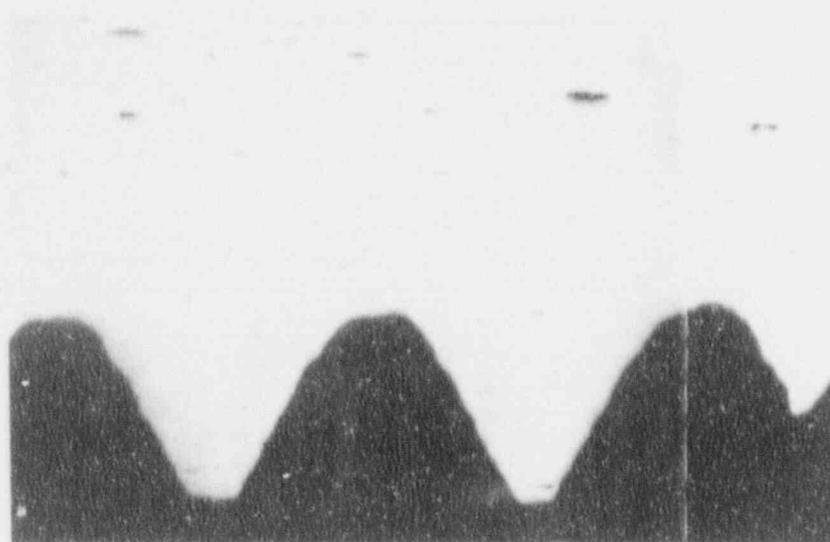
Figure K.9: An optical micrograph of cracked bolt 2, in the as-polished condition, illustrating the sulfide inclusion size and distribution, at 50 X magnification.

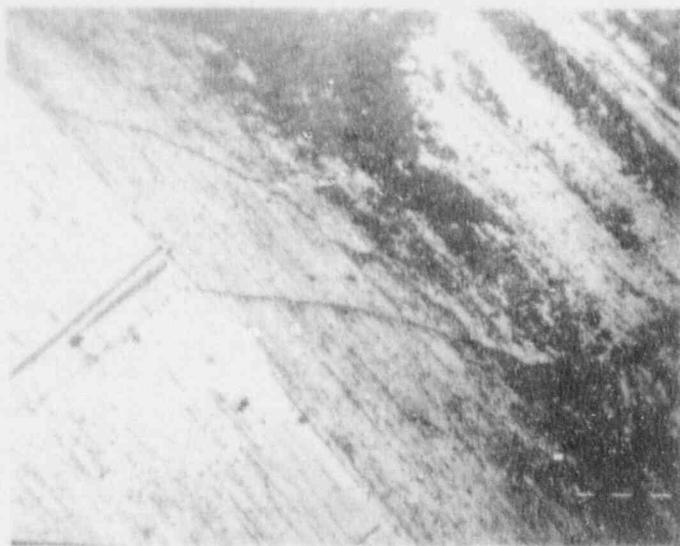
Figures K.11 through K.17, show the cracked dowel bolt which has been identified as bolt number 3. The crack initiated in the root of the first thread, propagated in the transverse direction, and then propagated in the longitudinal direction. The change in direction has been attributed to the presence of longitudinal sulfide inclusions which were the path of least resistance for crack propagation.

Figure K.12: A SEM photograph of cracked bolt 3, illustrating crack branching and propagation in the longitudinal direction, at 25 X magnification.

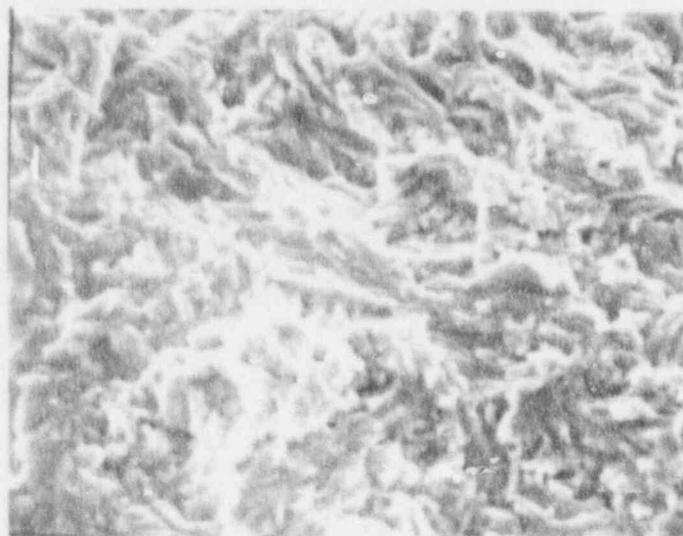
Figure K.15: A SEM photograph of cracked bolt 3, illustrating the fatigue zone of the fracture surface of the crack, at 1000 X magnification.

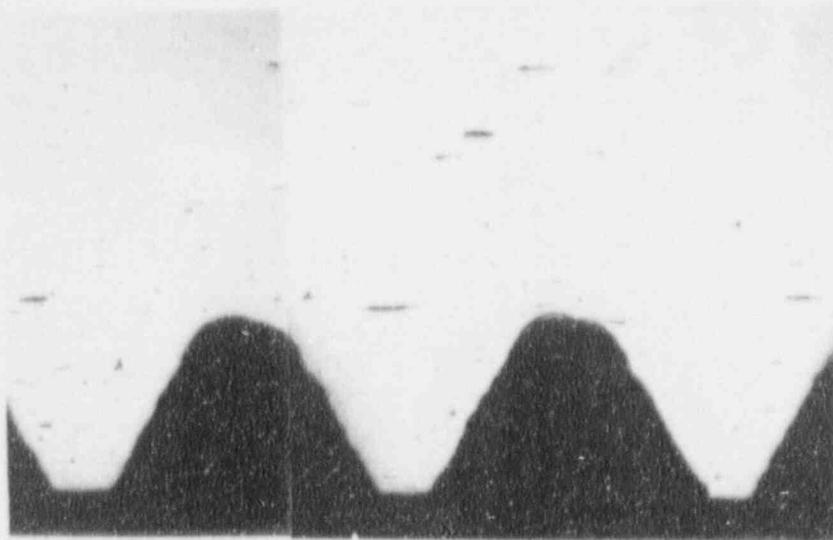
Figure K.16: A photograph of the longitudinal microstructure of cracked bolt 3, in the as-polished condition, illustrating the distribution and size of stringers, at 50 X magnification.

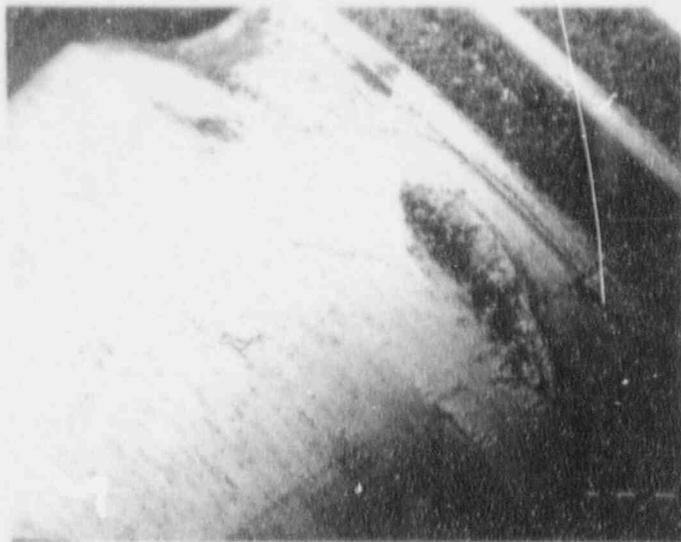
Figure K.19: A SEM photograph of cracked bolt 4, illustrating crack branching and propagation in the longitudinal direction, at 15 X magnification.

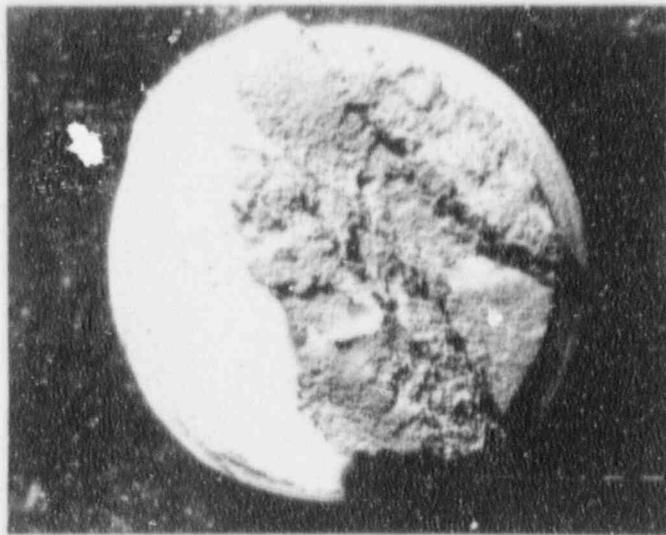
Figure K.20: A SEM photograph of cracked bolt 4, illustrating crack propagation to approximately 67 percent of the cross section of the bolt, at 6 X magnification.

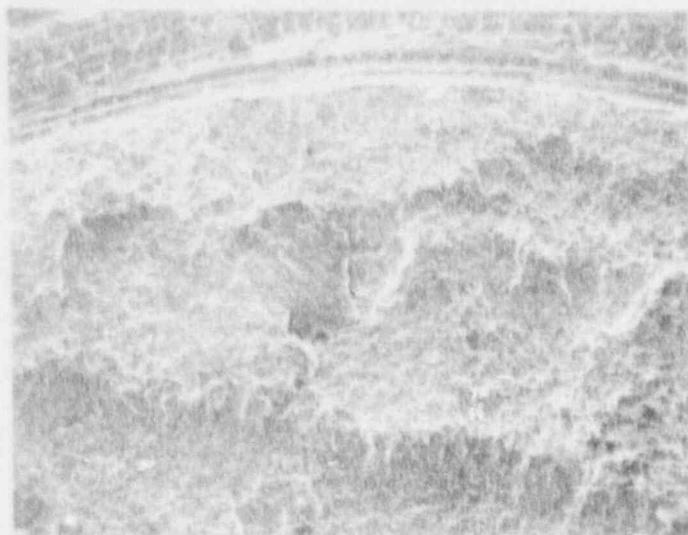
Figure K.21: A SEM photograph of cracked bolt 4, illustrating the fatigue zone of the fracture surface, at 50 X magnification.

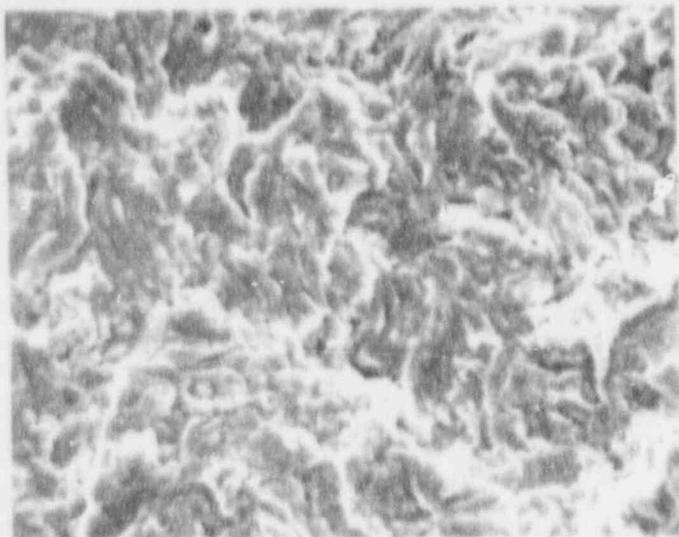
Figure K.22: A SEM photograph of cracked bolt 4, illustrating the fatigue zone of the fracture surface, at 1000 X magnification.

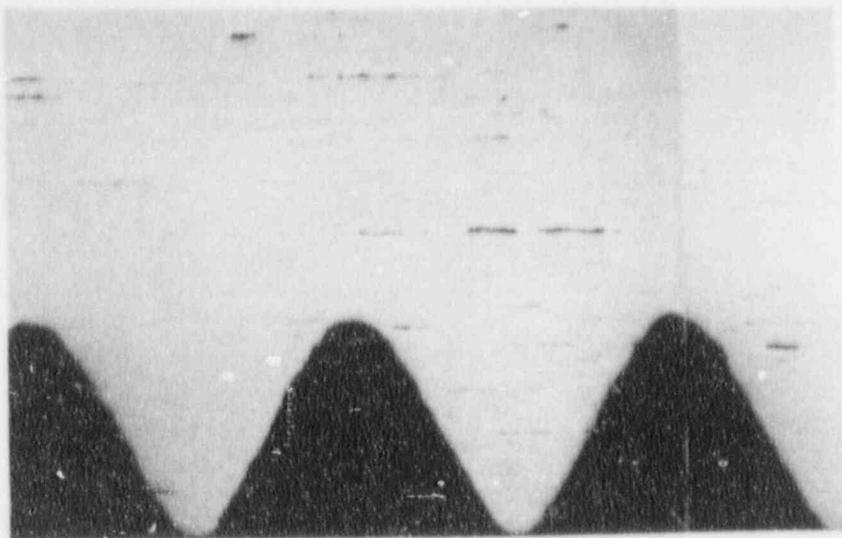
Sulfide inclusions were found in all 4 dowel bolts. However, the broken dowel bolt was found to have a higher population and larger size of sulfide inclusions than the 3 cracked bolts.

Figure K.23: A photograph of the longitudinal microstructure of cracked bolt 4, in the as-polished condition, illustrating the distribution and size of sulfide inclusions, at 50 X magnification.

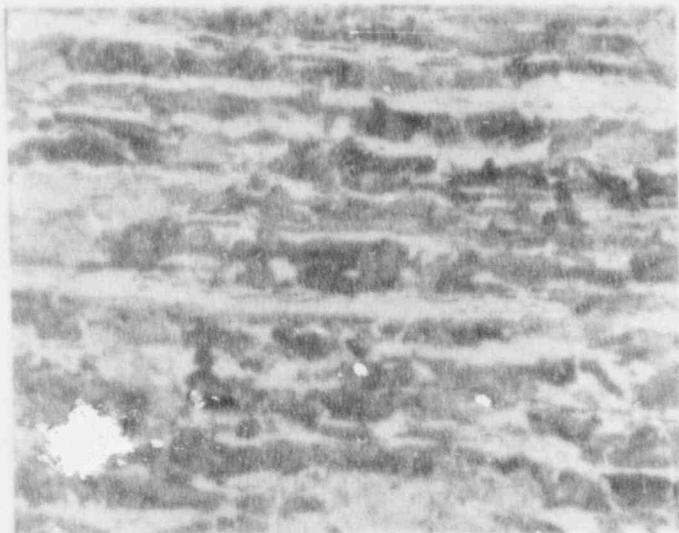
Figure K.24: A photograph of the longitudinal microstructure of cracked bolt 4, in the as-etched condition, illustrating platelets of ferrite and pearlite, at 400 X magnification.

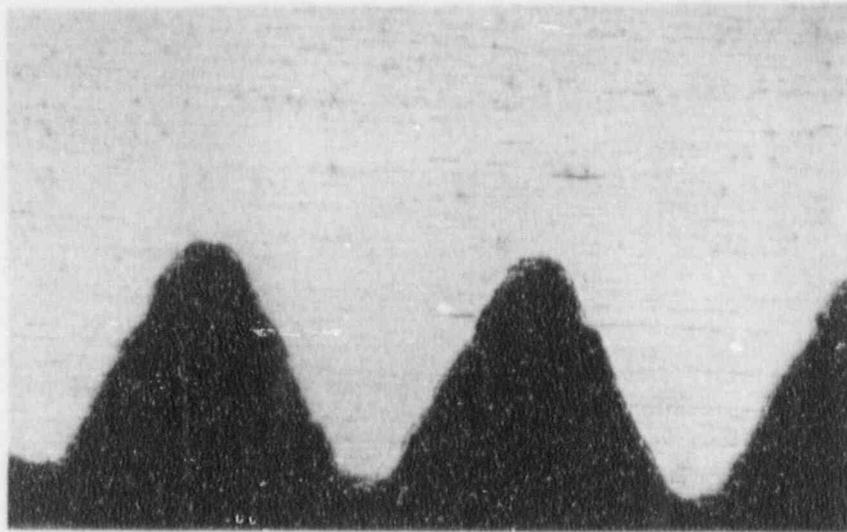
The analysis of the sampled dowel bolts indicated an absence of large sulfide inclusions. The sulfide distribution was acceptable and the batches of new dowel bolts were approved for use in the EDGs.

Figure L.1: Photograph of the longitudinal microsection, in the as-polished condition, of the Batch 1 Sample 1 dowel bolt, illustrating a relatively small population of small sulfide inclusions, at 50 X magnification.

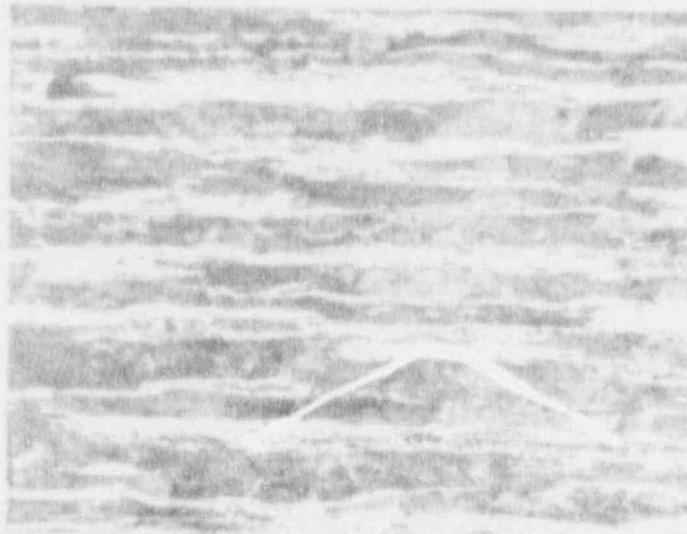
Figure L.2: Photograph of the longitudinal microsections, in the as-etched condition, of the Batch 1 Sample 1 dowel bolt, illustrating platelets of ferrite and pearlite, at 400 X magnification.

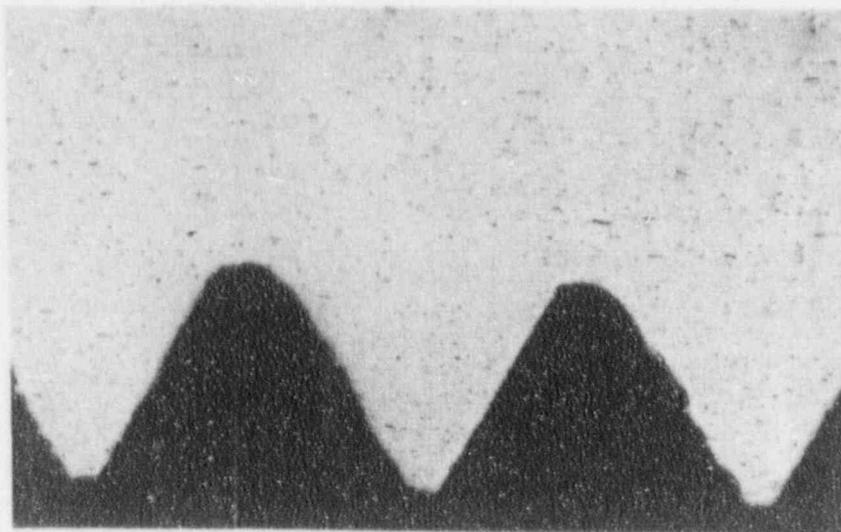
Figure L.3: Photograph of the longitudinal microsection, in the as-polished condition, of the Batch 1 Sample 2 dowel bolt, illustrating a relatively small population of small sulfide inclusions, at 50 X magnification.

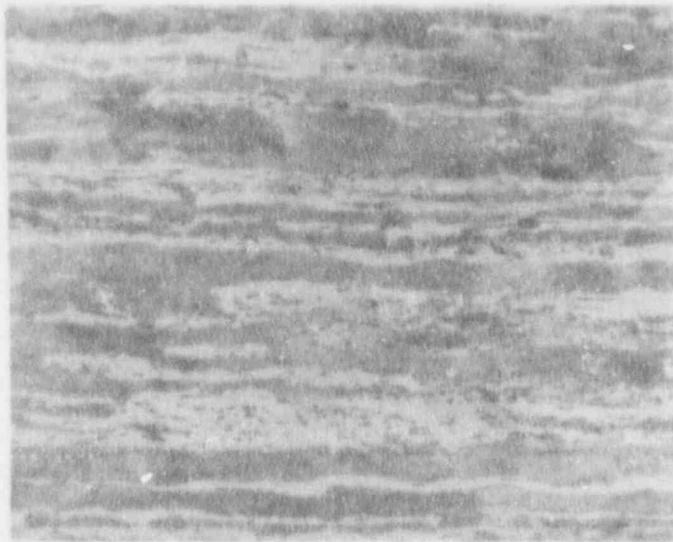
Figure L.4: Photograph of the longitudinal microsections, in the as-etched condition, of the Batch 1 Sample 2 dowel bolt, illustrating platelets of ferrite and pearlite, at 400 X magnification.

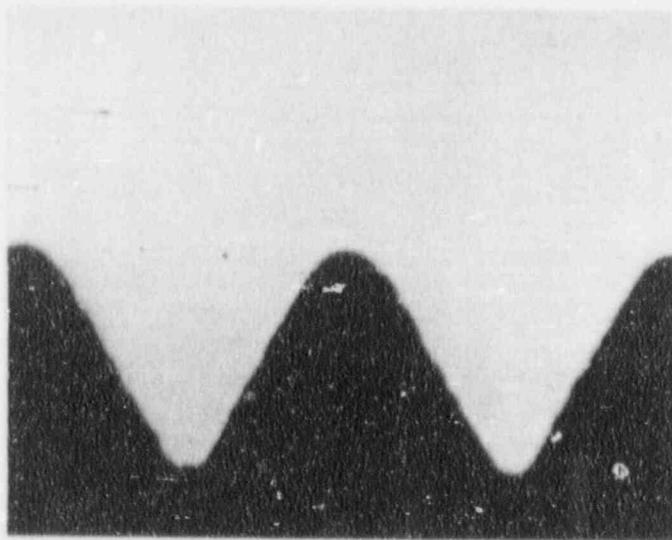
Figure L.5: Photograph of the longitudinal microsection, in the as-polished condition, of the Batch 2 Sample 1 dowel bolt, illustrating a relatively small population of small sulfide inclusions, at 50 X magnification.

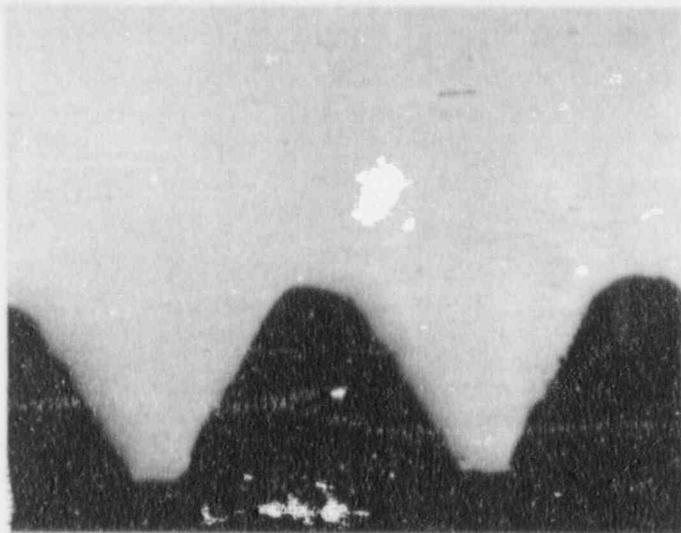
Figure L.7: Photograph of the longitudinal microsection, in the as-polished condition, of the Batch 2 Sample 2 dowel bolt, illustrating a relatively small population of small sulfide inclusions, at 50 X magnification.

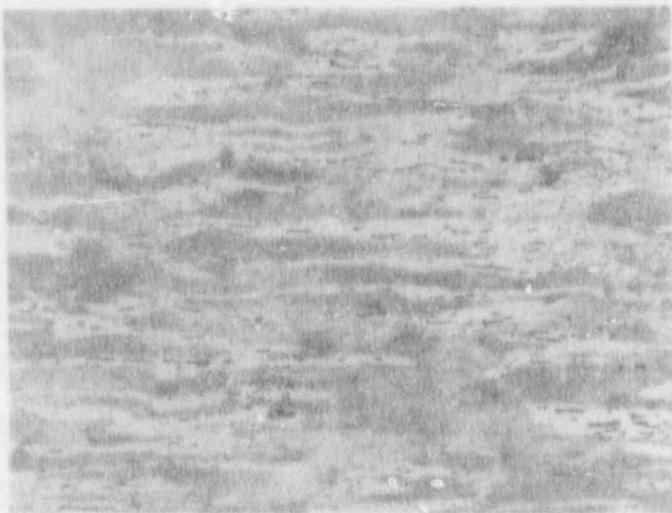
Figure L.8: Photograph of the longitudinal microsections, in the as-etched condition, of the Batch 2 Sample 2 dowel bolt, illustrating platelets of ferrite and pearlite, at 400 X magnification.

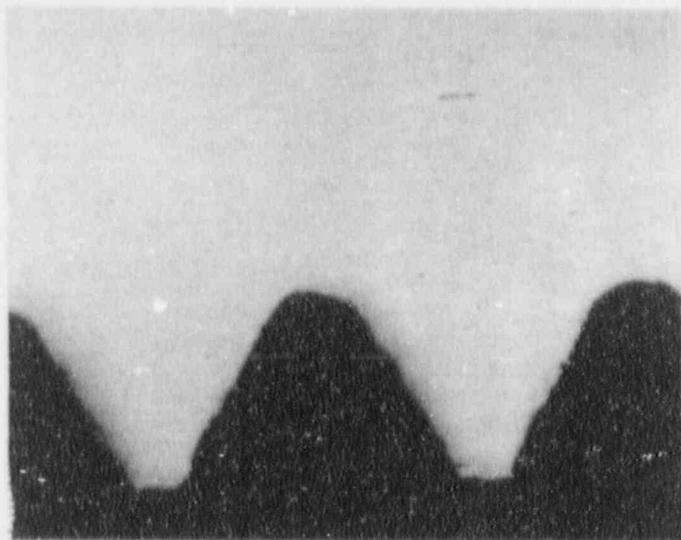
Figure L.7: Photograph of the longitudinal microsection, in the as-polished condition, of the Batch 2 Sample 2 dowel bolt, illustrating a relatively small population of small sulfide inclusions, at 50 X magnification.

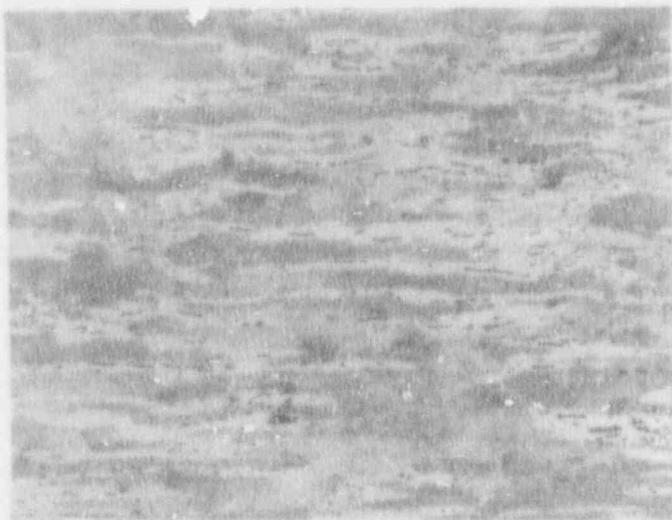
Figure L.8: Photograph of the longitudinal microsections, in the as-etched condition, of the Batch 2 Sample 2 dowel bolt, illustrating platelets of ferrite and pearlite, at 400 X magnification.
