U.S. NUCLEAR REGULATORY COMMISSION

Report No. 50-440/92004(DRS)

Facility Name: Perry Nuclear Power Plant

Inspection on March 26 - June 23, 1992 (Report No. 50-440/92004(DRS))

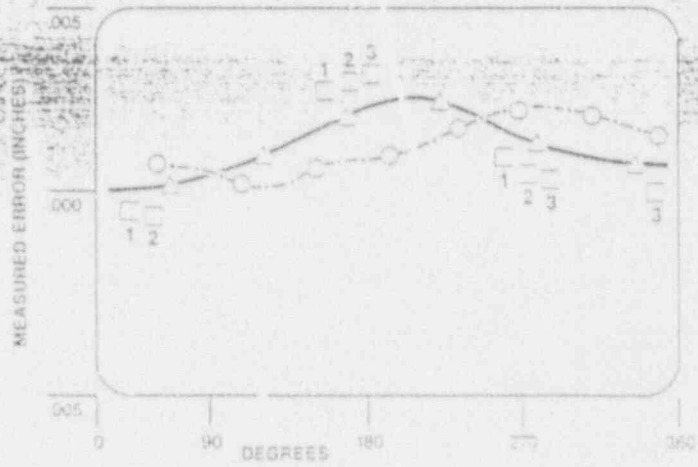
(F1) CONCENTRICITY DATA (F3) RIB STRAIGHTNESS  
(F2) RIB TO FLANGE ALIGNMENT (F4) REPORT PRINT

TYPE: MSIV A.M. 260 DI  
TIME: 13:05:03 LOCATION: TEST SITE 1 DATE: 4-19-91
