NUREG/CR-5892
UCRL-ID-113638

Highway Accident Involving Unirradiated Nuclear Fuel in Springfield, Massachusetts, on December 16, 1991

Presented to
the Nuclear Regulatory Commission

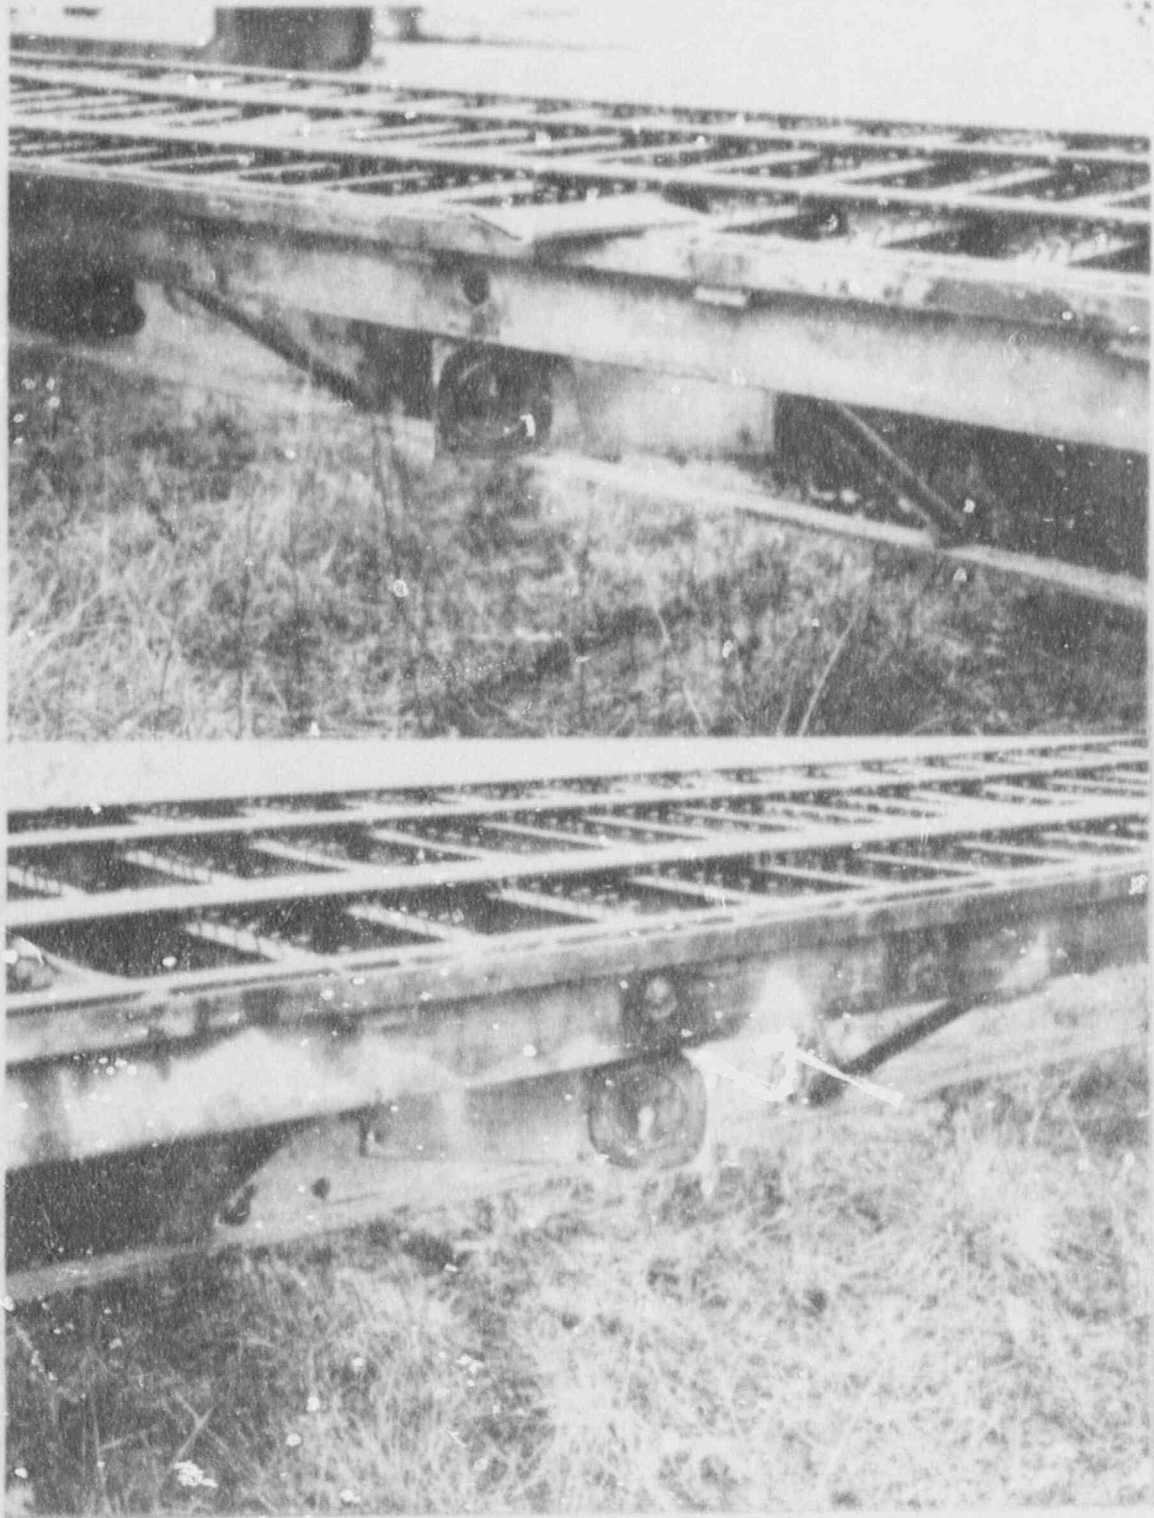
Figure 4.7 Photographs of Turn Warning Signs on Trailer

As a result of the fire, all of the non-metal components of the tractor and trailer were consumed and the tractor was reduced to a pile of rubble with only major drive train elements identifiable (see Figure 4.8). The trailer retained its shape and was easily recognizable as a trailer but all wood and rubber components were consumed by the fire. At the center of the trailer, the warning signs indicating wide right turns and the plastic reflectors were intact and the lettering was almost intact (see Figure 4.7).

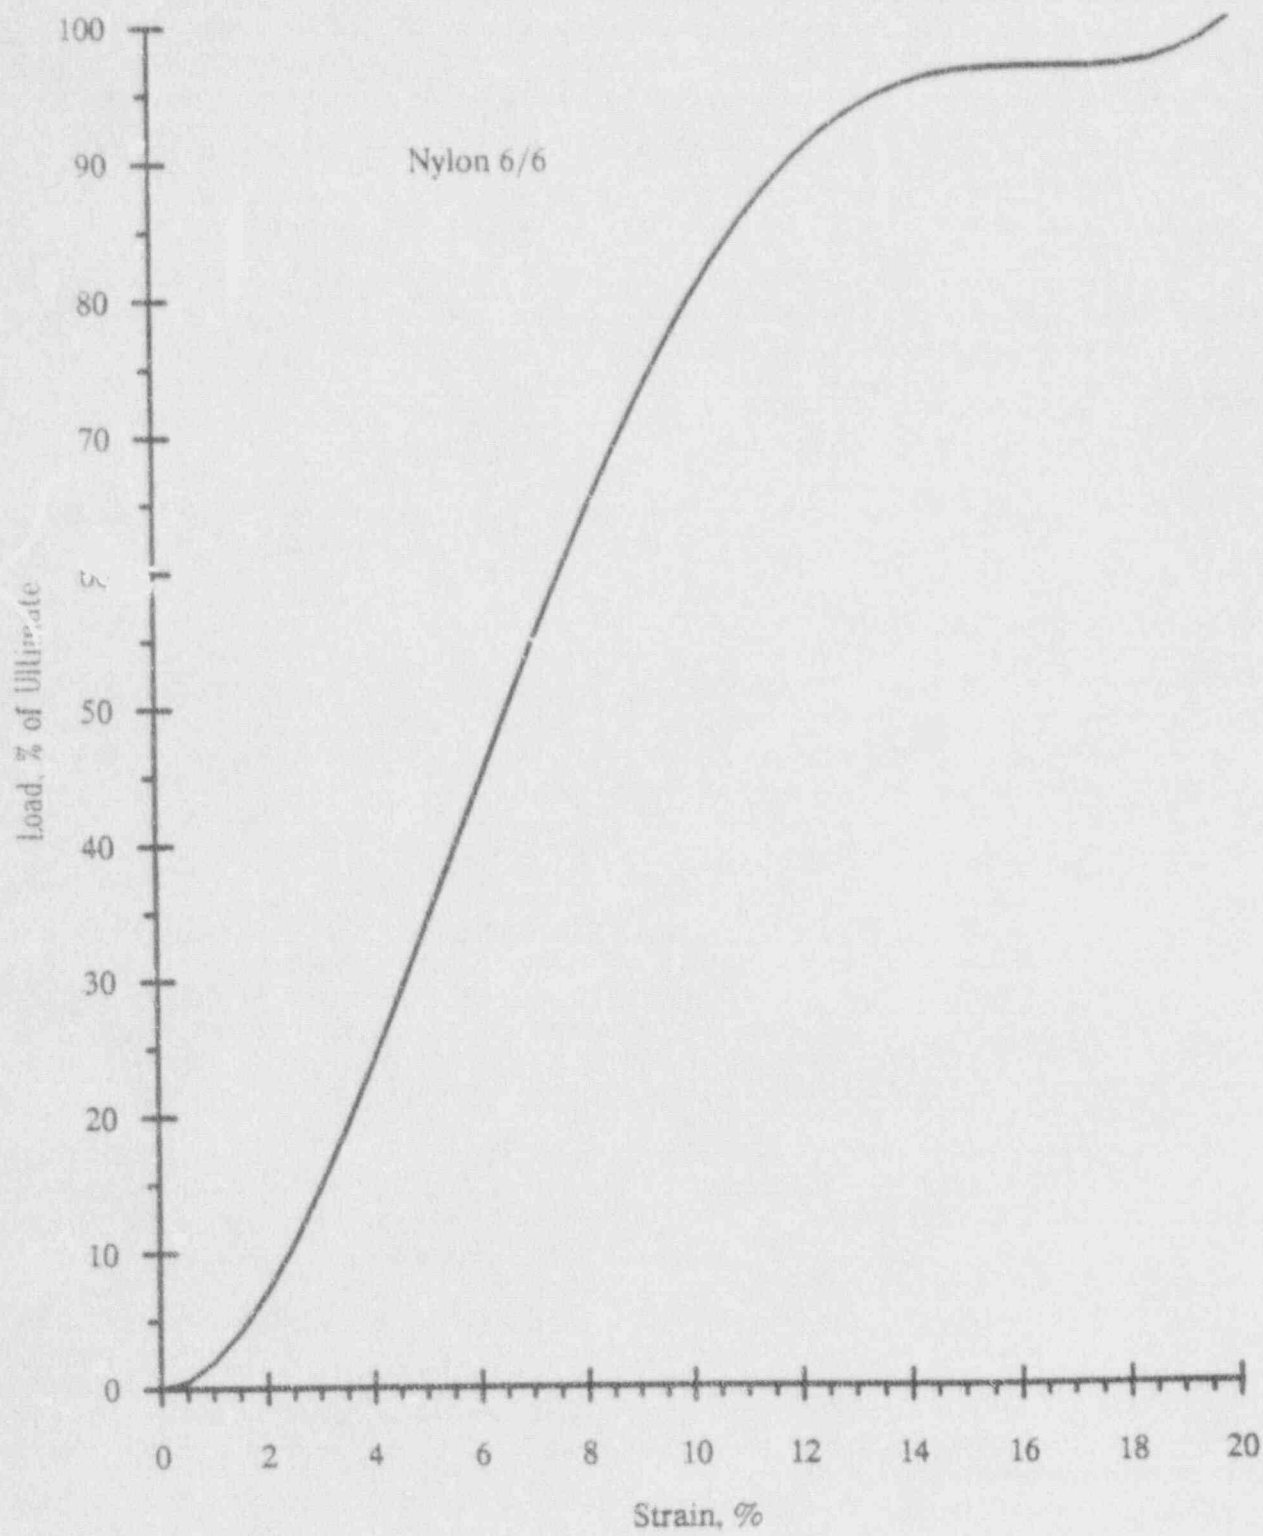
Figure 5.1 Load-Strain Curve for Nylon Straps

The tie-downs described in Section 3.3 are nylon straps fastened to the two sides of the trailer and passing over the containers. It is impossible to obtain samples of the nylon straps used on the truck involved in the accident because they melted and/or were burned during the fire. However, the data presented in Figure 5.1 (Grayson, 1984) is representative of the type of nylon that was used for straps of this type. Contacts with vendors of nylon straps for truck tie-downs have confirmed key elements in this figure so it can be used to represent the tensile properties of nylon straps for this analysis. GE requires that McGill Carriers have records of pull tests on each nylon strap that shows that the breaking strength is greater than 13,000 lb. When new, nylon straps typically have a breaking strength near 20,000 lb which provides an adequate margin to assure that the effects of age, wind damage, ultraviolet damage and other effects will not reduce the breaking strength below the required value.

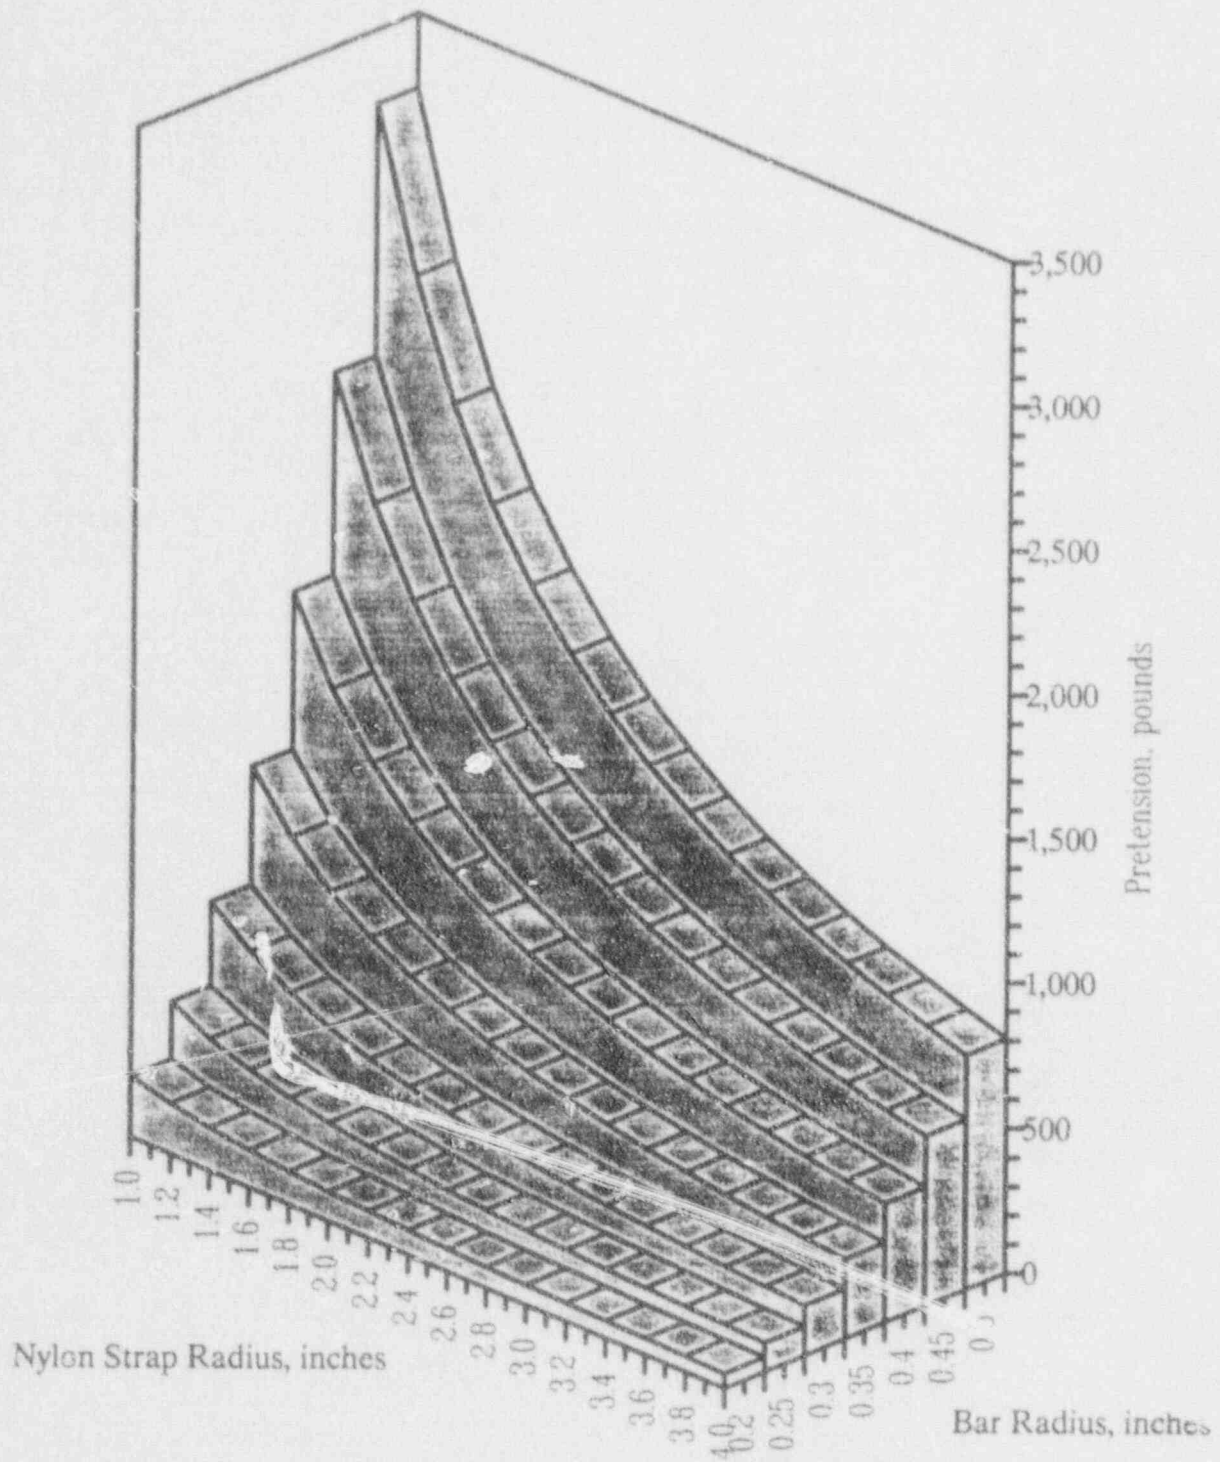
Figure 5.2 Pre-tension of Nylon Strap

A plot of the pre-tension as a function of the radius of the bar, R , and the radius of the roll of nylon strap on the ratchet, r , is presented in Figure 5.2. The maximum value of pre-tension is independent of the properties of the nylon strap and is less than 3,500 lb for all realistic values of the size of the bar and the amount of nylon strap that remains on the ratchet. Consequently, all additional analyses that utilize the pre-tension of the nylon strap will treat 3,500 lb as the upper bound of the pre-tension.

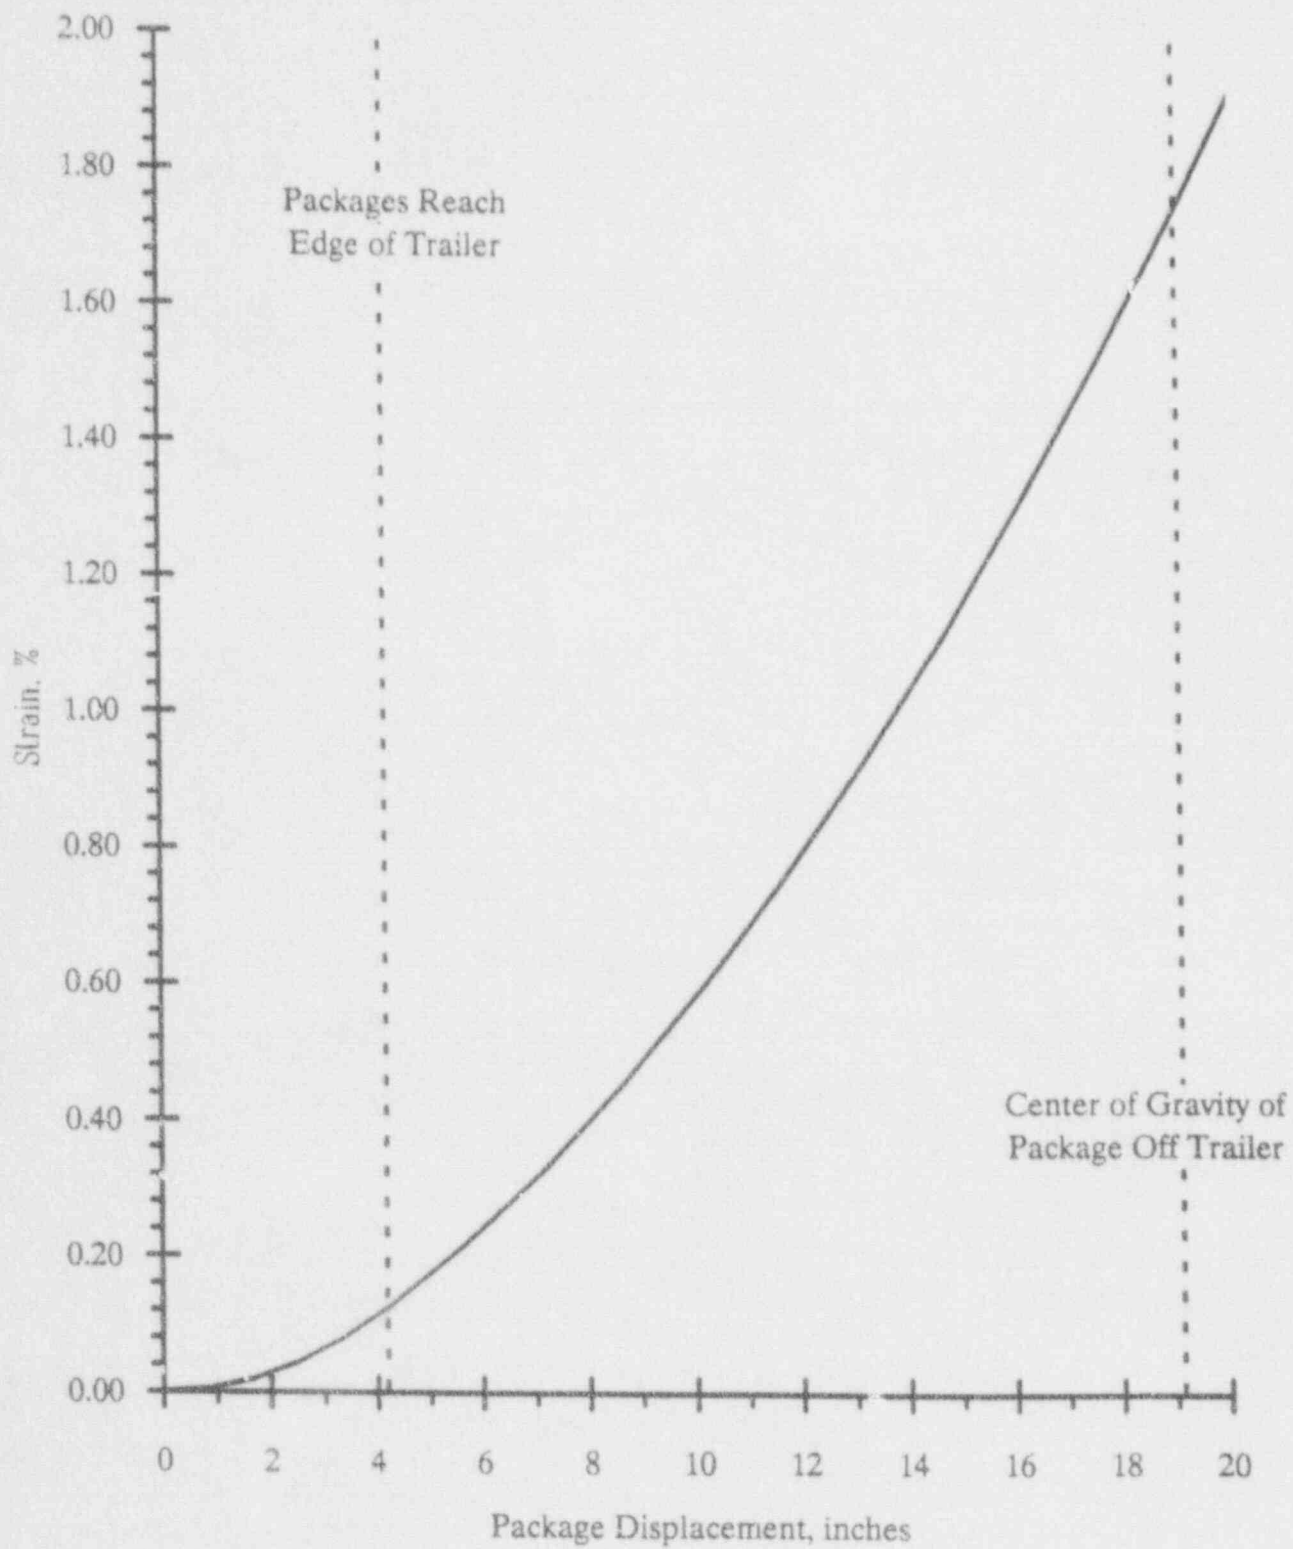
Figure 5.3 Strain in Tie-down Assuming No Friction Under Tie-down

The strain induced in the nylon strap is plotted as a function of the displacement of the containers in Figure 5.3. The strain can be converted to tension by referring to Figure 5.1, and the tension in the nylon strap is plotted in Figure 5.4 as a function of the displacement of the containers for several values of the pre-tension. Figure 5.4 assumes that the ultimate strength (100% load in Figure 5.1) is 13,000 lb. Since the containers remained on the trailer during the impact portion of the containers, it can be concluded that the

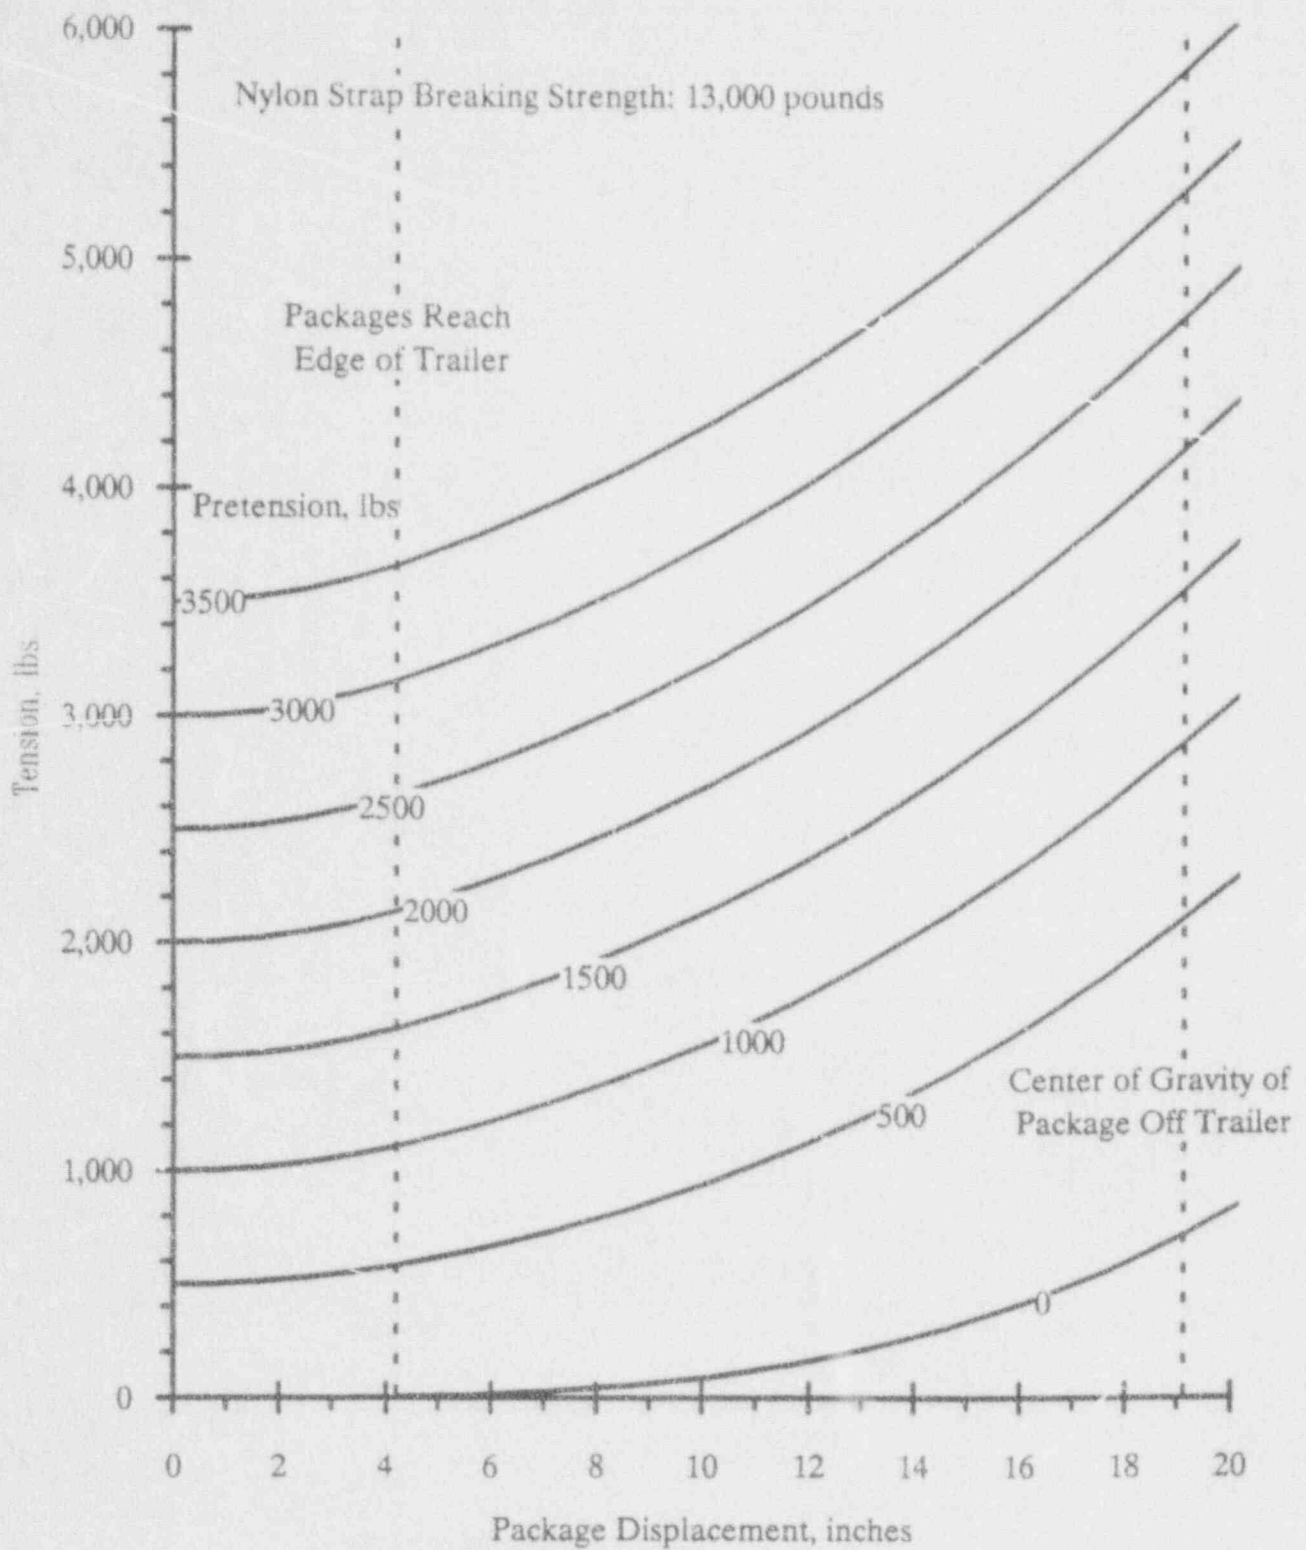
Figure 5.4 Tension in Tie-down Assuming No Friction Under Tie-Down

Assuming the containers moved to the point where the center-of-gravity of the outer container was at the edge of the trailer, the maximum tensile load in the nylon straps would be less than 6,000 lb which is well below the breaking strength of the nylon straps.

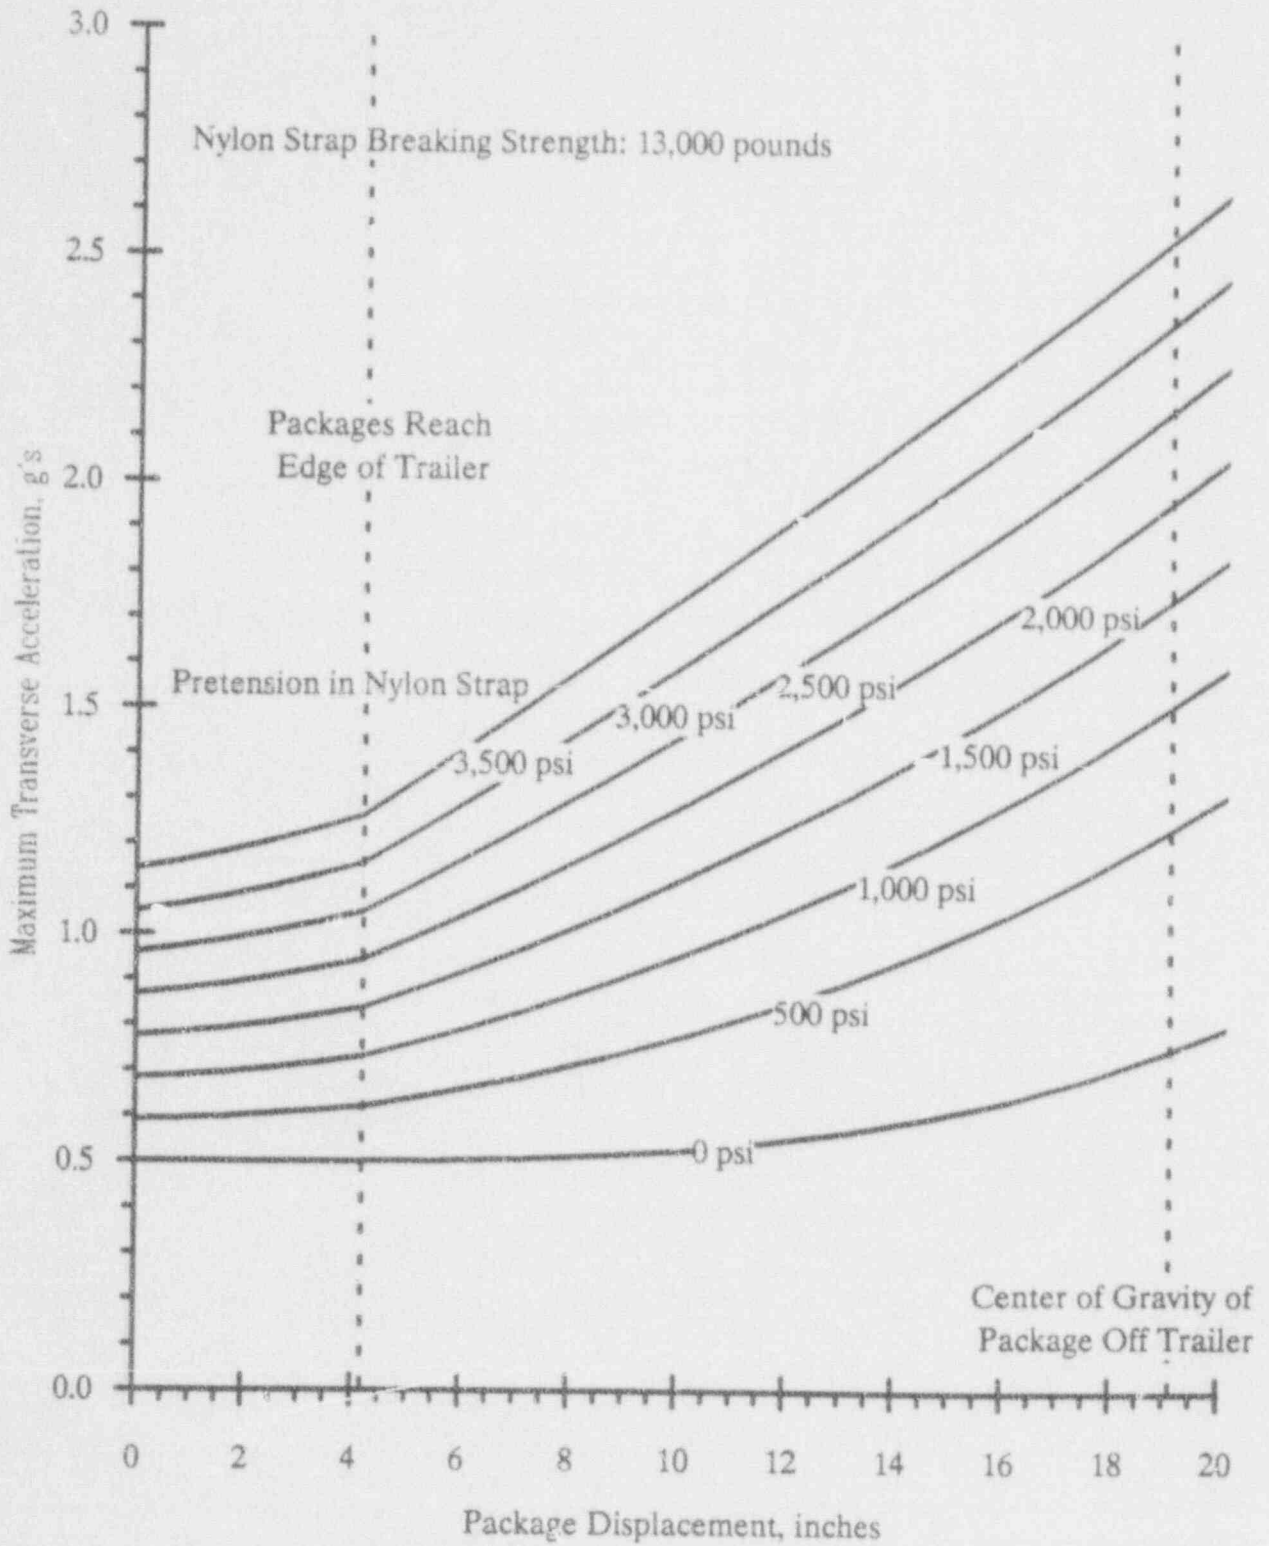
Figure 5.5 Maximum Possible Transverse Acceleration

The maximum possible acceleration that corresponds to various displacements of the containers is plotted in Figure 5.5 for several different values of the pre-tension of the nylon straps. During the impact portion of the accident, the trailer was swinging toward both sides, and it is possible that the containers slid to one side of the trailer and then, at a later time, slid to the other side. Consequently, the fact that the containers appear to extend about 4 in. (displacement of about 8 in.) off the left side of the trailer will be ignored, and it will be assumed that the maximum displacement of the containers was slightly less than the displacement that would have caused the center of gravity of any of the containers to be outside the trailer. This results in the conclusion that the transverse acceleration was no larger than about 1.5 g. This is a small peak transverse acceleration which implies that the trailer did not swing far enough to either side to strike the concrete barrier at the outside of the roadway or the guardrail dividing the north and south bound lanes.

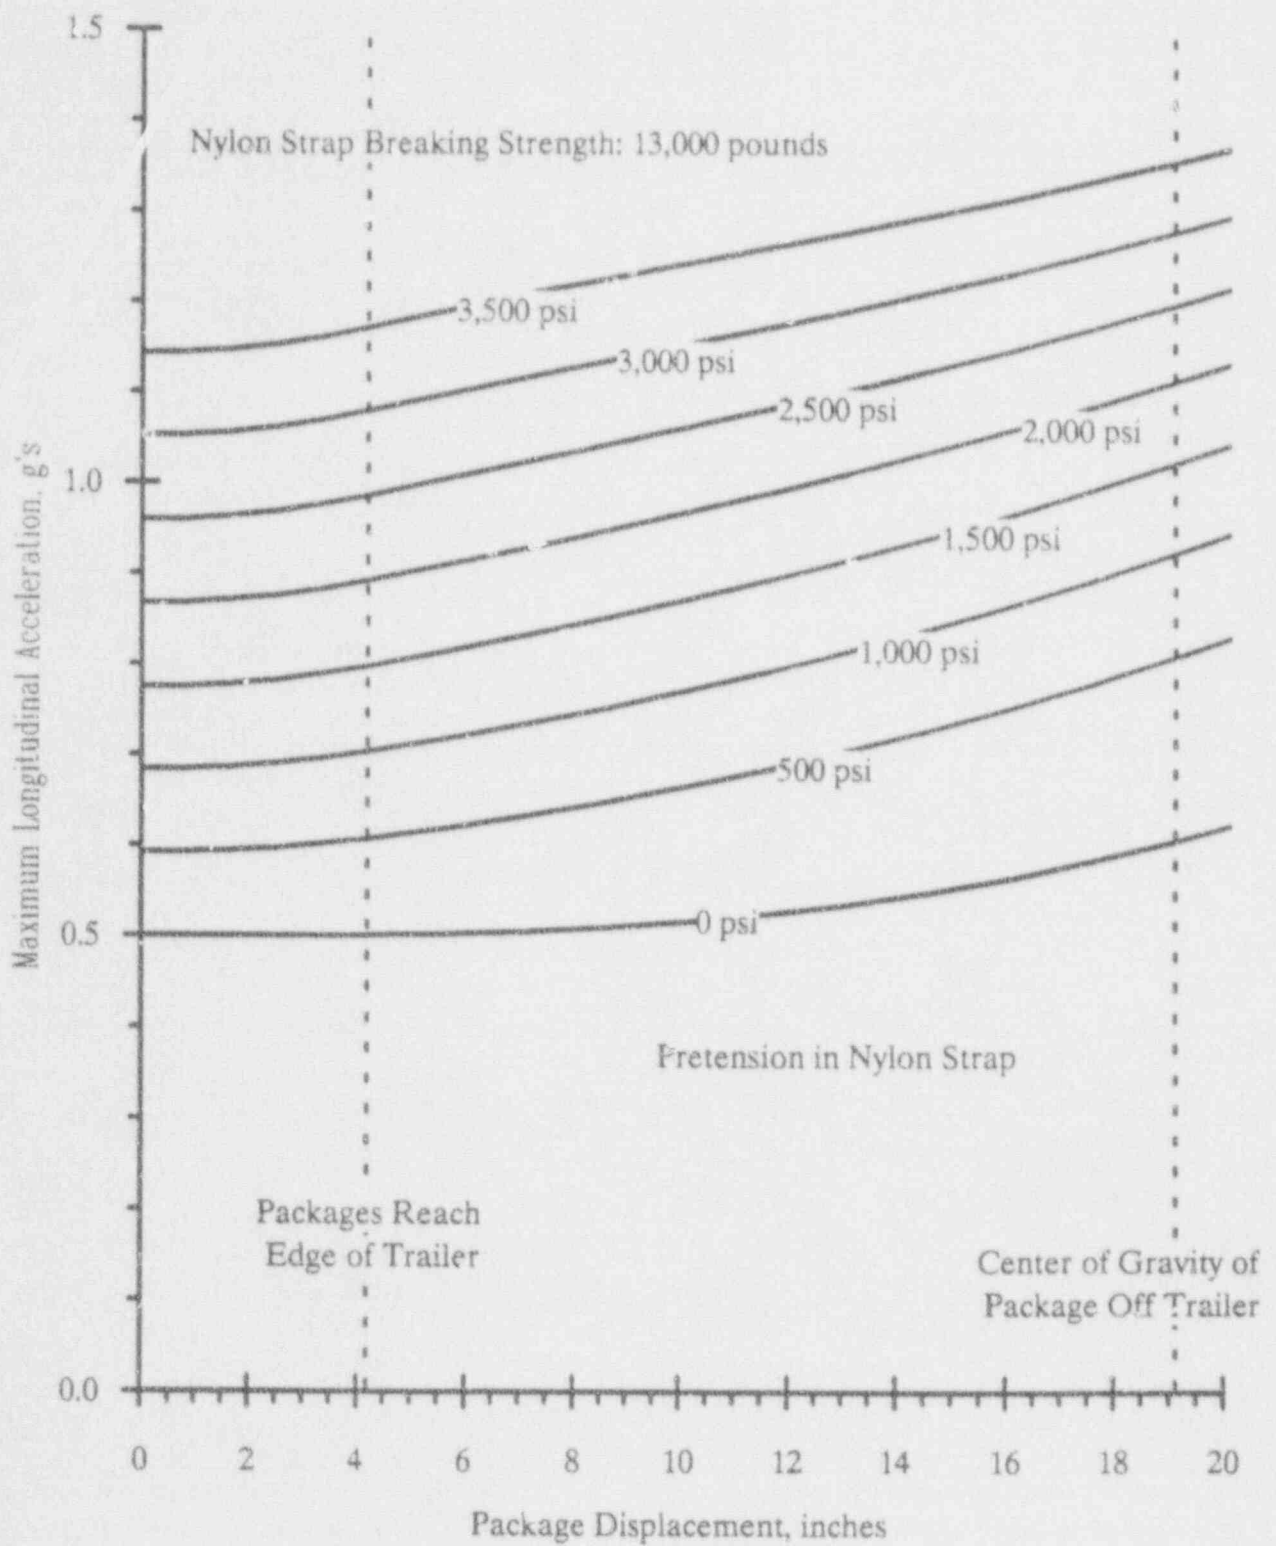
Figure 5.6 Maximum Possible Longitudinal Acceleration

The maximum longitudinal accelerations are plotted in Figure 5.6 as a function of the displacement of the containers and the pre-tension in the nylon straps. The maximum longitudinal deceleration must have been less than one g based on the observation that the containers did not slide forward by a large amount during the impact portions of the accident. The final resting positions of the containers after the conclusion of the fire appear to be 6 to 12 in. forward of the initial position on the trailer. However, this amount of motion is sufficiently small that it cannot represent gross sliding of the payload. The most likely explanation of the final position of the containers being forward of their initial position is motion during the fall off the trailer which could have included a sliding component which would have moved the containers forward.

It should be noted that this analysis indicates that if any container is to slide forward during the deceleration, it will be the center container in the top row. This container does not receive any of the downward forces due to the tie downs and it does not have another container resting on its top so it has the least frictional forces restricting its motion. The only frictional forces acting on the center container in the top row are the forces that arise from the clamping forces F_{xL} and F_{xR} which tend to hold the containers together in a single unit. If the center container in the top row were to move by about 6 ft, it would impact on the expanded metal barrier at the rear of the tractor. However, this barrier was free of any impact damage so it must be concluded that if there was any forward motion of the containers, it was not sufficient to allow the containers to reach this barrier.

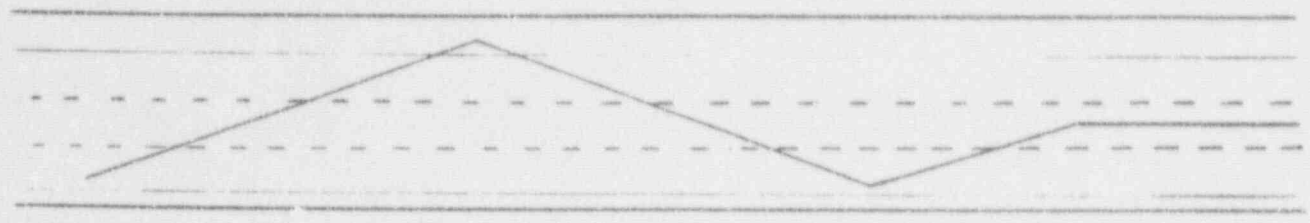
Figure 5.7 Trailer Dynamics During Impact Portion of Accident

The retarding force that is applied at the kingpin is the result of friction of the tires of the tractor. The force at the kingpin has been assumed to follow a path that is formed by three straight lines as shown in Figure 5.7. Assuming the kingpin follows straight lines will maximize the rotation of the trailer at the points where the tractor impacts on the guardrail or barrier.

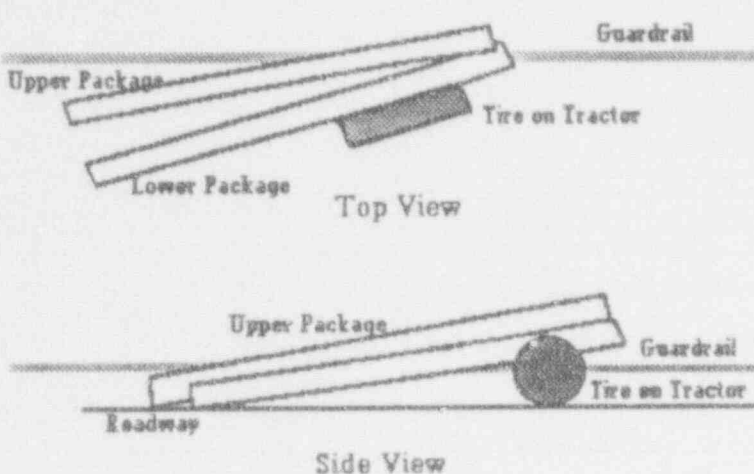
The most severely damaged inner container was observed to have one end resting on the guardrail and the other end resting on the roadway. In addition, another container was partially resting on the end which was on the guardrail. Marks on the most severely damaged container indicated that it was in contact with a burning tire for some period of time at the location of the maximum deformation. The location of maximum deformation was about one third of the length of the container from one end and can be characterized as distortion from a rectangle into a parallelogram with a transverse crease in one corner of the container.

The analyses that follow attempt to demonstrate that the deformation is consistent with the static loads that were applied to this container following its fall from the trailer and no damage should be attributed to any impact between the truck and the guardrail at the conclusion of the impact portion of the accident. The container is treated as a beam that is initially resting on the roadway at one end and resting on or leaning against the top of a tire about one third of the length of the container from the guardrail. When the containers fell from the trailer, the second container probably was resting on the edge of the damaged container but not resting on the guardrail. Probably, the second container did not contact the guardrail until the first container deformed, giving the misimpression that both containers were resting on the guardrail during the entire fire. Top and side views of these two containers are as shown below both before and after the bottom container deformed.

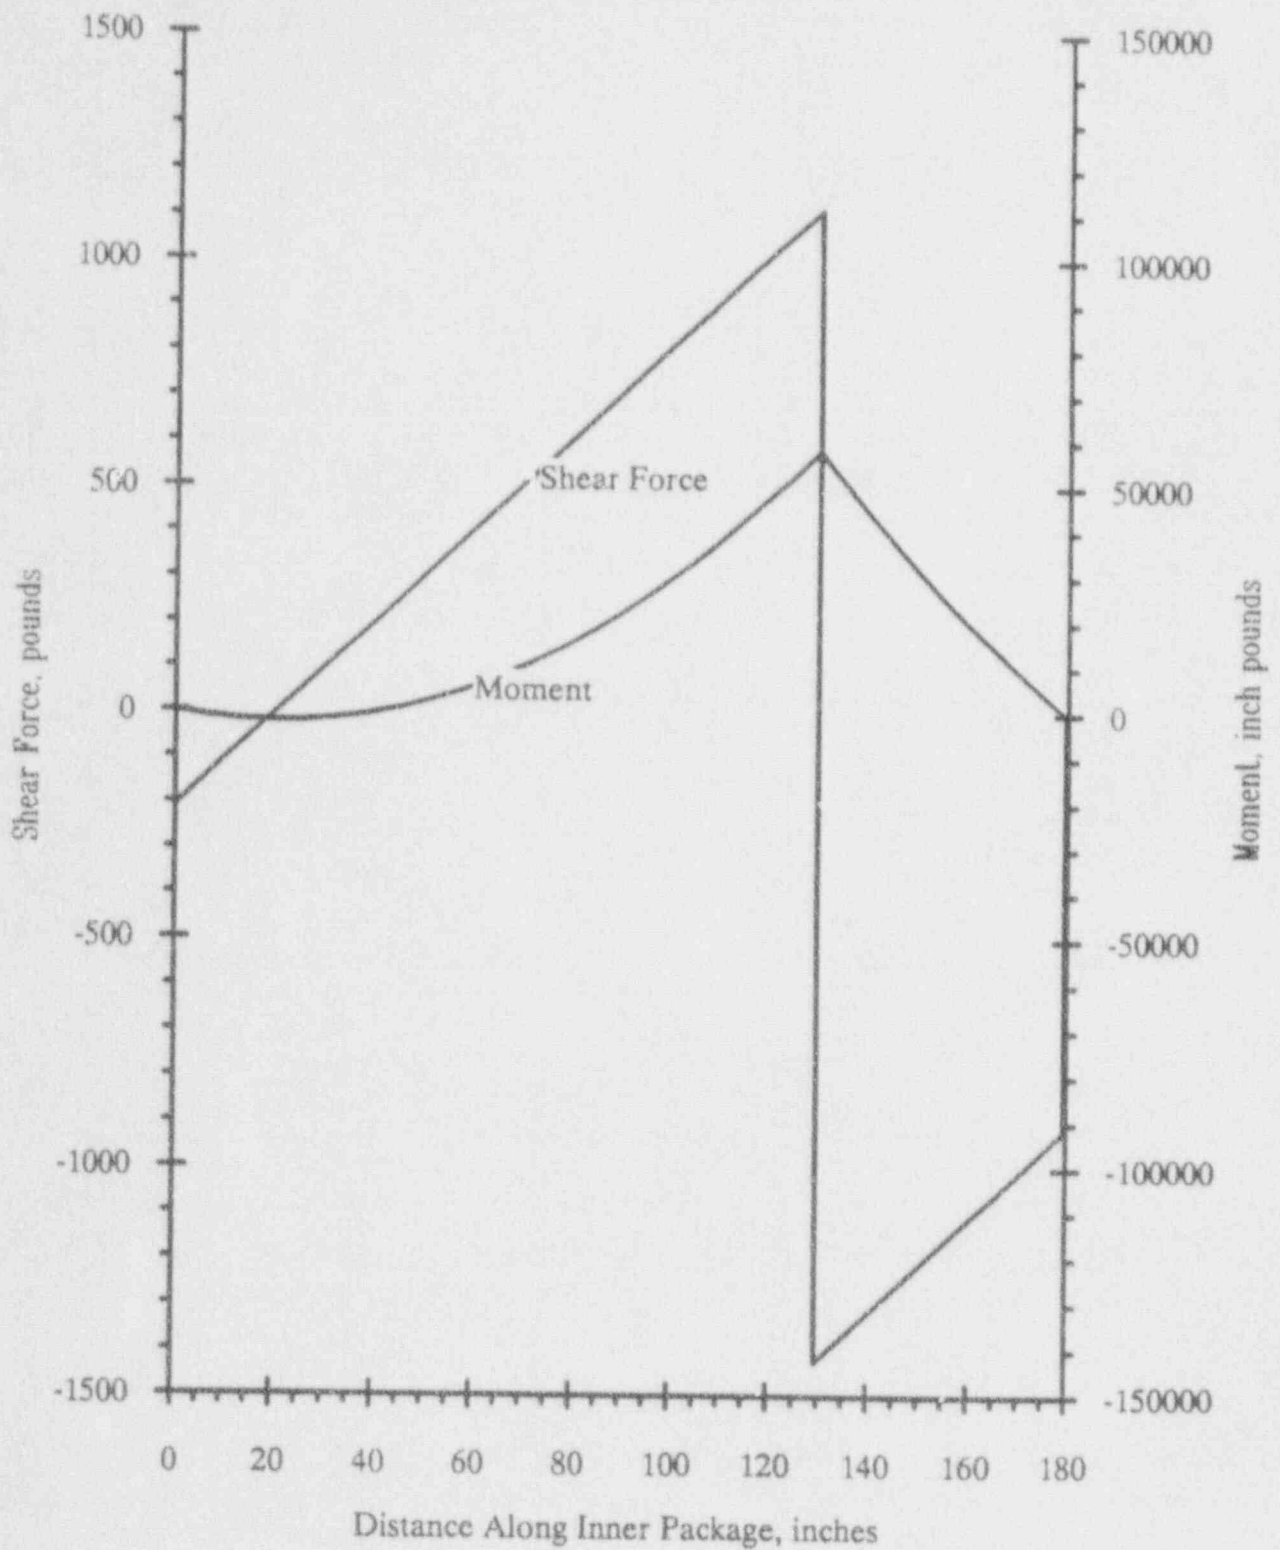
Figure 5.8 Shear Force and Moment Distribution in Beam Model of Container Supported by Guardrail

The shear forces and moments are plotted as a function of position along the beam in Figure 5.8. The maximum moment occurs at $x = (L-a)$ and is:

When the lower container is assumed to rest on the tire at a location 50 in. from the end of the container, the maximum moment is 58,000 in-lb, the moment of inertia of the inner container about an axis that passes through a corner of the cross section of the container at an angle of 45° to the sides of the container is 1488 in⁴ and the distance from this axis to the extreme fiber of the container is 21 in. These values give a maximum stress of 818 psi.

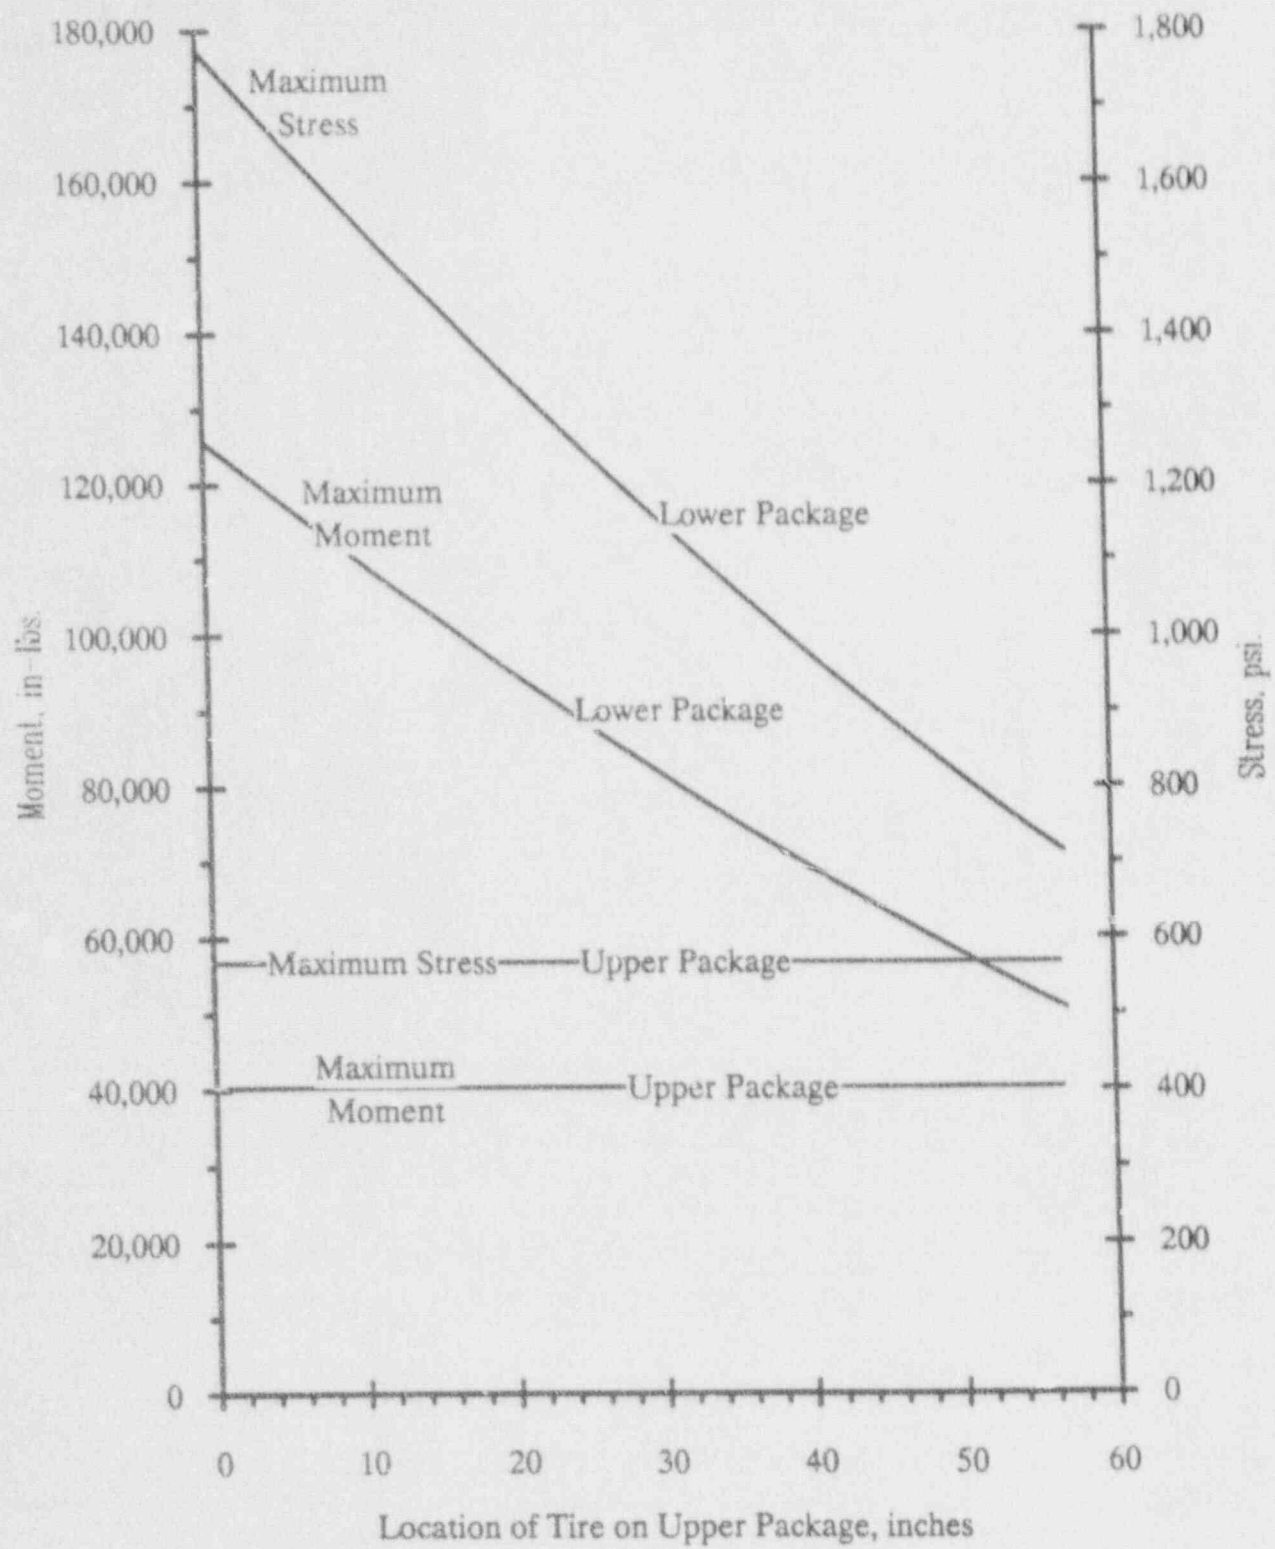
Figure 5.9 Maximum Shear Force and Moment in Beam Model of Container Supported by Guardrail

The maximum shear stress and maximum moment for both containers are plotted in Figure 5.9 as a function of the distance between the end of the upper container and the point where it is supported on the tire.

The maximum moment in the upper container of the two that were adjacent to the burning tire was 40,000 in.-lb when the tire supports the lower container at 50 in. from the end of the lower container. The maximum moment in the upper container is presented in Figure 5.9 for comparison to the maximum moment in the lower container.

The stress in the upper container does not exceed the yield strength of the carbon steel because the temperature of the upper container is substantially cooler than the lower container because the upper container is over 18 in. away from the burning tire. This separation will reduce the heat transfer from the burning tire to the upper container which will limit the temperature of the upper container to less than 1800 °F which, in turn, will result in a yield strength that is larger than 1,000 psi. Consequently, the upper container should not suffer a bending type of failure as was the case with the lower container.
