NUREG/CR-5892
UCRL-ID-113638

Highway Accident Involving Unirradiated Nuclear Fuel in Springfield, Massachusetts, on December 16, 1991

Presented to
the Nuclear Regulatory Commission

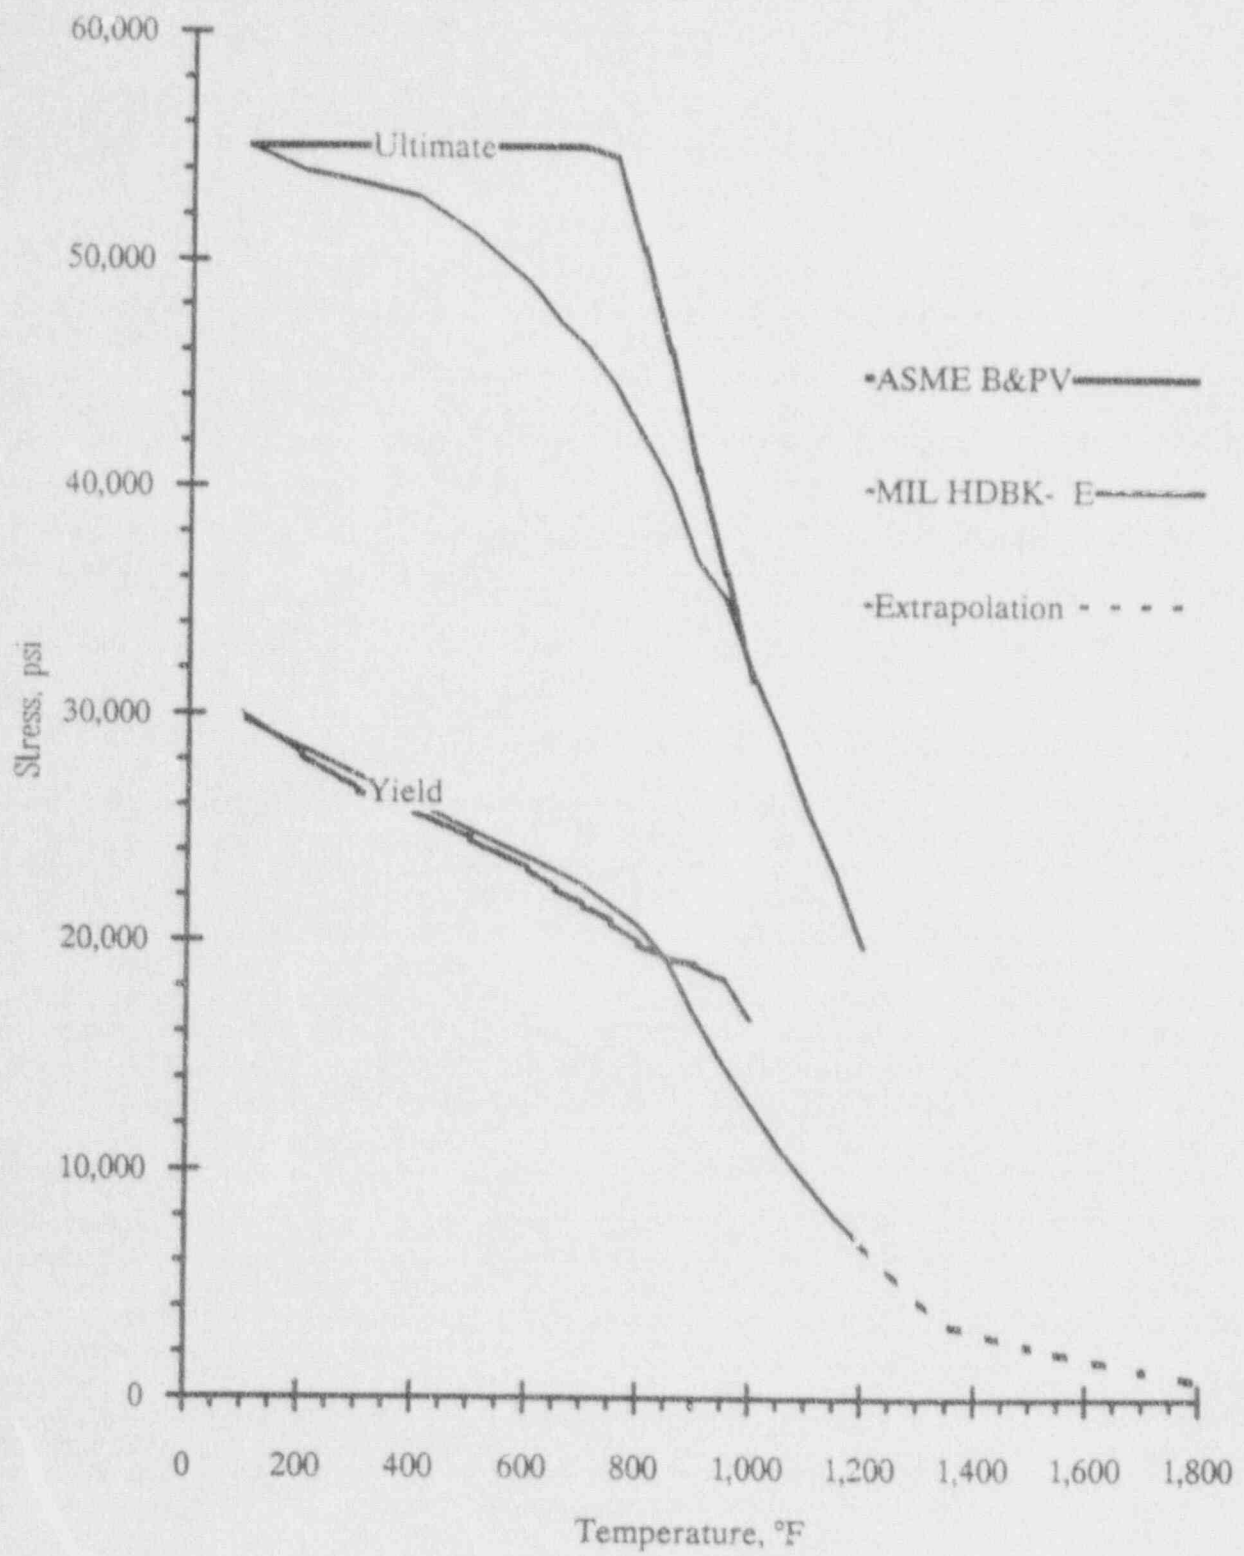
Figure 5.10 Temperature Dependence of Stress of Steel

The container which suffered the extreme damage was located adjacent to a burning tire which had a flame temperature near 1800 °F with flame characteristics that should have produced a high flame emissivity. Consequently, after 0.5 hour exposure to the burning tires, the metal temperature in this container should have been close to 1800 °F. The temperature dependence of the yield strength and ultimate strength of carbon steel are presented in Figure 5.10 as a function of temperature. Properties have been extracted from Appendix I of Section III of the ASME Boiler and Pressure Vessel Code and from the Mil Handbook to provide the strength of carbon steel up to 1200 °F. However, above 1200 °F there is very little tabulated data. The ultimate strength of armco iron has been reported for temperatures exceeding 1200 °F and has been used to extrapolate the data from the MIL-HDBK to temperatures approaching 1800 °F. At temperatures between 1700 °F and 1800 °F, the yield strength of carbon steel approaches 800 psi. Consequently, the inner container which was resting on the tire would fail in bending when the tire was involved in the fire and producing flame temperatures in the vicinity of 1800 °F.

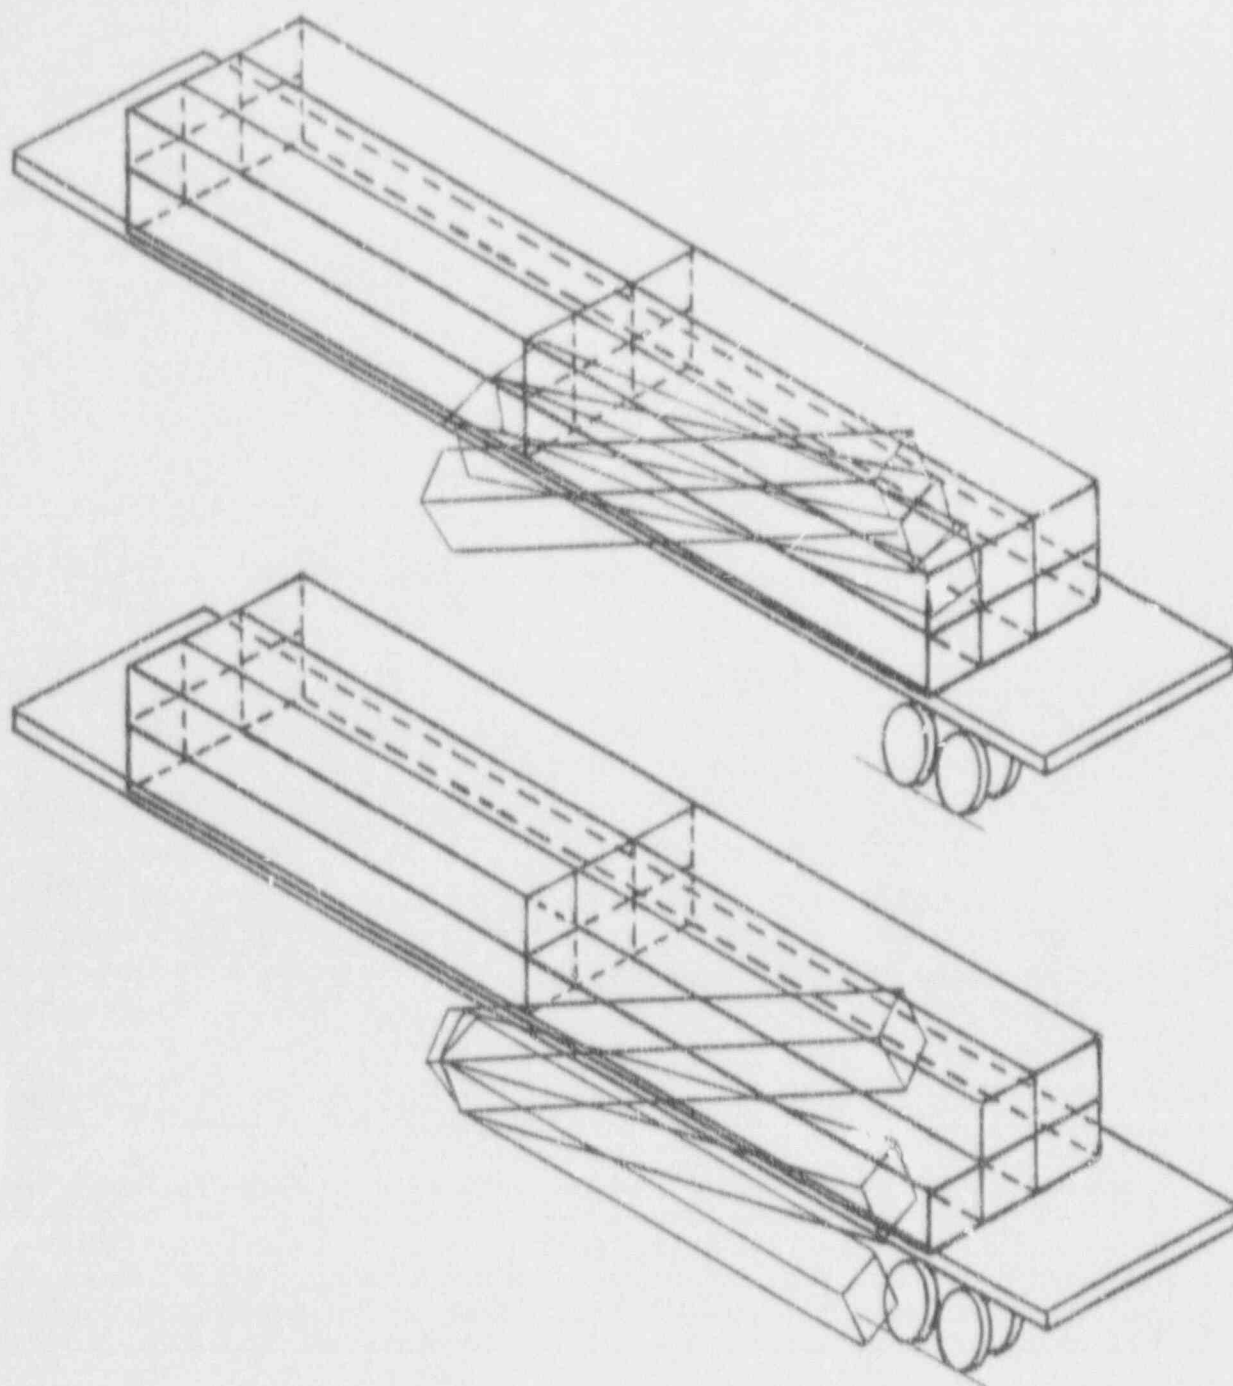
Figure 5.11 Motion of Container Falling off Trailer During Fire

The video tapes of the rear of the trailer indicate that the primary mechanism for a container falling from the trailer to the roadway was the reduction in strength of the front of the container resting on the trailer. This allowed the upper container to tip toward the front of the trailer and toward the outside of the trailer. When the center-of-gravity of the upper container reached a point where sliding was possible, the upper container would slide outward and forward until the front end of the container reached the roadway. At this point, the container would fall until it was entirely on the roadway. This sequence of events is summarized in Figure 5.11. The choice of the left container on the left side of the trailer to illustrate the motion of a container as it fell from the trailer was arbitrary to enhance clarity of the sketches. In fact, this particular container did not fall from the trailer in the manner described in this figure as will be discussed below.

The kinematics described in Figure 5.11 is consistent with the observation that the final resting position of a majority of the containers was closer to the front of the truck than the initial position

of the container. As the container is tipping off the container beneath, it will begin to slide down the inclined plain that is formed by the deformed end of the lower container. Since the fire progressed from the front of the truck to the rear, the front end of the containers will be deformed first, causing any container motion to be toward the front of the truck.

The kinematics described in Figure 5.11 does not address the motion of the two containers at the left rear of the trailer. These two containers fell as a coupled pair, until they had rotated about 90 degrees and both containers were about at the height of the trailer. At this point the containers separated and the container that was originally on top moved further away from the trailer and the container that was originally on the bottom fell and rested against the tire of the trailer.

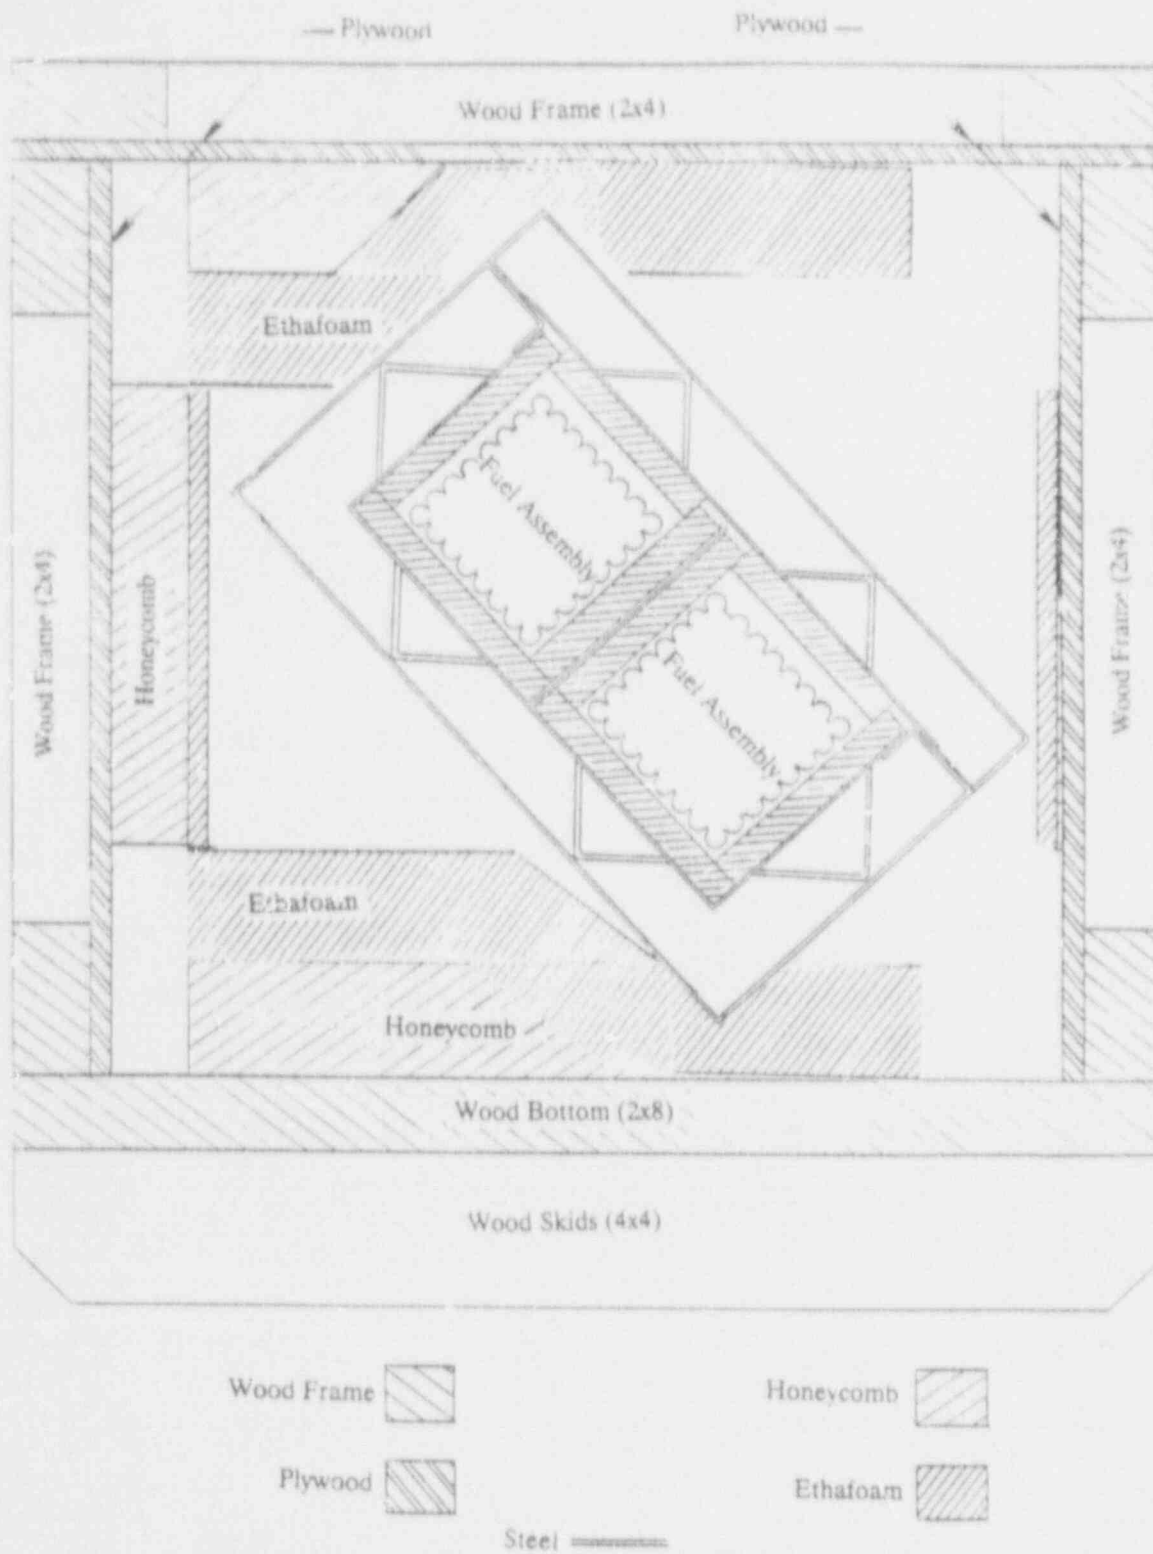
Figure 5.12 Possible Rotation of Inner Container Within Outer Container

The configuration of the inner and outer containers before the fire is shown in Figure 3.3. It is possible for the plywood to burn through along one side and the paper honeycomb on that side of the container would be consumed by the flames. Additionally, if part of the paper honeycomb in the bottom of the container were to be consumed by flames, it would be possible for the inner container to roll, or fall, onto a corner as shown in Figure 5.12. The mechanics of combustion are sufficiently complex that it is impossible to predict the occurrence of conditions that would cause this type of damage within the outer container so this must be left as a hypothesis.

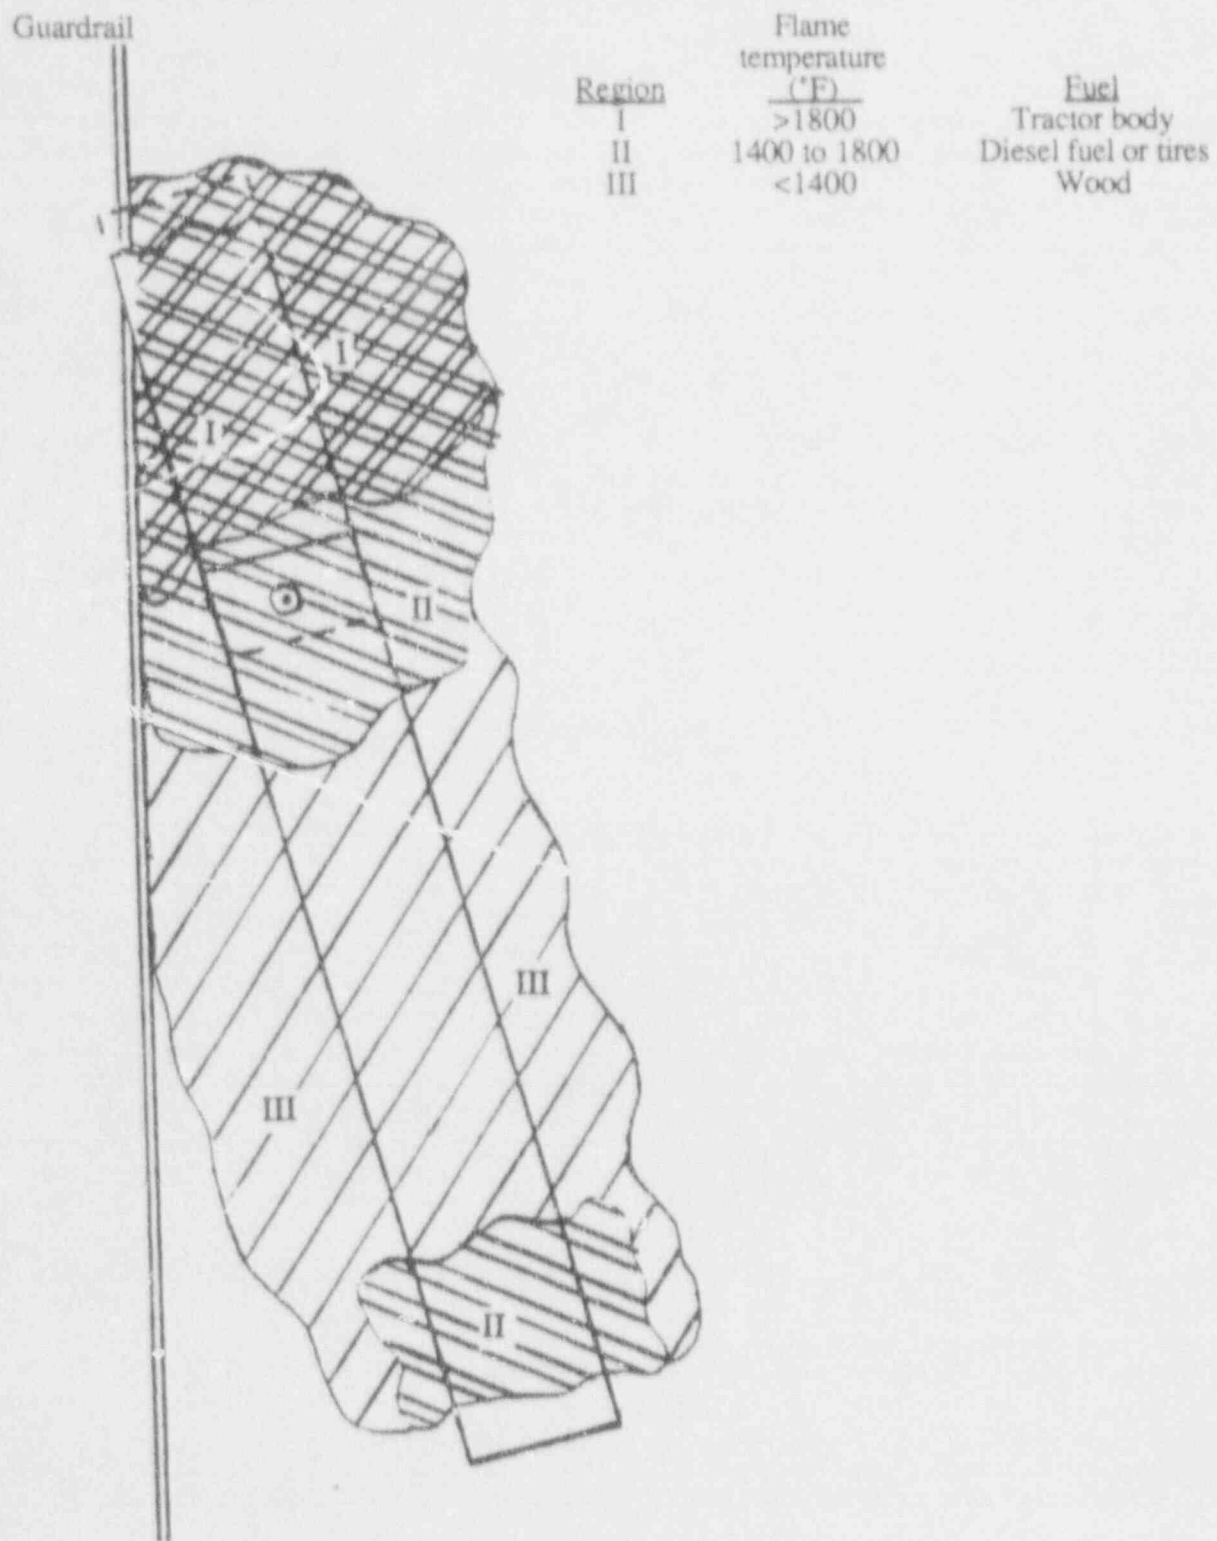
Figure 5.13 Flame Temperature Distribution During Fire

A sketch of tractor and trailer with locations of various flame temperatures is presented in Figure 5.13. This sketch is based upon the damage to the tractor, trailer and wind direction during the fire.

The fuel for the flames that surrounded the containers was primarily wood from the outer containers and the wood in the bed of the trailer. The flame temperature for a wood fire is about 1300 °F. However, some of the containers were adjacent to tires as they burned and experienced flame temperatures over 1800 °F.

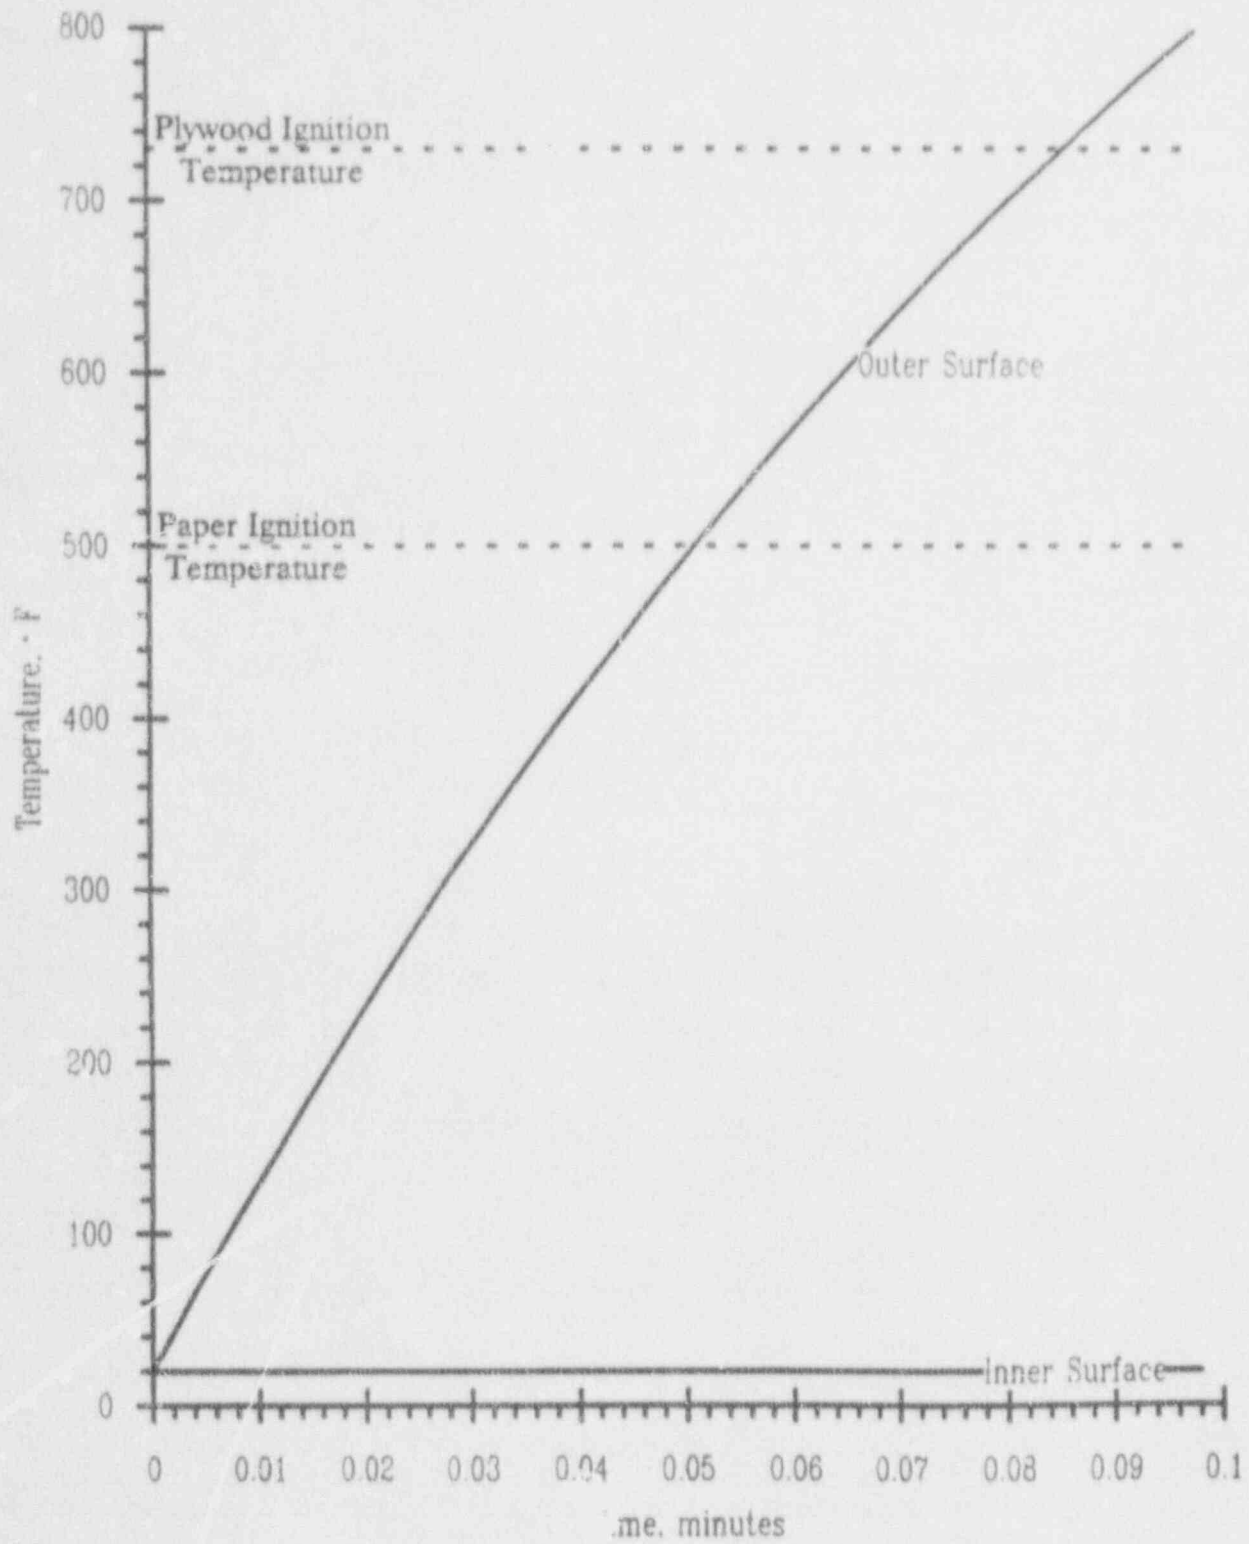
Figure 5.14 Plywood Temperature History When Exposed to Fire

Using finite difference calculation technique where the time step was selected such that the surface temperature did not increase by more than 15 °F in any time step, resulted in the histories of the surface temperatures of the plywood that are presented in Figure 5.14. The plywood surface was predicted to reach its ignition temperature (730 °F) about 0.08 min after the fire reached the surface of the plywood. At this time heat had conducted only a small fraction of the thickness into the plywood and the inner surface temperature was still 20 °F. Consequently, the plywood will ignite prior to the paper honeycomb that is inside the container.

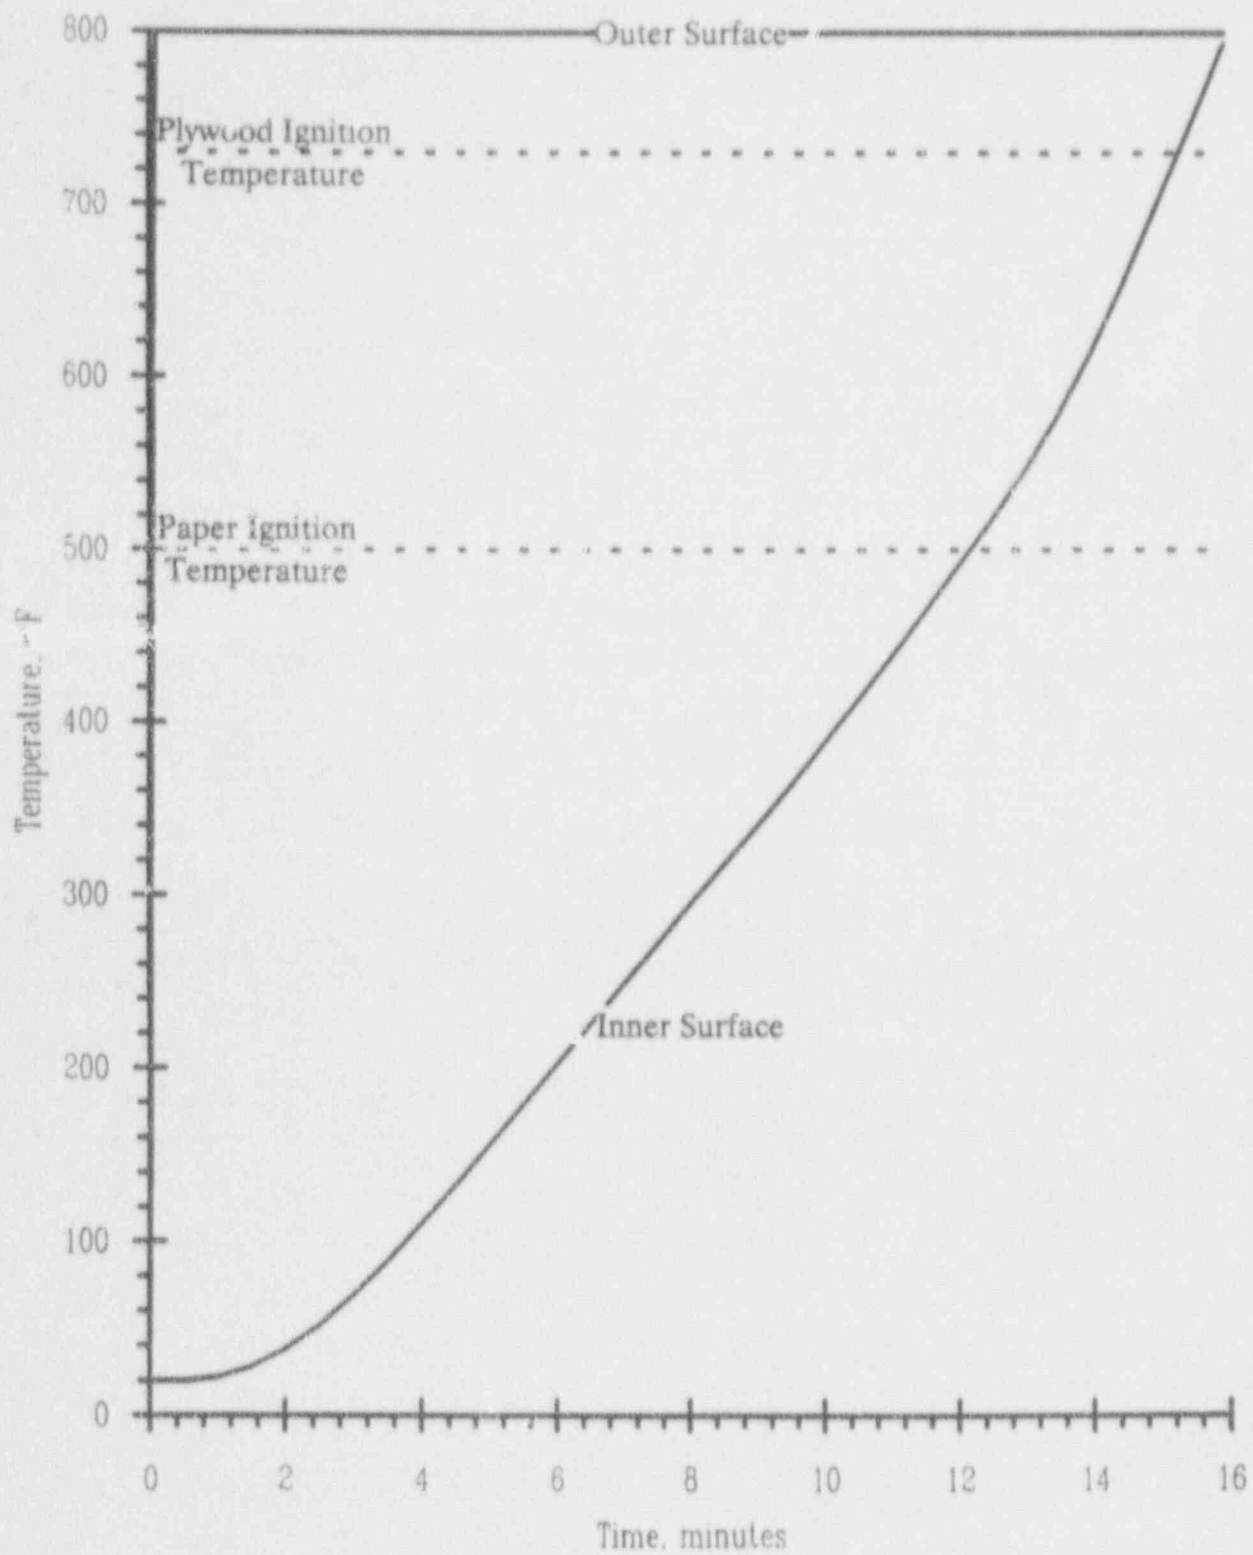
Figure 5.15 Extended Plywood Temperature History when Exposed to Fire

The temperature histories for the outer and inner surfaces of the plywood are presented in Figure 5.15 and temperature profiles through the plywood are presented in Figure 5.16 at selected times during the transient. Based upon this representation of the combustion process, the paper honeycomb ignites about 11 min after the flames initially impact upon the surface of the plywood. There are no records of the times that the containers fell from the trailer; however, the video tapes of the rear of the trailer indicate that the containers fell from the trailer while the outer containers were largely intact which was probable before the honeycomb had reached its ignition temperature.

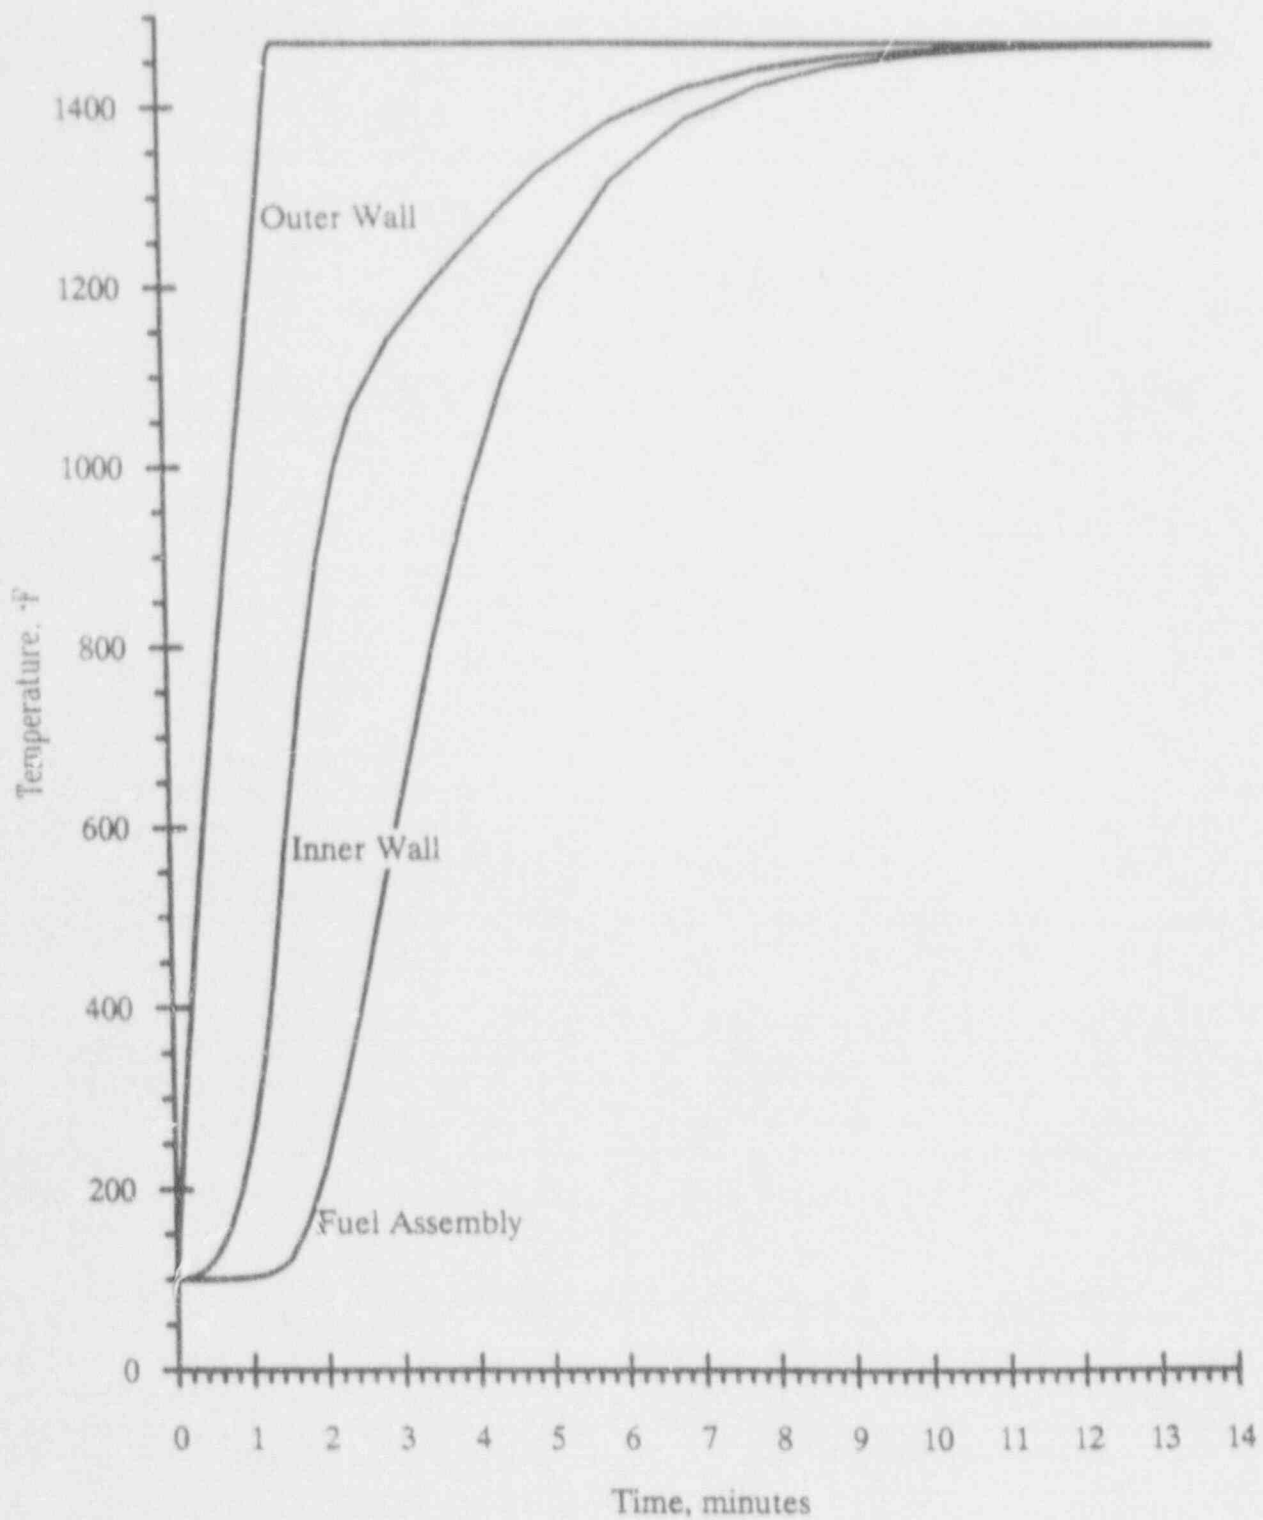
Figure 5.17 Temperature Histories in Inner Container After Direct Exposure to the Fire

The temperature history of the outer wall, inner wall and surface of the fuel assembly are presented in Figure 5.17. This analysis conclusively demonstrates that the metal temperature rapidly approaches that temperature of the flames, and after less than fifteen min, the temperature of the entire container is essentially equal to the temperature of the flames. Consequently, the evaluations of the inner container as a structural component should be based upon material properties at the temperature of the flames in the location of the container under consideration.

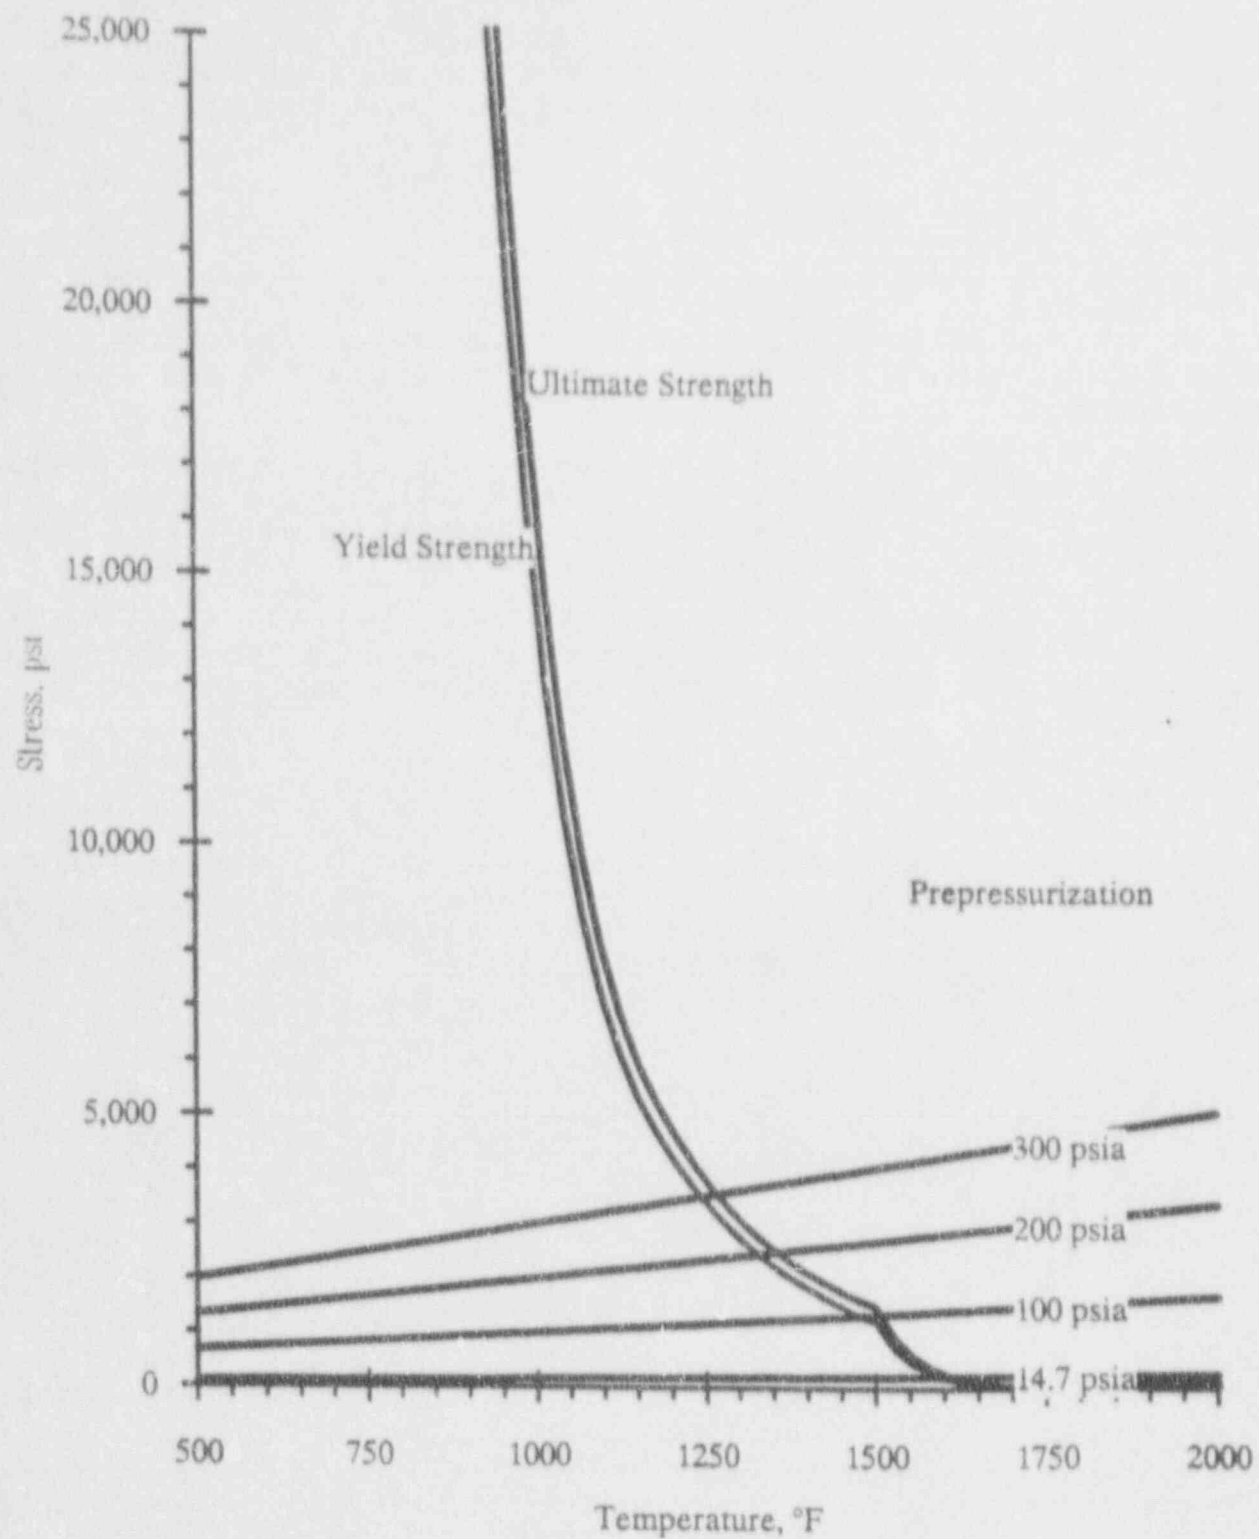
Figure 5.18 Stress in Clad at Elevated Temperatures

The cladding stress as a function of temperature is presented in Figure 5.18 based upon the assumption that the clad could be treated as a thin wall pressure vessel. The initial pressure inside the fuel rod at the time of fabrication has been evaluated parametrically because this value has not been released by GE. Also, the temperature dependence of the yield strength and ultimate strength of Zircalloy-2 are presented in Figure 5.18. There is a discontinuity in the curves of yield and ultimate strength at 1500 °F due to the transition between the α and β phases of zirconium.

The intersection of the yield strength and clad stress curves indicates the temperature at which the clad will begin to yield and expand. Similarly, the intersection of the ultimate strength curve with the clad stress curves indicates the temperature that will cause the clad to fail. The intersections occur at temperatures ranging from 1250 °F to 1600 °F. The value of 1250 °F is considered to be

somewhat low and 1600 °F is considered more reasonable for the onset of clad ballooning. The temperature dependence of the ultimate strength and yield strength of unirradiated Zircalloy have been taken from MATPRO (Hagrman, 1981) which is applicable up to temperatures that take the Zirconium into the β phase.
