NUREG/CR-5885
BNL-NUREG-52331

Metallurgical Evaluation of Weld Overlaid Pipe Sections From Brunswick Unit 2 Nuclear Power Station

Brookhaven National Laboratory

Prepared for
U.S. Nuclear Regulatory Commission

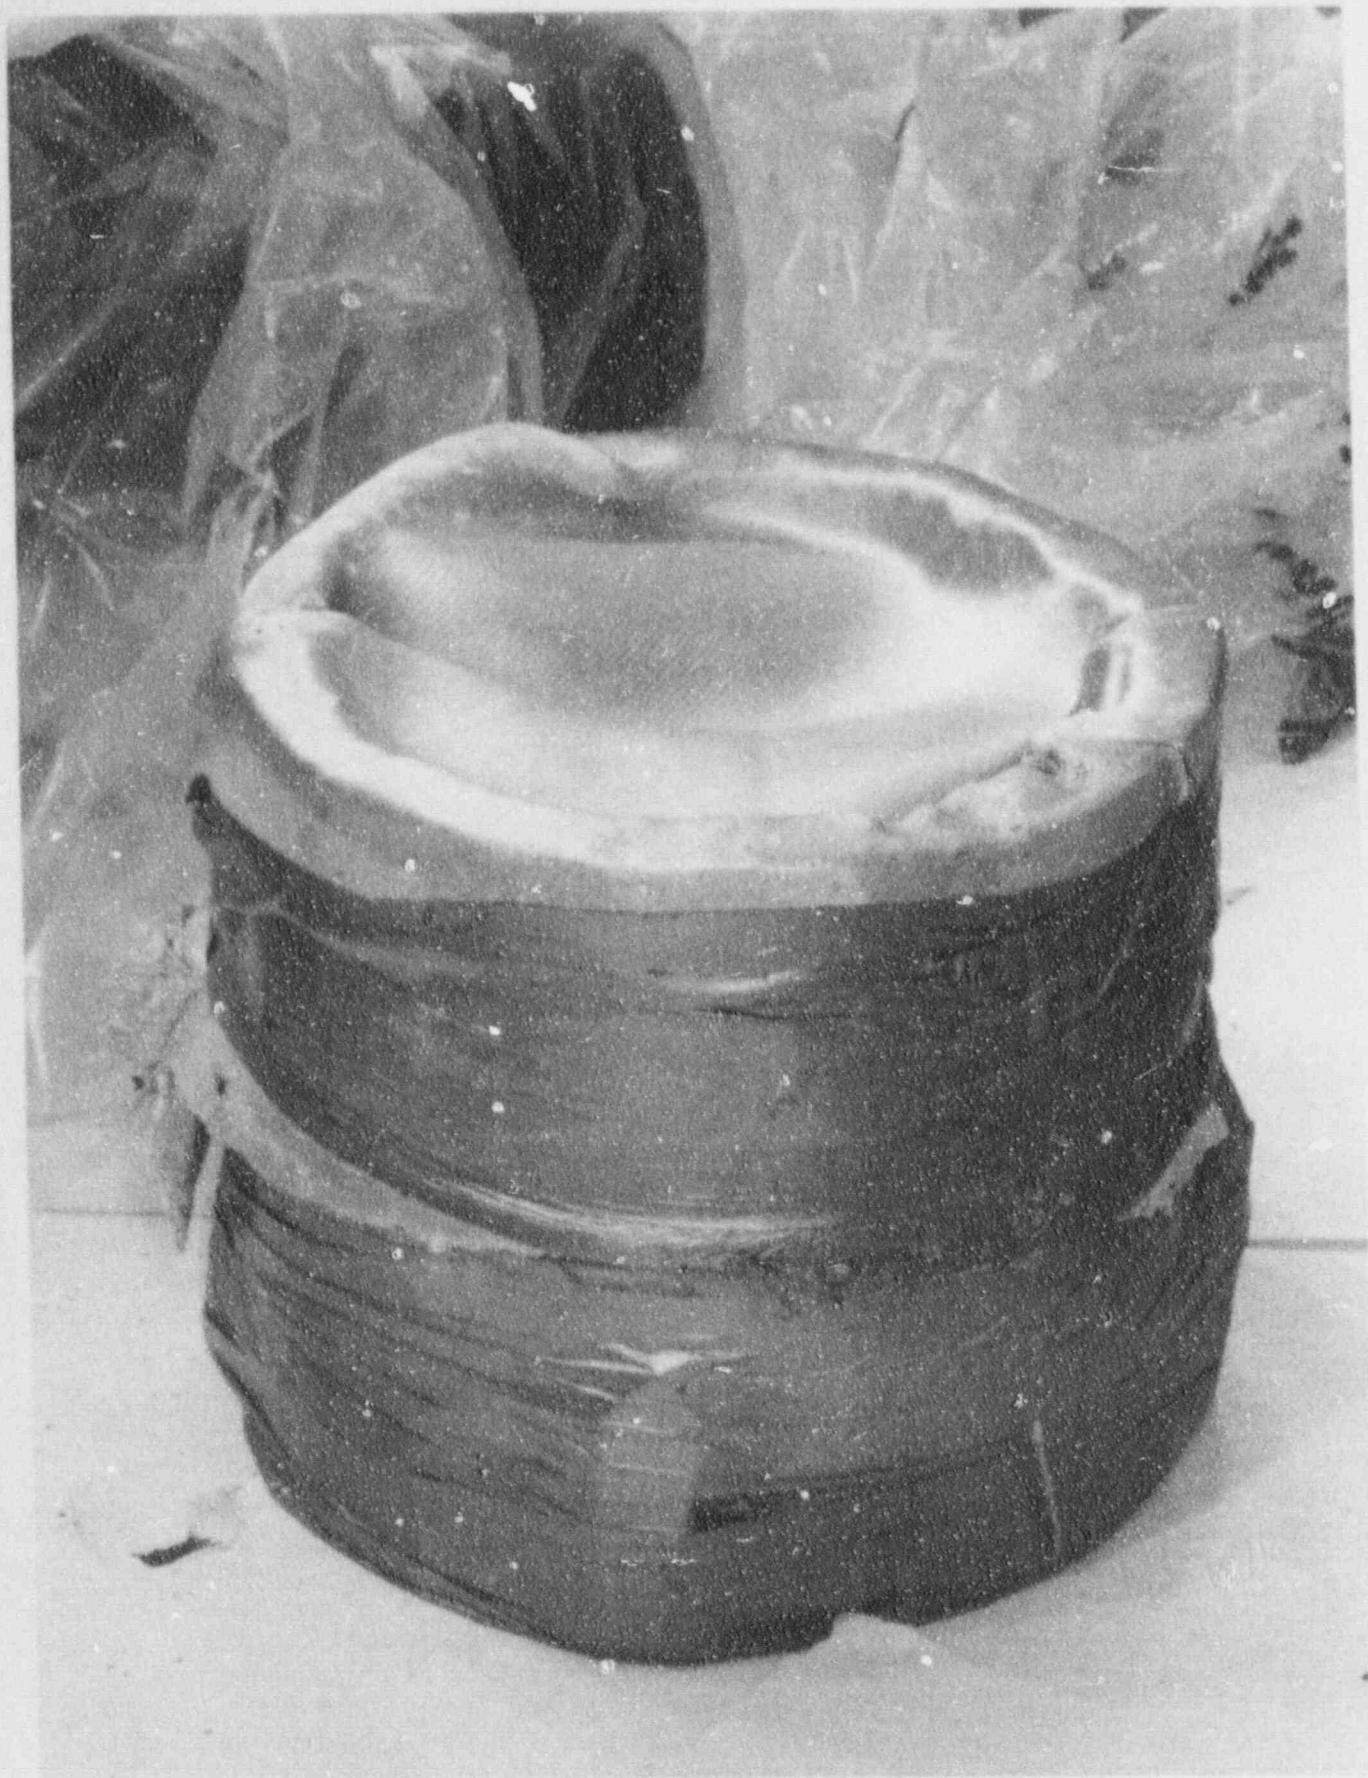
Four sections of radioactively contaminated pipe were received at BNL. The pipes were 12 inches in diameter and approximately 15 inches in length. The pipes were typically covered at both ends and wrapped in duct tape (Figure 3).

Figure 3 "As received" section of pipe from Brunswick Unit 2 (Typical).

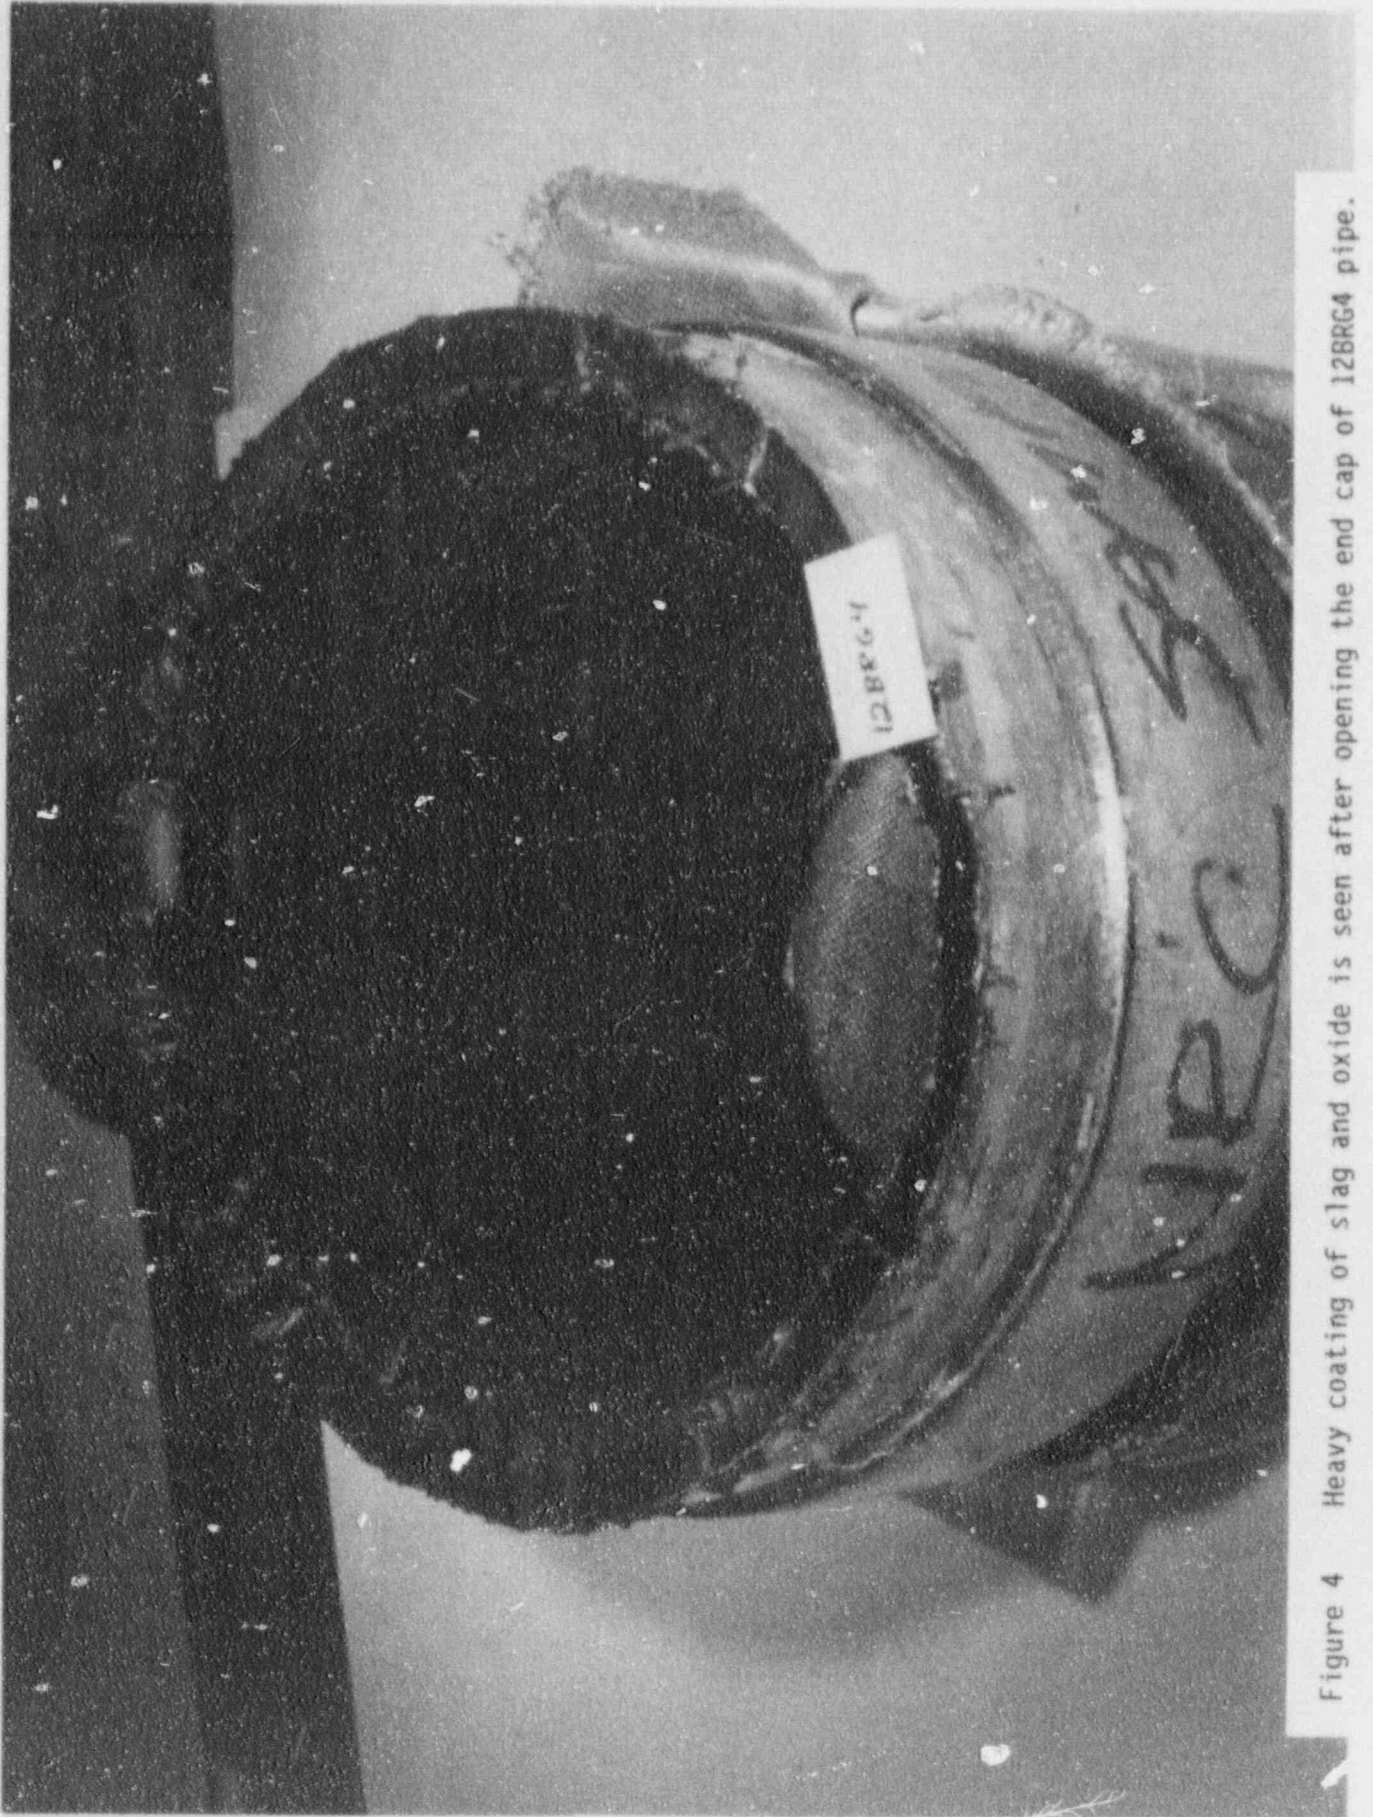
Removal of the end coverings and duct tape revealed that the inside surface of each of the pipes was covered with a heavy oxide coating and slag from the cutting process (Figures 4 - 7). There were no top dead center (TDC) or zero markings (station markers) readily evident on the pipe sections.

Figure 4 Heavy coating of slag and oxide is seen after opening the end cap of 12BRG4 pipe.

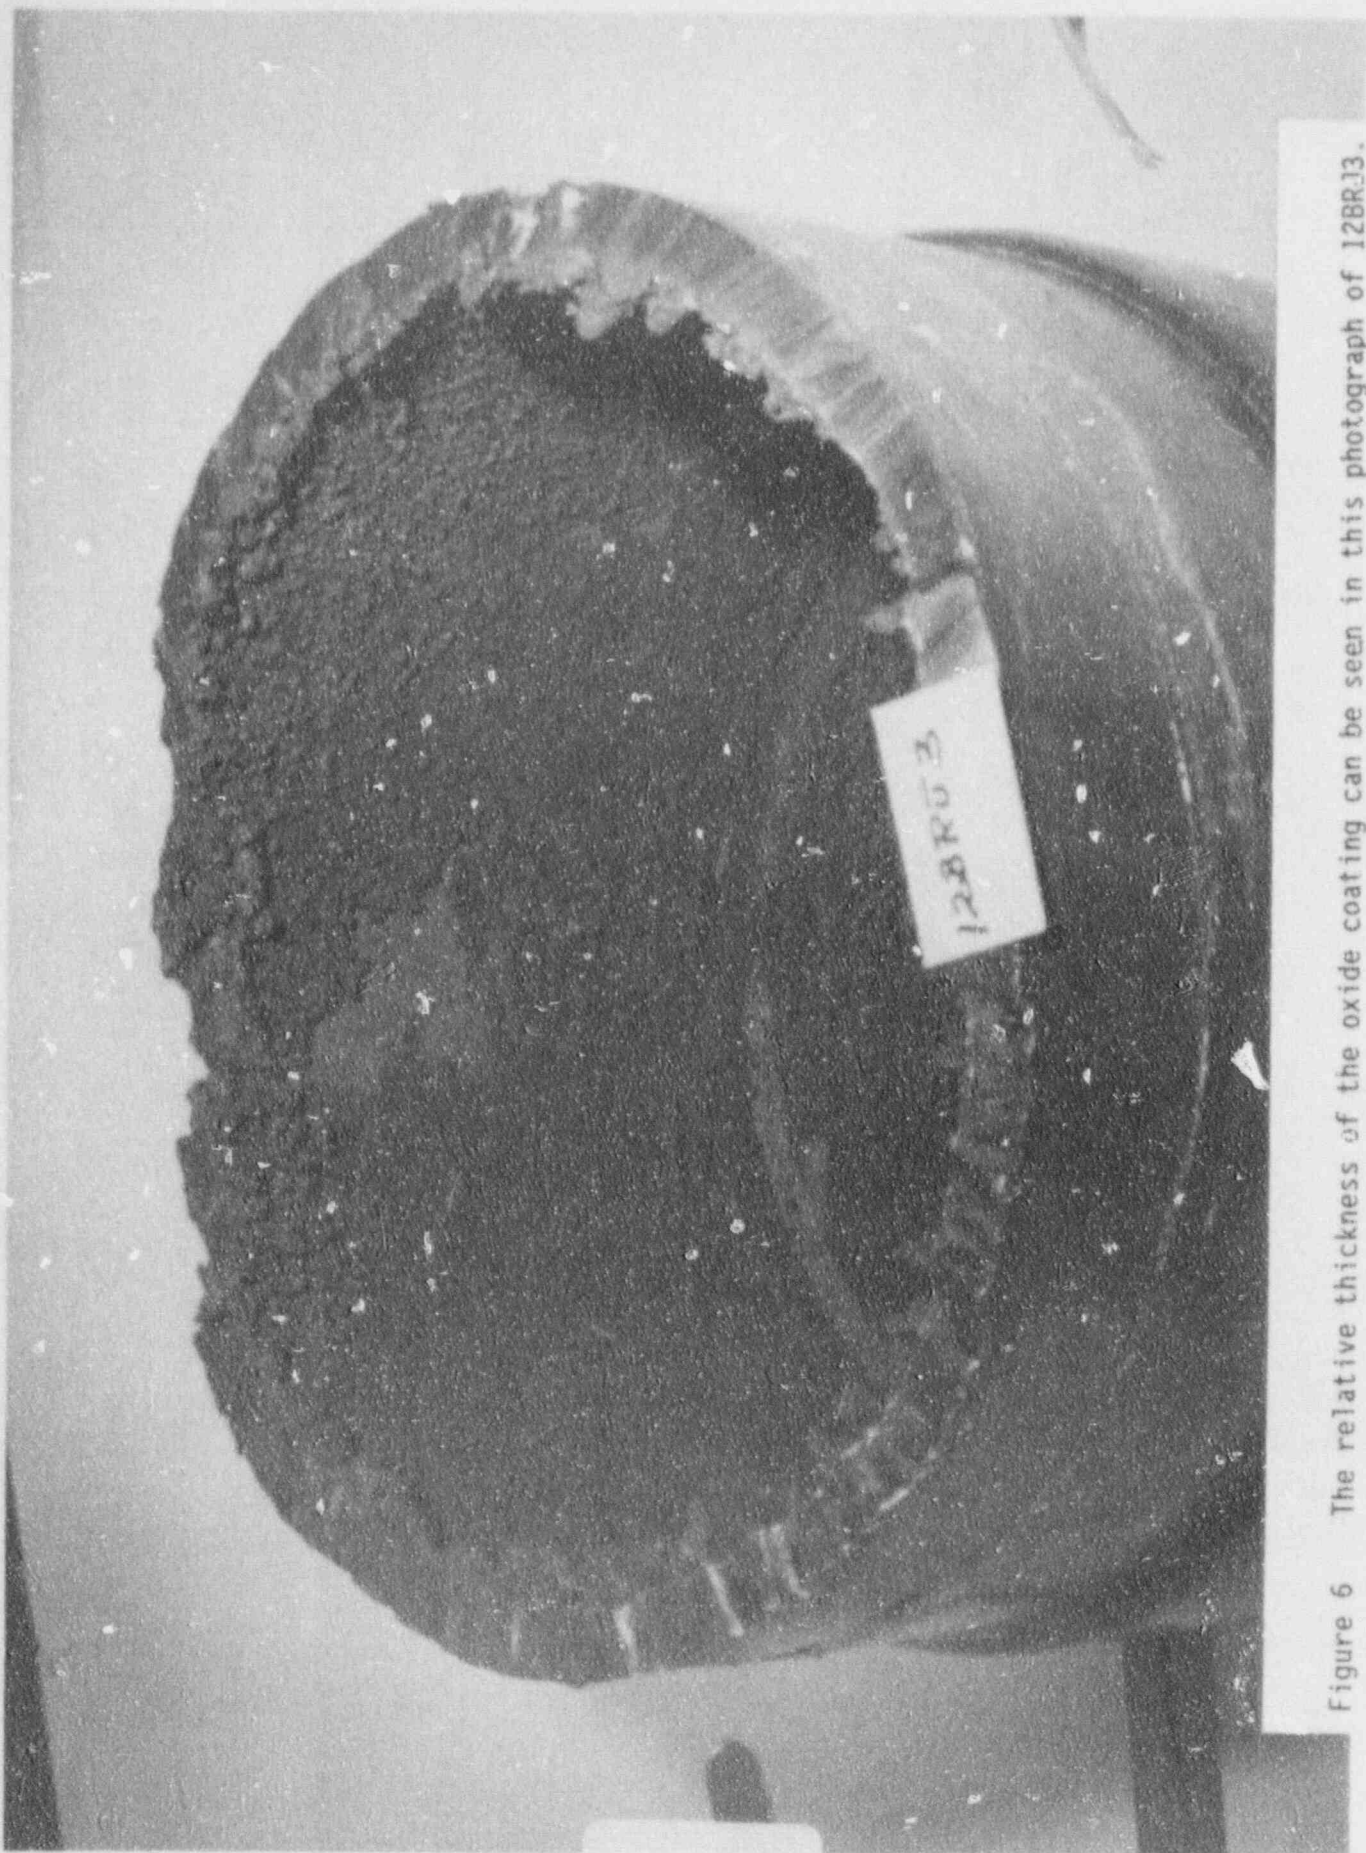
Figure 6 The relative thickness of the oxide coating can be seen in this photograph of 12BRU3.

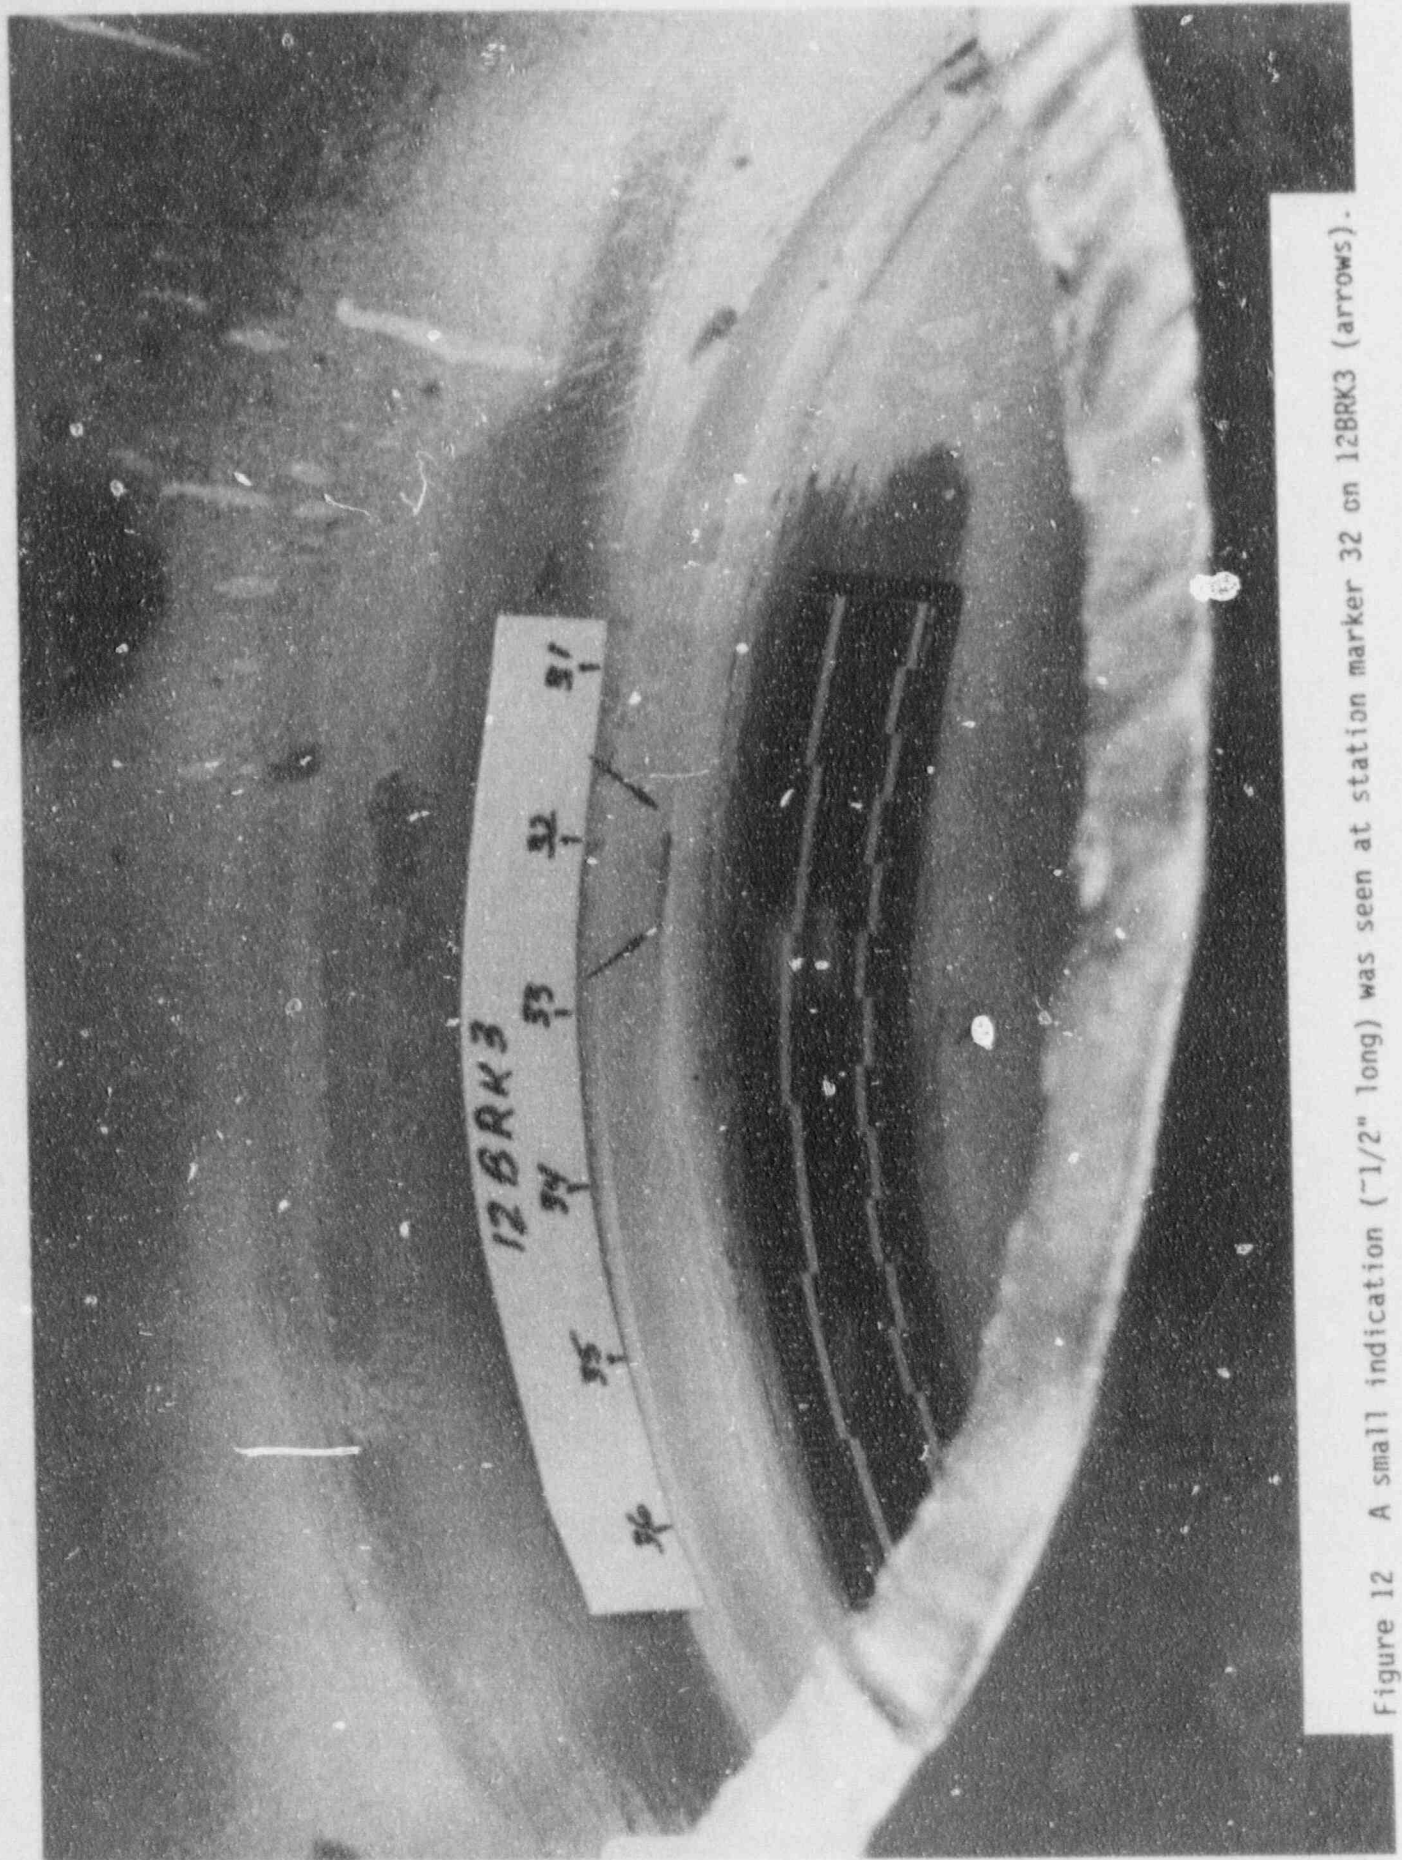
Faint dye penetrant indications (Figure 11) were seen between areas 7-5, approximately 1 1/4" in length (discontinuous) and at marker 32 (Figure 12), approximately 1 1/4" in length.

Figure 12 A small indication (~1/2" long) was seen at station marker 32 on 12BRK3 (arrows).

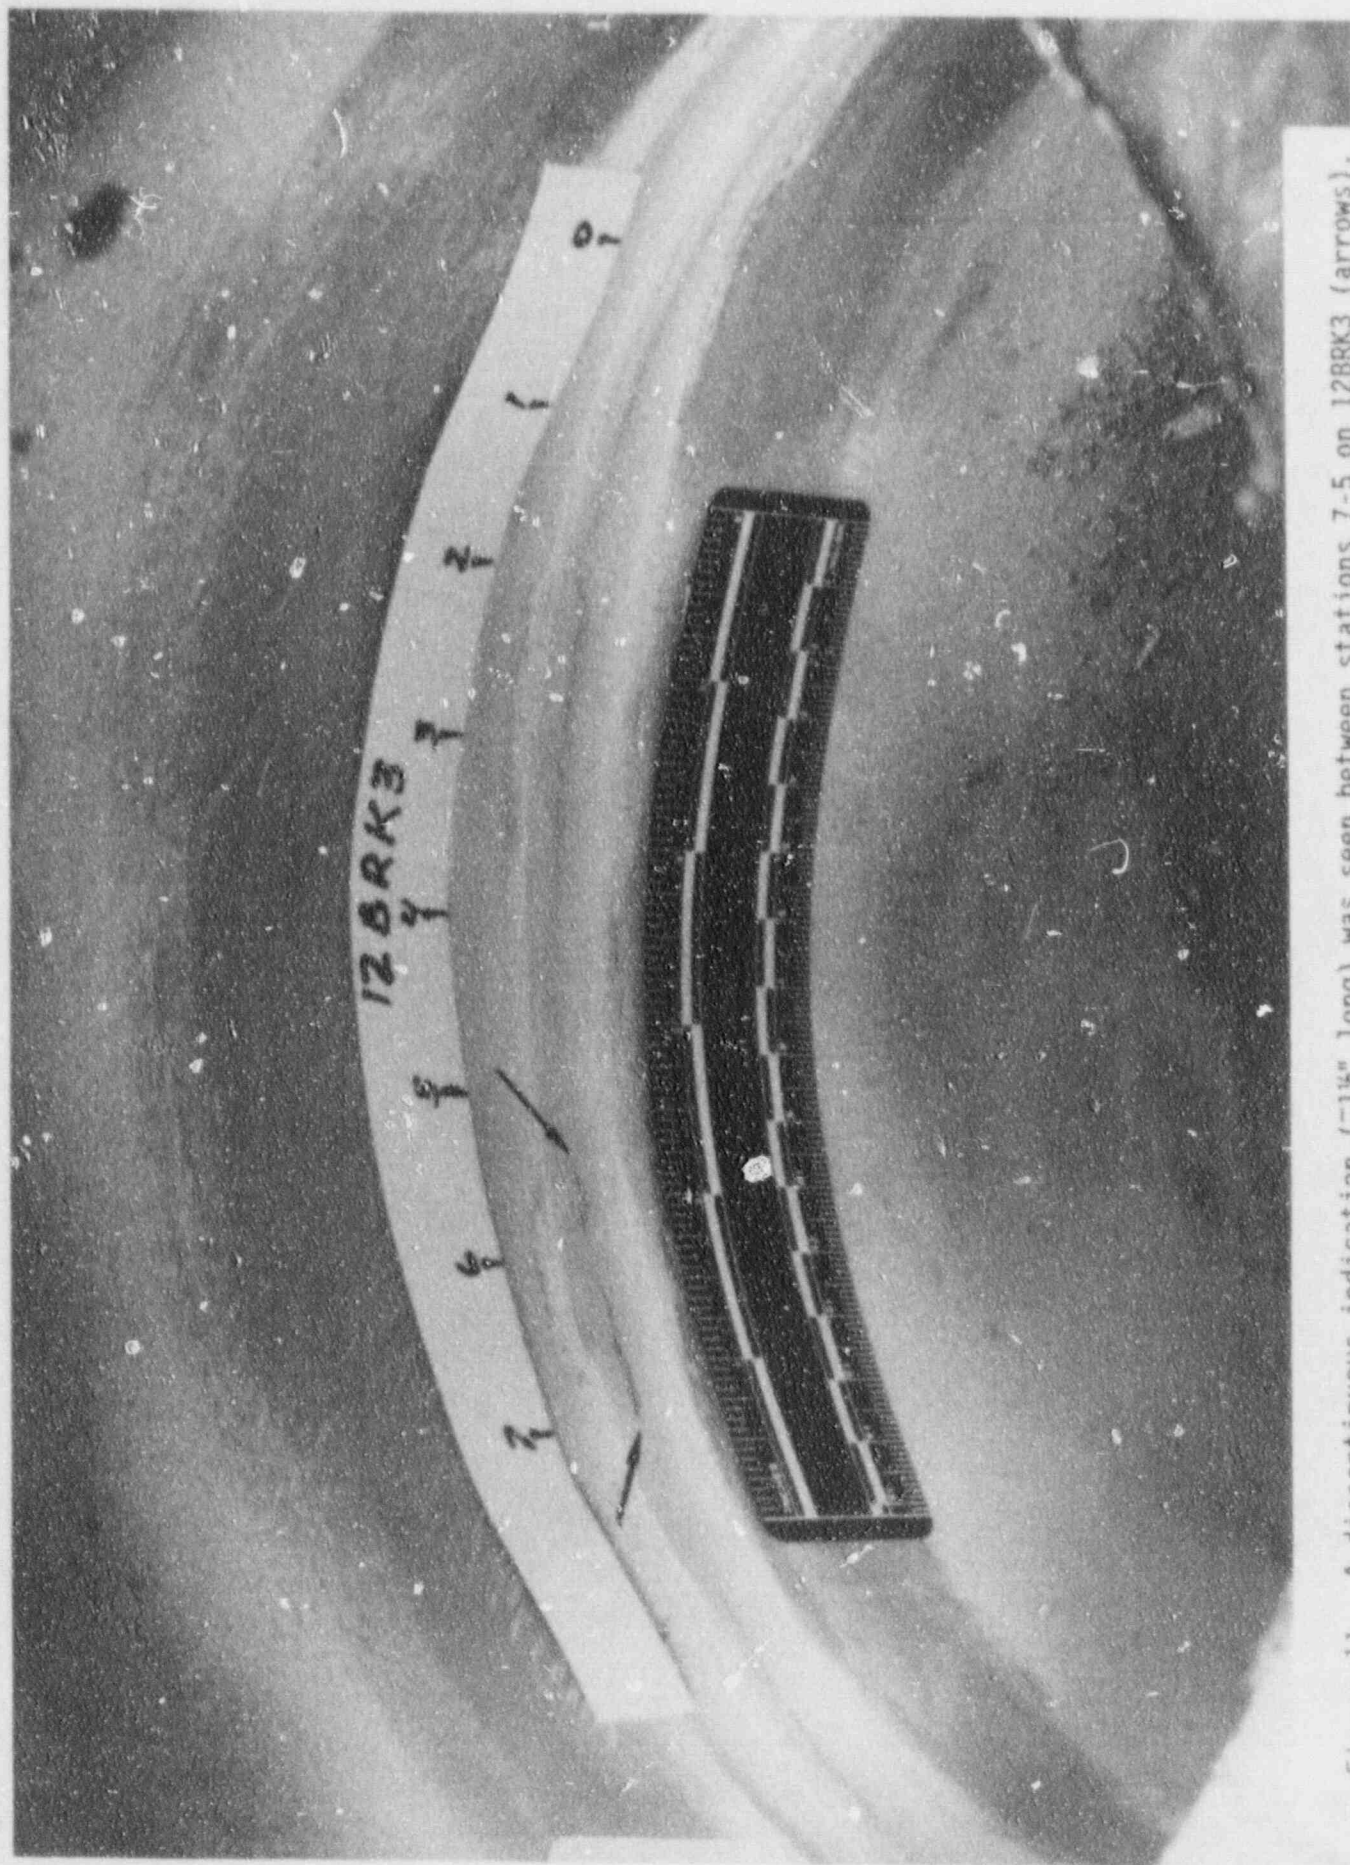
Figure 11 A discontinuous indication ($\sim 1\frac{1}{2}$ " long) was seen between stations 7-5 on 12BRK3 (arrows).

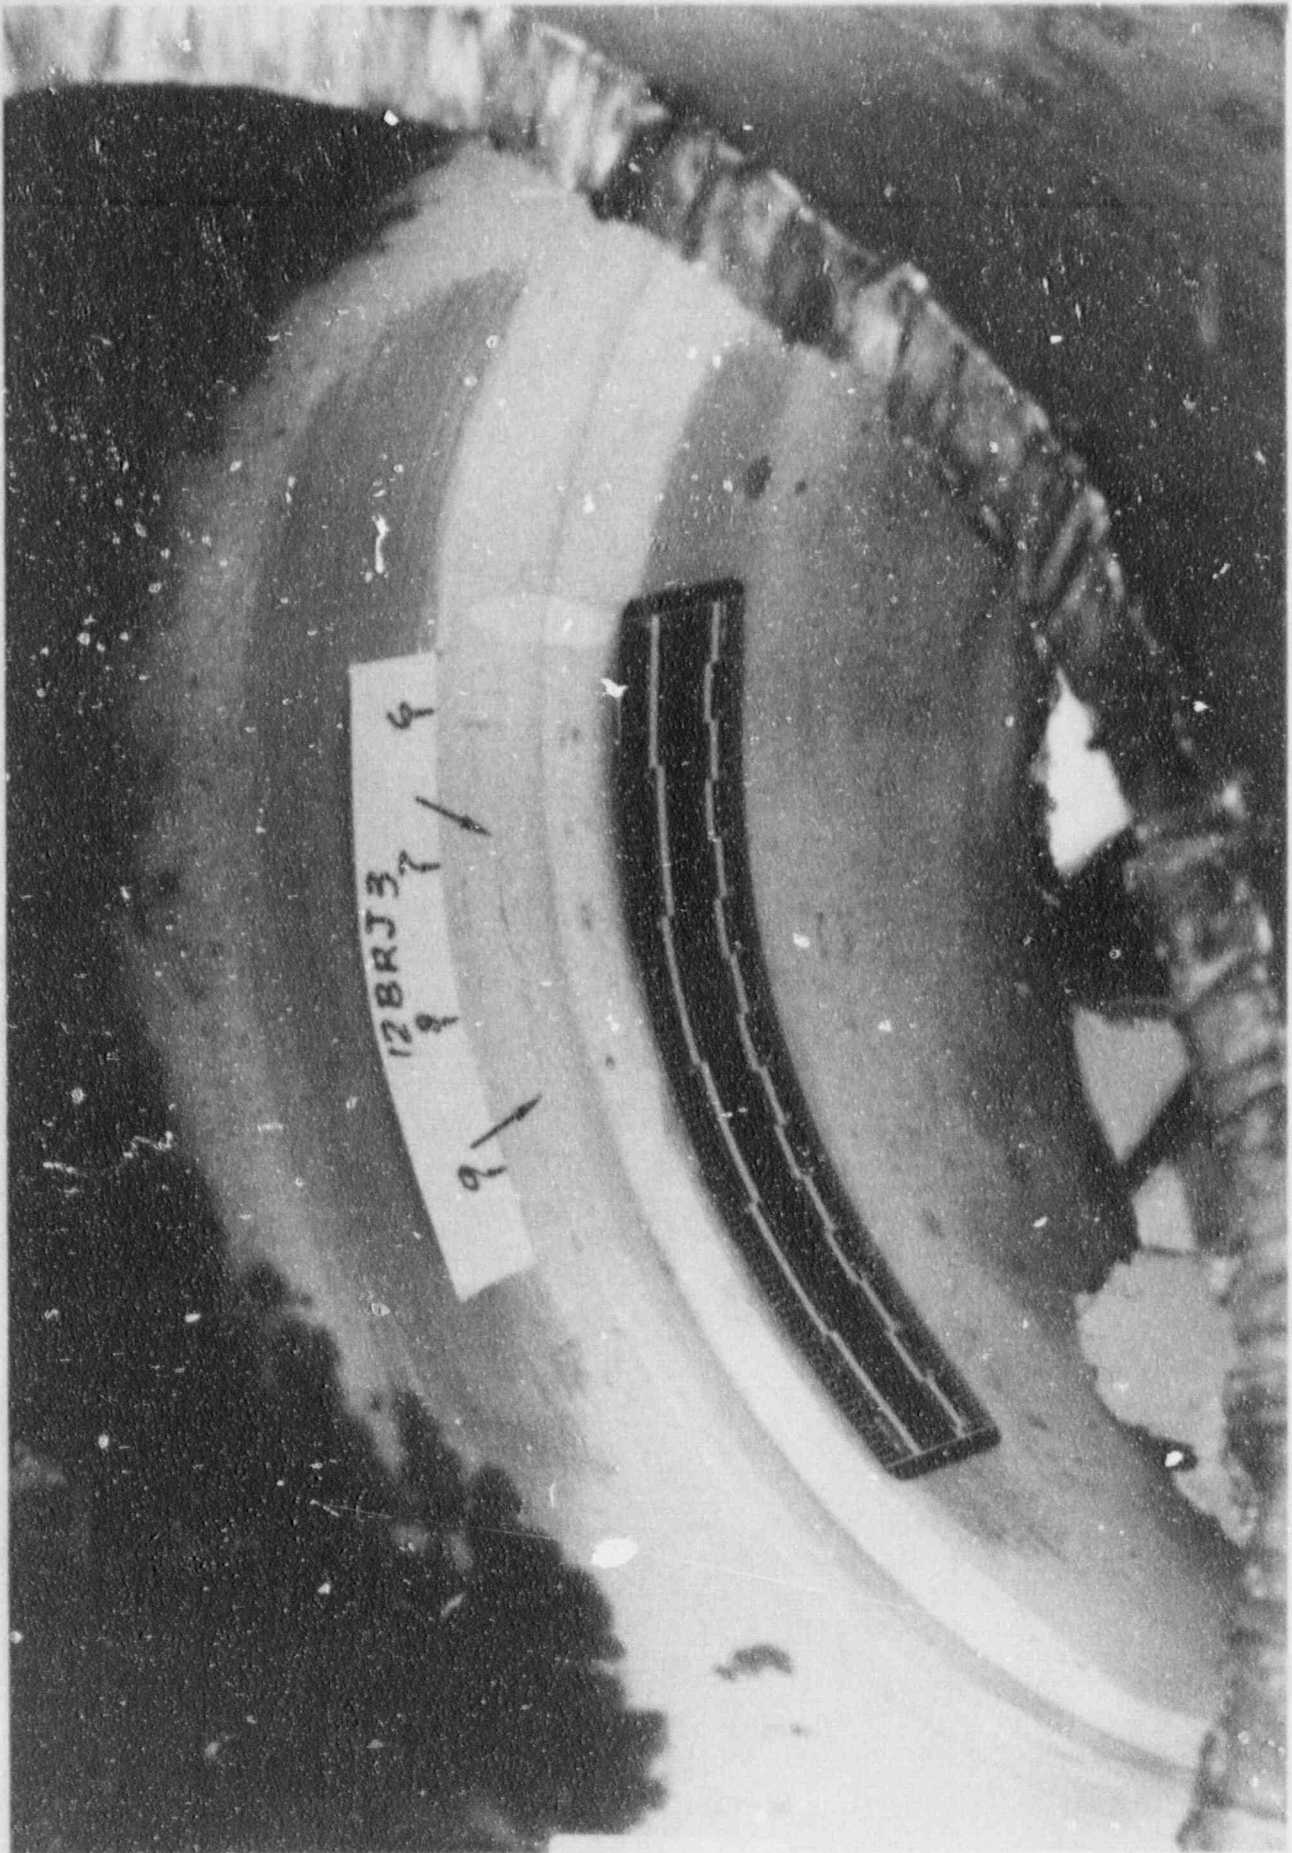
Two indications (Figures 14 and 15) were seen on this weld. The first was approximately 2" long between markers 7-9 and the second approximately 3/8" long between markers 33-32.

Figure 14 A "crazed" appearing indication was seen between markers 9-7 ($\sim 1\frac{1}{2}$ " long) on 12BRJ3 (arrows).

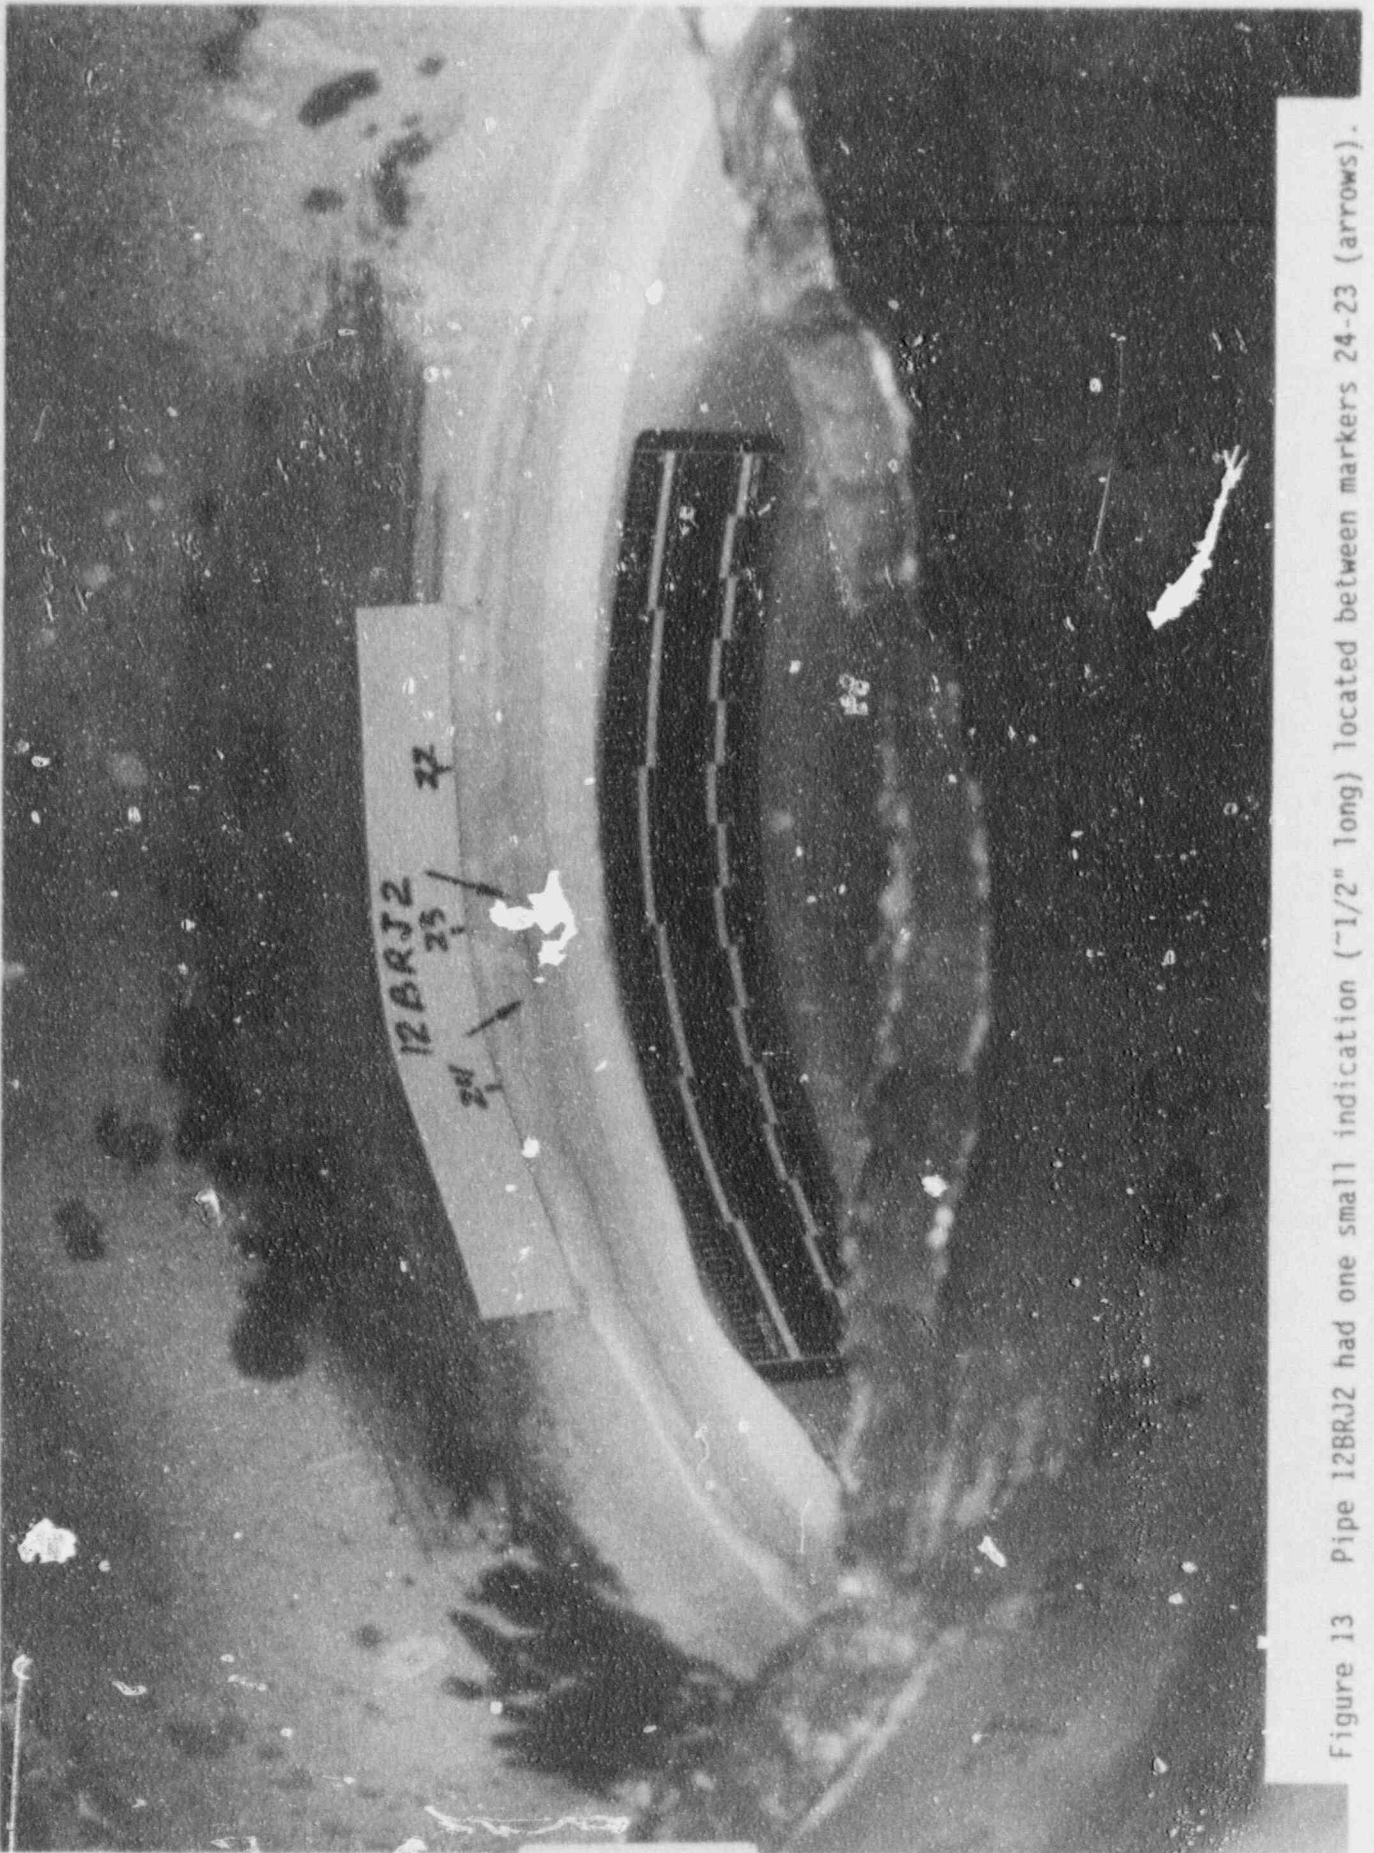
This weld (Figure 13) showed a faint 1 1/4" long indication between station markers 24-23.

Figure 13 Pipe 12BRJ2 had one small indication (~1/2" long) located between markers 24-23 (arrows).

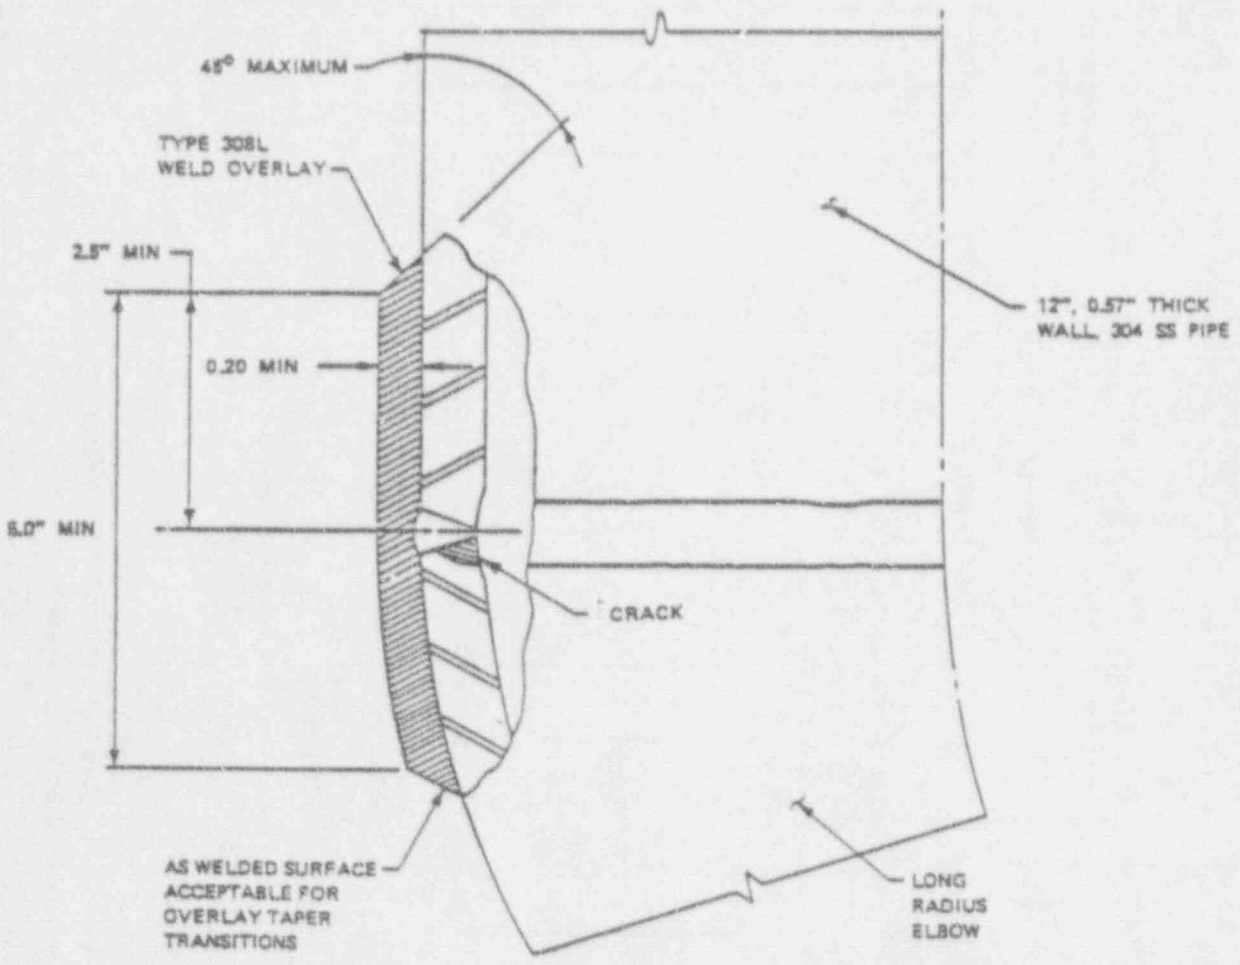
Figure 32 Sketch of weld overlay design for pipes 12BRJ2, 12BRJ3, and 12BRK3.

The two overlay designs [13] used for the four evaluated weldments; 12BRG4, 12BRJ2, 12BRJ3 and 12BRK3 are seen in Figures 32 and 33. Pipes 12BRJ2, 12BRJ3 and 12BRK3 were overlaid using the design in Figure 32. This design essentially centers the weld below the overlay to obtain a uniform stress distribution over the affected weld. There is also a reasonably good access for the ultrasonic inspection of these welds since there are no close welds to interfere with the ultrasonic signal.

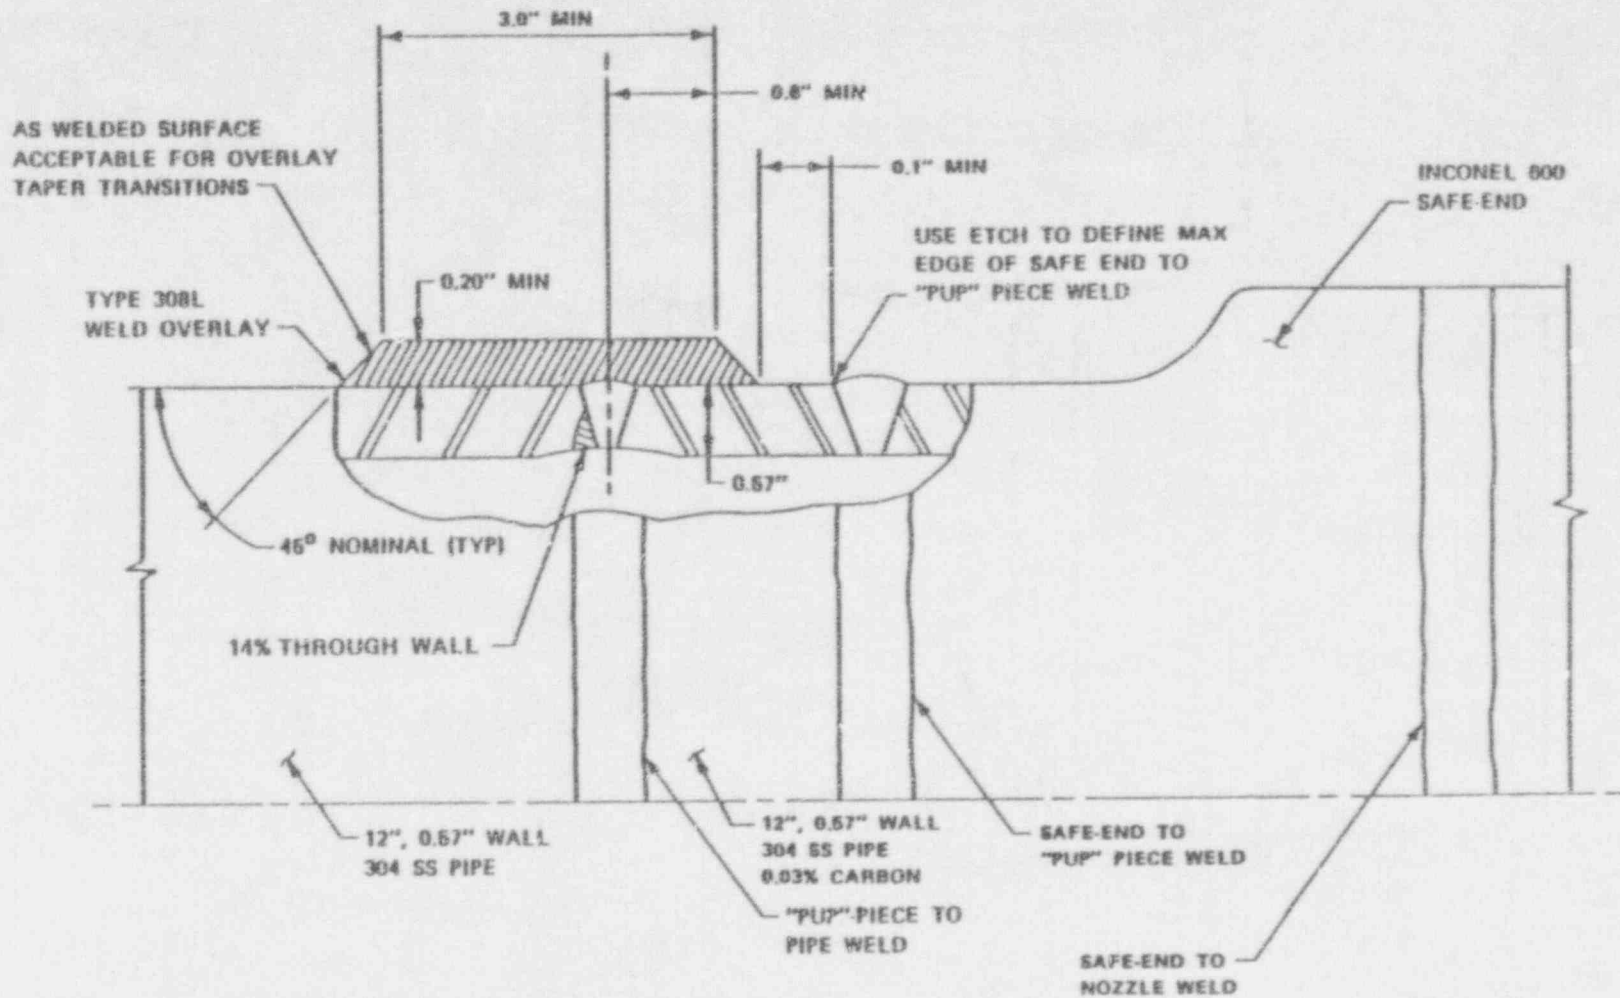
Figure 33 Sketch of weld overlay design for pipe 12BRG4.

The design of the overlay for 12BRG4 (Figure 33) was configured differently from the other three examined welds. The difference resulted from the addition of a "pup" piece of stainless steel between the original pipe and the safe end. This configuration shifted the overlay off center - away from the "pup piece." This shifting might result in misleading or erroneous ultrasonic inspection data. The importance of this issue lies in the "inspectability" of weld overlaid joints.

These observations lead to one of two possible scenarios:

- 1) That the crack on BRG4 was pre-existing in a 7 1/2" length and virtually "through wall" in depth and was neither located nor sized by the ultrasonic inspection system used; the GE Smart System; or
- 2) That crack growth occurred in the "through wall" crack after weld overlay was applied.

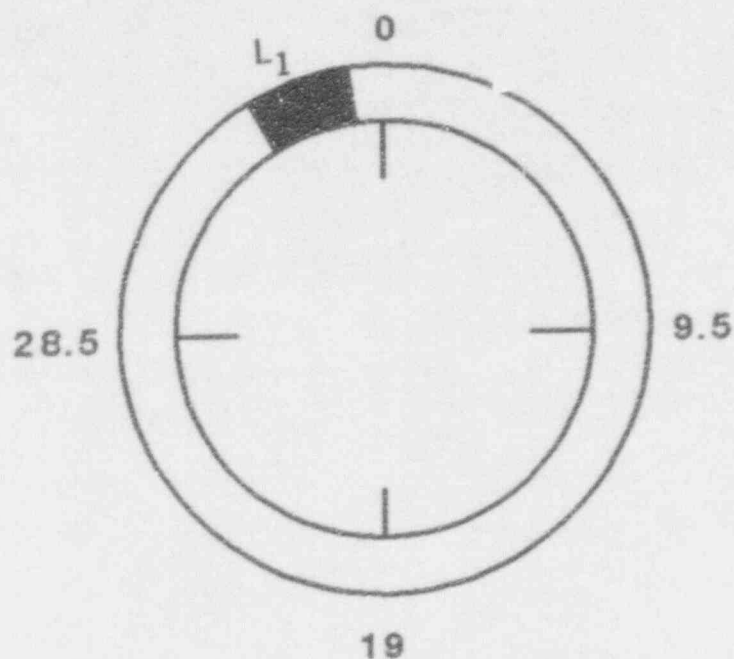
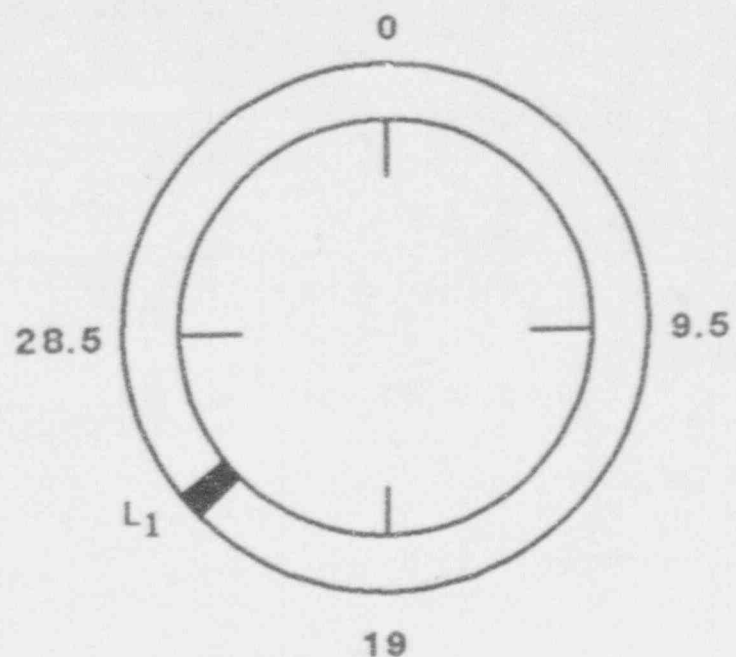
12BRJ2

- 1983 ISI - $L_1 = 2.25''$ long;
12% through wall (0.08 deep)
- Circumferential

- $L_1 = 0.500''$ long crack;
29% through wall (0.200" deep)
- Circumferential

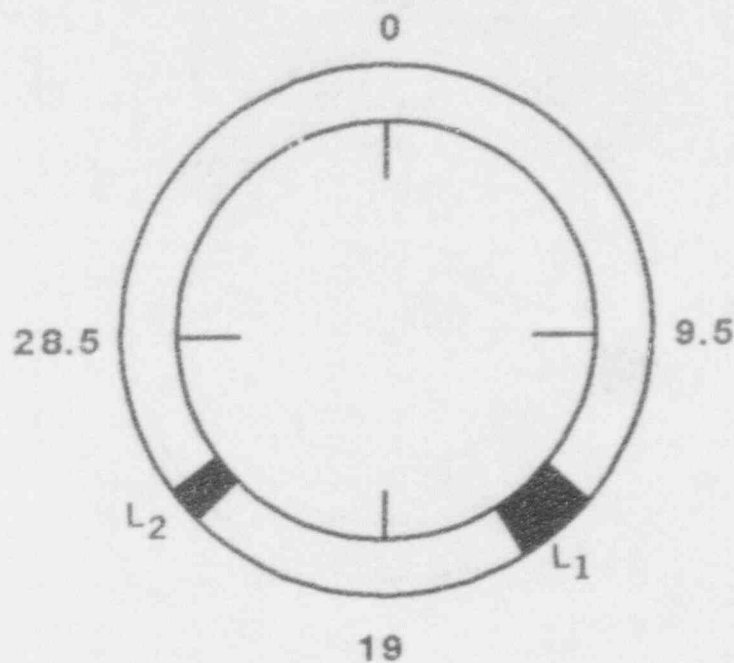
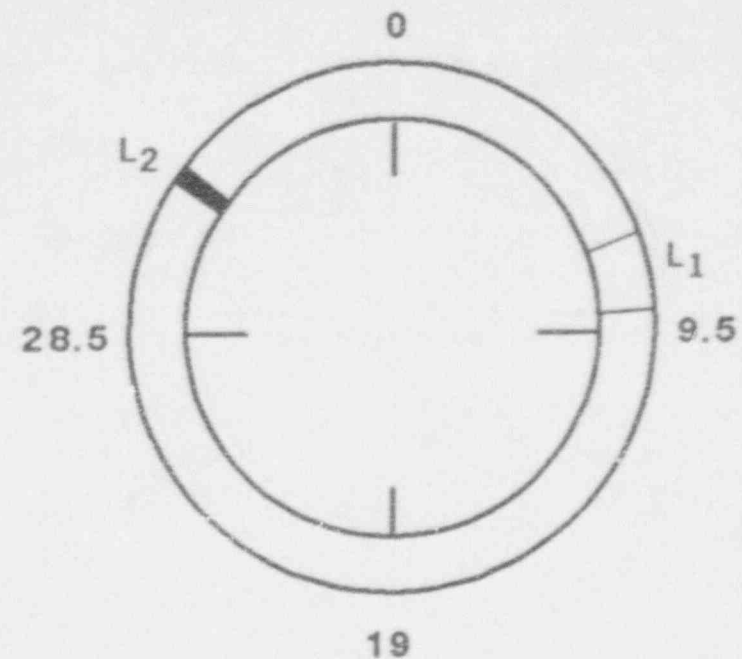
- 1983 ISI - L₁ = 1.75" Long,
11% through wall (0.07" deep).
- 1986 ISI - L₂ = 1.0" long,
30% through wall (0.204" deep).
 - Circumferential

- Two indications located by dye
penetrant L₁ = 1.5" long;
L₂ = 0.375" long.
- L₂ = 0.375" long crack;
48% through wall (0.328" deep).
 - Circumferential
