NUREG/CR-5885
BNL-NUREG-52331

Metallurgical Evaluation of Weld Overlaid Pipe Sections From Brunswick Unit 2 Nuclear Power Station

Brookhaven National Laboratory

Prepared for
U.S. Nuclear Regulatory Commission

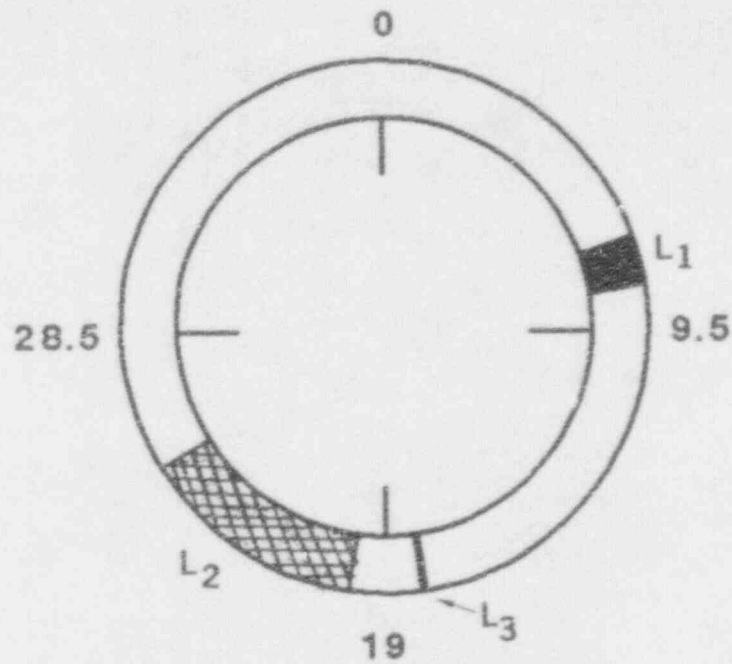
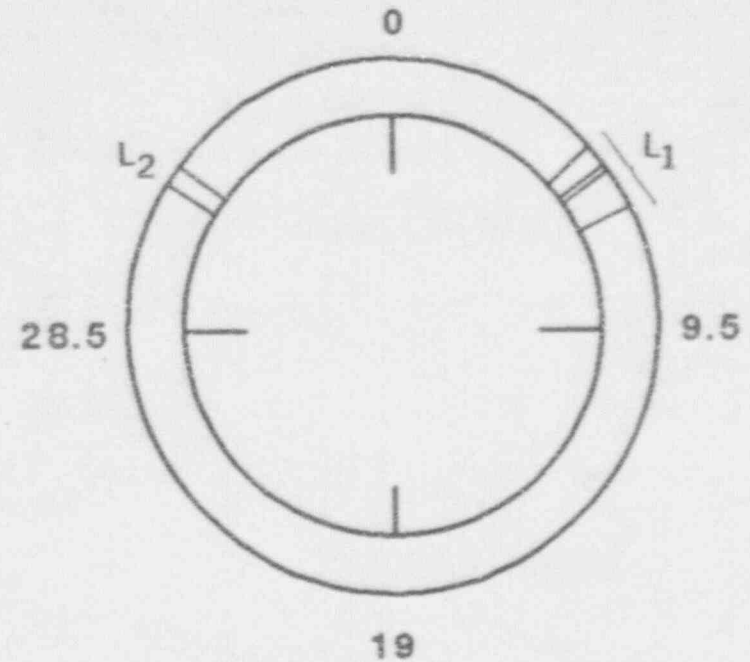
12 BRK3

- 1983 ISI - $L_1 = 1.25$ " long;
5% through wall (0.036" deep);
 $L_2 =$ ID Geometric Reflector.
 - Circumferential
- 1988 ISI - IGSCC recorded
at top 25% of base metal (L_3).
 - Circumferential

- Two indications located by
dye penetrant - $L_1 = 1.5$ " long
(discontinuous); $L_2 = 0.5$ " long
 - Circumferential
- No cracks present after
sectioning.

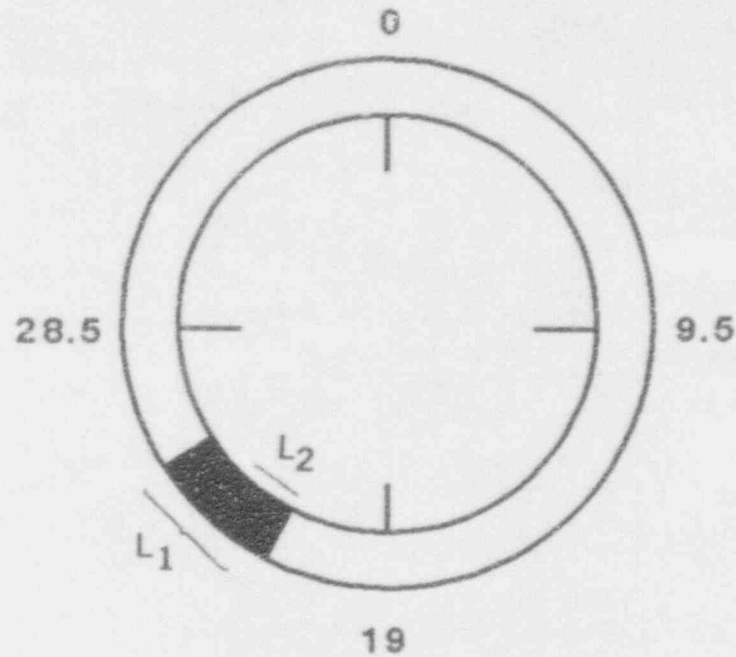
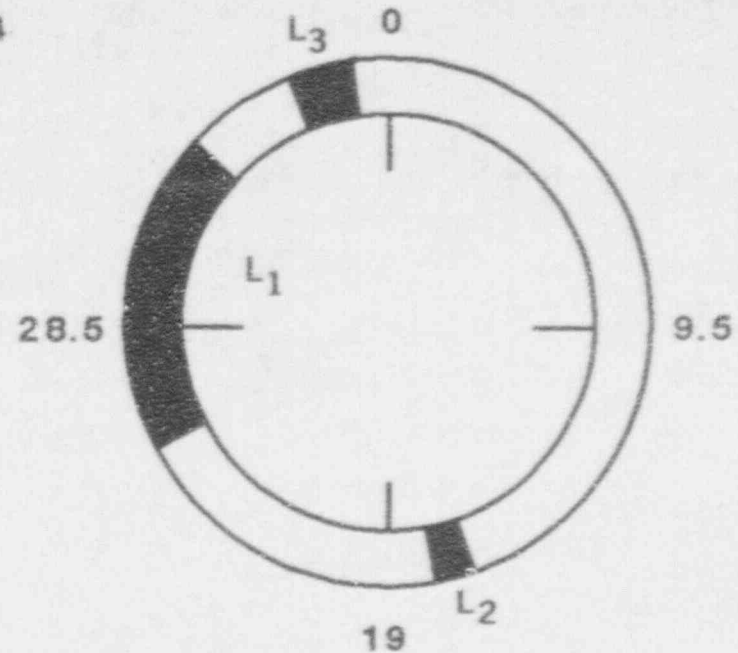
12BRG4

- 1983 ISI - L₁ - 2.0" long; 14% through wall (.100" deep)
- L₂ = 1.25" long; 7% through wall (.050" deep) - Split signals on UT
- Both Circumferential

- L₁ = 7.5" long (essentially through wall for 30% length).
 - Circumferential and axial components
- L₂ = 1.0" long; 29% through wall (.200" deep)
 - Circumferential
- L₃ = 1.75" long; 83% through wall (~20% of length - .538" deep)
 - Circumferential

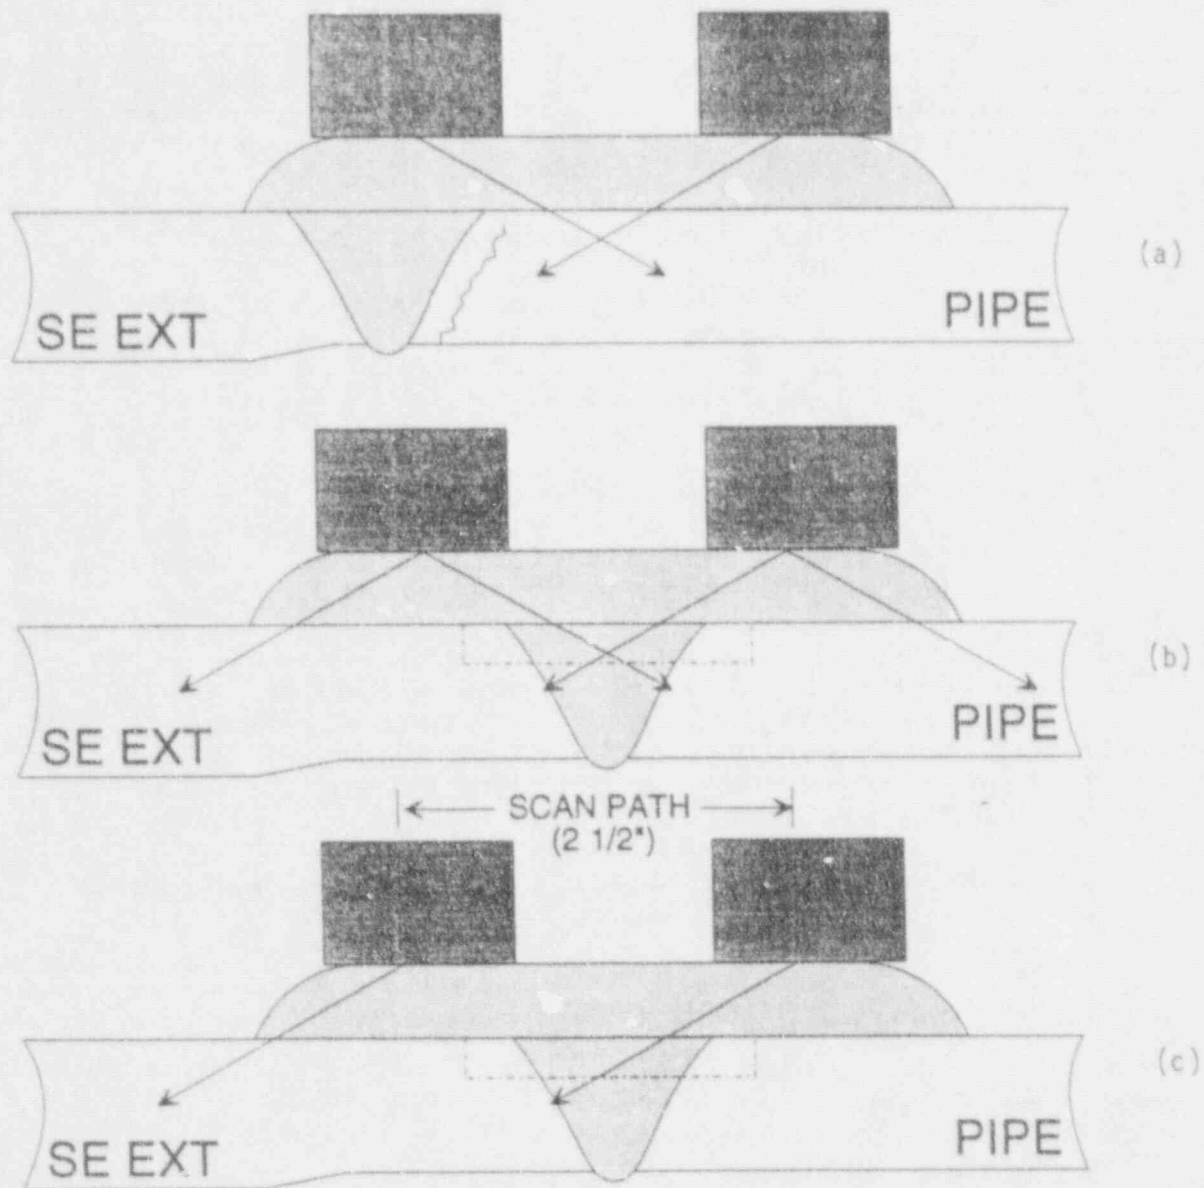
FIGURE 1. Ultrasonic Examination Coverage

Figure 1 illustrates the coverage limitation on BR-G4 due to the offset of the weld under the overlay as compared with the coverage which would be obtained on a weld centered under the overlay. Referring to Figure 1 (a), the angle beam examination looking in the upstream direction would be the most likely to detect the crack based on orientation; however, due to the offset, the area of the heat affected zone (HAZ) containing the crack cannot be scanned in this direction. While the area of the HAZ containing the weld can be scanned by the angle beam looking downstream, the orientation of the crack is not such that the soundbeam will be reflected back toward the transducer. If the weld were centered under the overlay, a sufficient scan path would exist for detection of a similar crack in the upper 25% of the original pipe wall on either side of the weld, as shown in Figure 1 (b) and (c).

- (a) Offset Weld Showing Coverage Limitation For Weld BR-G4
- (b) Coverage at Ends of Scan Path For Weld Centered Under Overlay
- (c) Scan Path On Overlay With Same Length as BR-G4 For Centered Weld
