U. S. ATOMIC ENERGY COMMISSION  
DIVISION OF COMPLIANCE  
HEADQUARTERS

CO Report No. 219/68-9

REPORT OF REACTOR PRESSURE VESSEL REPAIR PROGRAM

Licensee: JERSEY CENTRAL POWER AND LIGHT CO.  
CONSTRUCTION PERMIT NO. CPPR-15

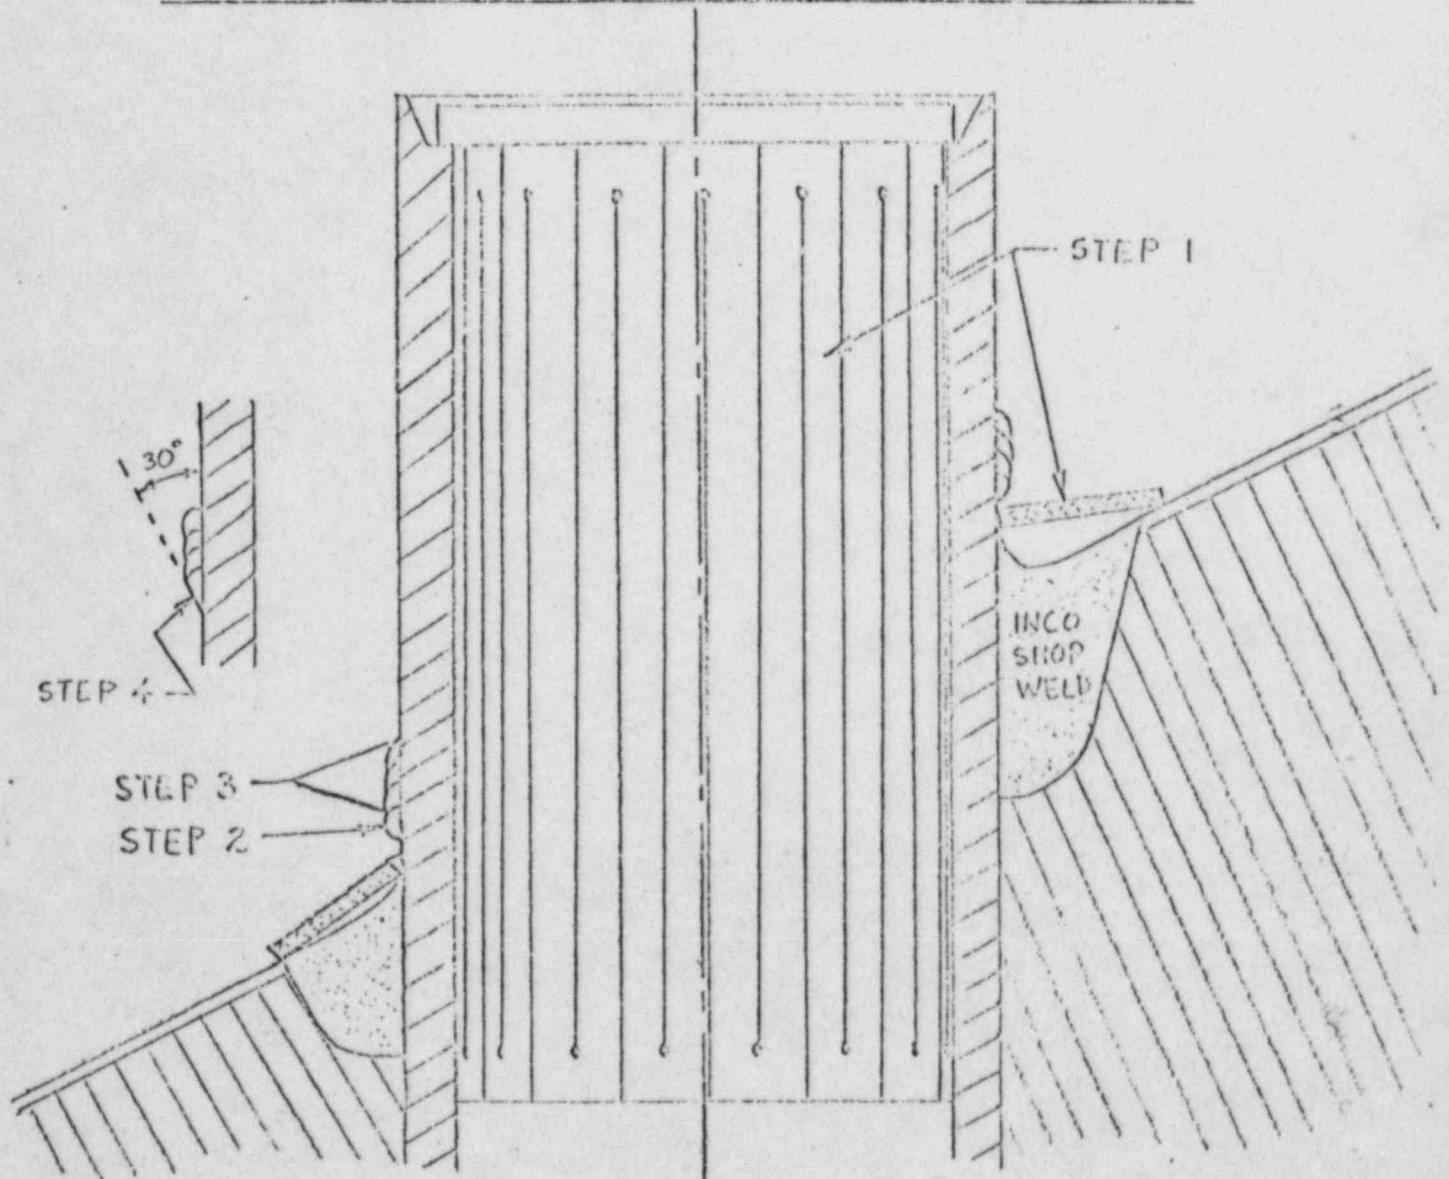
FIGURE 1

TYPE 308 AUSTENITIC STAINLESS STEEL BUFFER PASSES

Step No. 1 - Place a "collar" of heat resistant material over the shop weld to protect the Inco 182, and place a mandrel inside.

Step No. 2 - Using either the GE-3VA, GE-3VB or GE-3VC SMAW process or the GE-4VA GTAW process, deposit a weld bead circumferentially around the entire stub tube 1/2 inch ± 1/16 above the junction with Inco 182 shop weld.

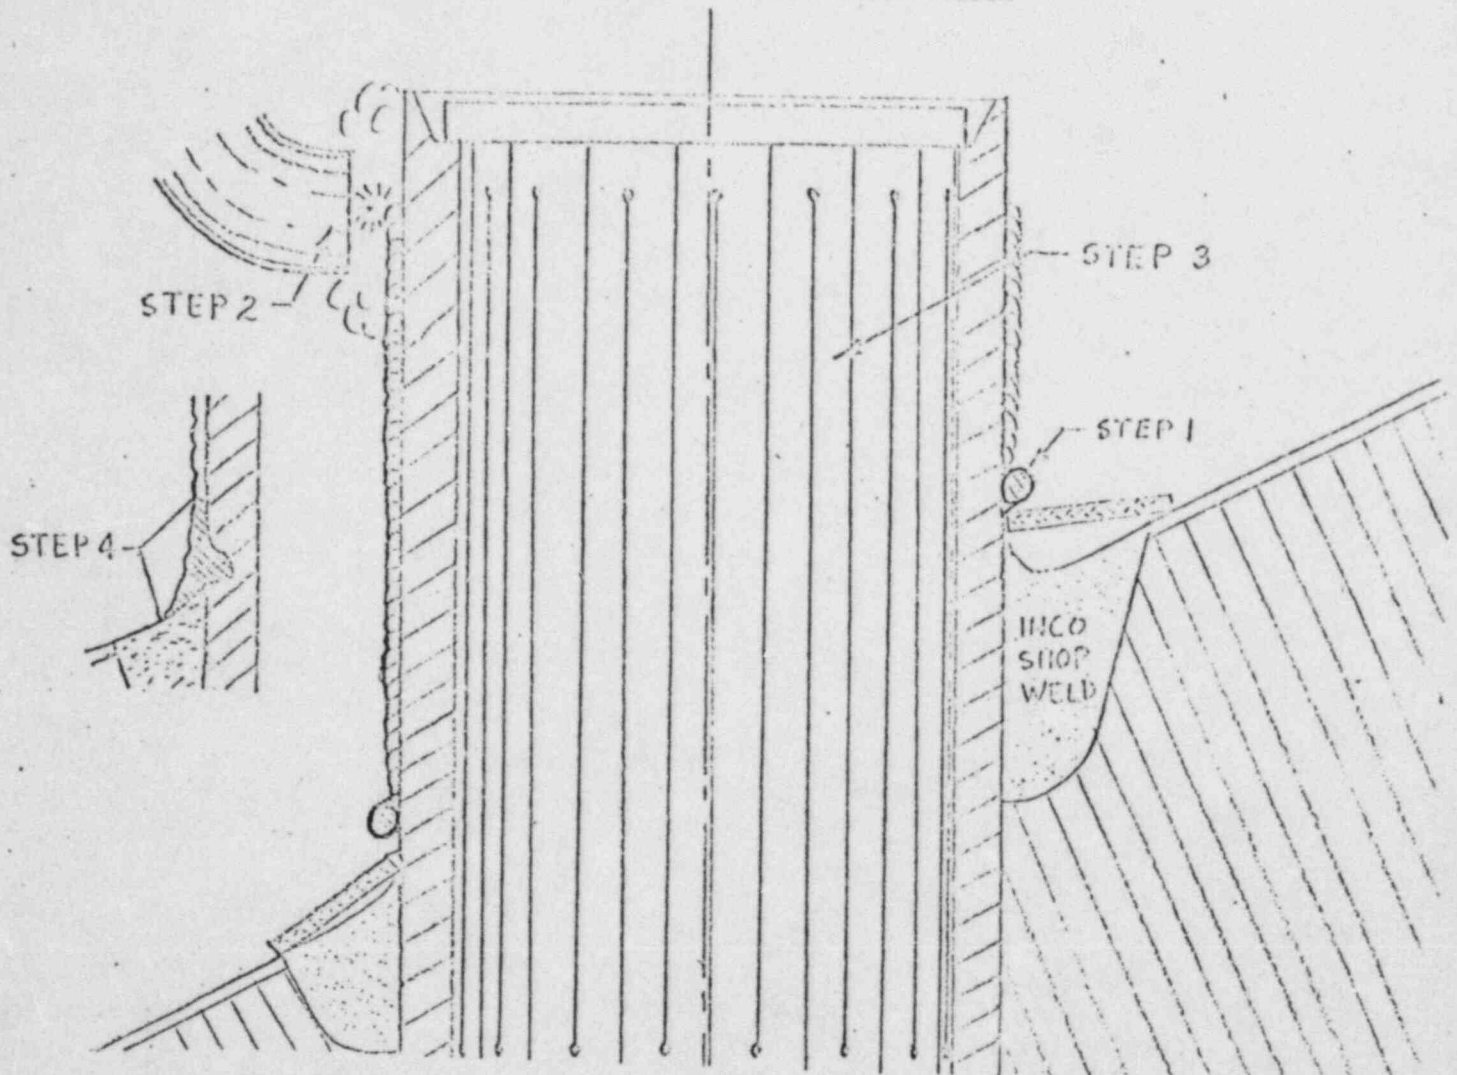
FIGURE 8

AUTOMATIC WELD OVERLAY OPTION

Step 1 - Protective barrier (see paragraph 3.2.2.3)

Step 2 - Applied next, by automatic GMAW using type ER308L filler. A minimum deposit thickness of 1/16 inch and a minimum overlap of 1/16 inch is required on each pass. The final as-deposited surface shall be suitably smooth or shall be smoothed by grinding or GTAW smoothing, in order to examine by dye penetrant to the accuracy established in Repair Procedure Number 1.

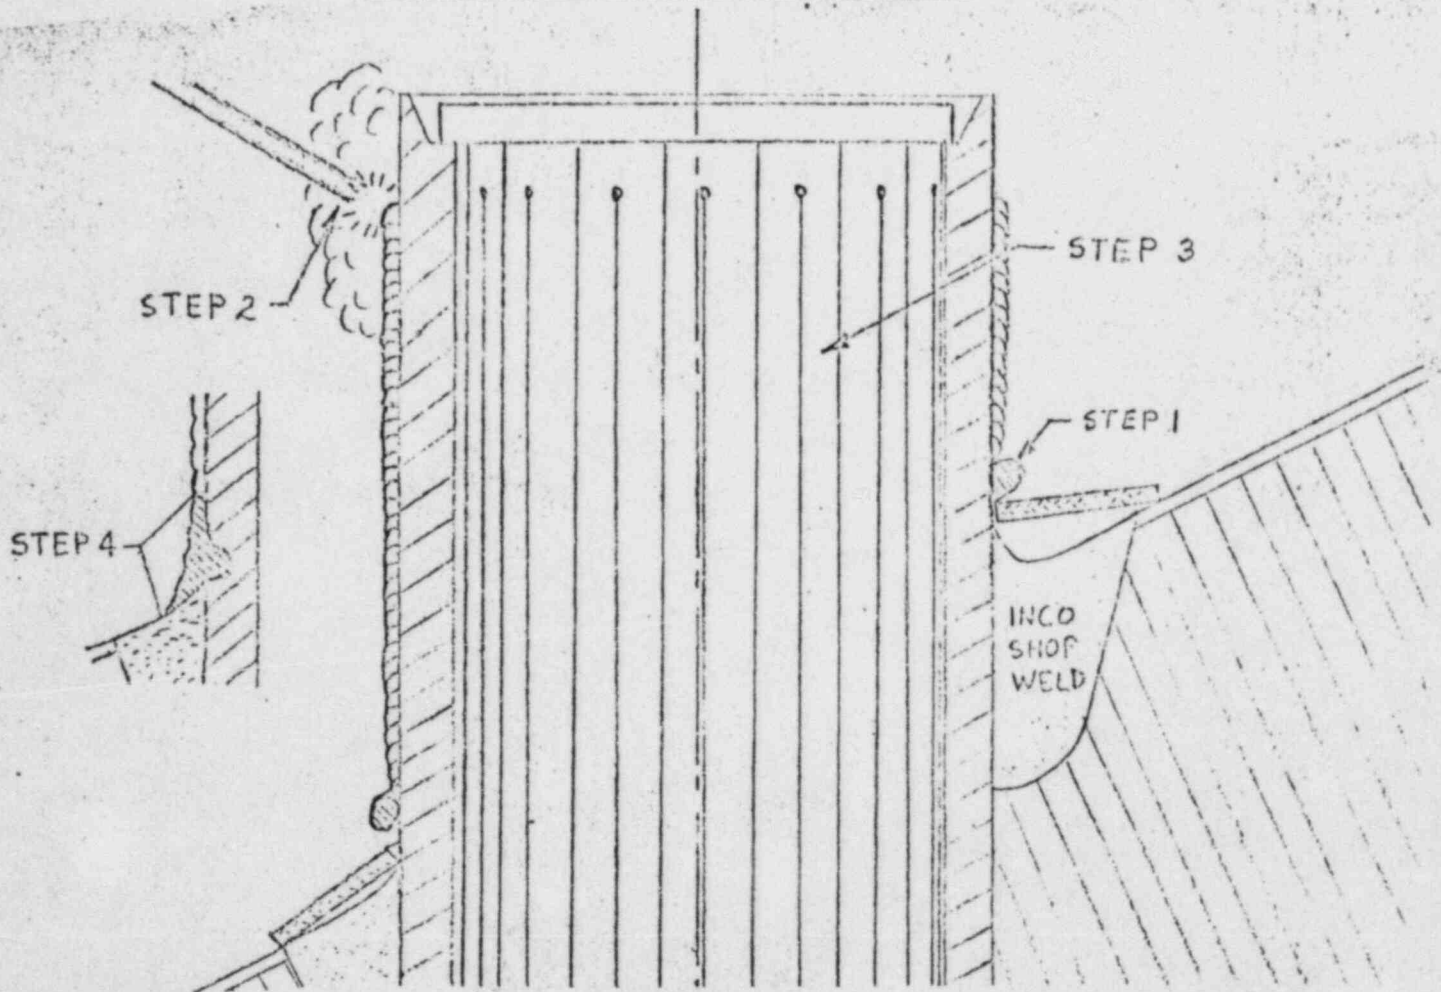
FIGURE 9

MANUAL WELD OVERLAY OPTION

Step 1 - Protective barrier (see paragraph 3.2.2.3)

Step 2 - Applied next, by manual SMAW, using type E308L filler. A minimum deposit thickness of 1/16 inch is required with a minimum overlap of 1/16 inch on each pass. The final as-deposited surface shall be suitably smooth or shall be smoothed by grinding or GTAW smoothing, in order to examine by dye penetrant to the accuracy established in Repair Procedure No. 1.

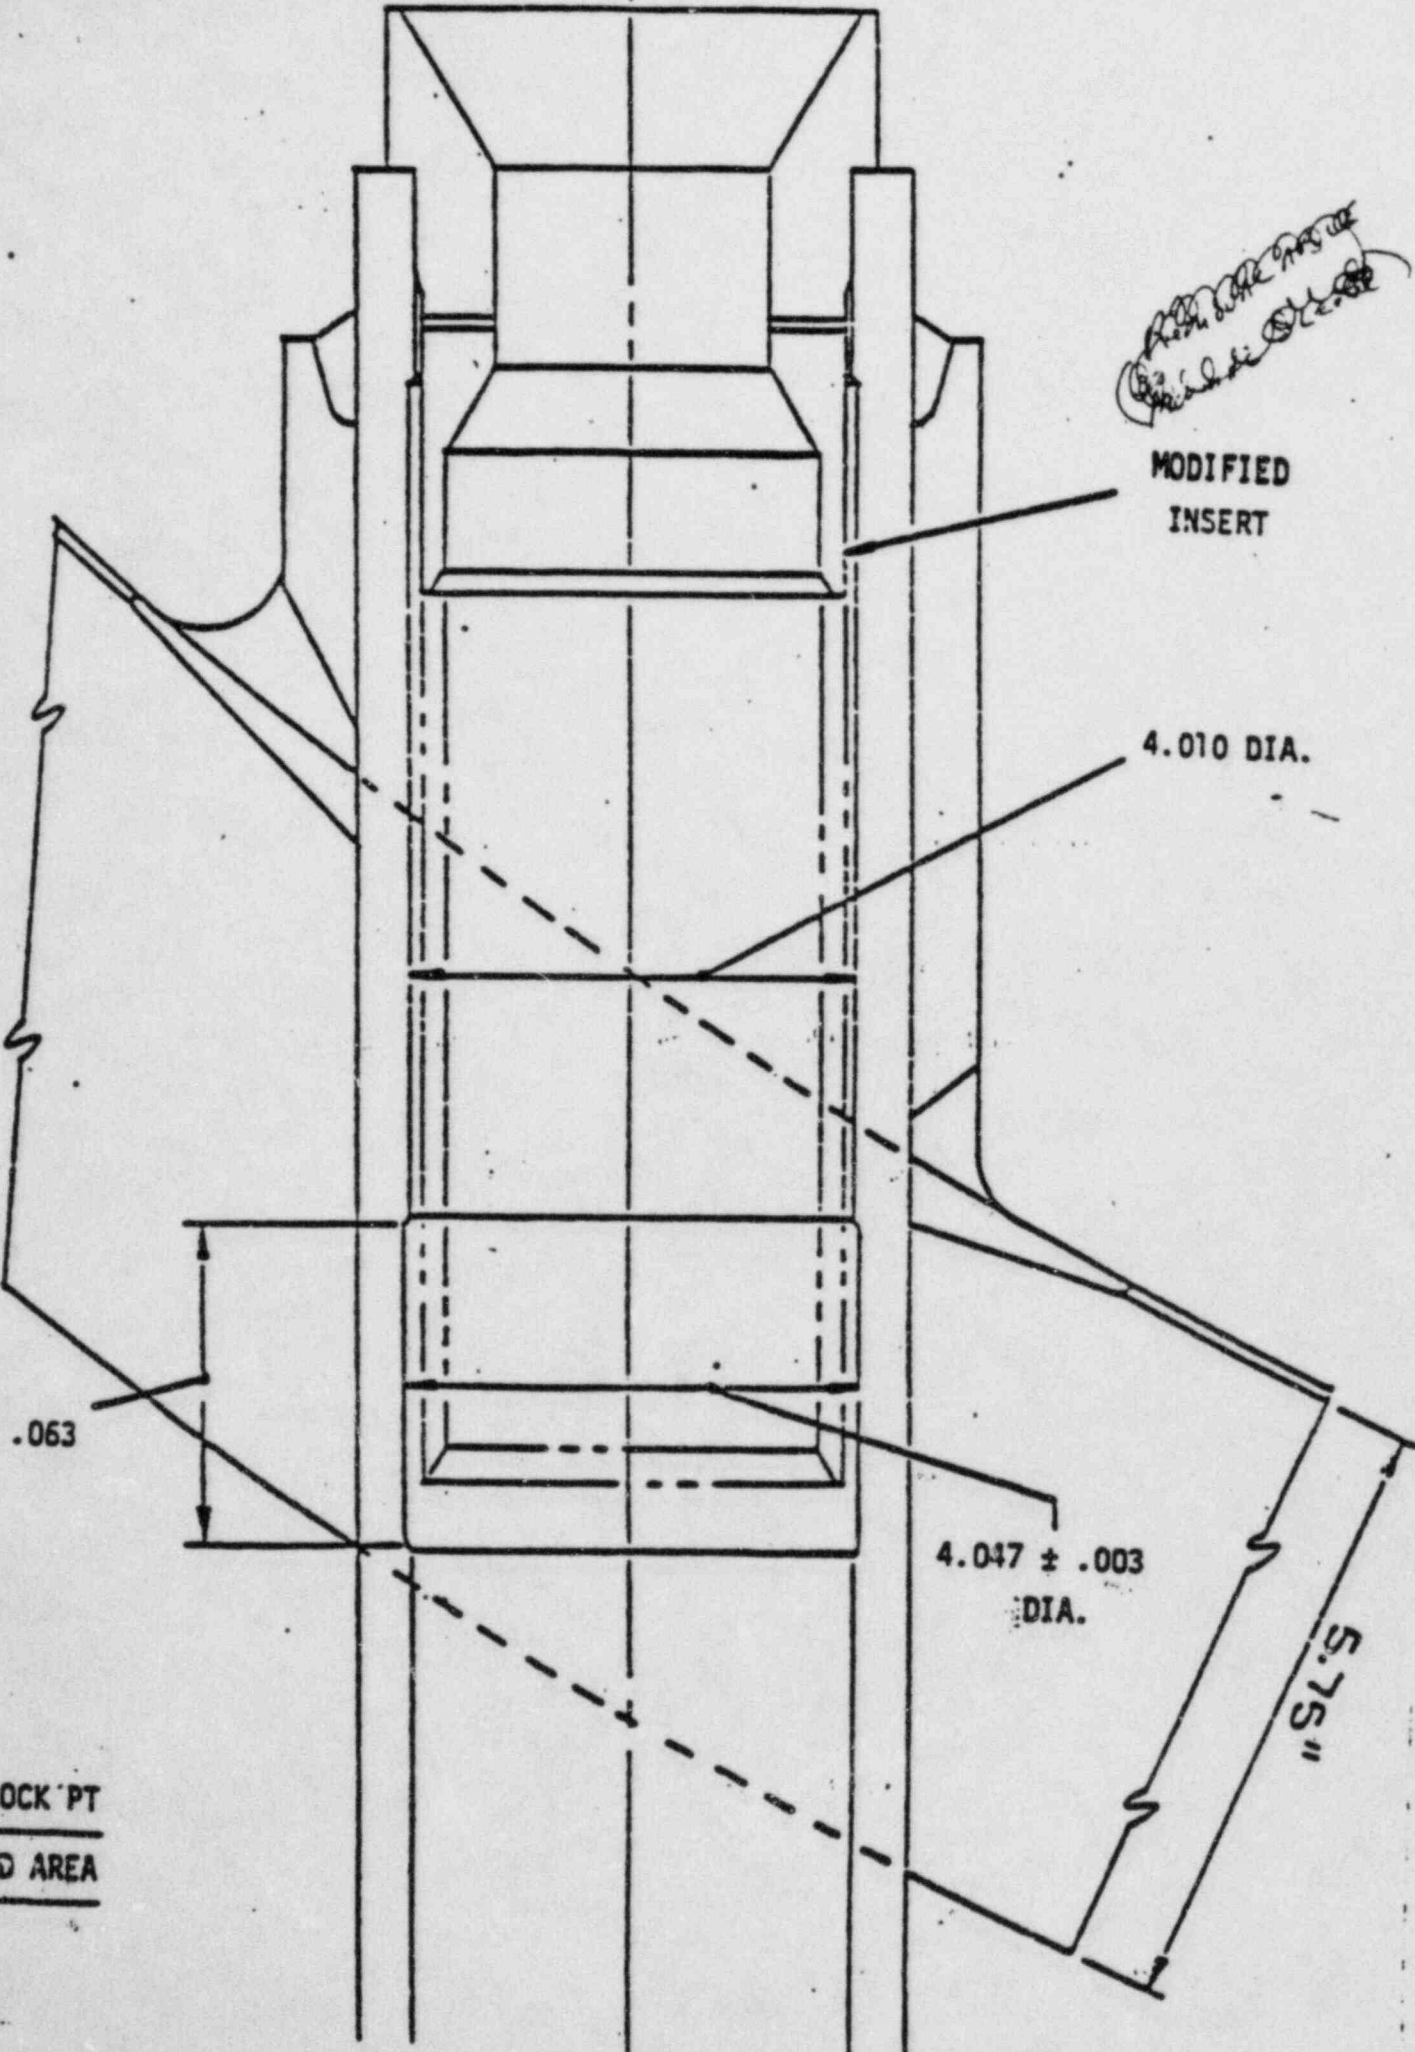
BIG ROCK PT  
ROLLED AREA

ROLL REPAIR AT BIG ROCK POINT

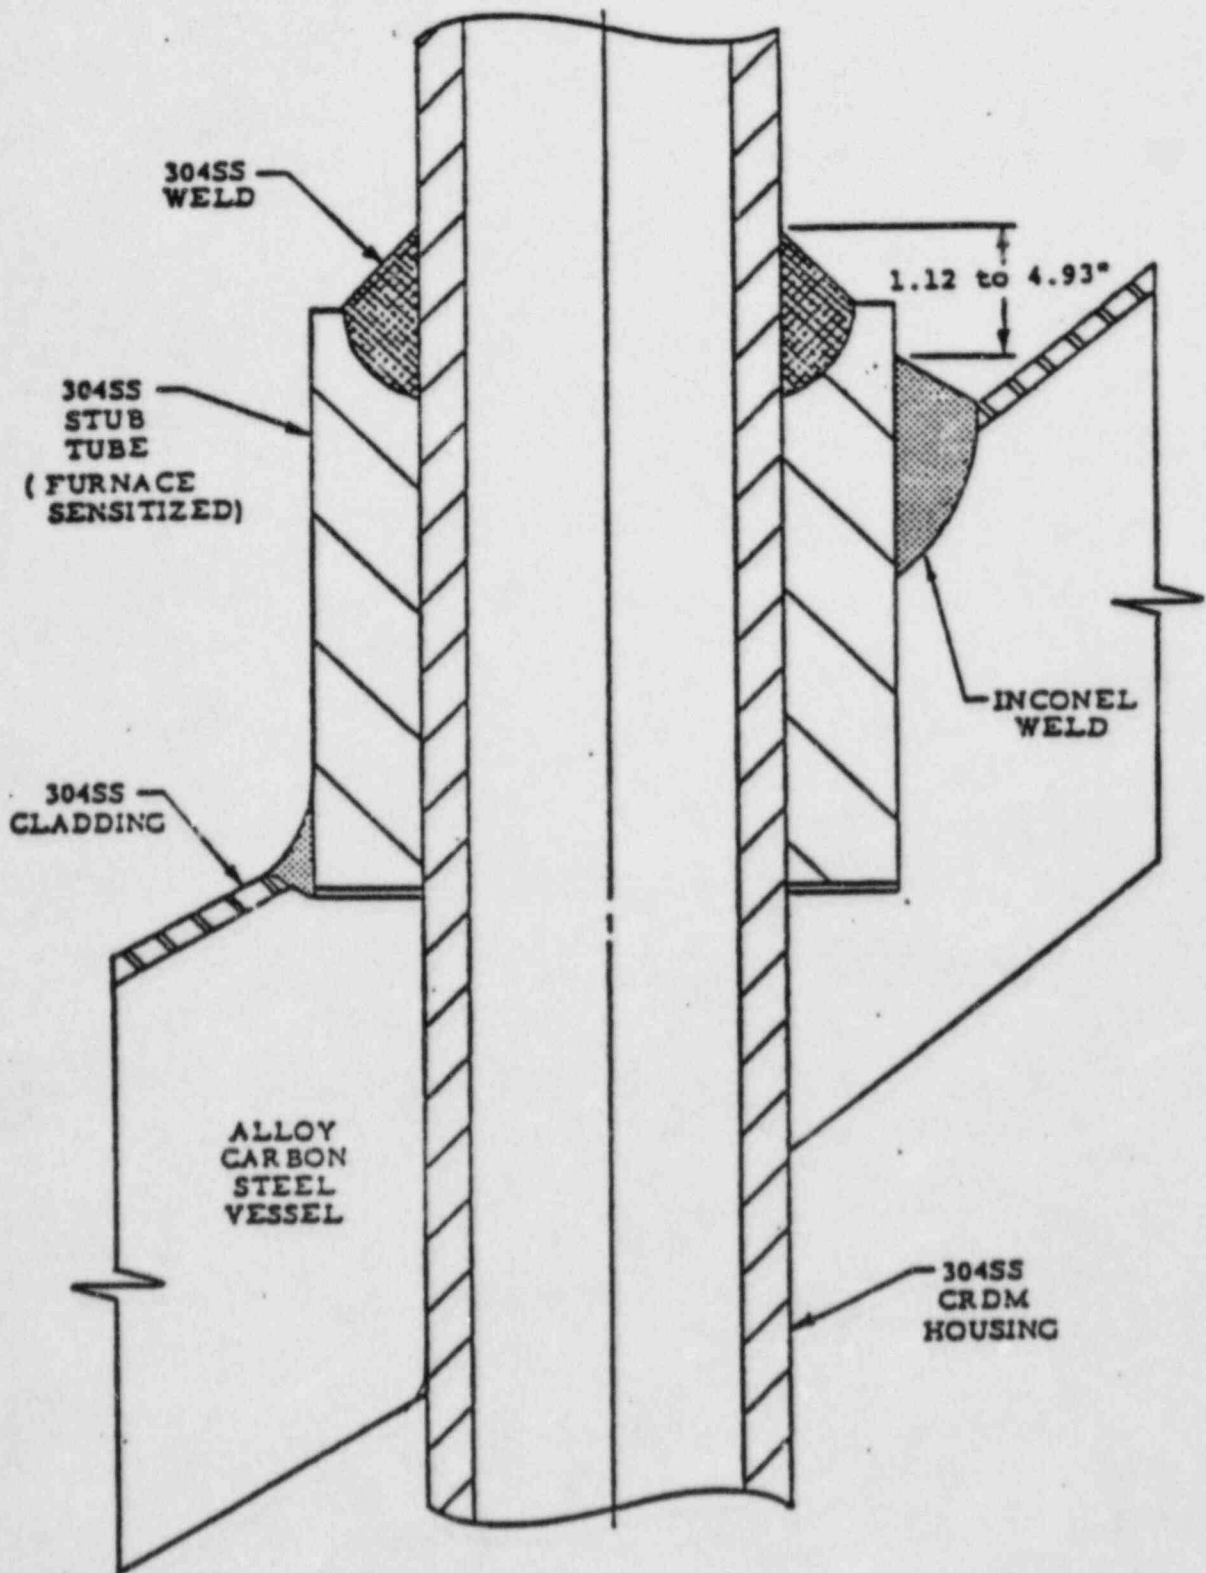
FIGURE I-1

CRD PENETRATION CONFIGURATION  
AT NINE MILE POINT
