FACILITY: Joseph M. Farley Nuclear Plant, Units 1 and 2

SUBJECT: SUMMARY OF MEETING HELD ON FEBRUARY 7, 1985, BETWEEN NRC AND APCo REPRESENTATIVES TO DISCUSS APCo's ACTION PLAN RELATING TO FAILURE OF A CONTAINMENT TENDON FIELD ANCHOR AT FARLEY UNIT 2

SUBJECT: FARLEY 2 - CONTAINMENT TENDON ANCHOR HEAD FAILURE

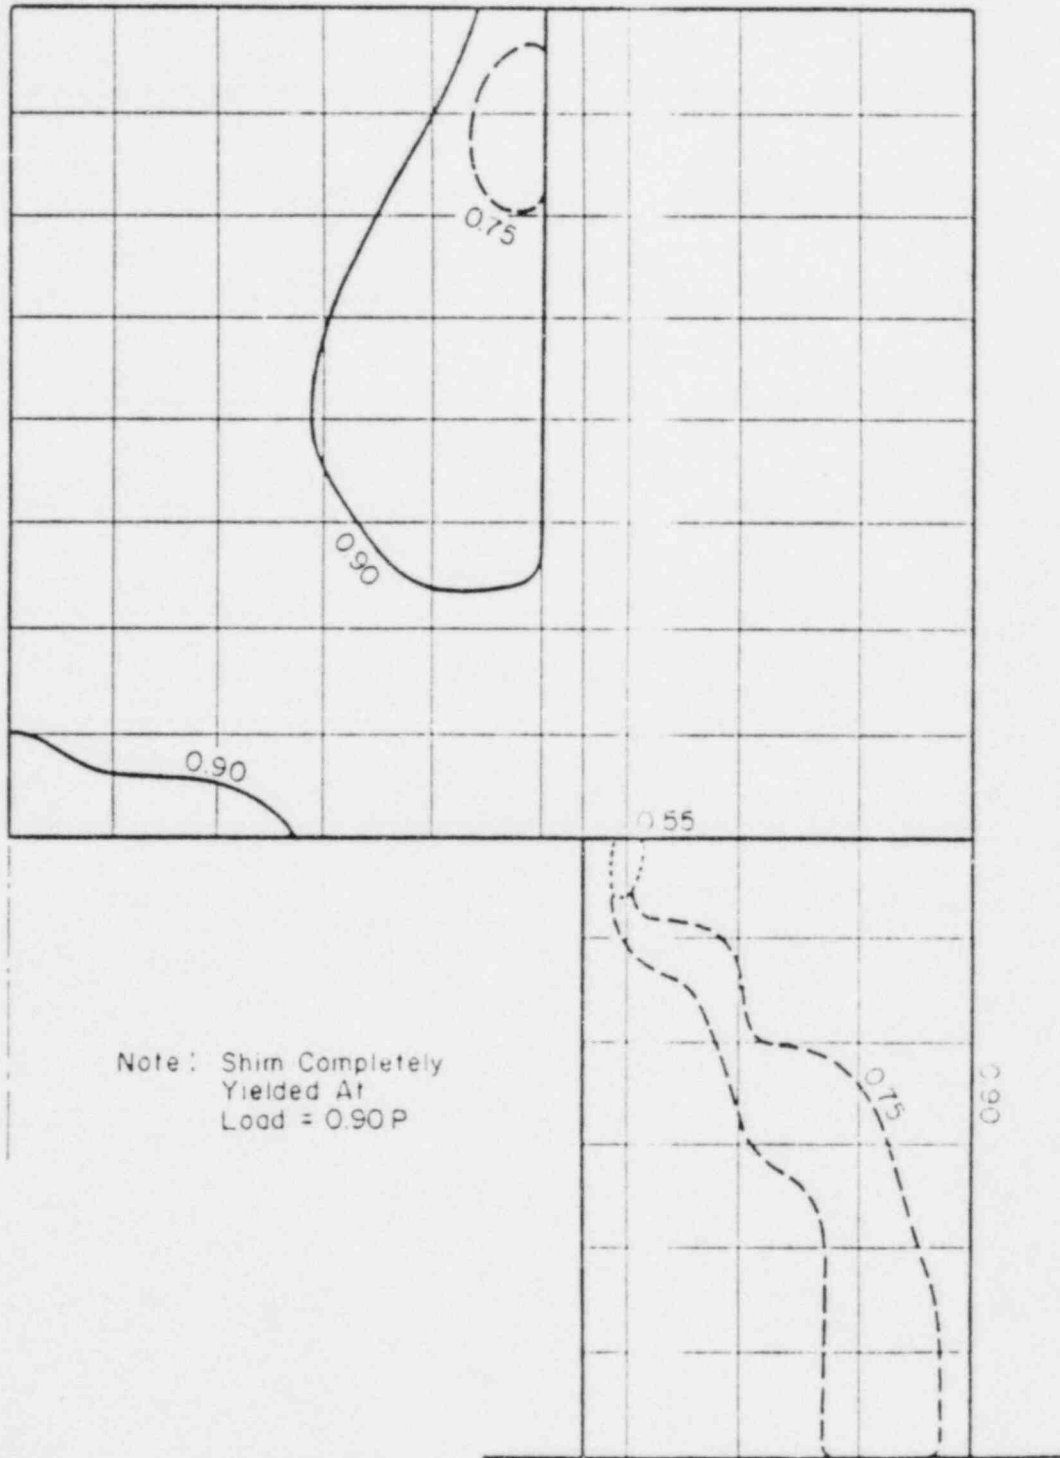
Fig. 48 Development of Yield Zones in Field Head ("Inelastic Shims/No Friction" Boundary Condition, and Effective Yield Stress 51 ksi in Flexural Region, 52.5 ksi in Shear Region of Honeycomb, 36 ksi in Shims)

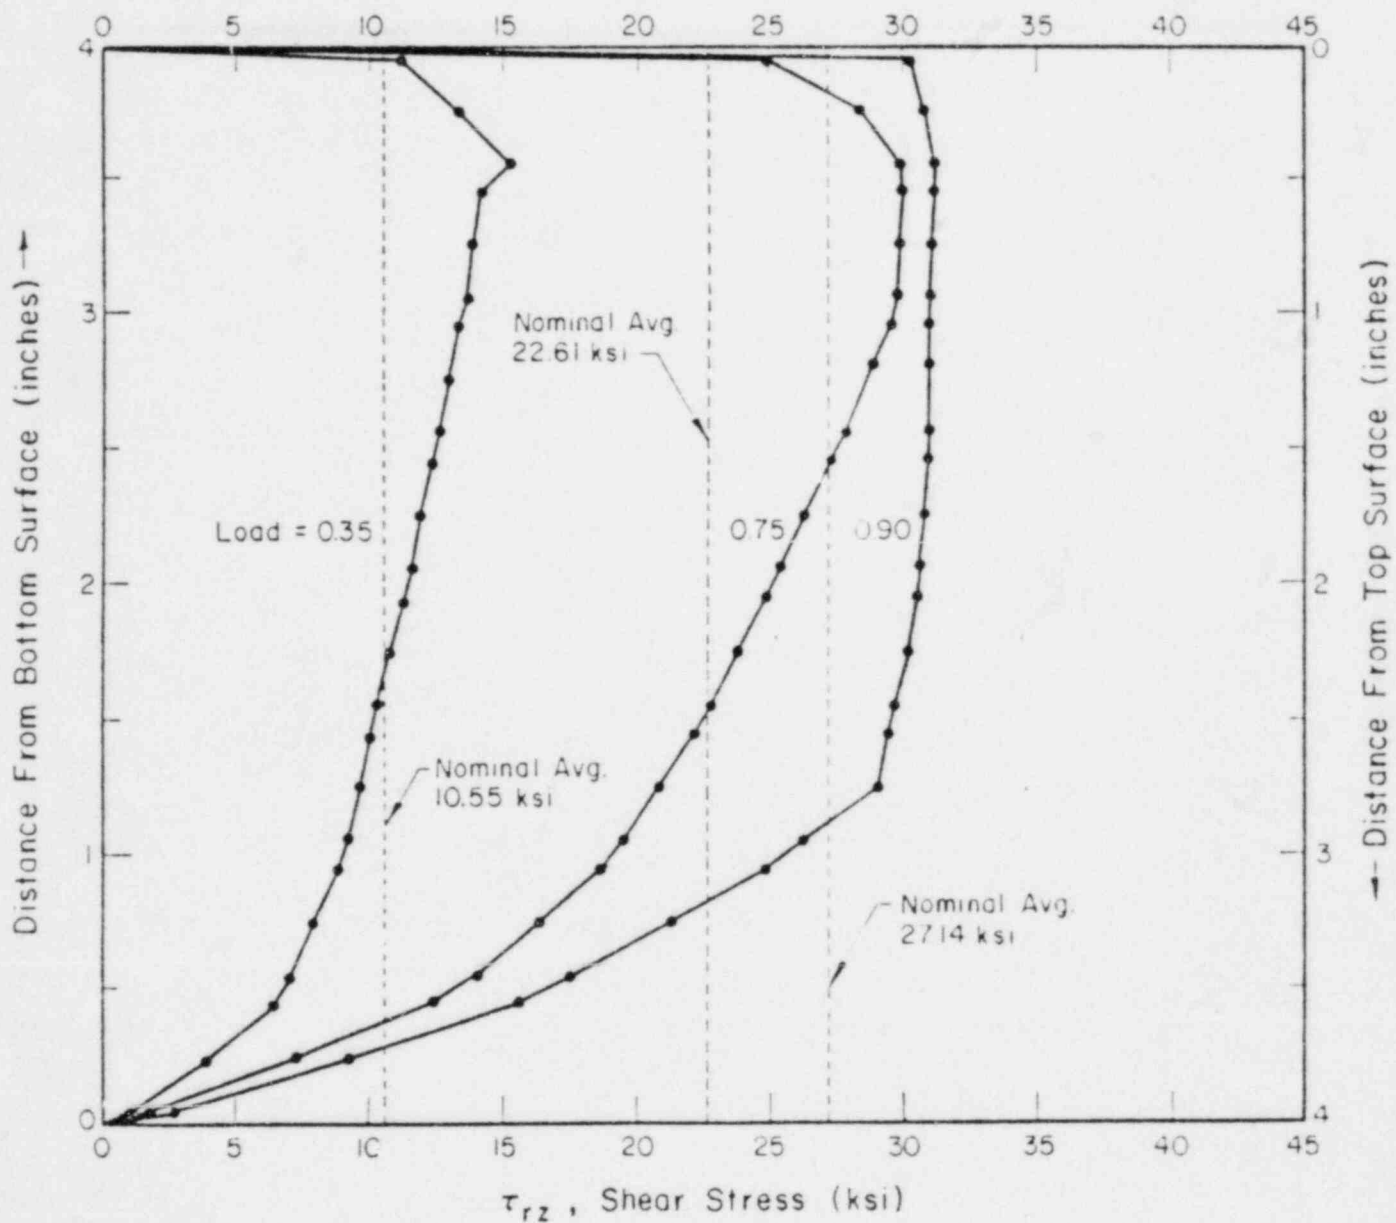
Fig. 45 Inelastic Distribution of Transverse Shear Stress at Edge of Honeycomb vs Applied Load (Field load with "Inelastic Shims/ No Friction" Boundary Conditions and Effective Yield Stress 51 ksi in Flexural Region, 52.5 ksi in Shear Region of Honeycomb, 36 ksi in Shim)

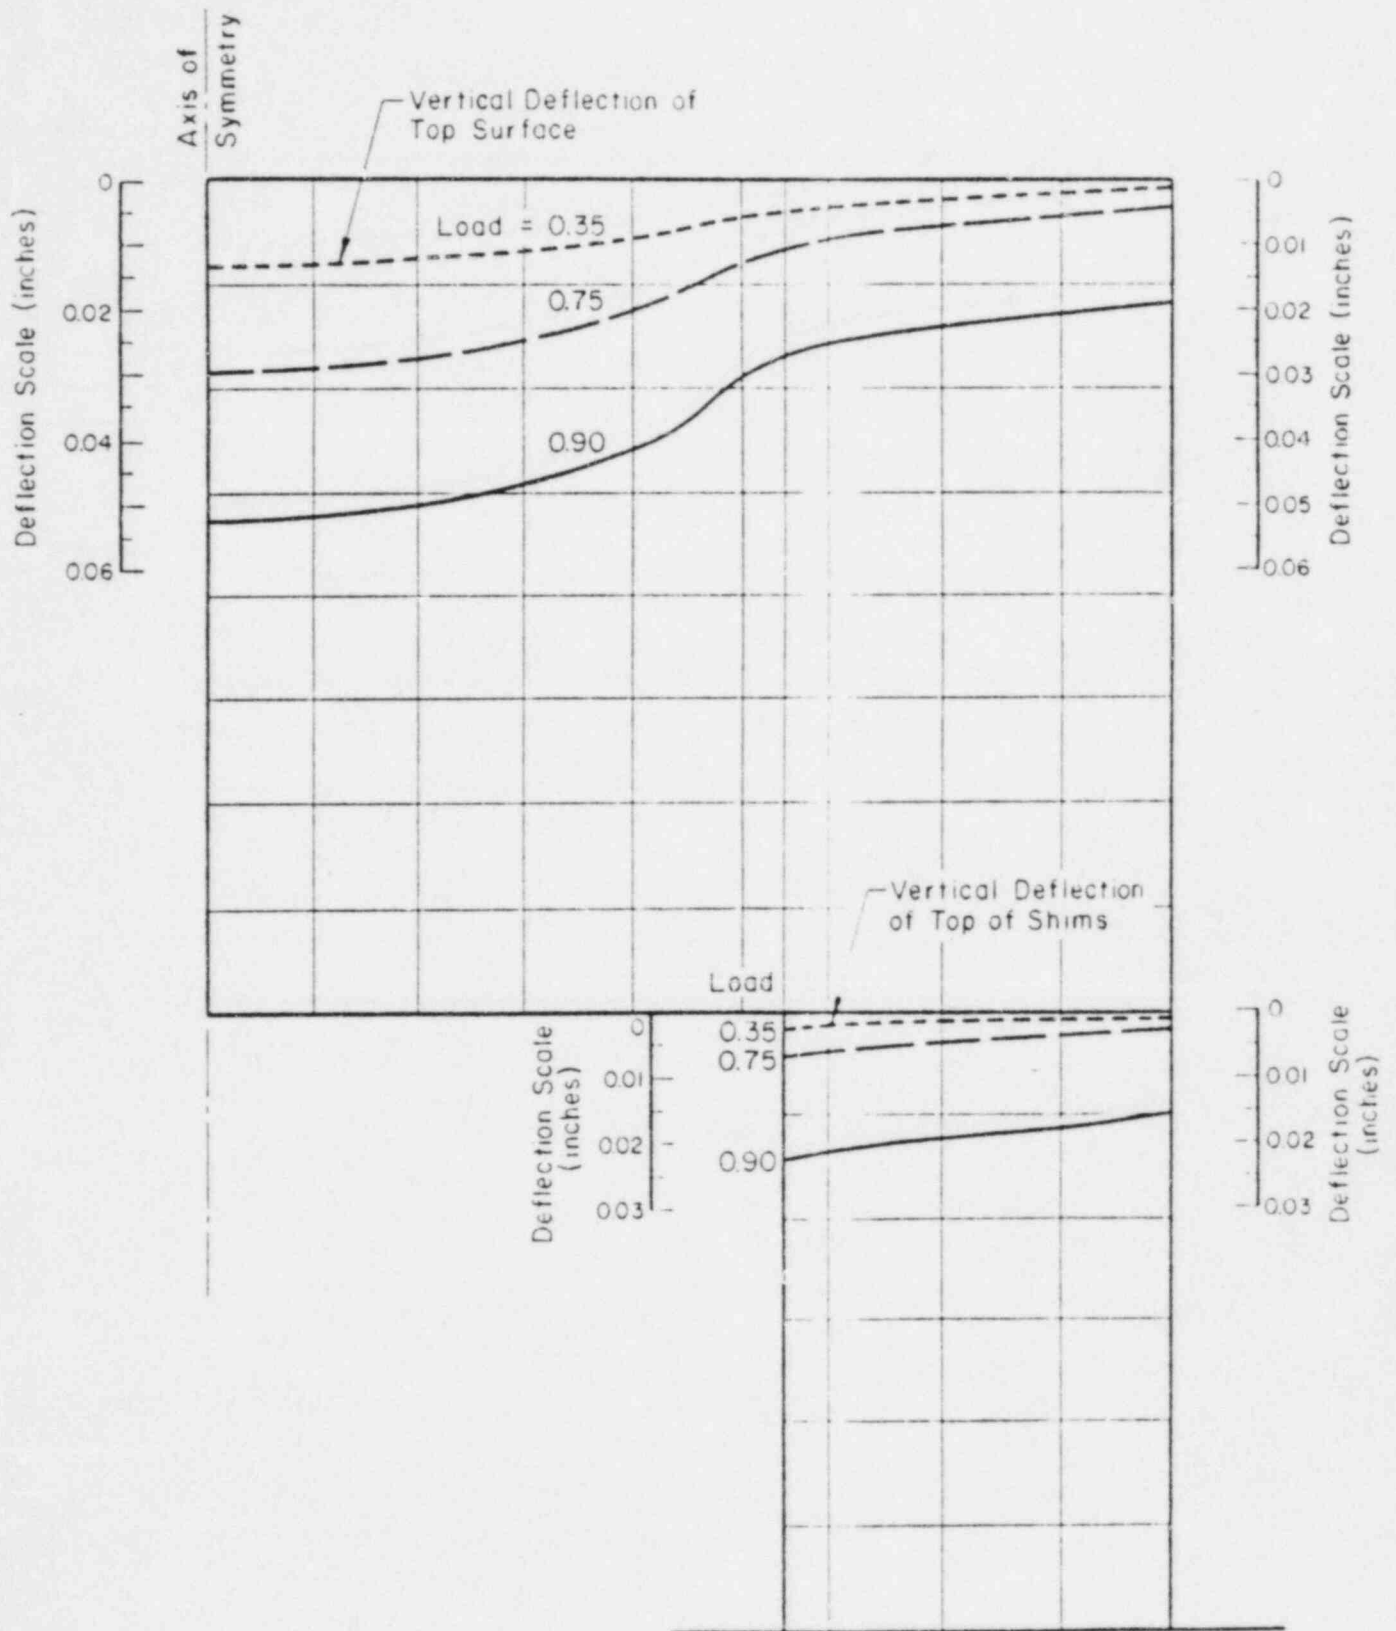
Fig. 51 Inelastic Deflection Profile Across Top Surface of Field Head vs Applied Load ("Inelastic Shims/No Friction" Boundary Conditions and Effective Yield Stress 51 ksi in Flexural Region, 52.5 ksi in Shear Region of Honeycomb, 36 ksi in Shim)

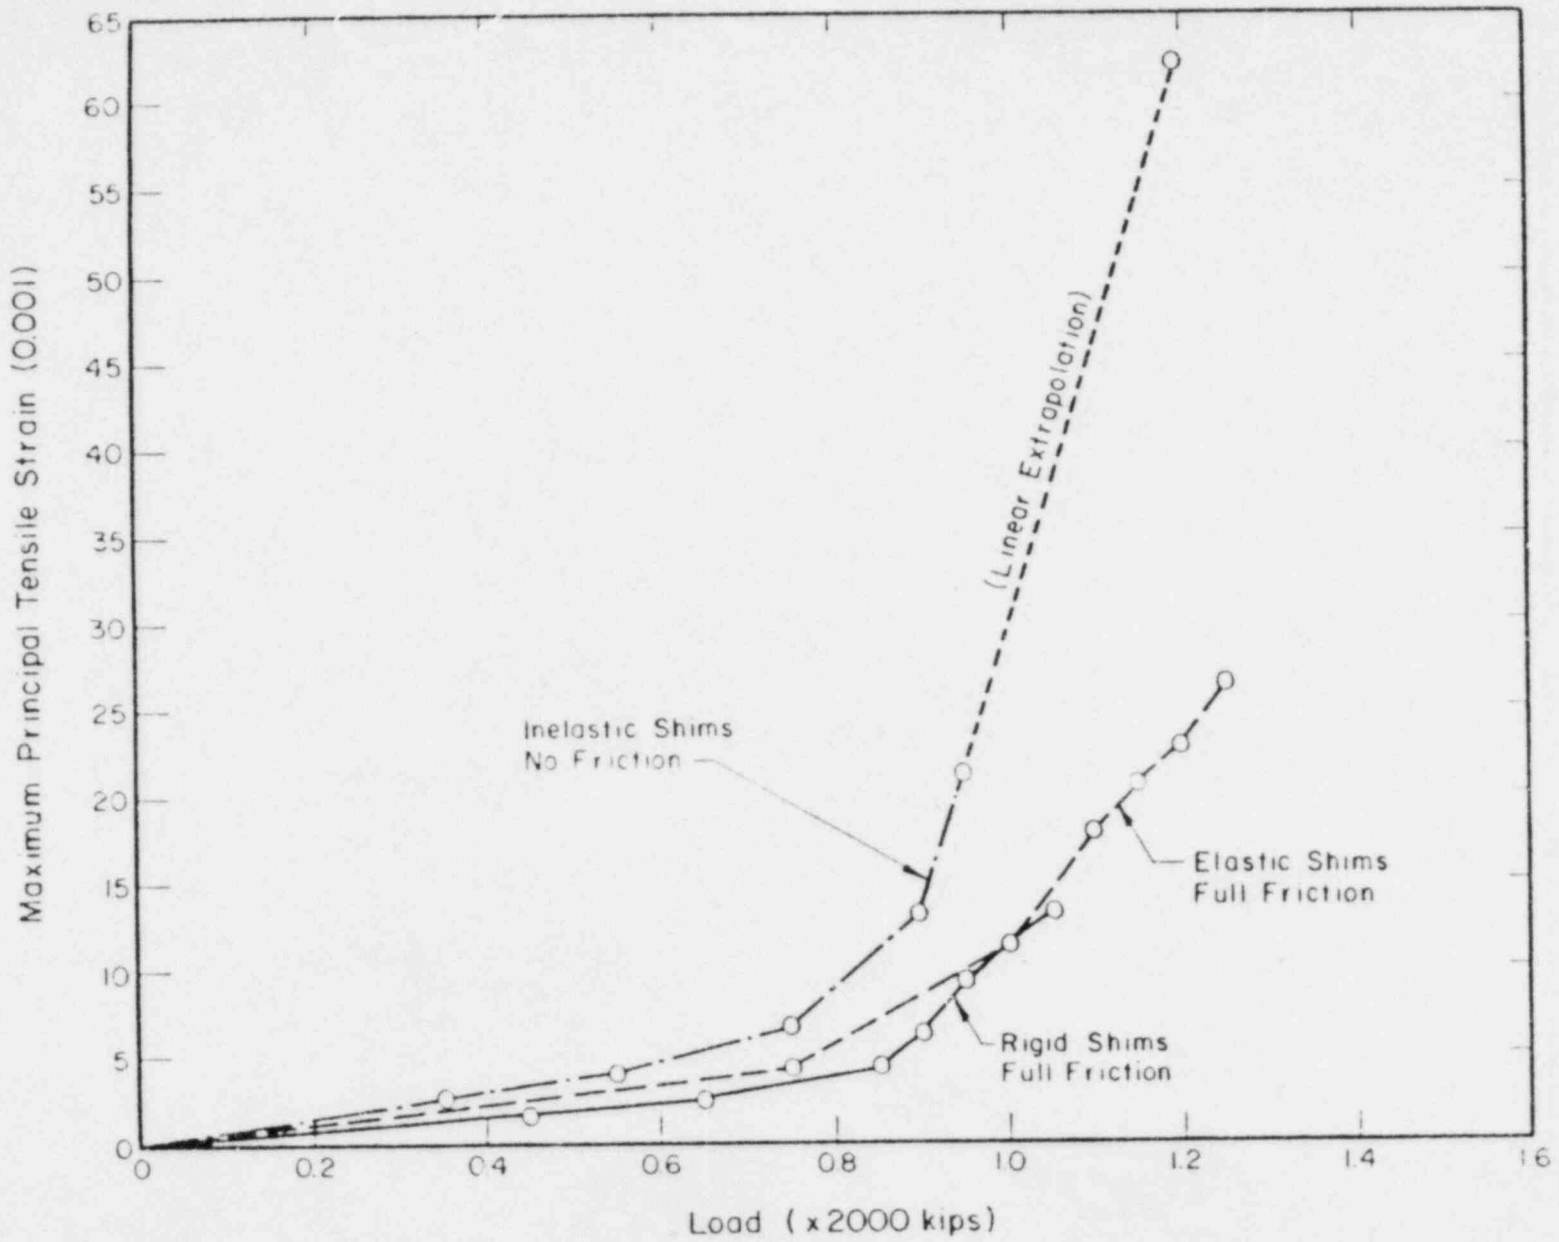
Fig. 53 Maximum Principal Tensile Strain in Ligament vs Applied Load
(Ref. p. 2250)
