Millstone Nuclear Power Station, Unit No. 3
Relief Request From ASME Code Section XI Requirements

FORM FOR RELIEF REQUEST FROM ASME SECTION XI REQUIREMENTS

UNIT: Millstone Unit 3 NCR # 392-189 DATE: 8/10/92
TIME: 1100

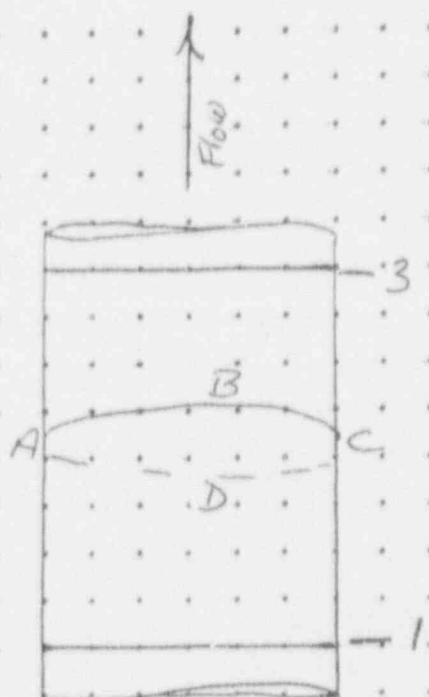
Side View
Looking Northwest

Note: Gridded for
Prior Examination
