EVALUATION OF A FAILED RIVERWATER
PUMP SHAFT COUPLING FROM
THE BEAVER VALLEY POWER PLANT

C. J. CZAJKOWSKI

JUNE 1992

Nuclear Waste and Materials Technology Division

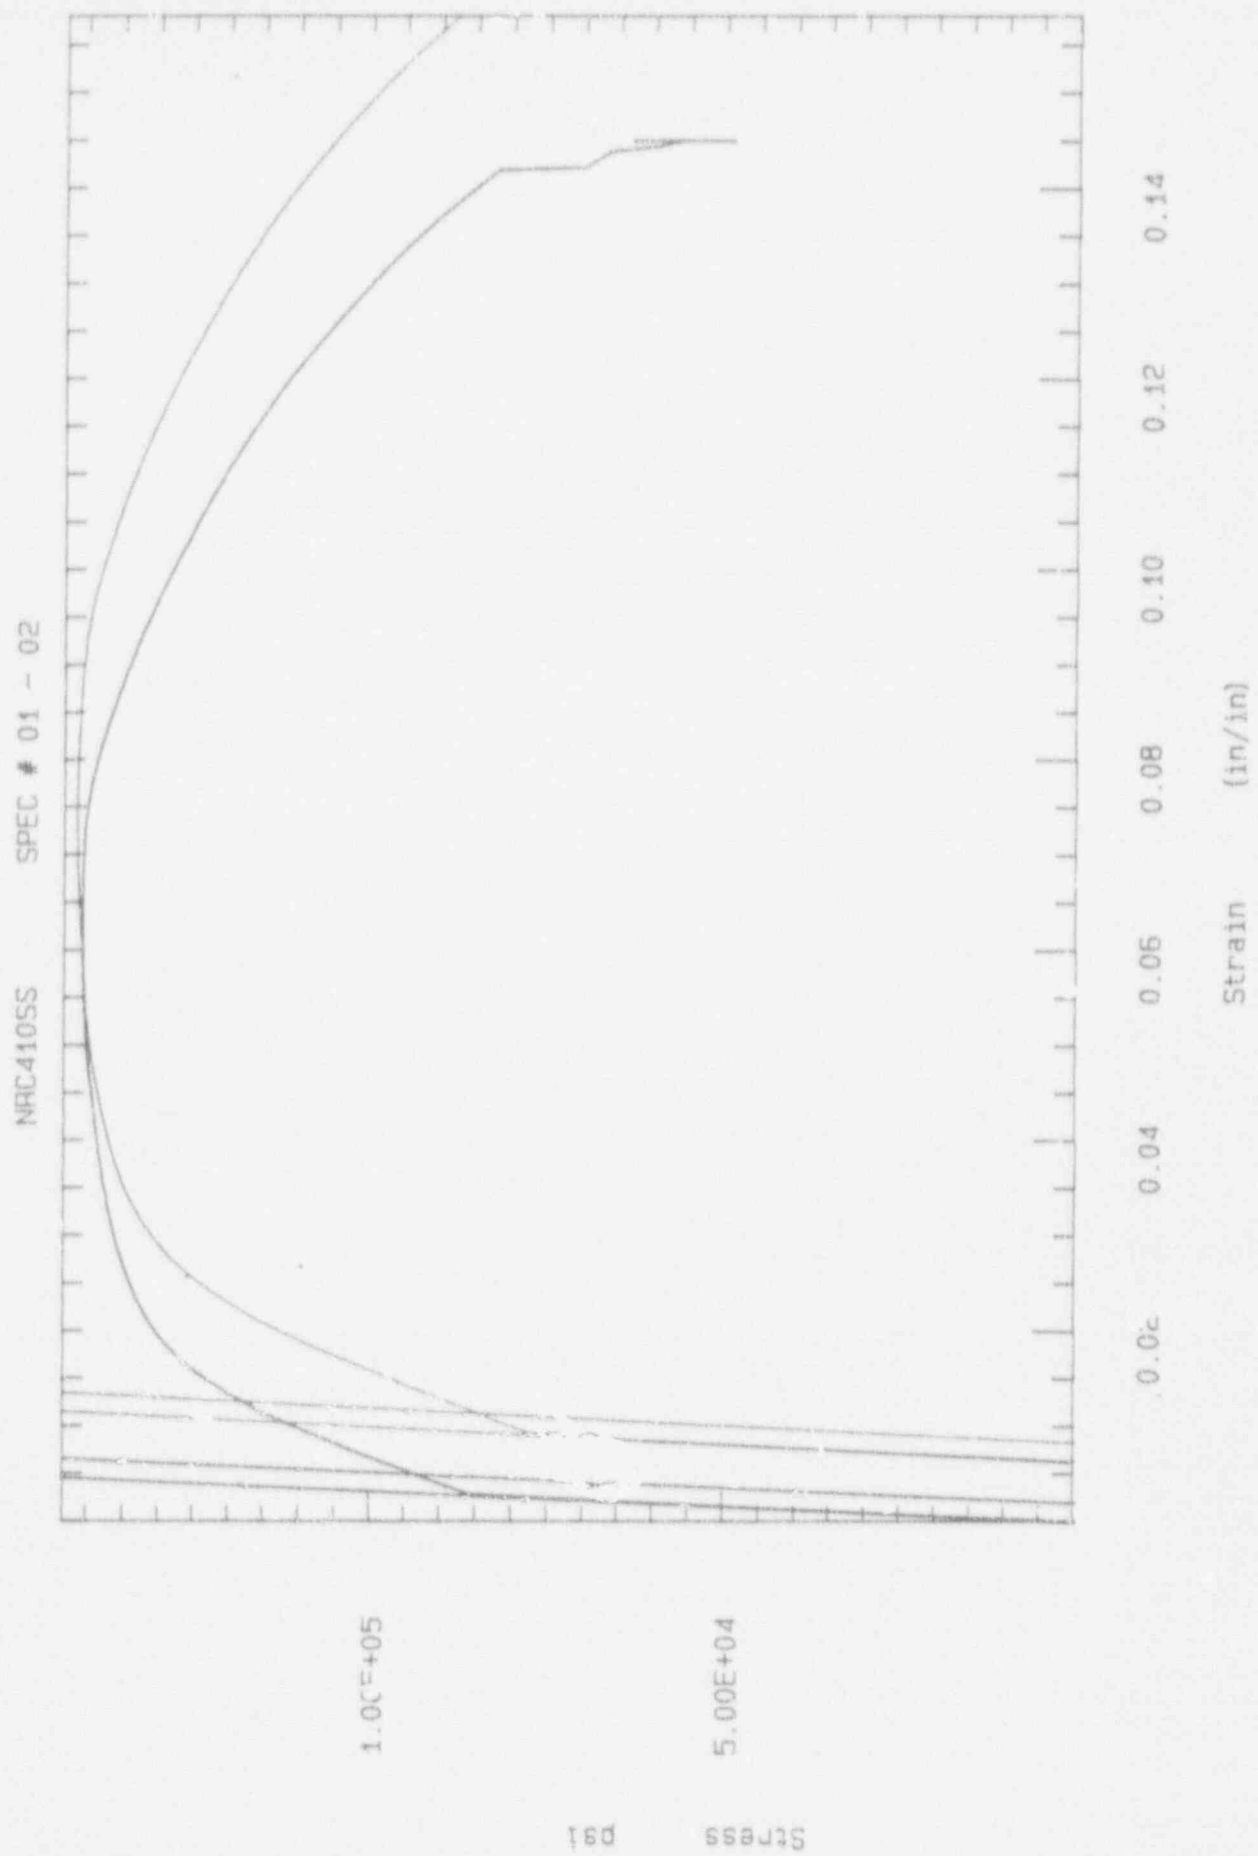
Four subsized tensile specimens were machined from the coupling. Figures 7 and 8 are the stress - strain curves generated from the testing. Specimens 1-3 were tested "as received", while specimen 4 had been vacuum degassed at 200°C for 48 hours prior to testing.

The tensile strength and reduction of area are very similar to that expected [2] from a 410 stainless steel tempered at 1000°F . Both the stress at 0.2% yield and the elongation were lower than that expected for the same steel.

Figure 7 Stress-strain curves for specimens 1 and 2.

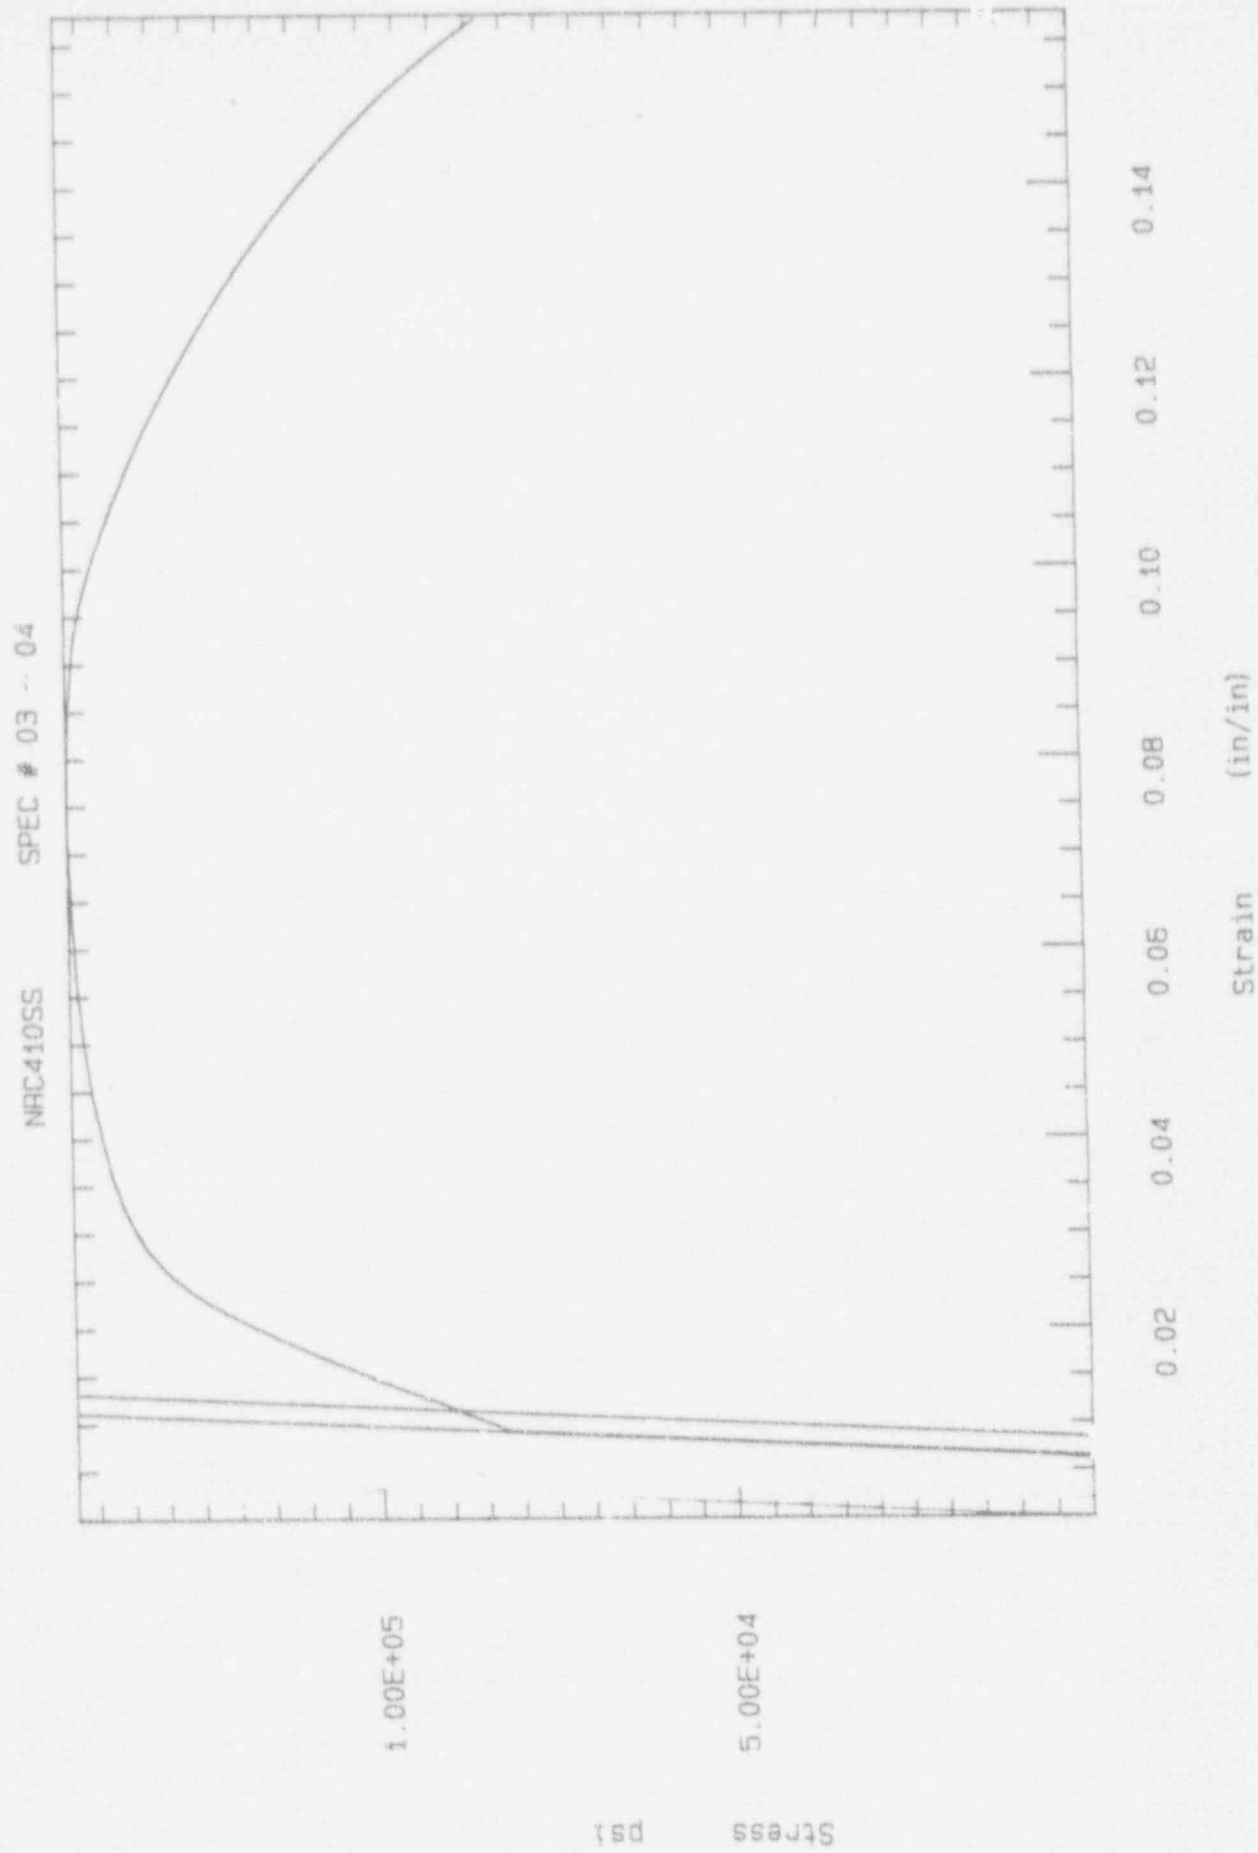
Figure 8 Stress-strain curves for specimens 3 and 4.
