UNITED STATES
NUCLEAR REGULATORY COMMISSION
WASHINGTON, D. C. 20555

SUBJECT: TRIP REPORT: AUDIT OF STRUCTURES AND CIVIL ENGINEERING
FEATURES, BEAVER VALLEY POWER STATION, UNIT 1.
TAC NO.: M83708

Enclosure 1 is a detailed trip report with five attachments. The attachments contain the following information:

Enclosure 1

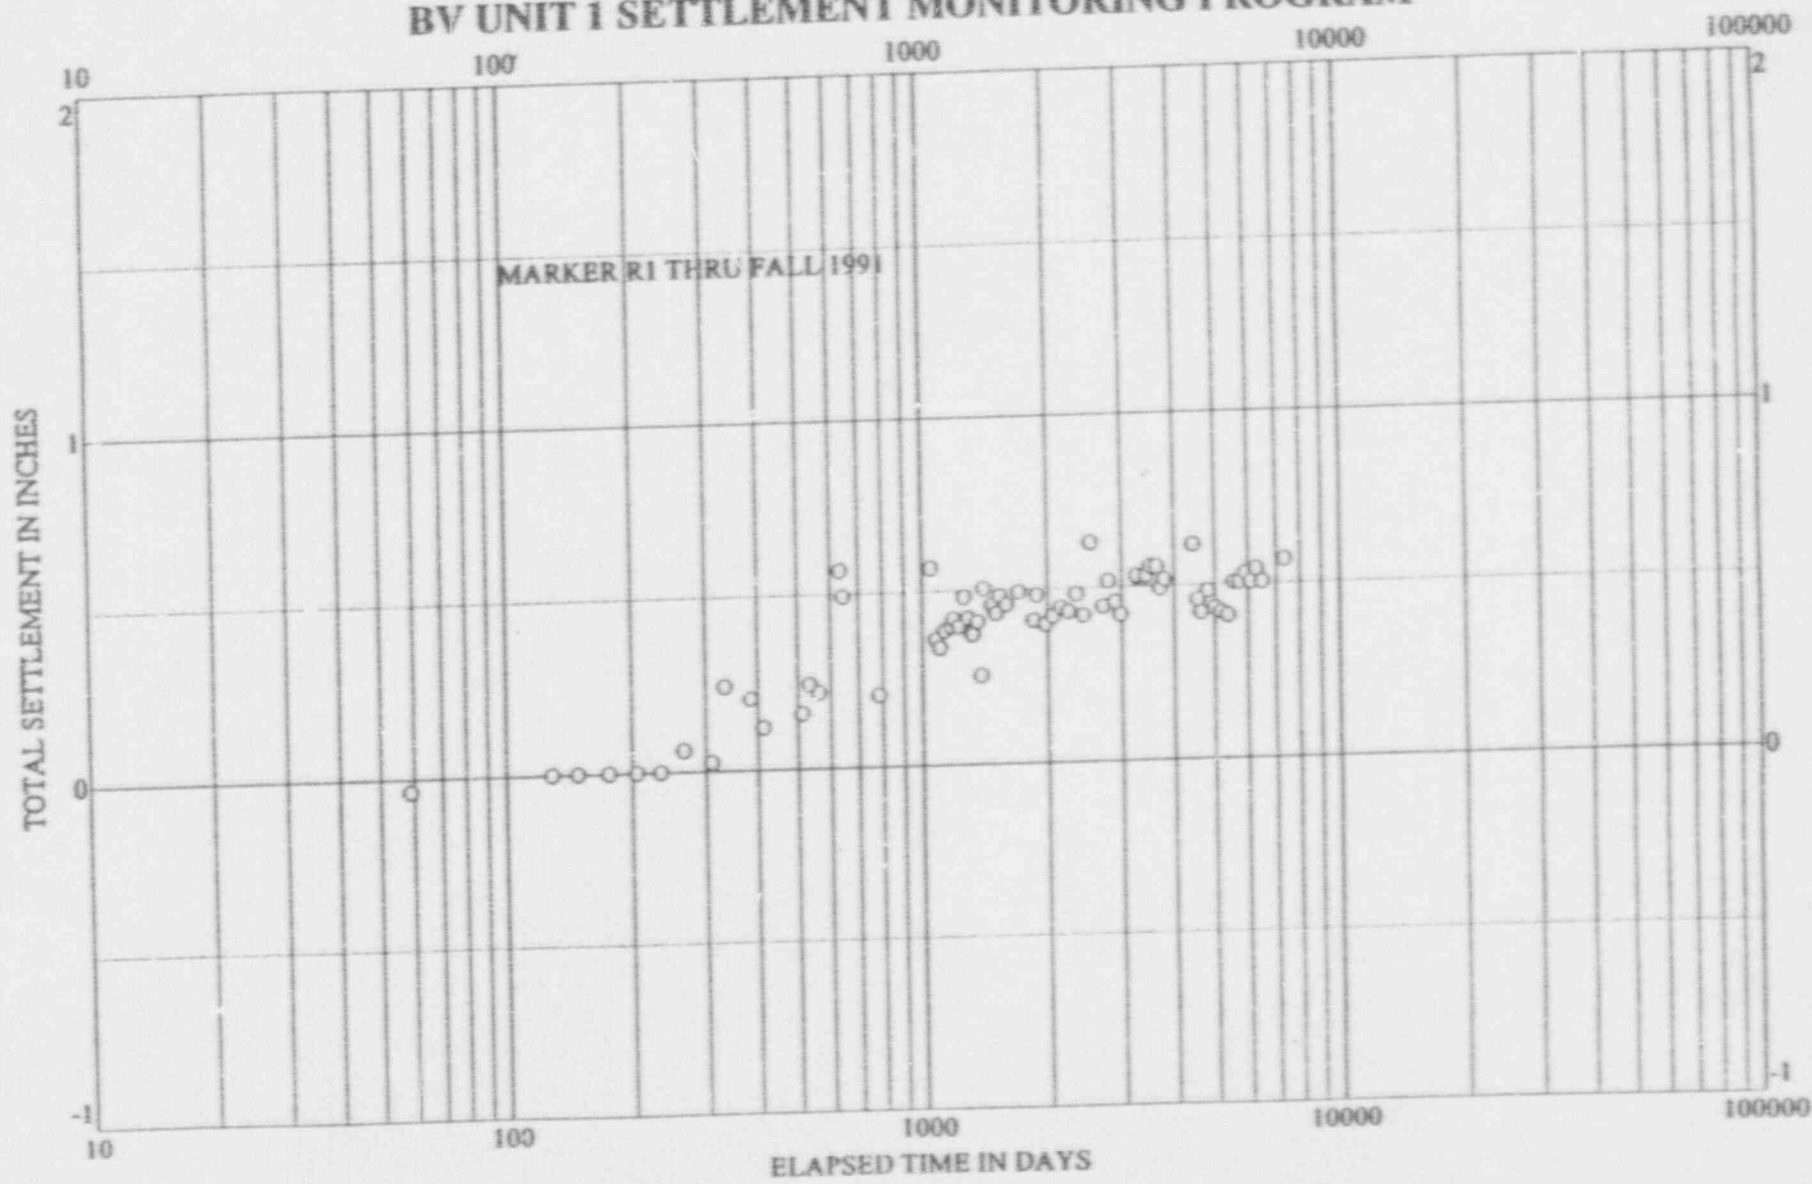
UNANTICIPATED SETTLEMENTS AND ENGINEERING DISPOSITION

- Outfall Structure 1973/1974
- Settlement markers indicated:
East Side Settlement ↓
West Side Heave ↑
- Solution: Entirely underpin the structure to ensure no further settlement
- Four (4) HP Piles driven to refusal and two (2) wide flange steel beams to fully support the structure
- No interruption of operation at outfall structure.
