To: Sherwin E. Turk
Deputy Assistant Chief Hearing Counsel, DELD

From: J. T. Chen, Geotechnical Engineer
EGEP/DE/NRR

Subject: APPLICANT'S RESPONSE TO STAFF AFFIDAVITS FILED IN THE
WATERFORD PROCEEDING

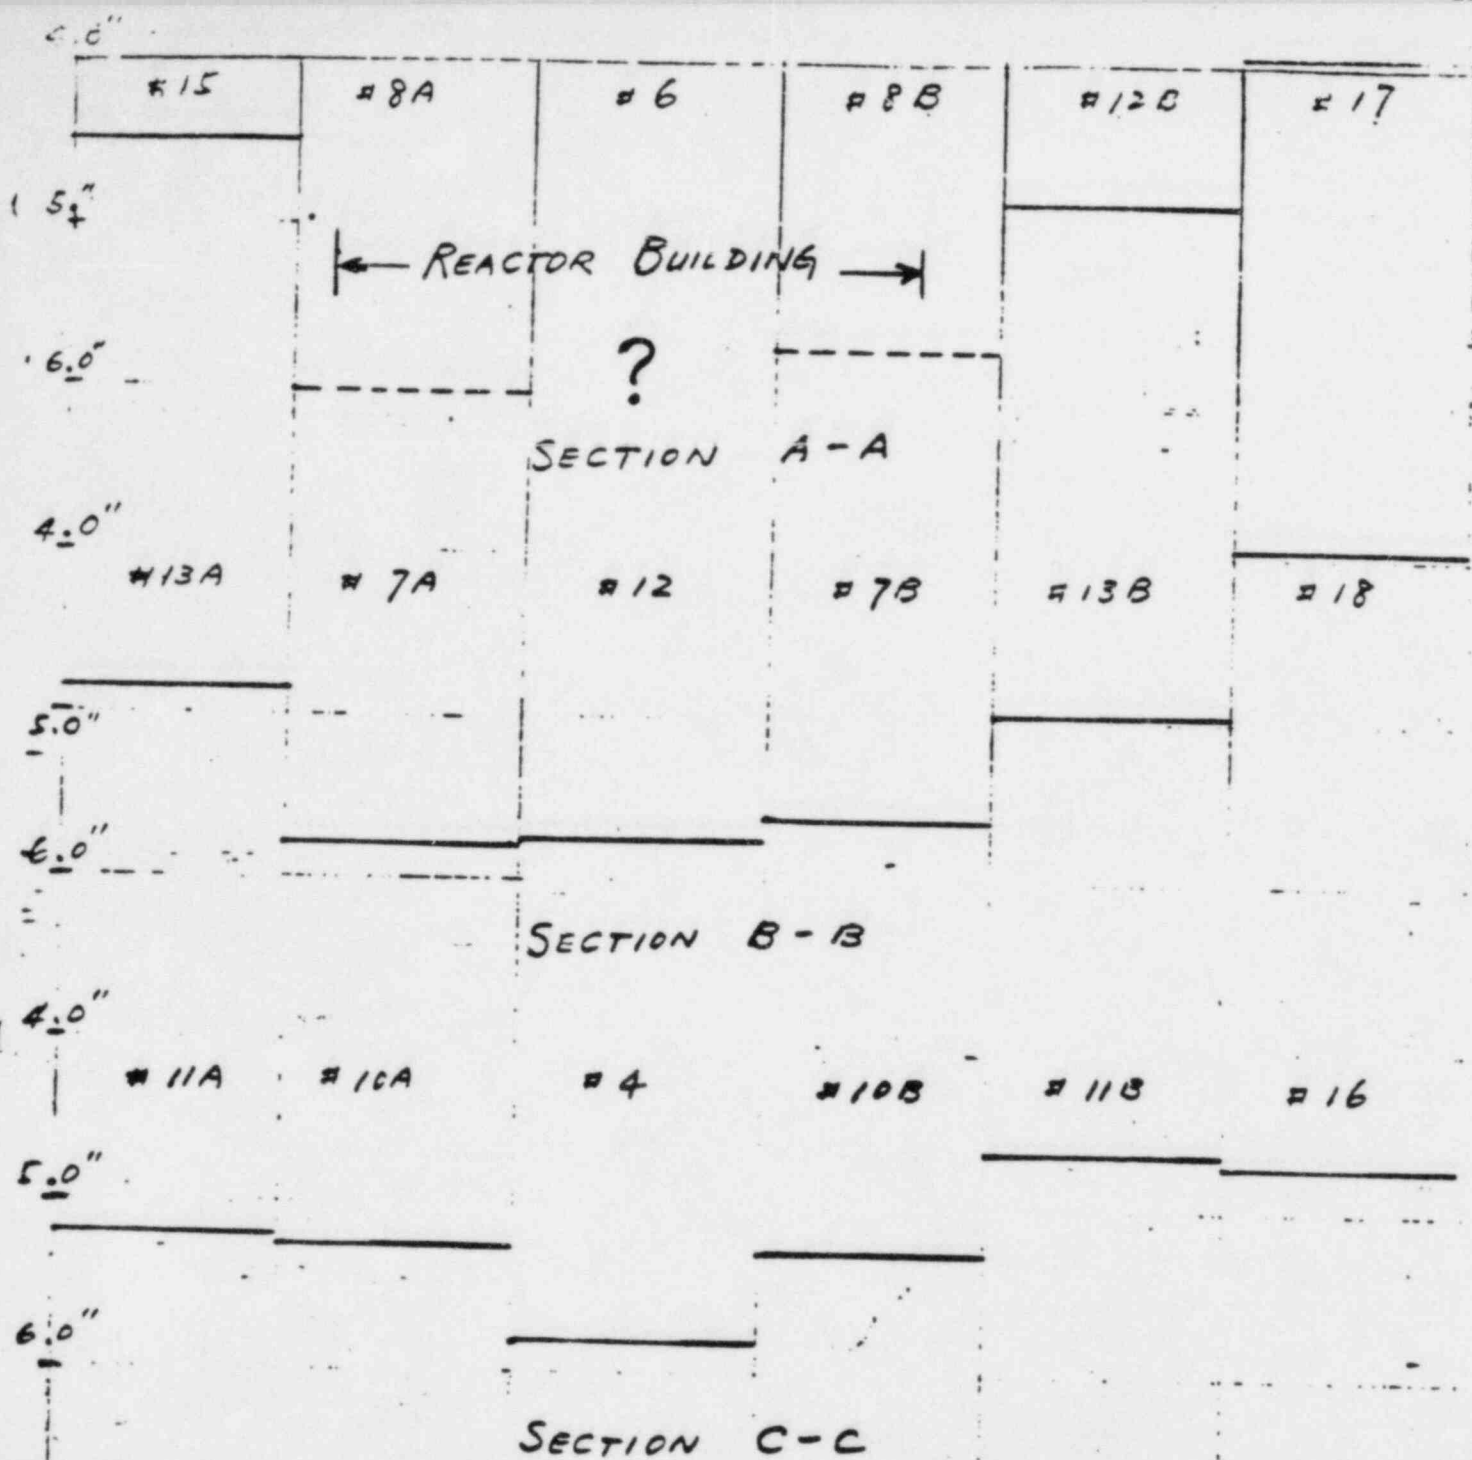
3. Figure 2 was used to illustrate the convexity of the basemat during construction (Ehasz Affidavit, page 12). However, the validity of this figure is questionable because it lacks measured data in the containment area to back it up. Based on LP&L's March 1984 submittal, settlements within the containment area were not surveyed since mid March 1976 due to the inaccessibility to the surveying pins. Therefore, the "actual" settlements within the containment area as shown in Figure 2 was imagined by LP&L, not necessarily be real. The measured settlements outside the containment area, however, showed that the top of the basemat has a concaved shape (see Figure 3). The data available directly measured data within the containment area (March 1976 data), also, showed a somewhat concaved shape (see Figure 4). Therefore, LP&L's statement about the convexity of the basemat, "As illustrated in Figure 2...reactor building centerline.", is somehow questionable!

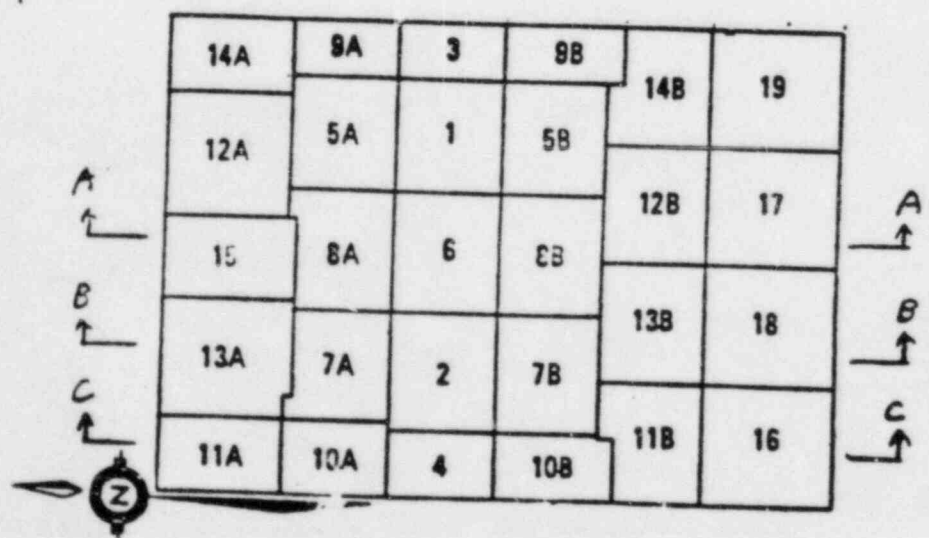
FIGURE 3

NOTE:
 ALL SETTLEMENTS ARE
 AVERAGES BASED ON ESI
 PLOT DATED 9-22-77
 SUBMITTED TO NRC
 IN MARCH 1984

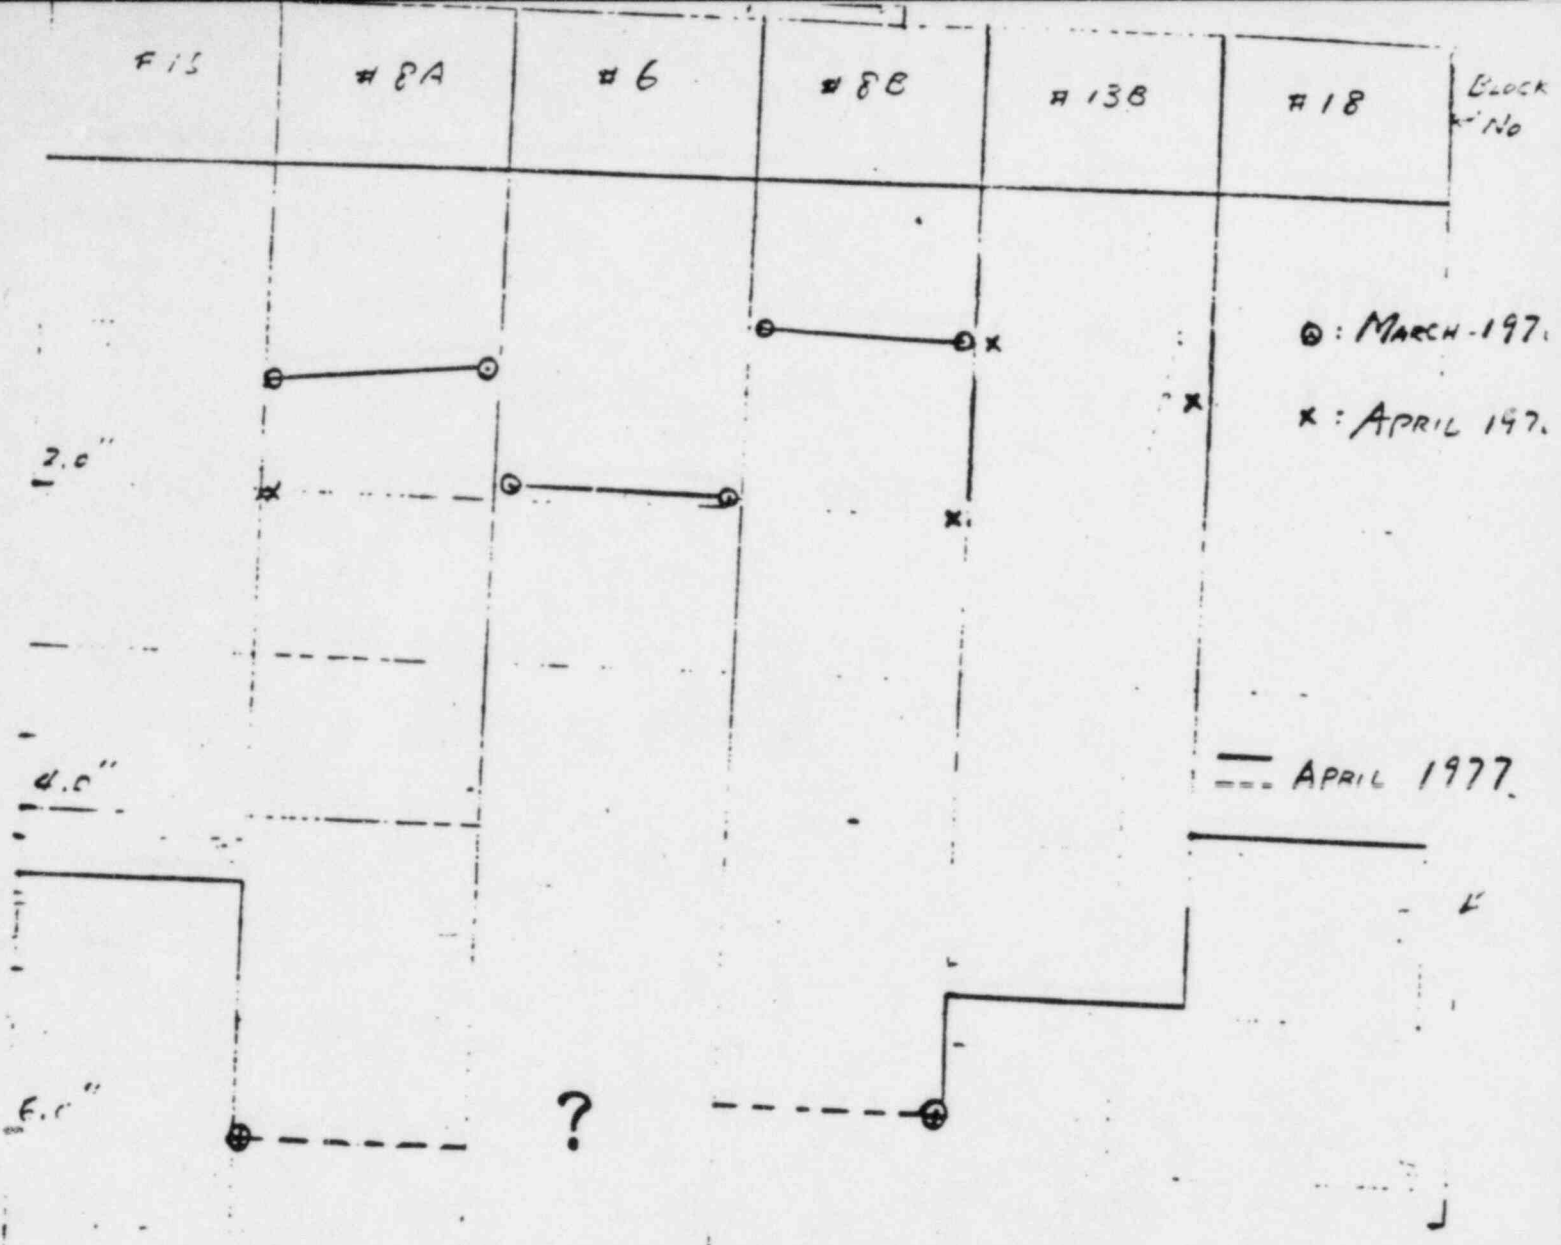
FIGURE 4

4. The measured data, in terms of absolute elevations against a benchmark external to the excavation, clearly showed that blocks founded on excavation strip #2 settled more than those blocks founded on the other strips initially. Strip #2 is the filter blanket and encountered the least compaction of the construction. The earlier measurements of the blocks #8A (which was founded mostly on strip #2) and #8B (which was founded mostly on strip #3) showed qualitatively that block #8A settled about 32% more than the block #8B in March 1976 (see Figure 4). However, as all the other blocks were placed, the basement would redistribute the structural load on the foundation soil and the appearance of soil non-uniform type settlement can no longer be detected from the measured settlement data.

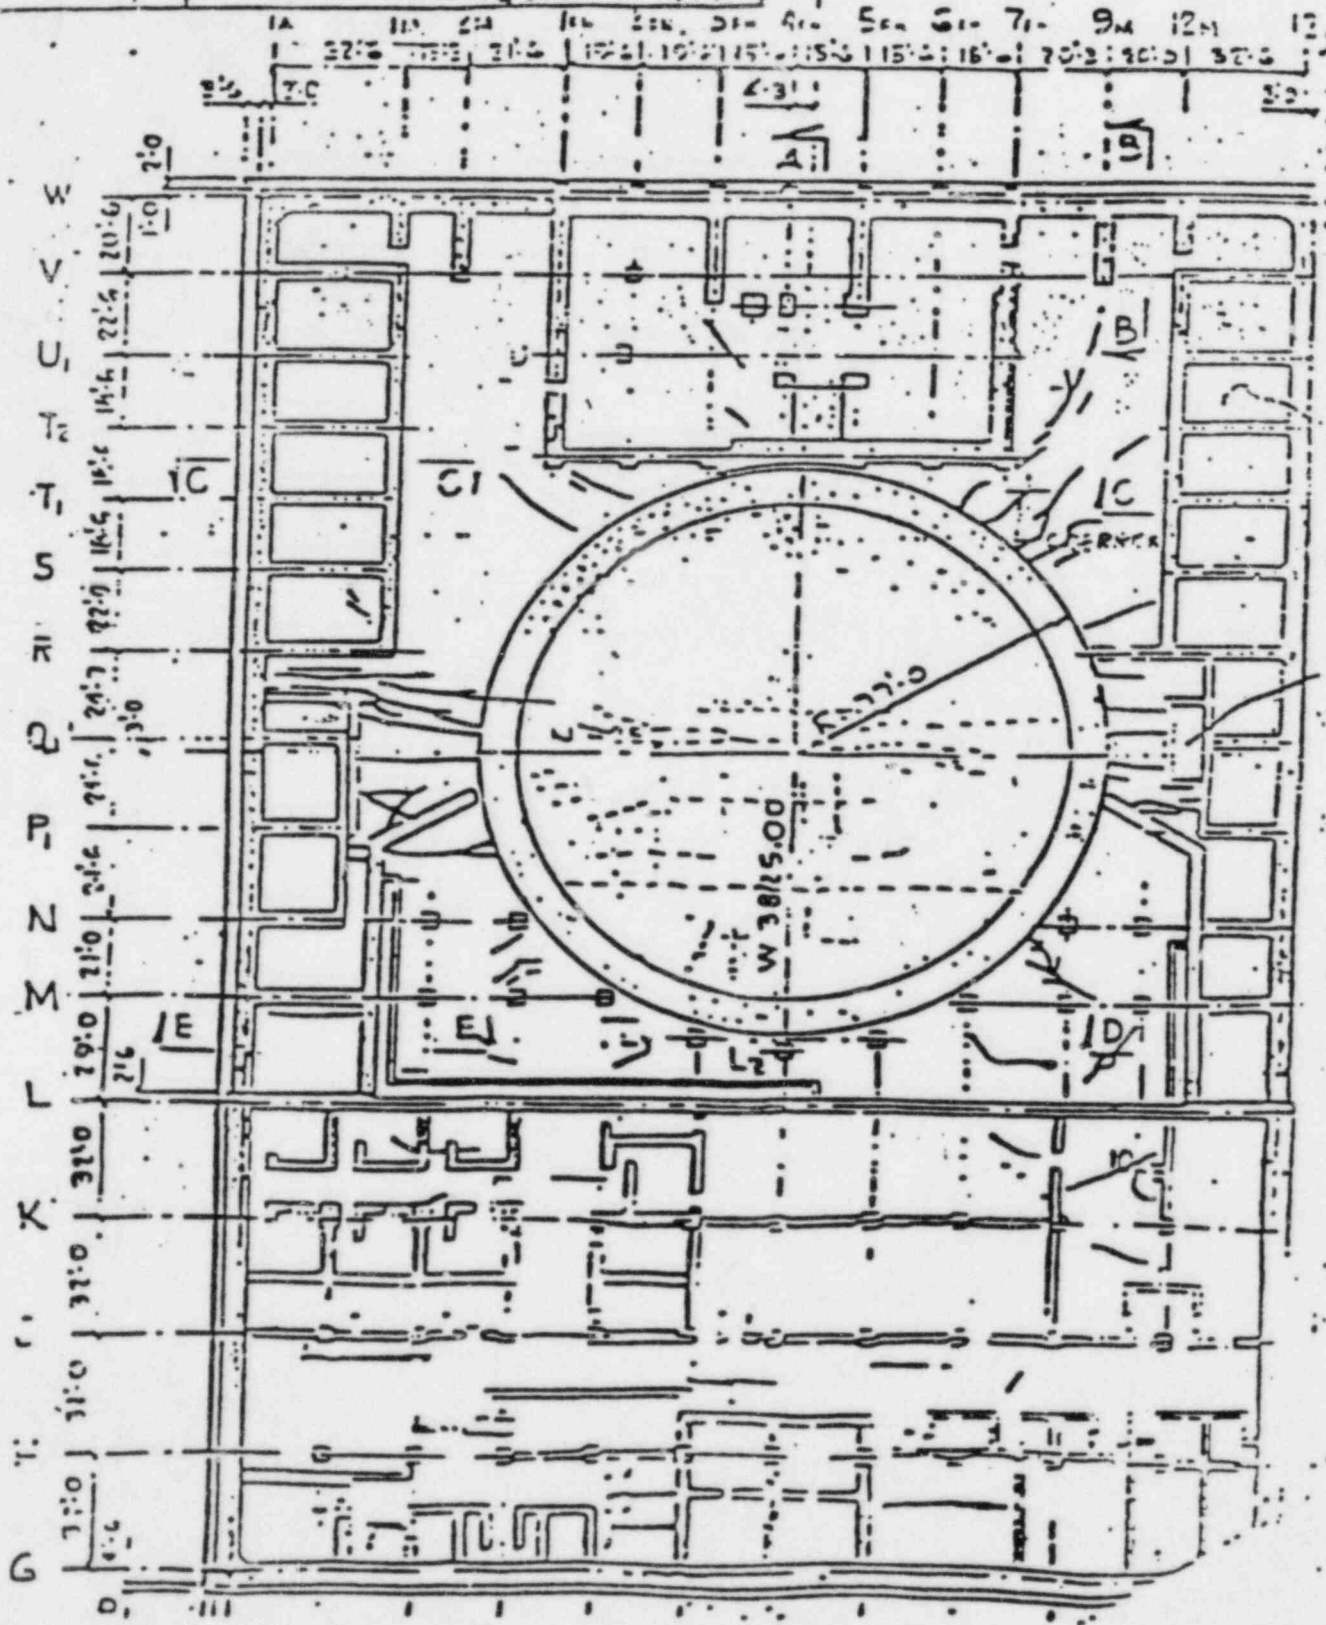
FIGURE 6

NOTE: CRACKS MAPPED BY HEA INC. (1977)
