Contaminated Mexican Steel Incident

Importation of Steel Into the United States That Had Been
Inadvertently Contaminated With Cobalt-60 as a Result of
Scrapping of a Teletherapy Unit

**U.S. Nuclear Regulatory
Commission**

Office of Inspection and Enforcement

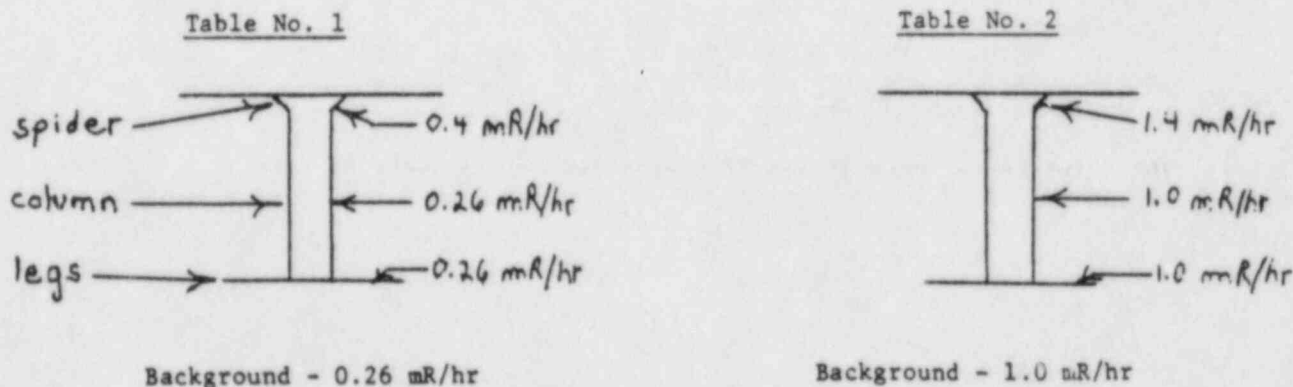
Table 1: Approximate levels of radiation for Table Nos. 1 and 2 (measured with Eberline E-520). (Levels taken at contact with surface.)

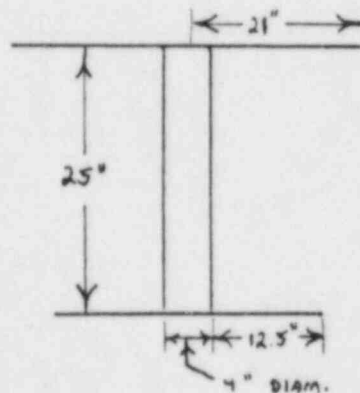
B. Dimensions of "mock up" profile.

Note: Table top diameter is 42"
