UNITED STATES
NUCLEAR REGULATORY COMMISSION
WASHINGTON, D. C. 20555

In early July I directed my staff, with assistance from Region IV, to perform an audit of Fort St. Vrain operations including problem areas associated with the June 23, 1984 event regarding the failure of a number of control rods to insert.

This preliminary report documents the NRC's special assessment of the operation of Fort St. Vrain Nuclear Generating Station (FSV). This assessment was requested by the Director, Office of Nuclear Reactor Regulation as a result of his review of several operating problems that occurred at Fort St. Vrain. This plant, which is located in Weld County, Colorado, is owned and operated by the Public Service Company of Colorado (PSC). Based on the results of this assessment, which found problems in each audit area, the staff has concluded that Fort St. Vrain not be restarted until all control rod drives have been inspected and refurbished or until modifications have been made or other appropriate corrective actions have been taken, that will provide reasonable assurance that the control rods will scram automatically on receipt of a scram signal. This report is preliminary in that vari

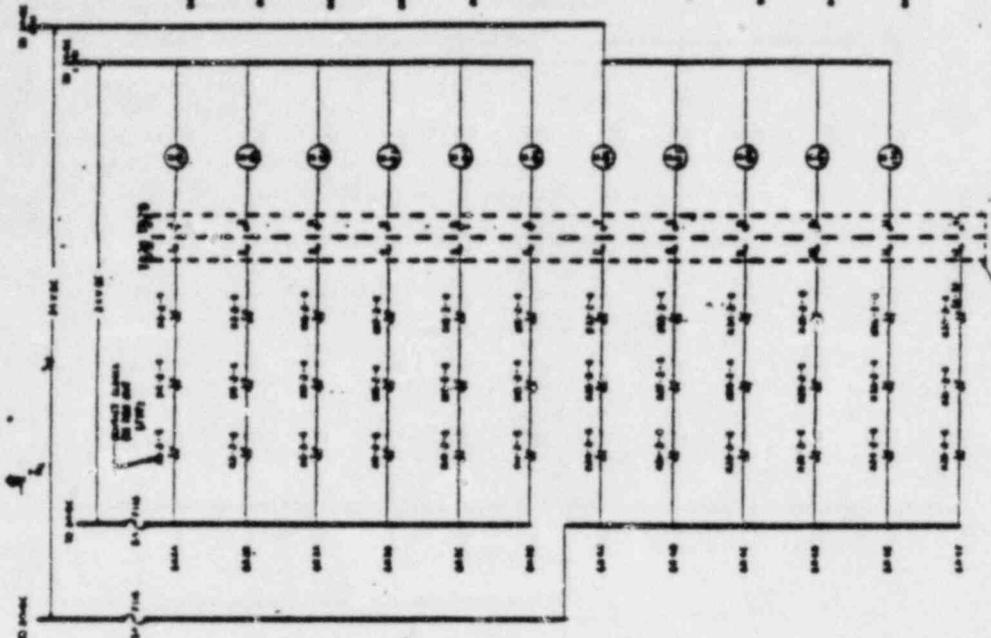
Figure 3.3 Control Rod Driver Mechanism

The slack-cable switch assembly shown in Figure 3.3 is provided for monitoring the tension in the cables supporting the control rod pair. The spring plunger exerts an upward force on the underside of the cable drum spindle, which counteracts the downward force caused by the control rod weight. In the event a control rod cable becomes slack, the upward force overcomes the control rod weight, and microswitches are actuated. Slack cable indication is signalled in the control room by both an alarm and a light.
