# Precursors to Potential Severe Core Damage Accidents: 1991 A Status Report

Appendices B, C, and D

Prepared by  
J. W. Minarick, J. W. Cletcher, D. A. Copinger, D. W. Dolan

Oak Ridge National Laboratory

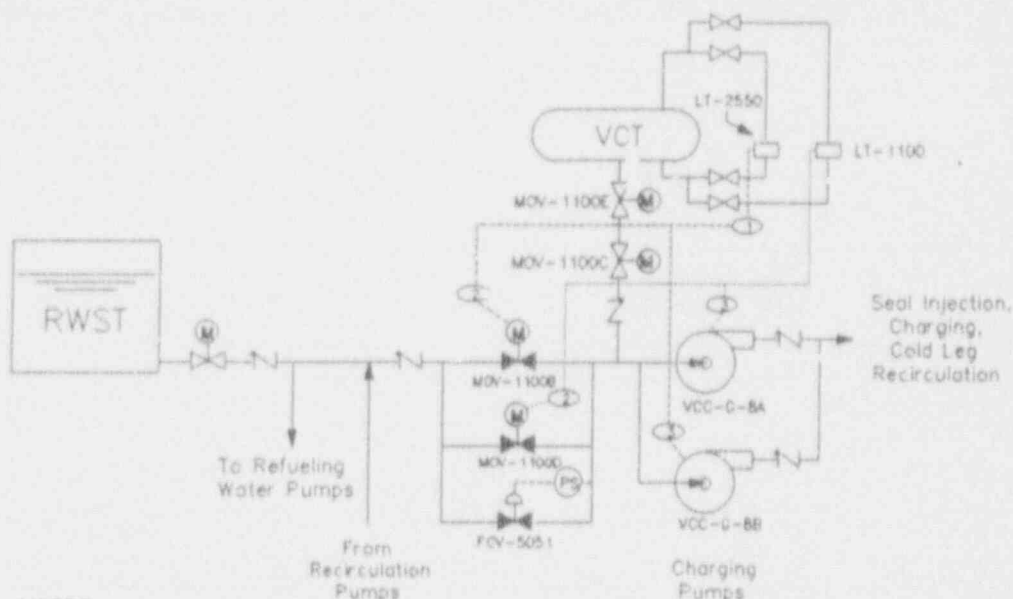
The automatic actuation for re-alignment of the charging pumps from the volume control tank (VCT) to the refueling water storage tank (RWST) on low VCT level was disabled. In the event of a small-break loss-of-coolant accident (LOCA), and if manual realignment failed, the charging pumps would become gas bound due to hydrogen from the VCT. This condition existed for ~17 h.

The valves controlled by LT-1100 and LT-2550 were still capable of being repositioned by their safety injection (SI) contacts. However, for certain small LOCAs, the VCT would have drained and the charging pumps would have been damaged before the reactor coolant system depressurized to the SI setpoint.

- ① Control Room Alarm on Low VCT Level.
- ② Opers MOV-1100 B & D on Low-Low VCT Level.  
MOV-1100 B & D Open Contacts Initiate Closure of MOV-1100 C & E.
- ③ Stops Charging Pump on Low-Low-Low VCT Level.

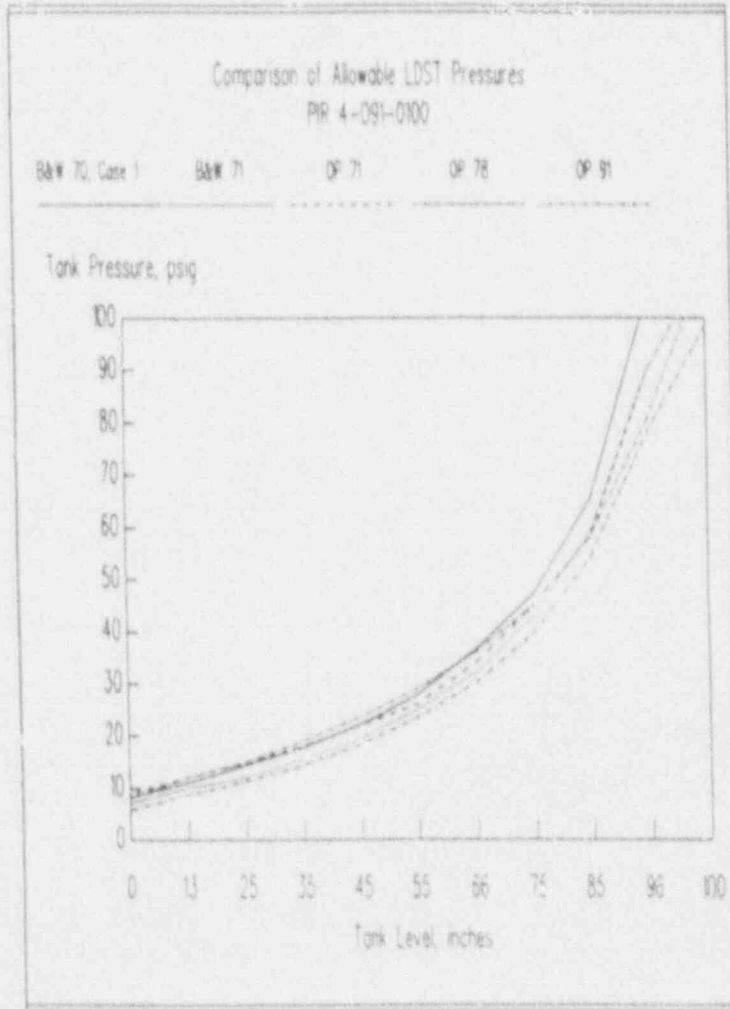
Figure 1 LDST Pressure vs. Level

On April 16, 1991, with Oconee 2 at full power, hydrogen was being added to the LDST. At the completion of this operation, a non-licensed operator observed that the hydrogen supply had not been isolated when the fill-line solenoid valve was closed. After manual isolation, the LDST pressure exceeded procedural limitations, and the excess pressure was vented. Both trains of HPI were declared inoperable for the duration of the overpressurization (~20 min) due to the potential for hydrogen to enter the HPI pump suction following a LOCA and damage the pumps.

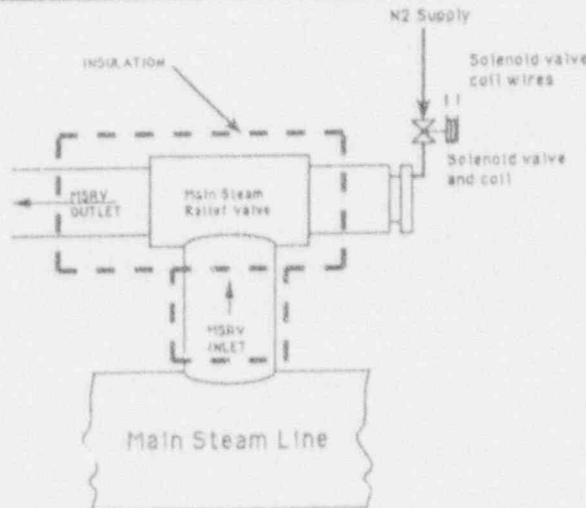
INCORRECTLY INSTALLED INSULATION

Improperly installed insulation on the automatic depressurization system (ADS) / safety relief valves (SRVs) resulted in damage to SRV control wiring. This condition existed throughout the refueling cycle. The high-pressure coolant injection (HPCI) system was also unavailable for periods of time during that interval. The conditional core damage probability estimated for this event is  $3.3 \times 10^{-6}$ . The relative significance of this event compared to other postulated events at Peach Bottom 3 is shown below.

Following shutdown for refueling in September 1991, three SRVs were removed for preventive maintenance. On examination, the control solenoid valve wiring insulation was found to be degraded on each SRV. The electrical cable insulation between the solenoid coil and its junction box was cracked and hardened on all three valves. A termination splice between the solenoid and the junction box was melted on two of the valves.

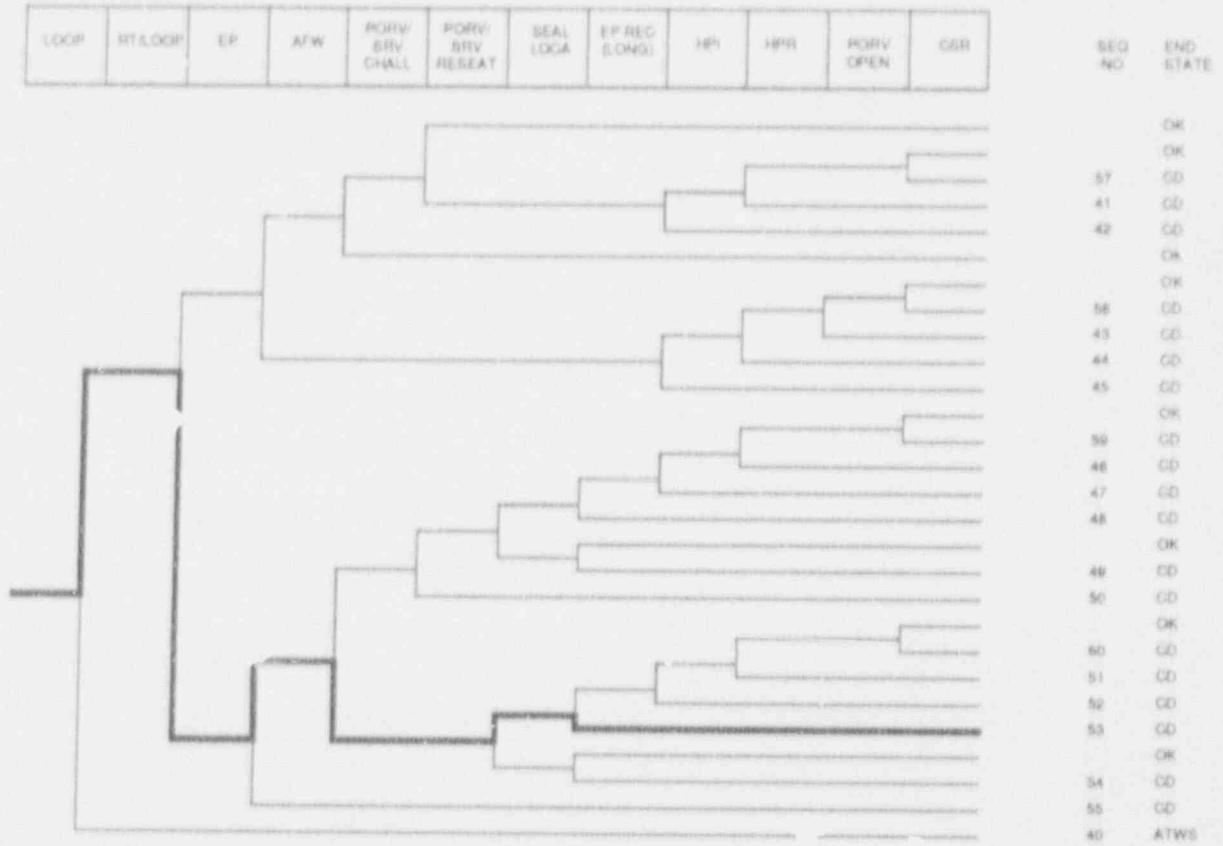
Dominant core damage sequence for LER 280/91-017

The conditional probability of subsequent core damage estimated for this event is  $2.9 \times 10^{-6}$ . The dominant core damage sequence, highlighted on the following event tree, involves a postulated loss of offsite power (LOOP) with failure of emergency power, successful auxiliary feedwater (AFW) initiation, a reactor coolant pump seal loss-of-coolant accident (LOCA), and failure to recover AC power before core uncover.

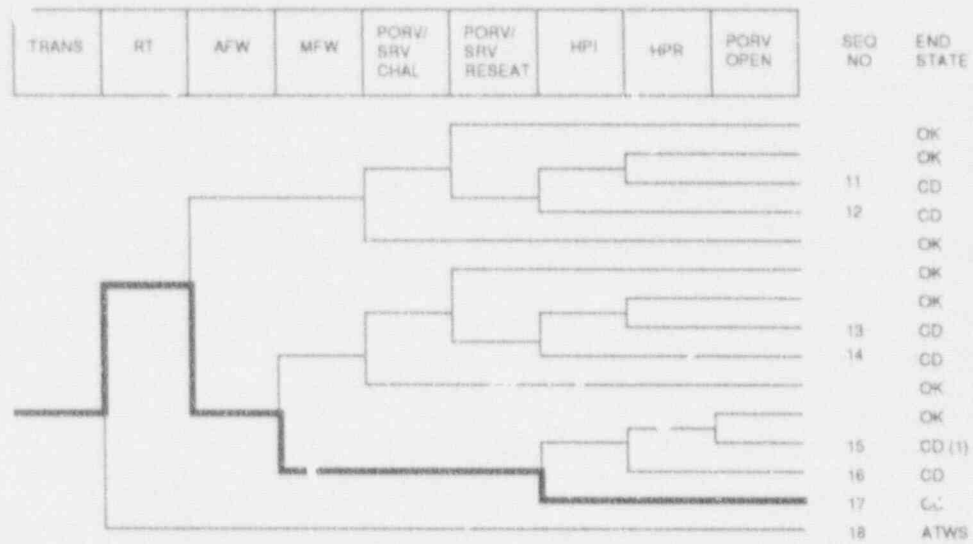
Dominant core damage sequence for LER 287/91-007

The conditional probability of subsequent core damage estimated for this event is  $1.8 \times 10^{-5}$ . The dominant core damage sequence, highlighted on the following event tree, involves a failure to recover from the LOFW, a subsequent failure of EFW, and failure of feed and bleed.

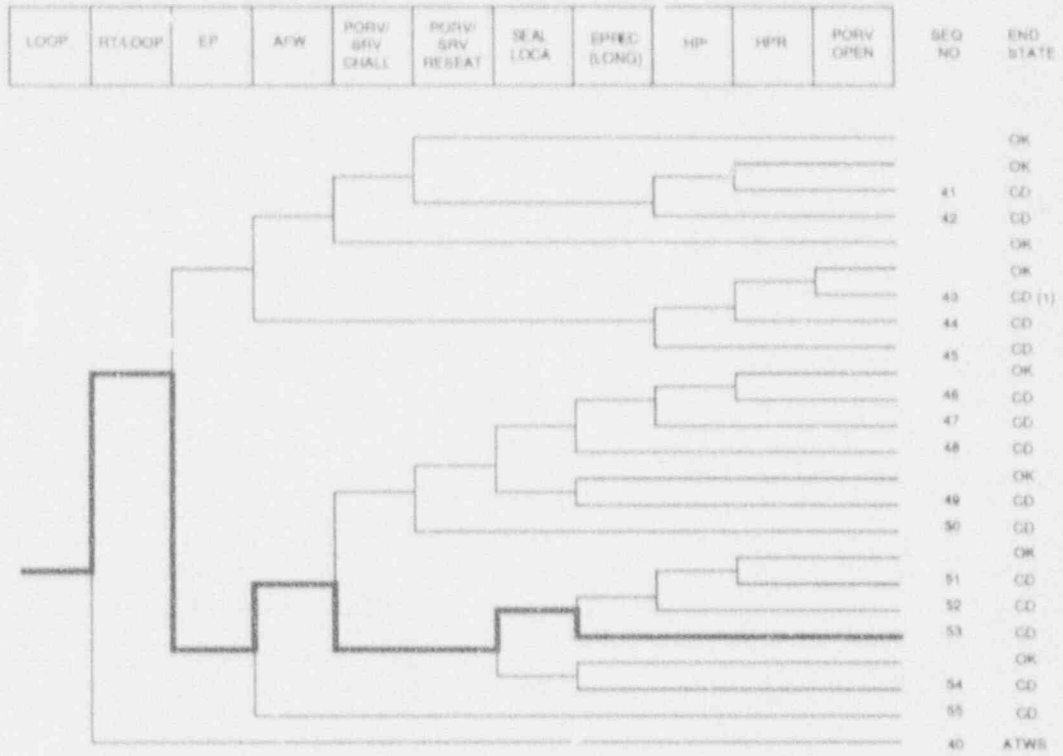
Dominant core damage sequence for LER 304/91-002

The second most dominant sequence involves a postulated failure of auxiliary feedwater (AFW) and feed and bleed following emergency power success. The probability of this sequence is affected by assumptions concerning those systems that can provide HPI and feed and bleed, as discussed earlier. Considering the charging pumps as an alternate high-pressure source reduces the core damage frequency estimate for this event to  $1.6 \times 10^{-4}$ .

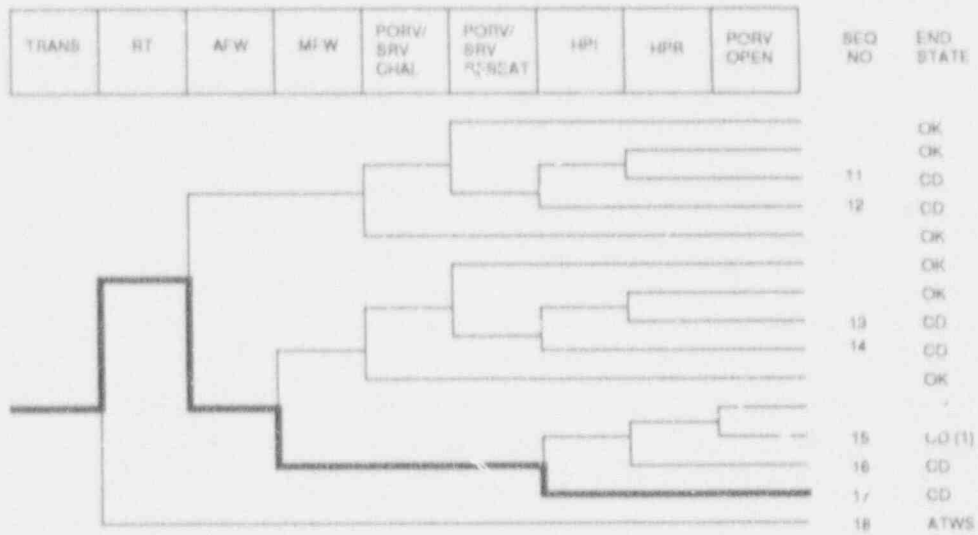
Dominant core damage sequence for LER 304/91-004

The conditional core damage probability for this event is conservatively estimated at  $1.0 \times 10^{-5}$ . The estimate is conservative because of the analysis assumption that the event occurred at power, when it actually occurred during startup. The dominant core damage sequence, highlighted on the following event tree, involves a reactor trip with unavailable secondary-side cooling and failure of bleed and feed.

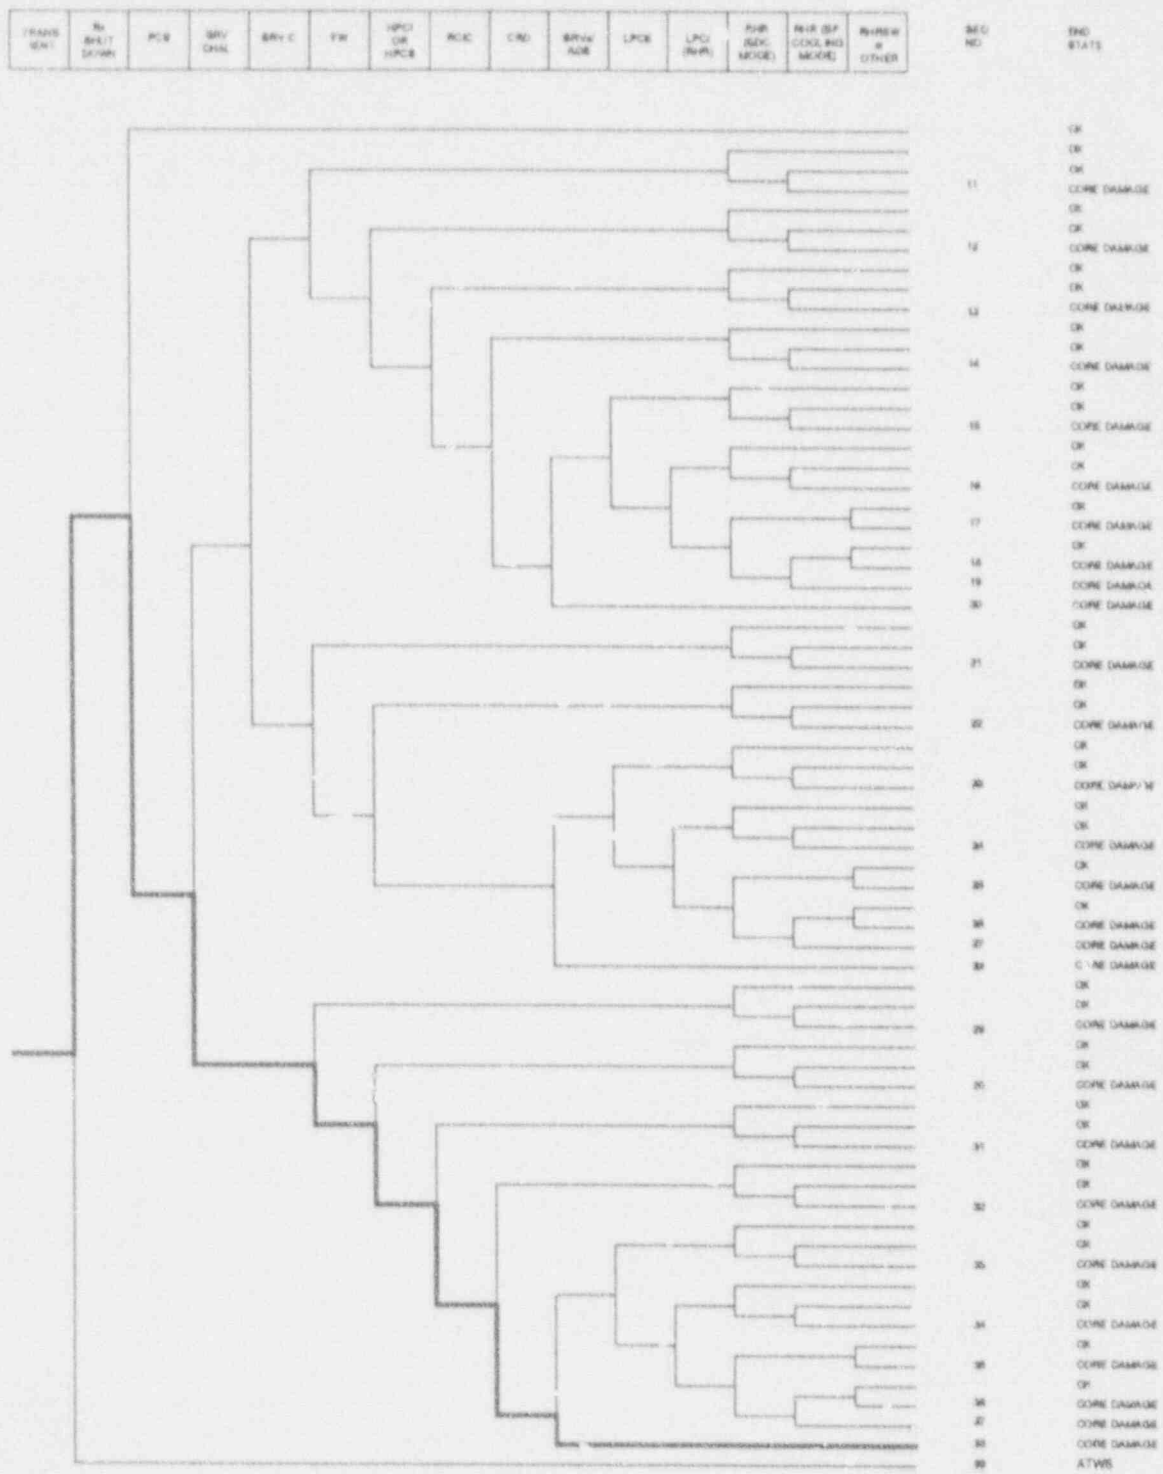
Dominant core damage sequence for LER 321/91-001

The conditional probability of subsequent core damage estimated for this event is  $1.1 \times 10^{-5}$ . The dominant core damage sequence, highlighted on the following event tree, involves a postulated failure to recover feedwater and HPCI, failure of RPV makeup using the control rod drive pumps, and failure to depressurize to allow use of the low-pressure systems.

An alternate analysis, based on the assumption that SRVs are always challenged (this is assumed in the ASP models for boiling-water reactor transients and LOOPs), and utilizing the feedwater nonrecovery probability currently included in the AS<sup>-</sup> model for Hatch, results in a conditional core damage probability estimate of  $1.5 \times 10^{-5}$ .

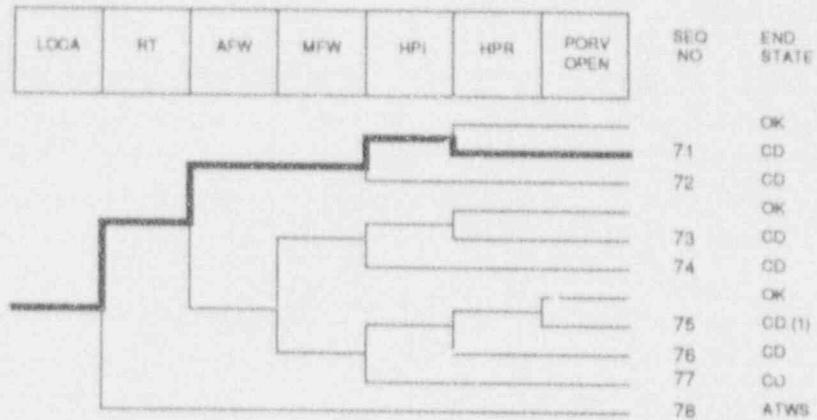
Dominant core damage sequence for LER 323/91-003

The core damage probability estimated for the event is  $2.1 \times 10^{-6}$ . The dominant core damage sequence, highlighted on the following event tree, involves a postulated small-break LOCA with successful high-pressure injection and failure of HPR. This estimate is believed to be conservative, since the actual event occurred in mode 4 and the ASP model success criteria and timing assume operation at power.

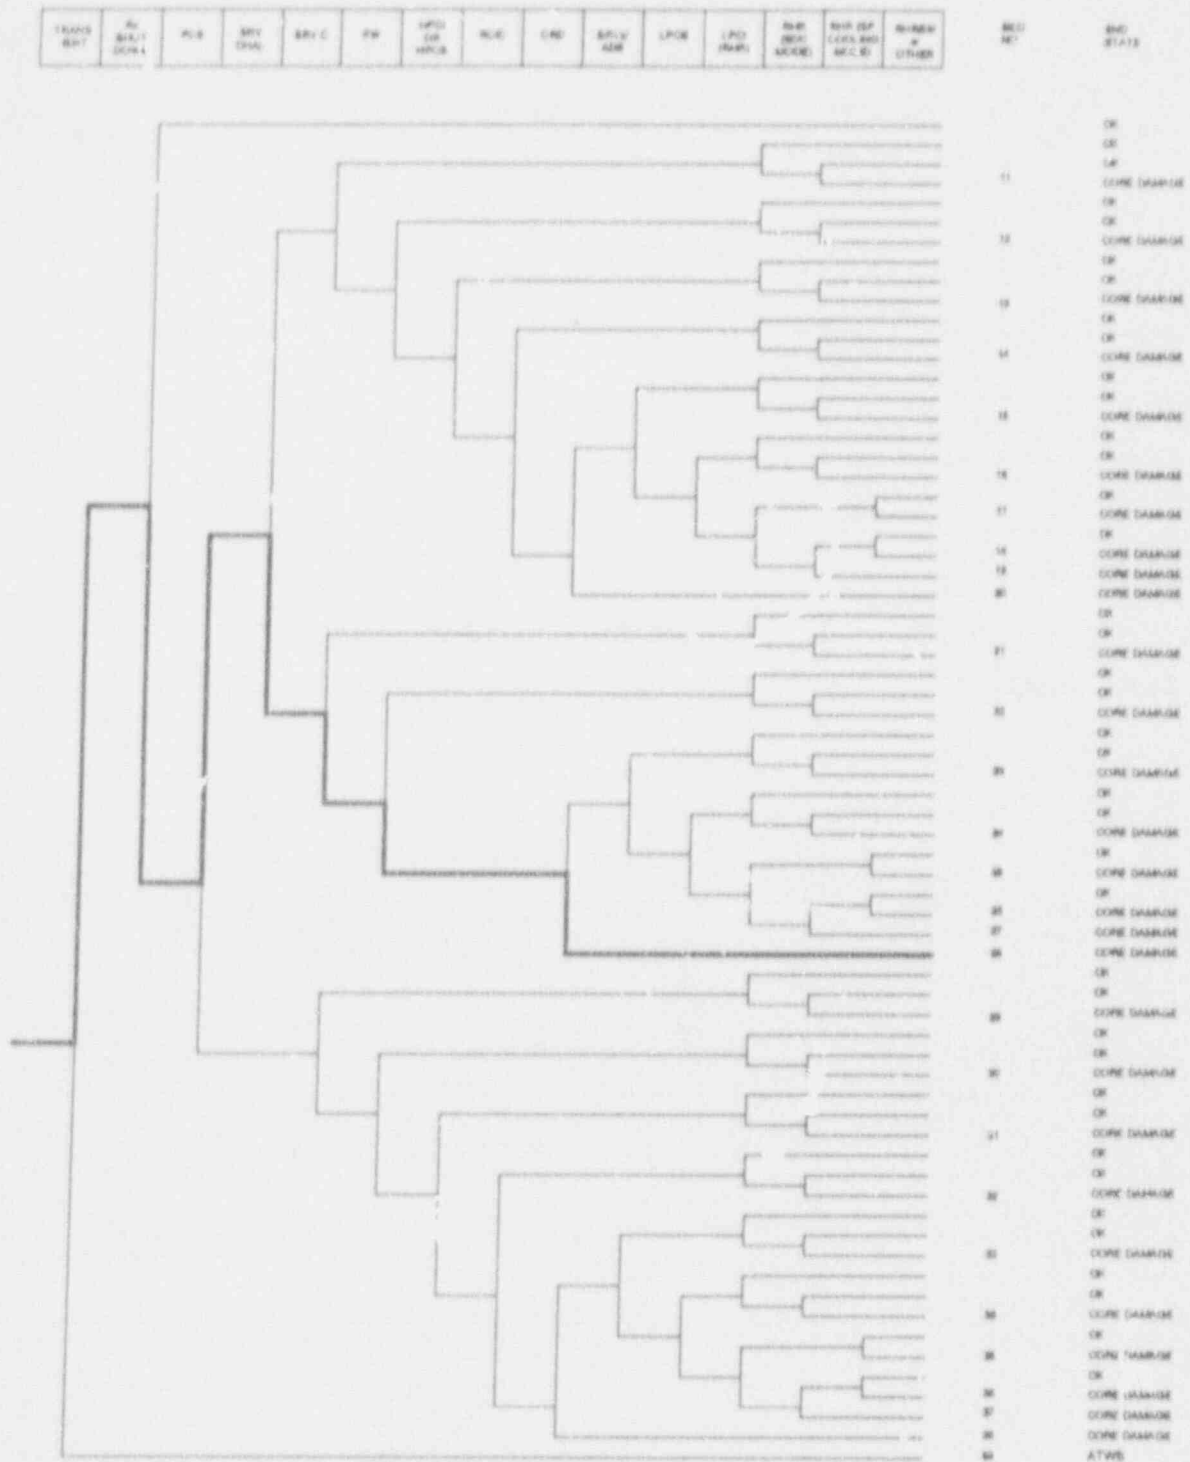
Dominant core damage sequence for LER 325/91-018

The conditional probability of core damage estimated for this event is  $6.0 \times 10^{-5}$ . The dominant core damage sequence, highlighted on the following event tree, involves a loss of feedwater, a stuck-open SRV (transient-induced LOCA), failure of HPCI, and failure to depressurize using the automatic depressurization system to allow use of the low-pressure injection systems.

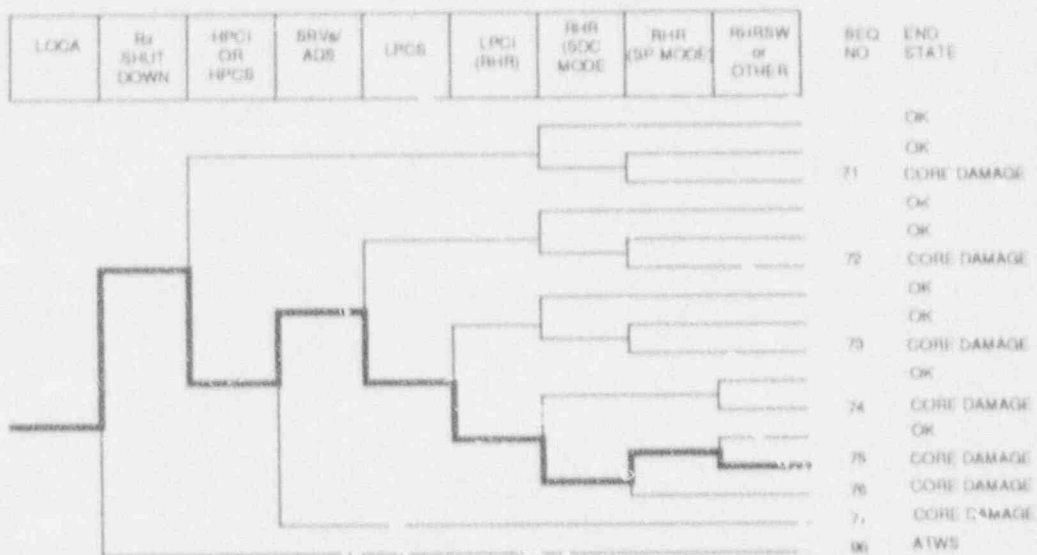
Dominant core damage sequence for LER 333/91-014

The conditional core-damage probability for this event is estimated at  $9.5 \times 10^{-5}$ . This includes the sequences documented on the calculation sheets included with this analysis, plus the contribution from postulated large-break LOCAs, as described above. The dominant sequence, highlighted on the following event tree, involves a postulated small-break LOCA with failure of high-pressure coolant injection, successful depressurization to allow use of the low-pressure systems, and failure of low-pressure injection (LPI).

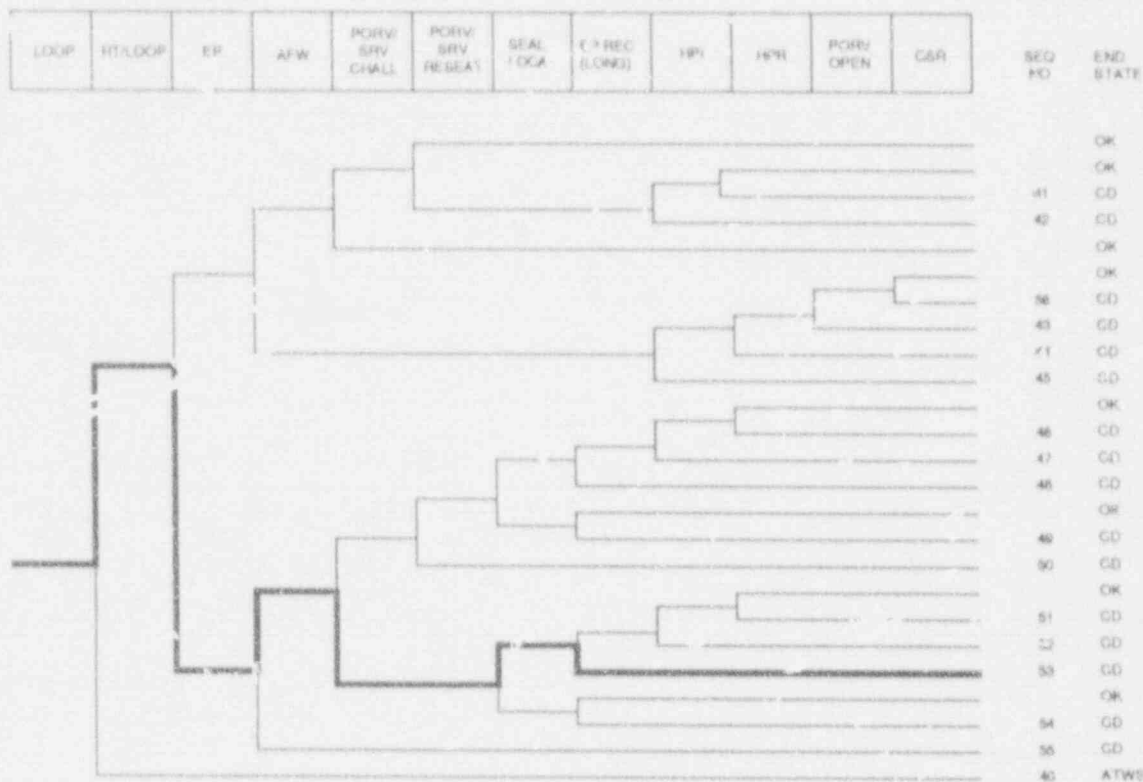
Dominant core damage sequence for LER 336/91-009

The estimated conditional core damage probability associated with this event is  $2.1 \times 10^{-4}$ . The dominant core damage sequence is a station blackout sequence. This sequence is highlighted on the following event tree and involves failure of emergency power following a postulated LOOP, a reactor coolant pump seal loss-of-coolant accident (LOCA), and failure to recover AC power prior to core uncover.

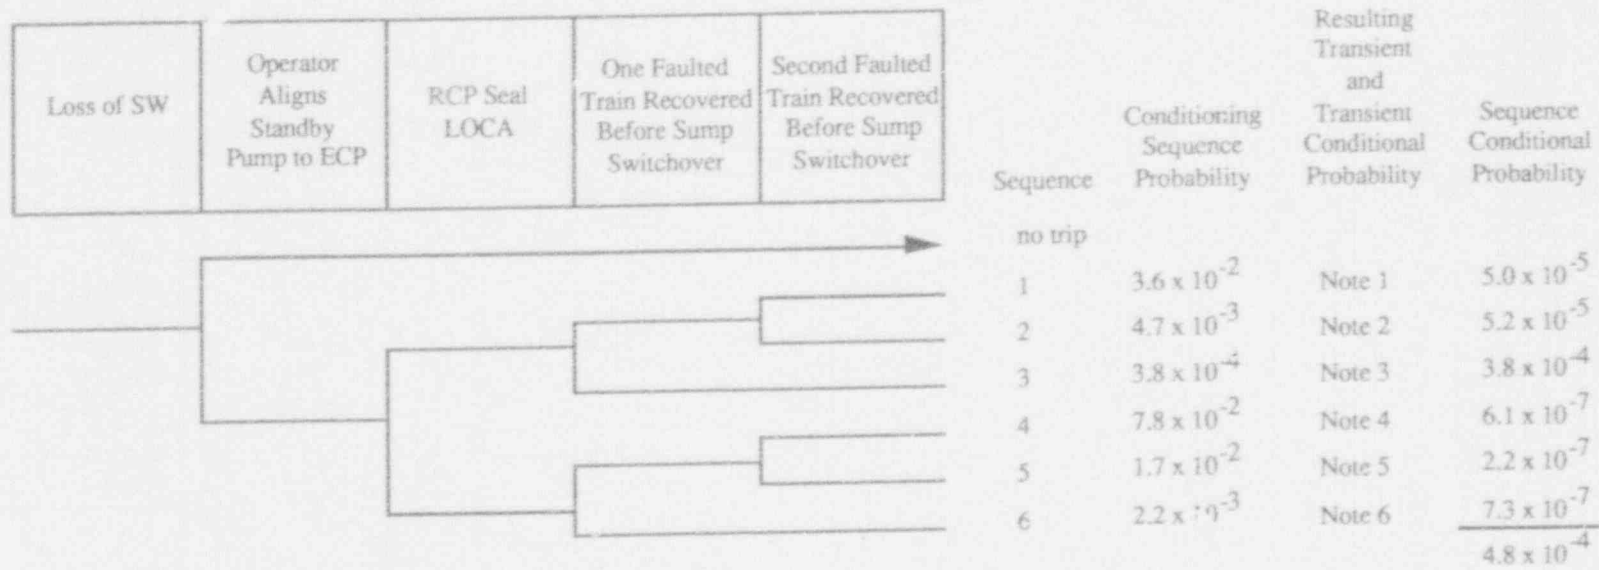
Fig. 1. Conditioning event tree for LER 368/91-012

The conditional core damage probability for this event is estimated to be  $4.8 \times 10^{-4}$ . This value is strongly influenced by assumptions made concerning recovery of the faulted SW trains and the probability of an RCP seal failure. The dominant sequence, highlighted on the following event tree, involves an RCP seal LOCA and failure of HPR and CSR due to unavailability of SW.

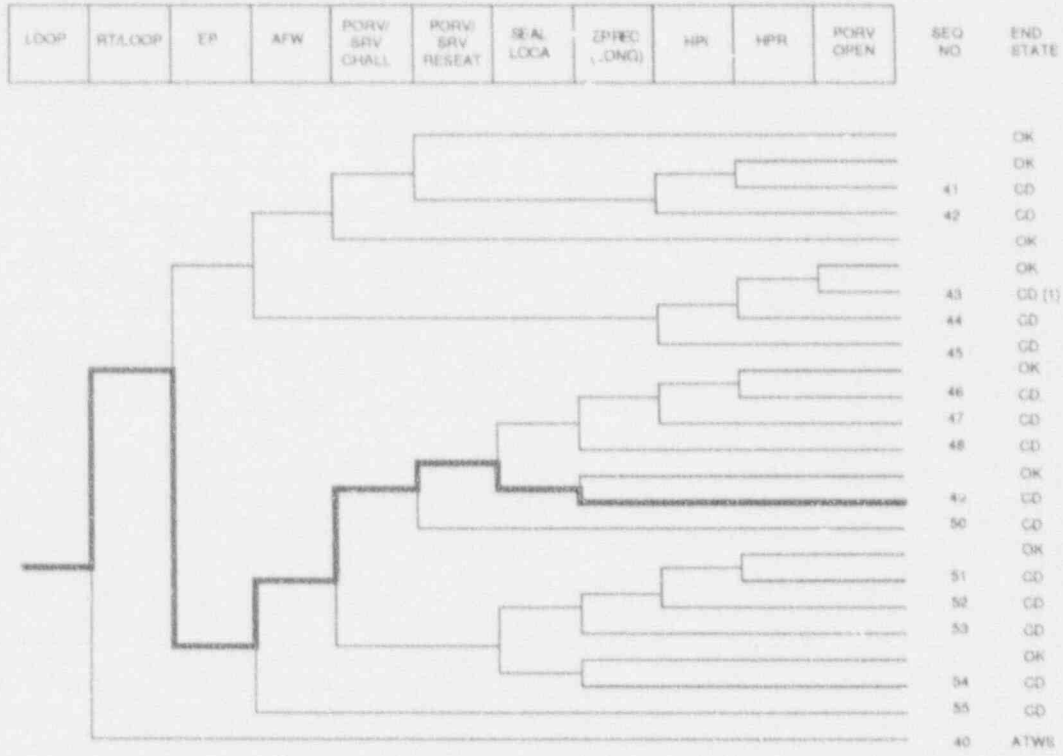
Dominant core damage sequence for LER 369/91-001

The estimated core damage probability associated with this event is  $2.6 \times 10^{-4}$ . The dominant core damage sequence, shown on the following event tree, involves a postulated loss of emergency power following the LOOP, and failure to recover AC power prior to battery depletion. If the unavailable PORV is assumed to fail feed and bleed, the resultant core damage probability is estimated to be  $2.9 \times 10^{-4}$ .

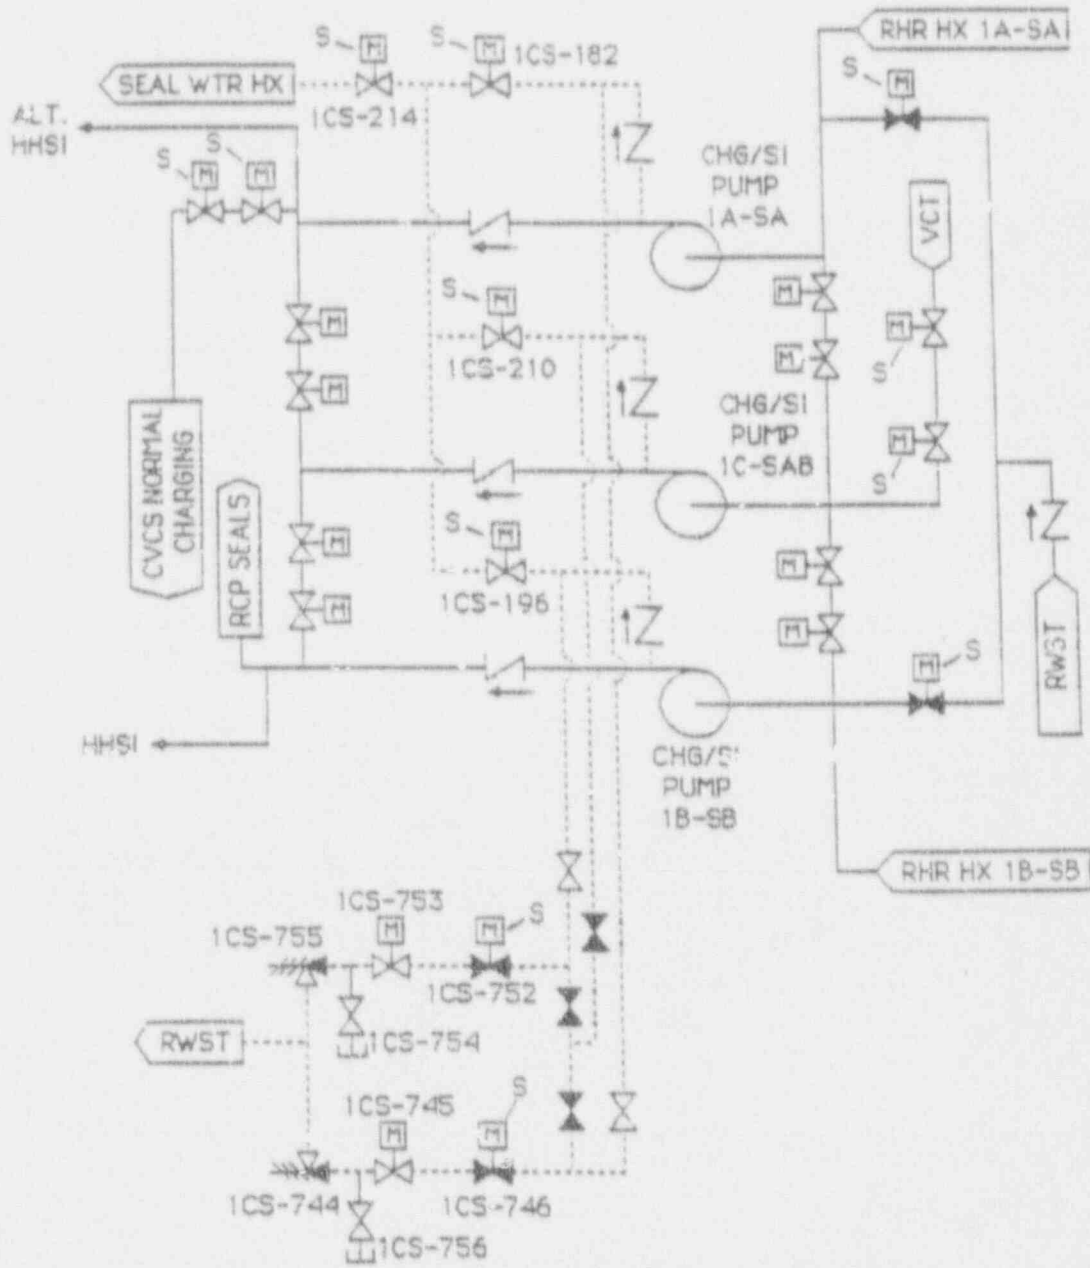
Fig. 1. Harris I charging/safety injection system

Harris is equipped with three charging/safety injection pumps (CSIPs) that provide charging and seal flow during normal operation and provide high-pressure injection (HPI) during accidents. Each pump is provided with a normal minimum flow path and an alternate minimum flow path for pump protection. During normal operations, the minimum flow path is via the seal water heat exchanger back to the pump suction. During safety injection (SI) operation, this path is isolated, and two alternate paths via relief valves to the reactor water storage tank (RWST) are aligned. Tests conducted during a refueling outage revealed that both relief valves were failed, as well as associated piping. Had HPI been demanded during the operating cycle, sufficient flow would have been diverted via the alternate miniflow system to fail the injection function. Under some circumstances, pump runout and failure could also have resulted.

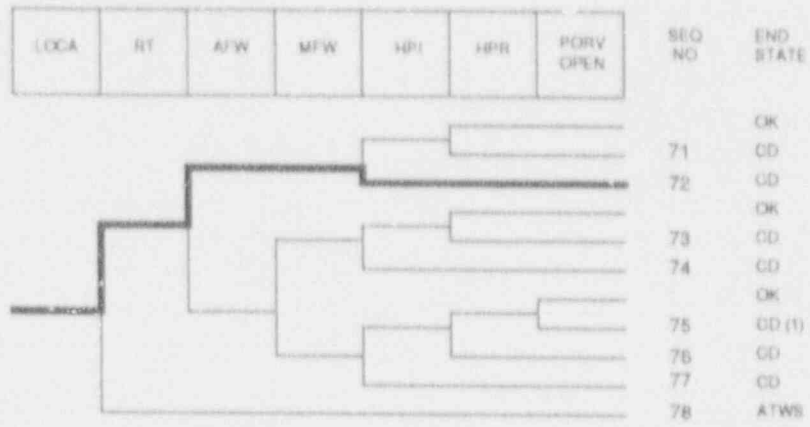
Dominant core damage sequence for LER 400/91-008

The conditional core damage probability estimated for this event is  $6.3 \times 10^{-3}$ . The relative significance of the event compared to other postulated events at Harris 1 is shown below.

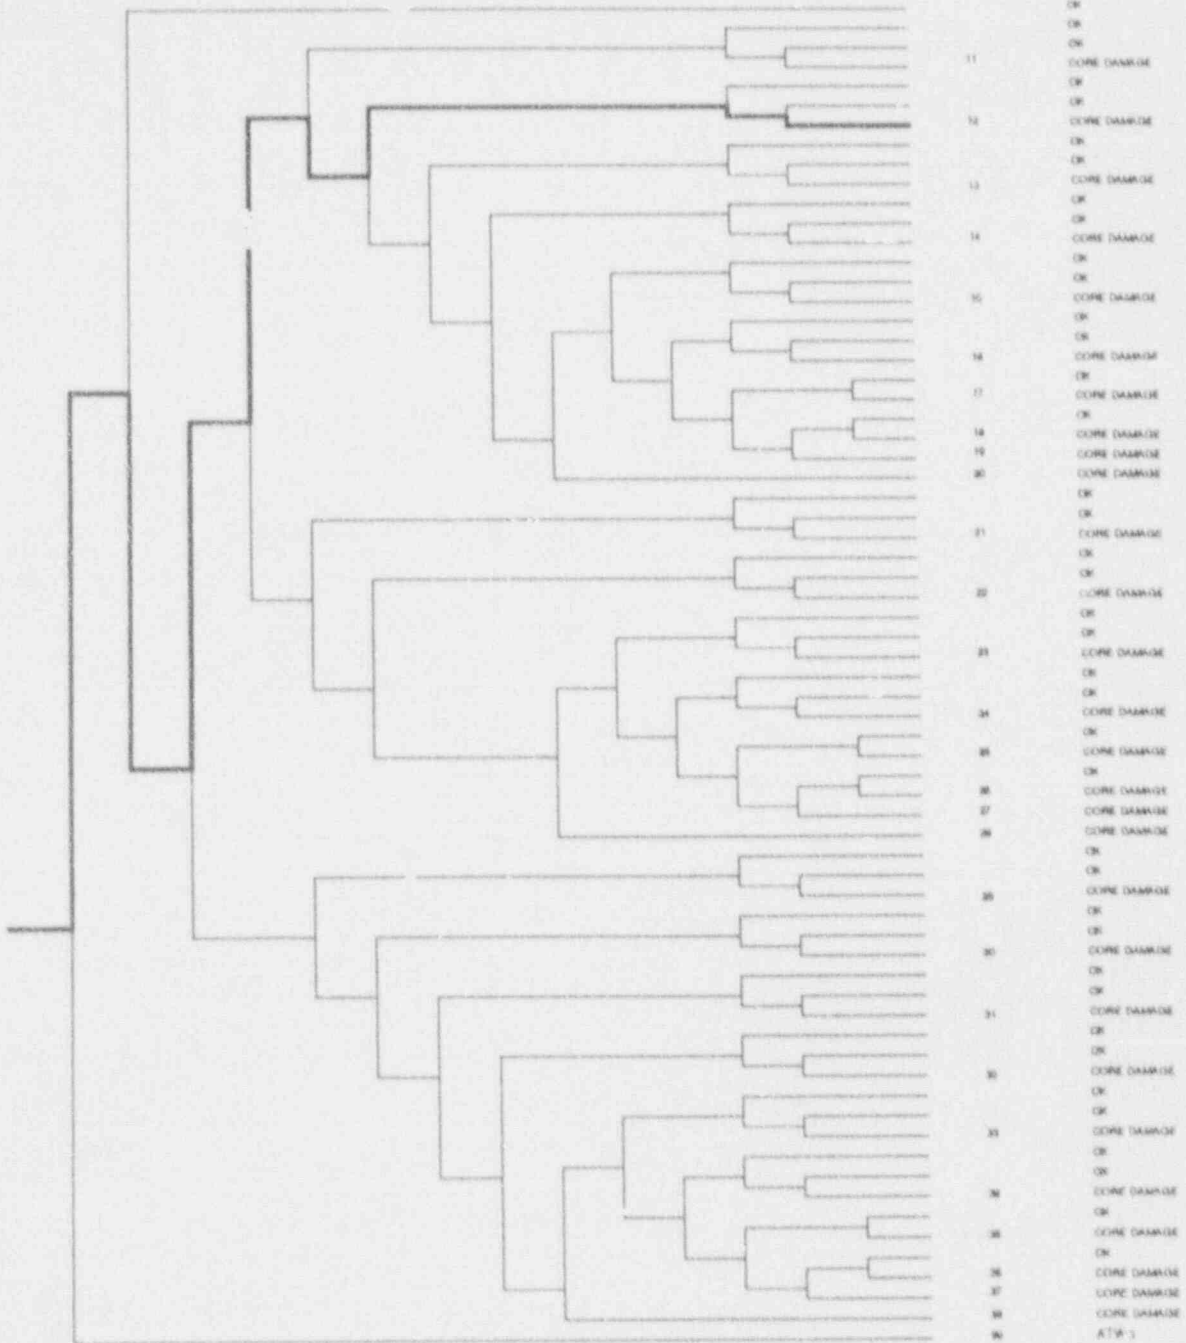
Dominant core damage sequence for LER 410/91-017

The conditional probability of subsequent core damage for the event is estimated to be  $3.8 \times 10^{-4}$ . The dominant sequence, highlighted on the following event tree, involves a loss of feedwater with unavailable long-term core cooling.

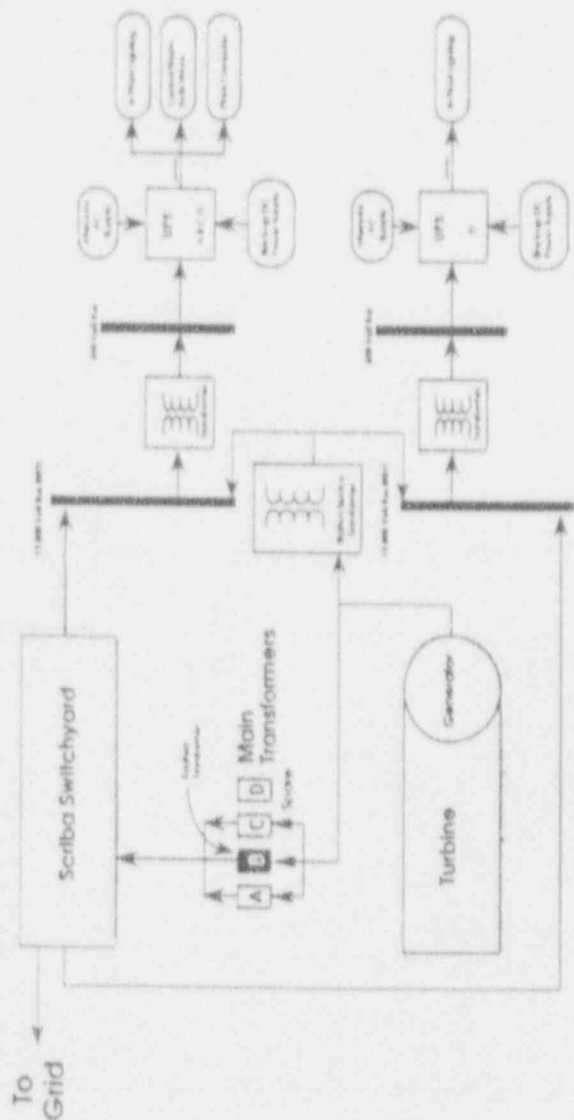
**NINE MILE POINT UNIT 2**  
 SIMPLIFIED ELECTRICAL DRAWING

- UPS - A - Control Room Indicators
- B - Control Room Indicators
- C - Panel Lighting
- D - Panel Lighting
- E - Panel Computers
- H - Main Stack Equipment

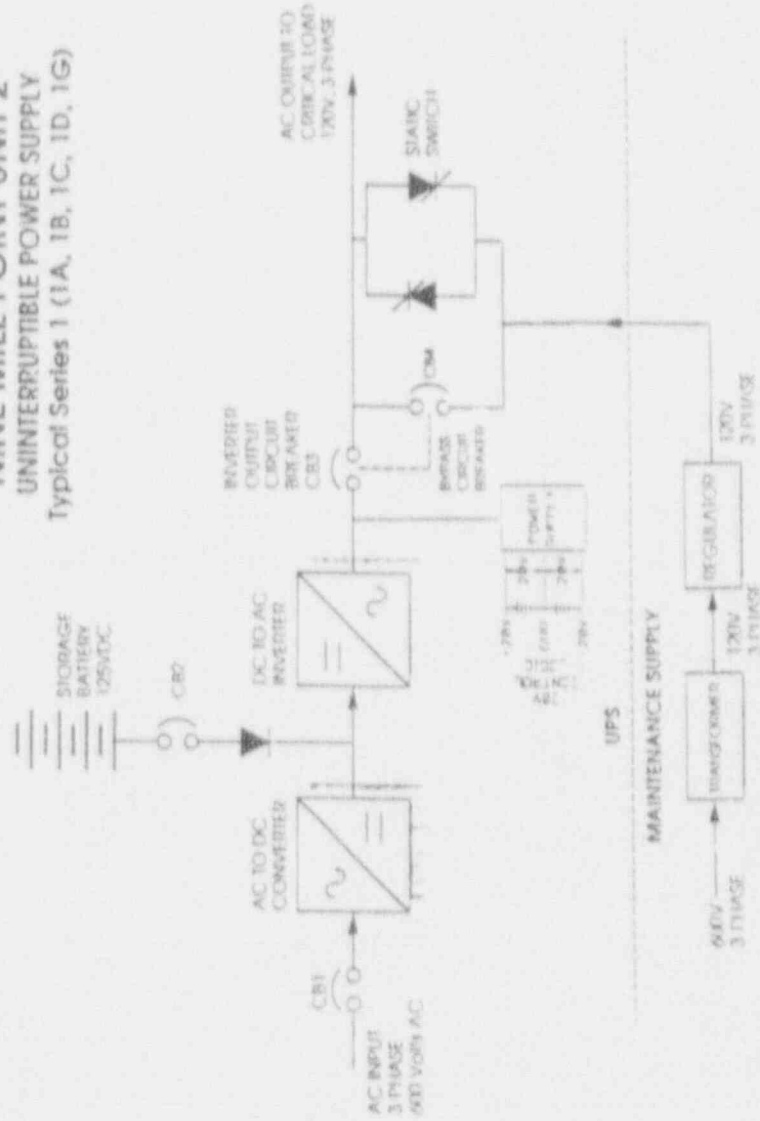
**NINE MILE POINT UNIT 2**  
**UNINTERRUPTIBLE POWER SUPPLY**  
 Typical Series 1 (1A, 1B, 1C, 1D, 1G)

Subsequent to the internal fault which occurred on the main step up transformer, five Exide UPS's (2VBB-UPS1A, 1B, 1C, 1D, and 1G) tripped resulting in loss of power to their respective loads. A root cause evaluation has been completed in accordance with Nuclear Division Procedure NDP-16.01, "Root Cause Evaluation".

Extensive analysis and testing has concluded that all five Exide UPS units shutdown as a result of a logic initiated trip. The failure of the "B" Phase Main Transformer caused a voltage collapse on the maintenance power supply to all five UPS units. The degraded voltage on the maintenance power supply caused the voltage on the UPS logic power supply to decrease below its trip setpoint, causing the units to trip. Concurrently, the automatic load transfer to the maintenance supply was prevented by design due to the degraded voltage conditions on the maintenance power supply.

The root cause for the simultaneous tripping of the five UPS units is improper design. The UPS is not designed to accommodate a degraded voltage condition of the maintenance power supply. The following design factors allowed the UPS logic power supply voltage to decrease below its trip setpoint as a result of the "B" Phase Main Step-up Transformer fault.

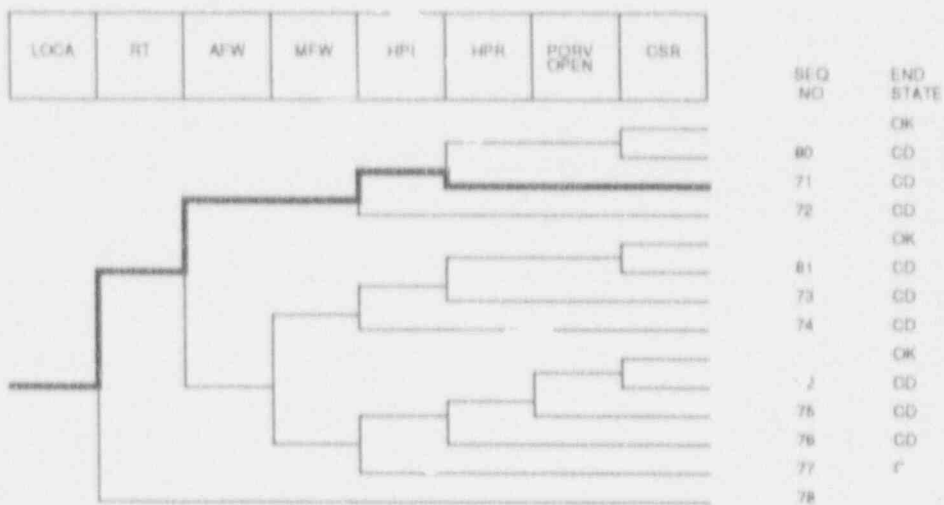
Dominant core damage sequence for LER 423/91-011

The conditional probability of subsequent core damage associated with this event was estimated to be  $8.1 \times 10^{-5}$ , assuming the charging pumps would be effective for safety injection. The dominant core damage sequence, shown on the following event tree, involves a postulated loss-of-coolant accident and HPR failure.

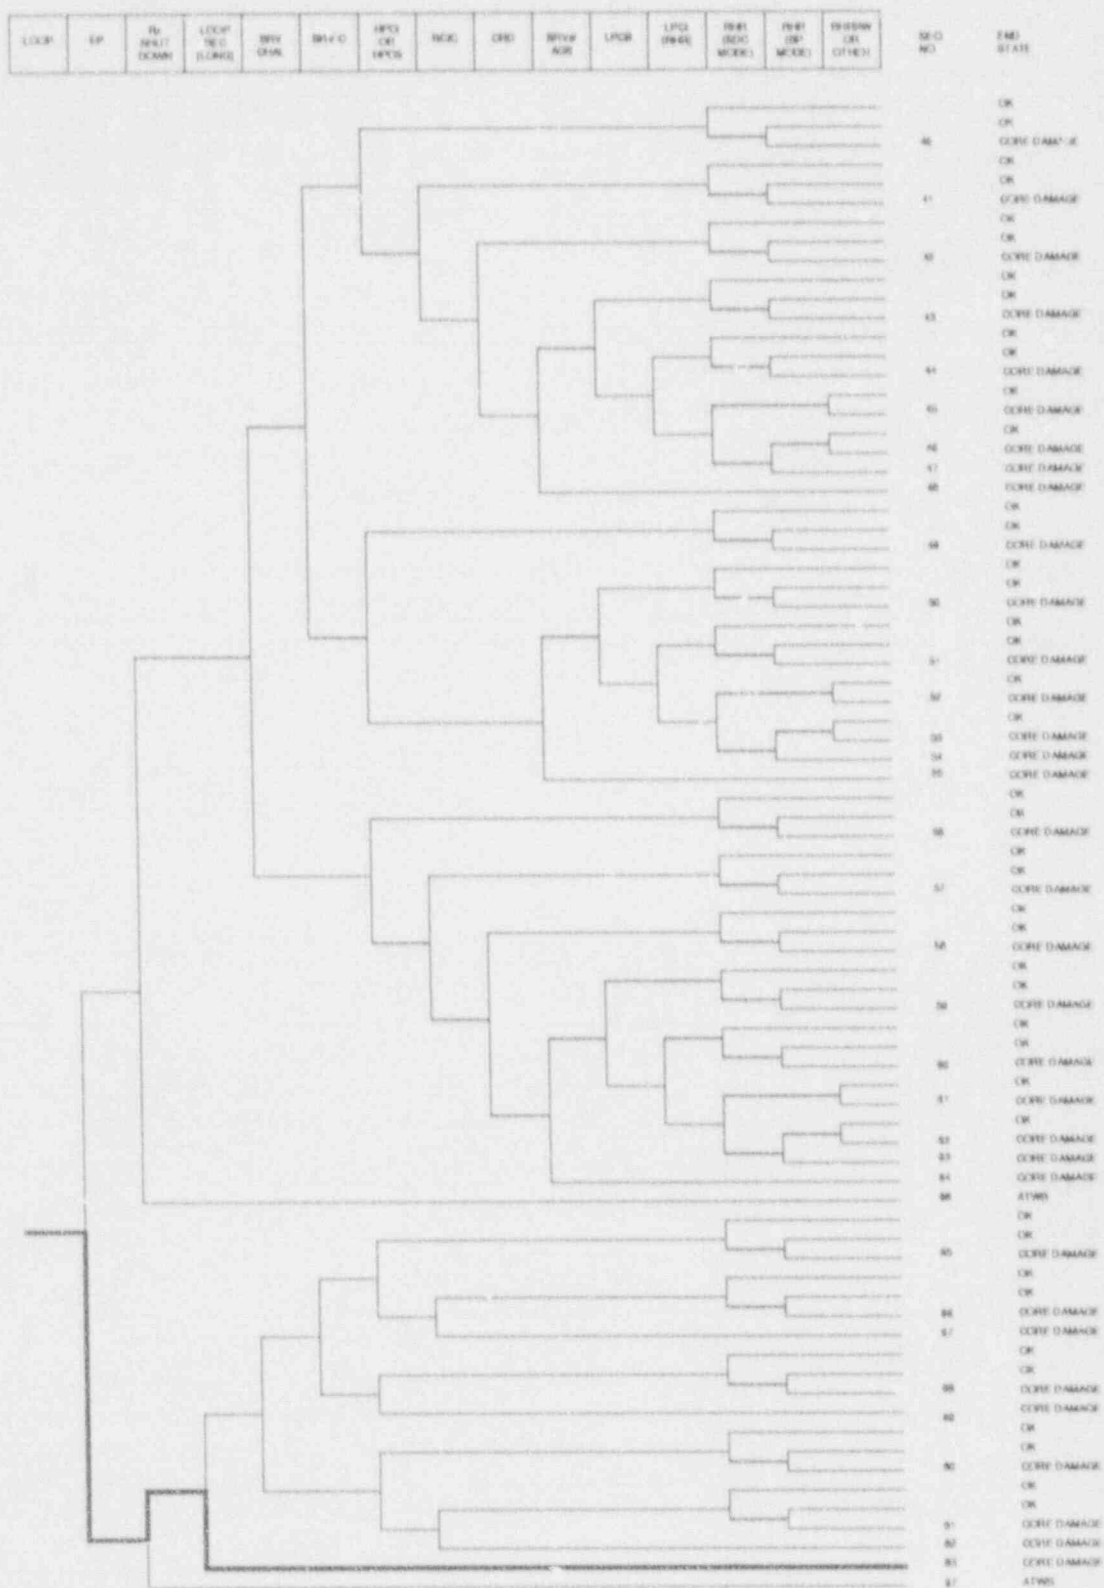
Dominant core damage sequence for LER 440/91-009

The dominant core damage sequence, highlighted on the following event tree, involves a postulated LOOP, a nonrecoverable emergency power system failure, and failure to restore AC power prior to battery depletion.

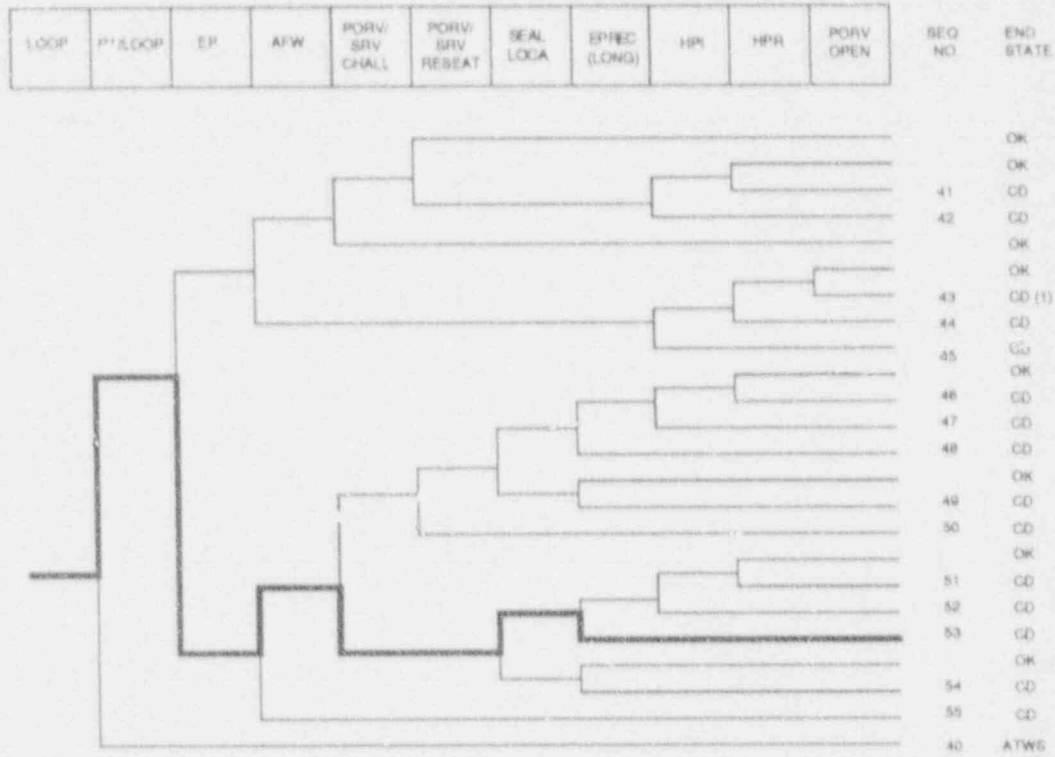
Dominant core damage sequence for LER 443/91-008

The conditional probability of core damage estimated for this event is  $4.4 \times 10^{-5}$ . The dominant core damage sequence, highlighted on the following event tree, involves a

LOOP, failure of emergency power, an RCP seal LOCA, and failure to recover AC power before core uncover.
