# Precursors to Potential Severe Core Damage Accidents: 1991 A Status Report

Appendices B, C, and D

Prepared by  
J. W. Minarick, J. W. Cletcher, D. A. Copinger, D. W. Dolan

Oak Ridge National Laboratory

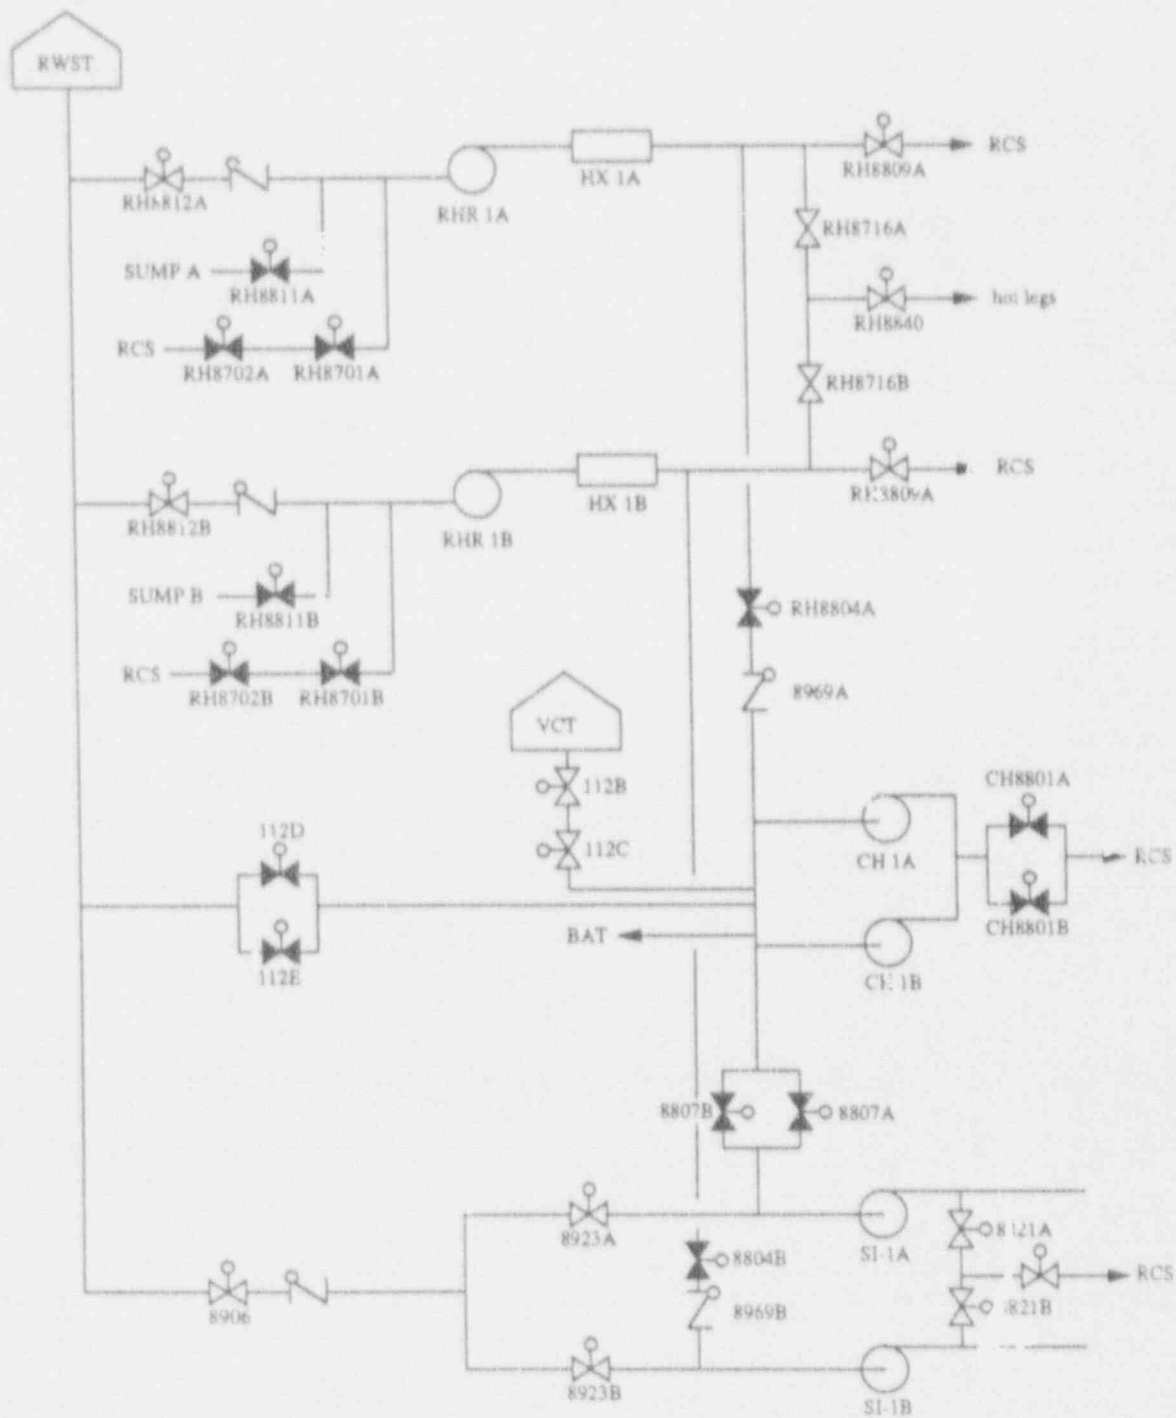
Fig. 1. Comanche Peak Safety Injection Systems

If the second SI pump were to be damaged by hydrogen traveling through the cross-connect in the pump suction, then the significance of the event is much higher —  $6.3 \times 10^{-3}$  based on the current Accident Sequence Precursor models and  $2.1 \times 10^{-3}$  using revised models currently under development. For this to occur, however, sufficient hydrogen would have to expand into the charging pump suction piping to damage both charging pumps and SI pump 1A, and also travel (via valves 8923A and 8923B) to the suction of SI pump 1B.

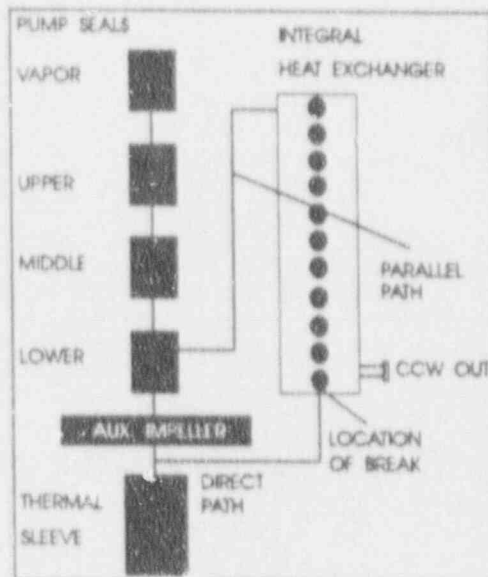
Figure 1: Palisades Byron-Jackson PCP Integral Heat Exchanger

Various break locations were considered within the PCP integral heat exchanger. The worst location of such a break would be at the inlet weld area of the tube side of the heat exchanger which contains the primary coolant. A break at this area would result in maximum flow due to the least flow resistance in the direct path (see Figure 1). A parallel path is also available for the primary coolant. This is reverse flow via the flow path that cools the seal package from the heat exchanger (see Figure 1). In order to maximize the flow from the PCS, a double-ended guillotine break was assumed. A RETRAN (EPRI transient thermal-hydraulic code) model to simulate this break, with and without the parallel path, was developed. The model incorporates the specific geometry of the Palisades Byron-Jackson pumps and the inter-connected CCW system.

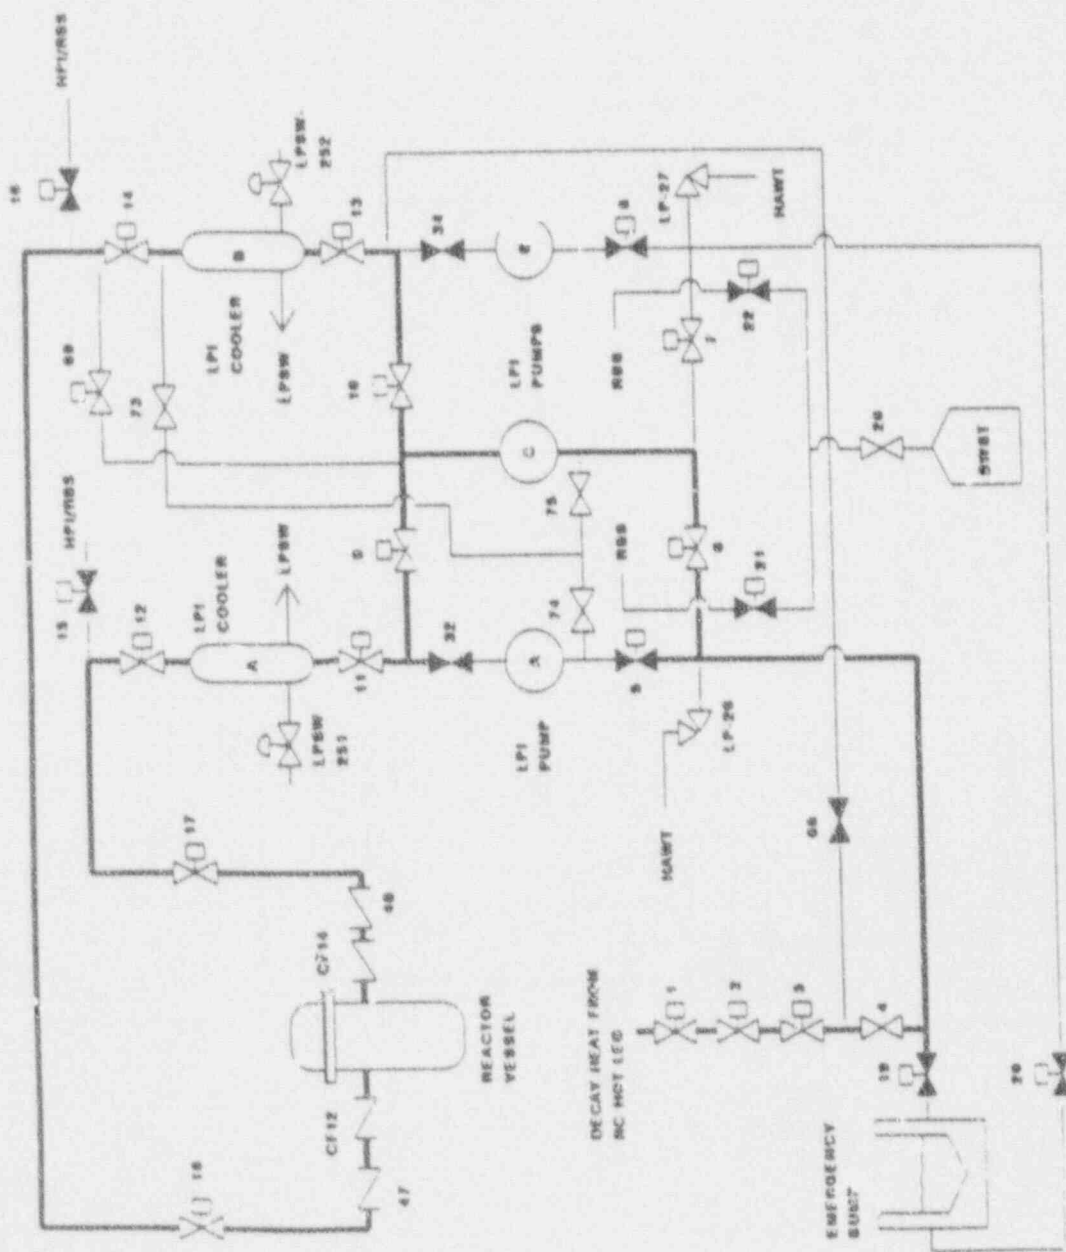
Figure 2

LOW PRESSURE INJECTION SYSTEM  
ALIGNMENT ON SEPTEMBER 19, 1991

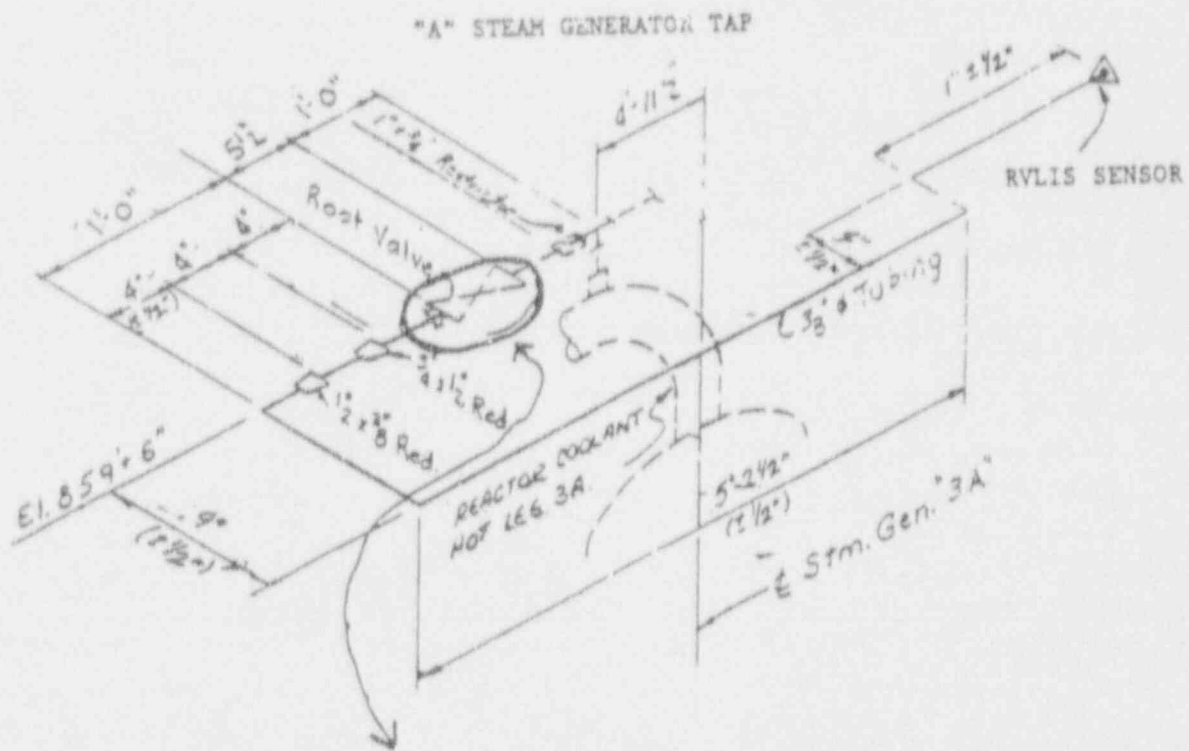
"Nominal" Gap Expected - 0.153 to 0.165 Inch

Actual Measured Gap - 0.182 Inch

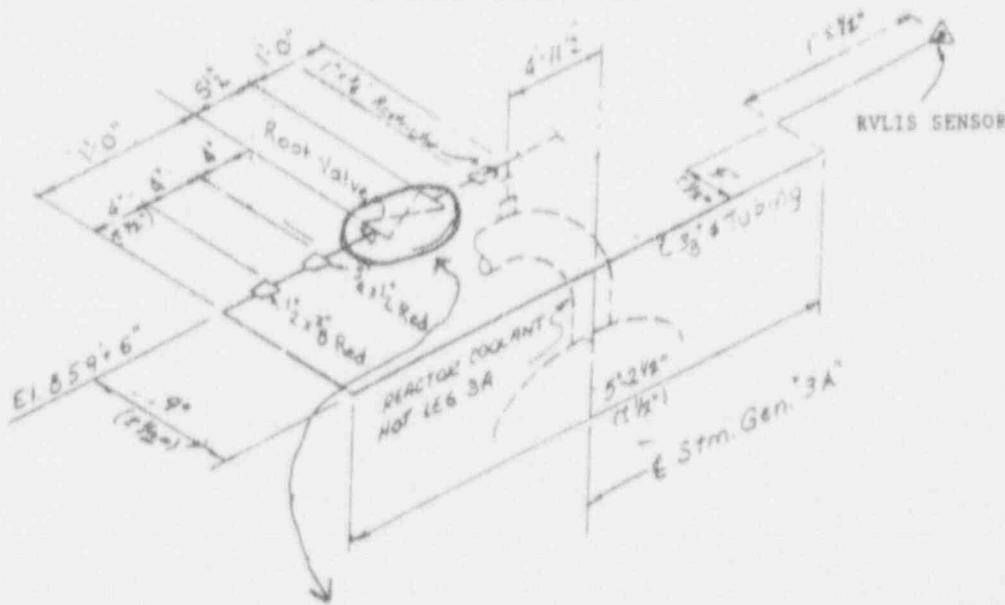
"A" STEAM GENERATOR TAP

"Nominal" Gap Expected - 0.153 to 0.165 Inch

Actual Measured Gap - 0.182 Inch
