GPUN

EVALUATION OF POTENTIAL EFFECTS OF LOOSE

OTSG PLUGS IN THE TMI-1 RCS

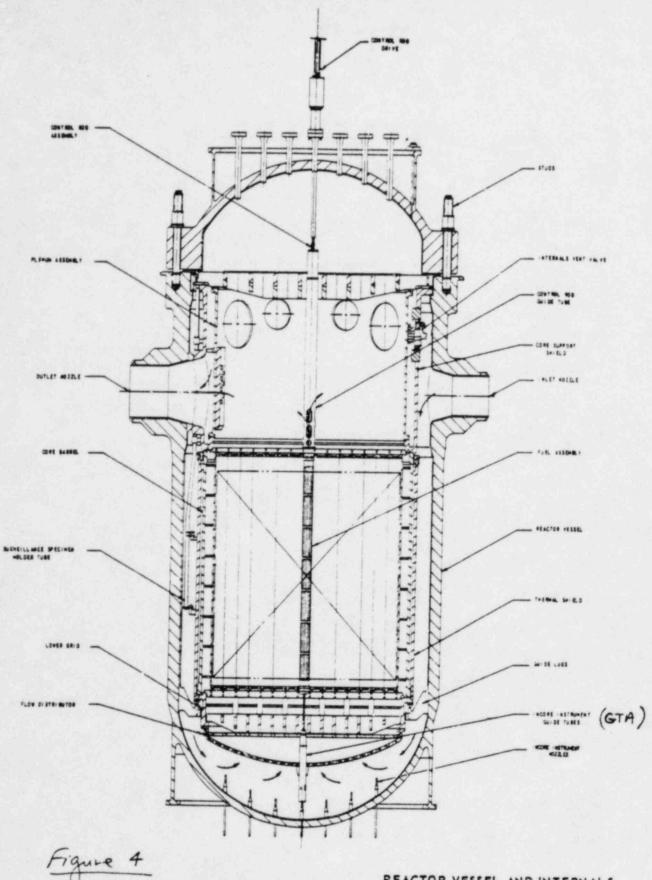
FIGURE 3 - 46 (AM. 34 11-22-72)

The most probable flow path for a plug is out of the lower dome of the OTSG, up the vertical cold leg, through the RC pump, into the horizontal cold leg, through the inlet nozzle, downcomer, lower plenum, lower internals, into the lower end fittings (LEFs) of the fuel assemblies where they will be trapped by inlet flow. Inlet flow paths and RV component arrangements are shown in Figures 3, 4 and 5.

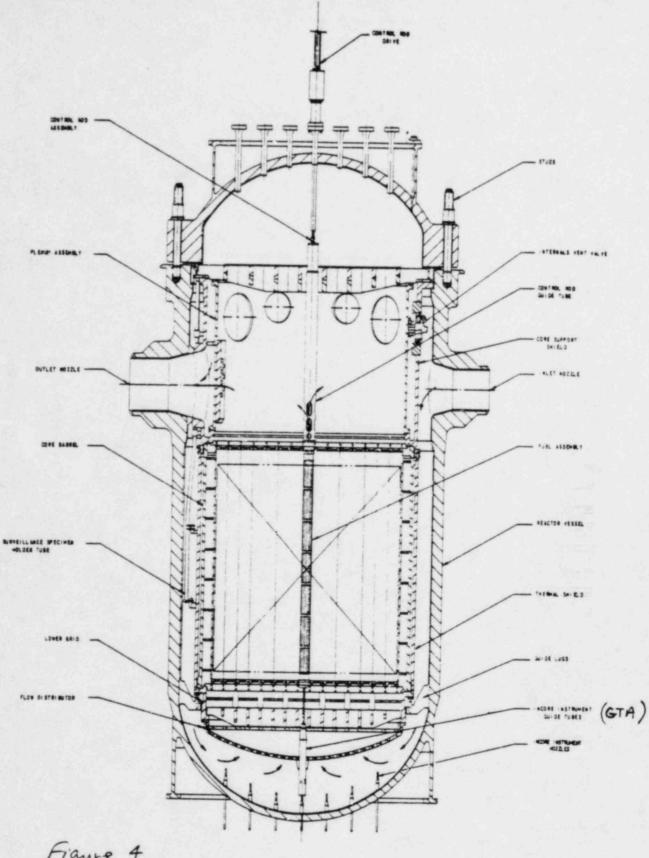
Figure 4

There is a small potential for plugs or fragments to enter the 4[•] diameter opening at the bottom of the incore instrument guide tube assembly (GTA) (Fig. 4). There is about a 1[•] annular gap between the GTA and the top of the incore nozzle. Entrance is unlikely since flow in the GTA is lower than in the RV plenum and entrained pieces would follow the stronger flow paths.

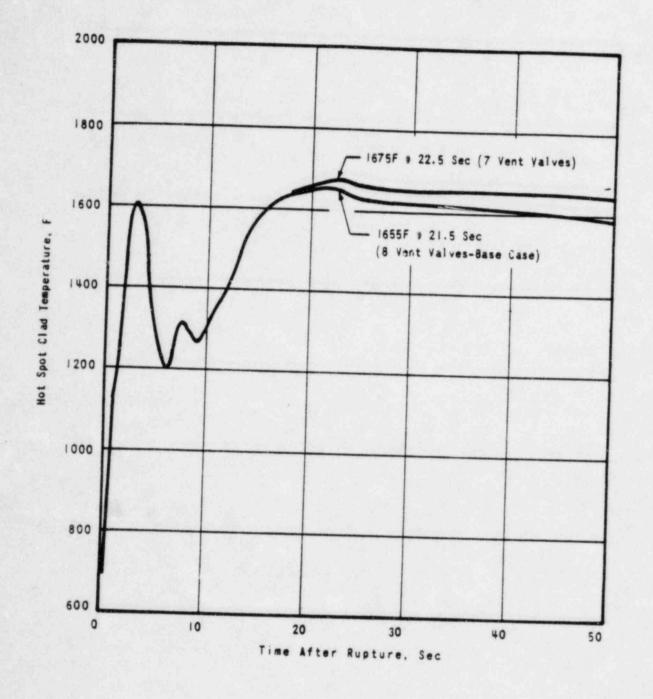
It is unlikely that any plugs entrained in the inlet flow will reach the valve elevation. There are deflectors on the core support shield that direct inlet flow downward into the downcomer. Thus, any flow in the valve region is low velocity and turbulent. The valve body and hinge components are massive relative to the plugs. Impact effects would be minimal. A dimensional study in the TMI-1 FSAR (Section 3) shows that the rotational clearances within the hinge are less than 0.03"; too small for a plug to enter. There is a larger gap (about 3/8") between the hinge outer journal and the valve body in which a deformed plug might wedge resulting in restricted valve motion. The probability of this occurring is extremely small given the flow conditions in the valve region and the small plug population. Even in the postulated case of a vent valve sticking closed, the effect on peak clad temperature during a LOCA has been demonstrated to be minimal as shown in Figure 16 taken from the TMI-1 FSAR.
