LICENSEE EVENT REPORT (LER)

FACILITY NAME (1) Catawba Nuclear Station, Unit 1						DOCKET NUMBER (2) 0 5 0 0 0 4 1 3			PAGE (3) 1 OF 0 4	
--	--	--	--	--	--	--------------------------------------	--	--	----------------------	--

TITLE (4)  
Ice Condenser Lower Inlet Doors Blocked Closed

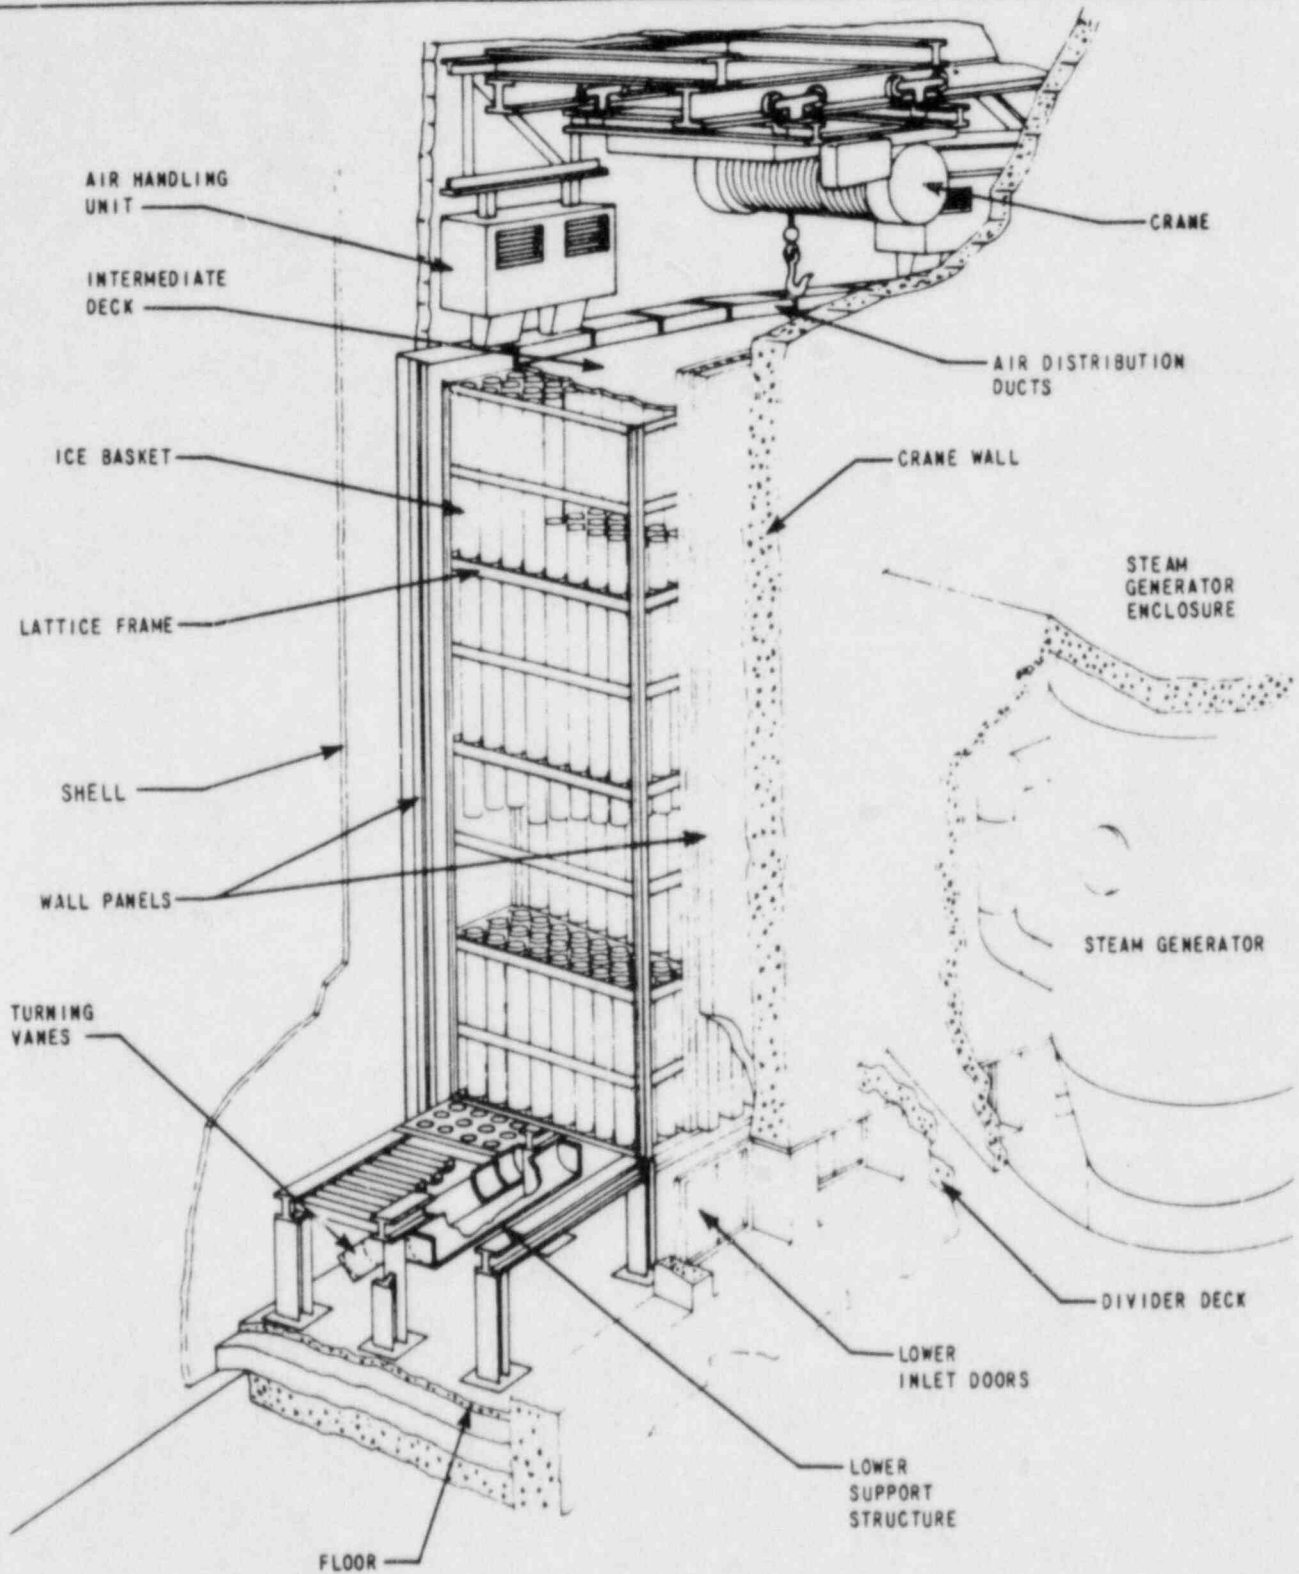
# Ice condenser

The concern raised by leaving the inlet door blocking mechanisms in place is a possible degradation in the ability of the ice condenser to control containment pressure following a postulated high energy line break inside containment. During such a break, lower containment (and upper containment) pressure will increase due to mass and energy releases. If the pressure differential across the ice condenser exceeds a certain value, the inlet doors will open. Calculations have shown that this value is less than approximately 0.1 psi, with the blocking mechanisms conservatively assumed to be wedged in place horizontally. This differential pressure will develop a force across the doors sufficient to buckle the blocking mechanism. In fact, the mechanisms are not wedged in place, but are simply allowed to drop into the space between the doors and the turning vane, thus holding the doors closed by their weight alone. The pressures developed by all but the smallest high energy line breaks would therefore easily push the mechanisms aside and allow the doors to fully open. For the very small breaks, which do not develop sufficient differential pressure to open the doors, containment spray, initiated by upper containment pressure increases due to bypass leakage, will control the pressure increase.

The consequences of a postulated high energy line break inside the containment with the mechanisms in place were further decreased since the Catawba Unit 1 core was essentially at zero burnup. The blocking mechanisms were completely removed no later than 50 hours after initial criticality. Thus, very small fission product inventories had accumulated. Further, the very low decay heat levels ensured that the core would be recovered, assuming ECCS availability, well before clad damage could provide a pathway for significant release of the core activity. In summary, the failure to remove the blocking mechanisms prior to entering hot shutdown did not significantly degrade the ice condenser performance, and the incident posed no threat to the health and safety of the public.
