LICENSEE EVENT REPORT (LER)

FACILITY NAME (1) Sequoyah, Unit 1	DOCKET NUMBER (2) 0 5 0 0 0 3 2 7	PAGE (3) 1 OF 0 7
---------------------------------------	--------------------------------------	----------------------

TITLE (4)  
Thimble Tube Ejection, Revision 1

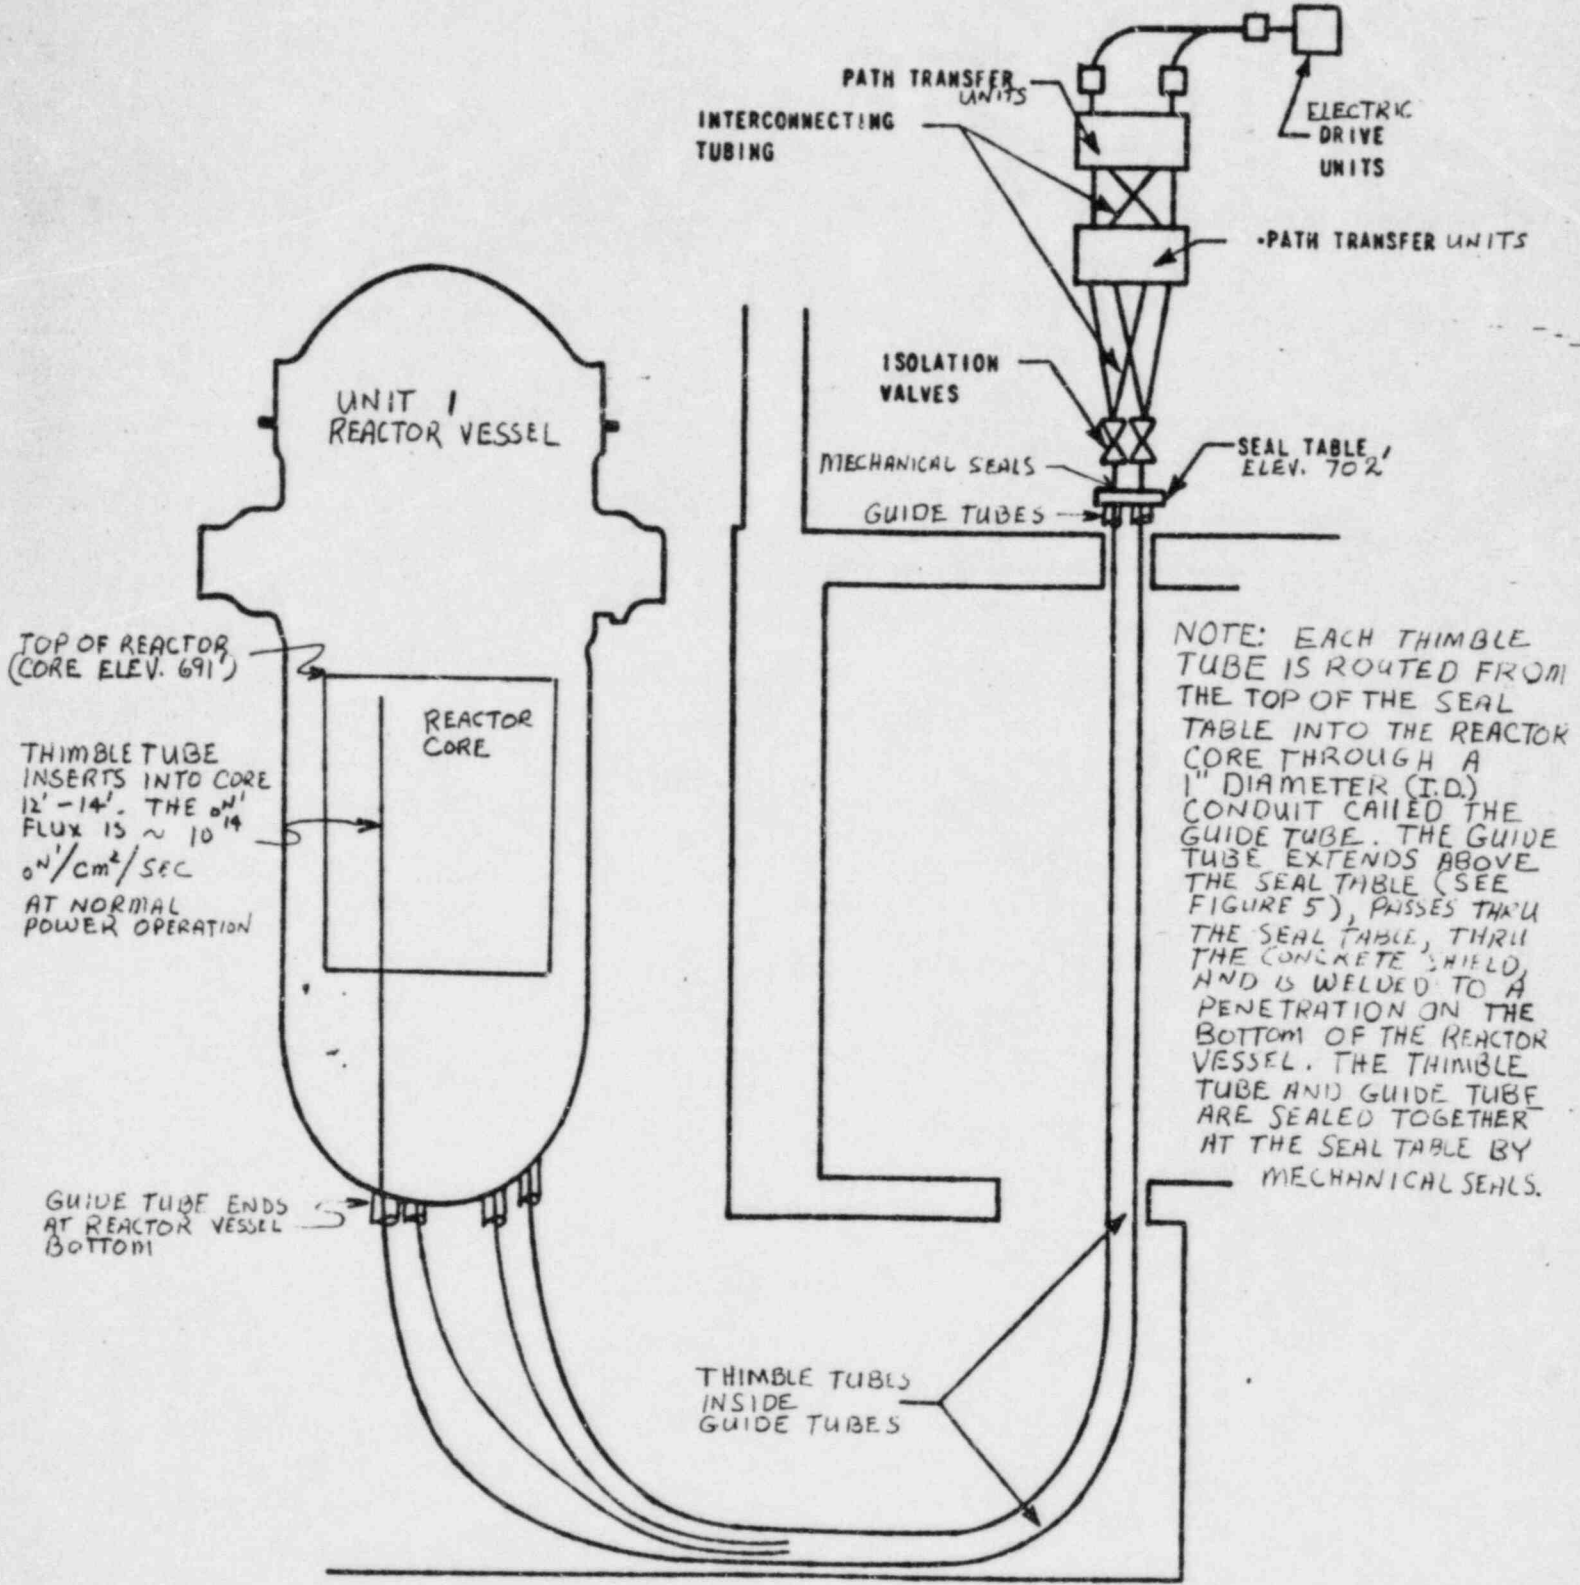
FIGURE 1 INCORE DETECTOR SYSTEM

- (1) Disconnecting the Overhead Drive Assembly (Not Discussed in SMI-0-94-1). The thimble tubes and interconnecting tubing were disconnected at the SWAGELOK union flare fittings between the high pressure fittings and the isolation valves (see figures 1 and 5). The overhead assembly was then rolled out of the way allowing access to the top of the seal table and the thimble tubes.

NOTE: THIMBLE TUBE EJECTION  
OCCURRED FROM D-12 (31) LOCATION

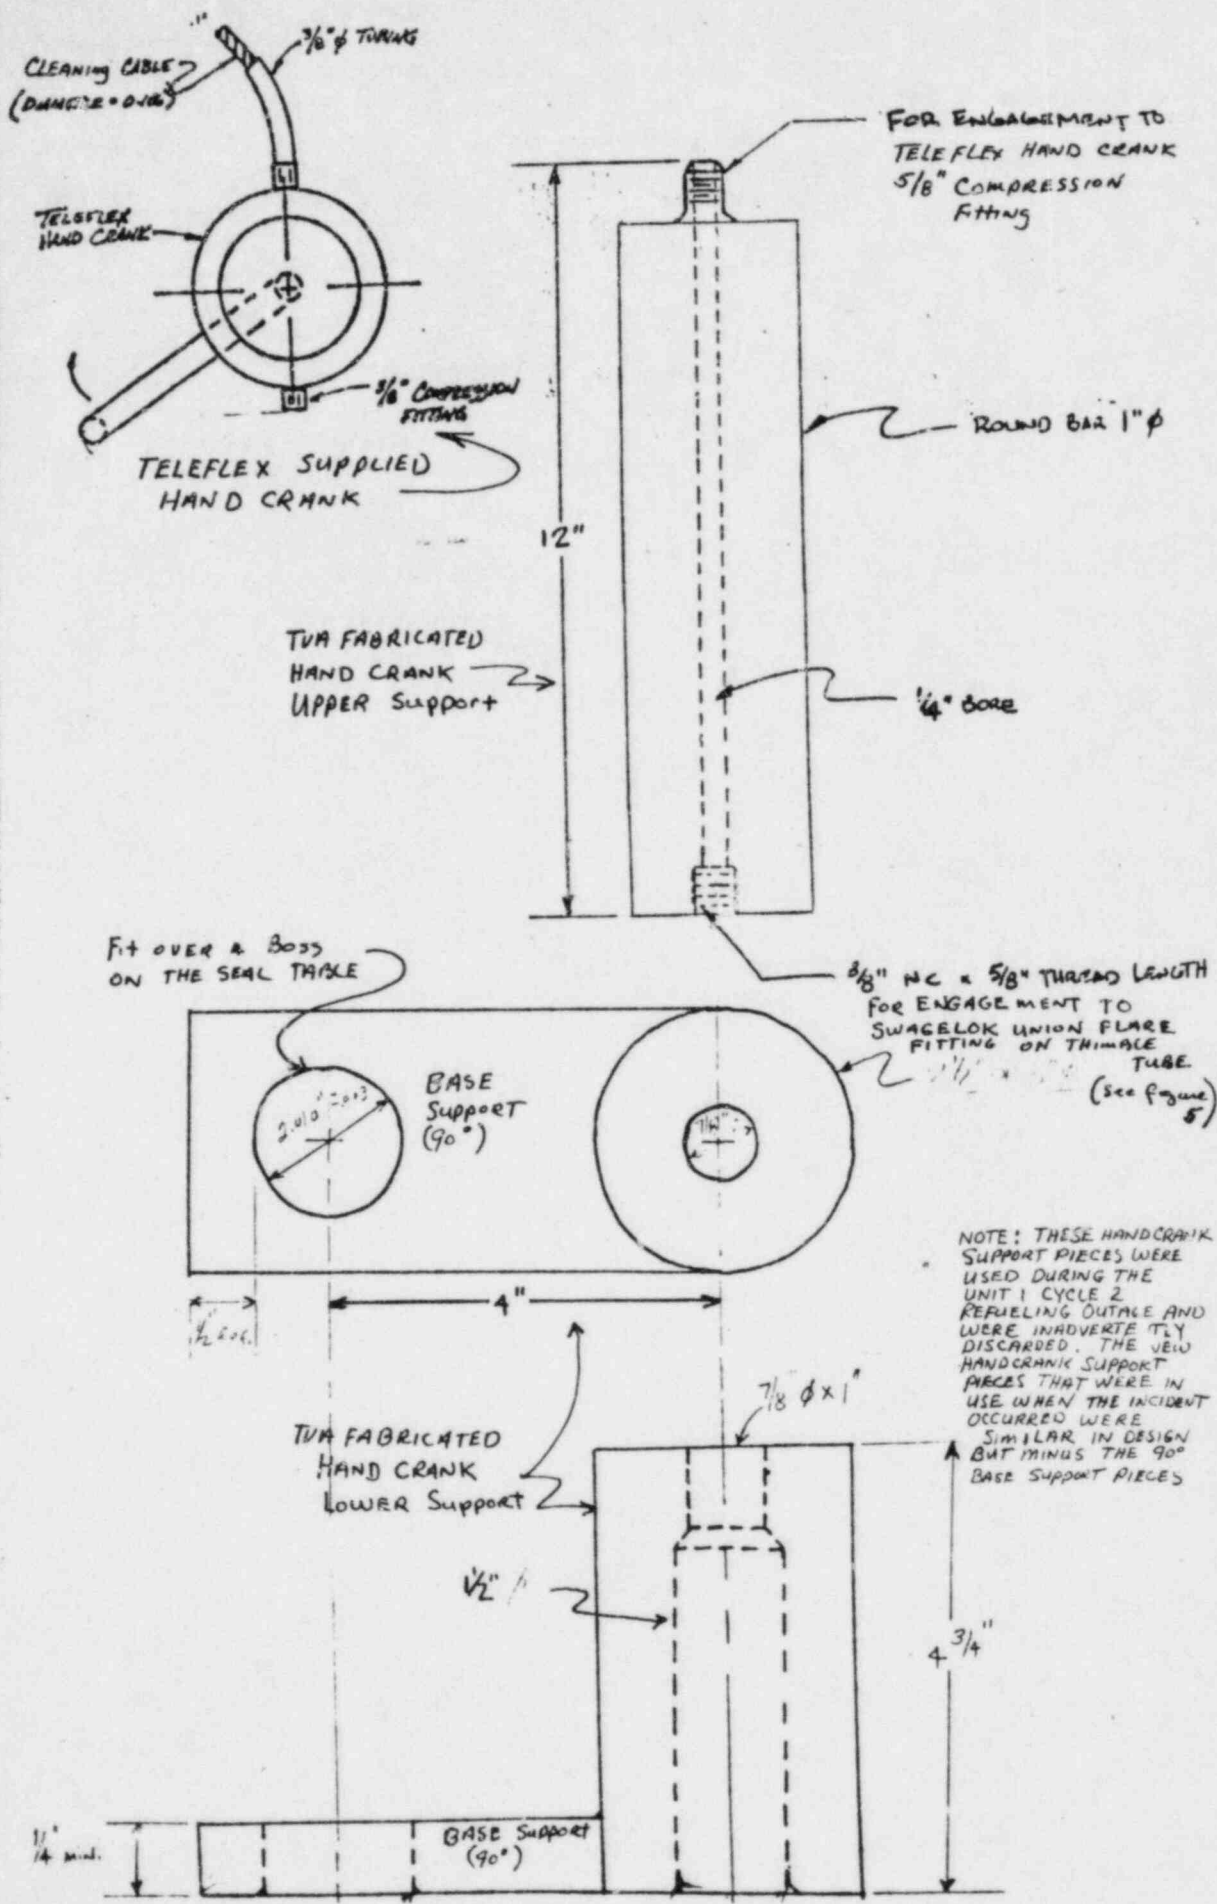
FIGURE 11A

- (2) Dry Brushing (Refer to figures 11A, 11B, 12A, and 12B). The dry brushing step involved the use of a brush assembly which consisted of a 0.200 inch od brass wire brush welded to a 0.187 inch od carbon steel helical (spiral wound) cable driven by a handcranked drivebox. The brush assembly was provided by the same vendor (Teleflex) that provided the detector drive system. The upper and lower supports for the handcrank device were fabricated by TVA. The lower support was equipped with a 90° base support that fit over a boss on a seal table providing additional stability to the support assembly as the handcrank was turned. The fit of the base support over the bosses for all the thimble tubes was not always secure. The brush assembly was used to "dry" brush each of the thimble tubes to dislodge particles and dried lubricant attached to the thimble tube wall by the scrubbing action of the brush. The brush was driven into the thimble 10 inches for each revolution of the handcrank. The brushing motion was strictly linear without any rotation of the brush.

NOTE: THESE HANDCRANK SUPPORT PIECES WERE USED DURING THE UNIT 1 CYCLE 2 REFUELING OUTAGE AND WERE INADVERTENTLY DISCARDED. THE NEW HANDCRANK SUPPORT PIECES THAT WERE IN USE WHEN THE INCIDENT OCCURRED WERE SIMILAR IN DESIGN BUT MINUS THE 90° BASE SUPPORT PIECES

DRYBRUSHING CLEANING TOOL (TELEFLEX SUPPLIED HAND CRANK) AND TVA FABRICATED HANDCRANK UPPER AND LOWER SUPPORT PIECES

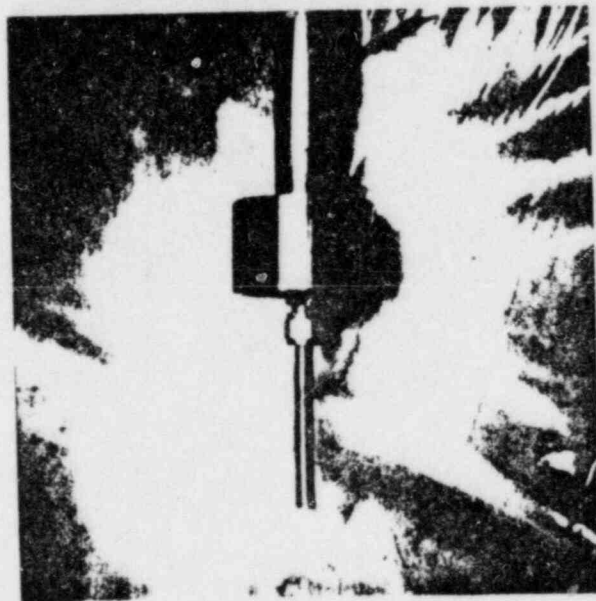
FIGURE 12B

The dry brushing tool (handcrank) and its support mechanism that had been used in past thimble tube dry brushing operations had been inadvertently discarded in radwaste. A handcrank device had been acquired from WBN. The support for the handcrank was not supplied from the vendor that supplied the dry brushing tool. The FSG second shift coordinator consulted with an FSG maintenance specialist who had been involved with prior thimble tube cleaning activities to determine what type of base support was needed for the new dry brushing tool. It was suggested that a new support device be fabricated somewhat differently than the one that had been used on previous cleanings. The change involved removing the right angle support on the base support (see figures 11A and 11B) to allow the base support to make better contact with the surface of the seal table. The problem with the old tool was that the support did not always fit up well with some of the "bosses" on the seal table and allowed the tool to move around during the turning of the handcrank. Figures 12A and 12B depict the tool and the base support in use when the accident occurred (part of the ejected thimble tube D12 is still attached to the upper portion in figure 12B).

CLEANING TOOL UPPER BASE SUPPORT WITH  
PART OF THIMBLE TUBE D-12 STILL ATTACHED  
(AFTER THE INCIDENT)

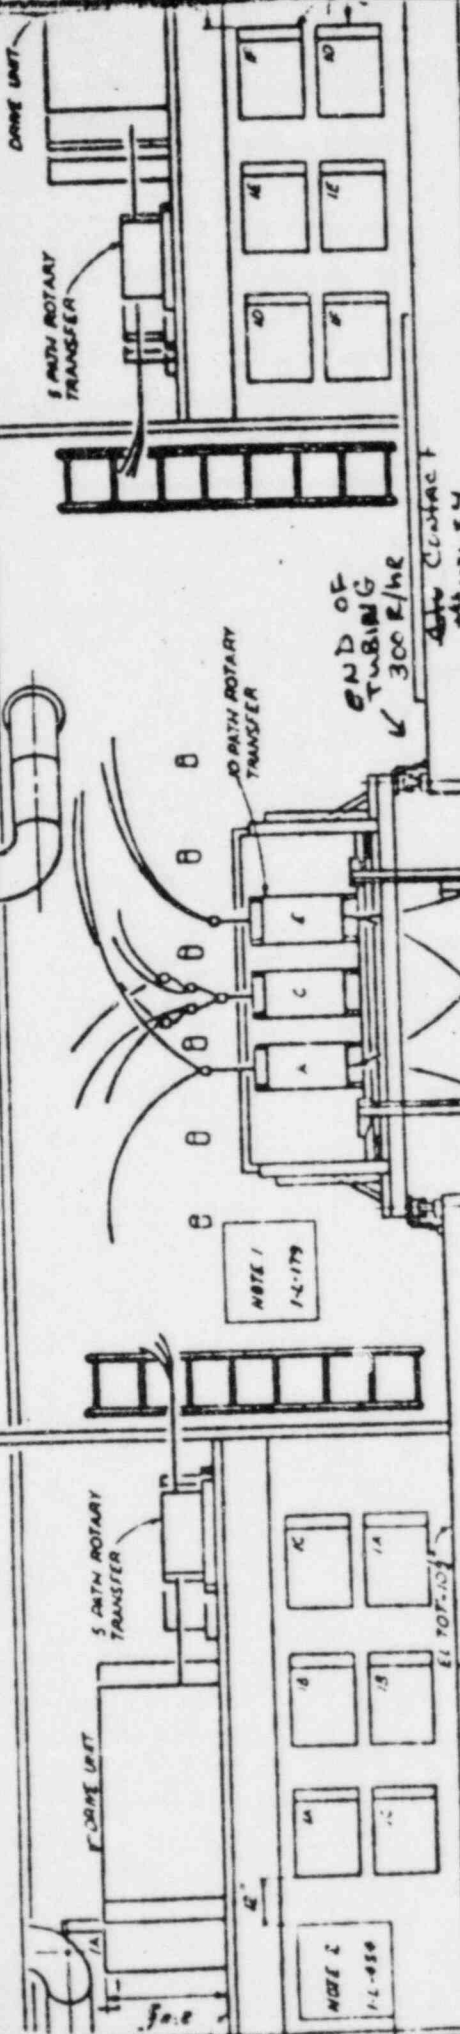
REPRODUCED DRAWING OF EJECTED THIMBLE TUBE  
FIGURE 15

The film was developed and the photographs returned to the plant. From the photographs the plant staff composed a drawing of the thimble tube configuration (see figure 15). An entry into the instrument room was made on April 23 at 1300 by the plant HP section supervisor, an HP shift supervisor, and an HP technician to confirm that the actual configuration was as depicted in the drawing. In addition, contact dose rates were taken at various locations on the ejected thimble tube with a radiation measuring instrument with an extendable radiation detector (see figure 16 for contact dose rates.) They determined that the actual configuration of the thimble tube was in agreement with that depicted in the drawing. The highest radiation dose received (based on high-range dosimeters) during the entry was 0.4 rem.
