U. S. ATOMIC ENERGY COMMISSION
DIRECTORATE OF REGULATORY OPERATIONS

RO Inspection Report No.: 50-219/73-04 Docket No.: 50-219
Licensee: Jersey Central Power & Light Co. License No.: DPR-16
Oyster Creek Priority: _____
_____ Category: C
Location: Forked River, New Jersey

Type of Inspection: Special

Dates of Inspection: March 13, 1973

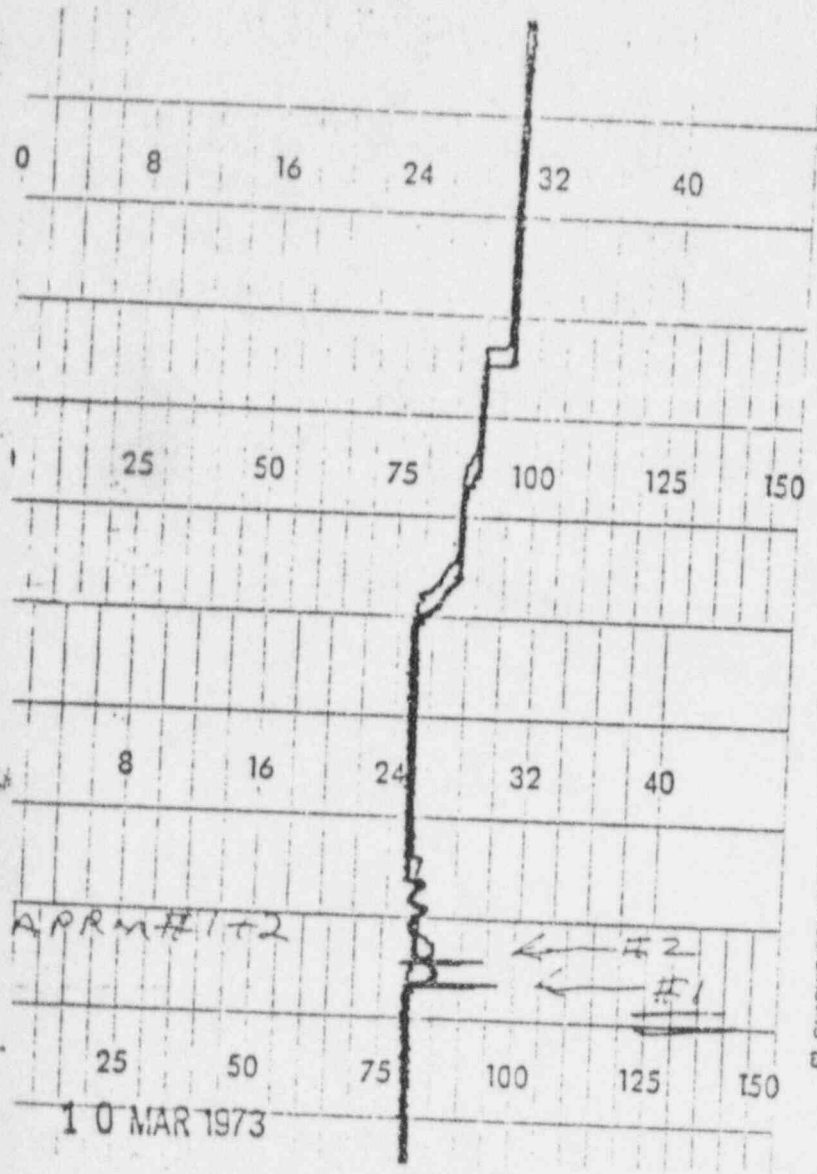
Recirculation Loop Temp.
B Loop

Contrary to the above requirement, the B recirculation pump was started on March 10, 1973 with a temperature differential of 117°F between the coolant within the idle recirculation loop and the reactor coolant temperature.

The B recirculation loop had been removed from service to replace brushes on the MG set that supplies power to the recirculation pump motor at 12:30 AM on March 10, 1973 by closing the pump discharge valve, opening the bypass around the discharge valve, and de-energizing the MG sets. Opening the bypass valve permits backflow through the recirculation loop and normally maintains the coolant temperature in the loop within approximately 10°F of the reactor coolant temperature, however, operating personnel did not consider the effect of continued operation of the cleanup system on idle loop temperature. The clean up system is fed from the B loop, upstream of the suction valve, and discharges to the B loop, downstream of the discharge valve. With the loop discharge valve closed and the bypass valve open, the colder water from the clean up system backflowed through the bypass valve gradually lowering the temperature of the water in the recirculation pump and the temperature of the feedwater to the clean up system. The recorder for the recirculation loop temperature showed that the B loop temperature dropped approximately 117°F while the loop was isolated and increased the same amount when the pump was restarted approximately 2 hours later (Attachment 1). The recorders for the average power range monitors (APRM) in the same quadrant as the B recirculation loop showed that the flux increased approximately 17% when the pump was restarted (Attachments 2 and 3). This flux increase is attributed to the associated increase in recirculation flow when the recirculation pump was restarted, and to a negative moderator temperature coefficient. Rod block alarms were received when the pump was restarted, but the flux increase was less than that required to initiate a high flux scram. The narrow range reactor pressure recorder showed a pressure surge of 4-5 psig at the time the B recirculation pump was restarted.
