U. S. ATOMIC ENERGY COMMISSION
REGION I
DIVISION OF COMPLIANCE

Report of Inspection

CO Report No. 219/70-7

Licensee: JERSEY CENTRAL POWER AND LIGHT COMPANY
Oyster Creek 1
License No. DPR-16
Category C

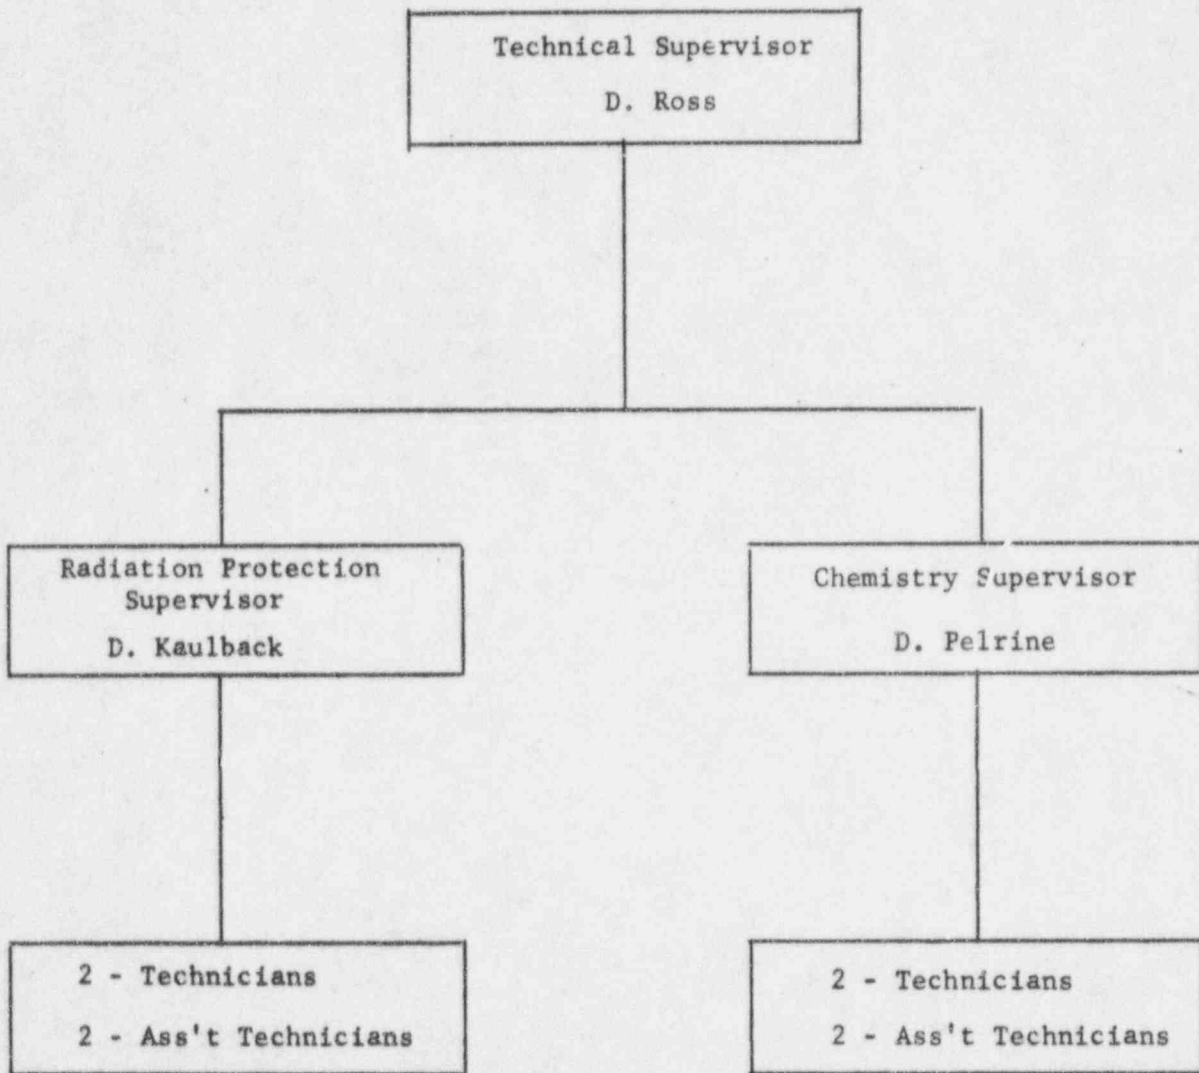
Mr. D. Ross informed the inspector that the present staffing in the Radiation Protection Group and the Chemistry Group is as shown in Figure 1 attached. Mr. Ross reported that Mr. Pelrein, Chemistry Supervisor has had 10 years of radiochemistry experience at KAPL and 8-10 years experience in radiochemistry and chemistry at Industrial Research Laboratories reactor. Mr. Kaulback, Radiation Protection Supervisor, has had prior health physics experience at the Saxton reactor and was present at the OC-1 facility prior to reactor startup.
