JERSEY CENTRAL POWER & LIGHT COMPANY (OYSTER CREEK 1)
CO REPORT NO. 219/70-6

Report of Inspection

CO Report No. 219/70-6

Licensee: JERSEY CENTRAL POWER AND LIGHT COMPANY
Oyster Creek 1
License No. DPR-16
Category C

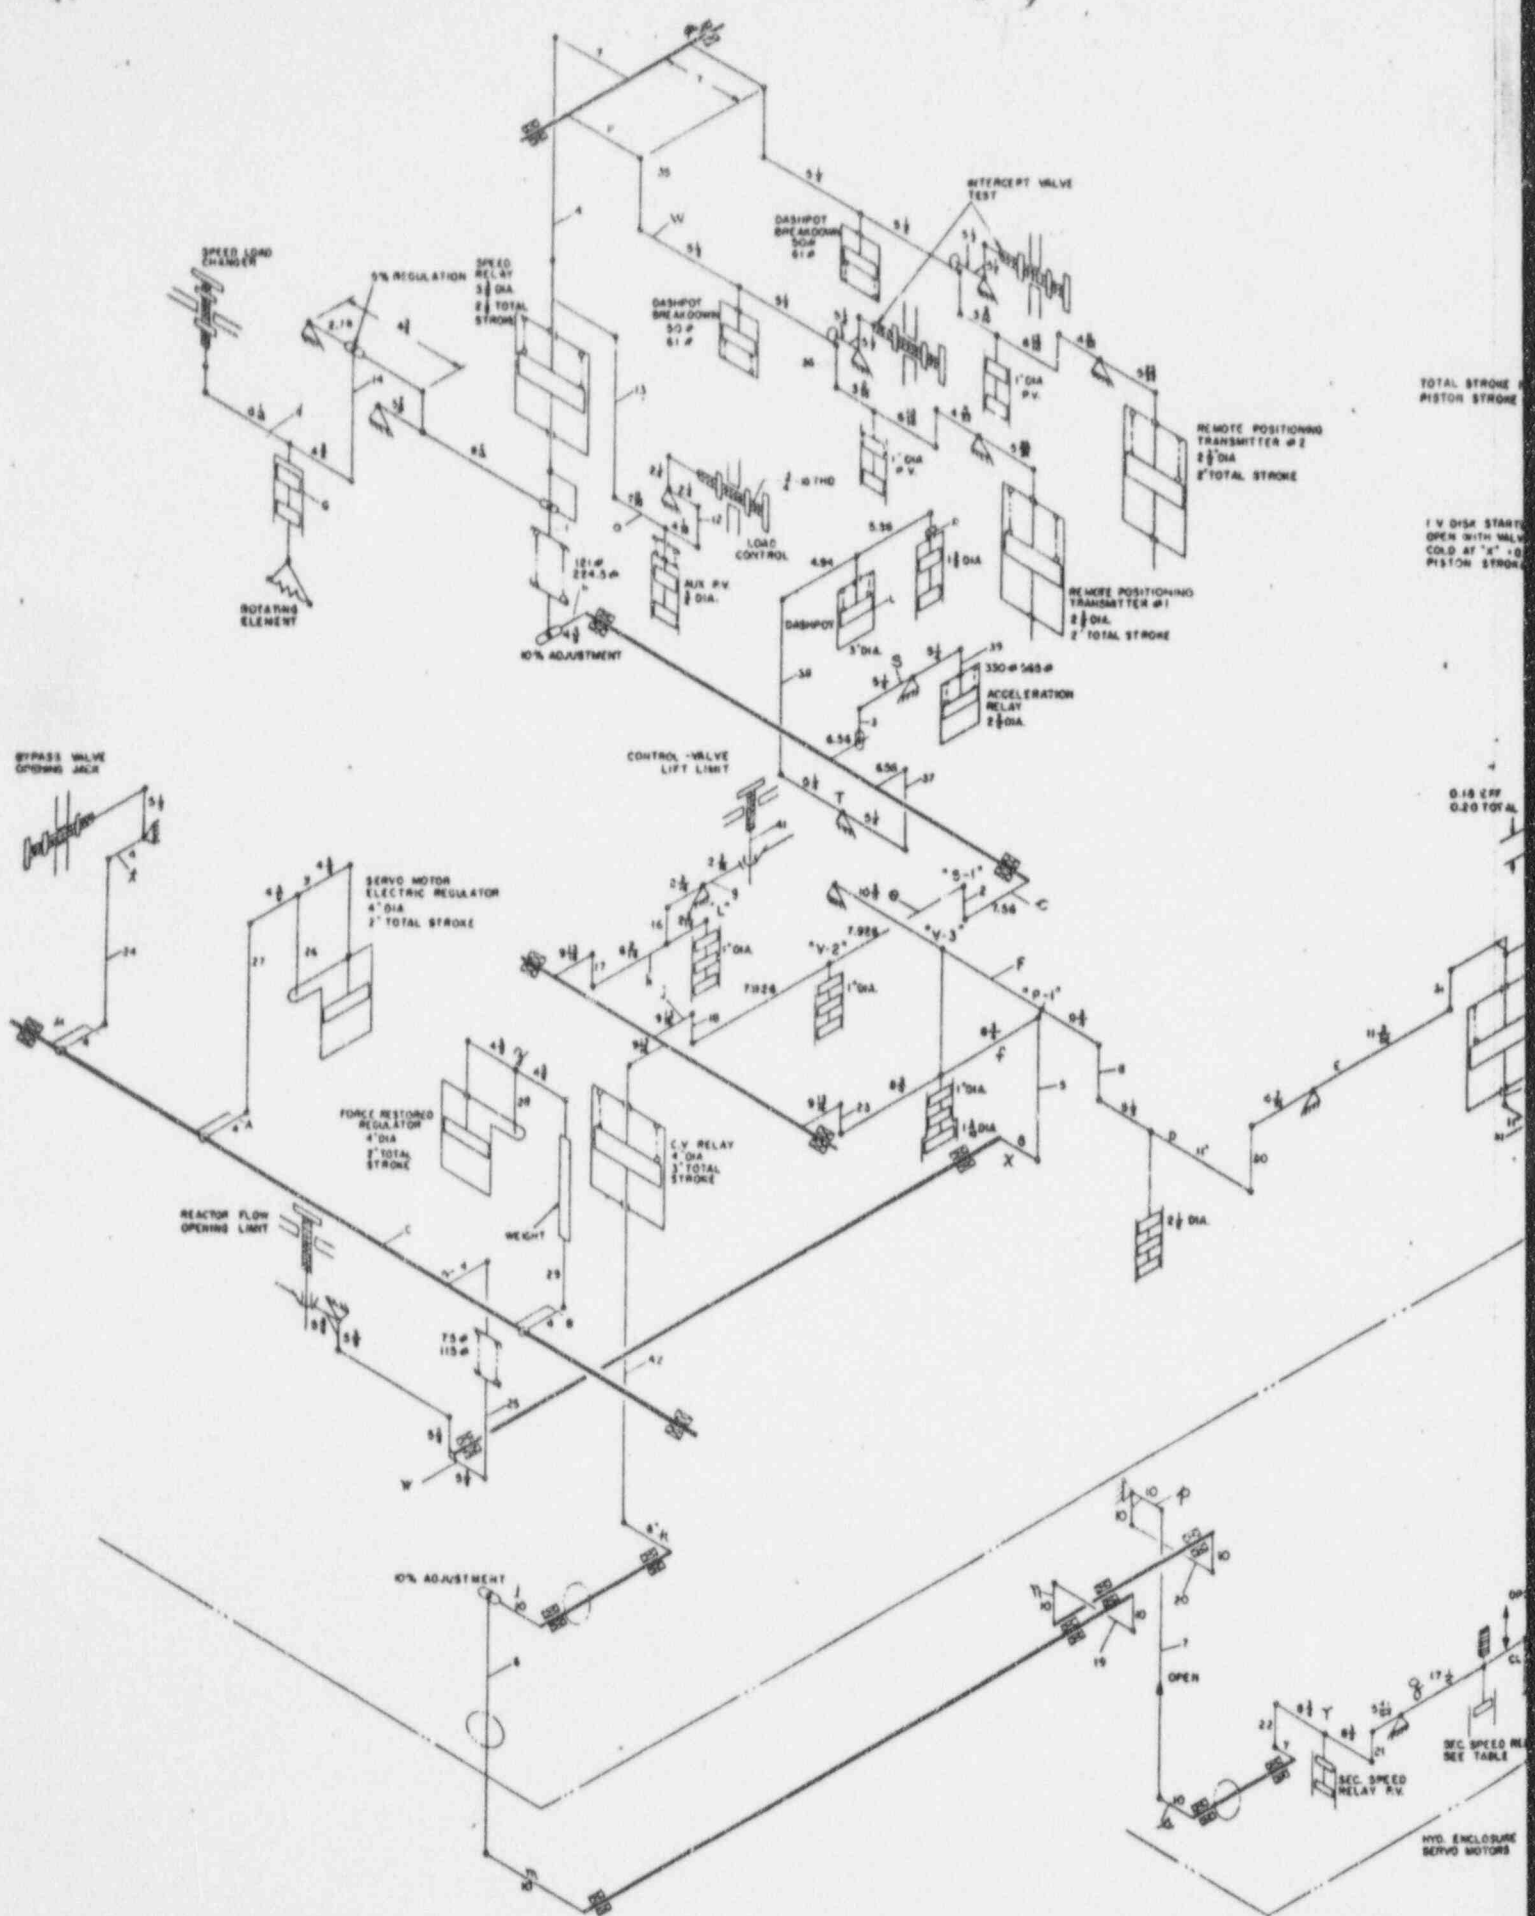
Figure 23'

transmitting motion from the rotating bar and lever on one end to the rotating bar and lever on the other end. The tube is always under a compressive load. The tube is made of aluminum with a diameter around 2-1/2 inches, a wall thickness around 0.150 inches and a length around 12 feet. (These were approximate dimensions obtained during visual inspection). Complete failure of this tube would immobilize the turbine bypass valves but have no effect on the linkage to the turbine inlet valves.

The failure of the aluminum tube representing link 34 in the mechanical linkage to the bypass valves was discussed next with GE. The tube was stated to be perfectly straight but had a crack through the wall around almost 360° of the circumference. The tube is under compression from the linkage system at all times. The highest compressive load occurs when the bypass valves open. The failure was noted to appear as a brittle fracture. There were a couple of marks on the tube but no evidence of deformation. Since aluminum is a ductile material and the tube was straight, it did not appear as if it had failed under axial load or through a bending mode.

FAILED TUBE

The JC - Oyster Creek maintenance personnel have visually checked all of the mechanical linkage in the bypass valve and turbine inlet valve control systems. They also dye checked the links for evidence of any cracks. GE is planning to make a careful review of their mechanical linkage design. They plan to install bigger links or use steel in place of aluminum for added strength. These changes are to be made in the next extended outage.

They also are considering placing covers over the linkage to protect them from inadvertent damage. (They are now open and running between steam pipes below the front standard of the turbine.) The broken tube is to be returned to Schenectady for metallurgical examination in the next shutdown. Hopefully, this will enable them to determine the cause of failure. They have already reviewed their mechanical stress calculations for the linkage. They plan to check these against the strain gage measurements on the broken link. The personnel from the LSTG of GE indicated a report on the results of their evaluation of the linkage failure would be made available to JC and the Compliance inspector would be permitted to review it.
